# Galloway Glens Landscape Partnership

## Can You Dig It?

Data Structure Report

1.2.g High Ground Wrecks and the Royal Observer Corps

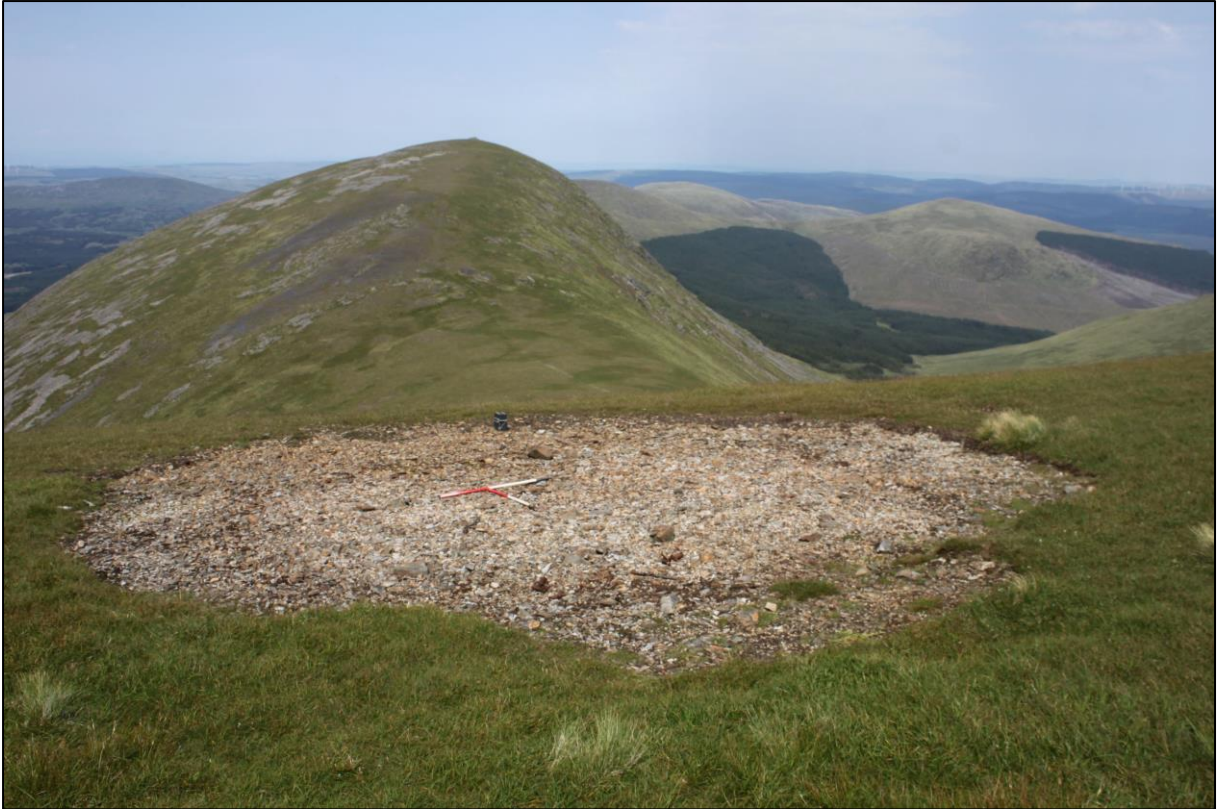
13. The site of the crash at **S3** remained visible as a sub-circular area of exposed bedrock (Figure 2a) measuring 8.8m east to west by 10.8m transversely. The exposed bedrock had been broken into small grey angular stones, which had an average size of 0.1m by 0.15m. The area also contained many fragments of charred aluminium, mostly pipes. A mainly intact battery was located at the northwest corner of the area (Figure 2b).

Figure 2a: General shot of **S3** from the southwest

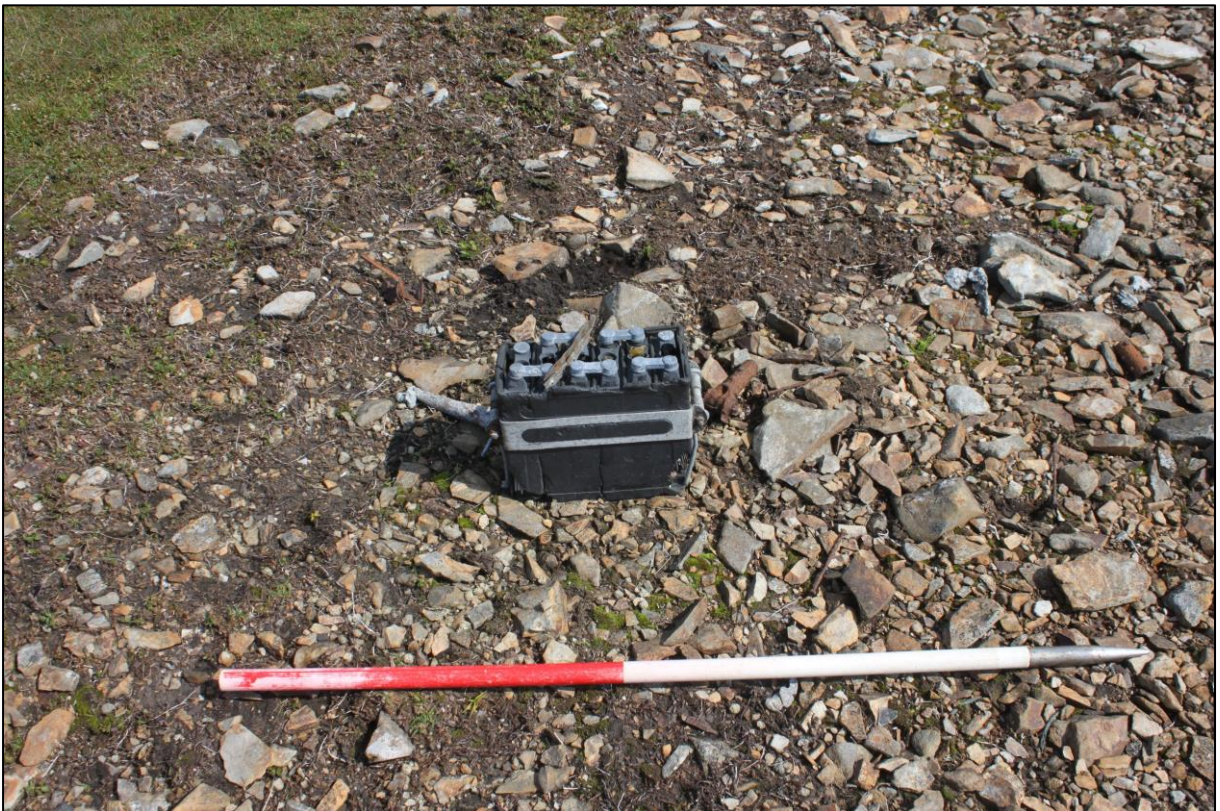
Figure 2b: Detail of **S3** showing battery

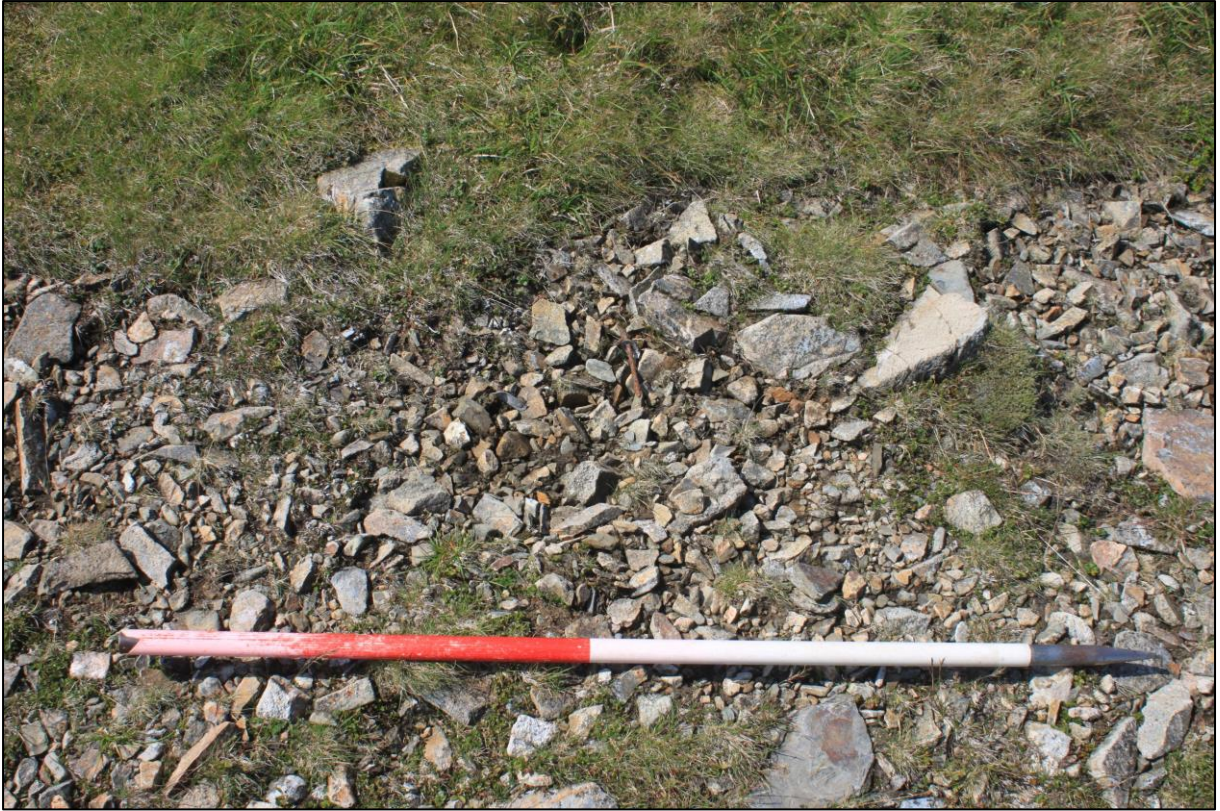
16. As with **S3**, the bedrock within each scar had been broken into smaller angular stones (Figure 3a). Several small metal fragments remained including pipes, screws, a possible tank, fuselage fragments and some timber fragments (Figure 3b).

Figure 3a: Detail of bedrock scars of **S4** from the south

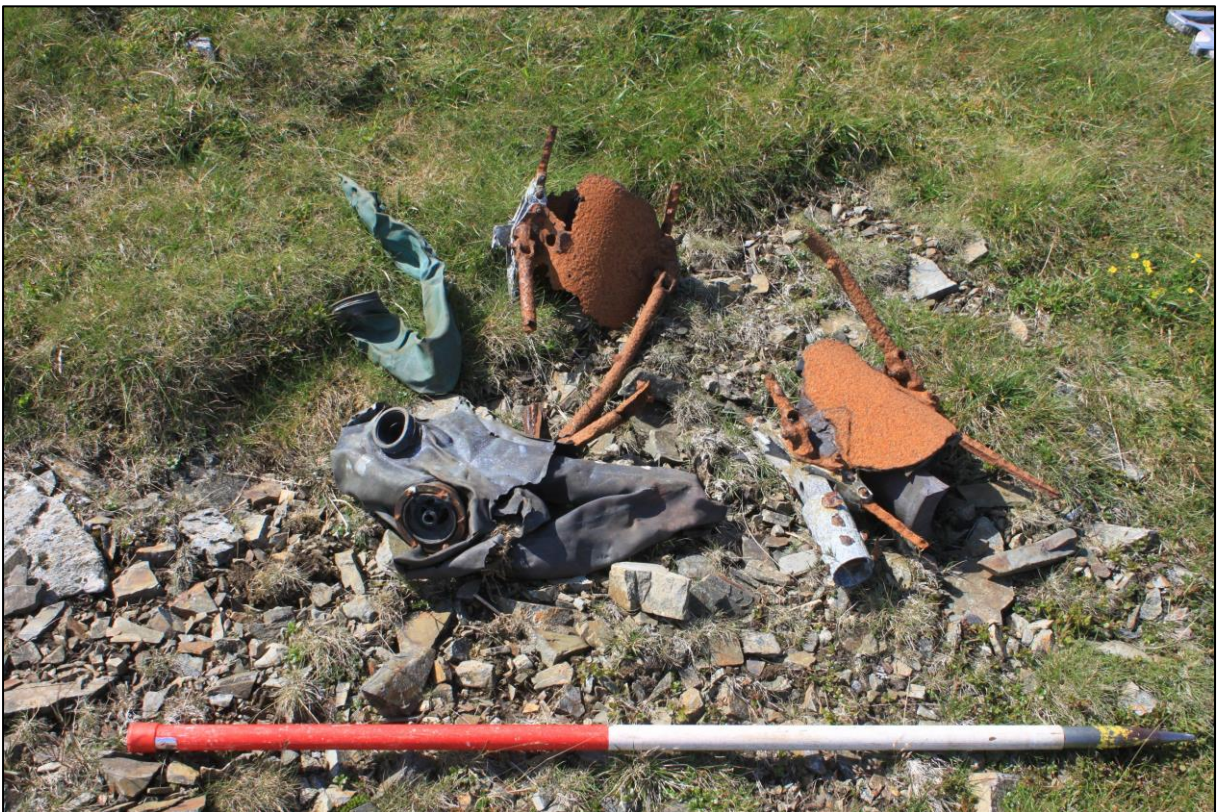
Figure 3b: Detail of wreckage of **S4** from the southeast

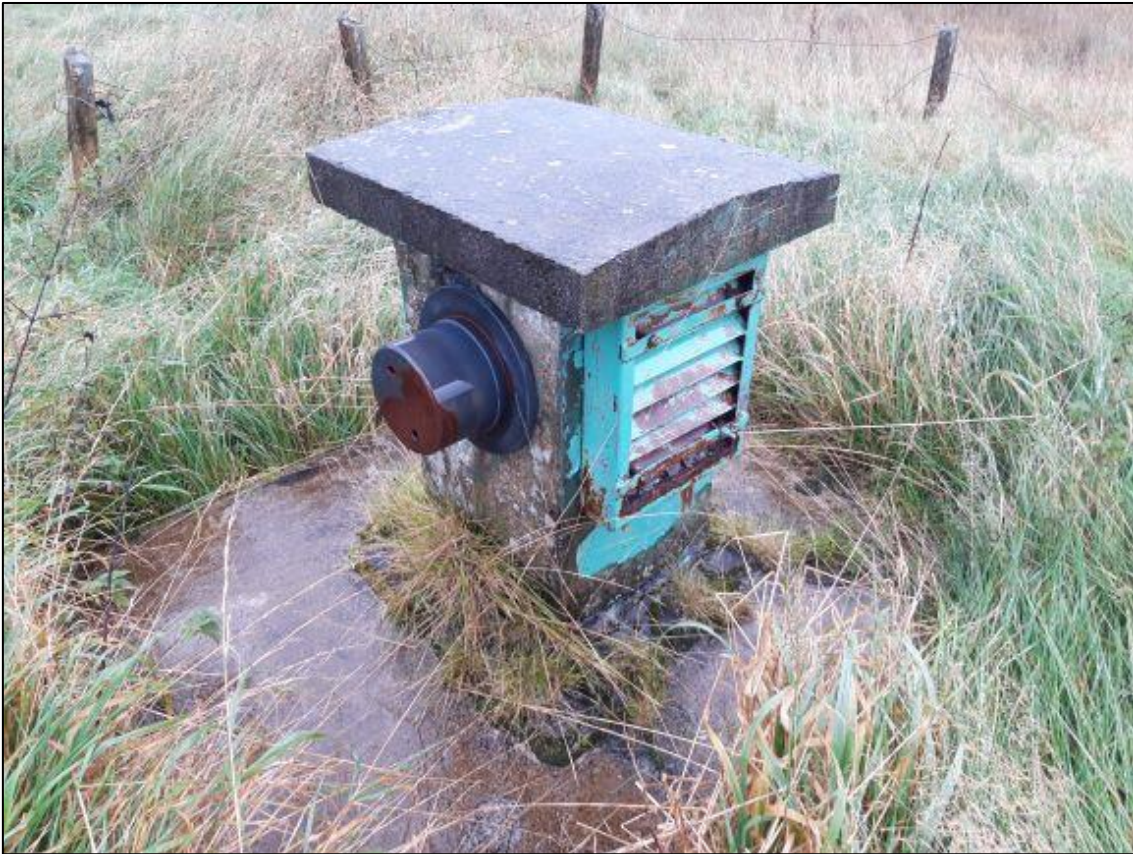
20. At **S7**, a circular black cover has been fitted to the side of the air vent which sits on its own (Figure 4a). This cover has been left unpainted.

Figure 4a: Air vent at **S7** showing the circular black cover attached to its side

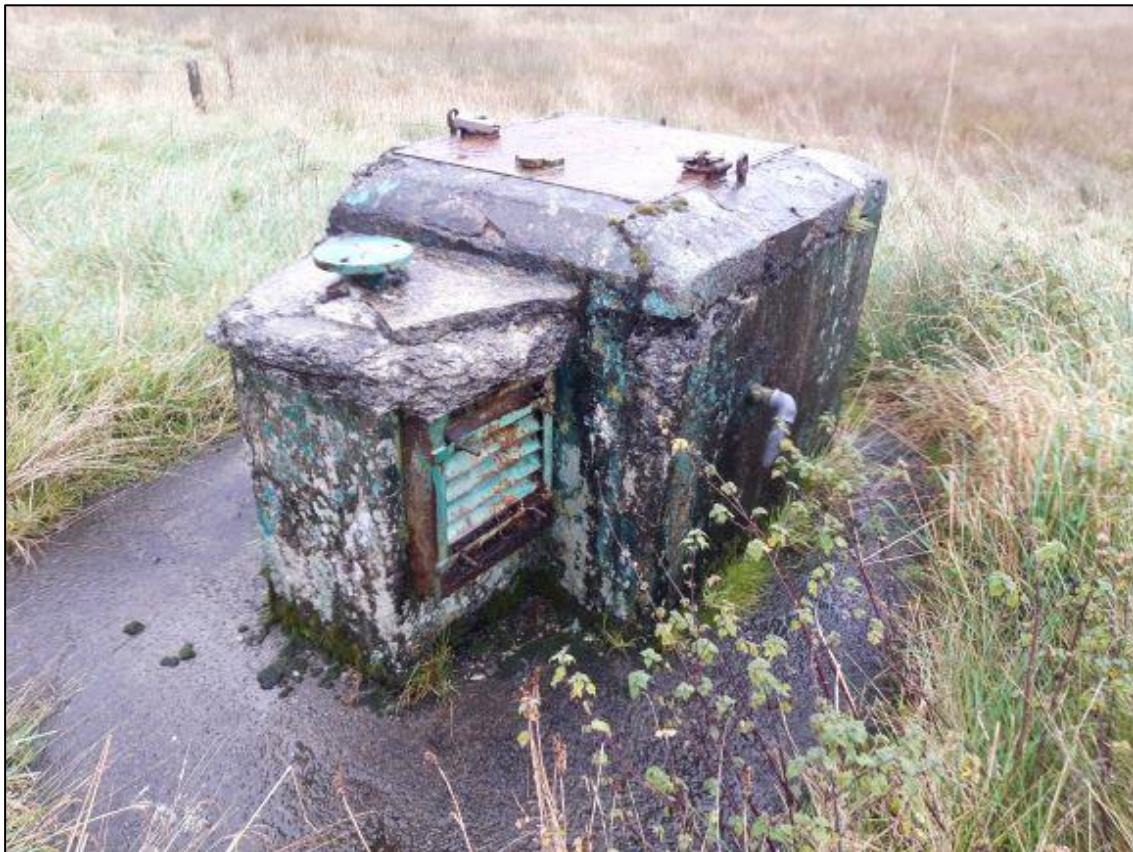
21. The features are in generally good condition with some vegetation growth present, although there is some rust on the metal fixtures and parts of the concrete casing on the access hatch appear to have broken off (Figure 4b).

Figure 4b: Access Hatch at **S7**

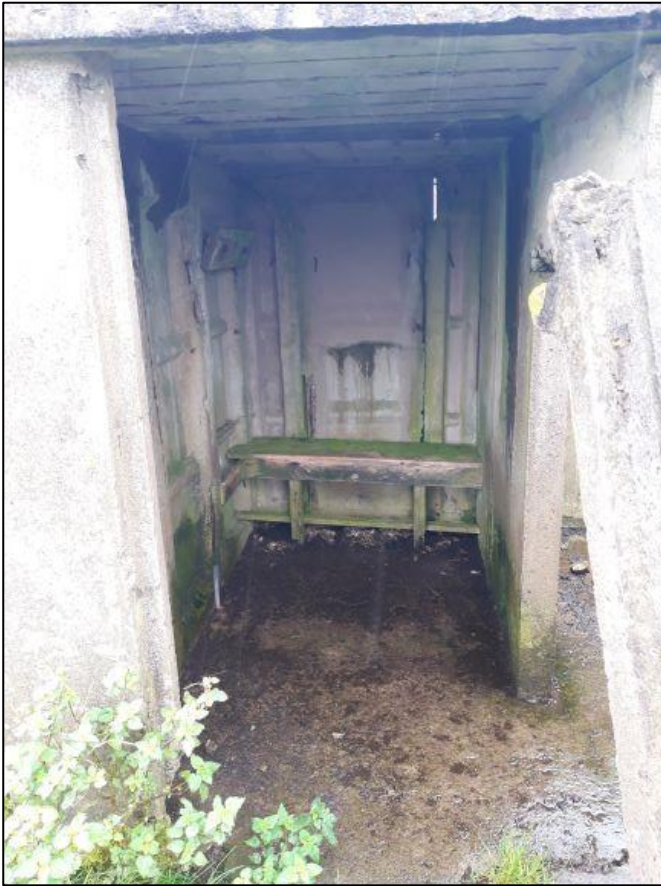
Figure 5a: Interior of roofed chamber in Orlit post at **S8** showing bench along rear wall

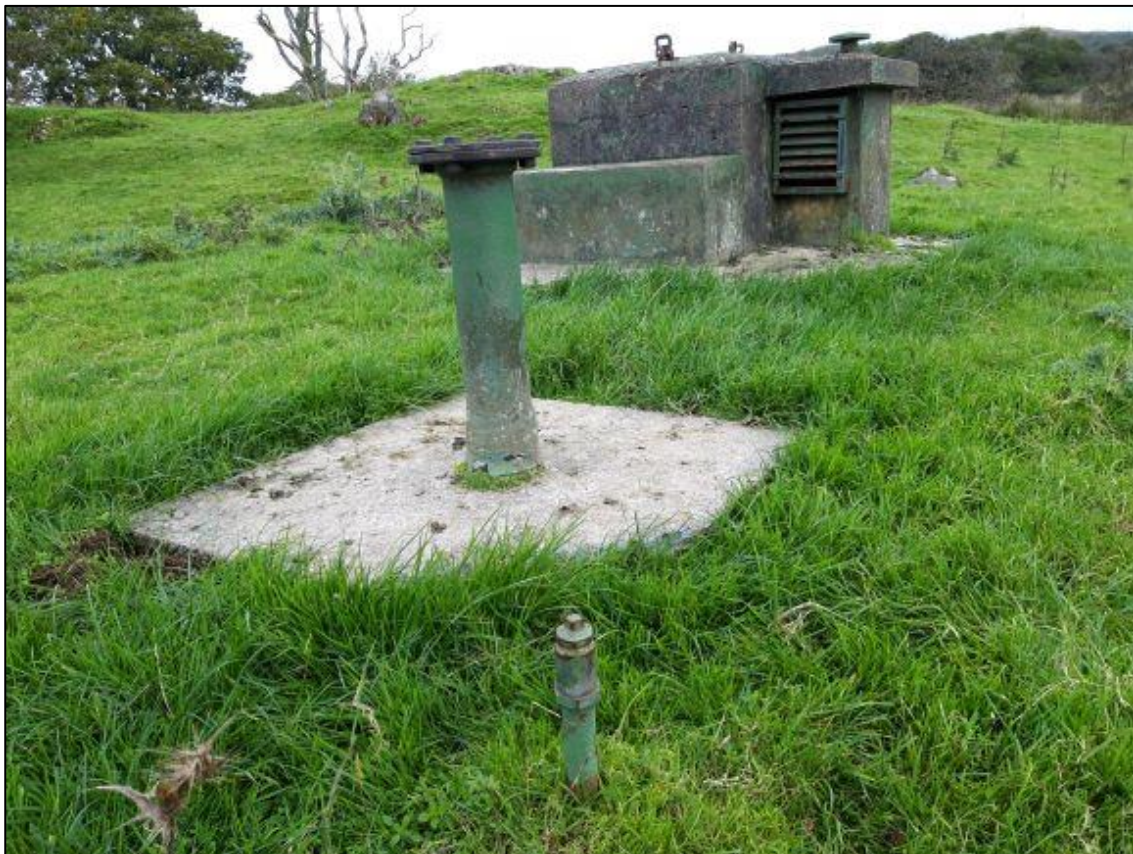
Figure 5b: Pipe (in foreground) possibly for a bomb power indicator baffle plate at **S9**
