Drumcross Farm, Bishopton, Renfrewshire:
Historic Building Recording
Data Structure Report

by Louise Turner

issued 28th April 2010

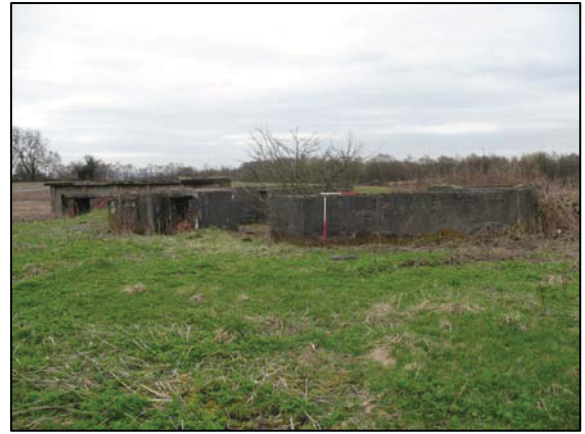
31. The Gun Pits represented the most diagnostic features on the site (Figure 5b). There were four in total, each of identical form. Octagonal on plan and measuring approximately 12.3m across the interior, each provided a level fixed platform for a 4.5 inch gun and storage space for the ammunition and fuzes required to fire it. The internal height of the walls was 1.65m, though in the majority of cases, it was impossible to identify the internal ground level due to later build-up of debris or vegetation growth.

Figure 5b: General view of Gun Pit 2, with Magazine 1 to left

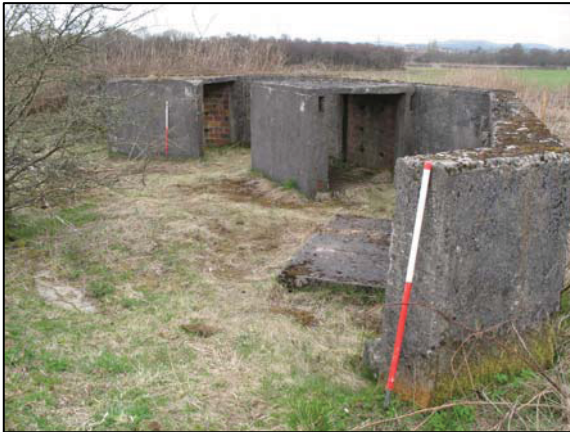
32. The main construction material was concrete, and each Gun Pit had six Ammunition Recesses spaced evenly around the interior walls (Figure 5c). There were two entrances measuring 3.6m wide on opposing sides each replacing one side of the octagon, with the axis through the entrances always orientated on the central Command Post. Originally, these entrances would have been fitted with gates to control access. The Holdfast for the emplaced gun would have been central to the Gun Pit.

Figure 5c: Interior of Gun Pit 2

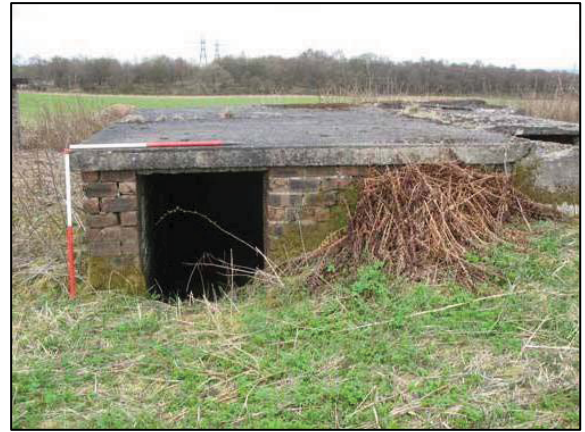
33. One brick-built structure with concrete slab roof abutted the exterior wall of each of Gun Pits 1, 2 and 3 (Figure 5d). All three structures observed were placed on the exterior of the middle section of one of the stretches of the octagonal wall (see Figure 3). They were not consistently placed on the same side of the Gun Pit.

Figure 5d: View of External Refuge (Gun Pit 2)

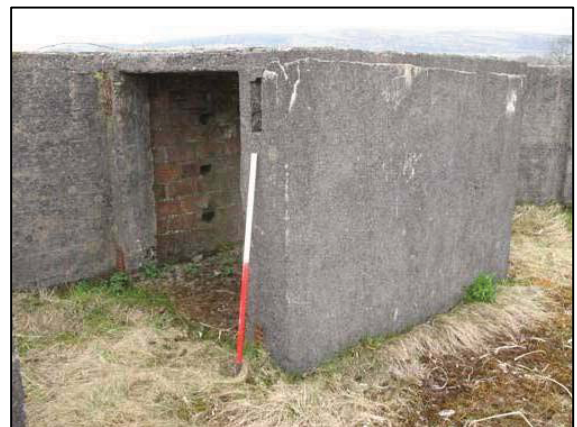
Figure 5f: Type 2 Ammunition Recess (Gun Pit 2)

35. The central Ammunition Recesses were, however, more robust (Figure 5f). The supporting wall thickness here was 0.33m, with ventilated bricks set into the concrete at the upper and lower ends of each stanchion (Figure 6a). It is possible that these more robust structures functioned as shelters for the gun crew, one allowing on-site gun maintenance to take place (the 'limber gunner's shelter') the other for the on-site personnel (Brown et. al. 1996) though the presence of sockets within the brick lining of all six recesses (Figure 6b) suggests that they could all, if necessary, have had racking inserted for the storage of ammunition and fuzes.

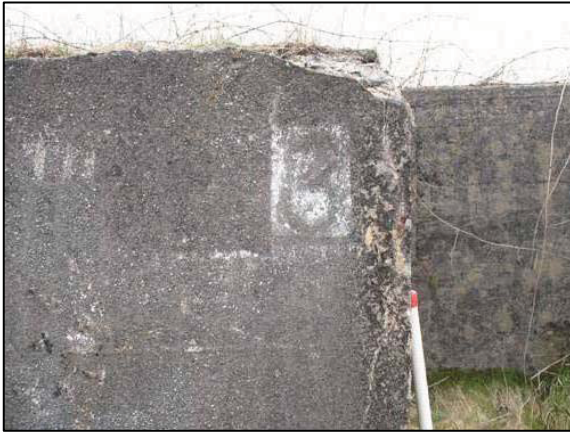
Figure 6c: Numbered Ammunition Recess (Gun Pit 2)

36. Each Ammunition Recess would have been fitted with doors set tangentially to the wall of the Gun Pit and each appears to have been individually numbered (Figure 6c). Original fittings still survived in places (Figure 6d).

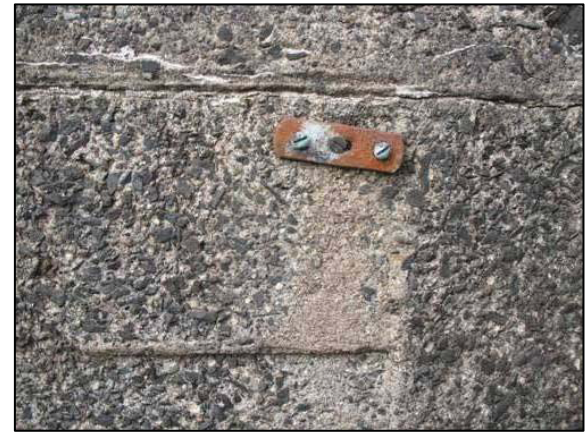
Figure 5d: 6d: *In Situ* fitting (Gun Pit 4)

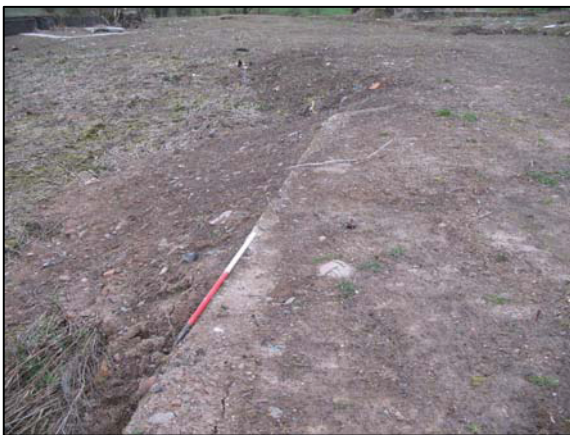
Figure 6e: Gun Pit 1; Outline of Structure exposed through bunding, NW Side

37. Gun Pit 1 had been almost completely engulfed beneath a modern bund, and as a result it was difficult to establish its condition. The outline of its external walls was, however visible over the western half of its extent, which suggested that at least some of the structure, perhaps representing half of its original extent, remained intact beneath the bund (Figures 6e and f), and even where traces no longer remain visible, it is likely that elements of the structure still survive as buried remains (Anderson pers. comm.).

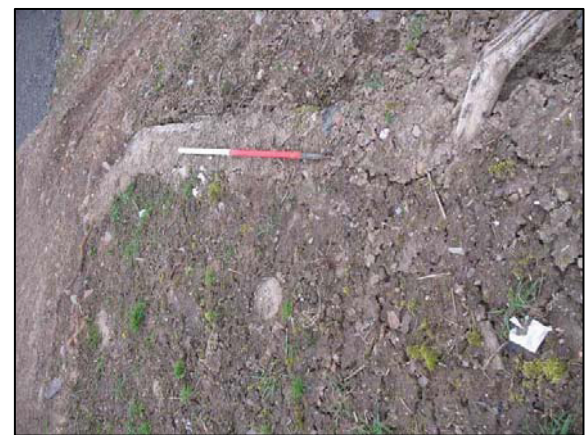
Figure 6f: Gun Pit 1; Outline of Structure - rotated

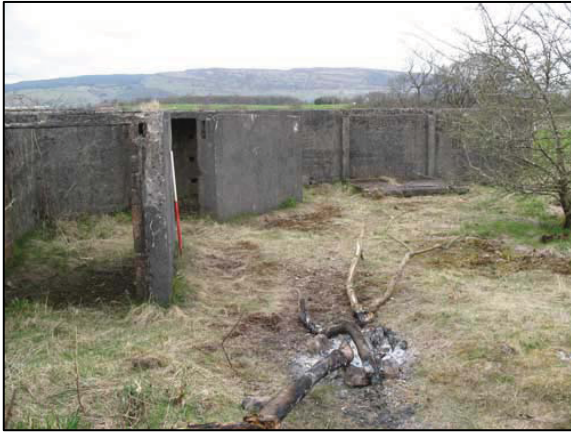
40. Gun Pit 2 lay outwith the extent of the modern bunding, and survived in good condition (for images, see Figures 5b-f & 6a-c). Its interior, though grassed over for much of its extent, was relatively free of soil-buildup with the original concrete base visible. The central holdfast, upon which the gun would have been mounted, could not, however, be identified, as a large tree had grown up in the central area, obscuring the original surface (Figure 7a).

Figure 7a: Gun Pit 2; View of Interior, with Tree to right of image

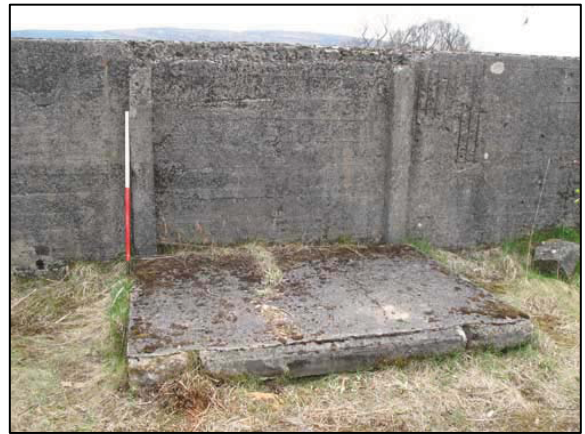
41. Five of the six Ammunition Recesses had survived in good condition, some with painted numbers still faintly visible. The sixth example had collapsed (Figure 7b). Its fallen concrete slab roof remained, but there was no trace of the brick and concrete walling that had once supported it. Judging from the way in which the roof lay flush against the basal slab, the wall had been removed perhaps through an initial attempt at demolition, in the period following the decommissioning of the site.

Figure 7b: Gun Pit 2; Collapsed Ammunition Recess

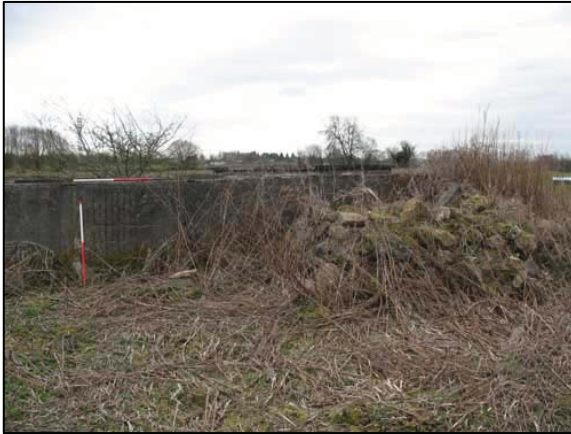
42. Though the interior of Gun Pit 2 was clear of soil buildup, the external walls were partially buried by banks of earth and rubble. Again, though blast banks would have been an integral part of the original layout, there was no indication that these 'earthworks' (which reached a height of 1m above the internal level of the gun pit) were part of the original design. They lacked any form or structure, and evidence of concrete hardstanding, exposed between Gun Pits 1 and 2 and Magazine 1, suggested that the ground level had been raised between 0.3 and 0.5m across much of the western portion of the Gun Park. A heap of rubble and masonry which abutted the NW side of Gun Pit 2 suggested that the site had been used as a rubbish dump for many years (Figure 7c).

Figure 7c: Dumped Masonry on west side of Gun Pit 2

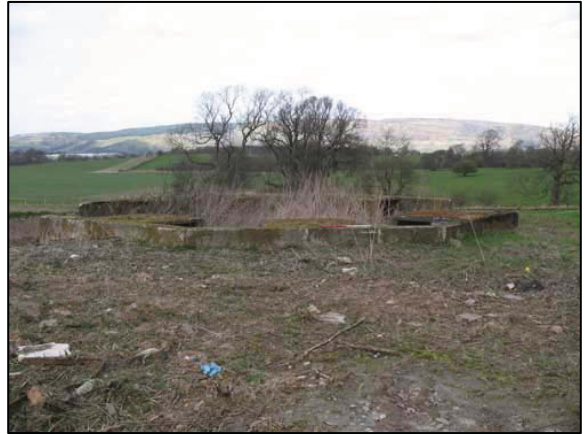
Figure 7d: Gun Pit 3, General View

43. Lying to the east of the recent access road, Gun Pit 3 had been largely obscured by similar dumped material, which obscured its external wall surfaces to a depth of 1.4m over much of their extent (Figure 7d). However, in this instance, the interior had also been subject to partial infilling to a depth of 0.4m and it was now also badly overgrown (Figure 7e). The original floor levels, and the central holdfast, could therefore not be identified.

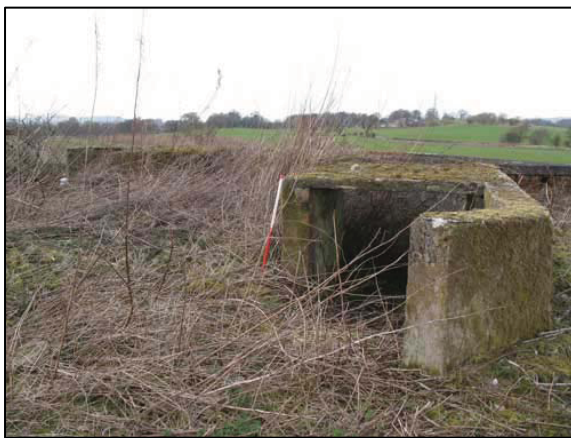
Figure 7e: Gun Pit 3, Soil Buildup in Interior

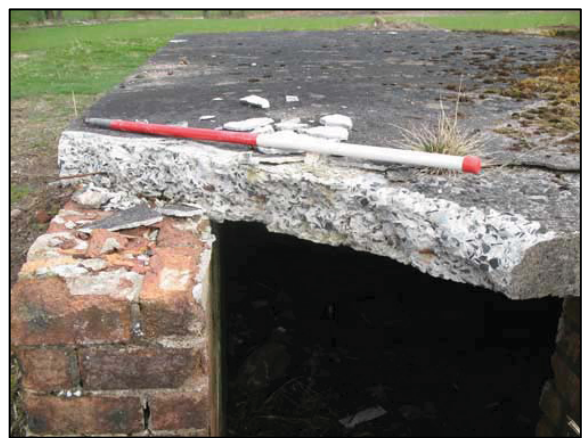
Figure 7f: Gun Pit 3, Recent damage to roof of Refuge

44. All six Ammunition Recesses remained in good condition, and they matched those of Gun Pit 2 exactly, with the two lighter 'Type 1' recesses flanking a more substantial central example ('Type 2') on either external wall. No numbering could be identified on any of these examples. The brick external refuge was also present, though it had been virtually buried as a result of modern large-scale dumping and its roof appeared to have suffered damage in the very recent past (Figure 7f).

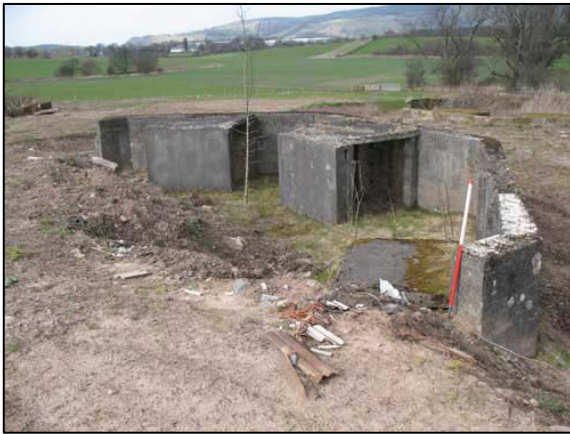
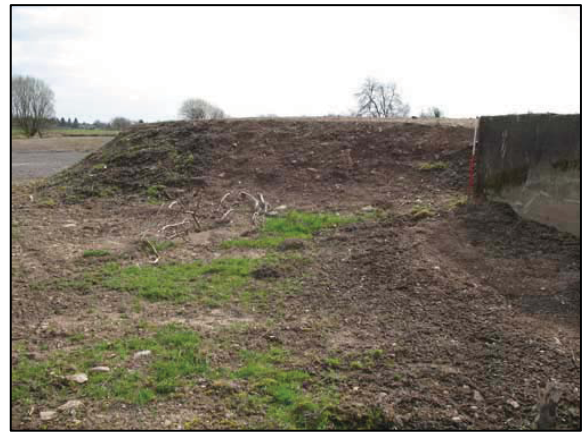
45. The last of the gun pits, Gun Pit 4, had, like Gun Pit 1, been partially buried beneath a modern bund (Figures 8 a & b). Roughly half of its original extant had been obscured in this way, though in this instance, it was unclear to what extent the external wall still survived beneath the bund. Discussion with the client suggested once again, however, that elements of the structure would still survive as upstanding, though now buried, remains (Anderson, pers. comm.).

Figure 8a: Gun Pit 4, View From South

Figure 8b: Gun Pit 4, View From E

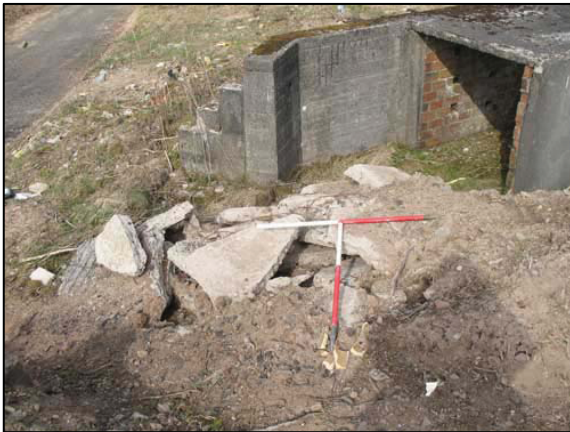
46. Only one small stretch remained visible at the surface of the bund, and this lay close to the north-west edge. Where the structure remained clear of the bund, it remained in reasonably good condition, though one of the ammunition recesses had collapsed (c.f. Gun Pit 2). There was, however, no sign of the external brick-built refuge structure and it seems likely in this particular instance that this feature has now been entirely removed. Fragments of concrete slab, recently broken, lay at the edges of the bund (Figure 8c), suggesting that at least some of the Gun Pit had been demolished during the earth-moving process.

Figure 8c: Gun Pit 4, Concrete fragments on edge of Bund

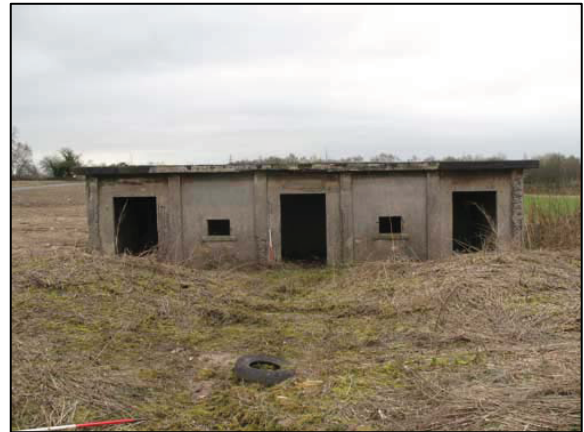
49. The first of the two magazines, Magazine 1, serviced Gun Pits 1 and 2 and was located at the south-west corner of the site (Figure 8d). According to Brown *et. al.*, these structures were often semi-sunken, or if this proved impractical because the water table was too high, they would be protected by a 3m high blast wall. No such feature was identified here, which probably reflects disturbance or partial demolition which took place after the site fell out of use.

Figure 8d: Magazine 1, N-Facing Elevation

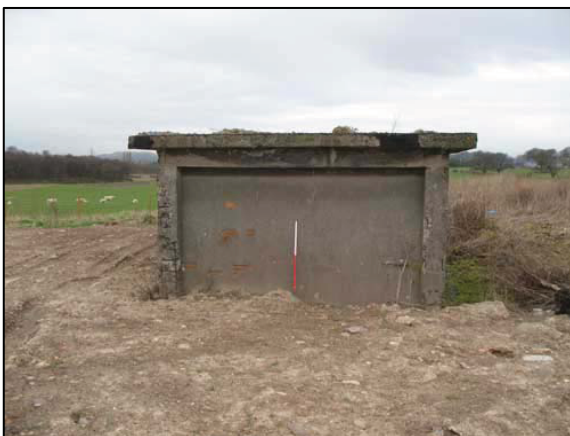
50. Recent large-scale earth-moving activities on the site had resulted in the creation of a substantial bund to the south and east of the structure, burying it to a depth of 0.4m in places (Figure 8e). The original WWII ground level could only be established through the exposure of a small section of concrete hardstanding immediately to the north of the structure, between the Magazine and Gun Pits 1 and 2.

Figure 8e: Magazine 1, Recent Bunding

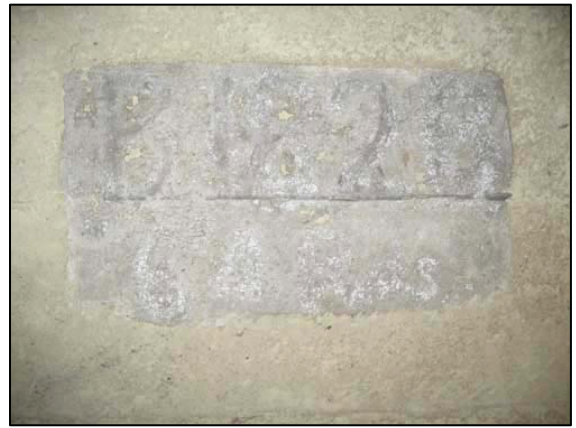
Figure 9b: Magazine 1 - Original Signage?

51. The Magazine survived in good condition. The structure was built of concrete stanchions infilled with brick, and roofed with concrete, and was subdivided into five bays of roughly equal size (roughly 1.96m wide). A corridor measuring roughly 1.2m wide ran the length of the structure, allowing access to each bay (Figure 8f). Bays 1, 3 and 5 had a circular vent in the roof, and each bay had originally been numbered (Figure 9a). There were additional examples of potential original signage in places, but their details could not be established (Figure 9b).

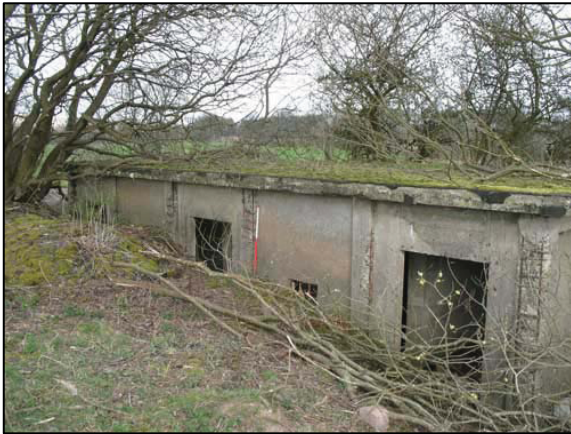
Figure 9c: Magazine 2, General View

52. Magazine 2 survived as a semi-sunken structure, which suggested that it may once have been surrounded by a blast bank (Figure 9c). It was evident, however, that this original banking had been later augmented by rubbish dumped upon the site. As a result of this additional material, access to all three doorways was restricted. The presence of a mature tree upon this bank of upcast earth suggests that the accumulation of this later material may have started not long after the site was abandoned.

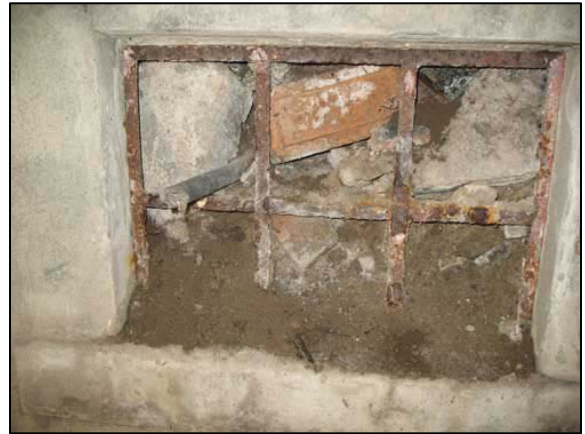
Figure 9d: Magazine 2, *in situ* window frame

53. Magazine 2 had some evidence of decay in terms of its structure, with the surface of the concrete eroded in places and sections of the internal reinforcing rods exposed. However, it still retained evidence for internal fixtures and fittings that were absent in Magazine 1. Cast iron window frames still remained in place in both windows (Figure 9d), and a stretch of ducting remained *in situ* in the west wall (Figure 9e).

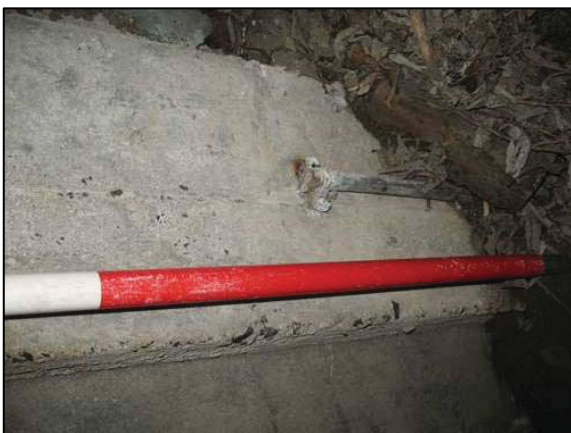
Figure 9e: Magazine 2, *in situ* Fitting - rotated

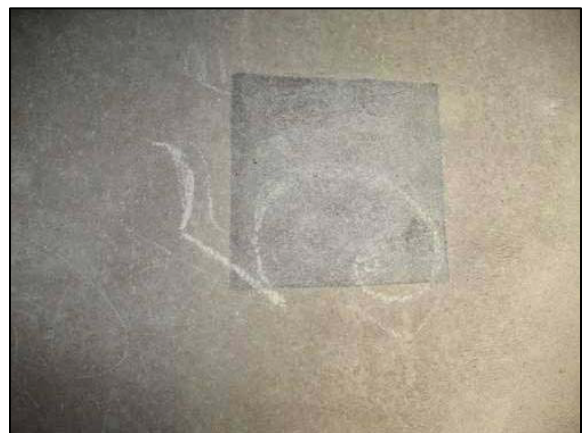
Figure 9f: Magazine 2, Numbered Bay – rotated

54. Once again, the bays had been numbered, and although the form of the numerals was broadly similar, there were noticeable differences between the two styles employed (Figure 9f).

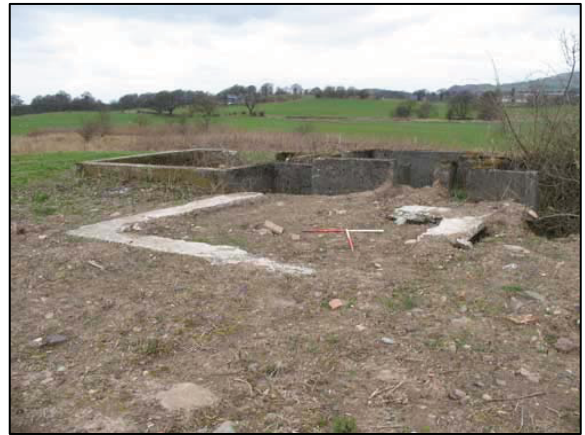
Figure 11d: Command Post, ruined footings to south

62. Footings of a further two rectangular rooms could be identified to the SSE (Figure 11d) and ENE. Much of the original extent of this structure had, however, been obscured as a result of recent earth-moving activities. These probably covered over additional elements – voids could be glimpsed in the vicinity of the visible structure, indicating that additional rooms survived beneath the bunding, but the character and extent of these could not be determined.
