BAA Glasgow HIAL Project Archaeological Mitigation

Data Structure Report

issued 5th November 2010

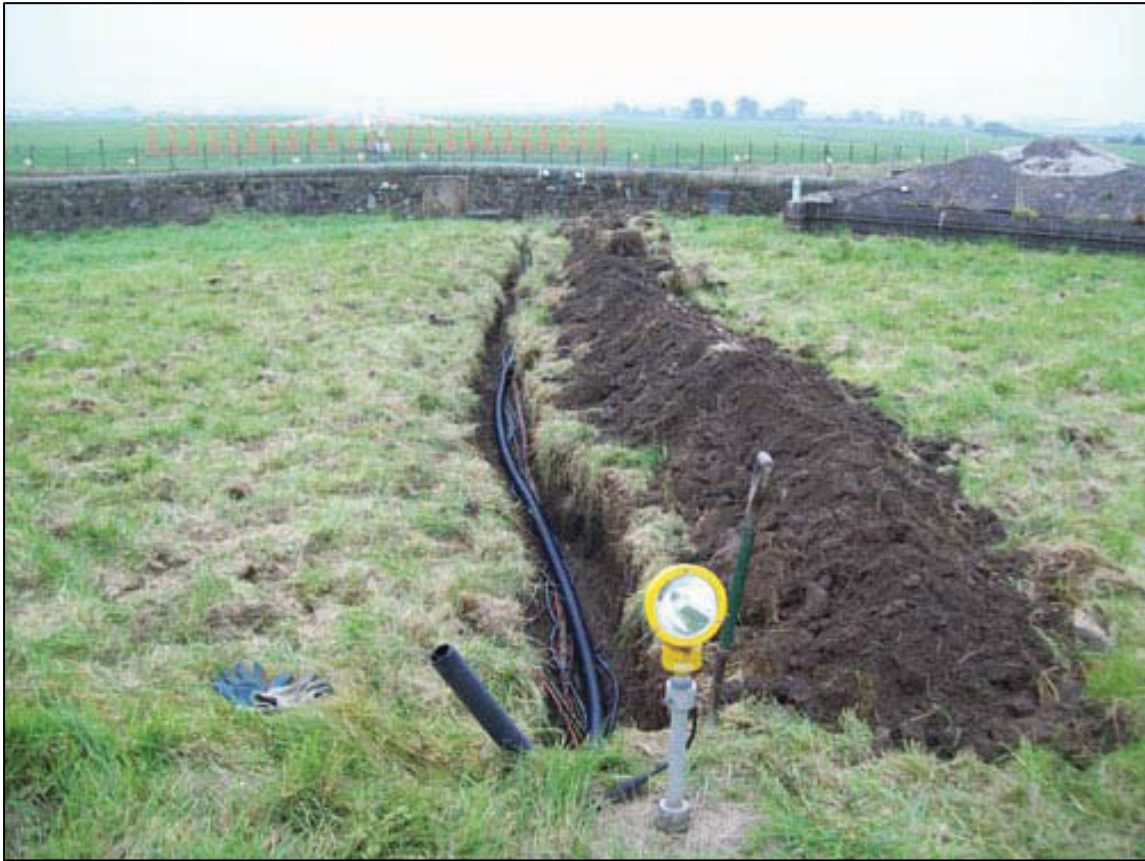
Figure 2a: Excavation in graveyard (looking south-west)

24. In keeping with the terms of the Method Statement (Rees 2010) the tracks excavated were hand cleaned and investigated for significant archaeological remains. In neither track was significant archaeology located. Topsoil (001) and turf was typically evident for the first 150mm depth of the excavation and for the remainder the fill was the backfill of the original cut to place the cables (002). Only modern, 20th century, material was recovered from (002) within the graveyard. This material included rusted metal tools, a Buckfast bottle and other rubbish. No significant archaeological remains were observed in the section and it is likely that the original disturbance for the track was wider than that created by this work.

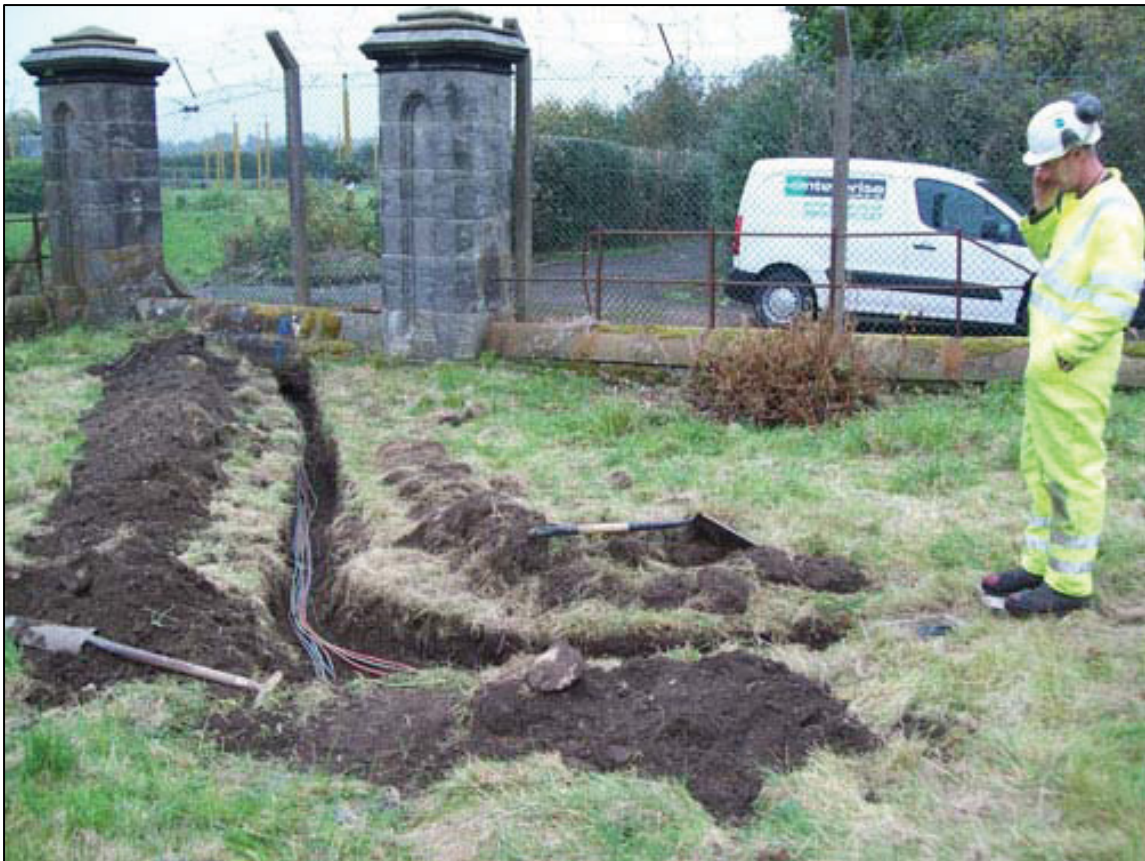
Figure 2b: Excavation in graveyard (looking north-east)

21. In keeping with the terms of the Method Statement (Rees 2010) all excavation work within the graveyard was carried out by hand. Prior to work commencing the two existing crossbars were supplied by eight cables running north-east to south-west across the graveyard and wired to the light bases via the transformer boxes (Figure 2a). It was the intention of this work to supply the existing bases from the closest corner of the graveyard and miss out the central section of cable. This would be accomplished by following the lines of the existing cables from the north-east and south-west corners respectively (Figure 2b).

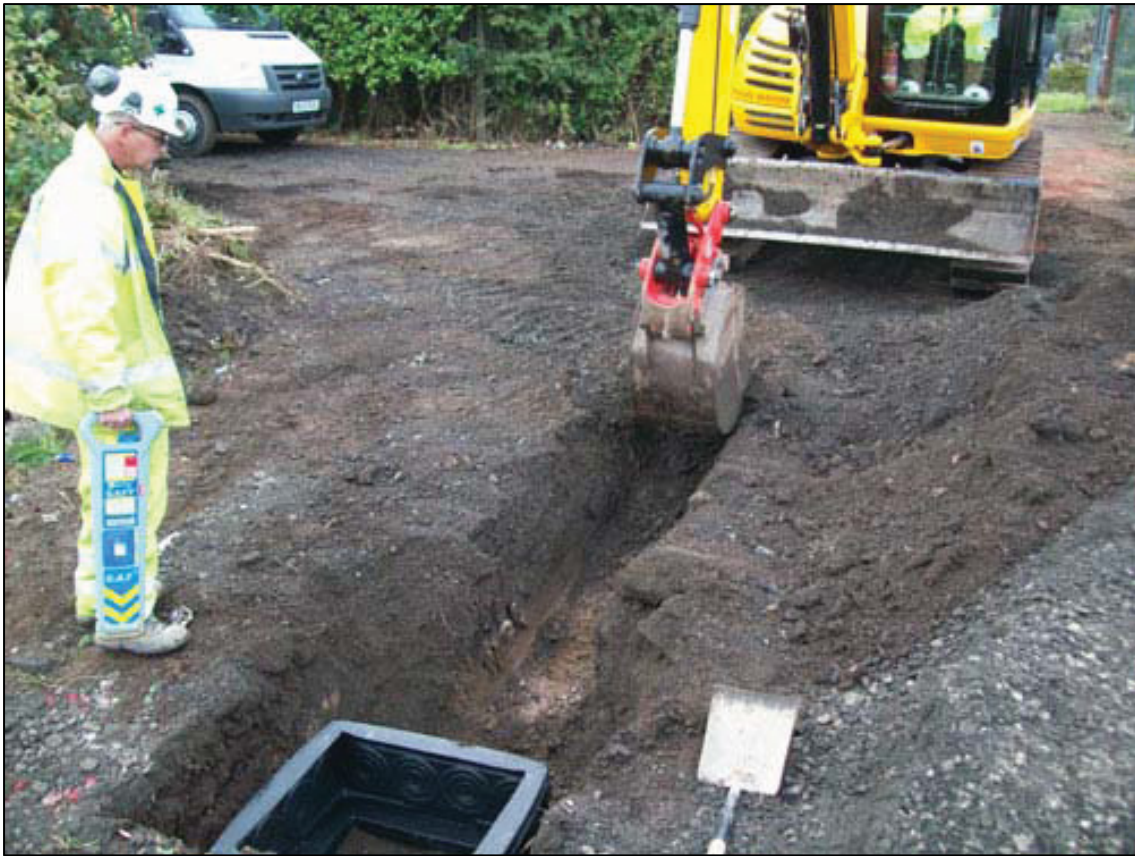
Figure 3a: Inspection hatch and track NE of graveyard

27. For the most part this excavation work was carried out by a small 360 excavator or a JCB 3cx depending on the requirements of the work (Figure 3a). Typically the track excavated was 600mm deep and 400mm wide permitting the placement of two plastic ducts in pea-gravel and with warning tape on top before being backfilled. The track was backfilled as work progressed so at no point during the works was the entire area open to inspection (Figure 3b). Within the scheduled area five inspection hatches with manhole covers were concreted into place along this line. This typically involved excavation of a 900mm box from the placement of the inspection hatch.

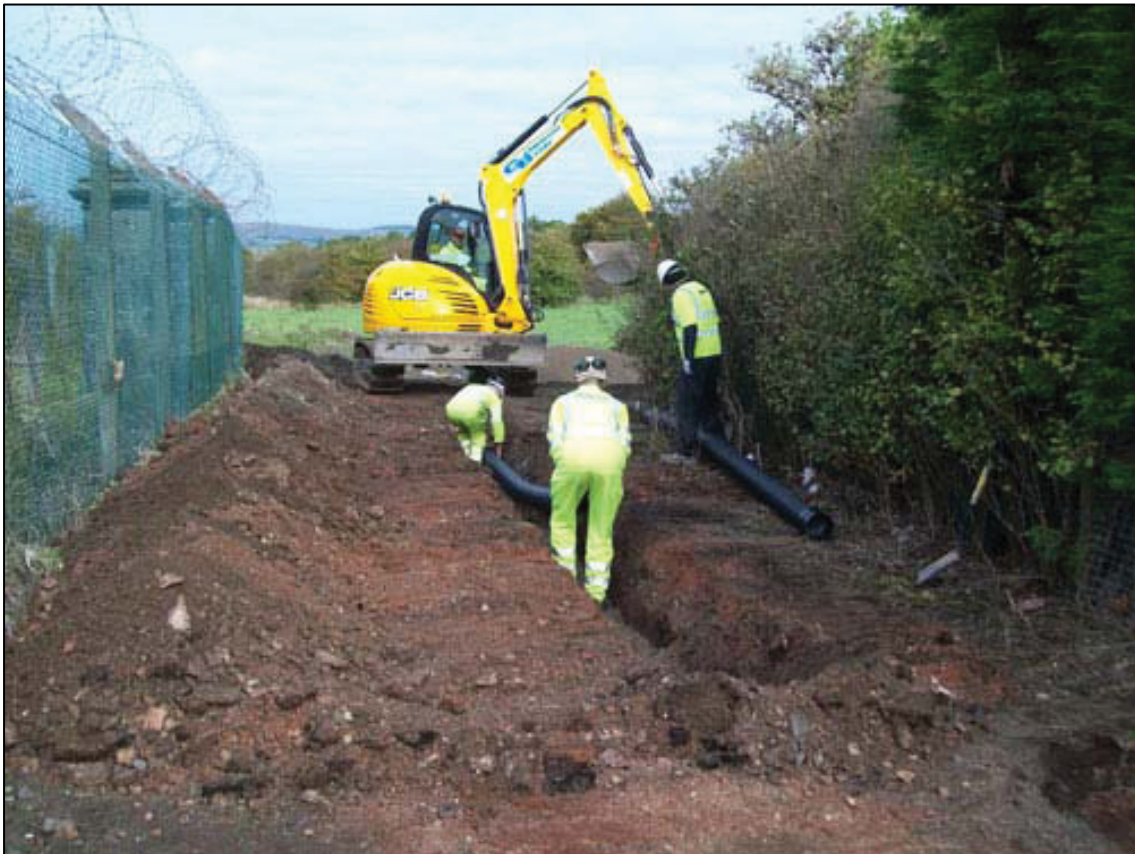
Figure 3b: Track to E of graveyard

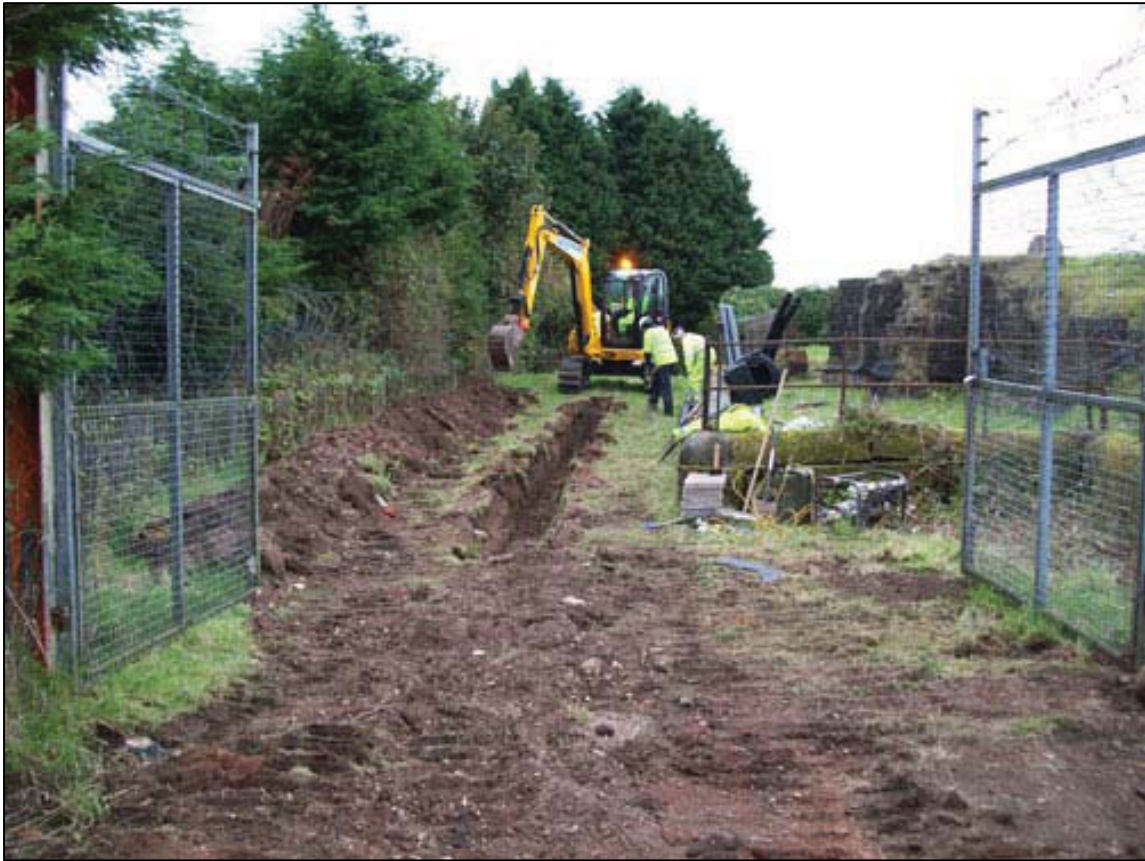
Figure 5a: Track to E of graveyard

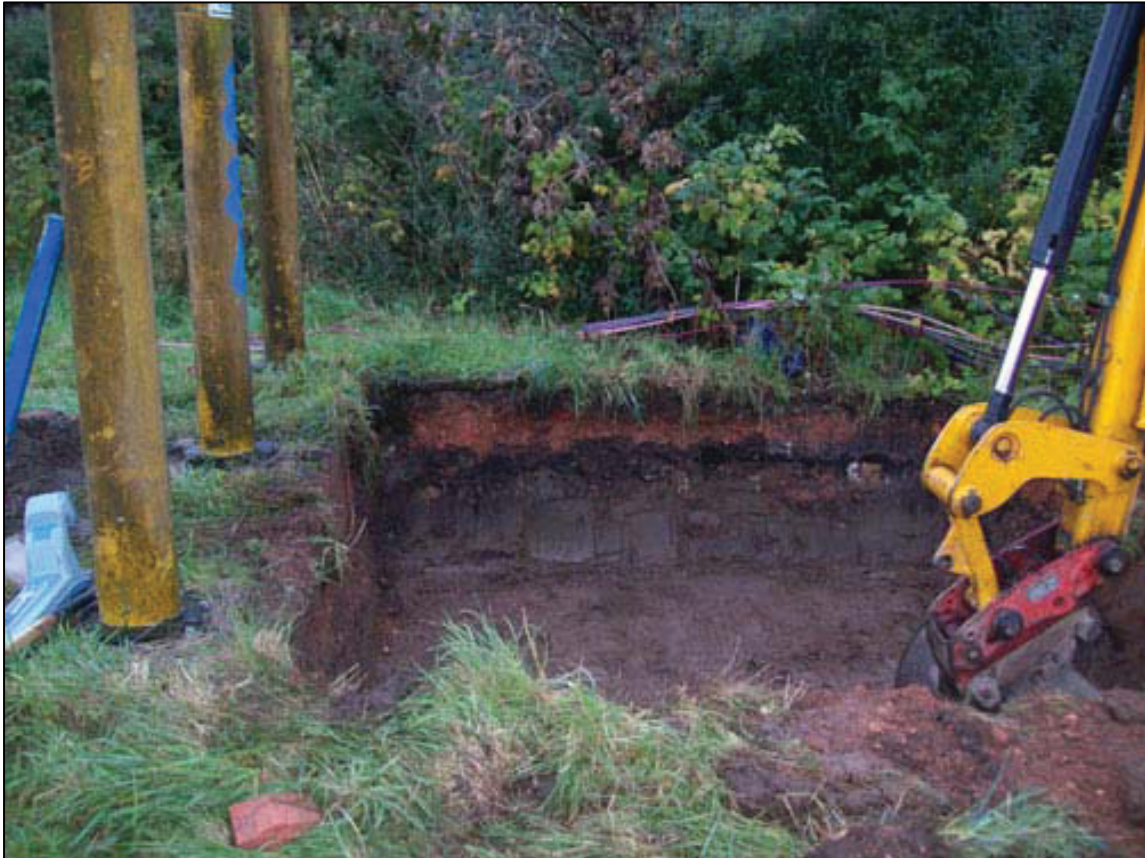
Figure 5b: Pit for new lighting base

29. The two new light bases which were excavated within the scheduled area (Figure 5b), to the north-east of the graveyard, involved a pit for foundations which was 3m by 2m and approximately 800mm deep from existing ground level. These pits were excavated by machine and provided an opportunity to examine a deep section through deposits in the north-eastern part of the scheduled area. Those deposits exposed were; topsoil (001) to a maximum depth of about 150mm, made ground and levelling (003) to a further depth of about 400mm and the remainder was through natural clay (004). The primary exception to this was in areas where the excavation work dug through an existing service track in which case the backfill was (002) as before.

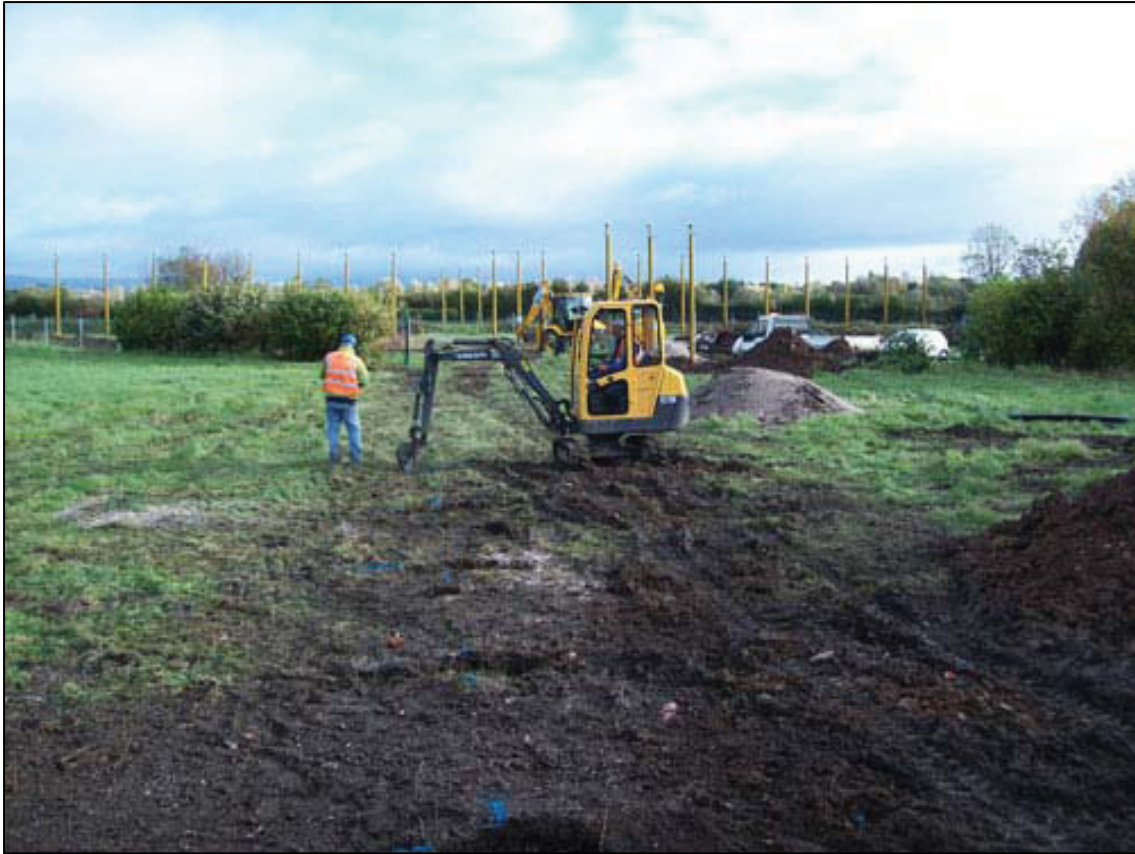
Figure 6a: Excavating for fence line

35. Establishment of the fence line involved excavation of a series of holes (Figure 6a) along the access road to the graveyard and then turning to form a second line directly north-east away from the graveyard. Both of these lines connected with existing fencing to enclose the area covered by the approach lighting. Excavation of these holes was carried out under archaeological observation according to the terms of the method statement and with a mini-digger.

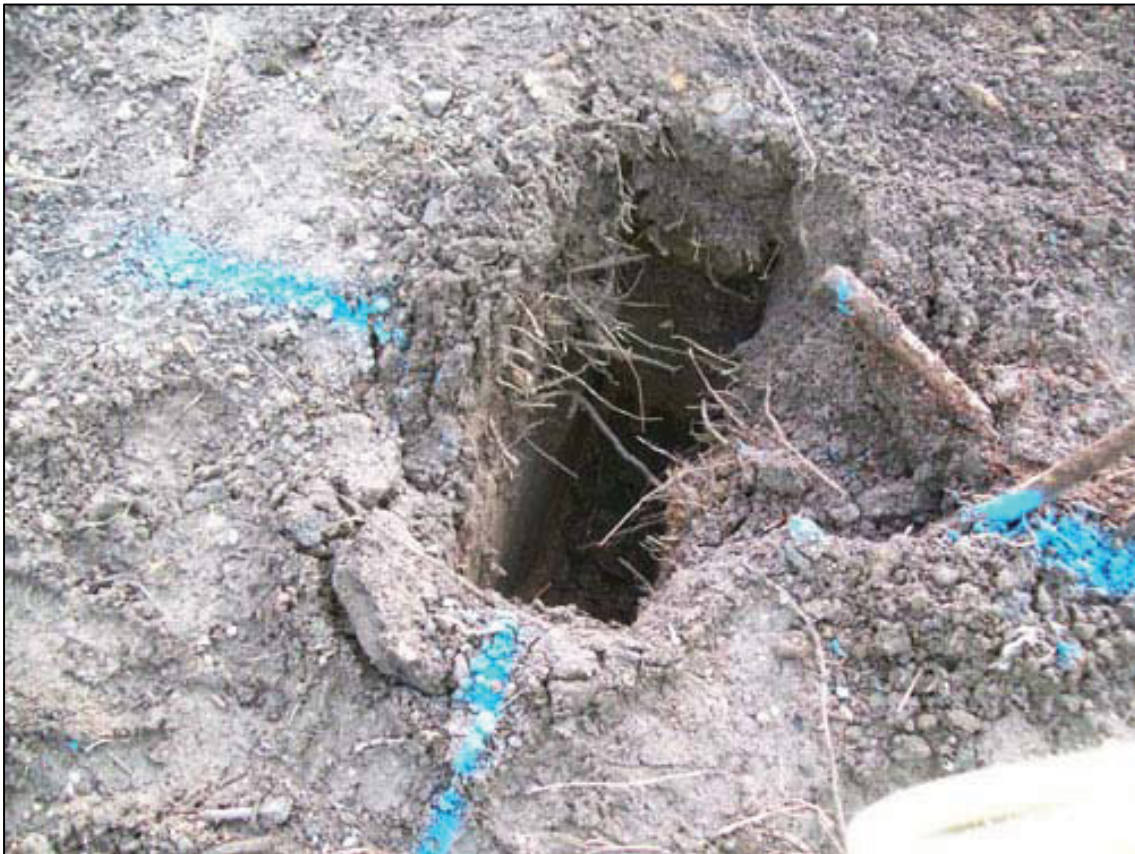
Figure 6b: Pit for fence line

36. The sediments uncovered during this work were identical in nature to those described for the placement of new lighting bases above; topsoil (001), made ground (003) and natural clay (004) (Figure 6b). The only variation to this was immediately adjacent to the access road where gravel had been placed as a road surface and the topsoil as described elsewhere was absent. Typically the holes excavated were about 400mm square and 900mm deep. No significant archaeological material was recovered from the excavation of these holes and no features or structural remains were observed.

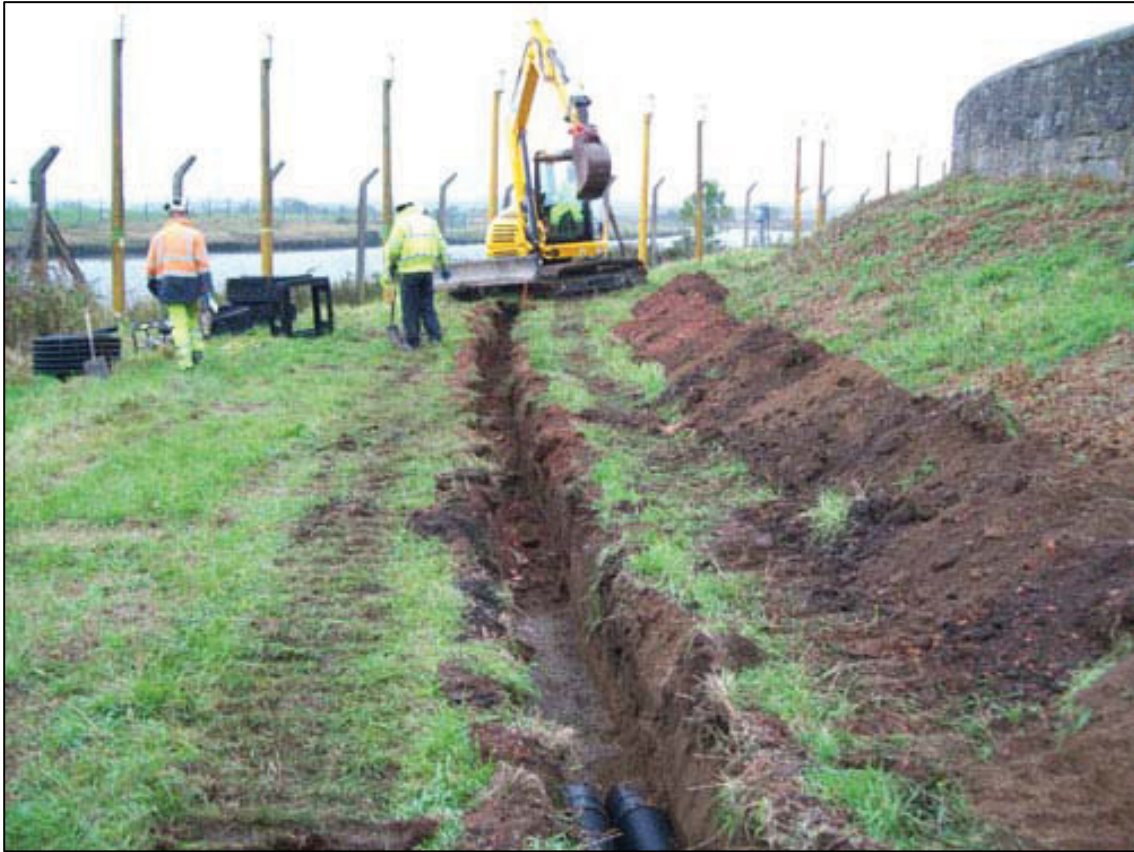
Figure 7a: Track to S of graveyard

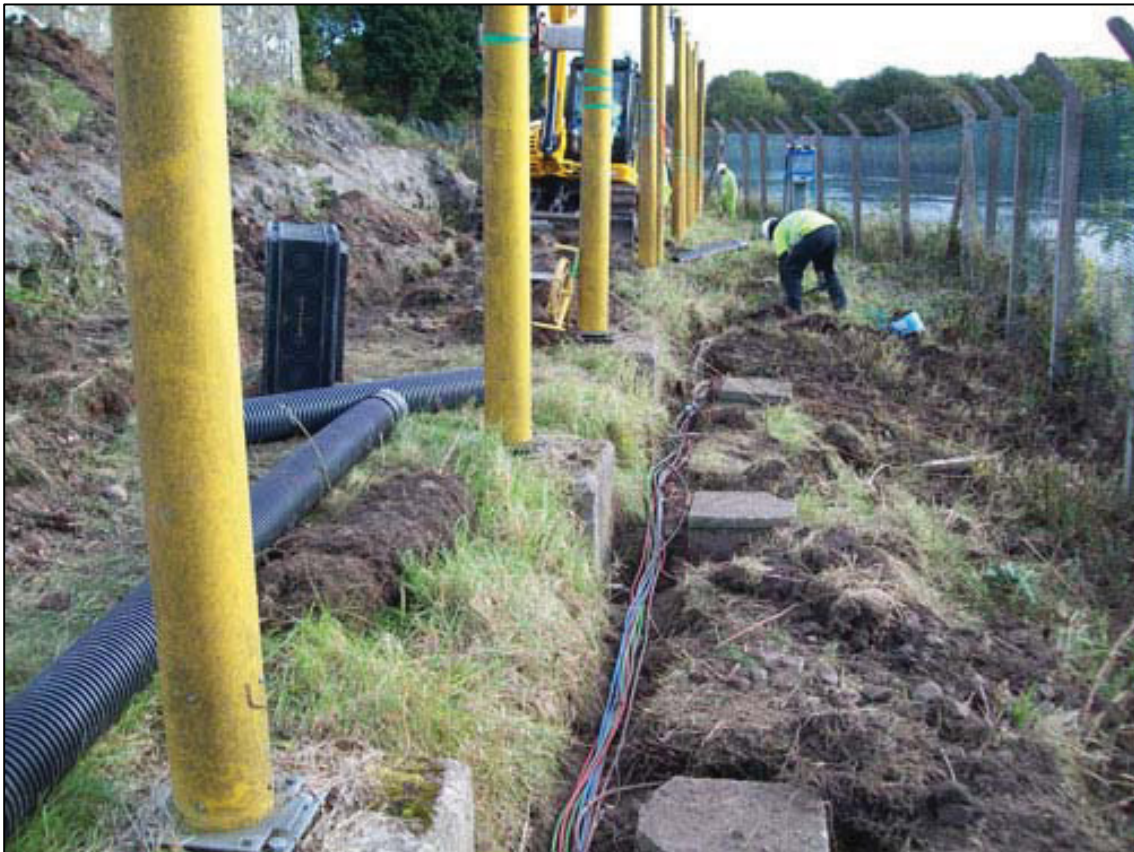
Figure 7b: Tracing cables to SW of graveyard

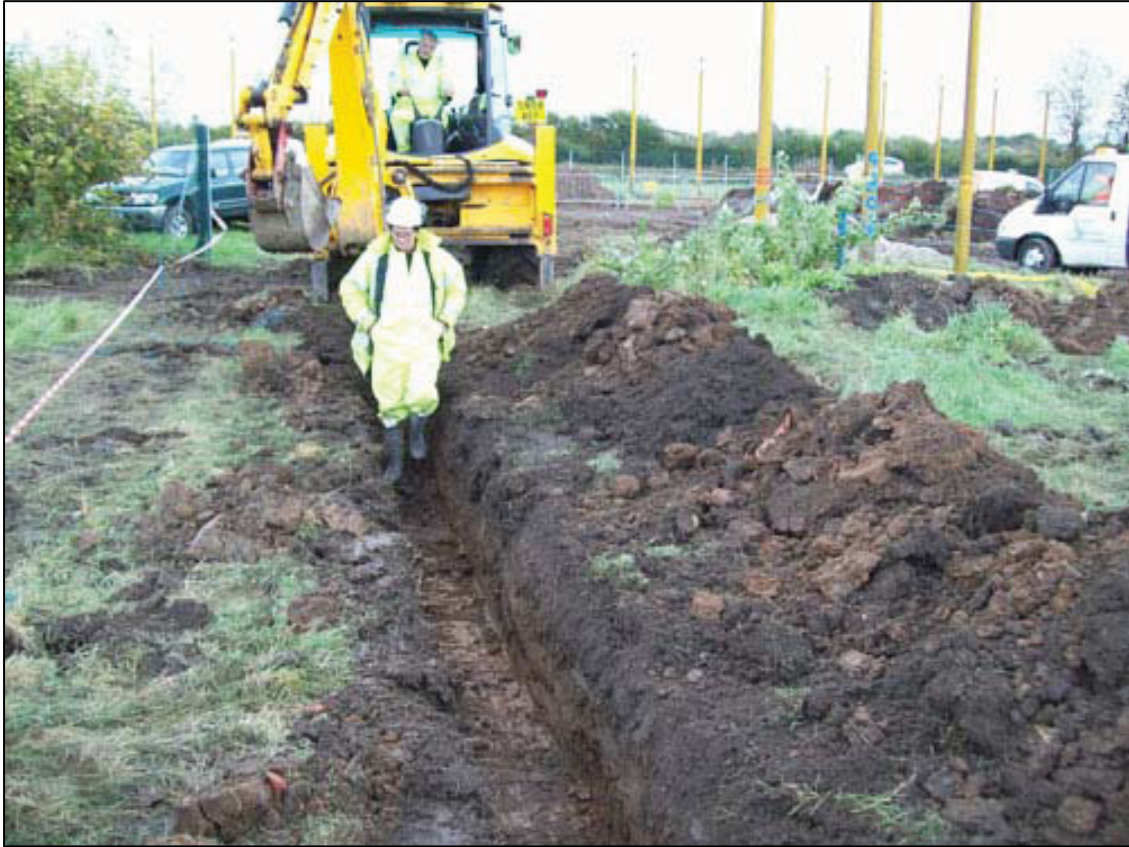
Figure 8a: Track at northern boundary of scheduled area

39. Out with the graveyard the excavations uncovered only topsoil (001), made ground (003) and clay subsoil (004) (Figure 8a) for all of the area to the east and north of the graveyard. The nature of the made ground, containing red blaes and type 1 gravel in multiple varying layers suggests repeated attempt to resurface the area. The fact that the blaes continues beyond the access road to the area beyond the scheduled area, north-east of the graveyard, suggests that it may have been laid during the placement of the existing approach lighting. Although it should be noted that there is no direct evidence to support this. The type 1 may be old surface material from the access road.

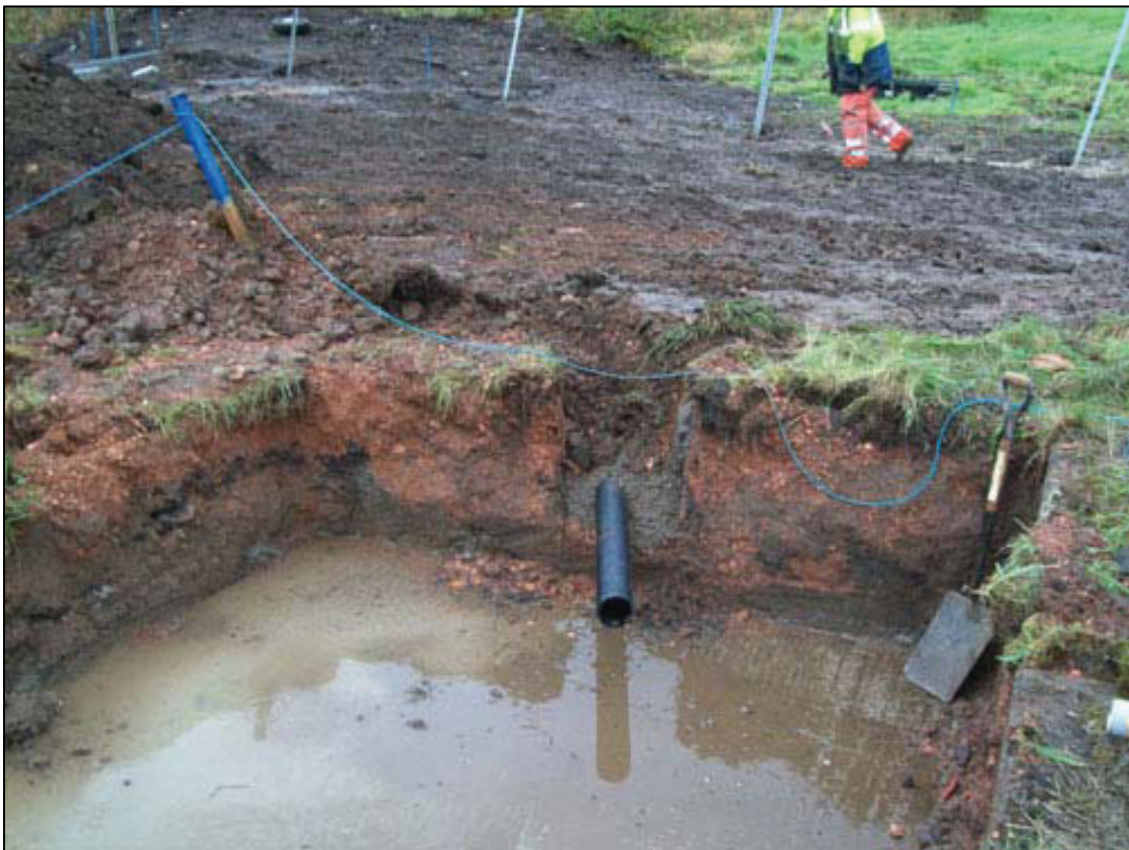
Figure 8b: Section through pit for new light base
