**THE GARAGE
GAIA HOUSE
WEST OGWELL
DEVON**

Historic Building Recording and Archaeological Monitoring and Recording

South West Archaeology Ltd. report no. 220703

Work undertaken by SWARCH for The Gaia House Trust (The Client)

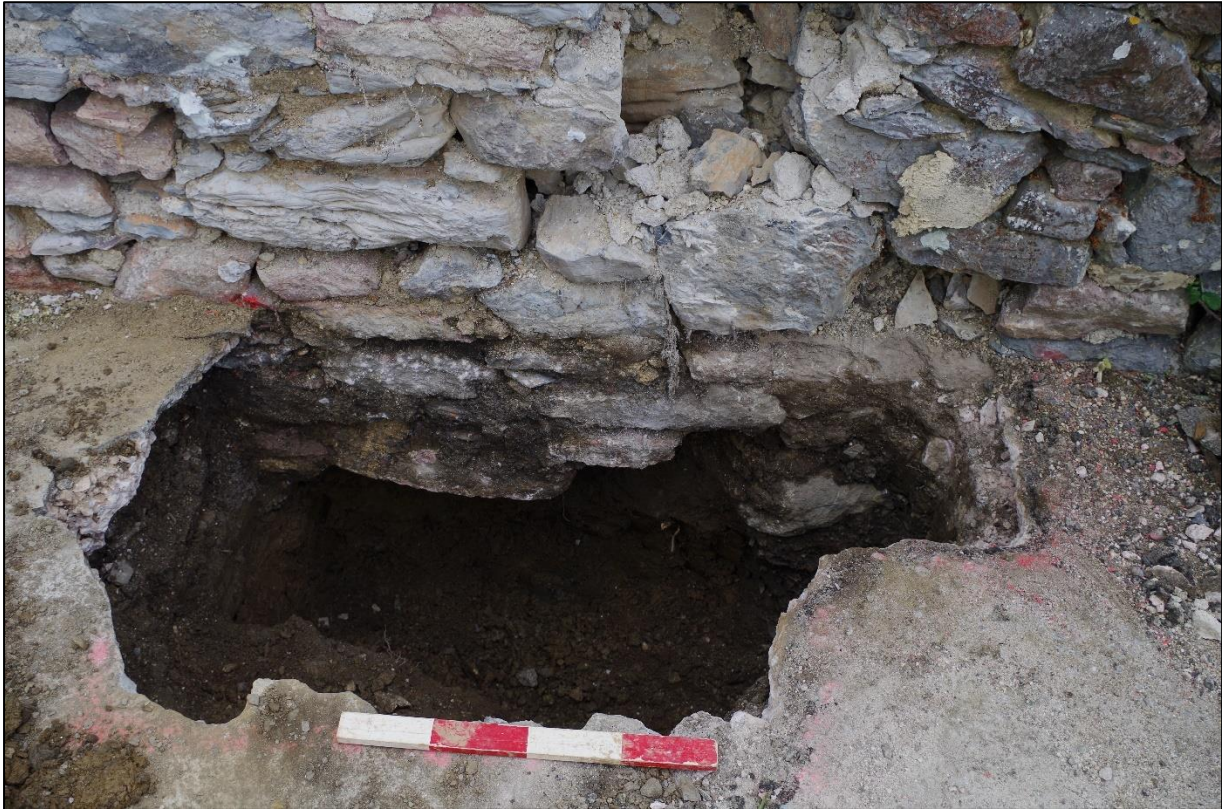
Underpinning Pit 1 was towards the southern end of the western elevation of the dividing wall between B2a and B2b and was excavated to a depth of 0.4m. The stratigraphy revealed, consisted of a c.0.1m thick concrete floor, and a 0.25m deep yellow-brown silt-clay subsoil with occasional charcoal flecks (101). This deposit overlay the natural yellow shillet, and abutted the wall footing {111}, which was built directly onto the natural. Wall {111}, was c.0.5m thick and its footing comprises generally large irregular sub-angular stones (c.0.45m×0.15m×0.5m) bonded in a soft yellow lime mortar, and in general roughly built, low-quality build (likely 19th century in form). There was no obvious trace of a foundation trench/cut; although one was noted at the southern end of this wall subsequently (see 3.2.3 below).

FIGURE 4: UNDERPINNING PIT 1, VIEWED FROM THE WEST (0.4M SCALE).

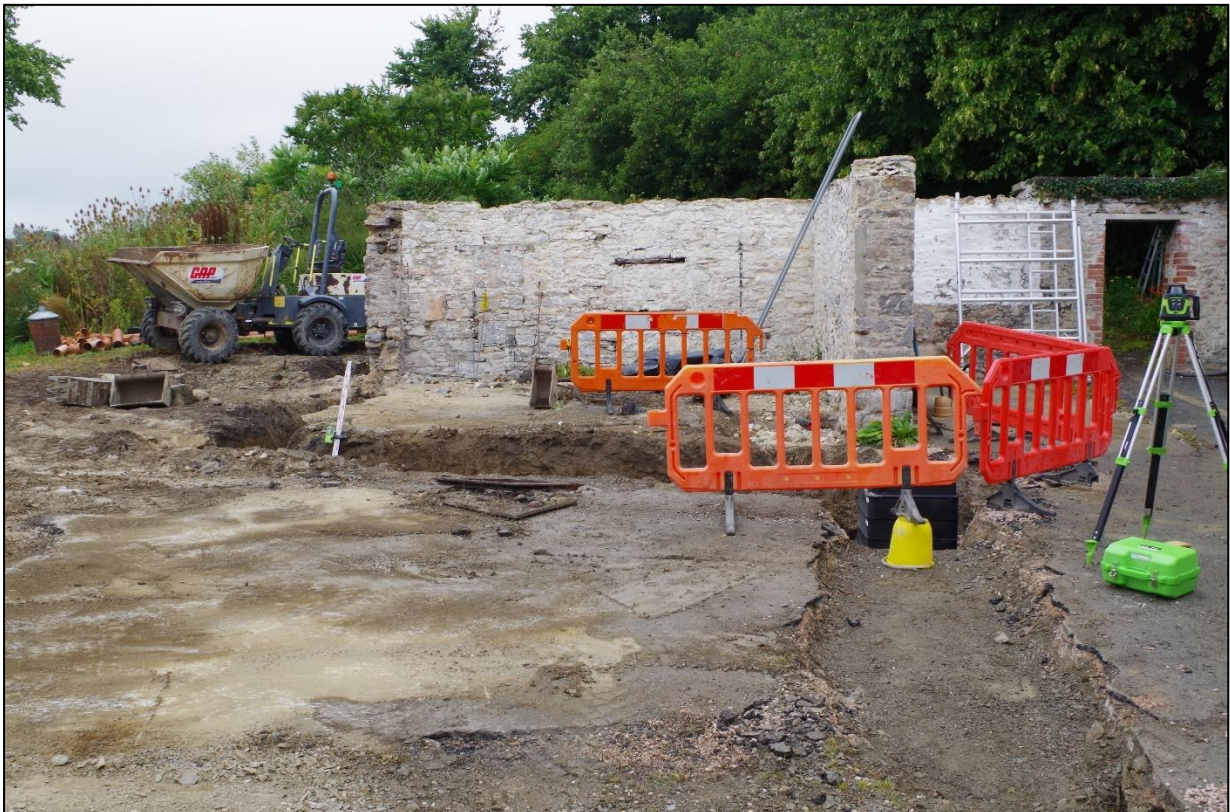
The original intention had been to retain the historic wall {110} however upon the removal of the concrete floor and block extension to the southern end of this wall, it became clear that the fabric was very unstable, and particularly to the southern end was unsafe, the wall was therefore demolished.

FIGURE 5: WORKS IN PROGRESS, FOLLOWING DEMOLITION OF WALL {110} AND EXCAVATIONS OF WALL FOOTINGS. FROM THE SOUTH.

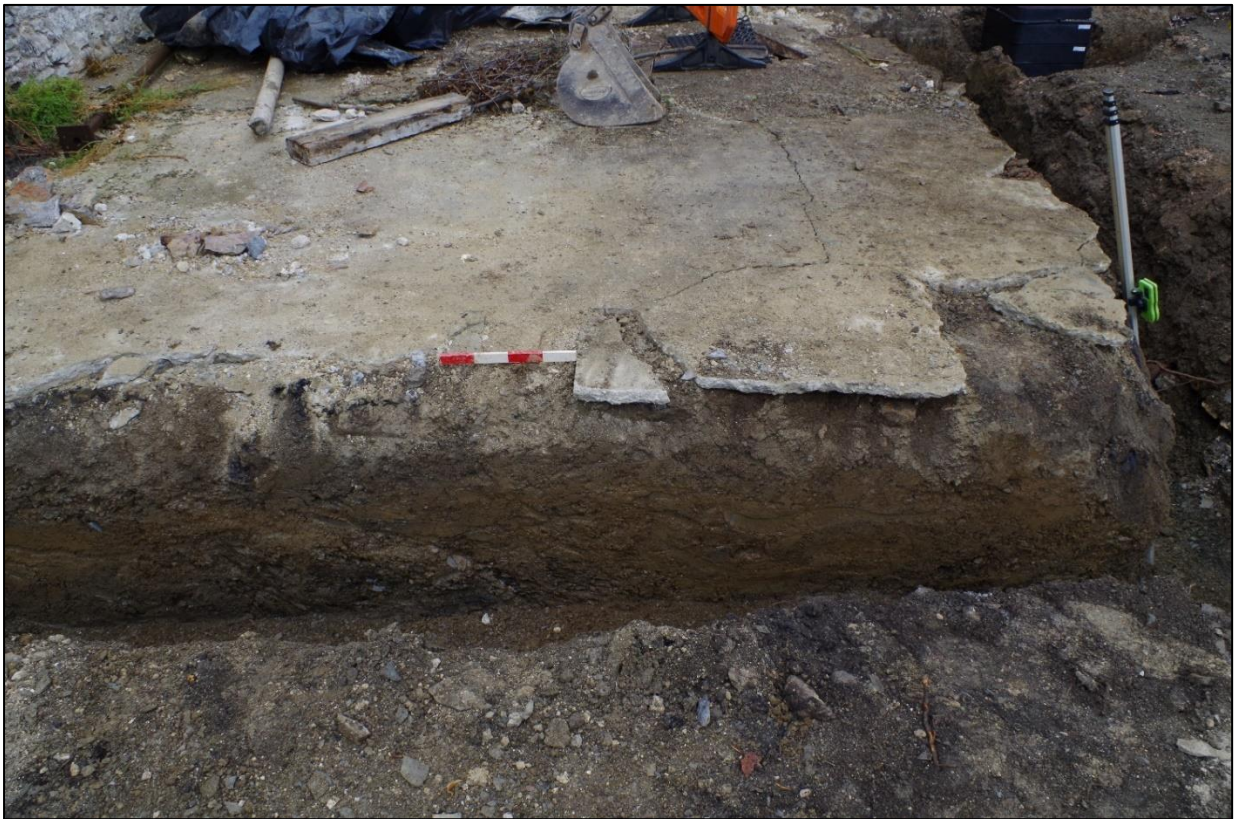
In the north-south length of trench, a cut terrace feature [108], which was 0.4m deep and was c.4m wide, it had gently sloping sides and a flat base. Cut [108] was filled by a single fill, a clean soft grey silt-clay with occasional shillet, i.e., redeposited natural. This feature could represent the remains of the wall foundation trench for wall {110}, partially surviving in the section, however the nature of the fill suggests it pre-dated the building, and it may have contributed to the structural failing of wall {110}.

FIGURE 6: WEST FACING SECTION OF FOOTING TRENCH, ALONG LINE OF DEMOLISHED WALL {110}, FROM THE WEST (0.4M SCALE).

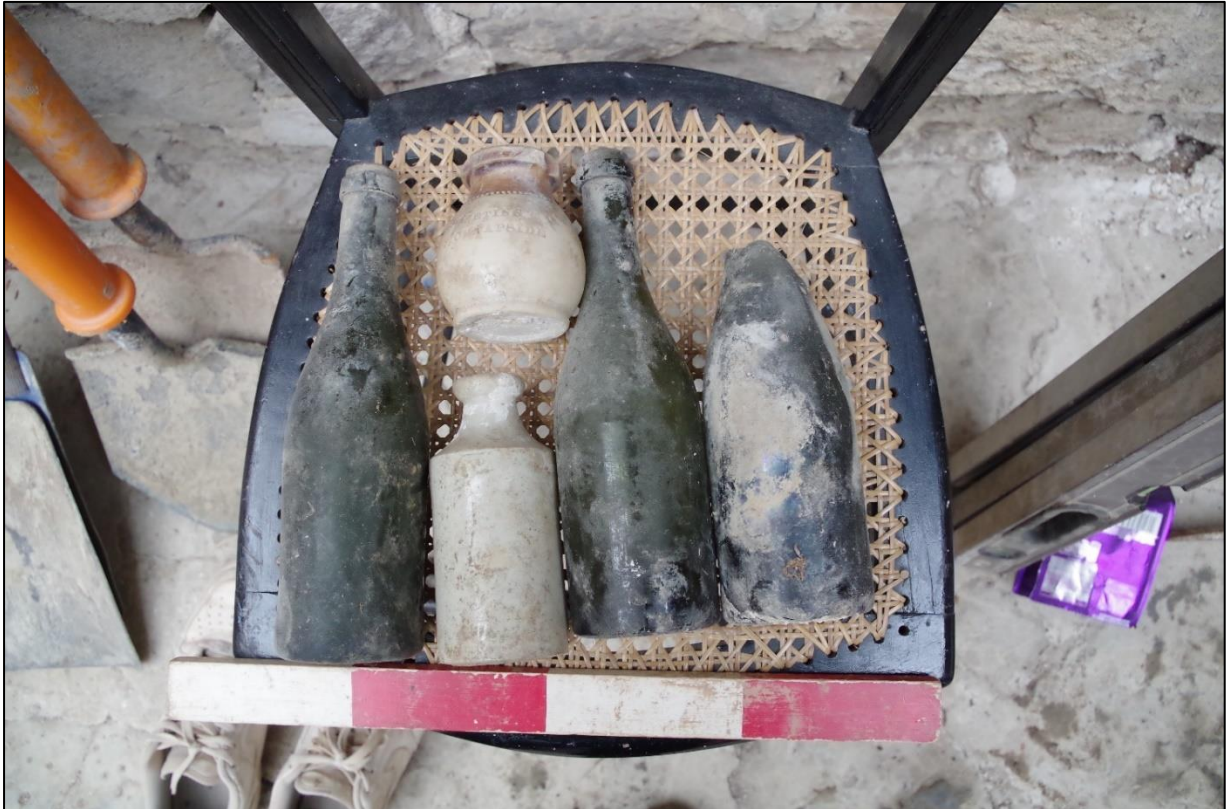
In the north wall of the structure built on the northern end of the Garden Wing (Room b3c), the builders noticed a slightly odd-looking stone in the wall and removed it, to discover a secret hiding hole containing three glass (wine) bottles and two stoneware jars one marked 'Sweeting & Co., Cheapside'. This provides evidence of someone's secret, and a story involving for example a light-fingered mid to late 19th century stable boy stealing food and drink from his boss and hiding the evidence of his crimes in the wall. This adds narrative and historic-illustrative value (the lives of servants) to the wider site and this building in particular.

FIGURE 7: A HIDDEN STASH OF BOTTLES AND JARS FROM IN THE WALL TO THE NORTH OF THE GARDEN WING (0.4M SCALE).

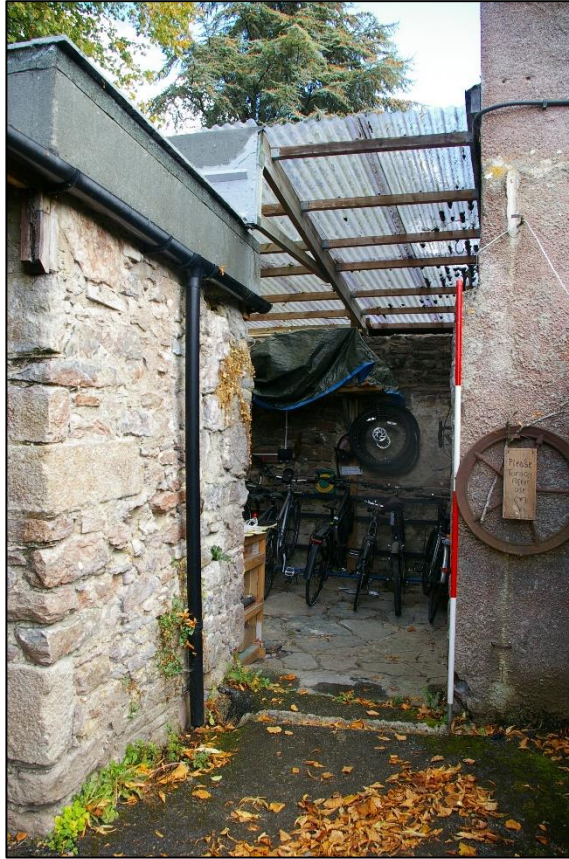
3. THE FORCED HOLE IN THE WALL OF THE 'GARDEN WING' WHICH LEADS INTO B3C AND RUINED CONTINUING WALL; FROM THE WEST-SOUTH-WEST (2M SCALE).

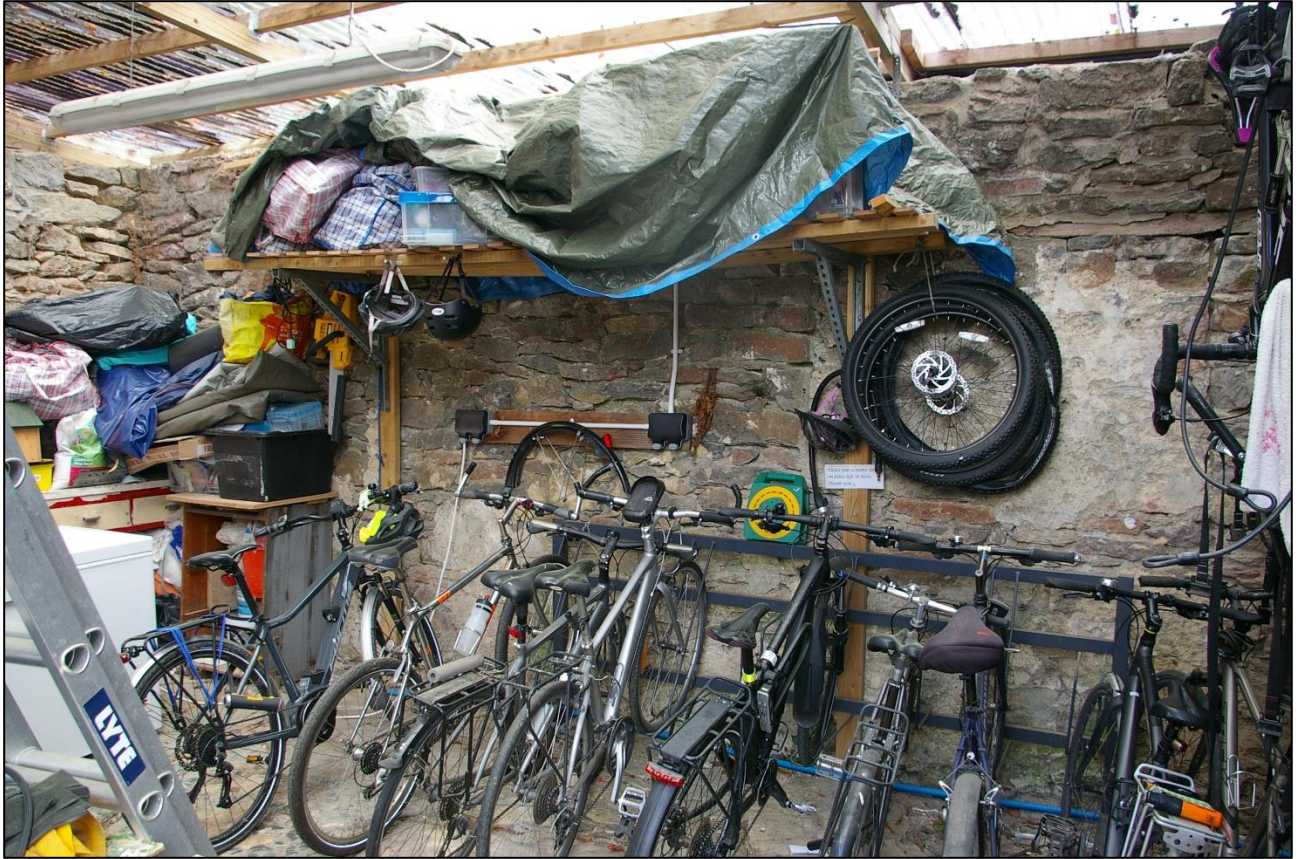
7. THE EAST WALL OF B3, FROM WITHIN B3C, SHOWING BLOCKED WINDOW BW5, TO THE SOUTH END; FROM THE SOUTH-WEST.

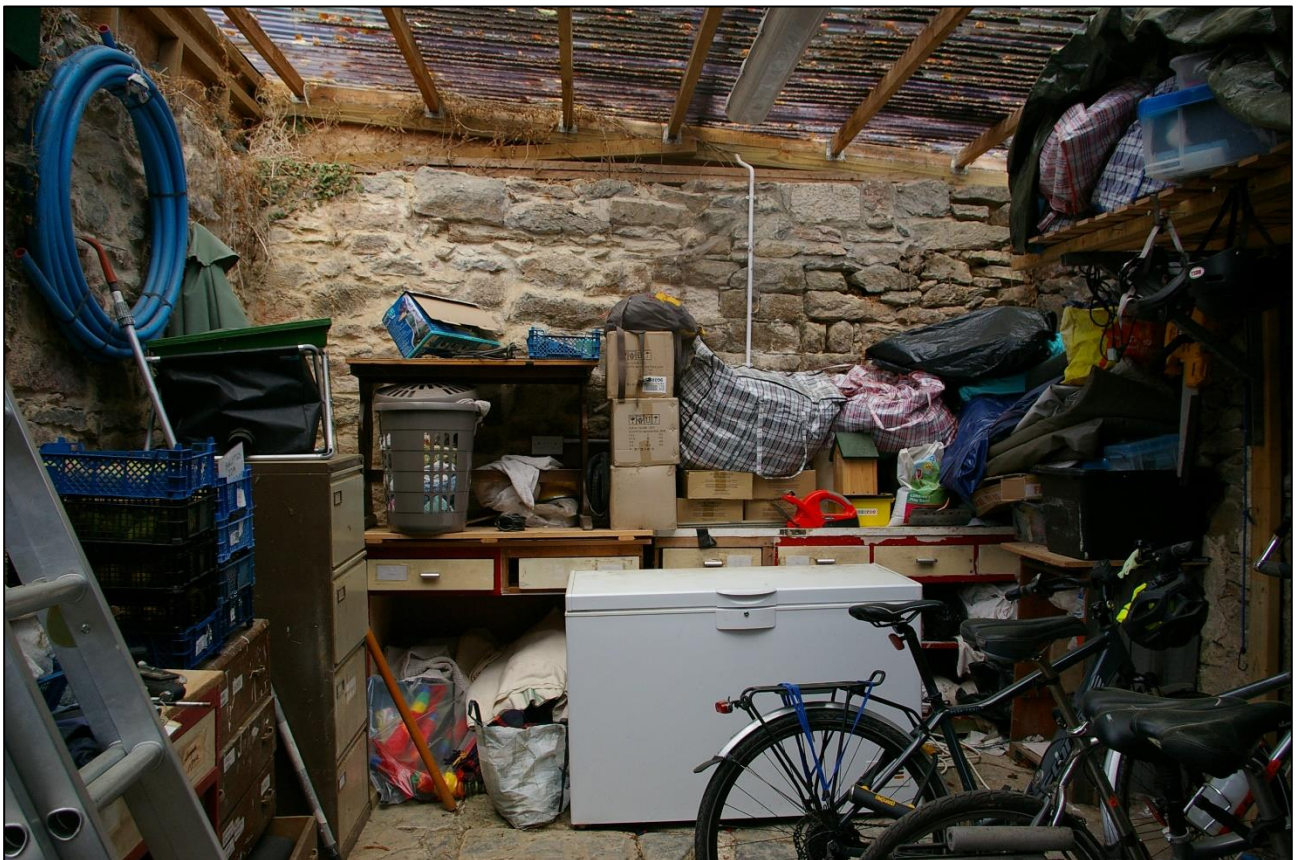
8. THE NORTH WALL OF B3, FROM WITHIN B3C, SHOWING LOTS OF REPOINTING AND REPAIR; FROM THE SOUTH.

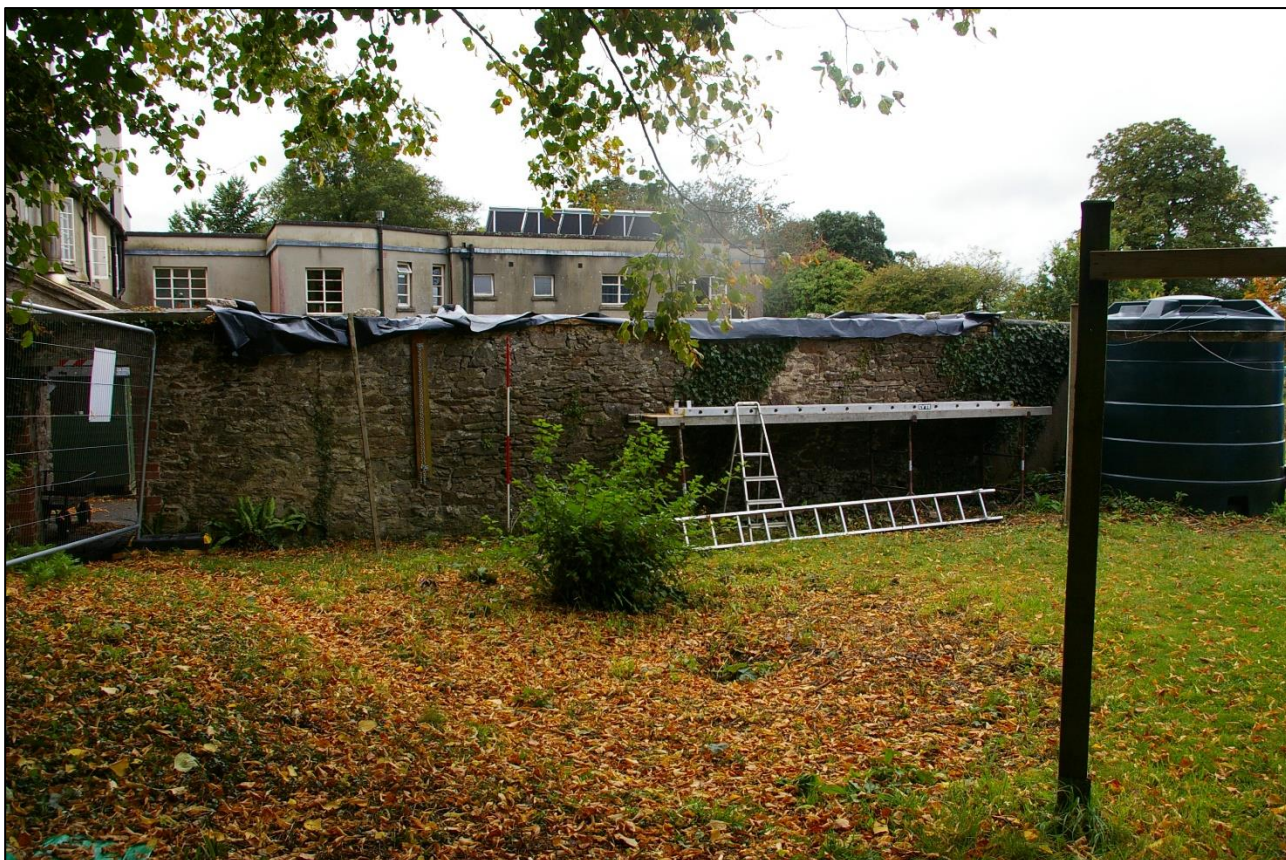
17. THE NORTH WALL OF B2 AND TO THE EAST END, JUST BEFORE THE FORCED ARCHWAY THE CHANGE OF BUILD AND CLEAR LINKING REPAIR SECTION OF WALLING; FROM THE NORTH-NORTH-EAST (2M SCALE).

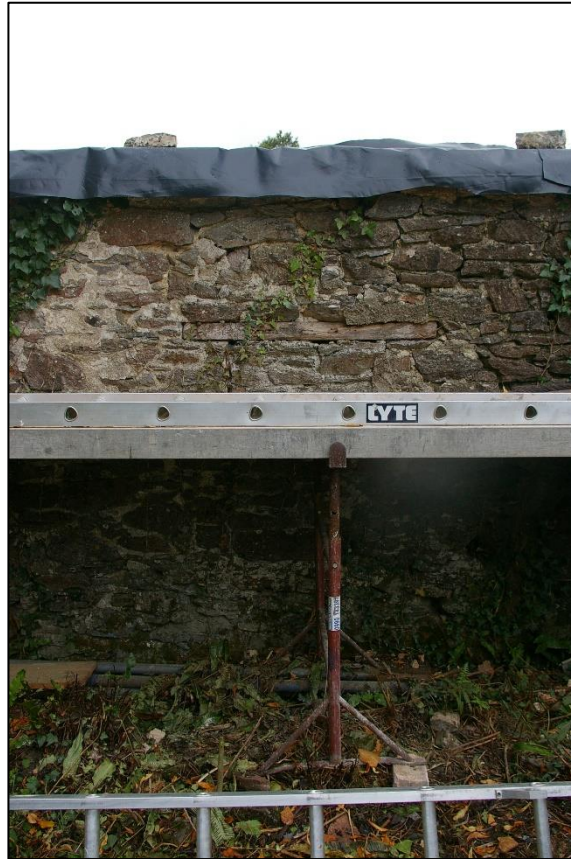
18. BW2, THE MORE OBVIOUS BLOCKED WINDOW ON THE NORTH WALL OF B2; FROM THE NORTH.

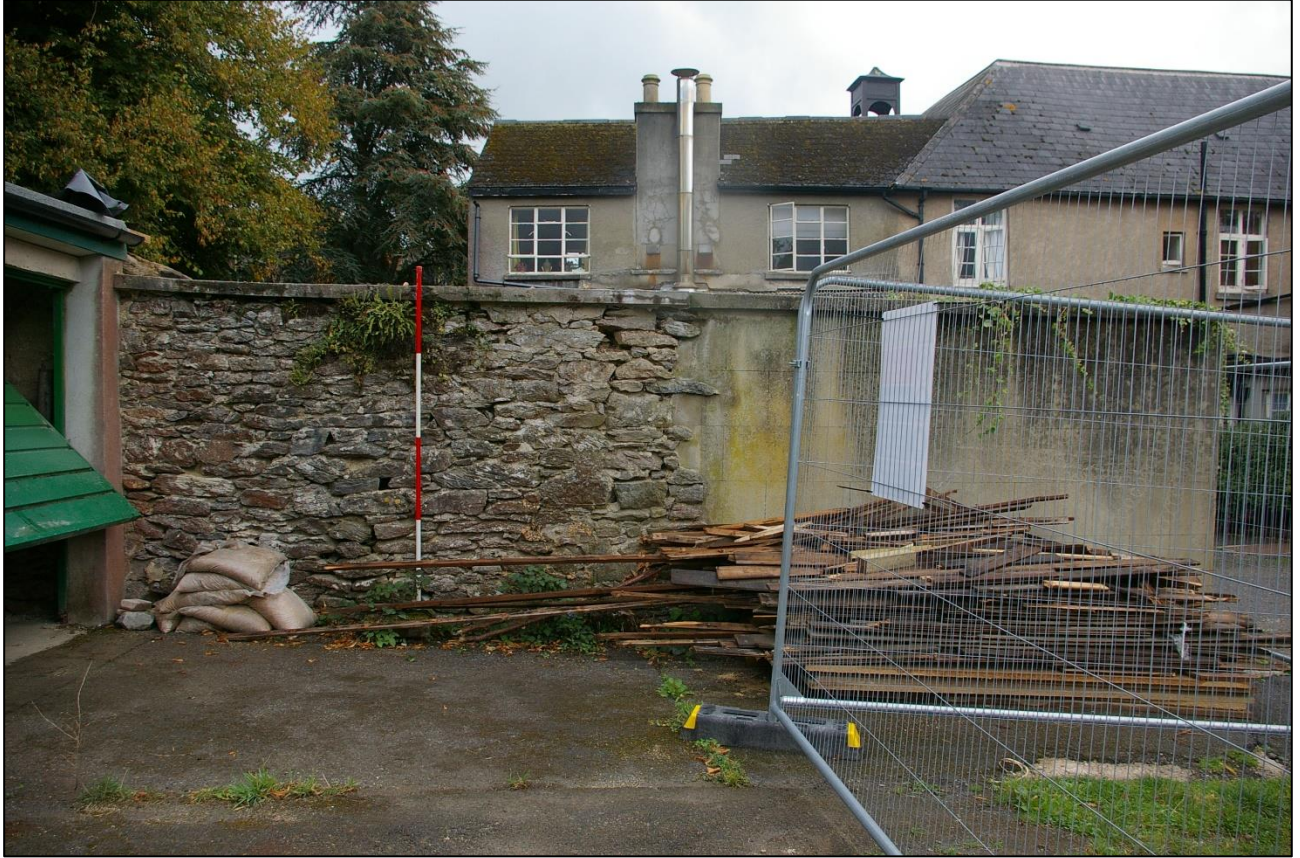
22. THE WEST WALL OF B2, SHOWING TRUNCATION AND POOR REPAIR AND RENDERED (BLOCK) END; FROM THE WEST (2M SCALE).

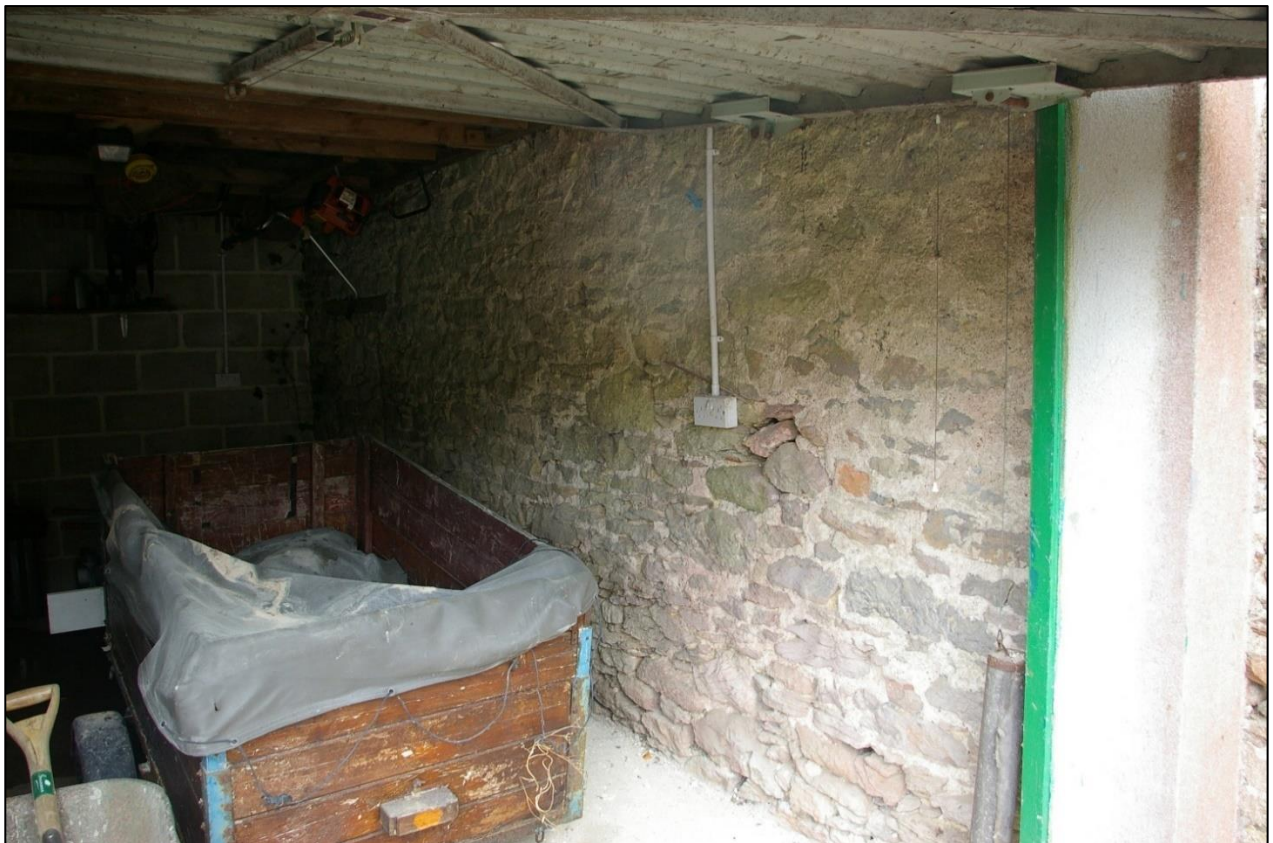
23. THE OUTER FACE OF THE WEST WALL OF B2, FROM WITHIN B1, SHOWING THE BLOCKED OPENINGS; FROM THE SOUTH-WEST.

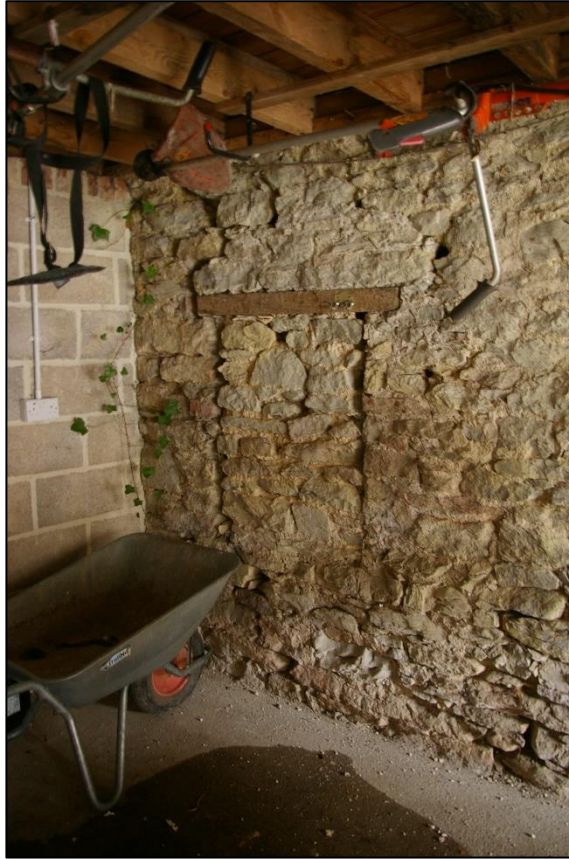
24. BW3 THE REALLY CLEAR BLOCKED OPENING ON THE NORTH-WEST CORNER OF B2; FROM THE SOUTH-WEST.

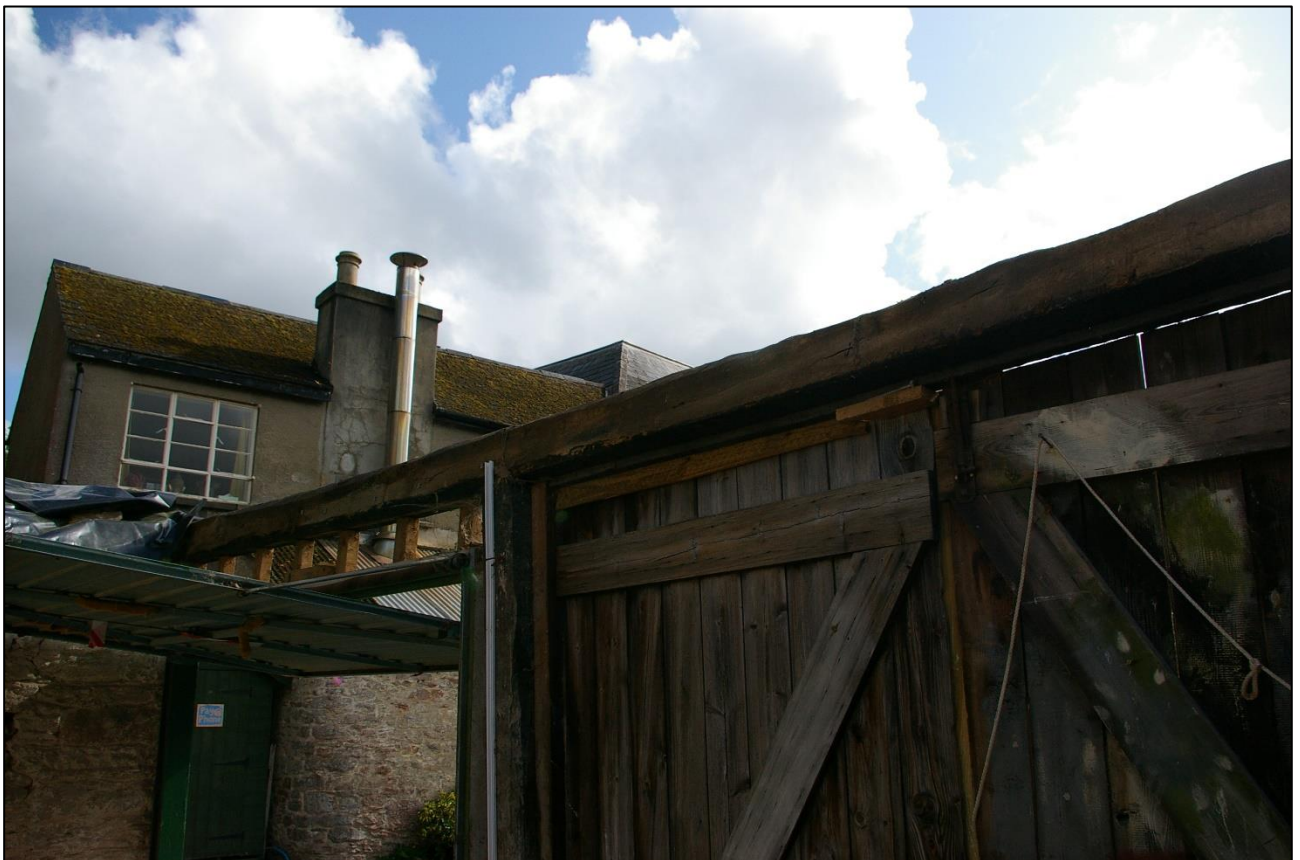
29. THE HEAVY POST AND BEAM WHICH BRACE THE SOUTH WALL OF B2; FROM THE WEST-NORTH-WEST.

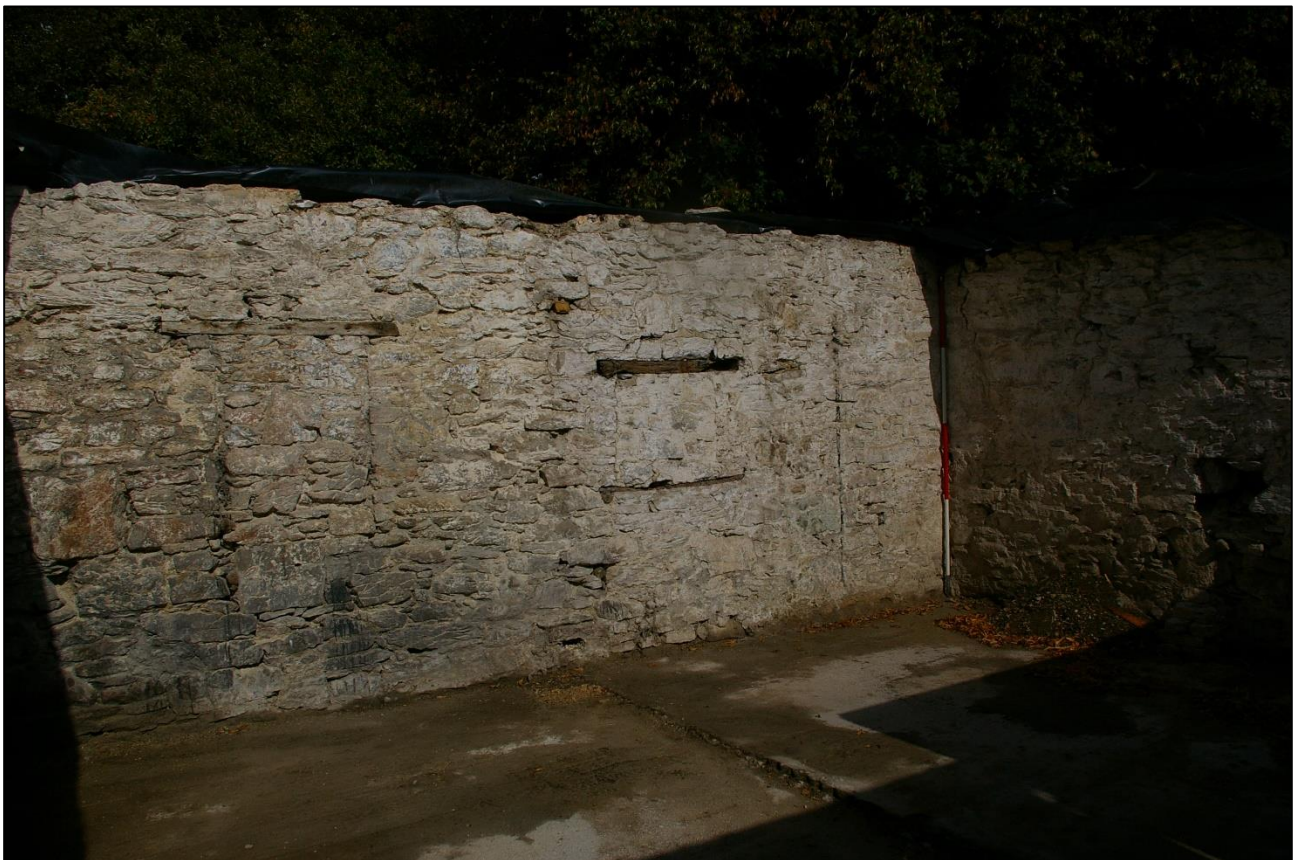
33. THE NORTH WALL WITH THE TWO VERY DIFFERENT BLOCKED OPENINGS BW1 AND BW2; FROM THE SOUTH-WEST (2M SCALE).

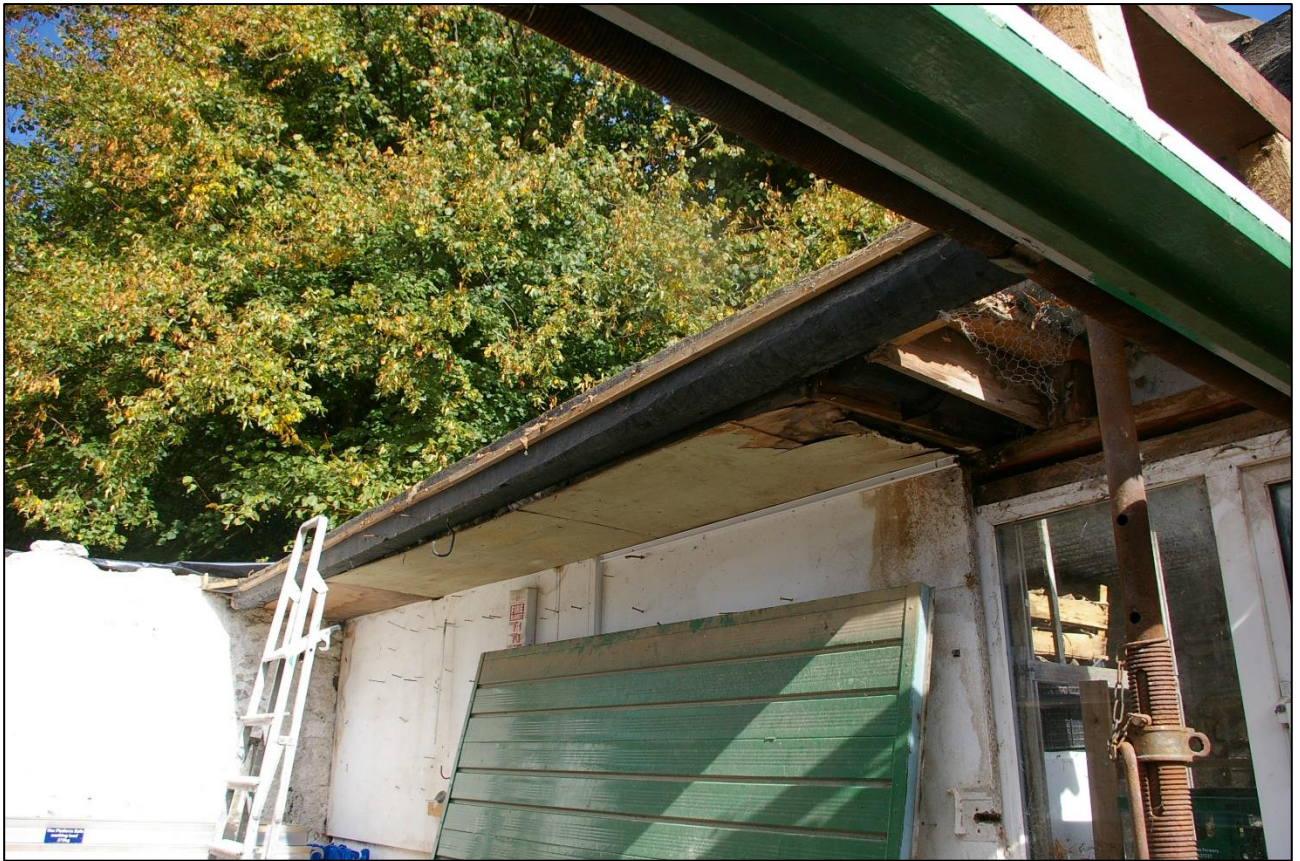
42. THE HEAVY BEAM WHICH CARRIED THE END OF THE SLATE ROOF OVER B2, AS THE EAST WALL, NOW CONCRETE BLOCK HAD BEEN BUILT OUT OF LINE FROM THE ORIGINAL BUILDING; FROM THE SOUTH-WEST.
