**NANQUIDNO VEAN**

**ST. JUST**

Archaeological Monitoring and Recording and Historic Building Recording

South West Archaeology Ltd. report no. 191007

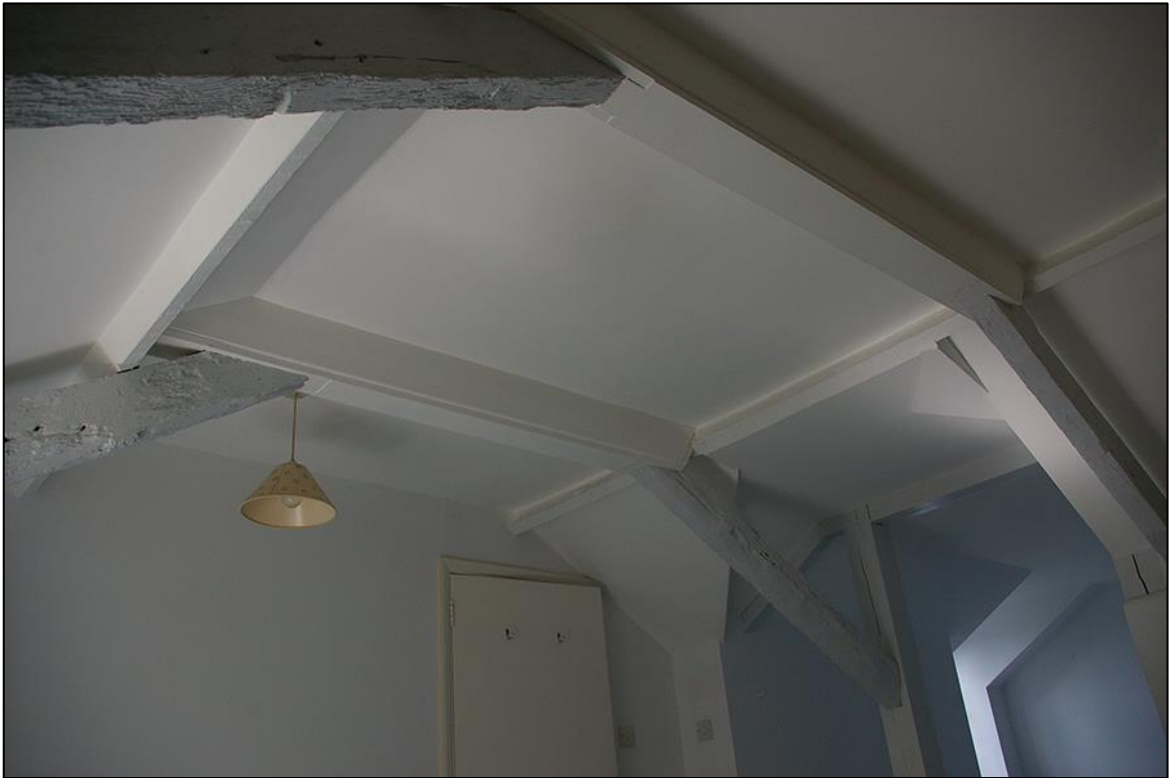
FIGURE 9: THE RUSTIC ROOF TRUSSES IN BUILDING 1, THEIR SPIKED LOW COLLARS REMOVED WHEN THE CEILINGS WERE RAISED; FROM THE EAST-NORTH-EAST.

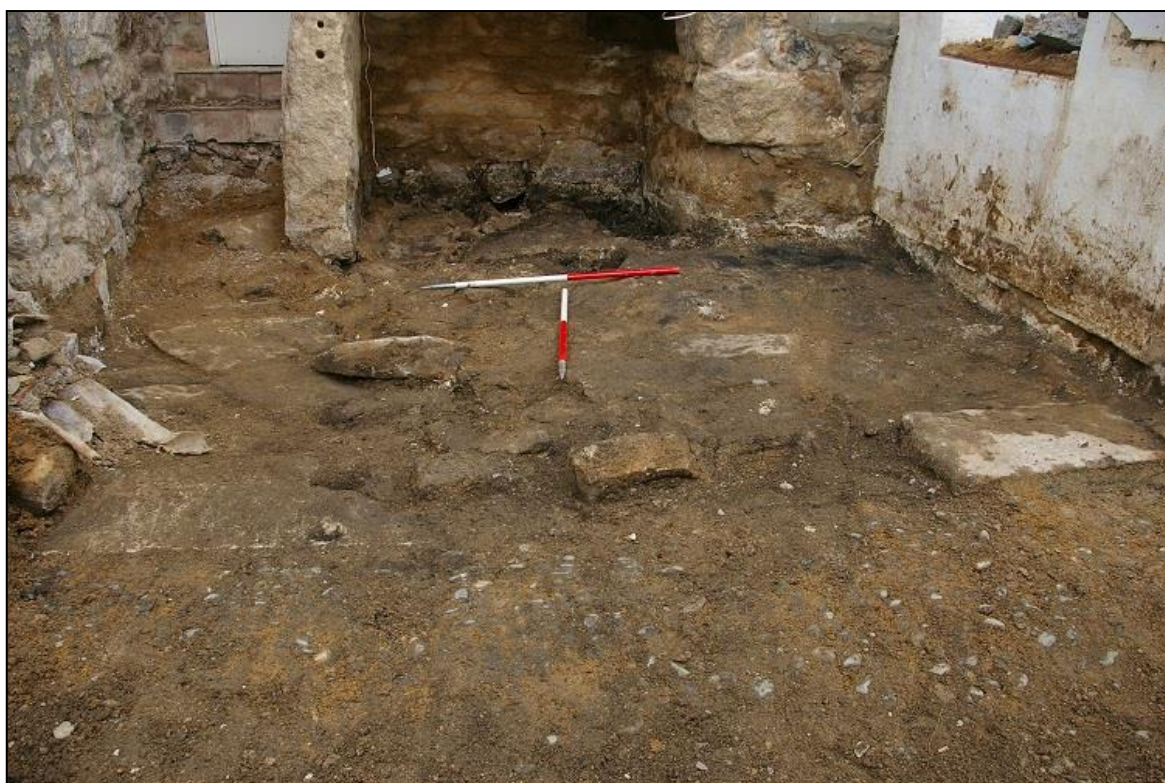
FIGURE 13: THE SLUMPED PAVED FLOOR IN R2 AND STONE PARTY WALL TO THE FORMER COTTAGE, WITH ONE ORIGINAL DOORWAY FORM THE PASSAGE, TO THE 'NORTH' END; FROM THE WEST-SOUTH-WEST (1M SCALES).

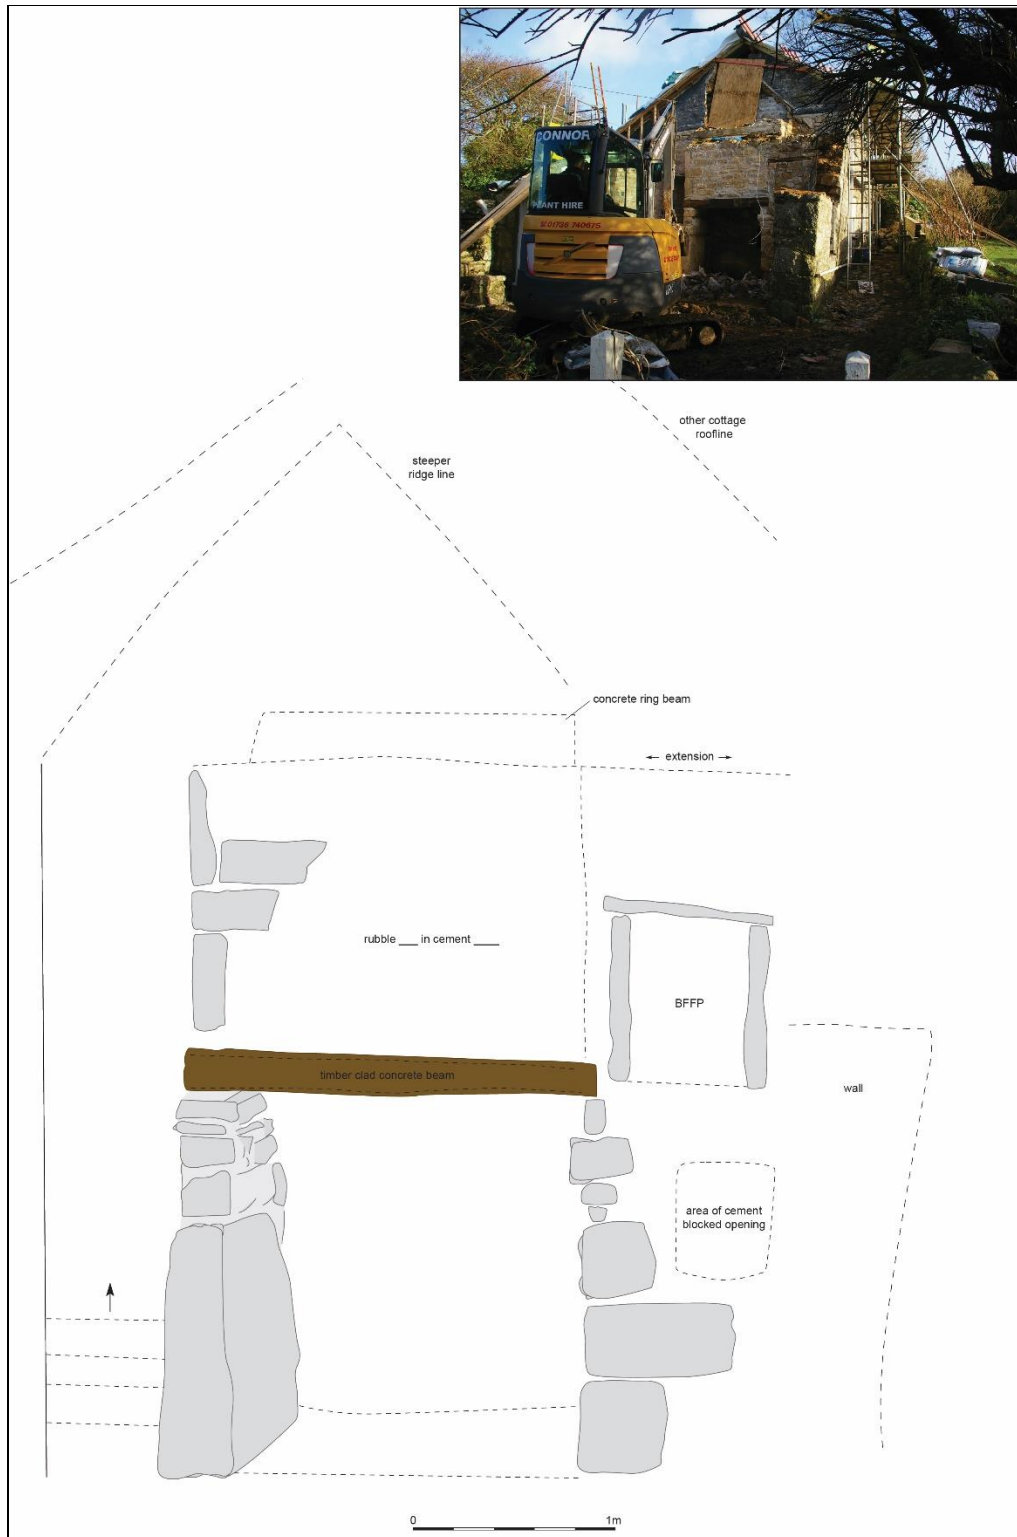
FIGURE 14: DRAWING OF THE STACK IN R2, ADAPTED TO LOOK 'MORE HISTORIC' BUT SHOWING FAIRLY SMALL BOX HEARTH AND FIRST FLOOR BEDROOM HEARTH, KEEPING PLACE AND SMALL OVEN OF VICTORIAN DATE.

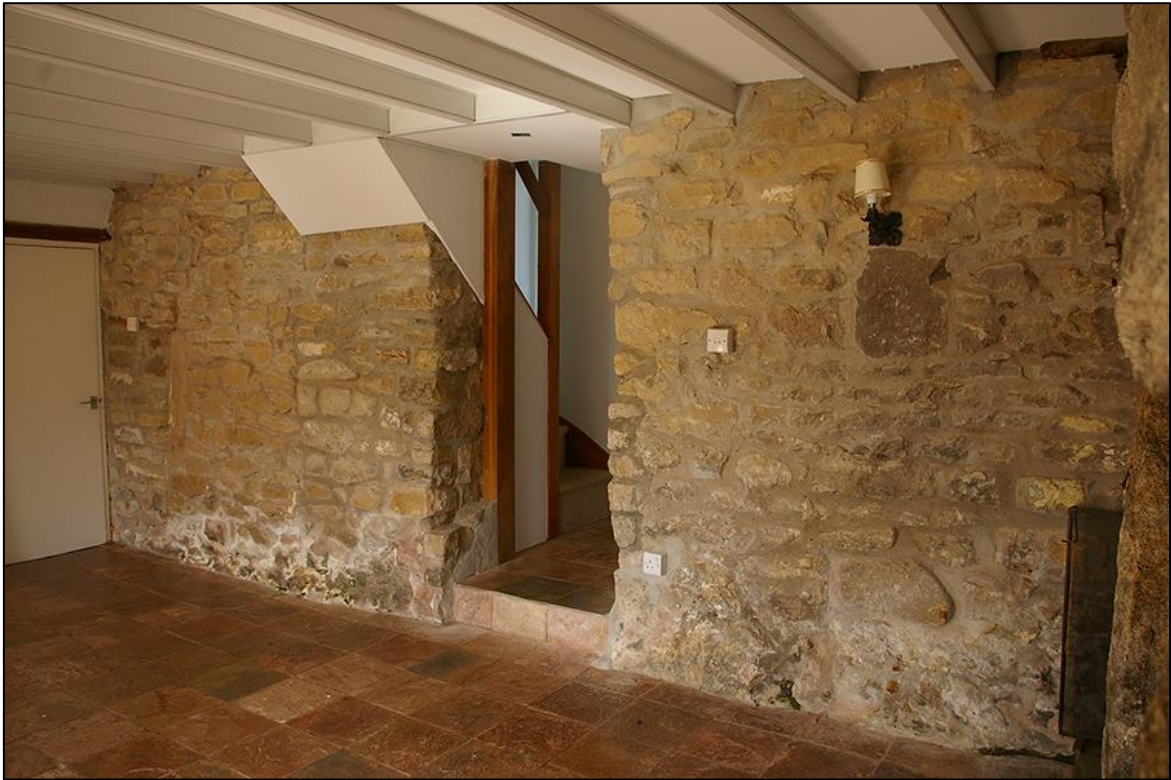
FIGURE 16: THE REAR WALL OF BUILDING 1, THE 18<sup>TH</sup> CENTURY COTTAGE, SHOWING BLOCKED OPENINGS AND STRUCTURAL PHASING; THE EVIDENTIAL VALUE OF THE BUILDING BEING HIGH. PHOTOGRAPH TAKEN FROM THE EAST-NORTH-EAST.

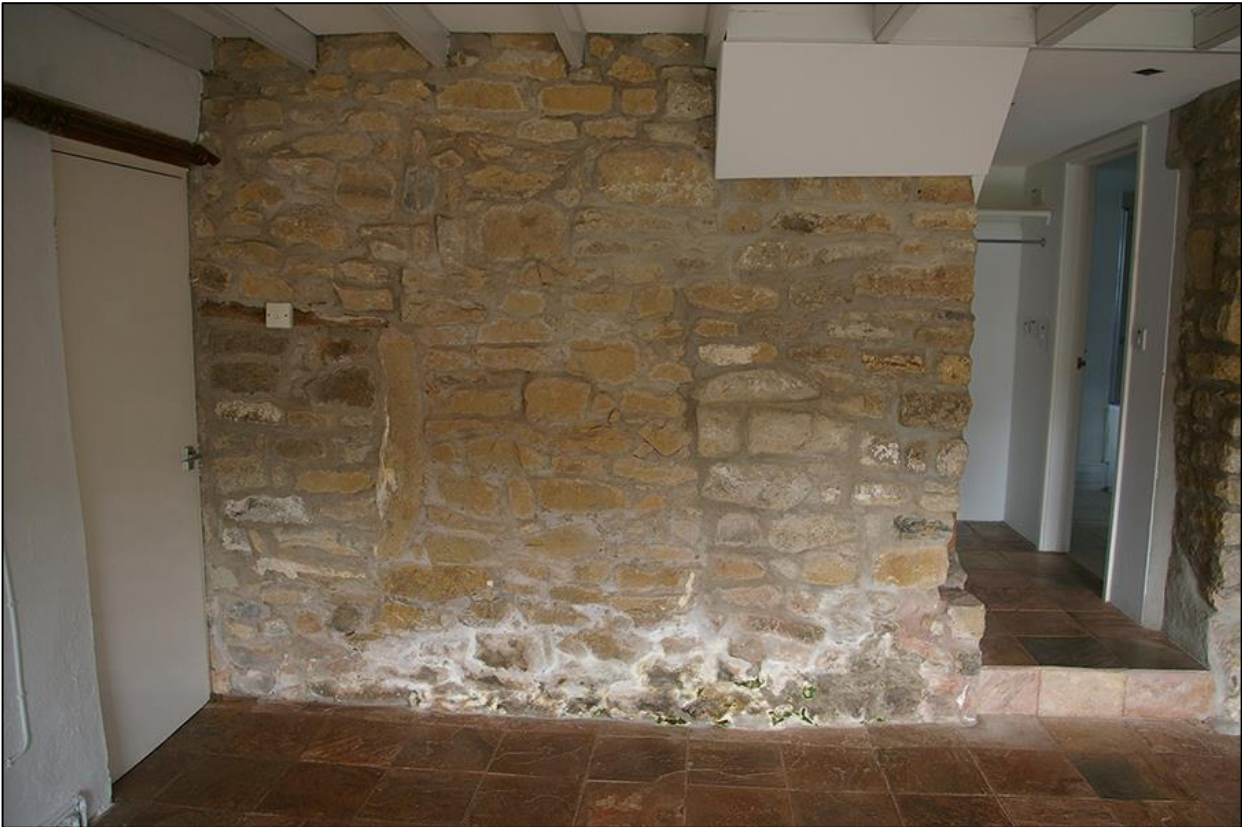
18. ROOM 1, THE BLOCKED OPENING AND BUILD LINES IN THE REAR WALL OF THE COTTAGE; FROM THE SOUTH.

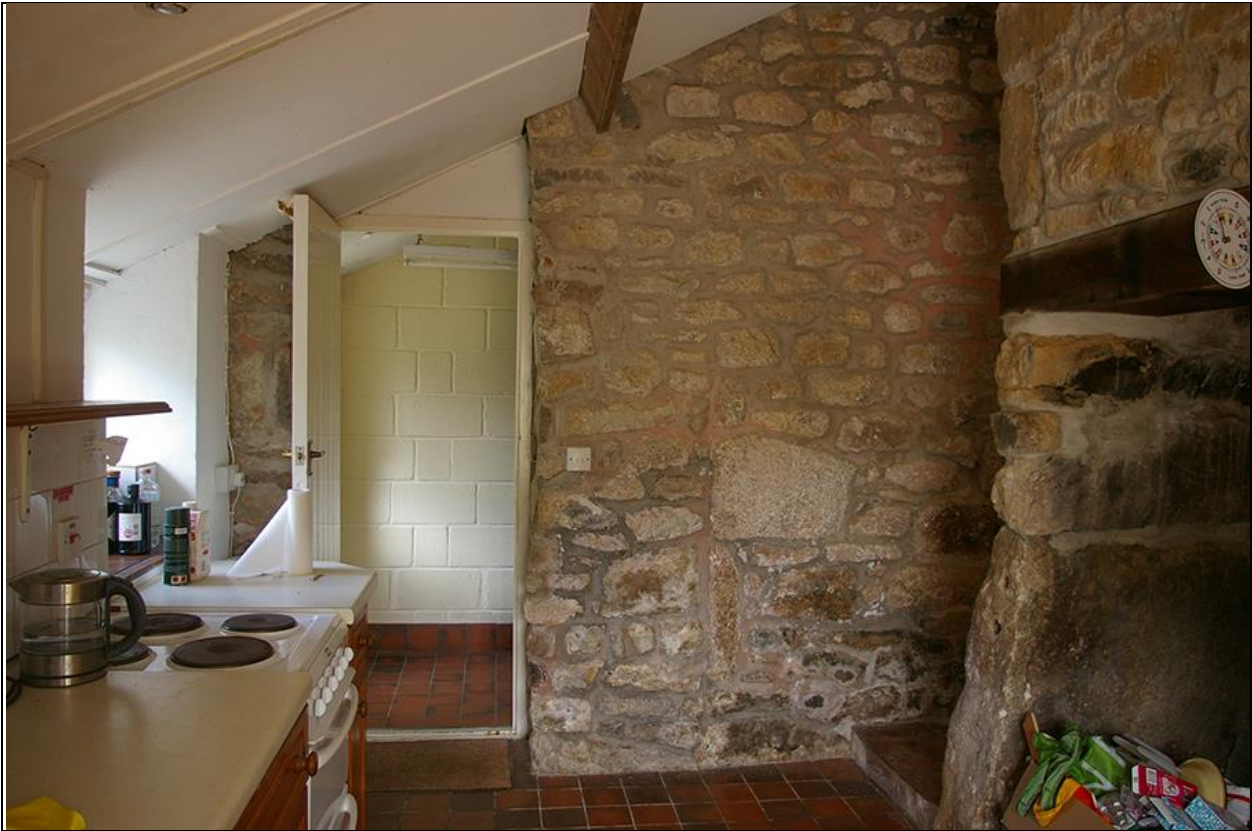
25. ROOM 2 , THE KITCHEN, SHOWING THE REAR WALL, WITH BLOCKED AND RE-CUT DOORWAY; FROM THE SOUTH-WEST.

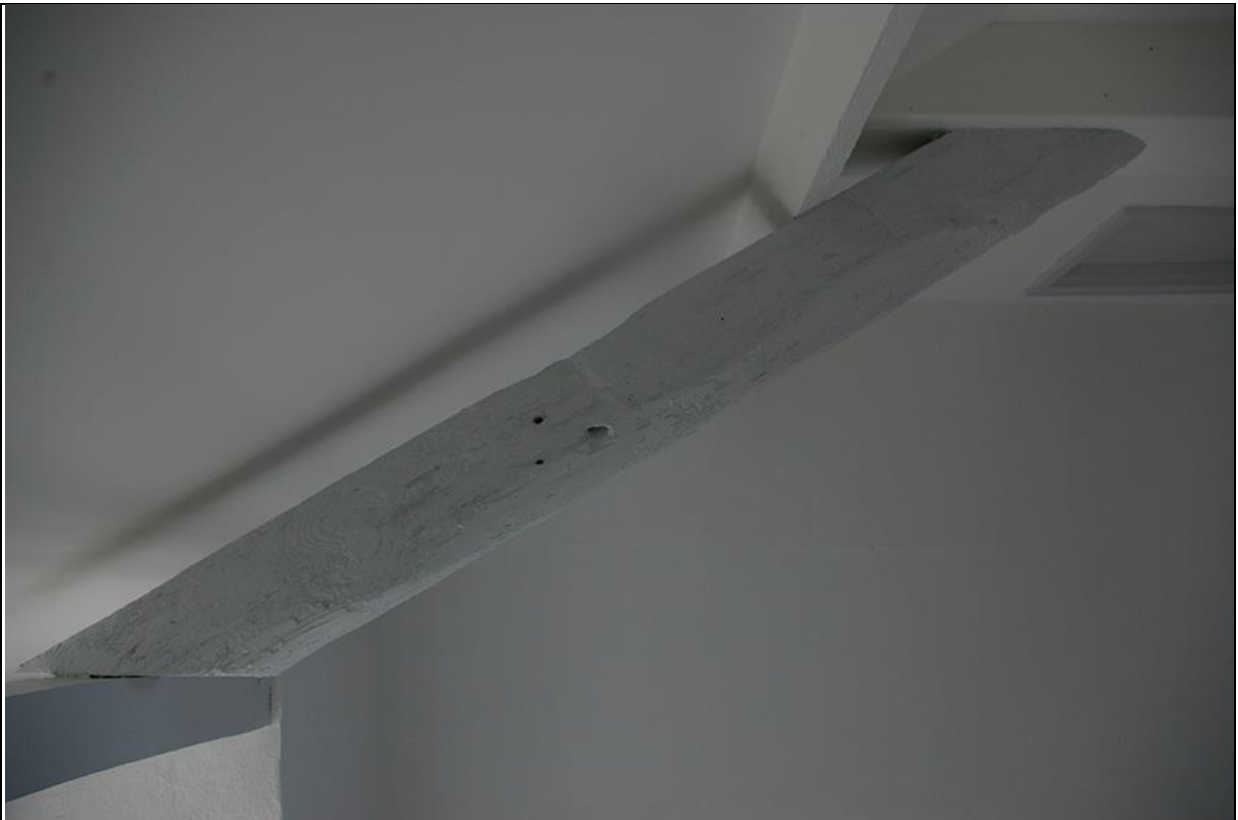
36. DETAIL OF THE RUSTIC A-FRAME OF THE ROOF, WITH HOLES WHERE COLLAR HAS BEEN REMOVED, WITH SPIKE HOLES AND A PEG HOLE; FROM THE EAST.

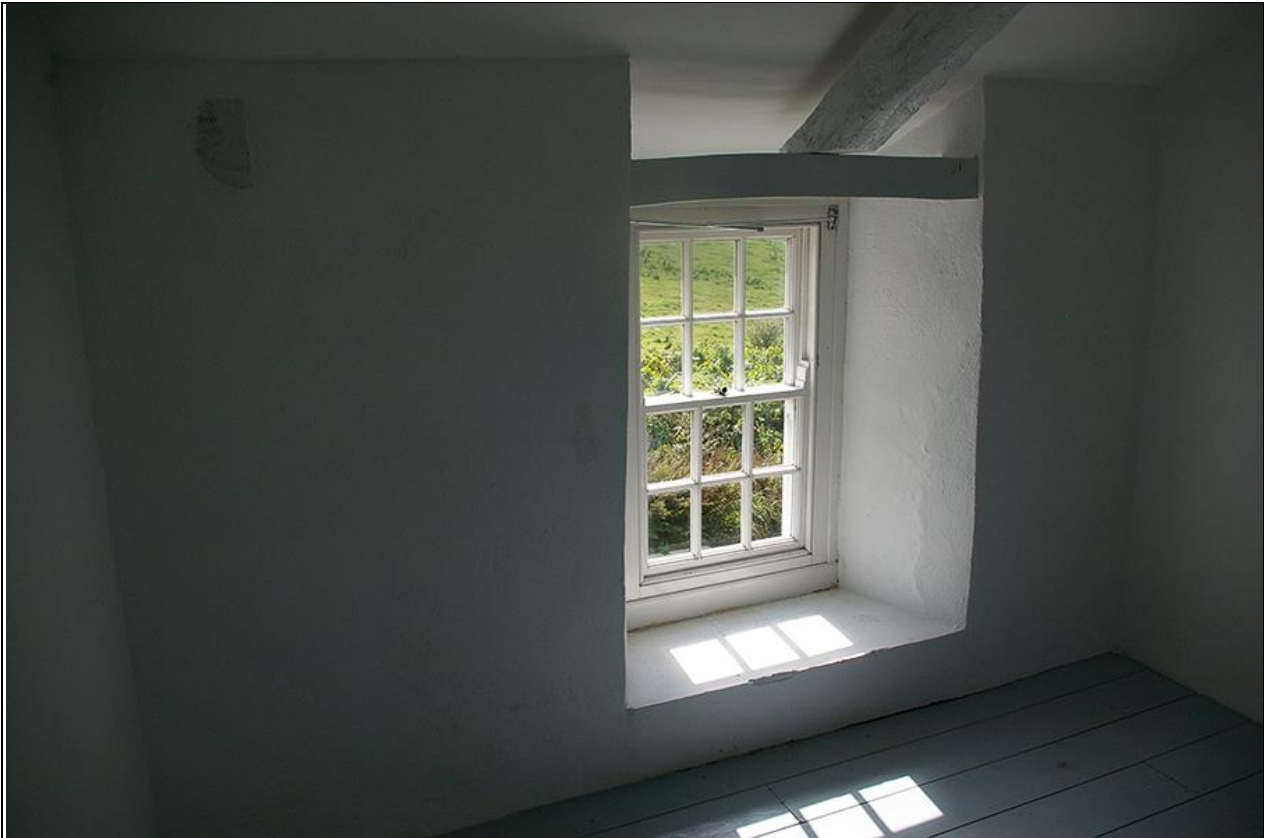
39. THE WINDOW OPENING IN R8, SHOWING DISTURBED REVEALS, SUGGESTIVE OF SLIGHT WIDENING WITHIN THE ROOM AND DEFINITE RAISING/REMOVAL OF THE EAVES, HENCE THE AWKWARD RELATIONSHIP WITH THE ORIGINAL ROOF TRUSS; FROM THE NORTH-NORTH-EAST.

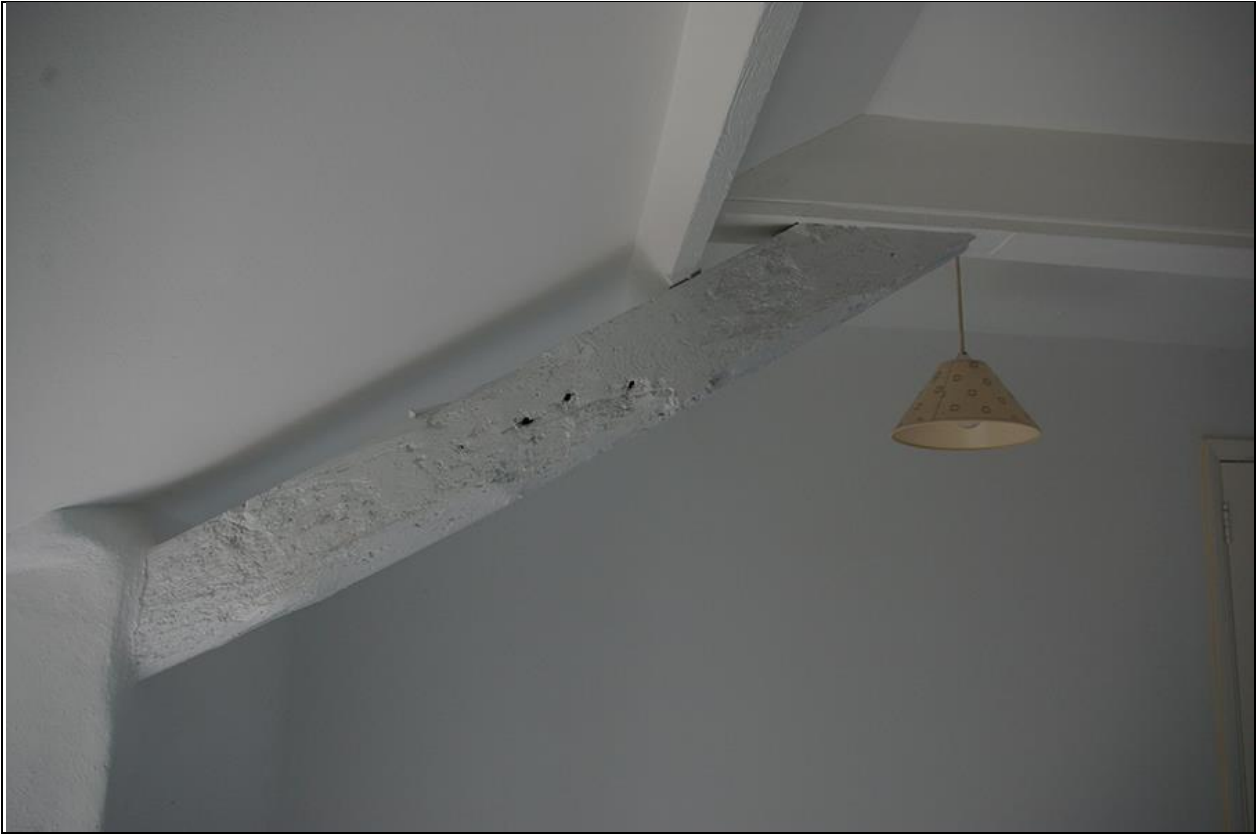
41. DETAIL OF THE TRUSS IN R9, AGAIN SHOWING HOLES FROM TURNED OVER SPIKES, FROM THE REMOVED COLLAR; FROM THE SOUTH-EAST.

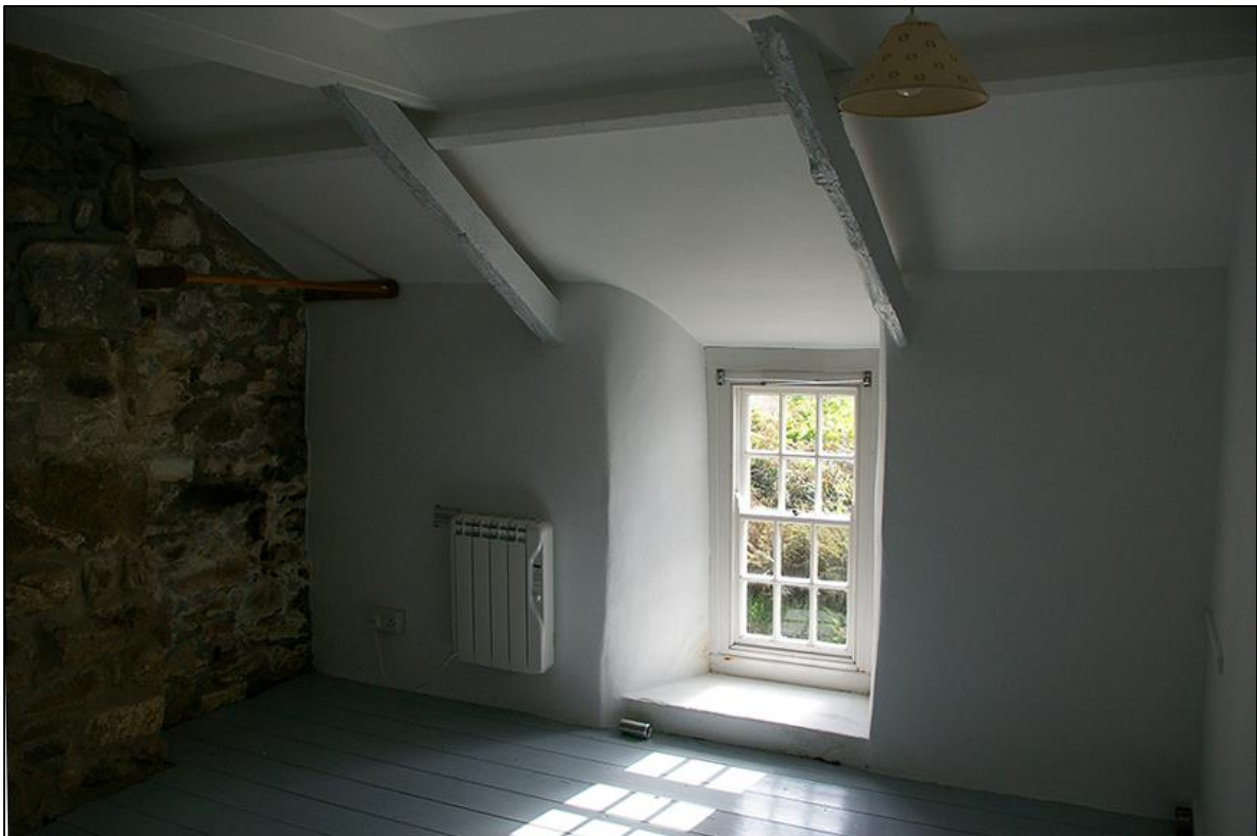
42. THE FRONT SOUTH WALL OF R9, AGAIN SHOWING ENLARGED WINDOW OPENING, CUT UP AT THE EAVES AND RUSTIC TRUSSES; FROM THE NORTH-WEST.

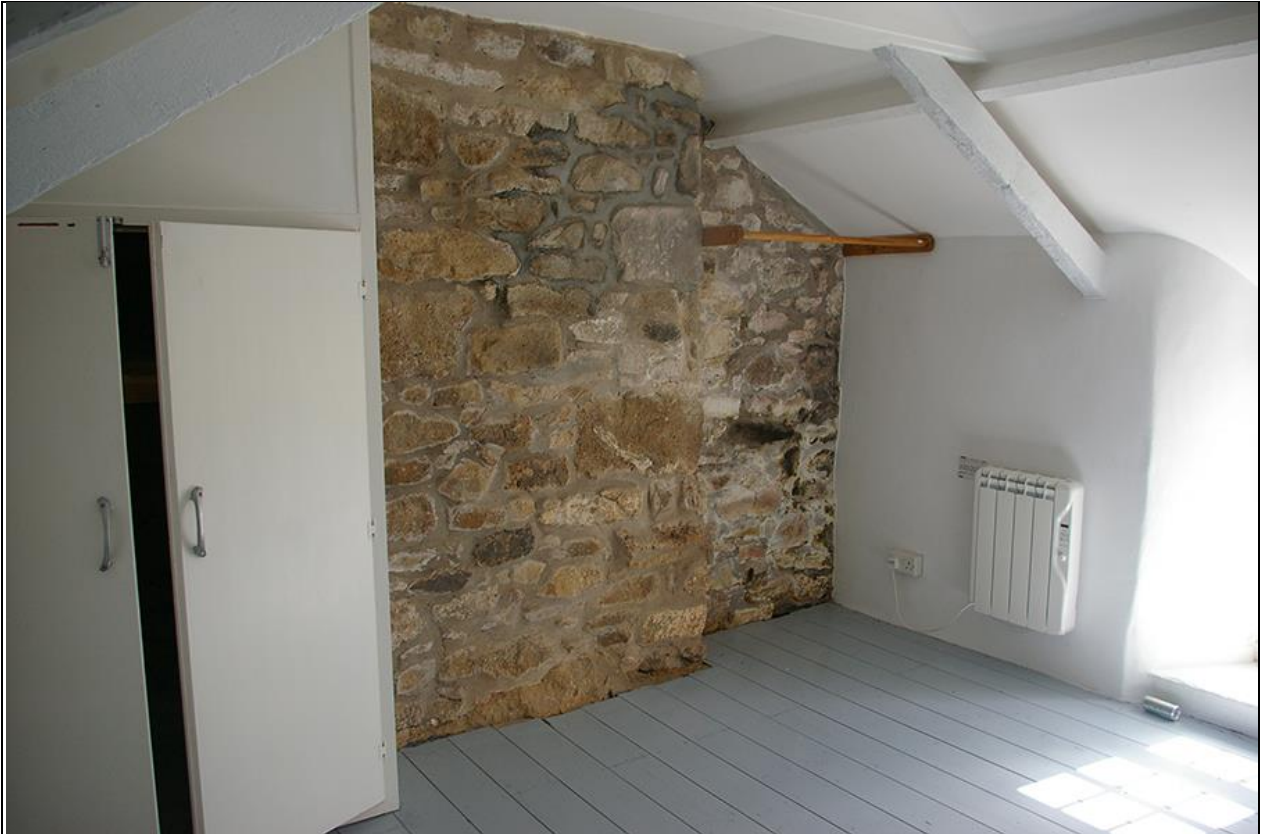
43. R9, THE LARGE HISTORIC STACK, HEAVILY RE-POINTED, THERE DOESN'T APPEAR TO BE A CLEAR BUILD LINE HERE FOR ANY BLOCKED FIREPLACE – SUGGESTING AN UNHEATED FIRST FLOOR FOR THIS SPACE; FROM THE WEST-NORTH-WEST.

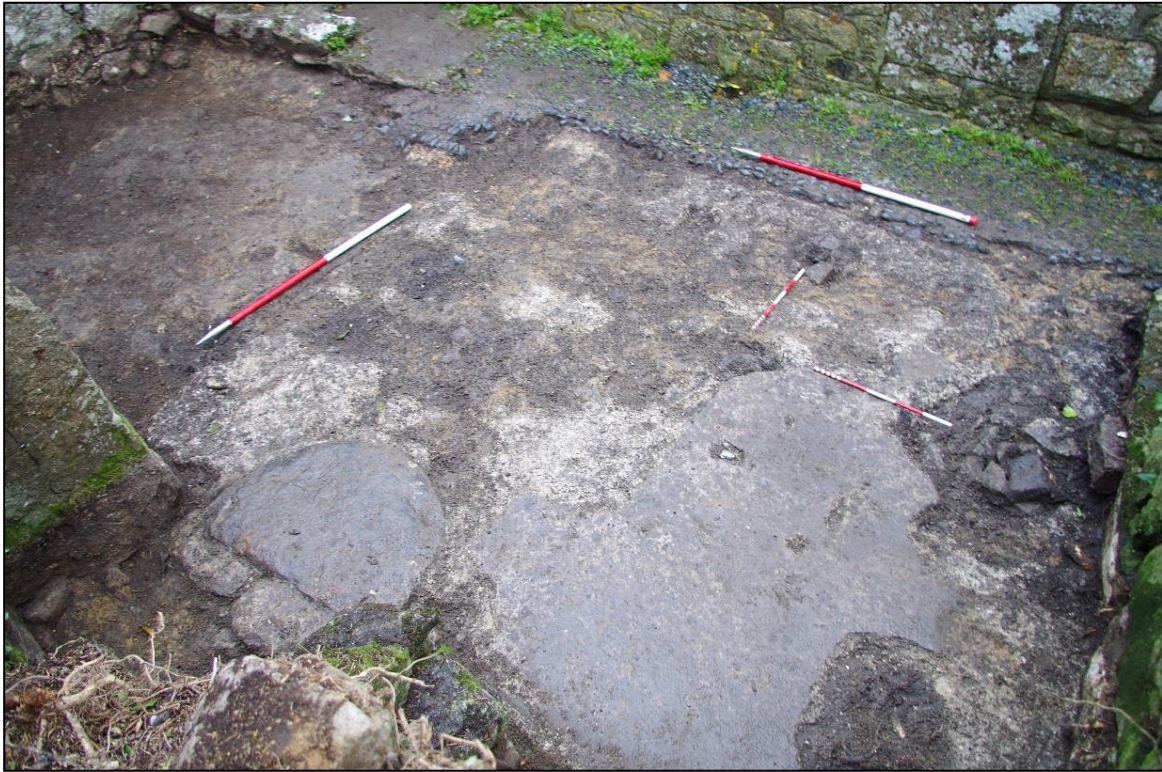
Within Room 12 to the west there is a white lime-packed floor (008), which has many phases of repair and minor alterations. The floor is of dirty white mortar, respecting the stone walls to the west and south, and abutting the plank partitions to the east and the north. Some areas of intact tamped upper-surface survive, polished by wear and cleaning to a sheen in the southern half, but it is largely eroded, parts of the north and east sides having gone entirely, leaving small patches overlying yellow clay bedding material (007). In the doorway area to the passage, in the south-east corner, the floor (008) can be seen to be water damaged and worn away and there is a larger single area of replacement lime-packing (009), fixing an area of wear from high traffic footfall. A more worn floor, thinner in depth and grittier in texture (005) survives to R13 to the rear of the space. This comprises yellowy-brown lime mortar; respecting the plank partitions to the south and east, and the older stone walls to north and west. Its upper surface is decayed having lost its top 'finish' and is largely destroyed by water ingress and saturation/decomposition, on the northern edge. The same yellow clay bedding material can be seen beneath this floor.

(008)	Layer	Floor of dirty white mortar in Room 12 of ruin, respecting stone walls to west and south, and plank partitions to east and north. Some areas of intact surface survive in southern half, but it is largely eroded, parts of the north and east sides having gone entirely, leaving small patches overlying yellow clay bedding material (007). Occasional black pebbles on the southern and western edges suggest that it replaced a cobbled floor as in the Room 11.	Abuts (006), {041}, {064}, {065}; abutted by (009), cut by [012], [014], [016], [018], [020], [022], {024}, [037]; overlaid by (004).	2.80m east-west x 3m north-south x c.8cm thick.	Mid-late C19

13. THE WHITE LIME-PACKED FLOOR (008) OF R12; FROM THE SOUTH-WEST (1M SCALES).

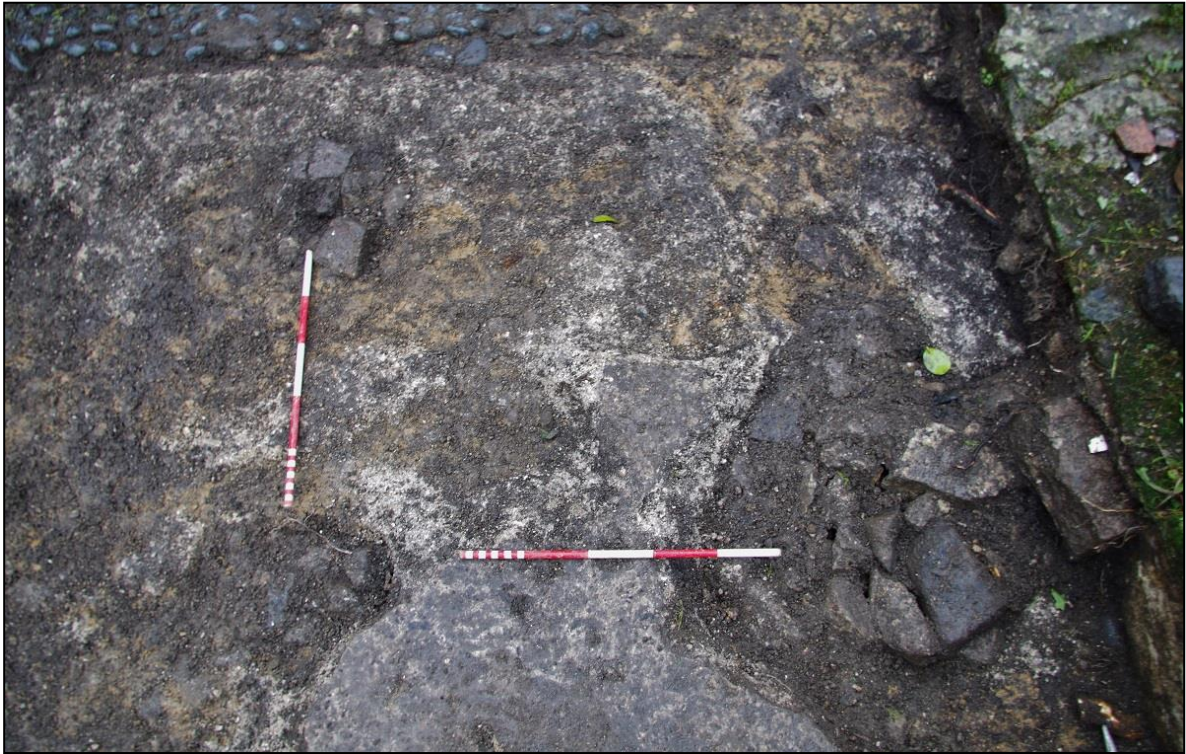
There is a sub-square arrangement of three sub-ovoid shallow postholes [012], [014], [016] against the partition to the passage and south wall, in the south-east corner of R12. These post holes cut the lime floor and the larger one to the south wall can be seen to be packed with stones. The lime-packed floor is much damaged here and stained suggesting increased foot traffic-wear in this location or water damage, the sub-square arrangement of posts may indicate a small lobby or other partition or a fixed piece of furniture, with a timber framework.

15. ARRANGEMENT OF THREE POSTHOLES, [012 ], [014 ], [ 016], IN THE SOUTH-EAST CORNER OF R12, SET INTO THE LIME-PAKED FLOOR (008); FROM THE WEST (5M SCALES).

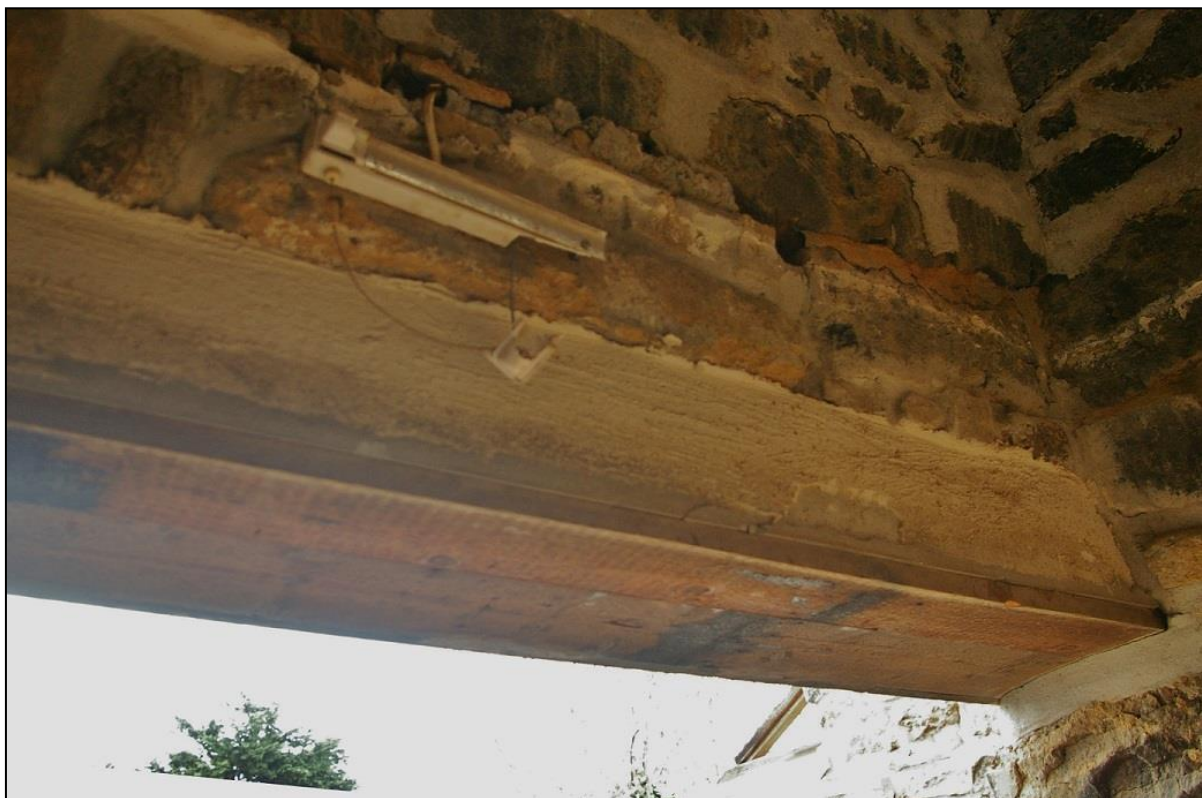
23. THE CONCRETE BEAM AND REBUILT SECTIONS OF THE STACK WHICH INDICATES A LINTEL HAS BEEN REMOVED AND A NEW LINTEL INSTALLED AT A MUCH HIGHER LEVEL; FROM THE SOUTH-EAST.

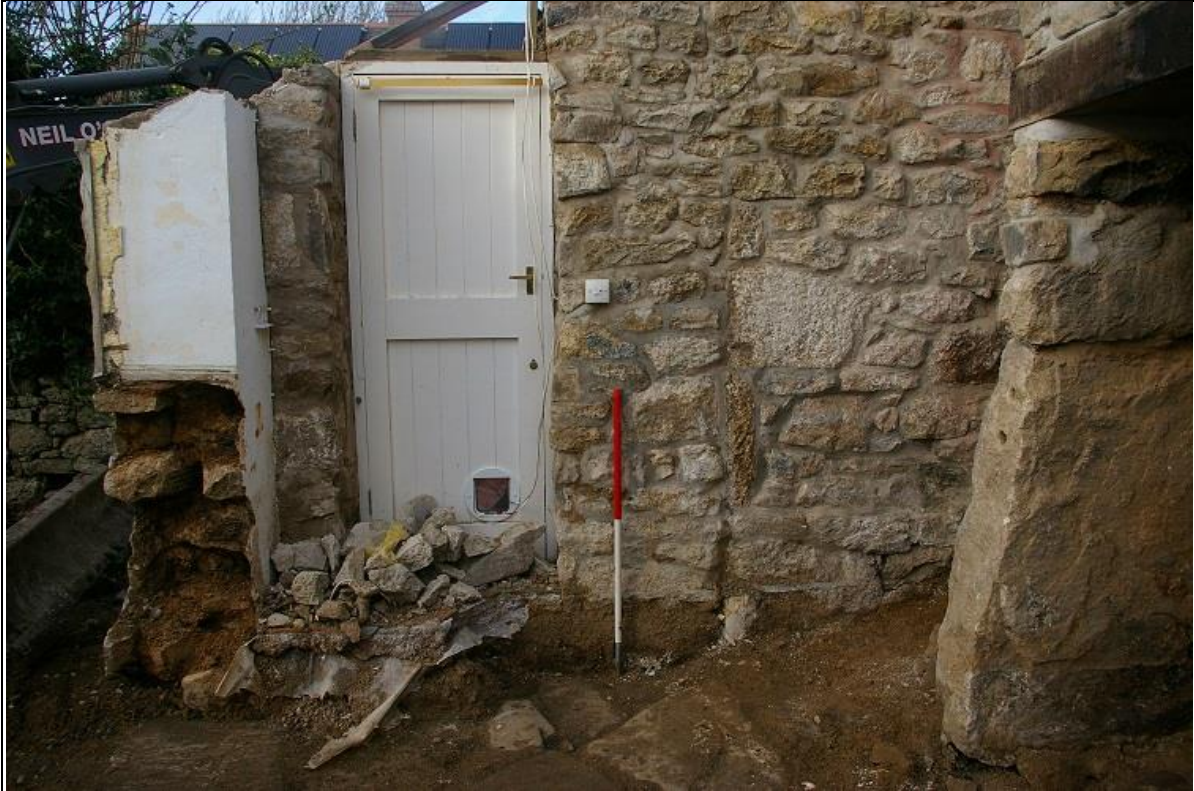
24. THE NORTH WALL OF R2 {067}, SHOWING THE STONE FLOOR ABUTTING THE NORTH WALL, WITH THE BLOCKED AND RE-CUT DOORWAY (1M SCALE); FROM THE SOUTH.

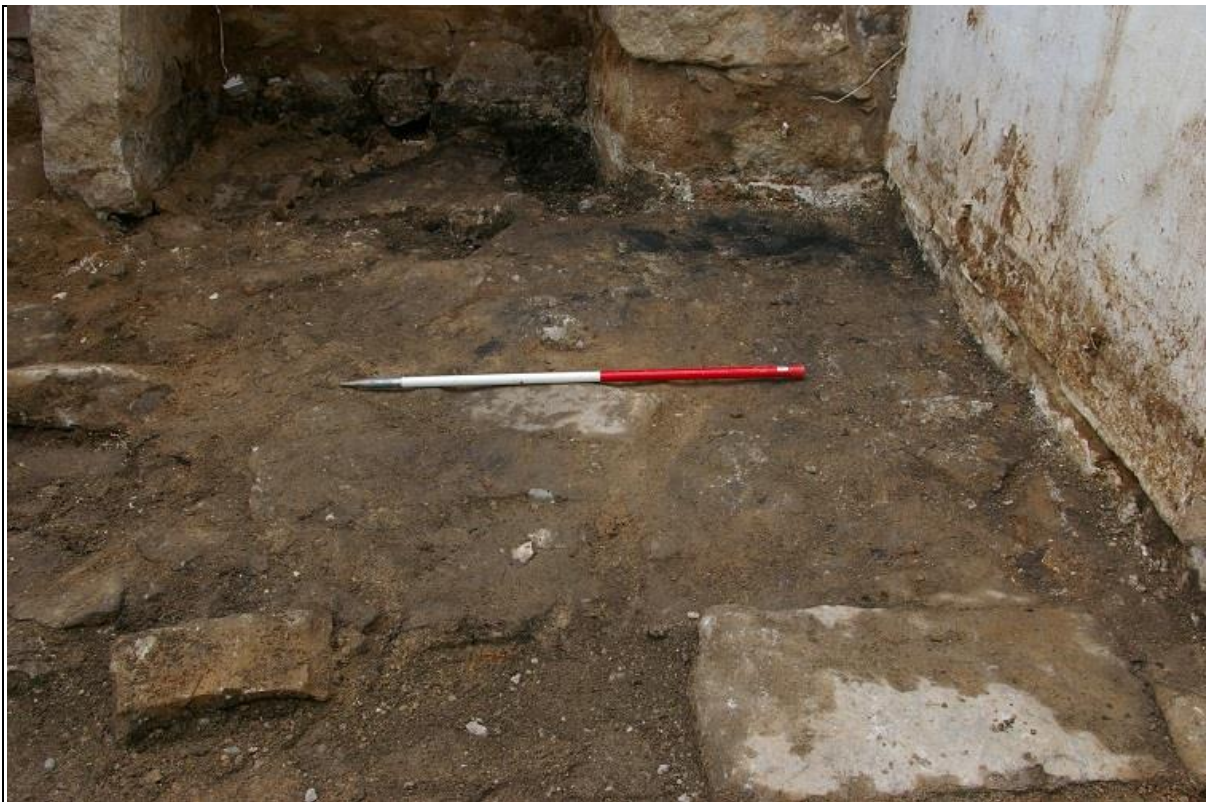
25. THE ROUGH LIME PACKED FLOOR (078) CRUDELY LAID OVER THE STONE PAVED FLOOR (093), WITHIN R2 (1M SCALE); FROM THE WEST.

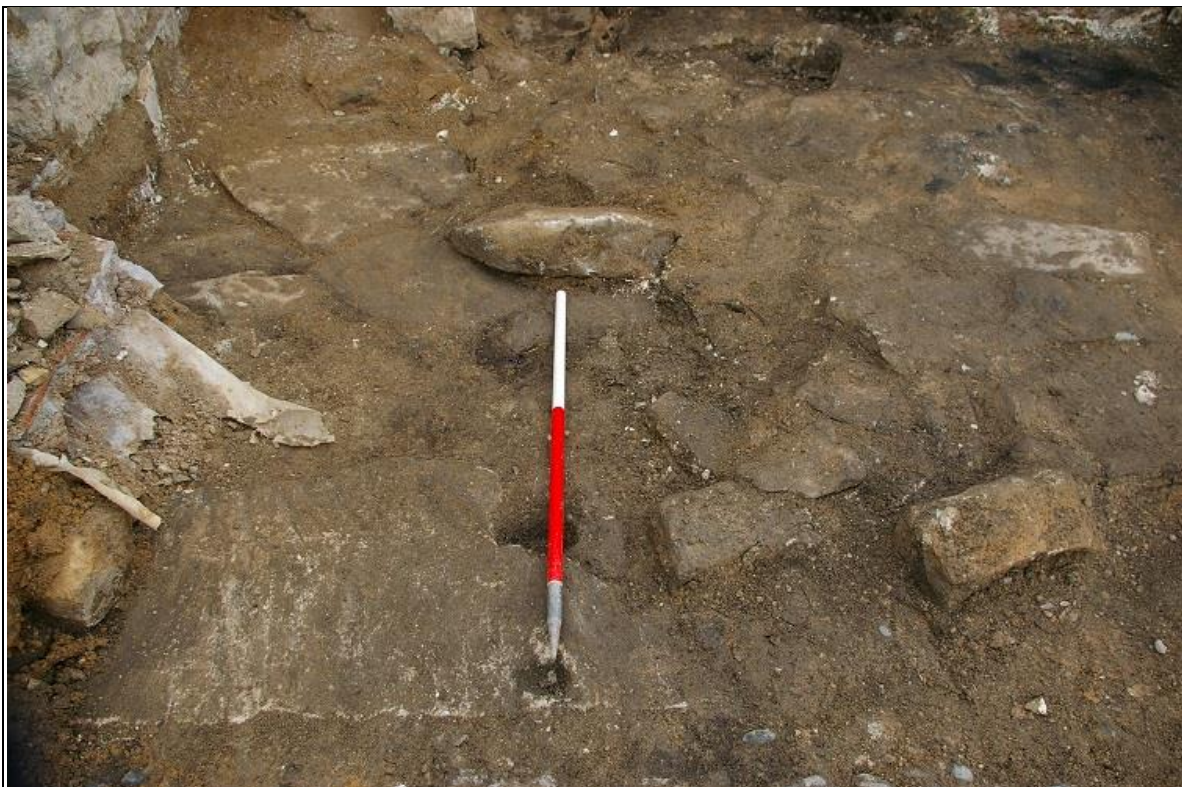
27. THE HISTORIC THRESHOLD {052}, CONTEMPORARY WITH THE COBBLED PASSAGE AND STONE PAVED FLOOR, WHICH HAS PARTLY SUNK INTO THE DRAIN BELOW THE FLOOR; FROM THE WEST (1M SCALE).

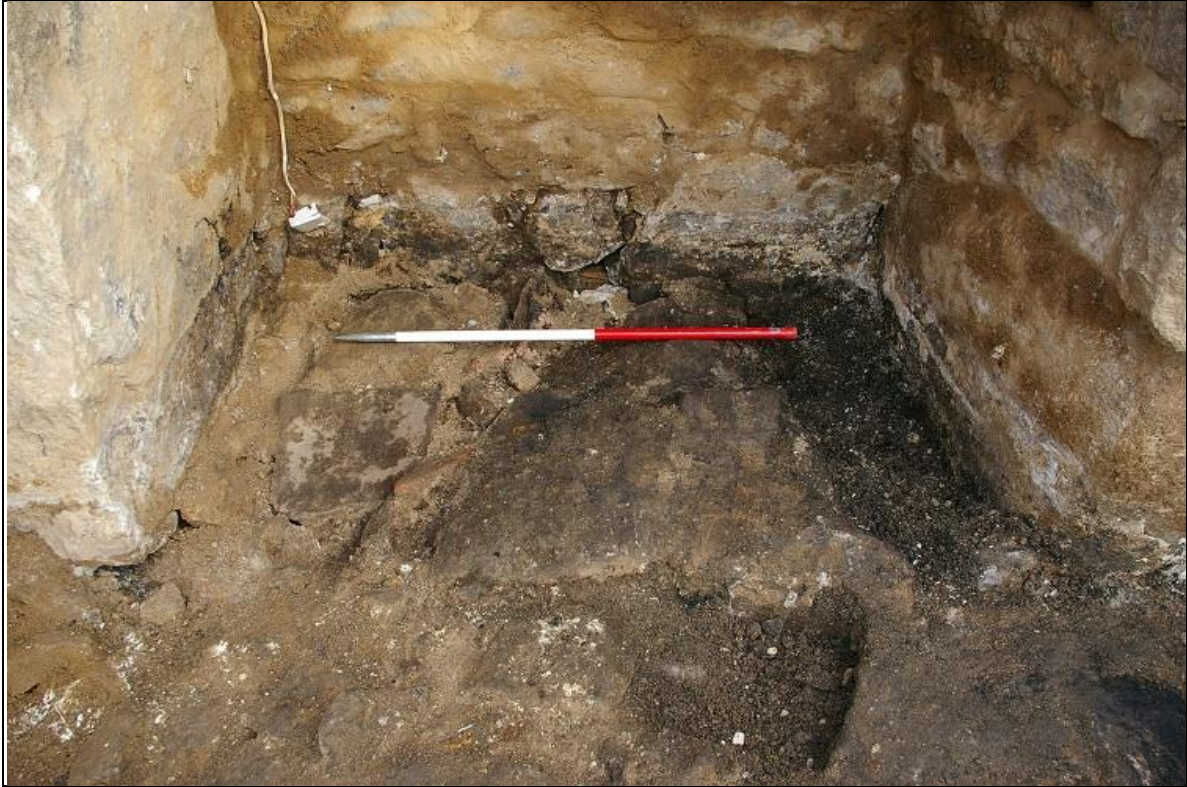
28. THE HEARTH IN R2{095}, WITH VARIOUS LARGE CRUDE SLATE SLABS (093) INCLUDING THOSE WHICH HAVE SUNK INTO A DRAIN BENEATH AND LATER BEEN PACKED WITH SAND TO OFFSET THE SLUMPING; FROM THE WEST (1M SCALE).

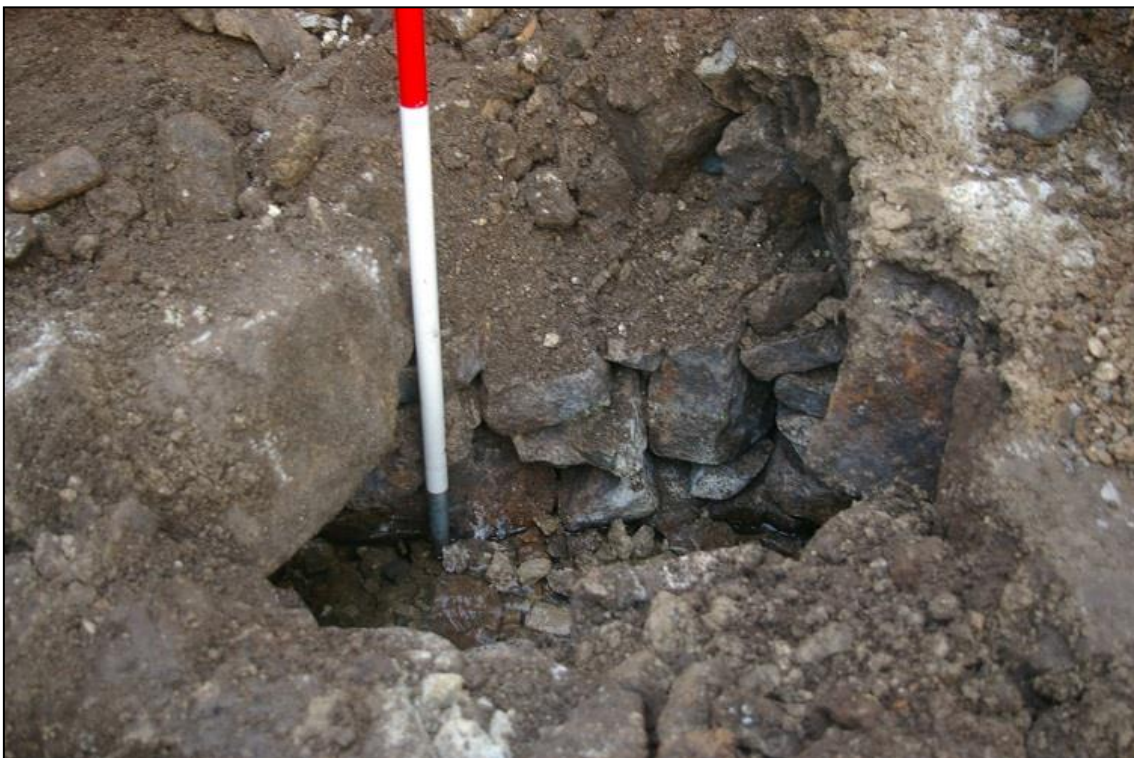
31. THE LOOSE RUBBLE BUILD OF THE DRAIN {076}, SHOWING IT'S ALMOST DRY-STONE CRUDE BUILD (1M SCALE); FROM THE SOUTH (1M SCALE).
