WHEAL ELLEN ENGINE HOUSE
PORTHTOWAN
ST AGNES
CORNWALL

Updated Historic Building Appraisal

South West Archaeology Ltd. report no. 220303

Report Version: FINAL

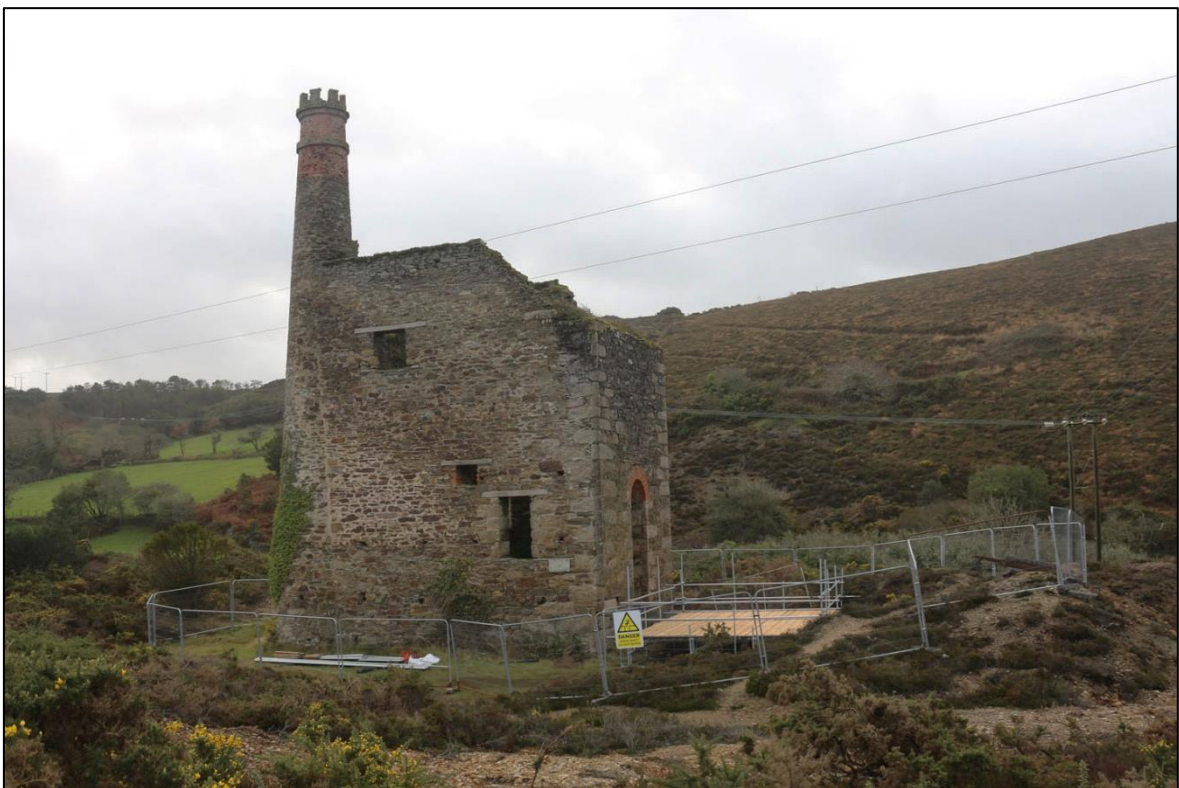
FIGURE 5: THE NORTH-EAST ELEVATION; FROM THE EAST-NORTH-EAST (NO SCALE).

The long north-east flank wall is of three storeys, with three irregularly placed openings, the round chimney shaft bracing the south-east corner. Heavy dressed and faced granite quoins can be seen to the north corner to the bob wall. The base of the elevation exhibits heavier battered stonework, of more irregular build and form and incorporates larger stones; the granite quoins at this level are also more roughly dressed. The stonework c.2m above ground level is less tightly built, in more typically 19th century rubble form. The stonework is graduated, becoming lighter in weight as the wall rises. Patches of the stonework here exhibit a mix of the original mortar pointing, cement repairs and a large area of more recent pointing, providing evidence of ongoing maintenance. There are three openings in this elevation. At internal ground-floor level there is a low doorway with granite reveals and timber lintel; this was the door to the boiler house. There is a small square opening just above this doorway with patched brick reveals and narrow timber lintel; this was for the boiler pipe. On a level with the top of the bob wall is a large sub-square irregular opening with narrow timber lintel and sill and ragged patched reveals; this was the cross-

beam socket. Two, possibly three lines of putlog holes (or perhaps joist sockets for the boiler house?) survive close to ground level. Internally, the same three openings are apparent, together with four lines of joist sockets. The walls steps in twice, once at internal ground-floor height, and again when level with the top of the bob wall. The chimney is round and tapers to the apex, built onto the engine house with straight joins, also of rubble build and tied in to the main building. The top of the chimney is in red brickwork top, with a projecting cornice to the top and crenelations.

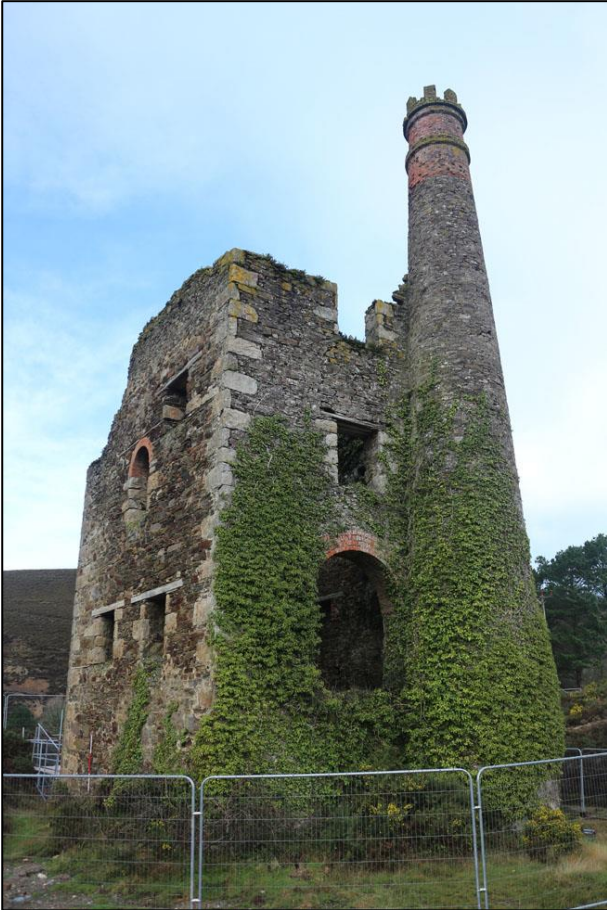
FIGURE 6 (LEFT): THE CHIMNEY WHICH CLASPS THE CORNER OF THE ENGINE HOUSE, FROM THE SOUTH (**NO SCALE**).
FIGURE 7 (RIGHT): INTERIOR FACES OF THE TWO LONG WALLS IN THE ENGINE HOUSE; FROM NORTH AND WEST.

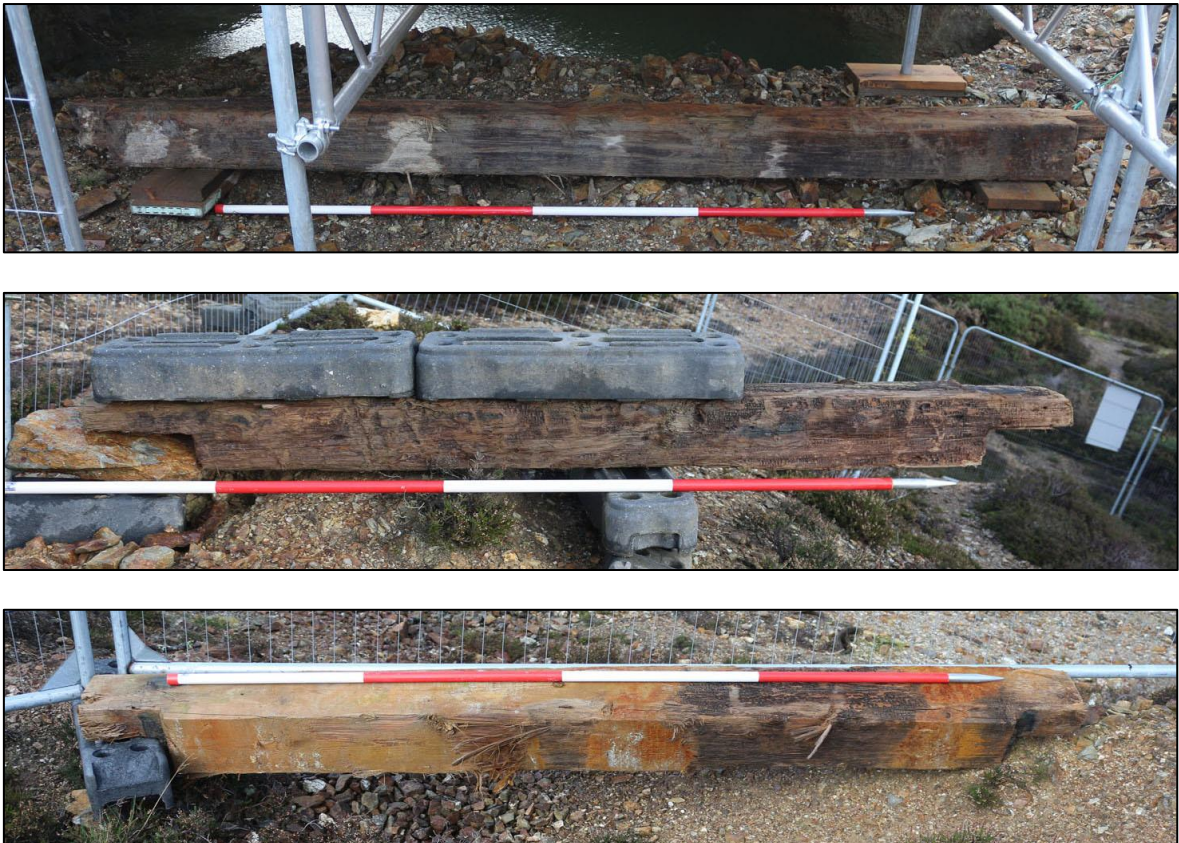
The main difference between 2017 and 2022 has been the exposure of the shaft that lies in front of the bob wall. A large rectangular hole c.2m wide and c.3m long and at least 30m deep. At the time of the site visit in January, it was full to the brim with water and a high water table was evident elsewhere around the site. During the summer the water may drop as low as 4m below current ground level. Timberwork survives around the head of the shaft. Three of the four timbers which had supported the original capping had been recovered and were recorded. Each one was a substantial sawn timber 0.18-0.2m square and 2.34m, 2.58m, and 3.47m long. The two ends of each timber were cut to fit a half-lap joint. The timbers were in excellent condition, stained orange or greenish-orange by the sulphides in the mine water. One of the timbers still preserved one of the carpenter's pencil marks. These timbers are probably re-used shaft lining.

FIGURE 10: THE THREE TIMBERS RECOVERED FROM THE SHAFT CAPPING (2M SCALES).

The very well-preserved timbers that were recovered are a result of a sealed environment, and it would be best to replicate this to ensure the preservation of the timbers around the head of the shaft. Left exposed to fluctuating water levels, the exposed timbers will weaken and rot, albeit slowly. As these timbers retain the unconsolidated material above the rockhead, the failure of those timbers will lead to the collapse of the shafthead and potentially – subject to the depth of the foundations – undermine the bob wall.

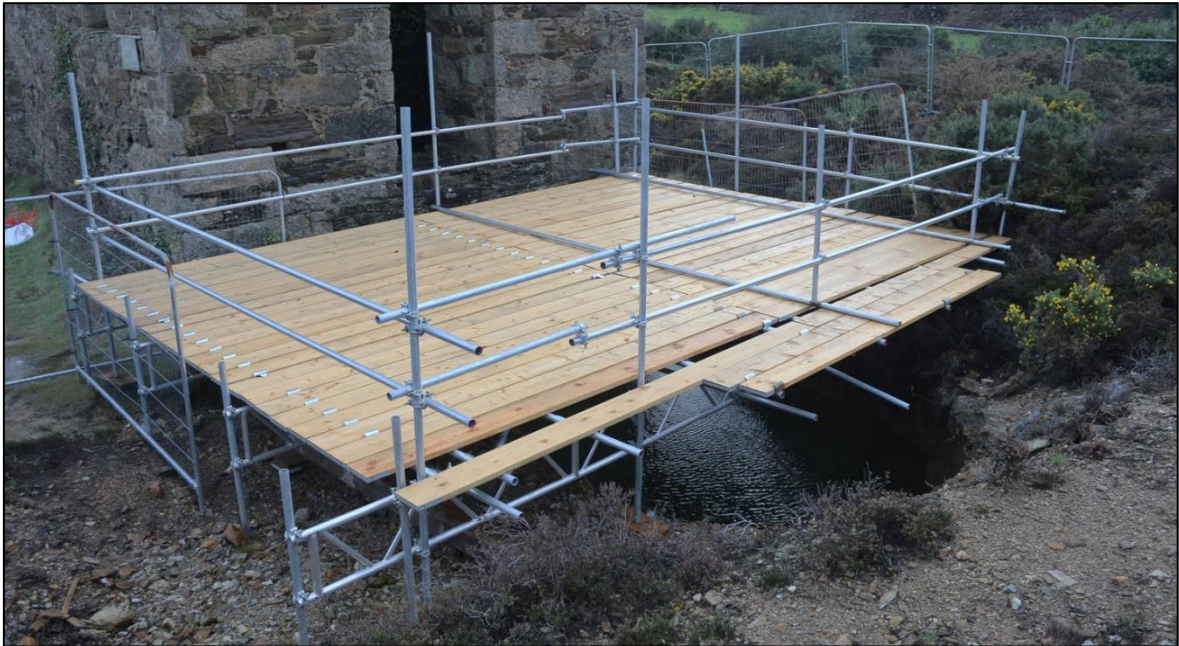
FIGURE 11: THE UNCAPPED SHAFT IN FRONT OF THE BOB WALL, WITH SCAFFOLDING COVERING IT; VIEWED FROM THE WEST (NO SCALE). THE HIGH WATER TABLE IN THE WINTER IS EVIDENT.

The exposed shaft should be capped sympathetically and covered over. Leaving it open (e.g. open but with a wall and pyramidal metal grid) would threaten the long-term stability of the shaft head, and there is no precedent for this at this location (e.g. issues with authenticity etc.). As the shaft was until recently sealed, and fills to the brim with water in winter, there is no ecological reason (e.g. bats) to retain an opening.

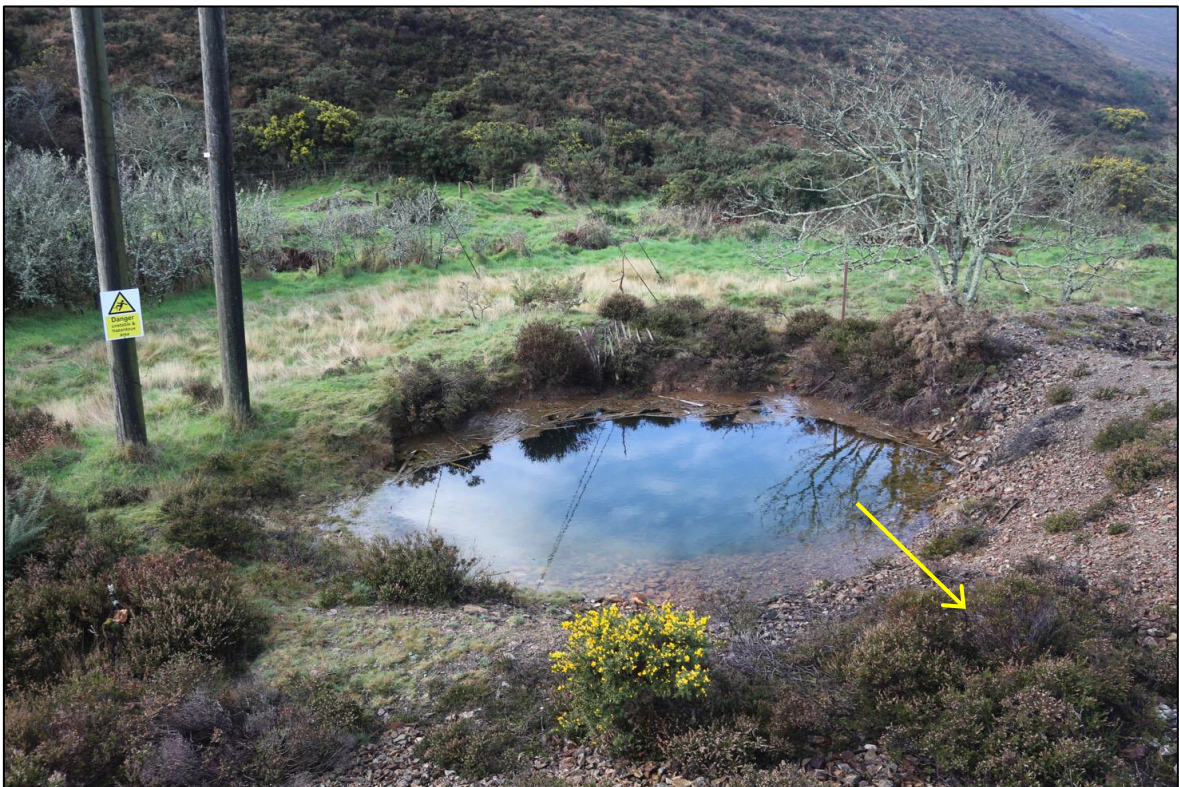
The engine house stands in a flat area of ground, with spoil heaps to the south, and wrapping around to the south-west, west and north-west. Some of these spoil heaps appear to have been disturbed, but this occurred before the current owners took possession. There are several uncapped shafts in the immediate vicinity. South-east of the engine house is a possible shaft, swathed in vegetation. South-west of the engine house (adjacent to a telegraph pole) is a third shaft; this currently presents as a shallow circular pool. Three granite marker posts were identified in a line to the south of the engine house; these are likely to be the boundary stones ('BS') marked on the historic OS maps, marking the boundary between St Agnes and Illogan. It is also possible they marked the boundary between mining setts. In either case, their survival *in situ* is fairly rare and noteworthy. Two of the stones had a 'W' carved into one face, with a number ('22') carved beneath. The style of the numbering would suggest a late 18th or early 19th century date.

FIGURE 12: THE UNCAPPED SHAFT SOUTH-WEST OF THE ENGINE HOUSE. THE LOCATION OF ONE OF THE BOUNDARY STONES IS INDICATED.

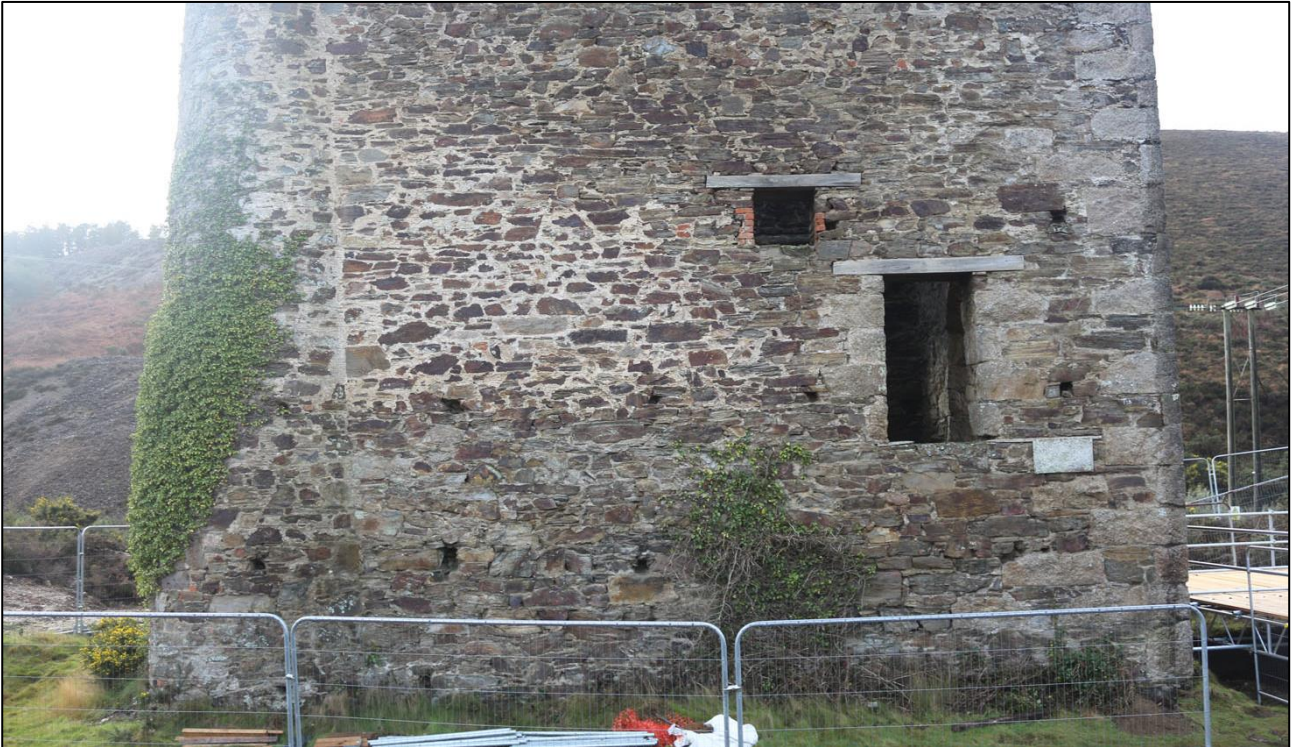
THE LOWER PART OF THE NORTH-EAST ELEVATION; VIEWED FROM THE NORTH-EAST (NO SCALE). NOTE THE PUTLOG HOLES.

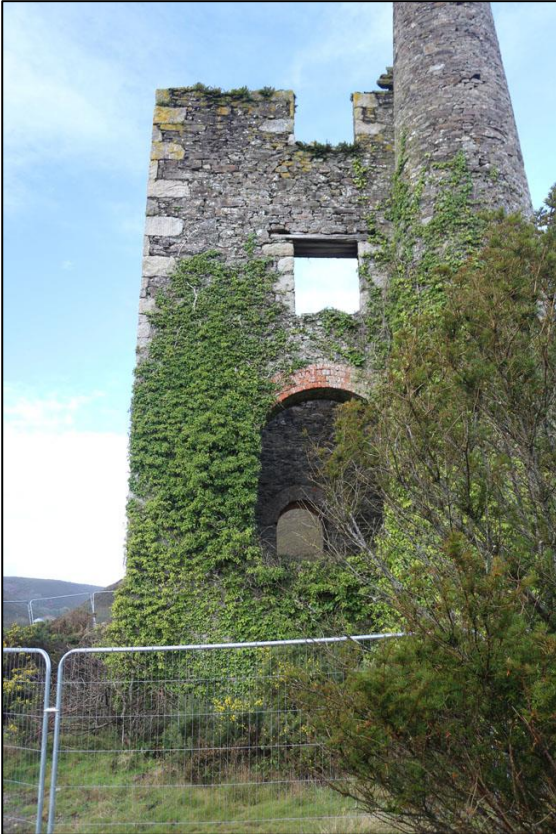
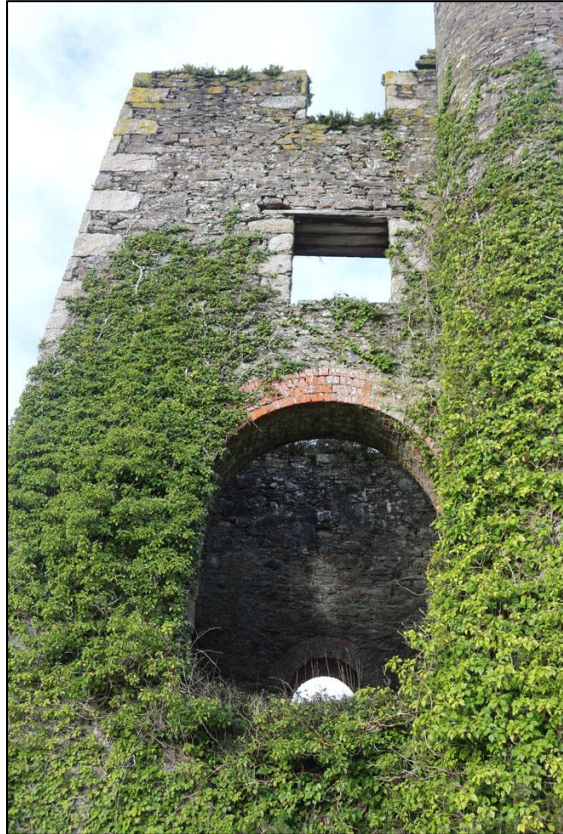
LEFT: THE SOUTH-EAST ELEVATION SHOWING THE CYLINDER DOOR; VIEWED FROM THE SOUTH-EAST (NO SCALE).
RIGHT: AS ABOVE, DETAIL OF THE OPENINGS.

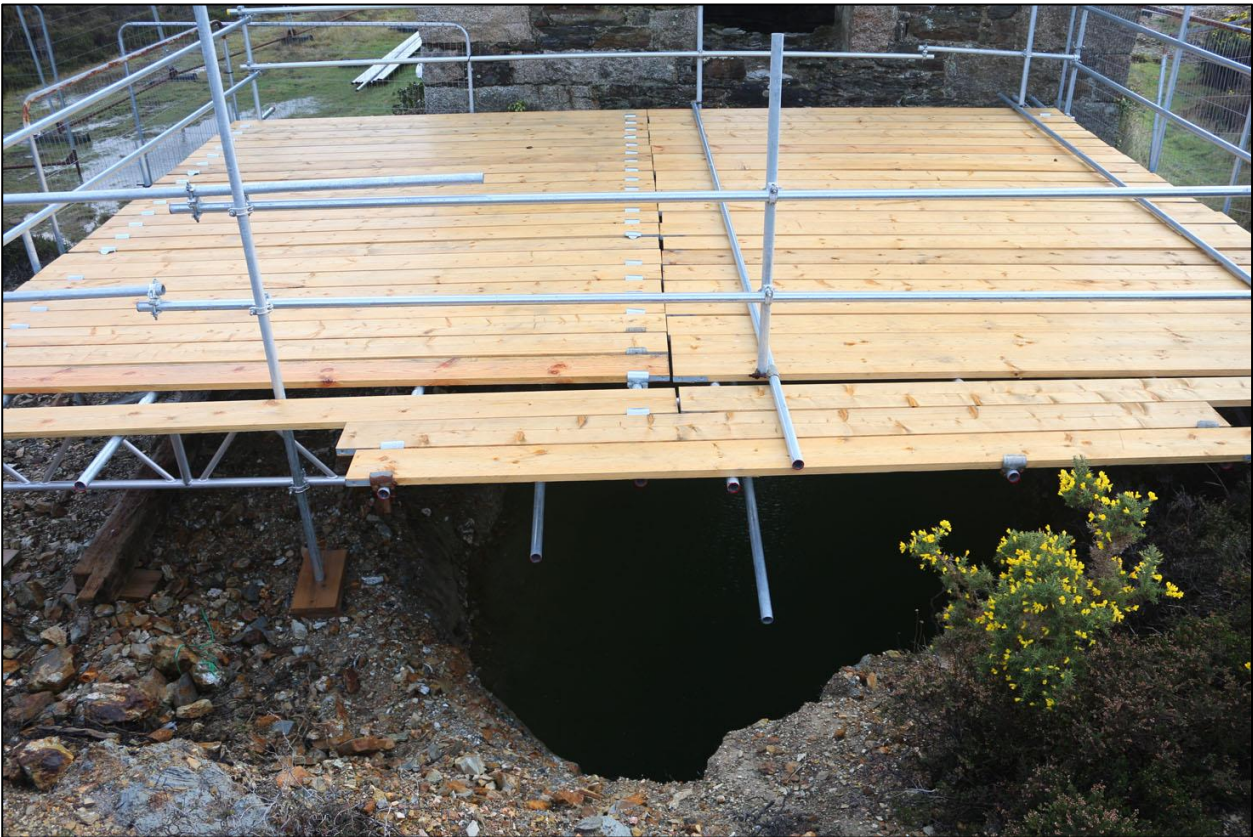
THE EXPOSED SHAFHEAD OUTSIDE THE BOB WALL; VIEWED FROM THE NORTH-EAST.
