BARN AT PIXTON FARM

IDDESLEIGH

Heritage Assessment

South West Archaeology Ltd. report no. 230523

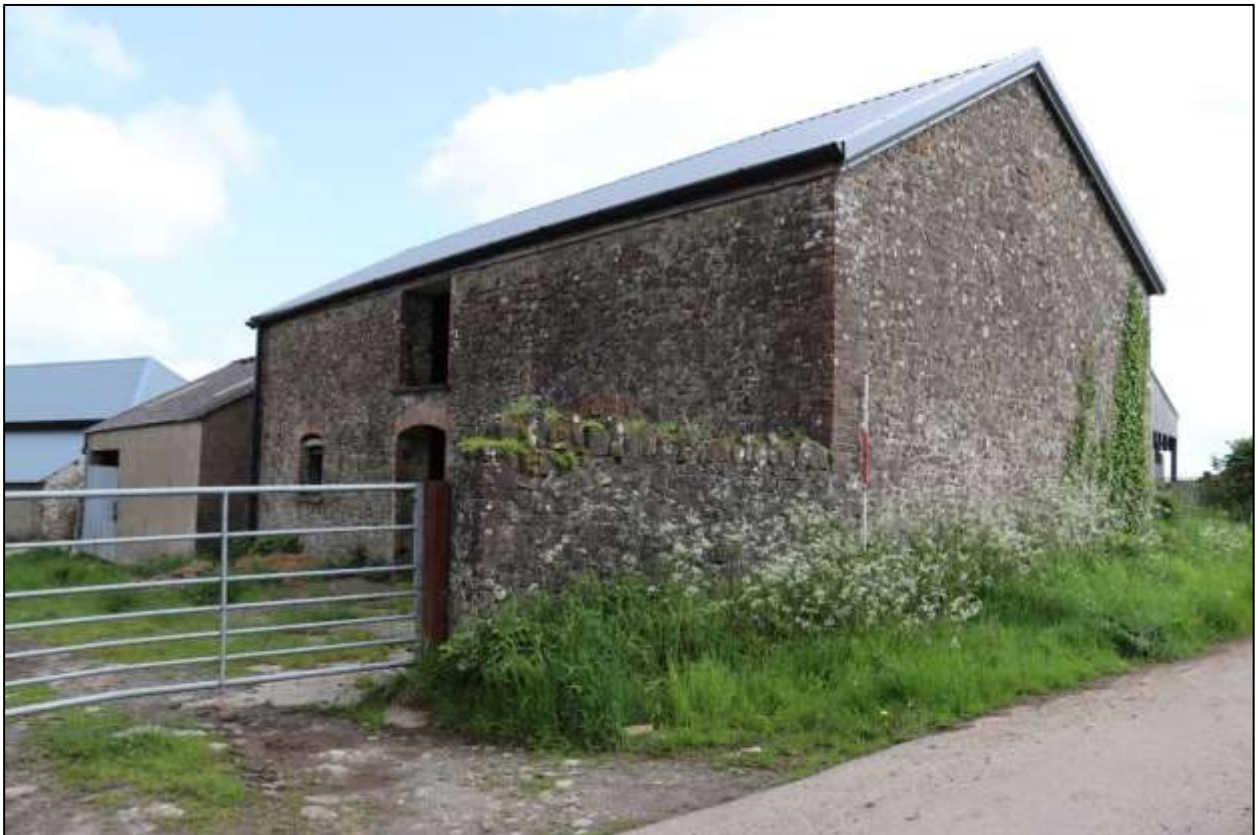
FIGURE 5: THE SOUTH ELEVATION OF THE BARN, BLIND AND SLIGHTLY ANGLED TO THE ROAD; VIEWED FROM THE SOUTH-WEST (SCALE 2M).

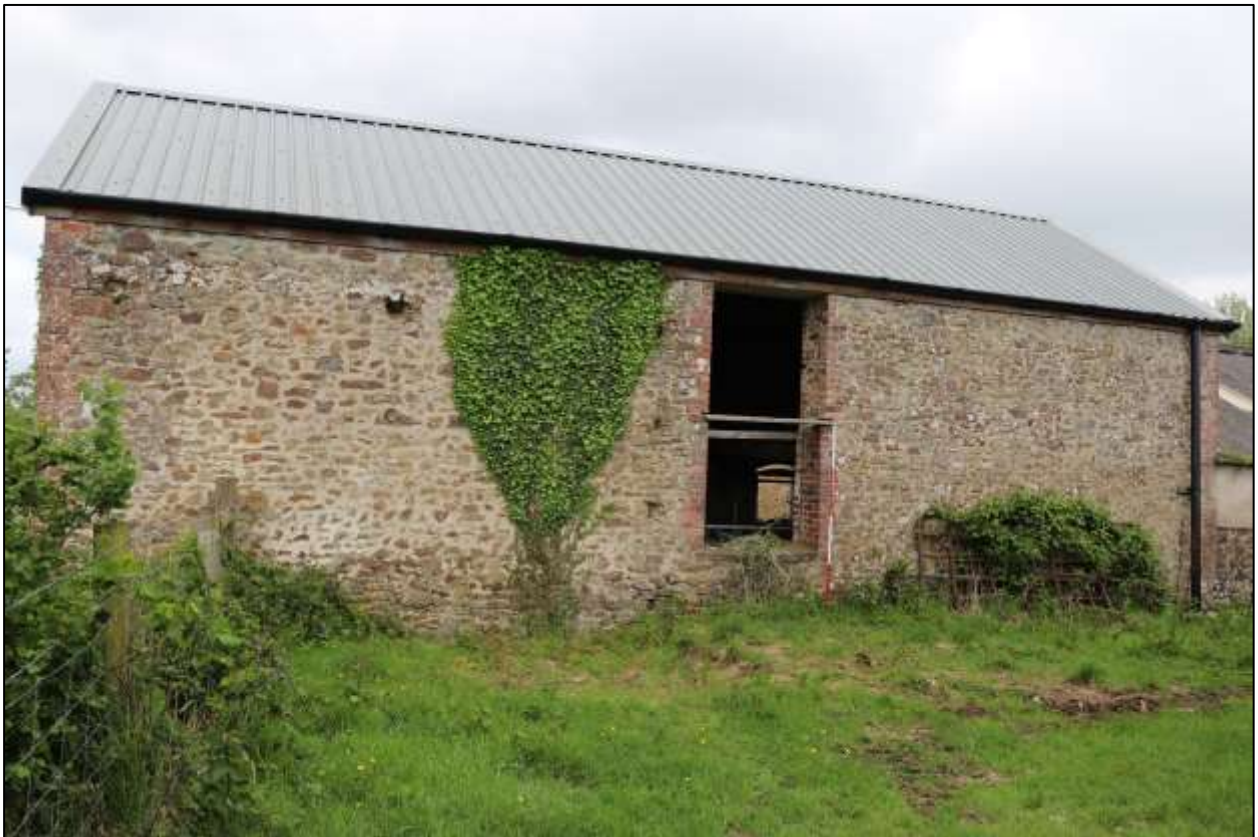
FIGURE 15: THE EAST ELEVATION OF THE BARN WITH DOUBLE-HEIGHT OPENING, AND SCARRING FOR A LOST LEAN-TO; VIEWED FROM THE ESE (SCALE 2M).

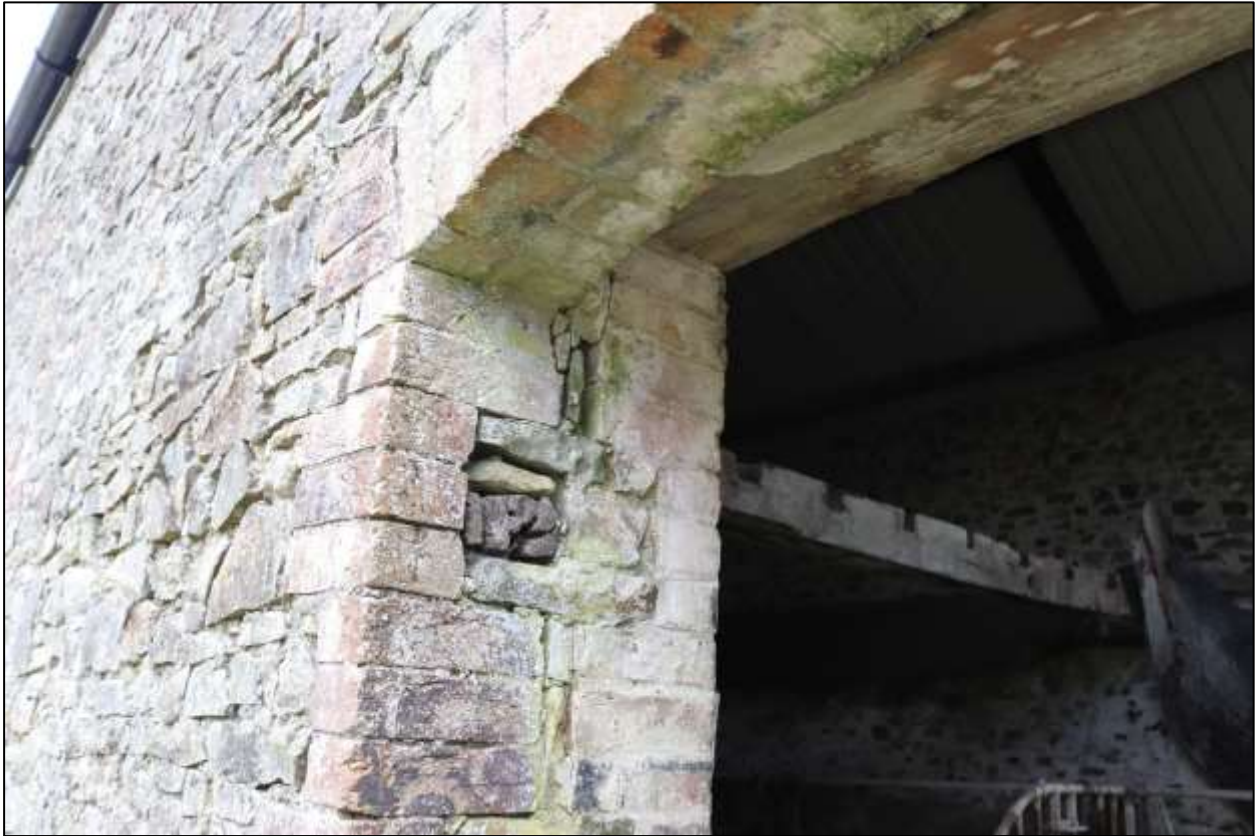
FIGURE 16: THE ORIGINAL DOORWAY TO THE BARN. BRICK DRESSINGS AND TIMBER SOCKETS FOR A DOOR FRAME THAT NO LONGER SURVIVES; VIEWED SOUTH-WEST.

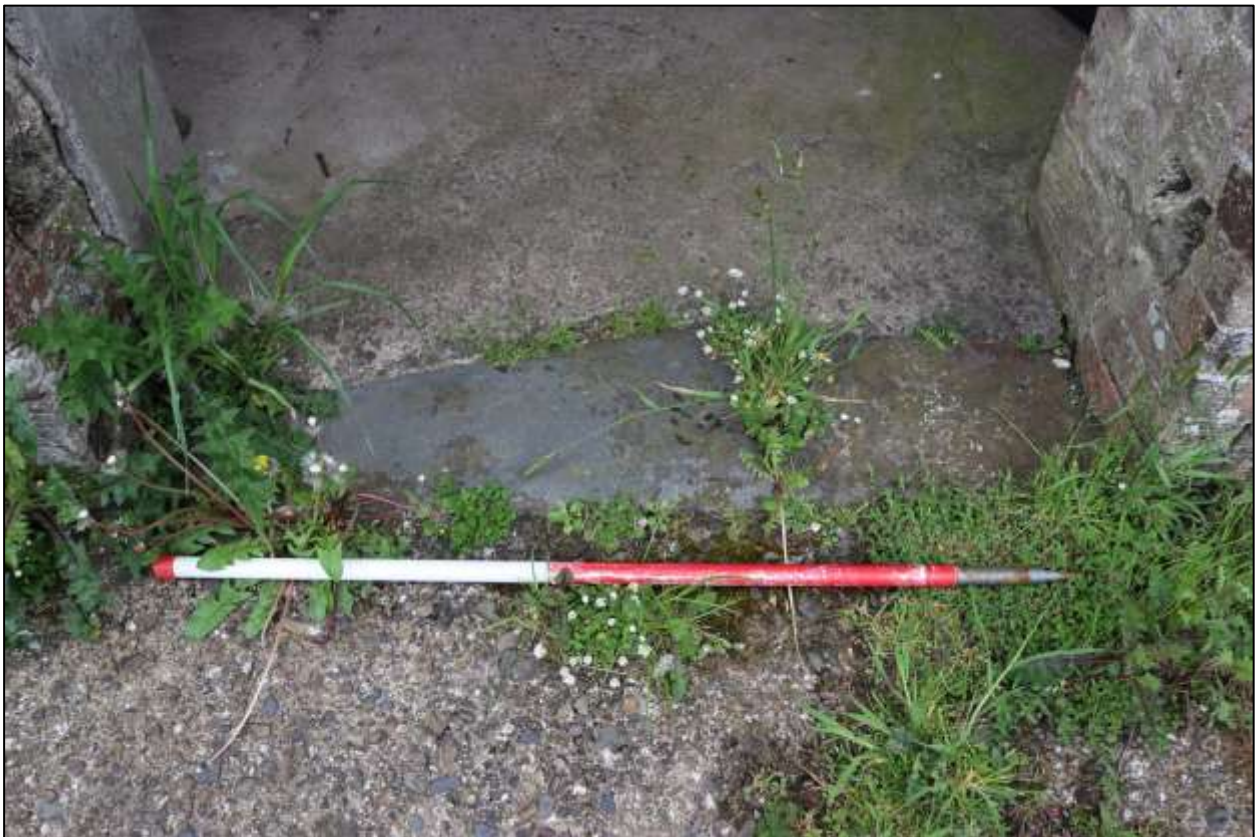
FIGURE 17: THE SLATE THRESHOLD SURVIVING TO THE CENTRAL DOOR; VIEWED FROM THE WEST (SCALE 1M).

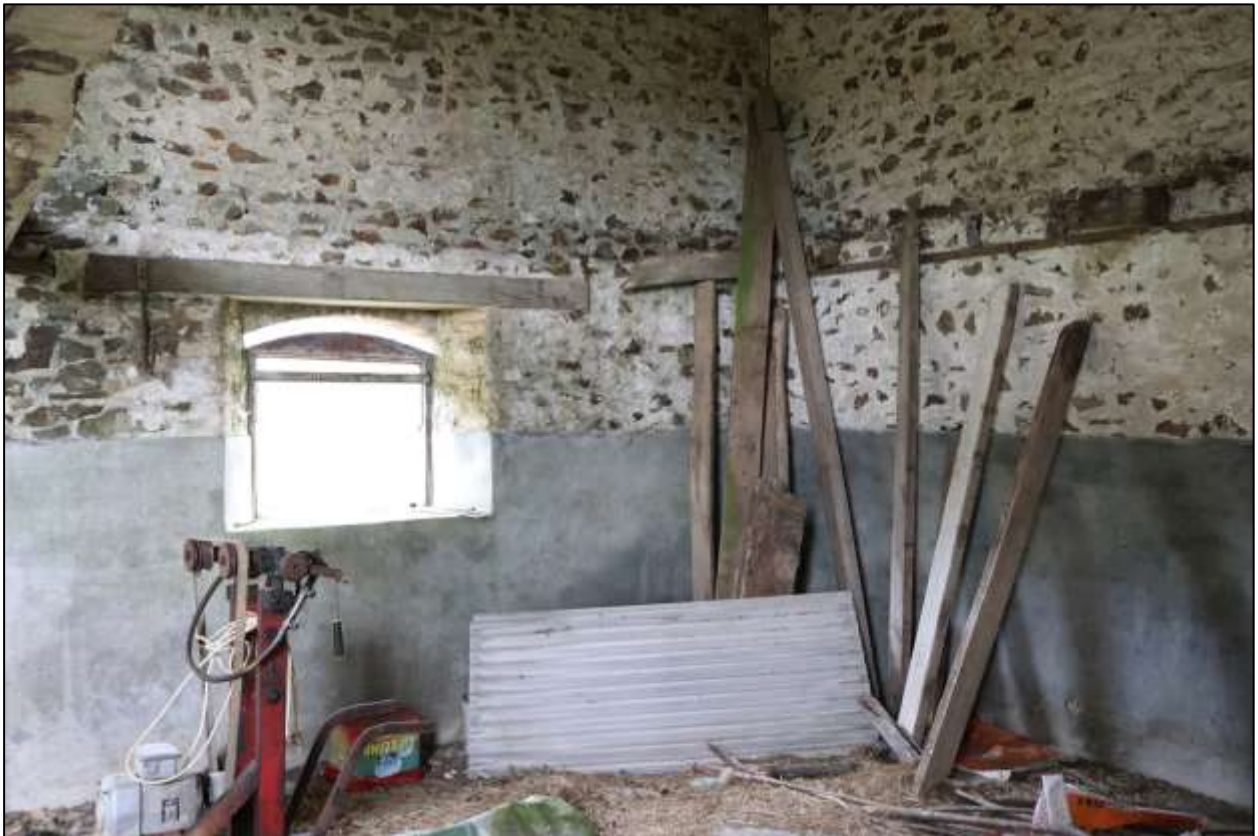
FIGURE 20: THE NORTH-WEST CORNER OF THE BARN, SHOWING THE SCARRING FOR THE LOFT FLOOR; VIEWED FROM THE SSE.

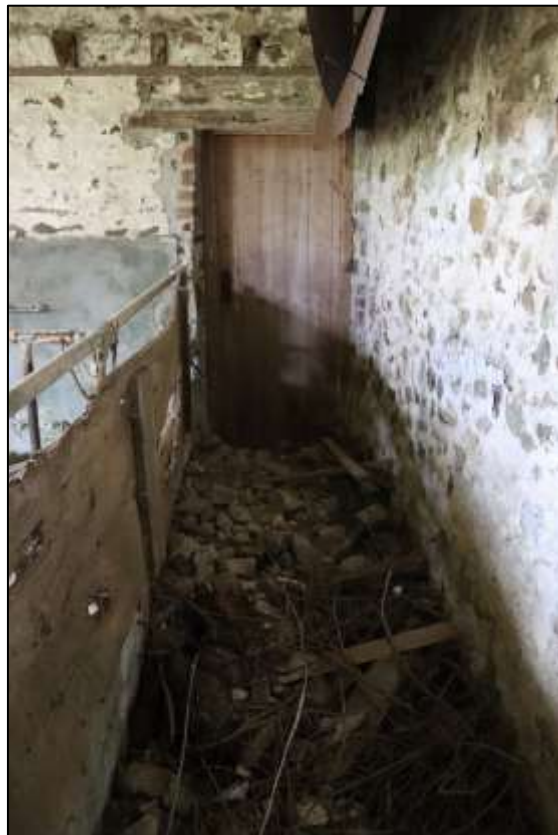
RIGHT FIGURE 22: VIEW ALONG THE FEED PASSAGE LEADING TO A PLANKED TIMBER DOOR WITH THUMB LATCH IN A PEGGED FRAME; VIEWED FROM THE SOUTH.

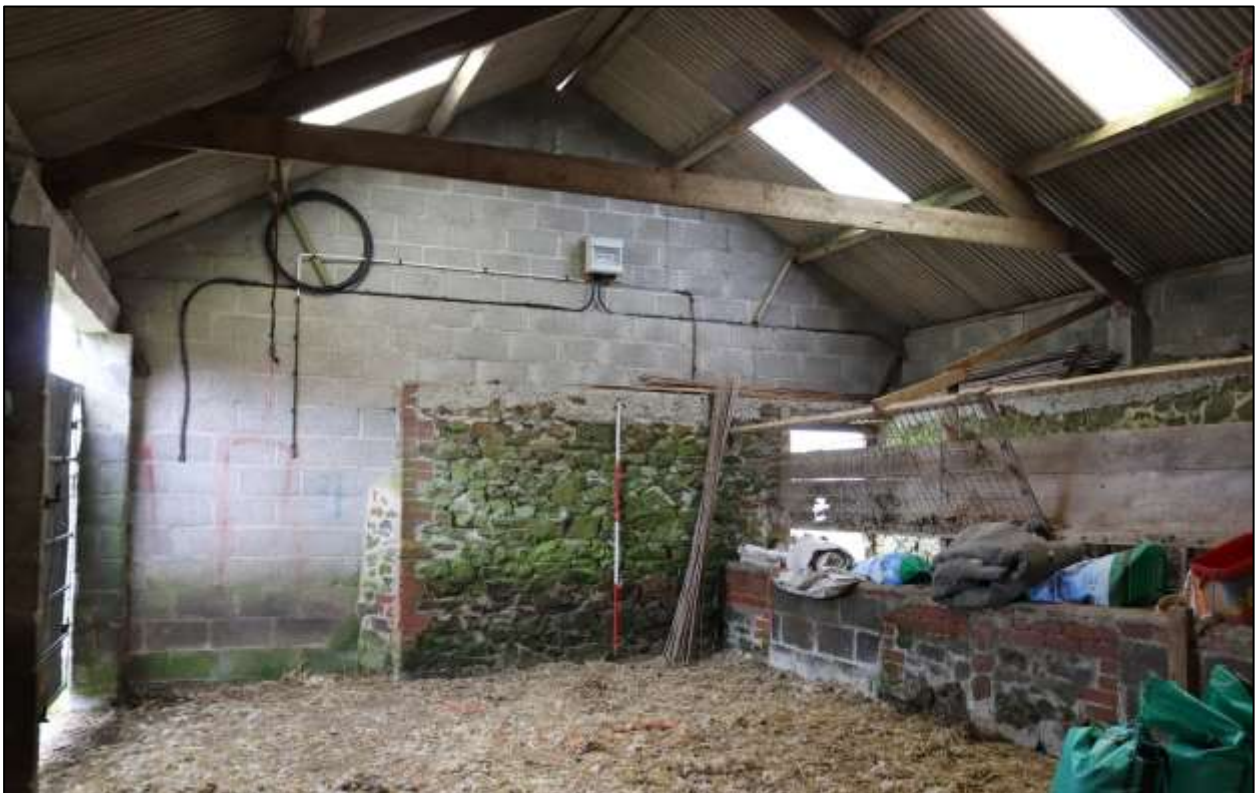
FIGURE 24: THE INTERIOR OF THE EXTENSION, SHOWING HOW IT INCORPORATES THE EARLIER WALL; VIEWED FROM THE SOUTH-WEST (SCALE 2M).

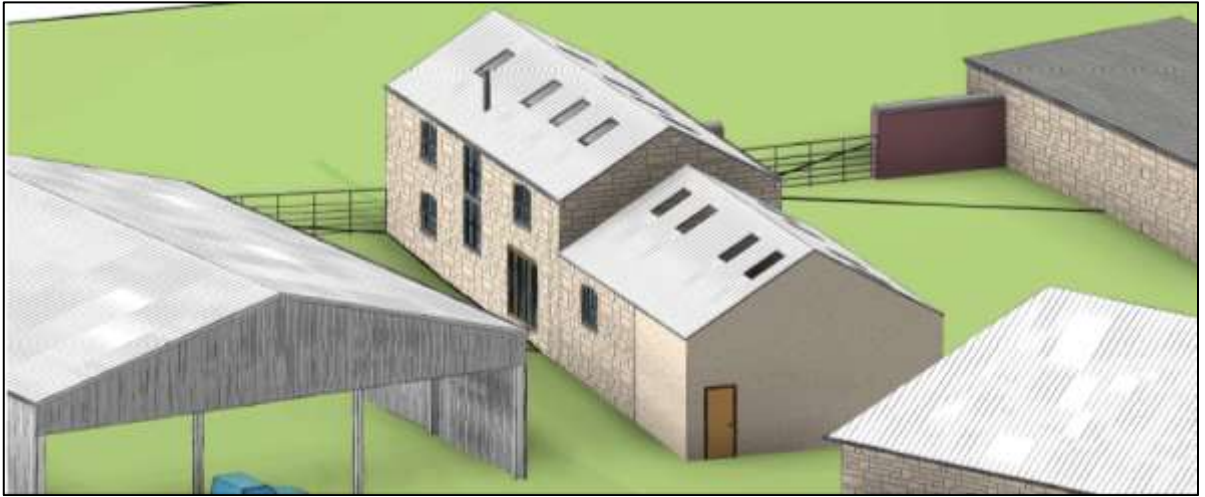
FIGURE 28: THE REAR PROPOSED EAST-FACING ELEVATION. SEVERAL NEW OPENINGS PROPOSED. (SUPPLIED BY CLIENT).

In general, the proposals for the Barn and extension are fairly sympathetic (see Figures 28-31), and as noted, the lack of period fixtures and fittings to the interiors renders them particularly flexible to adaption. New openings should be distinctly different to the existing shallow brick arched windows, with brick dressings, seen to survive to the ground-floor west elevation, to avoid inappropriate pastiche. Rooflights may be an alternative here.

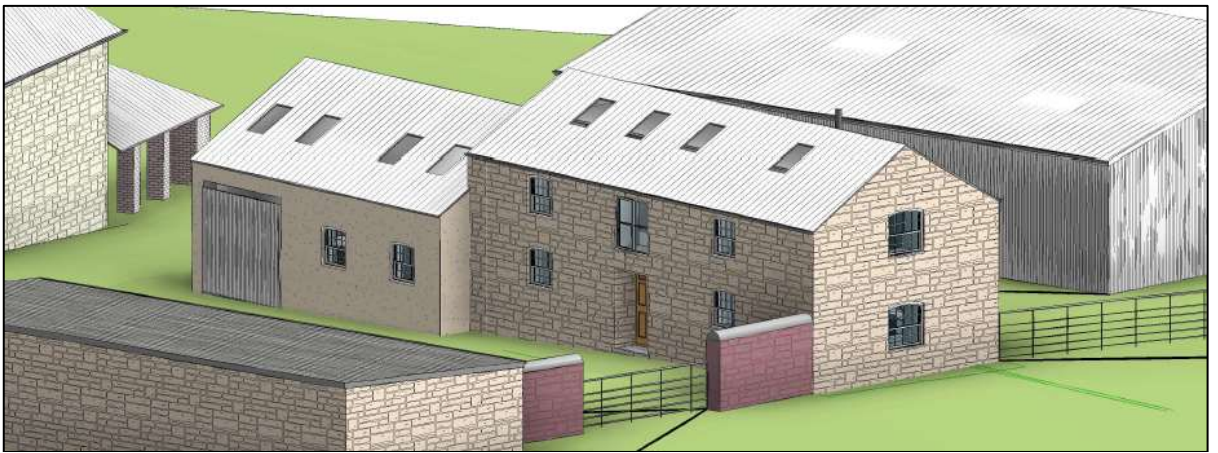
FIGURE 29: THE WEST ELEVATION TO RETAIN THE LOOK OF A FARM BUILDING. FORCED OPENINGS WOULD NEED TO BE DISTINCT WITHOUT BRICK DRESSINGS AND ARCHES TO AVOID PASTICHE (SUPPLIED BY CLIENT).
