A FORMER ENGINE HOUSE TOLGULLOW VEAN REDRUTH CORNWALL

Results of an Archaeological Assessment

Report No.: 110512
Date: 12.05.2011
Author: E. Wapshott

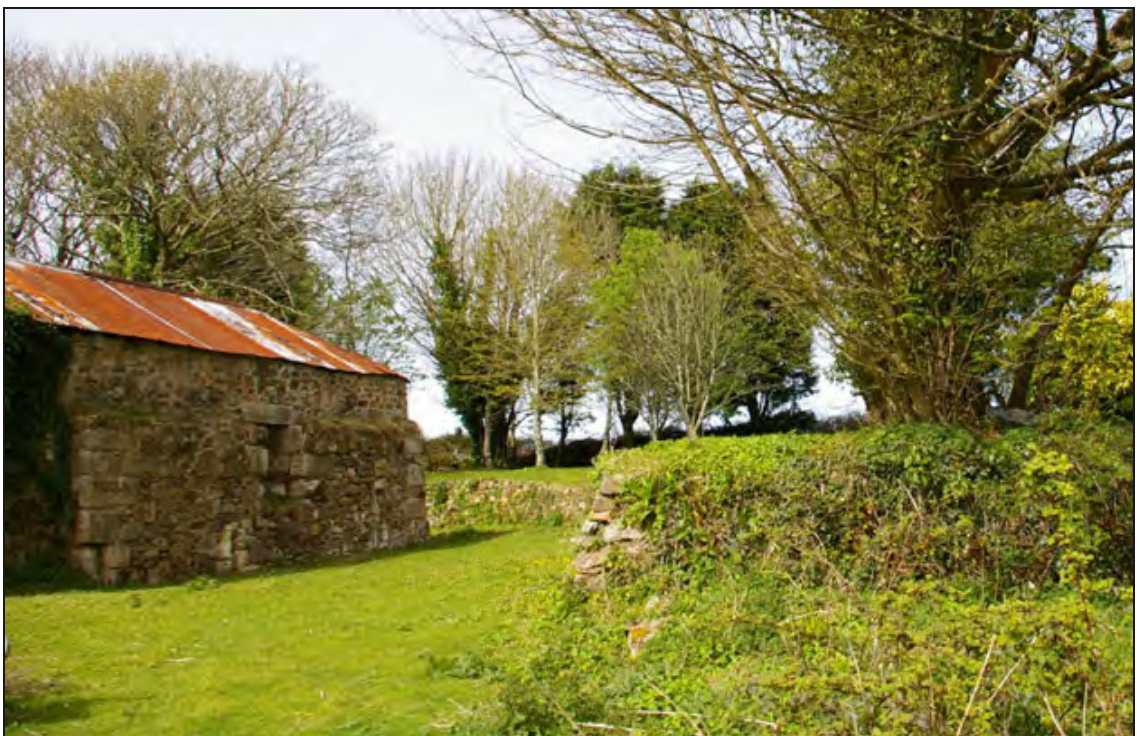
The detached former engine house (Figure 5) is situated just south-west of a range of standing buildings, all formerly part of the Tolgullow United Mine, including one believed to have been the counting house, now converted to dwellings and situated on the south-eastern outskirts of the village of St Day in Cornwall. The building is oriented north-south and is accessed to the east from the main trackway to the holding, through a wooden five-bar gate, in a traditional Cornish stone hedgebank within a large field laid to pasture. There is a small area of surviving historic cobbles at the entrance to the field. To the north and east is an area of raised ground contained within stone walls, with steps down to the building. Within this area lies a capped mine shaft and to the south, within the field lies a large spoil heap, both remnants of the former mining activity on the site.

Figure 5: The former engine house, viewed from the south-east.

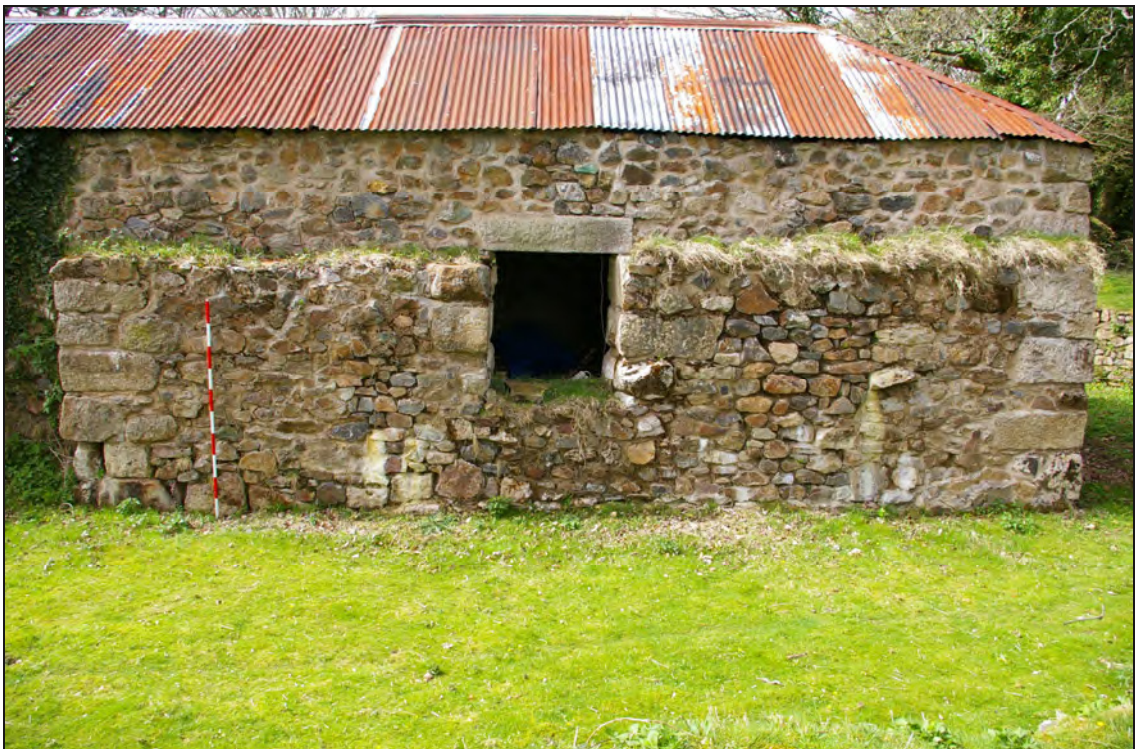
The elevation (Figures 6 & 7) is of rubble stonework with a substantially wider section to the north, which may comprise the former 'bob wall' of the engine house. This section of wall displays large quoins at its southern end, the centre of the elevation comprises large granite blocks that are roughly dressed, and to the north are granite block quoins of a more regular dressed appearance. The stonework of this section is cob bonded or has lime mortar, but also several phases of repair with cement, heavy re-pointing or rebuilding in sections. There is a large central opening in this section of wall which has rough granite block reveals. The rubble stone-work of the rest of the wall appears to be built around the thicker section, above it seems to be largely rebuilt or very heavily re-pointed, to the south end it has clay and lime mortar and cob bonding, with patches of greyish-white lime mortar and cement repairs. There appears to be a blocked opening at this southern end, high up in the elevation, which to the exterior is largely obscured by thick ivy. The quoins at the southern end have been re-mortared in cement and there is a large protruding rounded granite slab at the base, which is set back from the quoins. There is some considerable disturbance to the stonework at the south end, with much of the mortar being weathered and almost entirely absent in some areas which may also be the result of the removal of a once attached or abutting building.

Figure 6: The northern end of the east elevation of the building, viewed from the east.

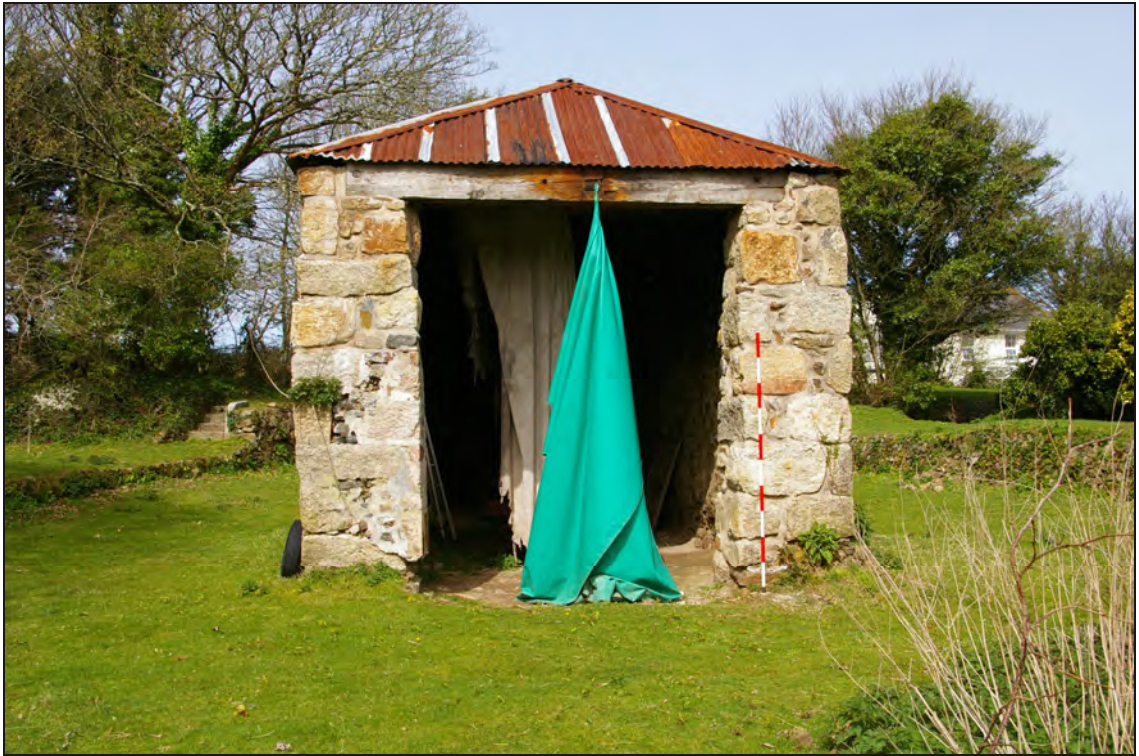
The south gable wall (Figures 8 & 9) is open between the southern ends of the east and west walls which are dominated by substantial stone quoins and linked by a large timber lintel, formerly a railway sleeper or section of former framing for the engine which once sat *in situ* within the building. The exterior granite quoins are formed from large roughly dressed blocks with smaller less-worked blocks facing into the opening. The blocks appear to be mortared in cement; this may be due to heavy re-pointing but it appears to return to both the east and west walls suggesting either the south end of the building has been truncated with the shortened end rebuilt, or it has been repaired due to bad condition. The lower interior west side of the elevation appears to have had further repairs in a very white mortar and the recycled timber lintel suggests that the wide opening we see today is a later development or re-development of the typically large entrance archway found at the front of an engine house. The quoins appear to be robbed away at the base or an earlier floor has been removed, with the extant surface being much lower than the original.

Figure: 8 The south elevation of the building, viewed from the south.

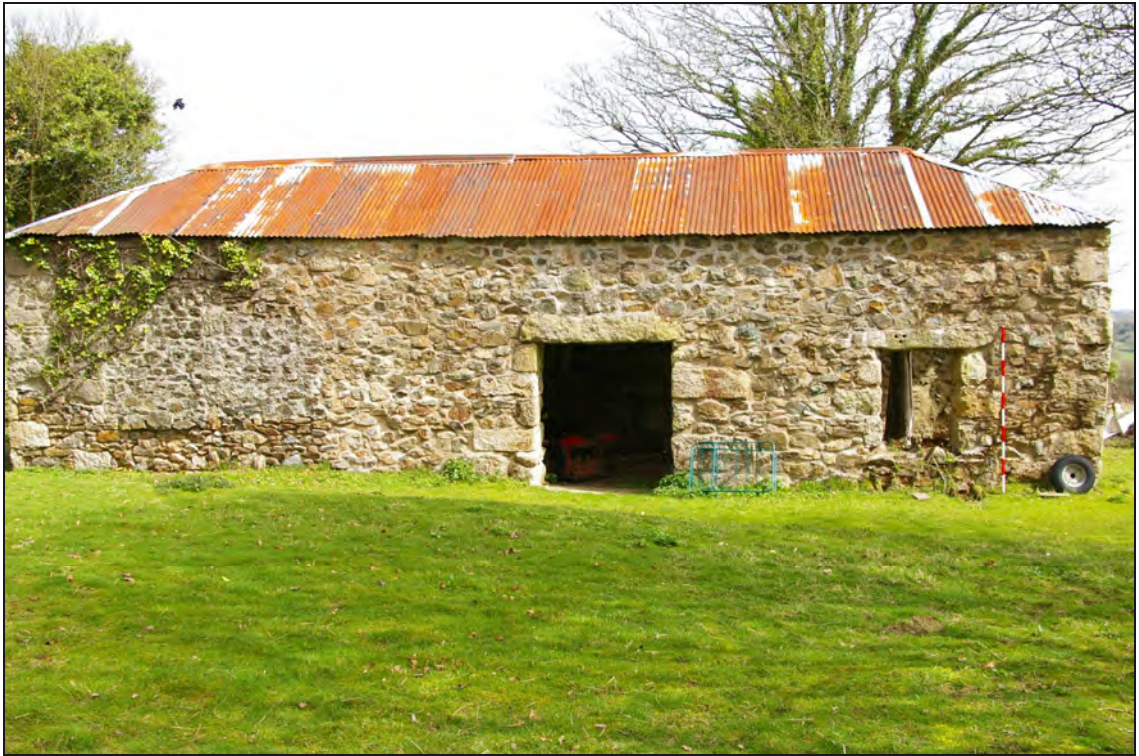
Figure 10: The west elevation of the building, viewed from the west.

The west elevation (Figures 10 & 11) is of rubble stonework construction with granite quoins to the north and south ends with two openings; a central doorway with a large exterior granite slab lintel and concrete lintel to the interior and with very substantial granite block reveals, and a window to the south with a granite slab lintel and granite block reveals. The lintel of the window has drilled holes at its northern end and is part of the former framing for the pumping engine machinery. There are several phases of blocked openings at the north end. A large, narrow rectangular former opening with granite reveals and a narrow timber lintel is seemingly cut by or cutting another former smaller, but wider opening lower on the elevation to the south. Both are now blocked with rubble stone-work in a grey lime mortar. The elevation appears to have been rebuilt from the position of these blocked openings to the south end with cement mortared stonework, although this may be a case of heavy re-pointing. The north end of the elevation is far more weathered and is partially obscured with ivy. The quoins to the north are of dressed granite blocks, formally arranged, the upper portion of the southern quoins have been rebuilt in much larger rougher blocks which are bowing outwards; the bottom six blocks however do appear quite formally arranged and these may only have been re-pointed heavily, rather than rebuilt, obscuring any historic mortar. The elevation also appears to have been rebuilt at the eaves as it is presumed that as an engine house it was much taller in height to accommodate the pump engine.

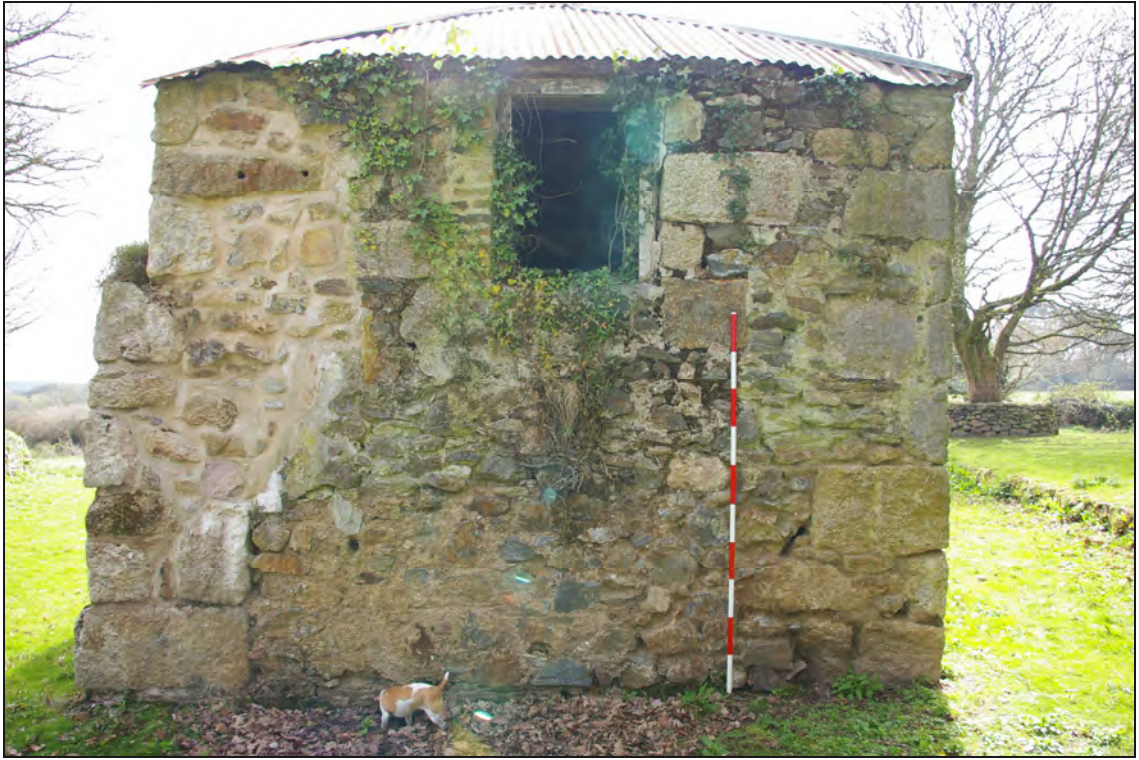
The elevation is of rubble stone, with quoins to east and west (Figure 12 & 13). The wall contains a variety of bond types with a clay and lime the earliest, with later lime and then 20th century cement mortar repairs. To the west the quoins are more formally arranged using roughly dressed granite blocks with smaller rubblework to the interior of the wall. To the east side the wall has been rebuilt or heavily re-pointed and mortared, the rubble stone-work appears to abut the large granite blocks of the ‘bob wall’ and no real attempt has been made to tie the two together. However the granite blocks do not appear as weathered as those to the west and there is very heavy handed usage of cement mortar at this point. Above the wider area of ‘bob wall’ there also appears to be an area of rebuild which has utilised a granite block with two circular drilled holes, probably some form of weight or brace for the former iron machinery housed in the building.

There is a large opening at eaves height in the centre of the elevation which has substantial granite quoins to either side; this opening has been partly blocked by a single skin of bricks and has had a timber door frame inserted, no doubt converting it to a loading door used for feed or bedding stores. There is a large timber positioned at the base of the elevation towards the east side, this appears to span a pit, which has been partially exposed following an earlier structural appraisal in May 2008. Both the opening and pit date to the historic use of this building as an engine house.

Figure 12: The north elevation, viewed from the north.

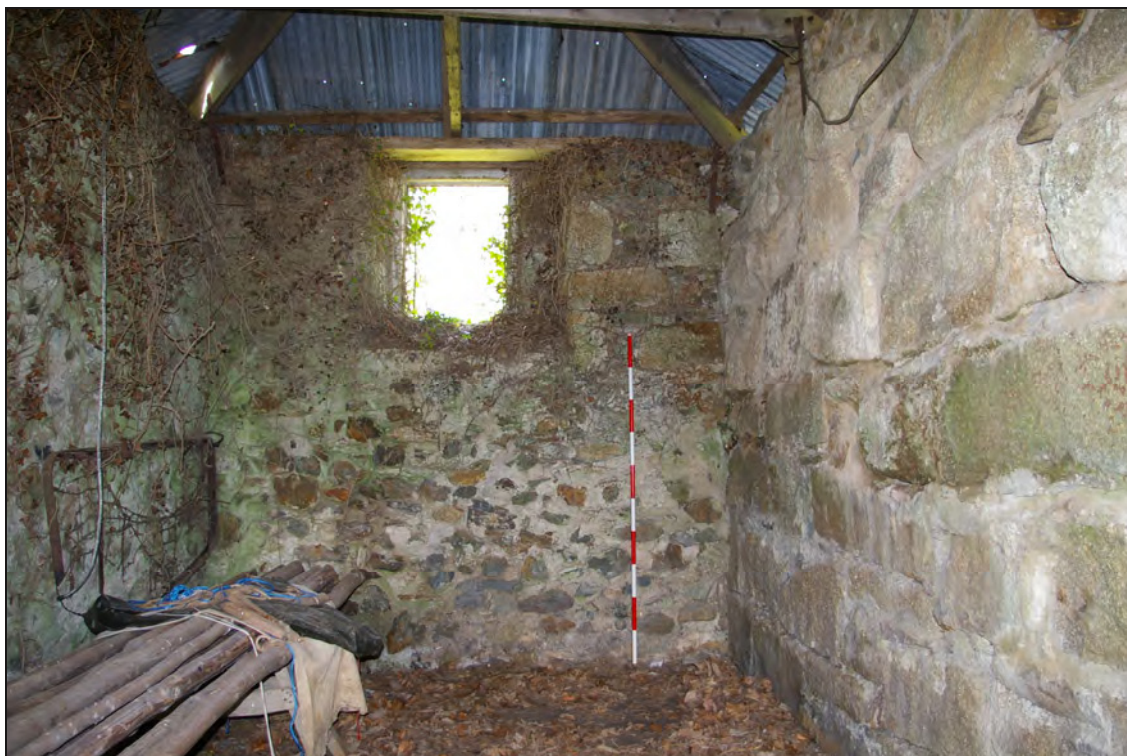
Figure 14: The interior north end of the building , viewed from the south.

The west wall has clearly been significantly repaired and possibly almost entirely rebuilt towards the southern end in the 20th century; creating the central doorway and window, the doorway is noted as having what appears to be a concrete lintel. At the north end the blocked historic openings are visible, with granite reveals now built into the wall. There is a large wooden post bolted to the wall just to the south of the blocked openings, before the point from which the wall appears rebuilt. The ivy visible on the exterior of the building has crept inside at the north end and although now dead this does obscure some detail. The opening in the north wall has an internal timber lintel and a single skin of bricks partially blocking the opening. The stonework displays numerous phases of repair to the mortar with some cement used, there are quoins to the east at the top of the wall (Figure 14).

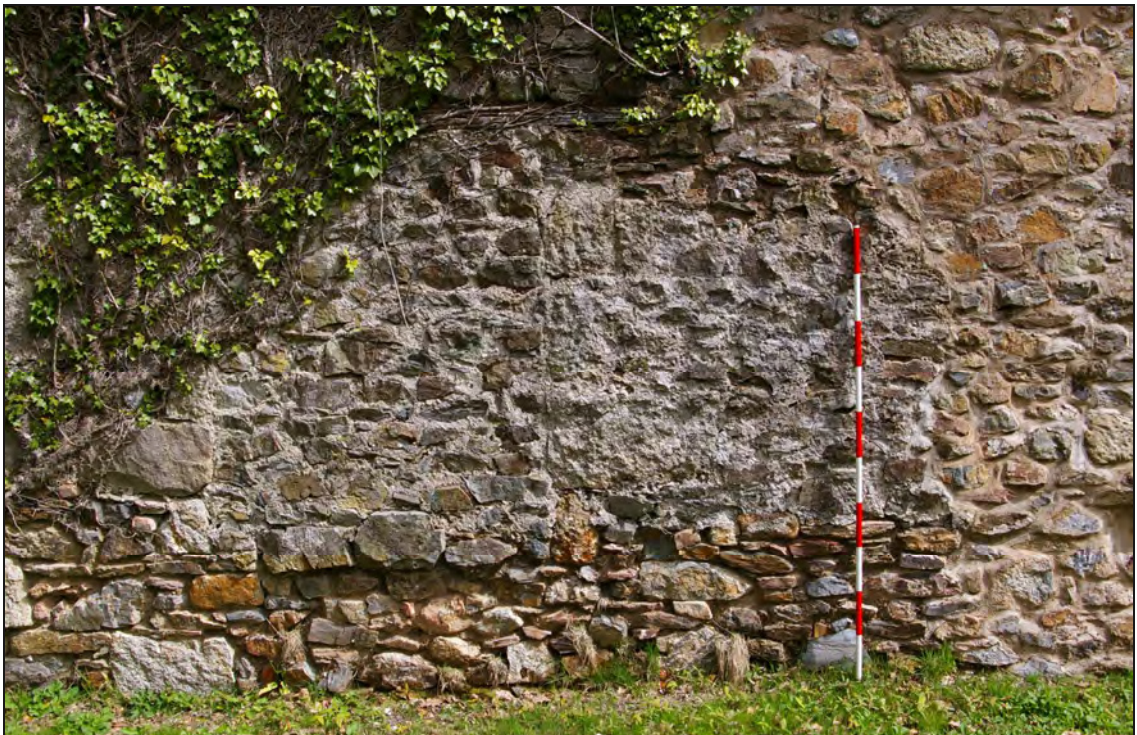
Figure 15: The north end of the west elevation showing phases of blocked openings, one with stone reveals.

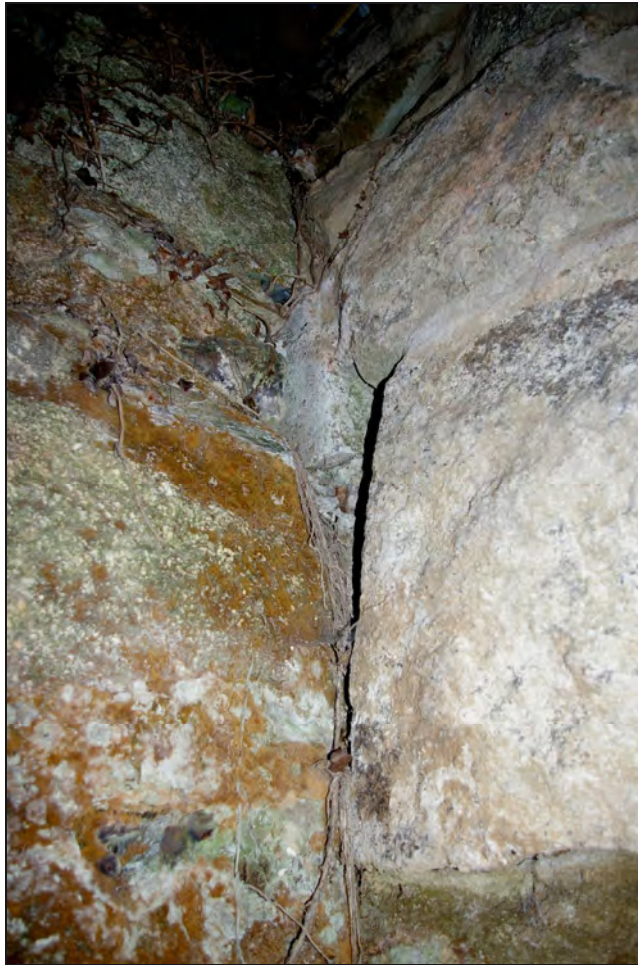
survey, some areas of wall appear to not have received heavy re-pointing but have the appearance of being partially rebuilt or repaired using cement mortar. This is supported by the presence of a cement block visible within the construction of the north-eastern corner of the building within a deep crack (Figure 16). This cement block appears to abut the quoins of the north wall and is within a cement mortar, as are the granite blocks in the upper portion of the east wall, adjacent to the corner. The exterior face of the corner at this point, shows the heavy cement pointing and the re-use of granite blocks which may have formed part of the bracing or stands for former machinery, having large holes drilled into the blocks for iron bars. Therefore some parts of the building have been subject to more than just re-pointing, with repairs or partial rebuilding being required on some elevations.

Figure 16: A cement block visible within the construction of the north-eastern corner of the building

In respect of the historic appearance of the building it is recommended that the heavy cement pointing should be raked out and removed and a more appropriate lime mix pointing applied to match the mortars, cob and pointing still found on some sections of wall.
