THE COMMUNITY CENTRE ST DAVID'S HILL EXETER

Results of Archaeological Monitoring
&
Historic Building Recording

Report No.: 120208
Date: 08.02.2012
Author: S. Walls
E. Wapshott

SWARCH project reference: ESD11
National Grid Reference: SX915928
OASIS reference: southwes1-108890
OS Map copying Licence No: 100044808
Planning application No: 10/1453/03 and 10/1523/07
City Archaeologist: Andy Pye
Project Director: Colin Humphreys
Monitoring & recording: Dr Samuel Walls
Building Recording: Emily Wapshott
Report: Dr Samuel Walls; Emily Wapshott
Report Editing: Deb Laing-Trengove
Graphics: Dr Samuel Walls

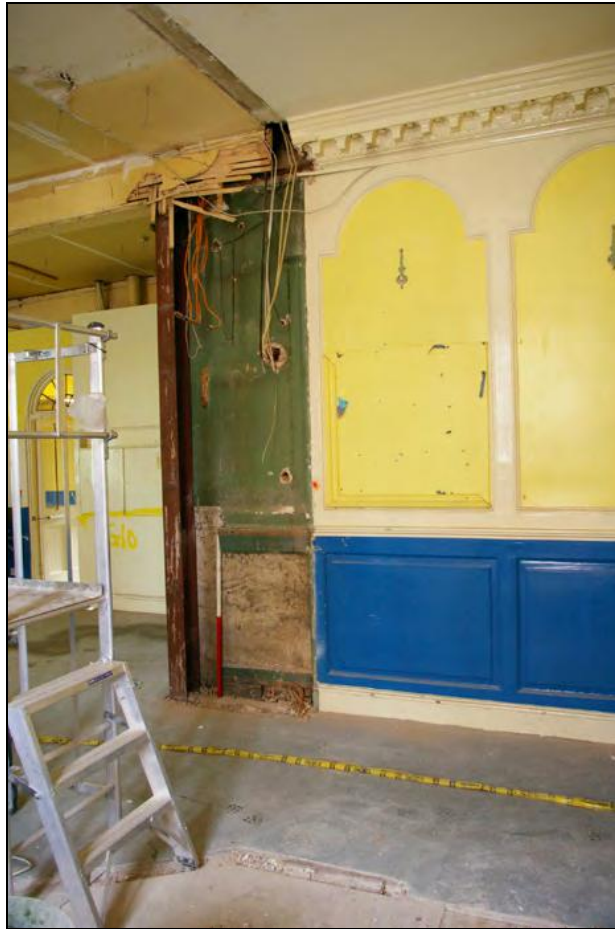
The panelling adjacent to the staircase was revealed where a section of later wall had been removed, this panelling dates to the first phase of the building (1740-1760). The main panel below the dado rail has been lost, exposing the simple lime plastered finish to the wall behind. Where the modern partitions have been removed there has been some damage to the end of the cornice and this had exposed the timber blocking and lathe and plaster, providing a cross-section of its structure (Figure 3). The southern wall of the hallway had been proposed for removal and contains the historic doorway to the Rear Lobby. This doorway was described in the 2005 report as having a 'triple order fanlight' above the door; the wall was extant at the time of visit. The modern false ceiling had been removed showing that the cornice to the east wall of the room had been lost, with a moulded main ceiling beam exposed, with beading to both faces.

Figure 3: View of the south wall of the Entrance Hall adjacent to the stairs, viewed from the north-west.

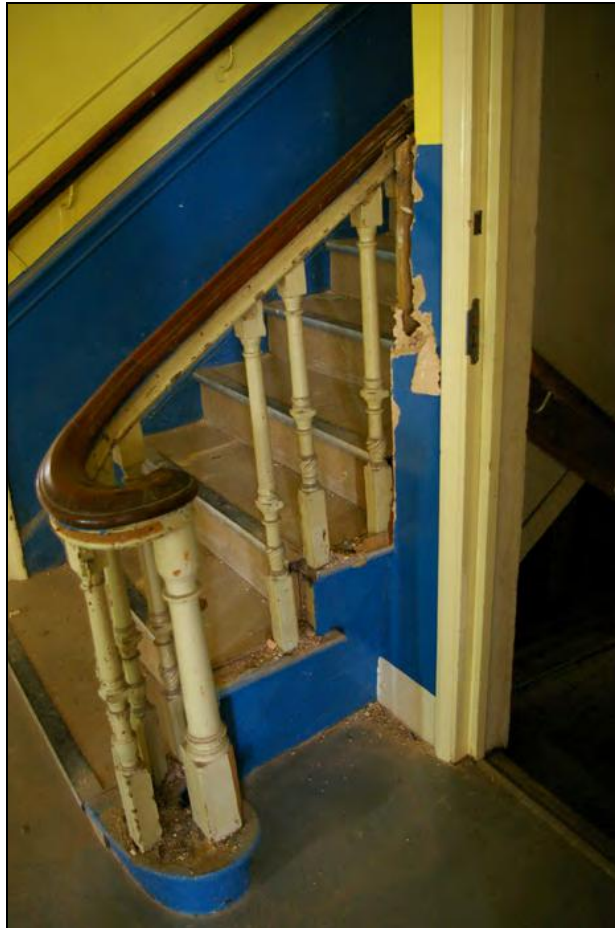
The stairs, also part of the first phase of the building, have moulding and details corresponding to the cornicing and panelling in the Entrance Hall. The banisters to the first and second flight of stairs were formerly boxed in and have been exposed by the removal of the intermediary fire walls. The curtail step and the majority of the balusters have survived and were revealed upon removal of further boarding (Figure 4). The simple tapered column balusters which are part of the original decorative scheme have been replaced on the first two flights by alternatively placed intricate turned later 19th century examples. This may have been an issue of fashion, updating the style of the staircase on the section of stair with the heaviest foot traffic. Upon inspection it was observed that the handrail has been cut back at the sides at some point in the 20th century to provide a flat surface for the boarding, losing the ovolo moulding to the edges, but it remains continuous and the stairs which are one of the most significant historic features in the building, are otherwise unaffected by the remodelling as fire lobbies are to be created on each of the landings. On the 10th June a trench was inspected within the area the former lift was removed and new lift shaft is being inserted, an area of good quality brickwork was exposed, which is a Flemish bond form and this wall may be evidence of cellars from the first phase of the buildings from the 1740-1760s phase as it seems to be abutted by a fill of earth and bricks and other sundry debris items, presumably from later phases of building (see Appendix 3).

Figure 4: View of the base of the stair with curtail step.

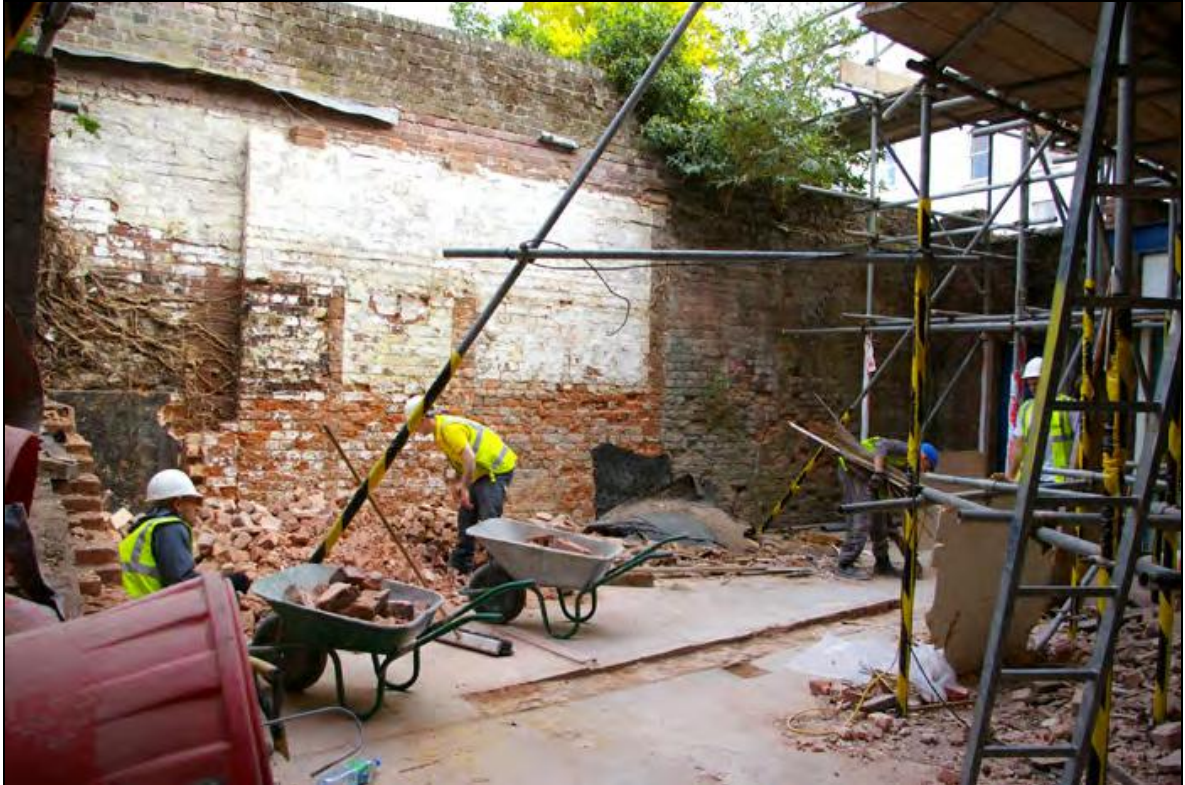
The small buildings within the yard to the west of the main range dating to the late 19th and 20th centuries have all been demolished with the area having been opened up and stripped back to the historic outer brick walls. It has become clear due to the demolition that the brick walls of the buildings within this yard were built up against the outer yard wall. The concrete floor and the Yard surface have been left intact. The exterior wall is a mixture of English bond and English garden-wall bond (Figure 5).

Figure 5: View into the Yard/Office/Toilet area during demolition, viewed from the south-east.

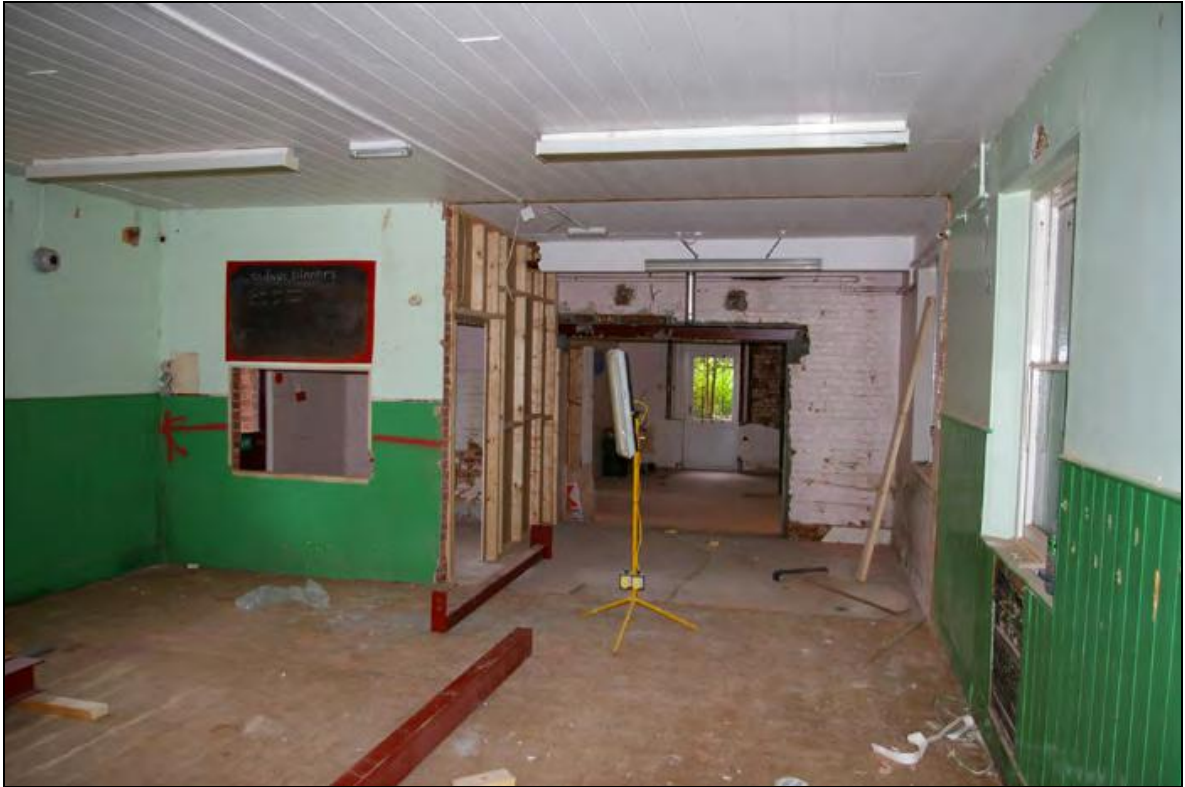
The north-west wall of the Canteen, adjoining the Servery was removed and a large opening has been forced between the Servery and Model Railway Room, through the 1863-1880s wall. A modern partition has been inserted to the south of this forced opening making a smaller square room out of the former Servery. A further modern partition has been inserted to the east end of the Canteen, creating a narrow cupboard or storage space against the eastern wall. Some of the Victorian tongue and groove panelling has been removed but is largely still intact. Where panelling has been removed it exposes the brickwork which appears to be of a mixture of styles (Figure 6).

Figure 6: View to the Model Railway Room, showing the shortened Served area and the surviving 19th century plank panelling to the north wall, viewed from the north-east.

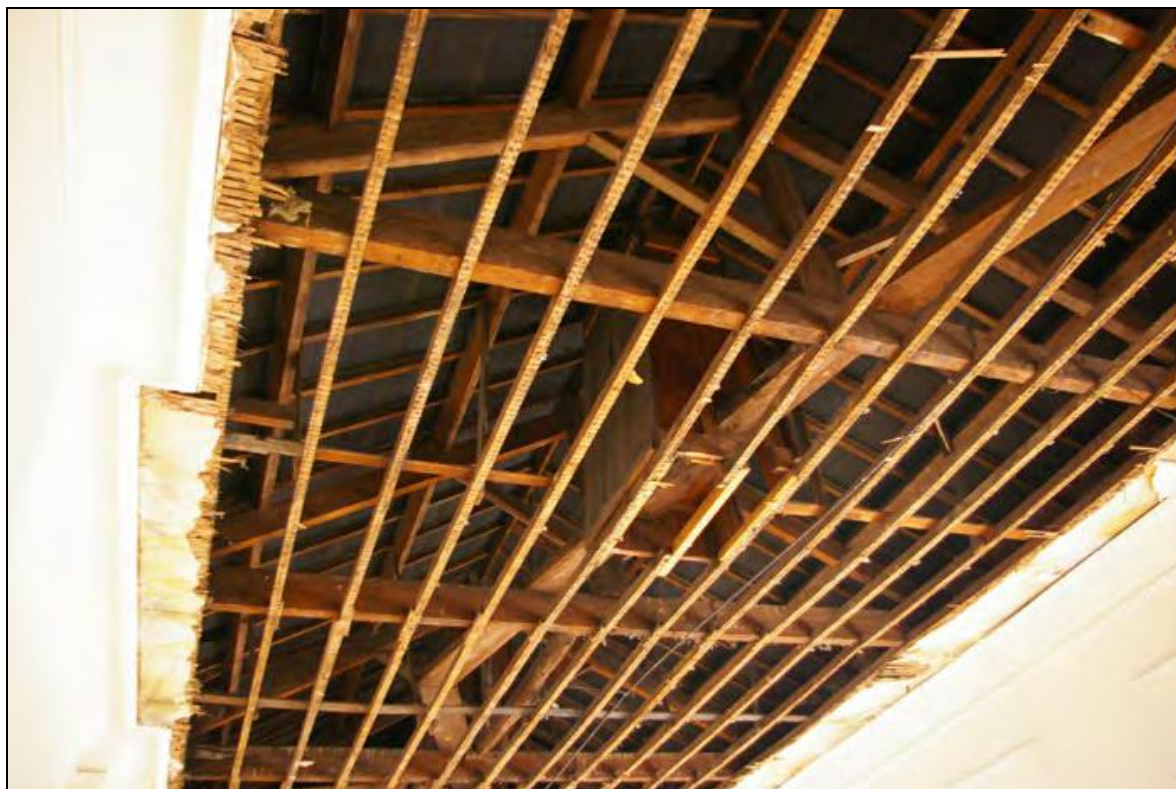
The ceiling has been removed, some lathe and plaster survives to the edges and the cornice remains intact revealing the boarded vents within the roof structure. The chimney breast to the west had the boarding removed revealing the fire-box. All modern fittings have been removed and the surviving skirting boards are visible (Figure 7).

Figure 7: View to where the plaster ceiling has been removed, exposing rafters and leaving lathes to the edges, viewed from the east end of the room.

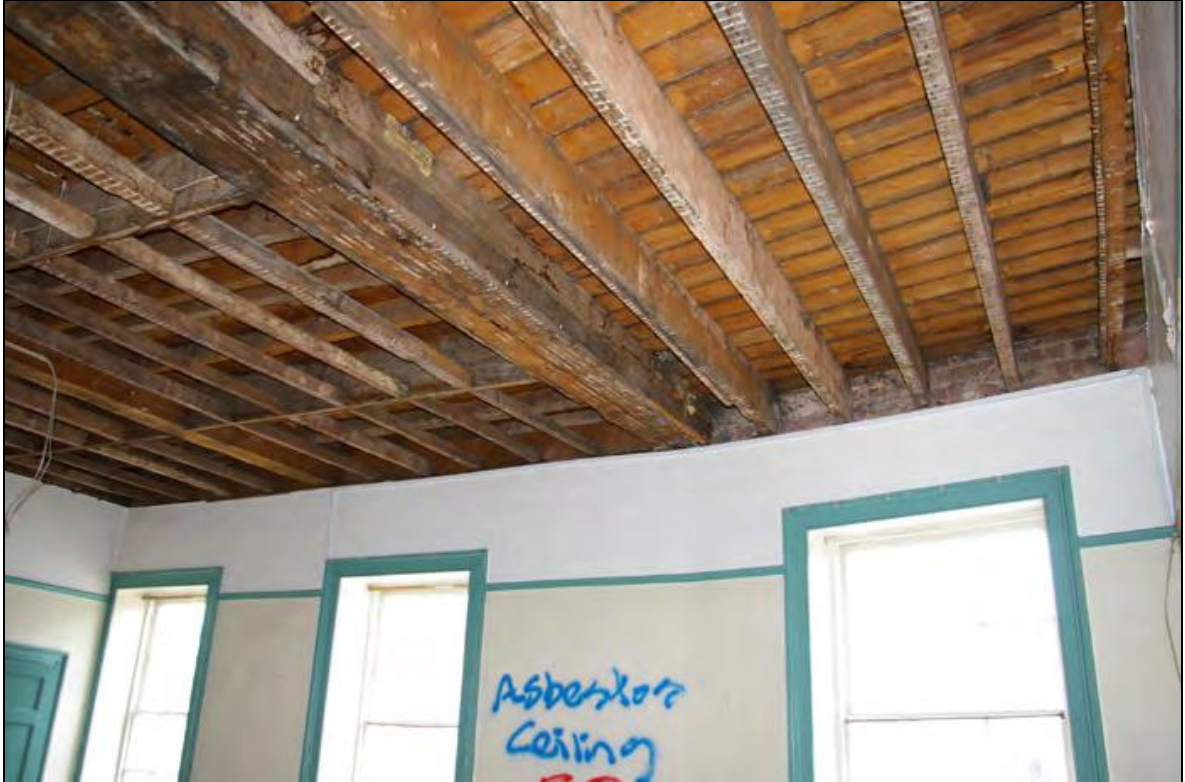
The ceiling has been removed and a very substantial beam exposed crossing the room from north-west to south-east, where the 1790-1820 section of the building meets the 1862 phase of construction; the point at which the front façade turns to the south. The joists of the floor above are socketed into this joist within the 1790-1820 phase, with the joists running roughly east-west, whereas the joists in the 1862 phase run roughly north-south (Figure 8).

Figure 8: View of the removed ceiling of the Heavitree Room, showing exposed joists, floorboards and beams, viewed from the south-east corner of the room.

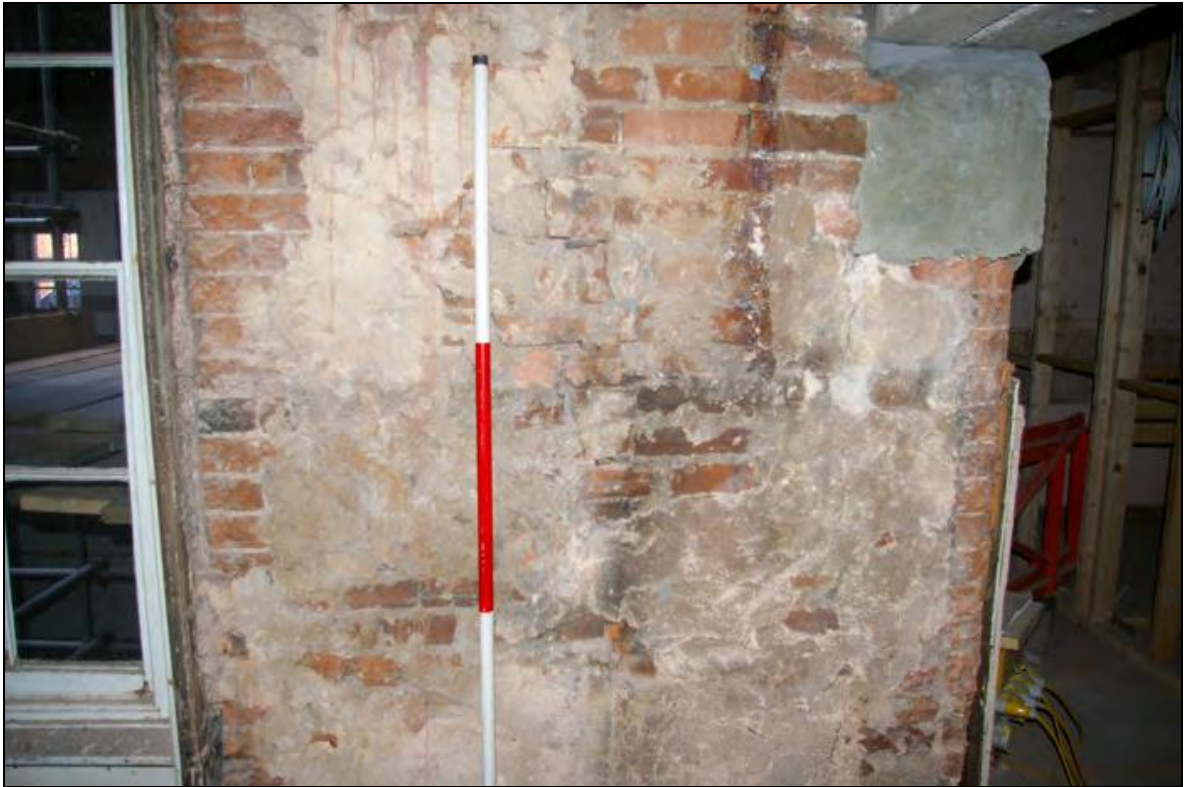
The hallway area outside the Pennsylvania room and Table Tennis Room No.2 has been significantly narrowed by the creation of the cupboard within the space opened up by the removal of the stairs. The stairs to the second floor have also been removed at this point with new joists and flooring being inserted in the floor above. The historic sash window and frame have not been affected. A section of the deep moulded skirting has survived under this window to the wide section of wall from the 1862 phase of the building. The break in the phases of the building can clearly be seen at this point with the 1862 wall dropping back to the exposed brick section of the earlier 1790-1820 section. The exposed section of brickwork also displays multiple phasing as the 1790-1820 phased bricks can be seen abutting and partially tied-into the earlier 1740-1760s construction and it can also be seen how the opening immediately to the west was forced through this former first phase exterior wall, the timber lintel from this opening has been replaced by a reinforced concrete lintel (Figure 9).

Figure 9: South wall of the first floor Hallway to the Pennsylvania Room, showing the join between the 1790-1820 phase and the sub-phase of 1760-1790, with some modern repairs, viewed from the north.

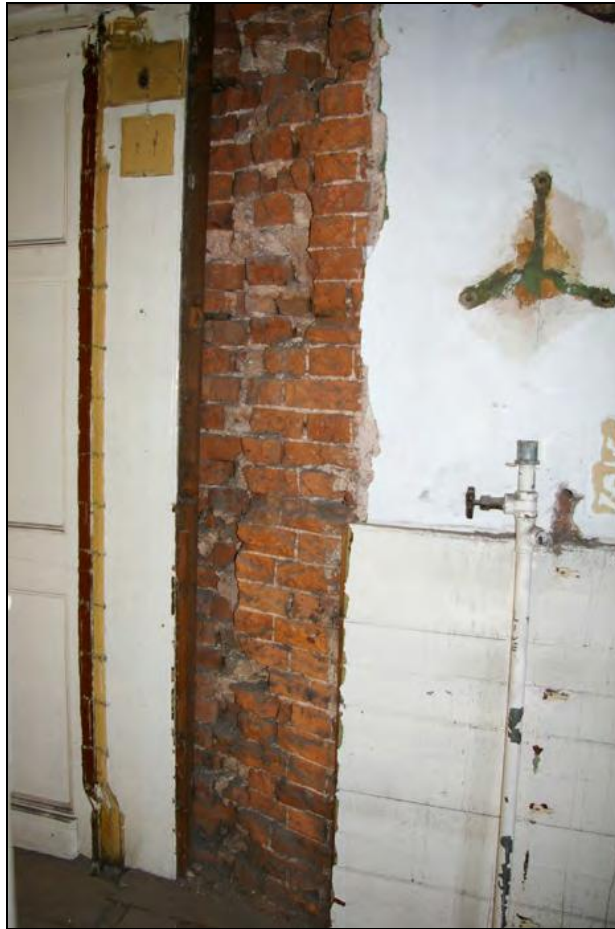
A short panelled corridor leads through to this lobby that was formally fitted with large cupboards as a dressing area or linen store. The large 19th century cupboards have been partially stripped away from all but the west wall, adjoining the kitchen and the plaster has been largely removed exposing the brickwork and highlighting the multiple phases of build in this small area. Immediately adjacent to the end of the panelling on the north side of the corridor there is a substantial break in the brickwork between the first phase (1740-1760) and a previously unidentified possible sub-phase

dating to 1760-1790 (Figure 10). The short section of south wall, dating from 1790-1820, which forms an alcove formerly within bedroom No. 1, can be seen to abut the return of this sub-phase.

Figure 10: Brickwork exposed within the corridor from the second floor landing to the Dressing Room, north wall, viewed from the south-east.

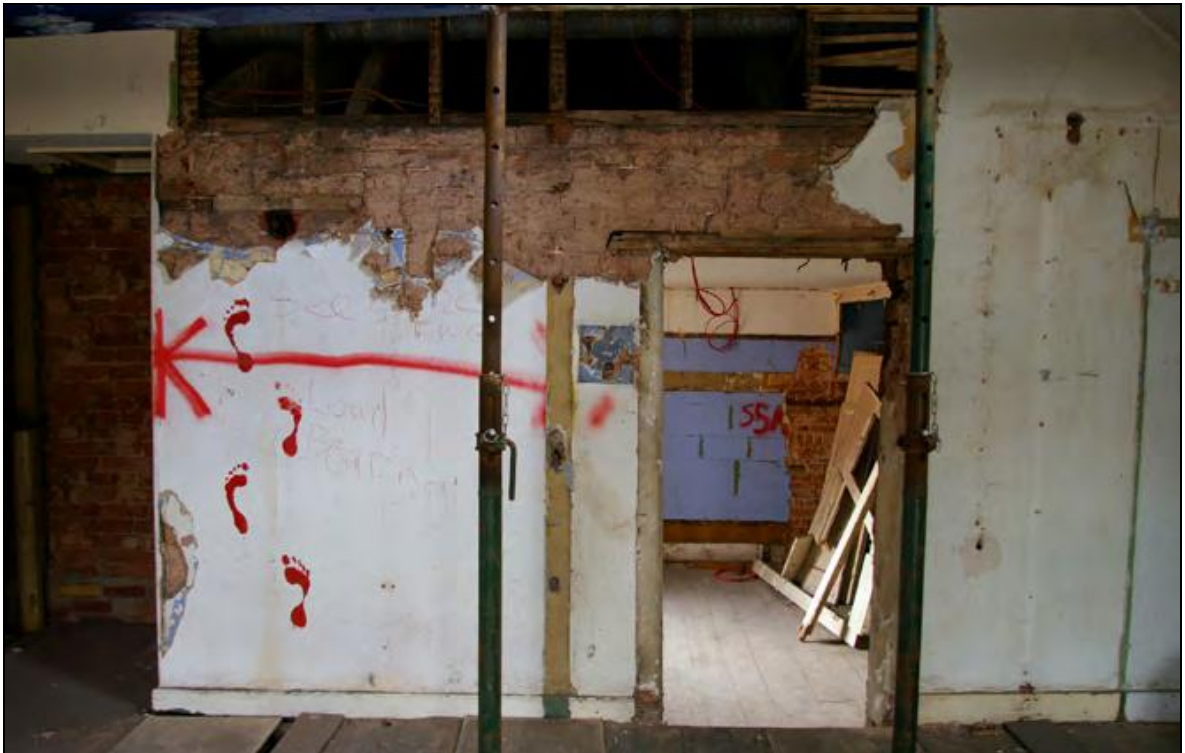
The roof structure here is temporarily supported on adjustable props. The south wall adjoining the dressing room has been stripped exposing the 1760-1790 brickwork illustrating how the 1790-1820 phase was built on a higher level; the south internal wall was extended upwards using lathe and plaster to close off the roof void of the lower adjoining building. This section of wall has now been removed opening a view into the roof structure of the earlier phase (Figure 11). The modern partitions forming the lobby and the internal walls of the bedrooms have all been removed. The east wall adjoining the tea room has been stripped revealing heavy timber framing, possibly formerly of brick-nogging, which may have formed the outer wall of this phase before the 1860s extension was added.

Figure 11: The south wall of Bedrooms 1 and 2, adjoining the Dressing Room, viewed from the north.

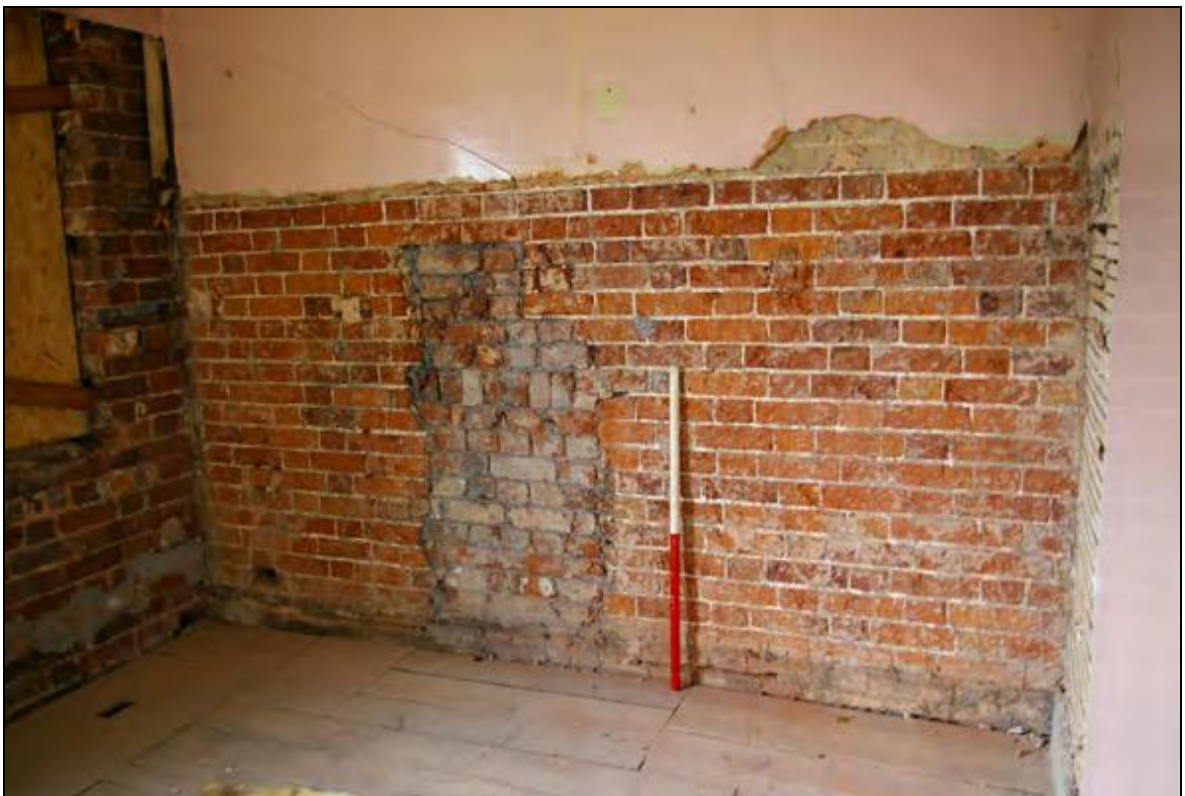
The north and west walls of this room have been stripped, revealing multiple phased brickwork. The rear wall of the 1740-1760 phase is visible in the north-west corner, abutted by the rear wall of the 1760-1790 sub-phase and containing the scar of the possibly reduced chimney stack, or the rear of the blocked fireplace associated with the blocked fireplace in the dressing room. There is a possibility that there were back-to-back fireplaces here, forced into the chimney stack when the 1862-1880 extension was built, because the floor boards of the room appear to be cut around a hearth (Figure 12). Built up against this north wall is the west wall of the 1862 phase, in which one window has been partially blocked with board and is proposed for removal. One large window survives, cut by the internal partition to the south. The lathe and plaster of the internal treatment of the east wall is partially exposed showing the late 19th century brickwork underneath. Part of a moulded skirting with stepped ovolo moulding survives to the east wall.

Figure 12: The north wall of the Bathroom, showing the position of the removed chimney stack from the blocked fireplace in the Dressing Room, viewed from the south.

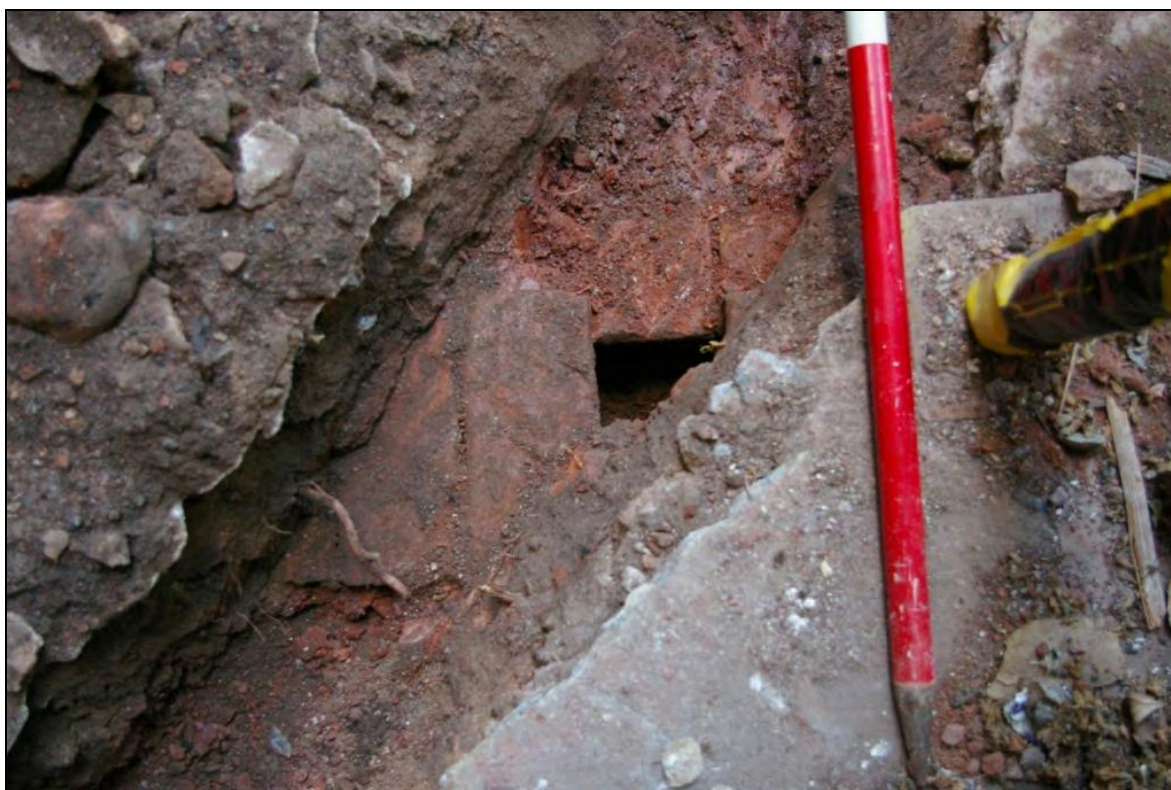
The rear lobby floor was comprised of a plywood and chipboard covered pine plank floor suspended on 3" joists. Below the air-gap was a (0.06m deep) 'sooty' dark-grey brown sandy-silt, with frequent brick and coal fragments. This material (101) continued out of the back door where it was covered by the 0.06-0.1m thick concrete path, which extended across the rest of the length of the trench. Context (101) extended 0.4m out from the back door and abutted {102} a 0.3m thick red brick capped drain (Figure 14). To the south-west of this drain it was abutted by a 0.05m thick layer of red-brown clay-sand loam (104) with occasional patches of coal dust. Context (104) had been severely truncated by pipe trenches to both the north and south. The wall {102} had cut (105) a compact purple-red clay (natural?) which extended the length of the trench and to the limits of excavation (0.13m excavated).

Figure 14: The brick capped drain exposed in Trench 1, viewed from the north-east (2m scale).

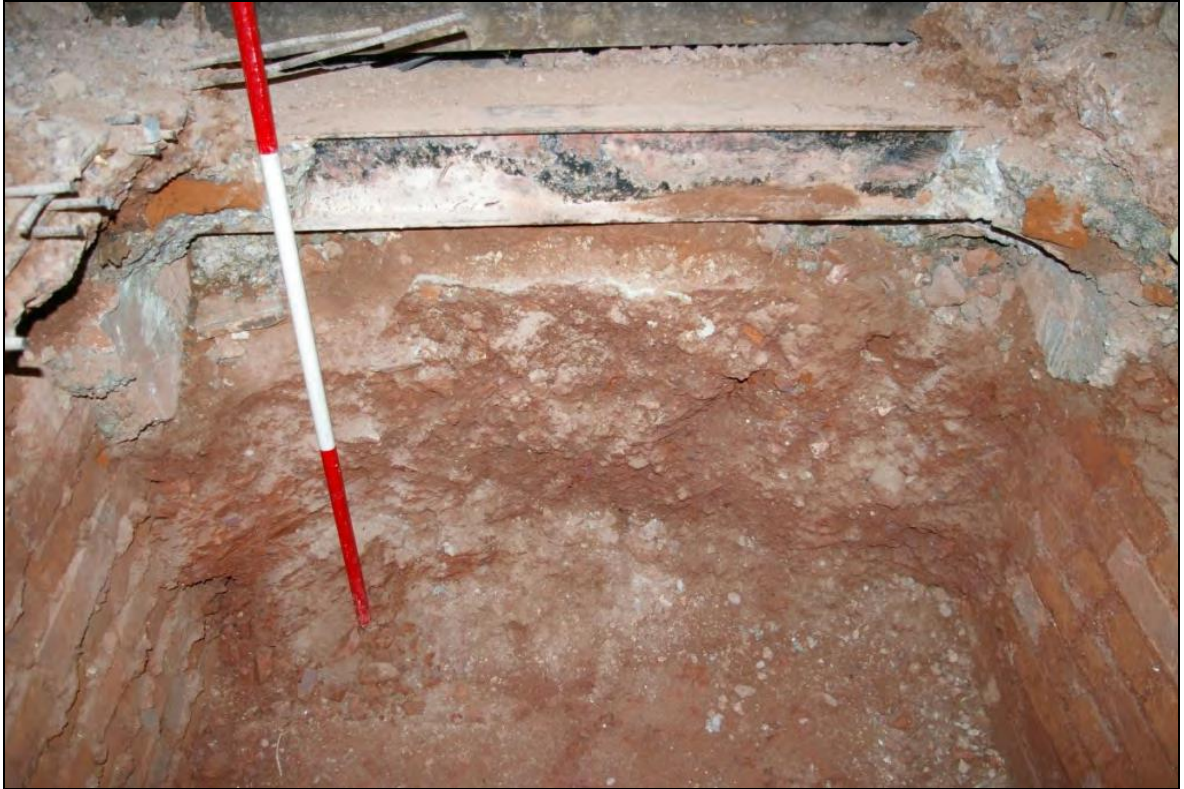
The excavations revealed that the current wooden floor sat on a concrete floor within the area of the lift, which overlay a 0.3m thick deposit of loose and very mixed grey-red clay-silt (112) with frequent mortar fragments and small stones (up to 40mm). Deposit (112) overlay context (113), a slightly more compact (but still loose) red clay, which contained frequent mortar fragments and occasional large sub-angular stones, particularly against the western cellar wall. This 0.4m thick deposit (113) overlay the same hard and compact (natural?) red-purple clay (105) recorded in the other areas. Deposits (112) and (113) are suggestive of infill deposits, which presumably date to the shortening of the cellar in 1790-1820.

Figure 15: The south-west facing section of Trench 7, with the cellar walls to the west and east clearly visible (2m scale).
