Devon County Council Historic Environment Record

Civil Parish & District: Bratton Fleming, North Devon	National Grid Reference SS64293774		Number:	
Subject: Archaeological watching brief during the demolition of the boiler house and construction of a new extension and services at St. Peters Church. Photo attached? YES				
Planning Application no: N/A		Recipient museum: Museum of Barnstaple & North Devon		
OASIS ID:		Museum Accession no:		
Contractor's reference number/code: BFS	3P11	Dates fieldwork undertaken: 03/06/11, 06/06/11, 15/06/11

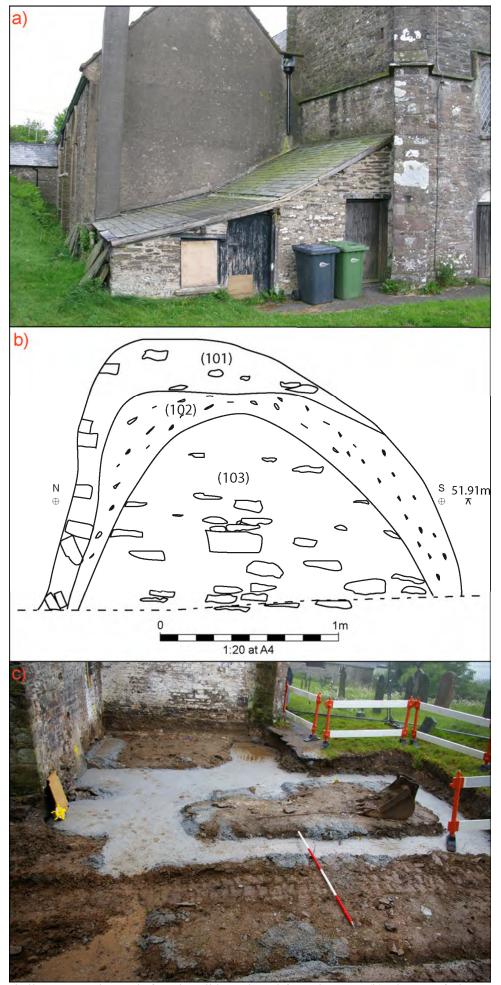
The boiler house and store (coal shed) were constructed of roughly coursed and dressed sub-angular stone with a hard light grey cement bonding and pointing. The simple mono-pitch slate roof steeply descended the store onto the shallower pitch of the boiler house. The former store had two openings, the main entrance in the west elevation with a sawn pine plank door, and an opening in the north elevation (into the boiler house) which was blocked with red bricks. The store also had an internal (north-south) partition, which was part of the same construction as the north elevation, which suggests that the current entrance (and western room) were added at the same time as the boiler. The floor of the boiler house was sunk 0.55m below the store and the churchyard level, and was accessed via a corner stair of roughly dressed stone with four concrete steps leading from the blocked opening in the south elevation and the main western opening. The removal of the render and chimney on the exterior of the west elevation of the north aisle revealed no evidence of changes in build, with only a few structural repairs (typically with brick) evident, and these all related to the boiler house and store.

The northern boundary hedge bank extends to a height of approximately 1.75m and 2.1m width (Figure 2b), although narrowing and shortening towards the west. The bank was seemingly constructed in three distinct phases, with the latter represented by a mid-brown clay-silt (101), which was heavily root disturbed and included a roughly dressed stone (up to 150mm) northern face (onto the modern Church Close). The roughly dressed face also included occasional large pieces of quartz, which were not seen elsewhere in the bank, suggesting some degree of selection of stone away from the locality of the churchyard and its boundaries. Deposit (101) was probably added to consolidate the bank, most likely when the road and bungalows were constructed to the north of the churchyard in the late 20th century. Deposit (101) overlay (102) a gritty light grey-brown silt-clay with frequent slate fragments (up to 80mm in size), and occasional sub-angular stones (up to 100mm). This material (102) is perhaps consistent with the clearance of debris from re-roofing or rebuilding the church, presumably during the 19th century, and may relate to the extensive rebuilding of the church in the 1850s-60s. A large sherd of 17th century North Devon Sgraffito Ware was recovered from this context (102). The core of the bank was comprised of (103) a loose mid-brown silt-clay with frequent large sub-angular stones (up to 600mm). A large fragment of window mullion/sill was recovered from (103), which suggests that the bank dates to the extensive rebuilding of the church in the 1850s-60s. No ditches were evident on either side of the bank, although only the turf was removed so they may survive in-situ.

In the area of the proposed extension the 0.1m deep dark brown topsoil (100) was removed to reveal a grey-brown gritty silt-clay (104), which contained frequent slate fragments, sub-angular stones, brick fragments, mortar/lime dust and human bone fragments. Brick fragments were only seen in the area around the former boiler and store, while Slate fragments were particularly prevalent in the area to the north of the north aisle, where the ground rose dramatically. These deposits continued to the west along the length of the proposed drain, but no archaeological features were encountered.

Figure 2: (a) The boiler room and store before demolition, viewed from the west. (b) The west facing section through the hedge bank, and (c) the excavated area of the building footings, viewed from the north (2m scale).
