Historic Environment Record

| Subject: Recording during repairs to bridge | | |
| National Grid Reference: SS80211 47452 | Civil Parish: Oare | Scheduled Monument Number: SO229 |
| Planning Application Number: N/A | Event Number: | Recorder and Organisation: Sam Walls, South West Archaeology |

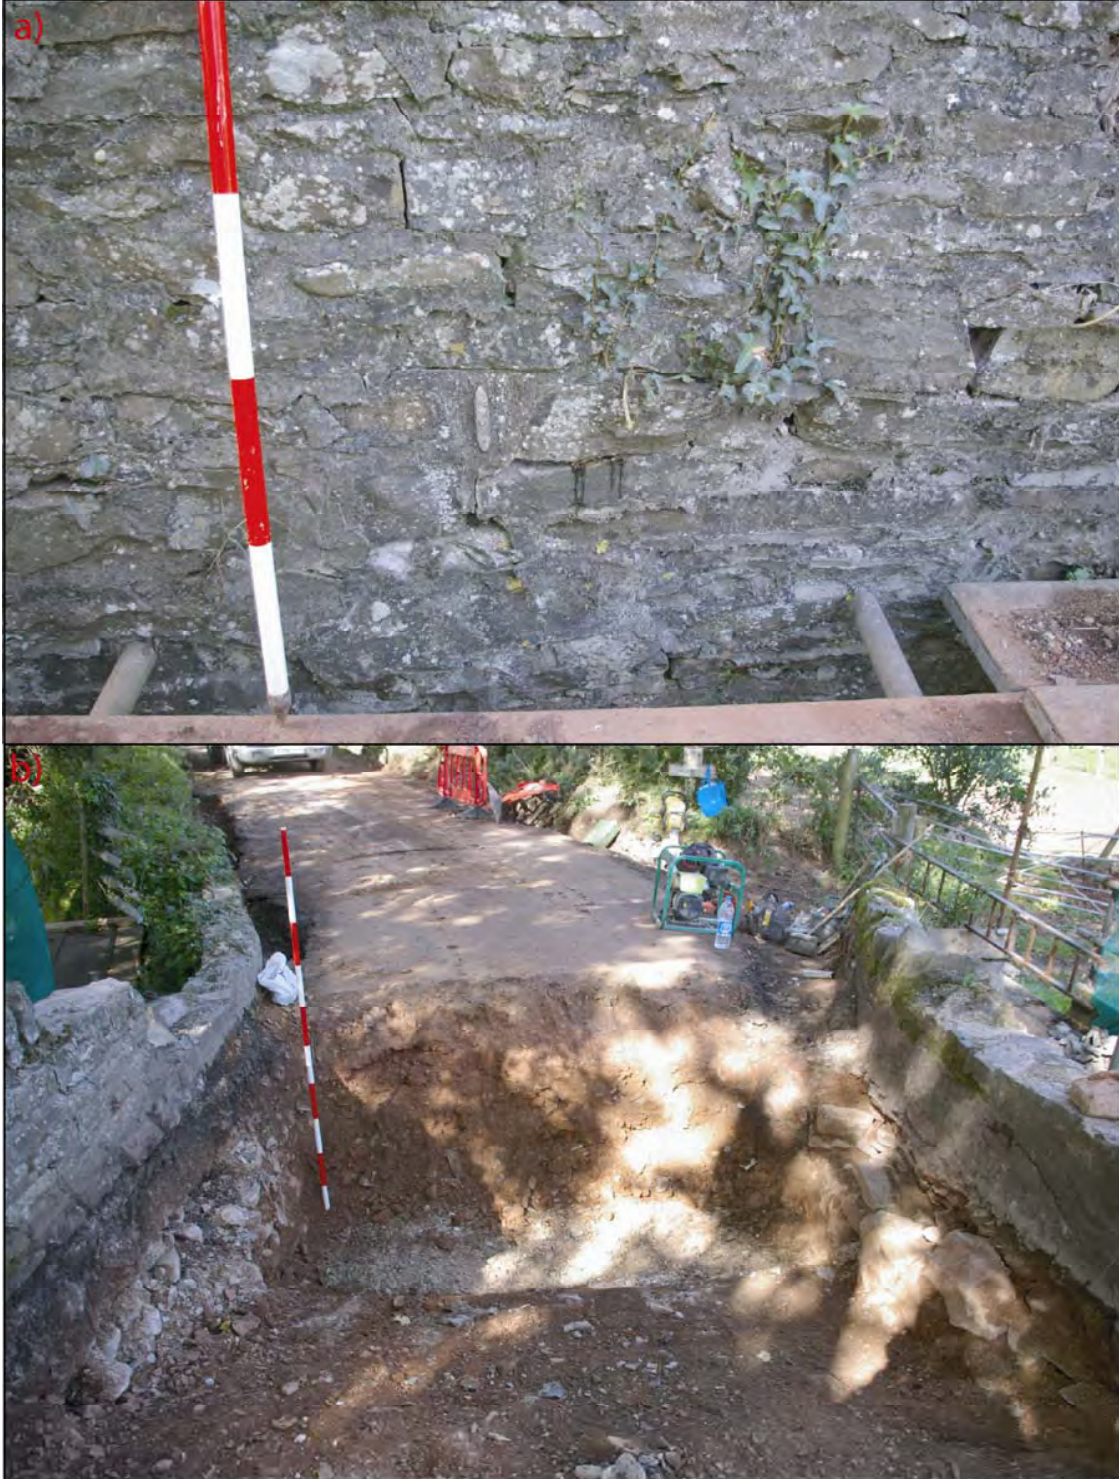
The second area of demolition ran north for 7.9m from the southern end of the eastern parapet (extending to within 2.6m of the other area of repair). This was a much more extensive repair, with the southernmost 4.4m of the parapet completely removed together with a significant portion (up to 0.97m) of the southern spandrel panel (see Figures 3b-c). The spandrel panel was constructed of a dressed outer (eastern) face of roughly coursed stones with a lime mortar bonding (re-pointed with cement) and with a rubble infill bonded by earth and lime mortar.

Figure 2: (a) The top portion of the southeast spandrel panel, viewed from the east (2m scale).

(b) Post-excavation shot of the northern end of the bridge, viewed from the south (2m scale).

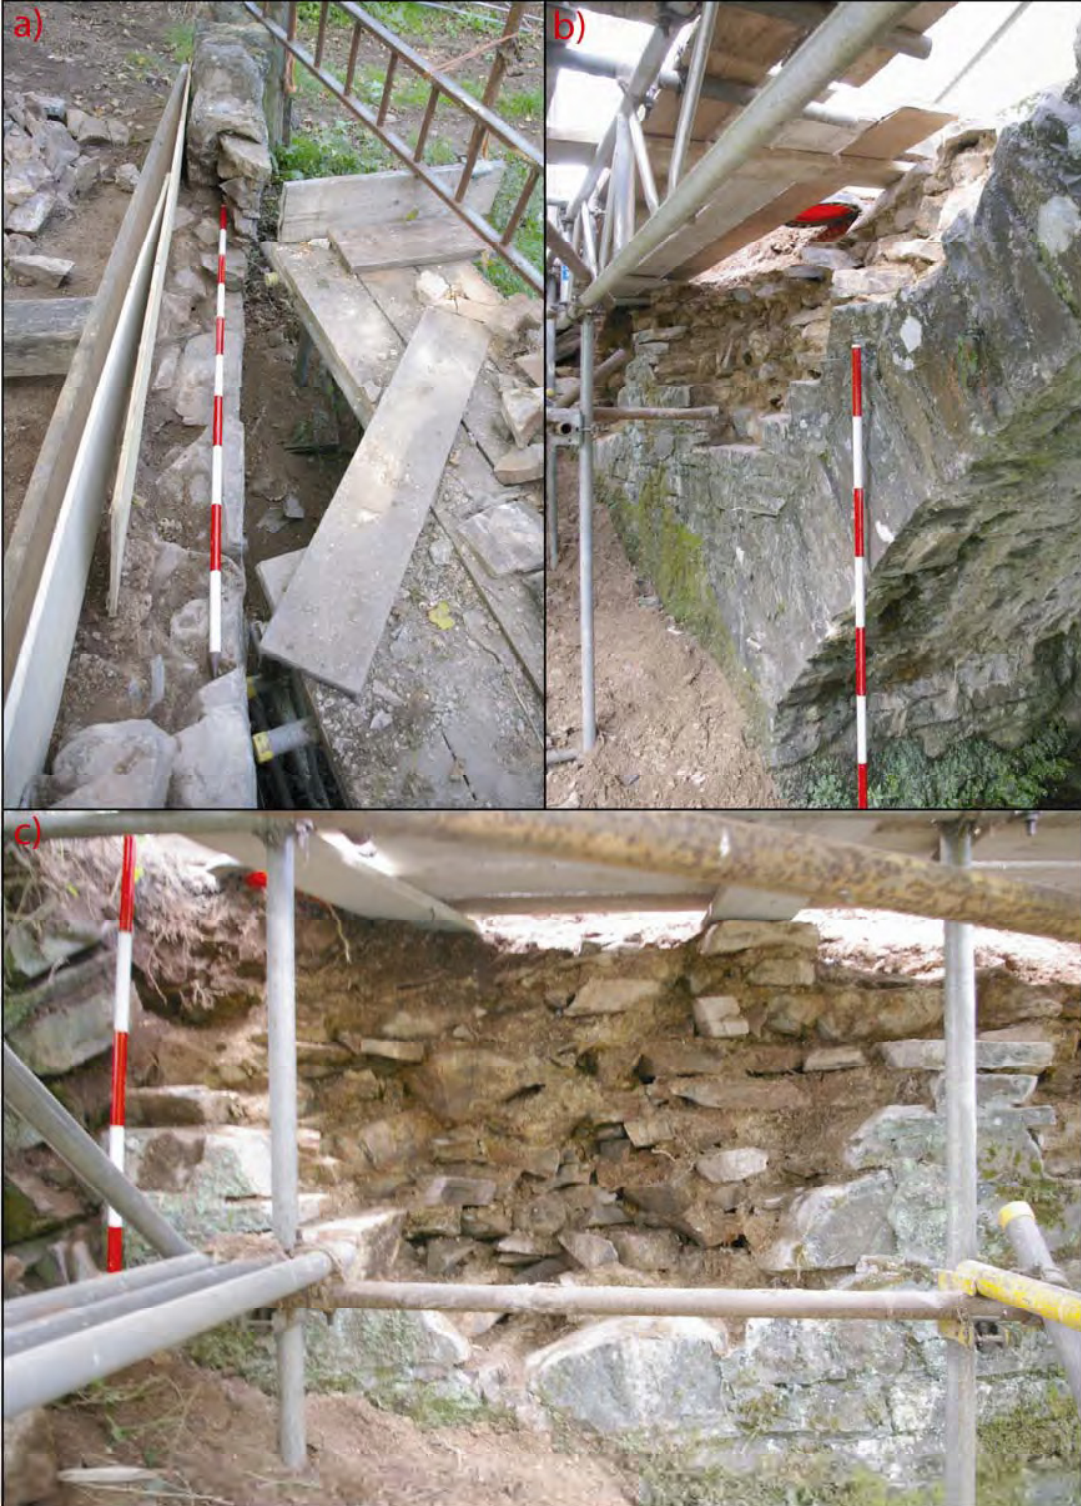
Two main areas of the fabric of the bridge were carefully demolished as part of the repair works. The parapet located 0.9m from the northern end of the eastern wall was reduced in height by 0.75m for 2.3m, before raising 3-4 courses (0.4m) at its southern end remaining at this height for a further 0.7m before returning to the top of the parapet (Figure 3a). This stonework had primarily been re-laid during the 20th century (it had a cement bonding), although within the initial 2.3m section the lowest two courses (0.2m) had a lime mortar bonding. The very soft sandy cream-coloured lime mortar contained rare flecks of coal and occasional small sub-angular stones (up to 0.01m). These two courses of stonework relate to the primary construction of the bridge, and it was clear that the parapet had been constructed of a coursed and dressed outer face of large sub-angular to sub-rounded stones (up to 0.5x0.2x0.1m), with a roughly coursed and dressed inner face with an earth and rubble infill. Several of the stones used in this part of the bridge, both in the rubble infill and as part of the dressed outer face, were clearly river-worn. These tend to be of a slightly greyer colour than the greyish-yellow stones which are primarily used, and they are identical to those seen in the stream (Oare Water) below.

The northern 3.5m of this southern repair (i.e. the central portion of the eastern parapet) was reduced to the base of the parapet (c.1.1m) and the point at which the wall widened. During this careful reduction of the surviving stonework, it became clear that there were at least three phases of 'modern' repair to the parapet, with three different types of cement visible. The repaired stonework accounted for the majority of the parapet, with only the lowest two courses of stonework retaining the original lime mortar bonding and an earth and rubble core to the wall. The facing stones of the two original courses of the parapet, and the stones of the southern spandrel panel, were individually numbered so that they could be placed back in their original positions, but the rubble core and inner roughly-coursed face were not (as these were highly irregular and will not be visible). The removal of the parapet in this central portion exposed the arch barrel itself in places (see Figure 3b). The arch was bonded with lime mortar and constructed from slightly larger stones (0.5x0.25x0.15m) than seen elsewhere in the bridge, but no further detail was attainable, as only the top of the eastern face of these stones was exposed during the repairs.

Figure 3: (a) The northern part of repairs to the eastern parapet, viewed from the south (2m scale).
(b) The repairs to the southeast spandrel panel, viewed from the northeast (2m scale).
(c) The southern end of repairs to the southeast spandrel panel, viewed from the east (2m scale).
