The Walronds

Cullompton

A Revised Gazetteer

August 2014

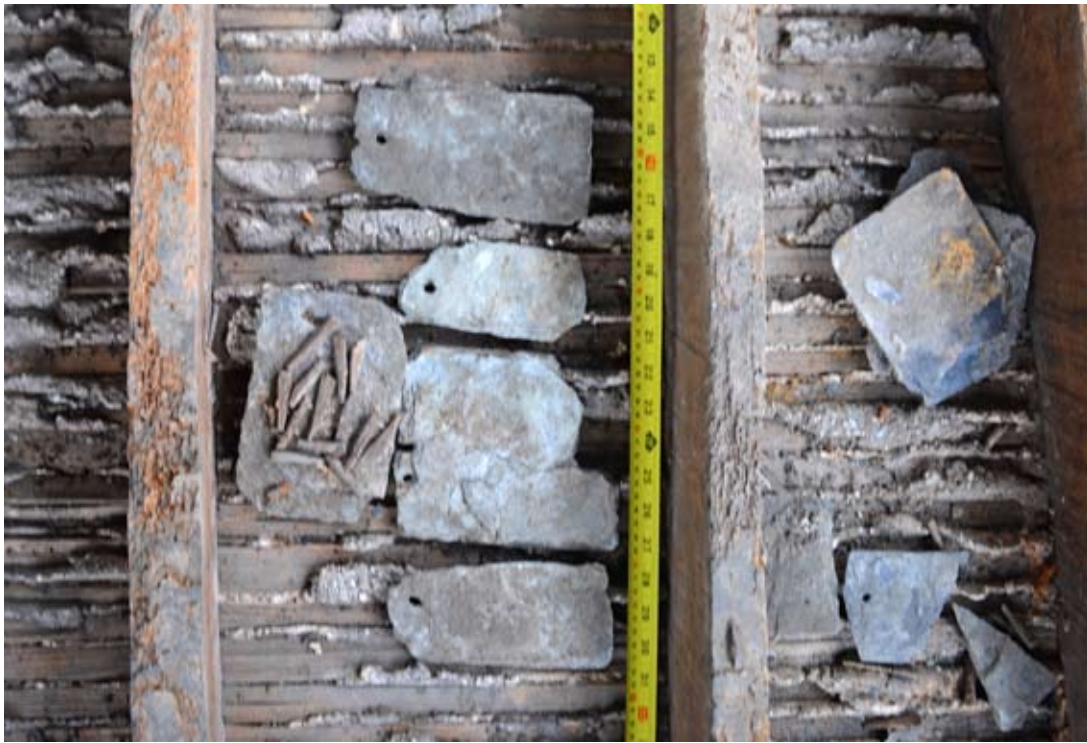
Some of the slates and pins in the roofspace of the south wing, 16.11.2012.

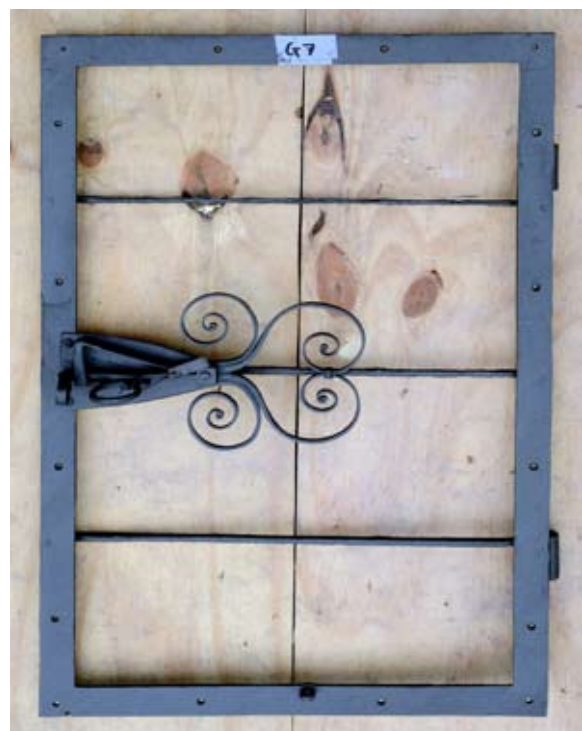
The inside of the central 1890-91 casement in W.G. 07 during repairs, 20.05.2013.

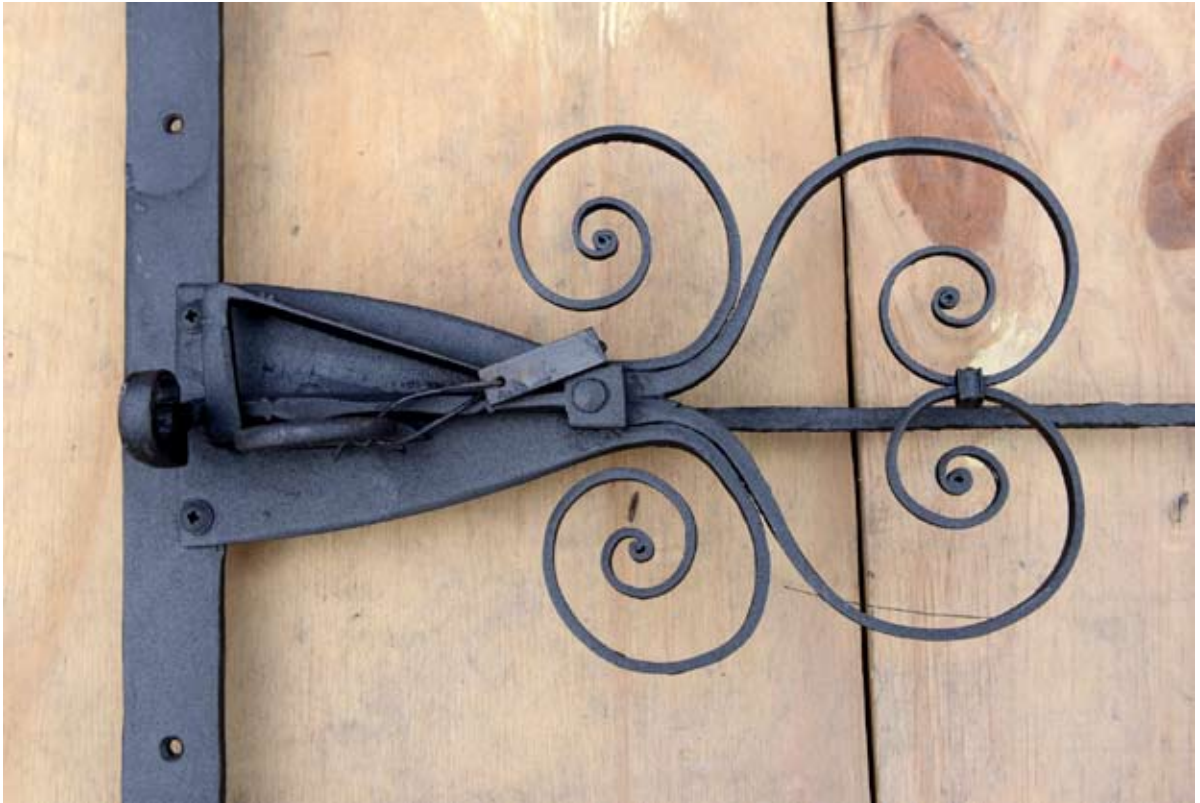
Detail of the inside of the catch on the inside of the central 1890-91 casement in W.G. 07, serving the parlour, with replacement screw fittings. Photographed during repairs and conservation at Brockweir, 20.05.2013.

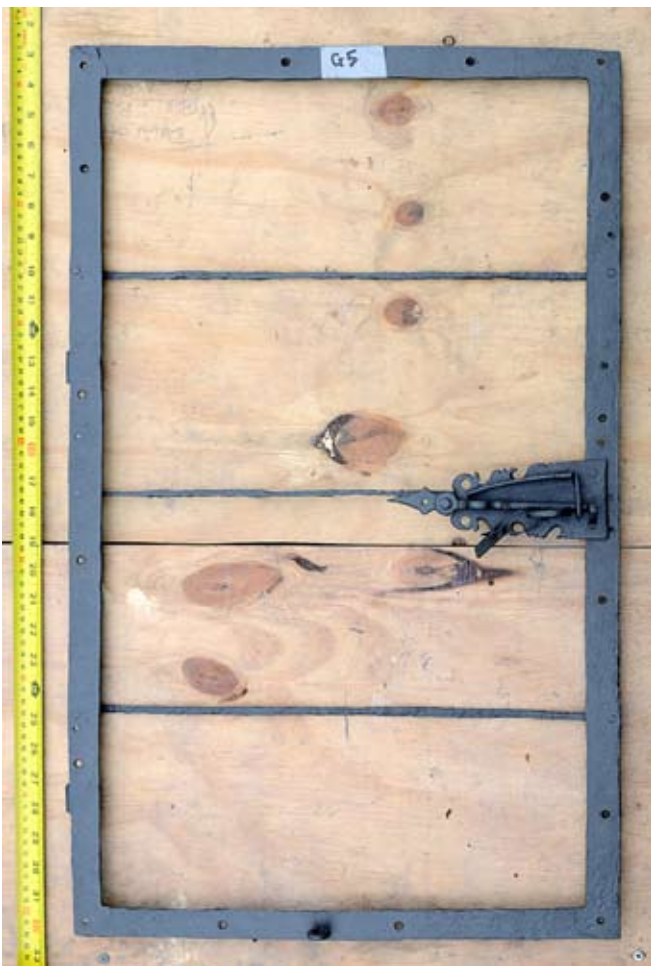
The central casement of the hall window G.W.05 is certainly ancient and might well date from c1605. The three photographs here show, from top to bottom, the inside of the casement, a detail of the outer backplate of the catch and the inside of the catch and backplate.

The photographs were taken during repair and conservation work at Brockweir, 20.05.2013.

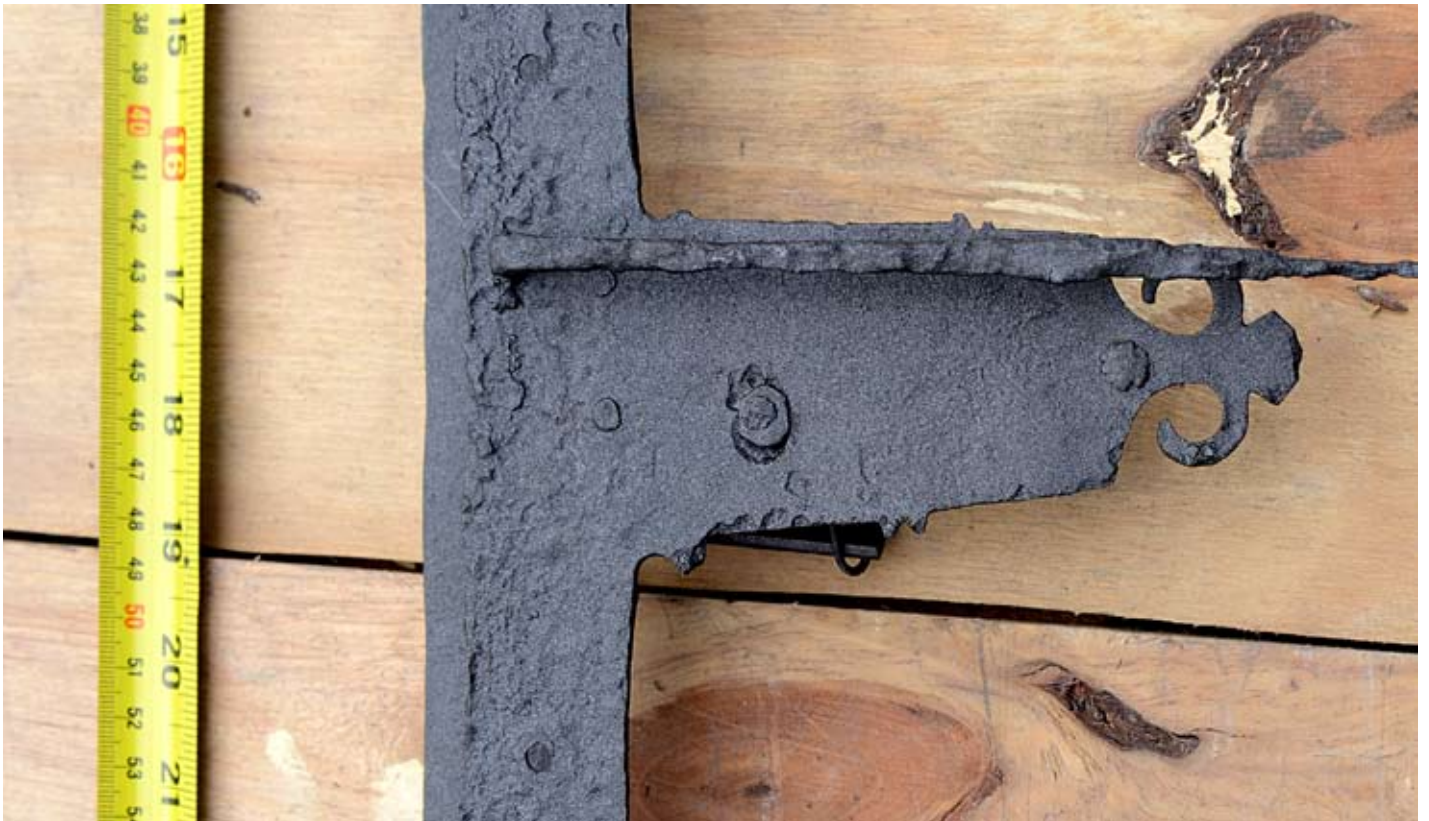
Detail of the backplate and catch of the northern casement of the east-facing first floor window W.F.08 from outside (above) and inside (below). Uniquely at the Walronds before 1890-91 the backplate is welded to the frame and maybe re-used from fragments recovered from the burnt out remains of the the 16th century house. The catch may date from c1605. The photographs were taken during repair and conservation work at Brockweir, 20.05.2013.

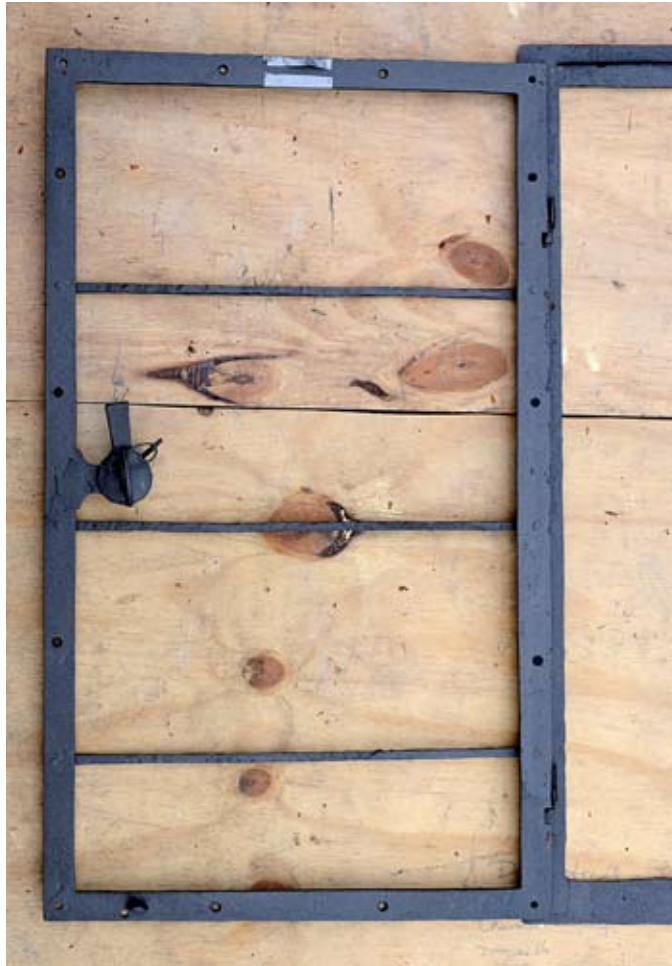
The southern casement of the east-facing first floor window w.F.08 is a typical Burrow wrought-iron casement from 1890-1. Both photographs show the inside of the casement with the whole casement above and a detail of the turnbuckle catch below, which is welded rather than rivetted to its inner frame. The photographs were taken during repair and conservation work at Brockweir, 20.05.2013.

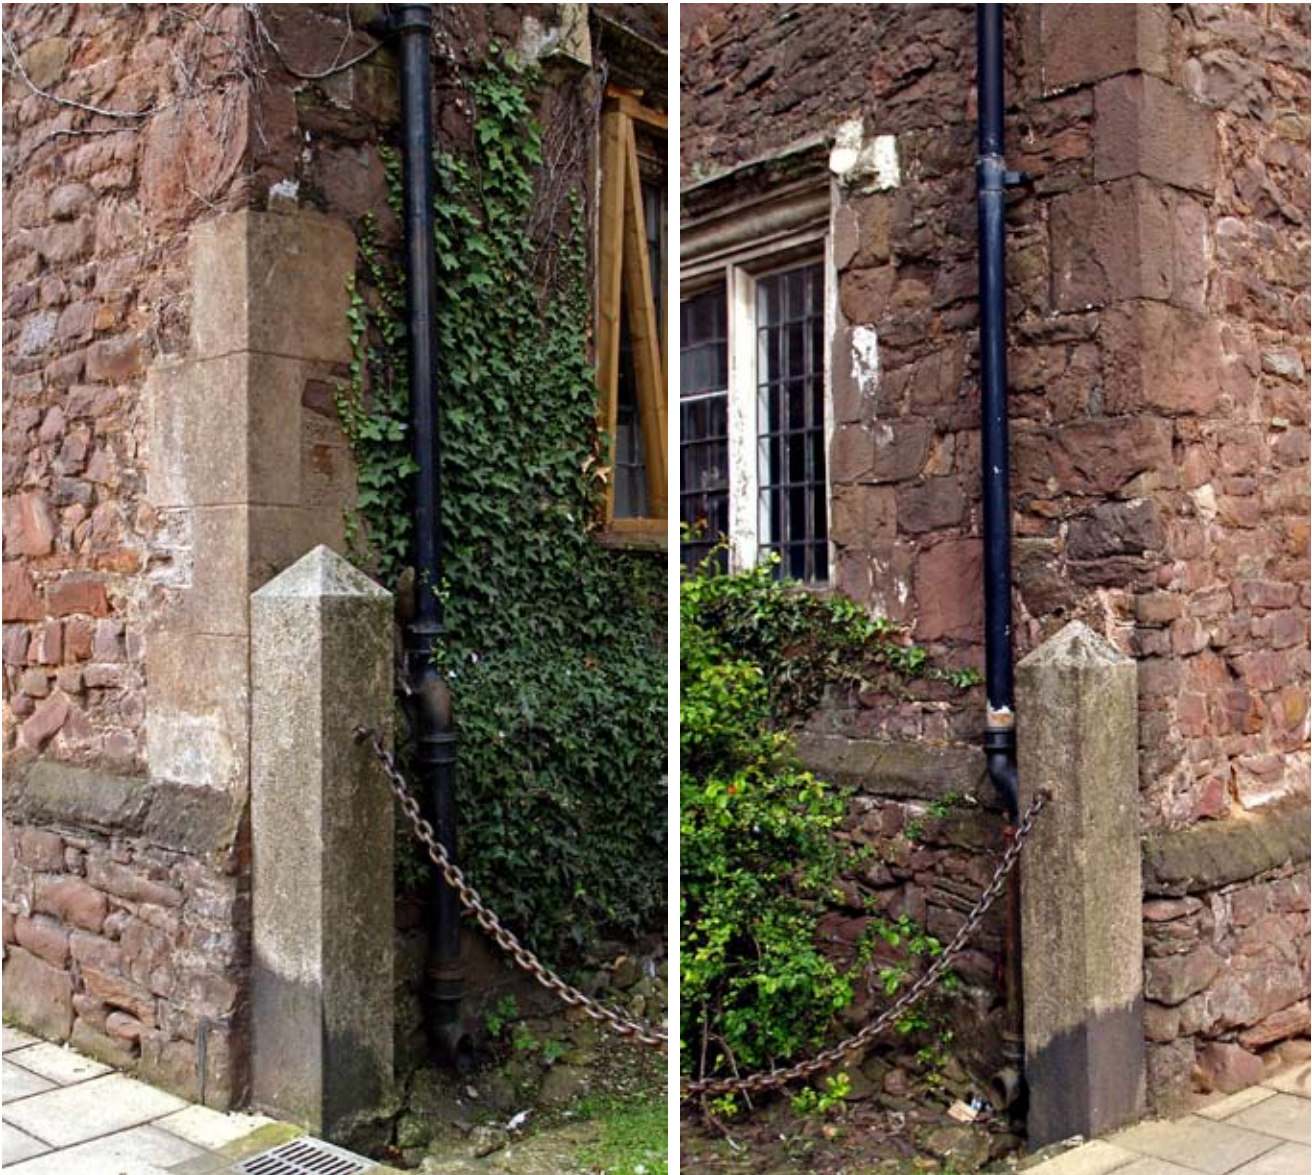
The proud quoins stop each side high enough to indicate the c1605 design of a front wall to the forecourt. The inner corners of the front wings are presented, north to left and south to right, both photographs from 06.08.2009.

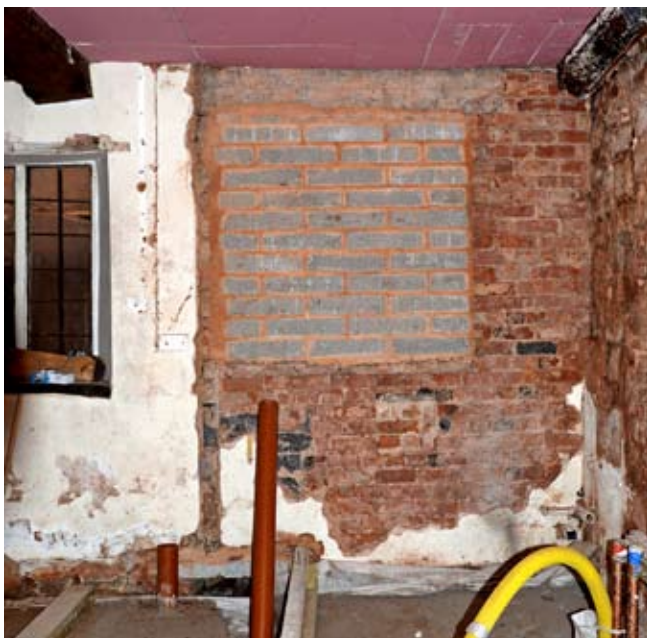
The south wall of the kitchen is faced up with reused 1890-1 brick. In 2012-13 window W.G. 20 was taken out and the opening blocked up, 30.01.2013.

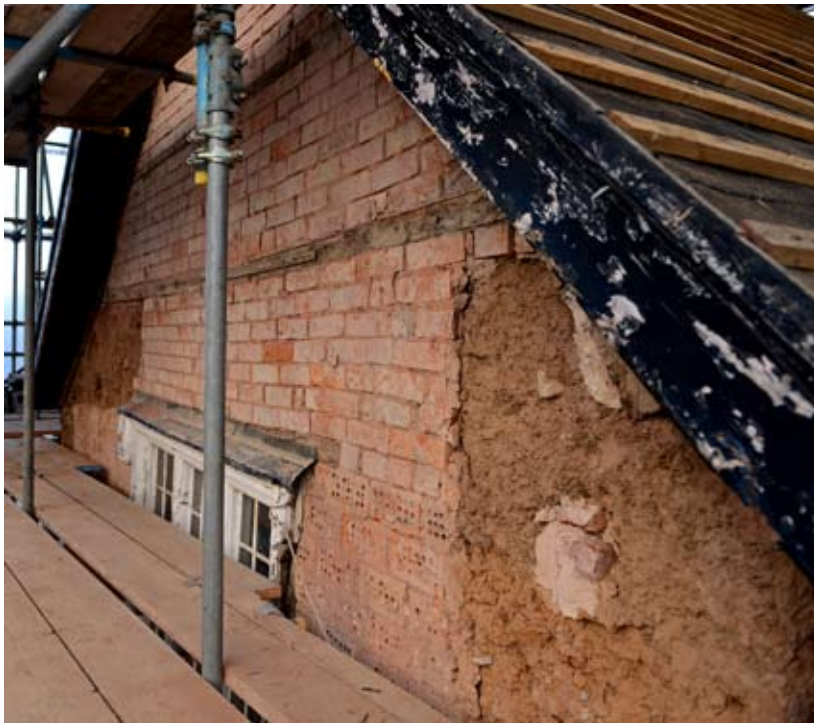
The lower level of the south wall showed extensive evidence of 1970 and 1989 work including brick repairs and alterations. A large patch of brick in the western gable is probably from the 1970 repairs.

The probably c1970 brick repair to the gable in the west end above the first floor window, W.F. 19, 29.10.12.

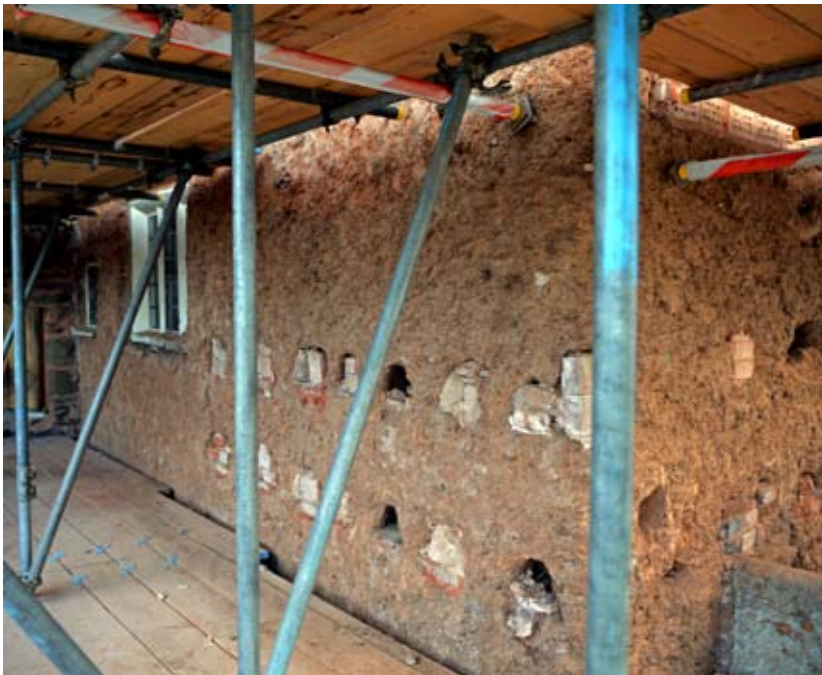
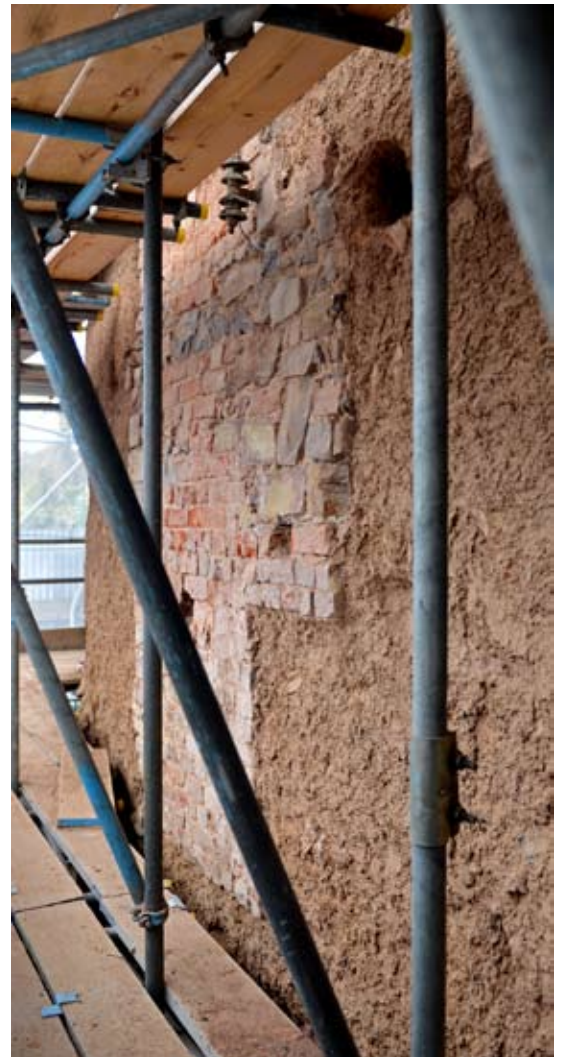
Chimney flue and blocked window. In October 2012 the outside of an inserted chimney flue was uncovered roughly in the centre of the south wall at first floor level. In the centre it was enlarged as if blocking a first floor window. The mixture of brick and stone rubble bonded in a lime mortar is typical of the Burrow period alterations from 1890-1.

The blocked pigeon holes in the north wall and the chimney flue and blocked window in the south wall, both 29.10.12

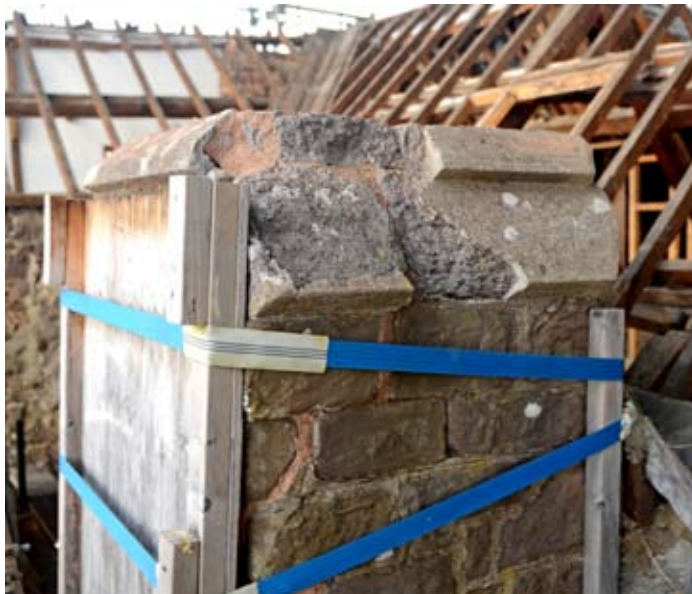
Chimneystack The projecting hall stack is constructed from rubblestone with weathered offsets and a corbelled base to the section carrying the first floor flue. The shaft was taken down c2008, but its form is recorded in 20th century photographs (Severn papers). Although undated there is one which probably dates from the 1940s or 50s (Pilgrim series) which shows a tall stone rubble double shaft with probably Burrow-period brick at the top. Another from c1970 (Heard series) shows a reduced shaft. In 2012-13 the shaft was restored with a purple stone base on four courses above the base with red brick above.

Detail of the top of the hall chimneystack and base of the shaft before repairs, 29.10.2012.

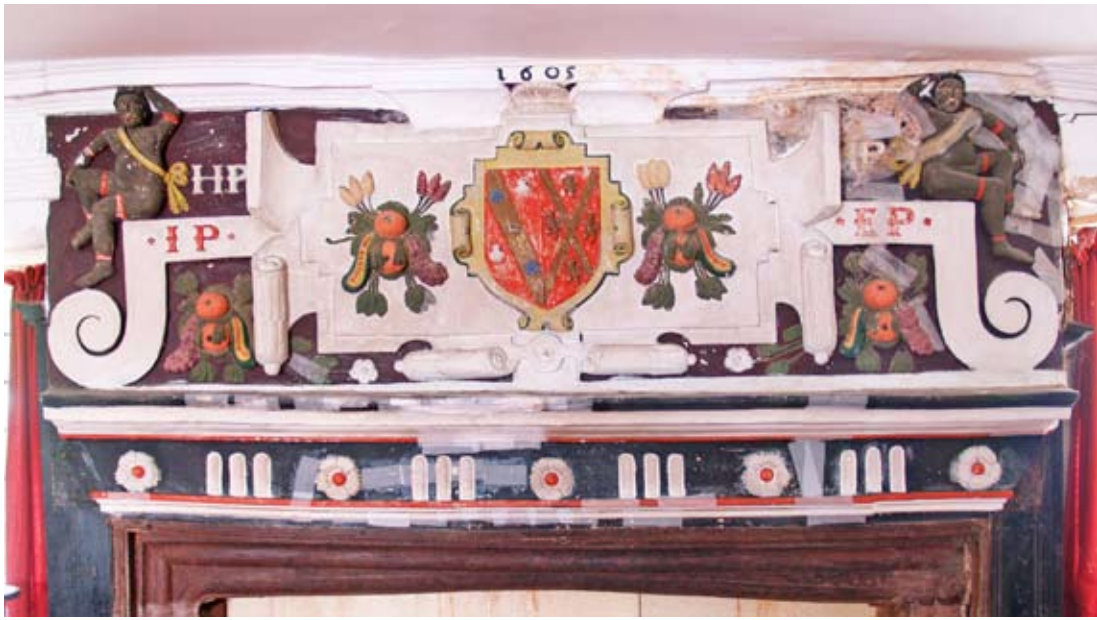
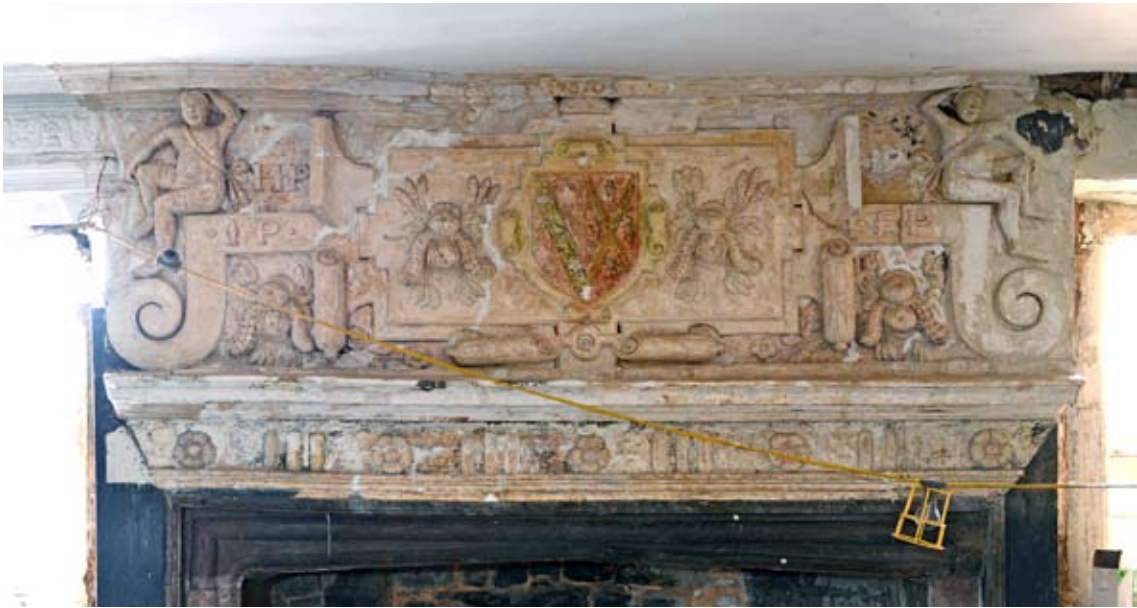
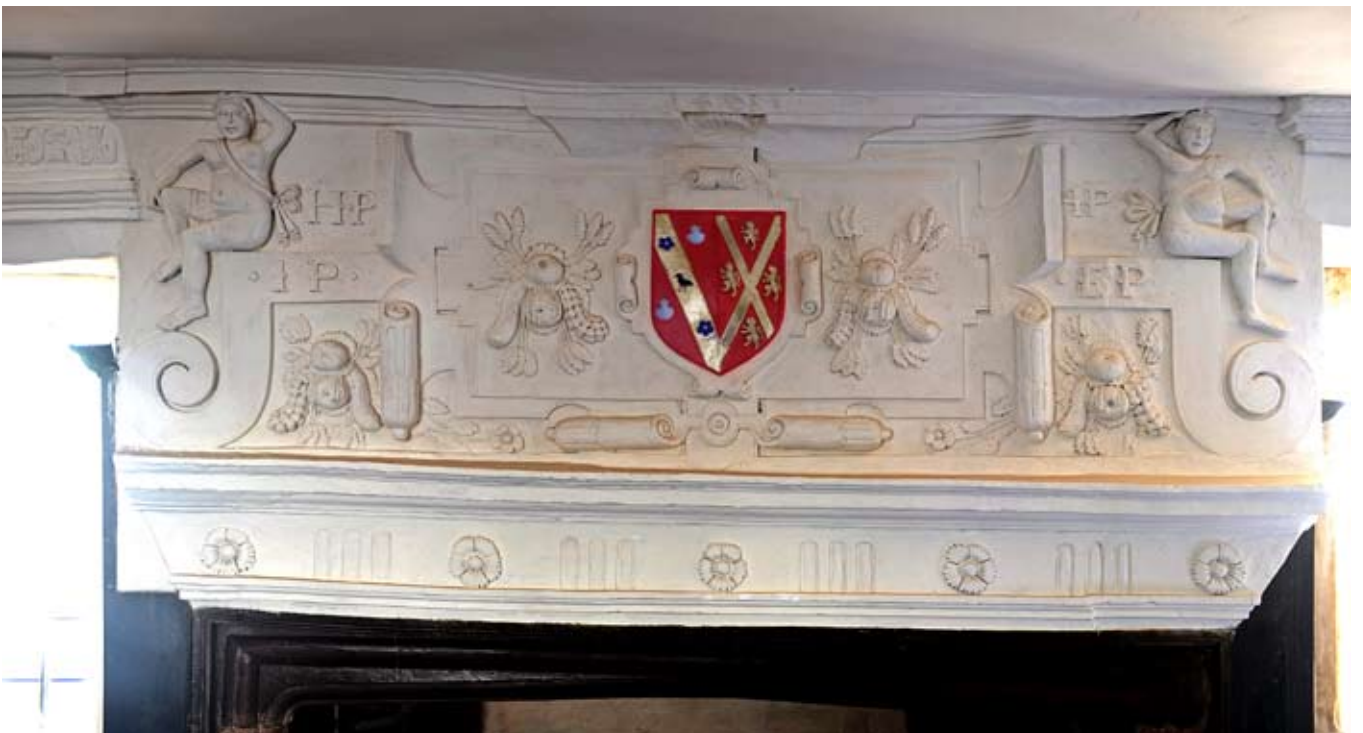
Summary of 2009 expert report: The overmantel is modelled and cast in lime plaster, with a lime-rich backing coat containing hair (but surprisingly little hair in comparison with some of the ceilings here) forming the base and a finer lime skim. Cast elements are added in lime plaster. The larger elements would have been supported on an armature, probably of timber. The laths are riven oak, fixed with iron nails. The projecting sill, formed from a single longitudinal timber to which laths were nailed to carry the plaster mouldings. The upper panel – the overmantel proper – which would consist of vertical studs or a frame to which the longitudinal laths were nailed and, again, the plaster built up in layers to form the strapwork panels; cast elements would then be added to the face,

The ornamental plasterwork overmantel before repair, 01.07.2009, during repair, 18.06.2013, and after repair, 23.05.2014

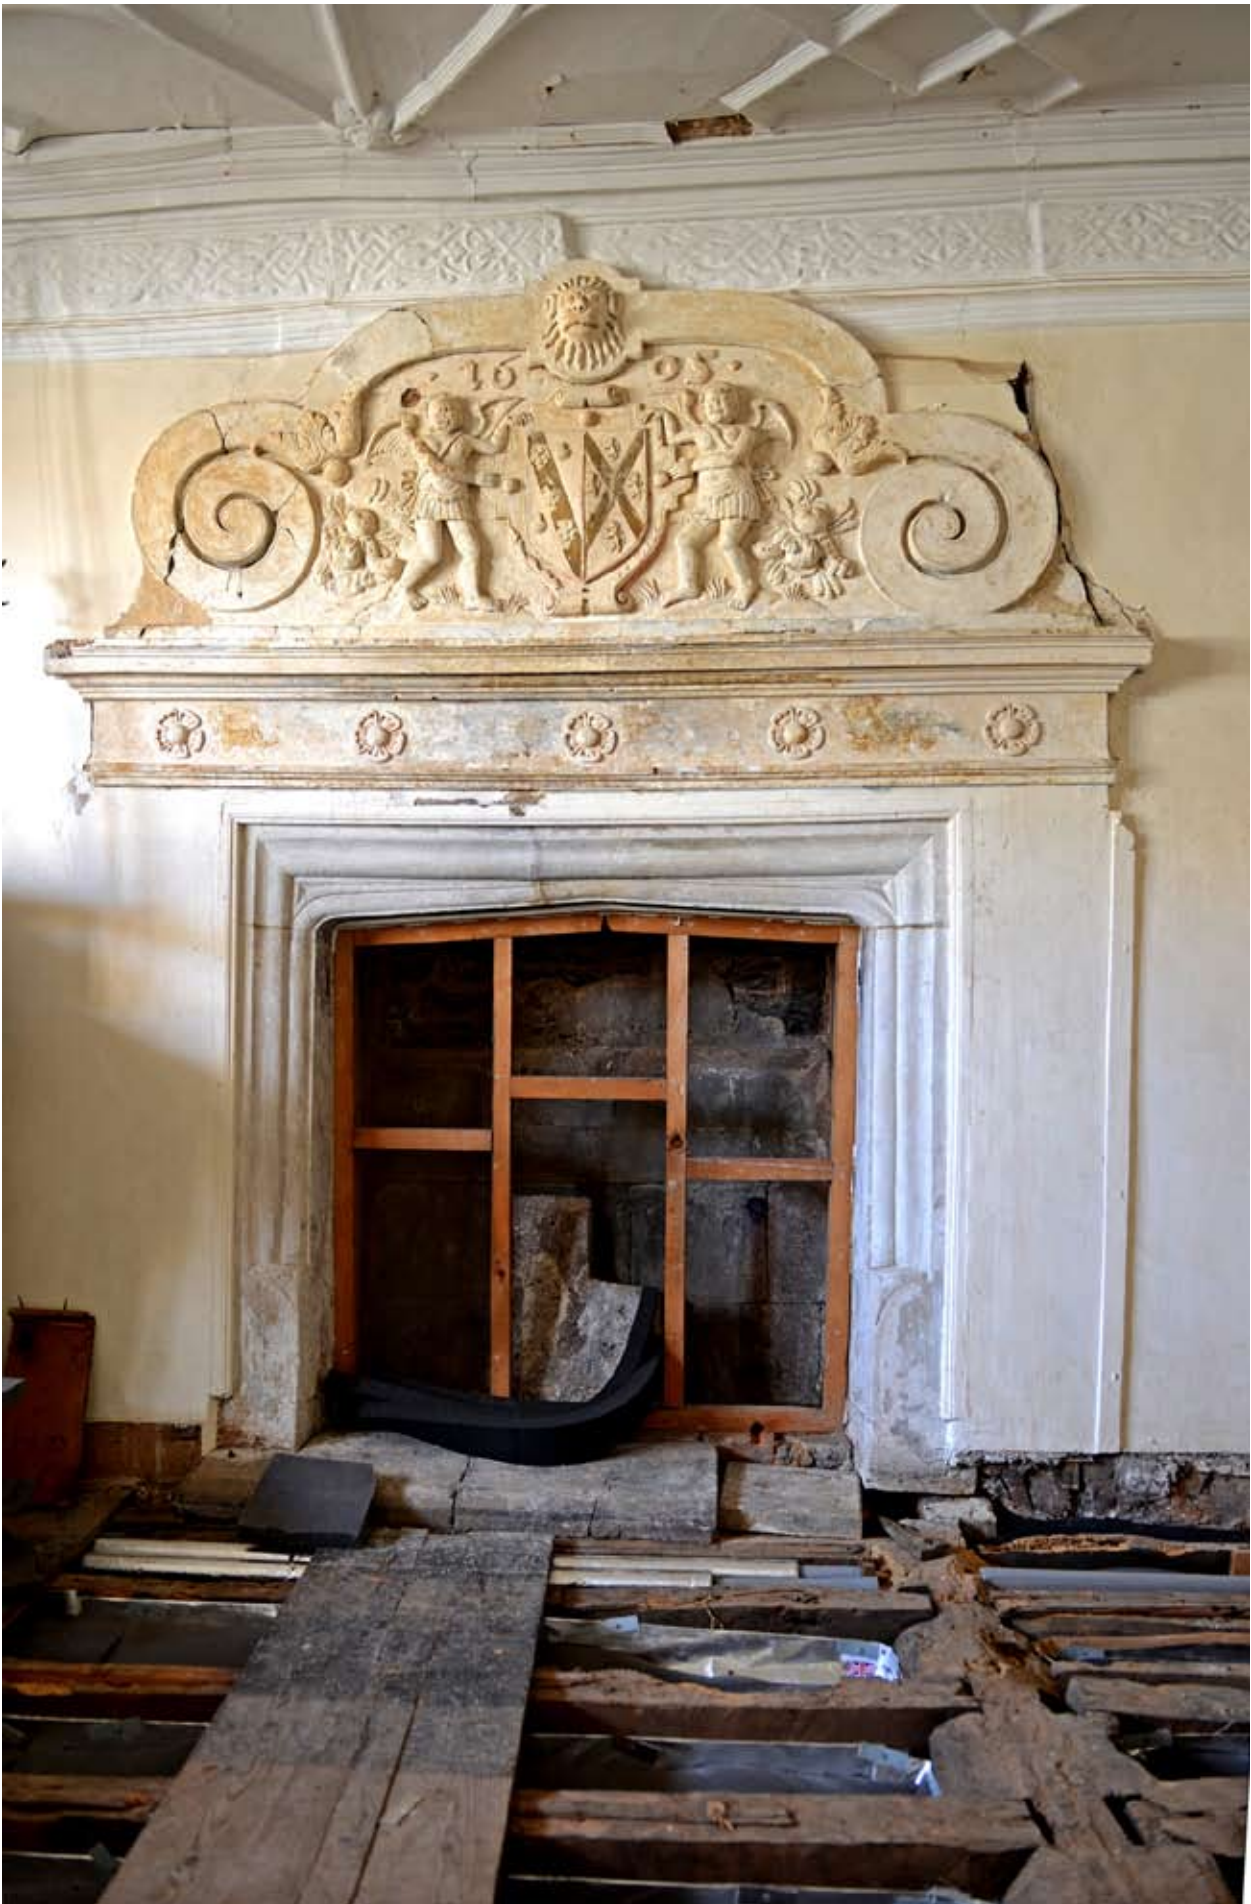
The fireplace and plaster overmantle in the Great Chamber undergoing repairs, 30.01.2013.

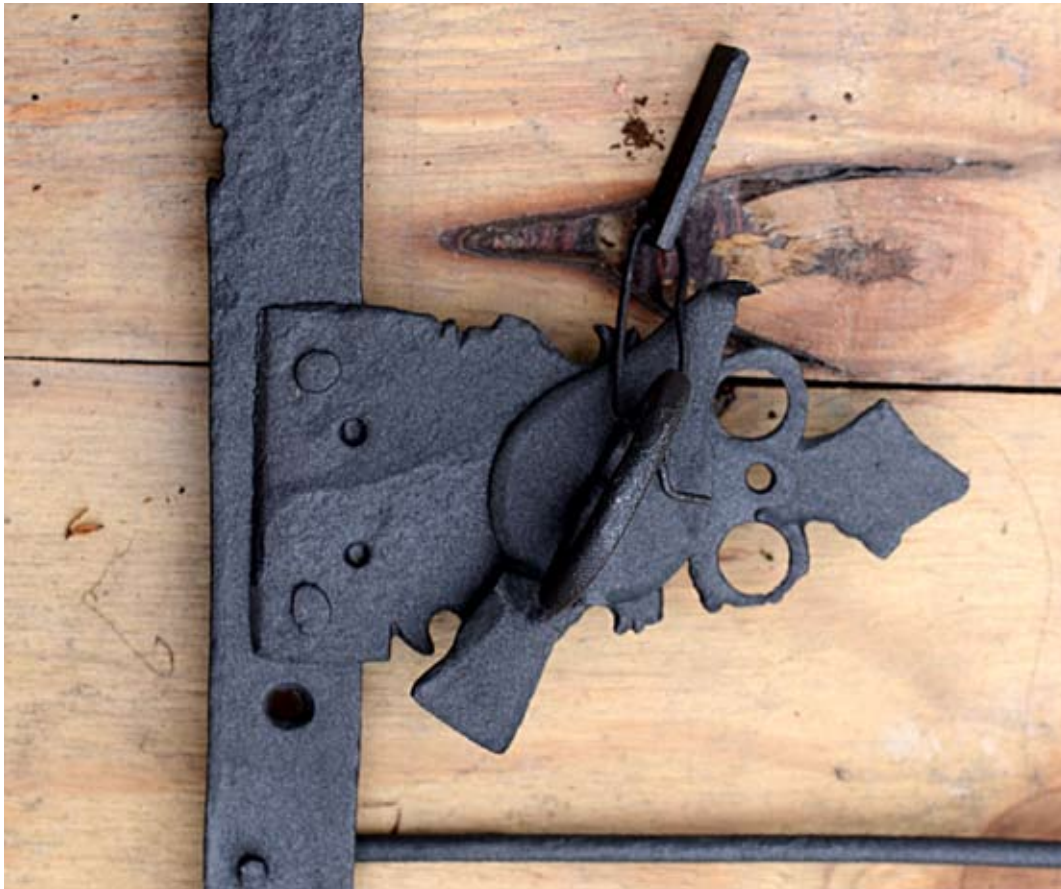
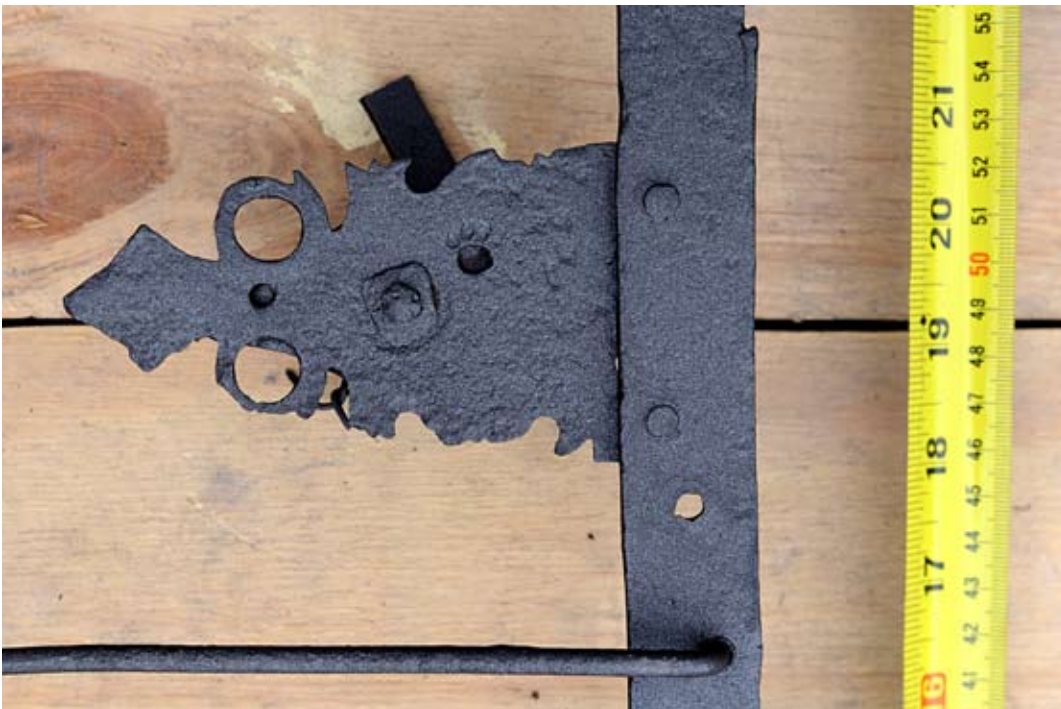
Summary of 2009 expert report: A stone[sic] three-light window with a central casement. The leadwork is 19th century and the glass is cylinder glass (60%) from the 17th century. There are twin internal ferrous stanchions. Copper ties. (Holy Well Glass Condition Report, September 2009)

Inside and outside views of the c1605 wrought-iron catch in the east window casement (W.F. 04). The turnbuckle looks like an 1890-1 Burrow replacement. One can see the scar left from the removal of the original spring latch system. Photographed during repairs at the Brockwier Glass workshop, 20.05.2013.

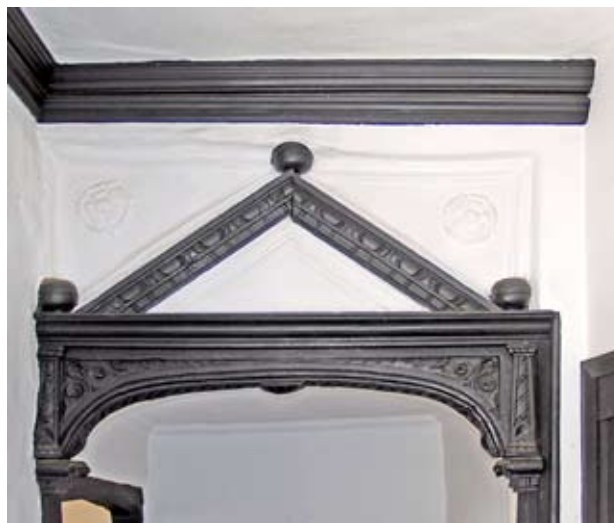
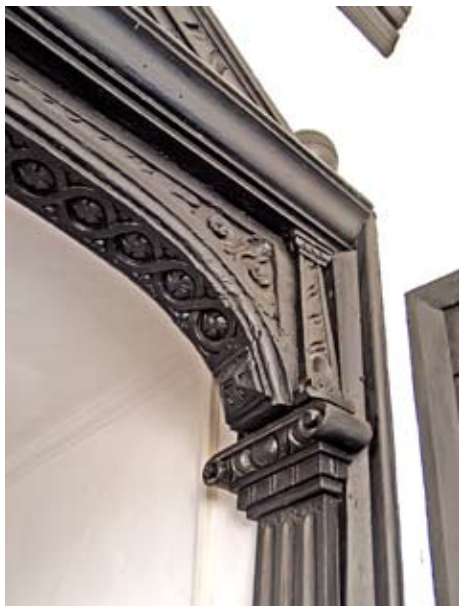
The head of the Mannerist arch to the porch entry to the Great Chamber from 02.06.2009 and the head during plaster repair on 12.03.2014

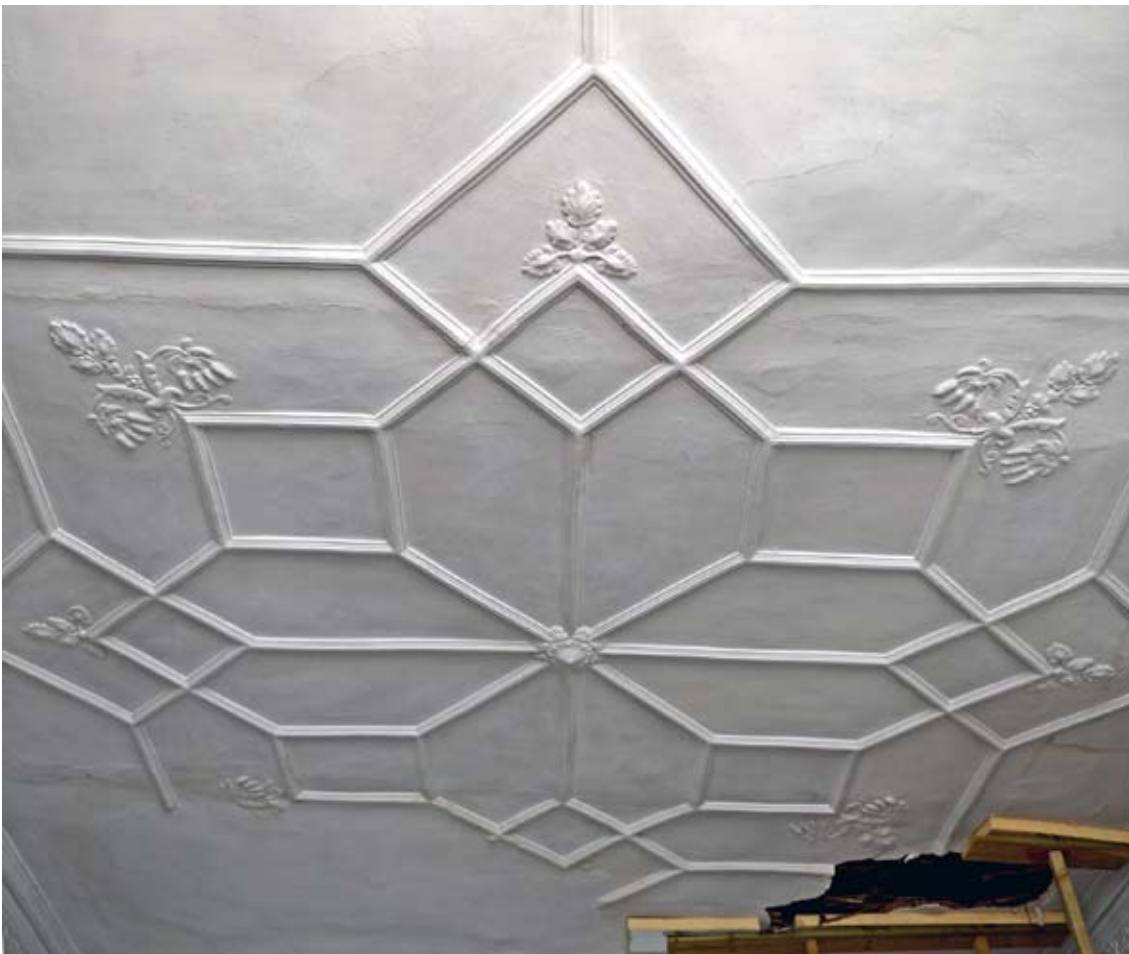
The ornamental plaster ceiling awaiting repair, 17.10.2012.

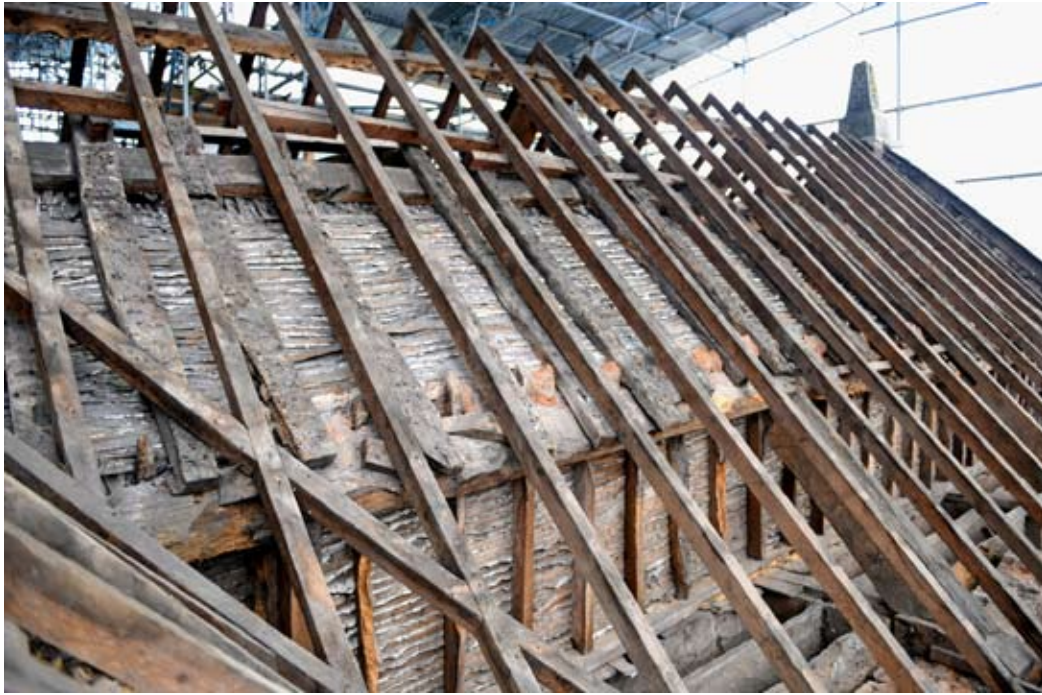
The southern pitch of the south wing roof looking east. The working common rafters are replacements from 1890-1 but the original were preserved between the purlins since the laths of the c1605 ceiling are nailed to them, 16.11.2012.

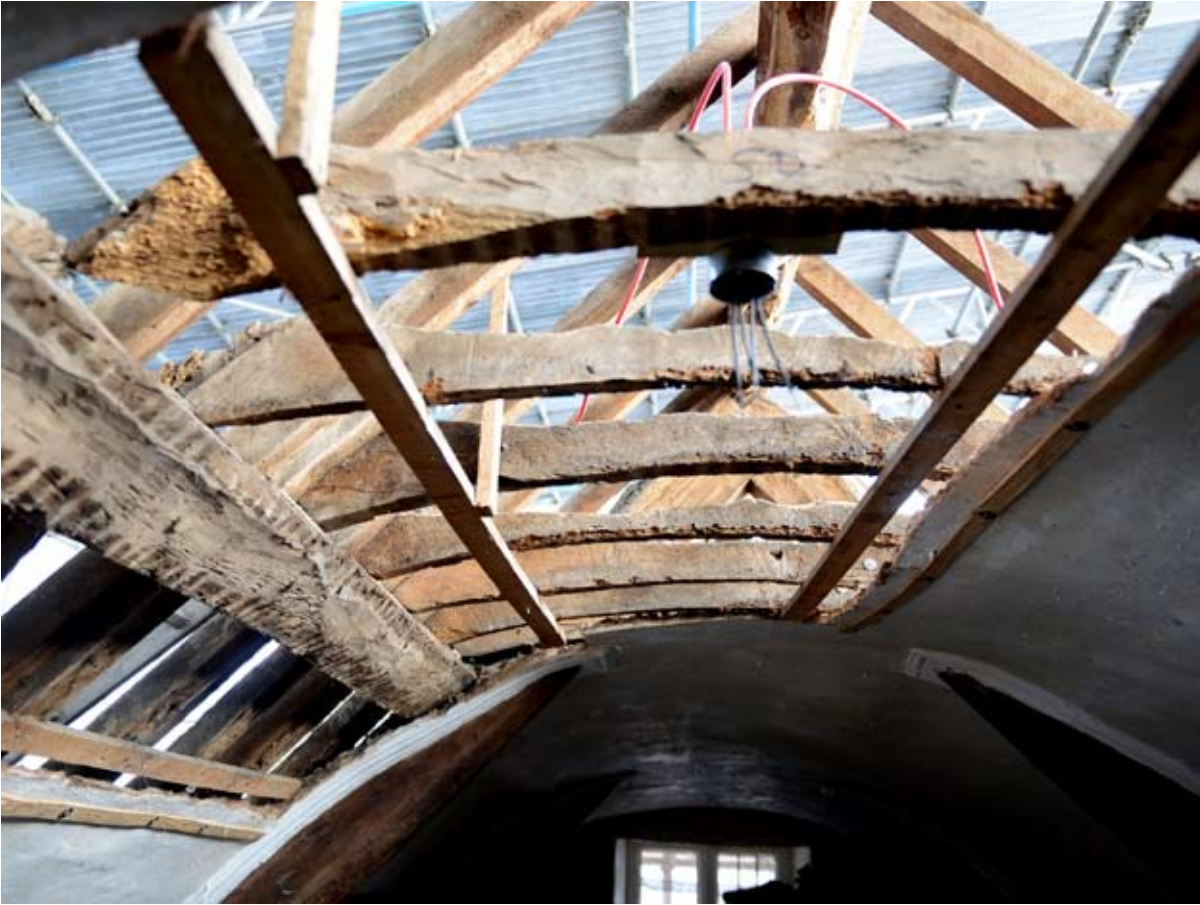
Plaster repairs showing the construction of the coved ceiling in the south wing, 30.01.2013.

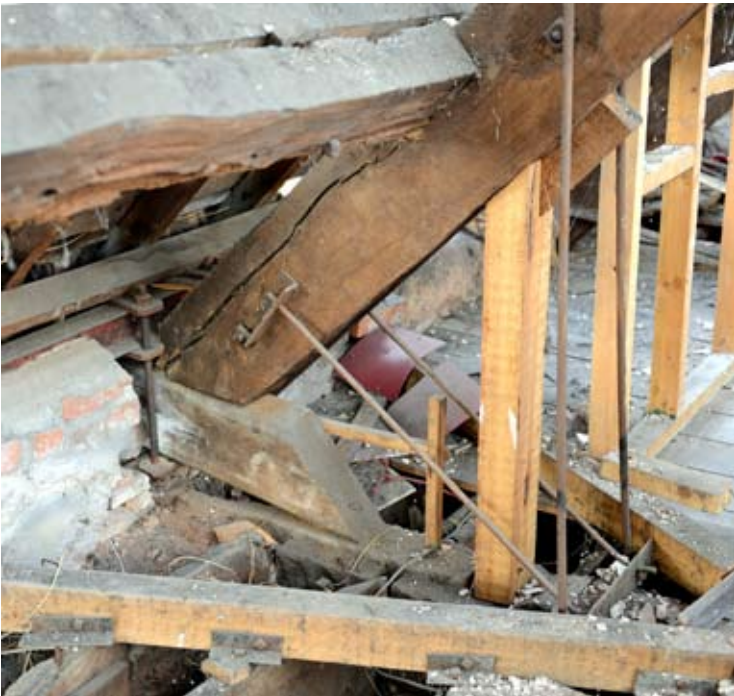
The much-repaired truss set just north of centre, 17.10.2012.
