EAST WORLINGTON HOUSE EAST WORLINGTON DEVON

Results of a Desk-Based Assessment
Historic Building Recording & Archaeological Evaluation

Report No.: 120718
Date: 18/07/2012
Authors: S. Walls
T. Green
C. Humphreys

National Grid Reference: SS77491361

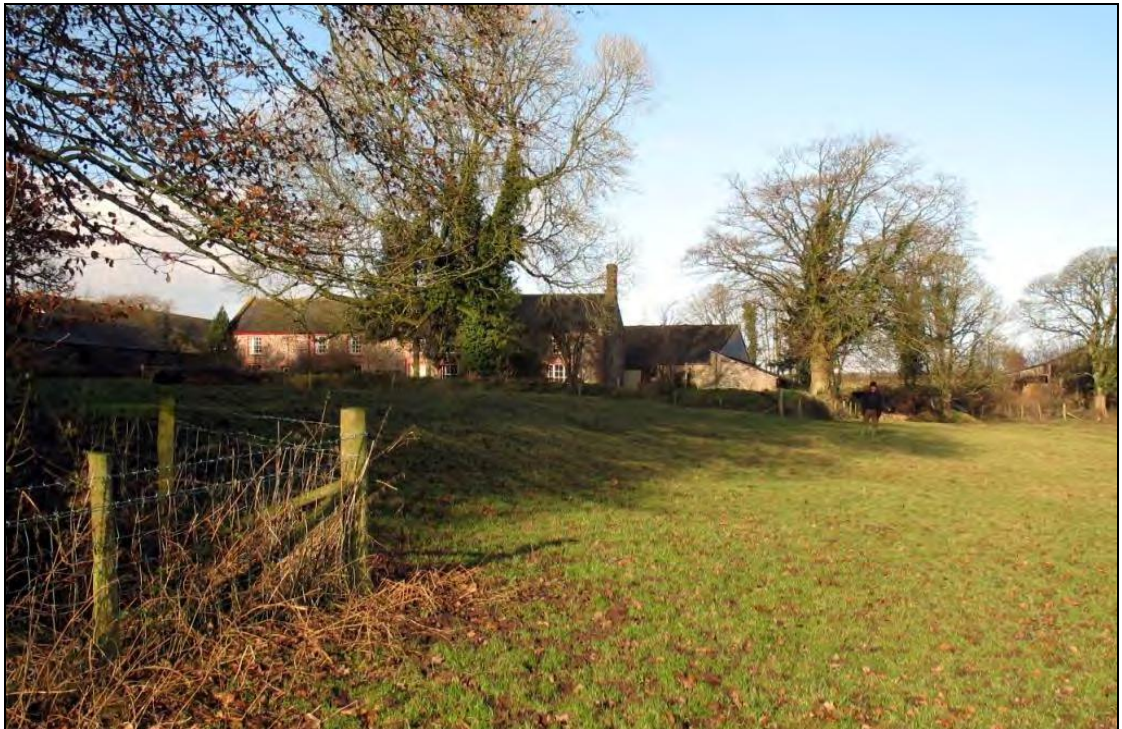
Figure 3: The earth bank to the east of the churchyard, possibly completing a roughly square manorial enclosure.

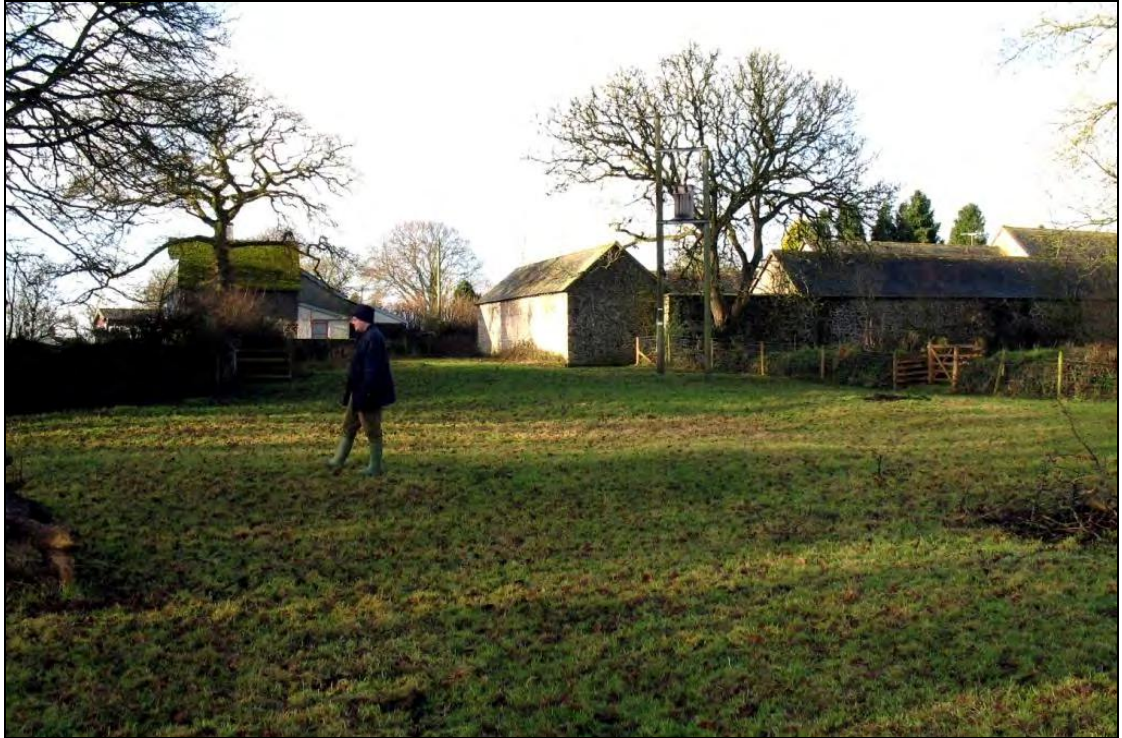
Figure 4: The open area to the east of the churchyard in which earthworks suggest a building platform. The figure is standing at the south-east corner of the earthwork.

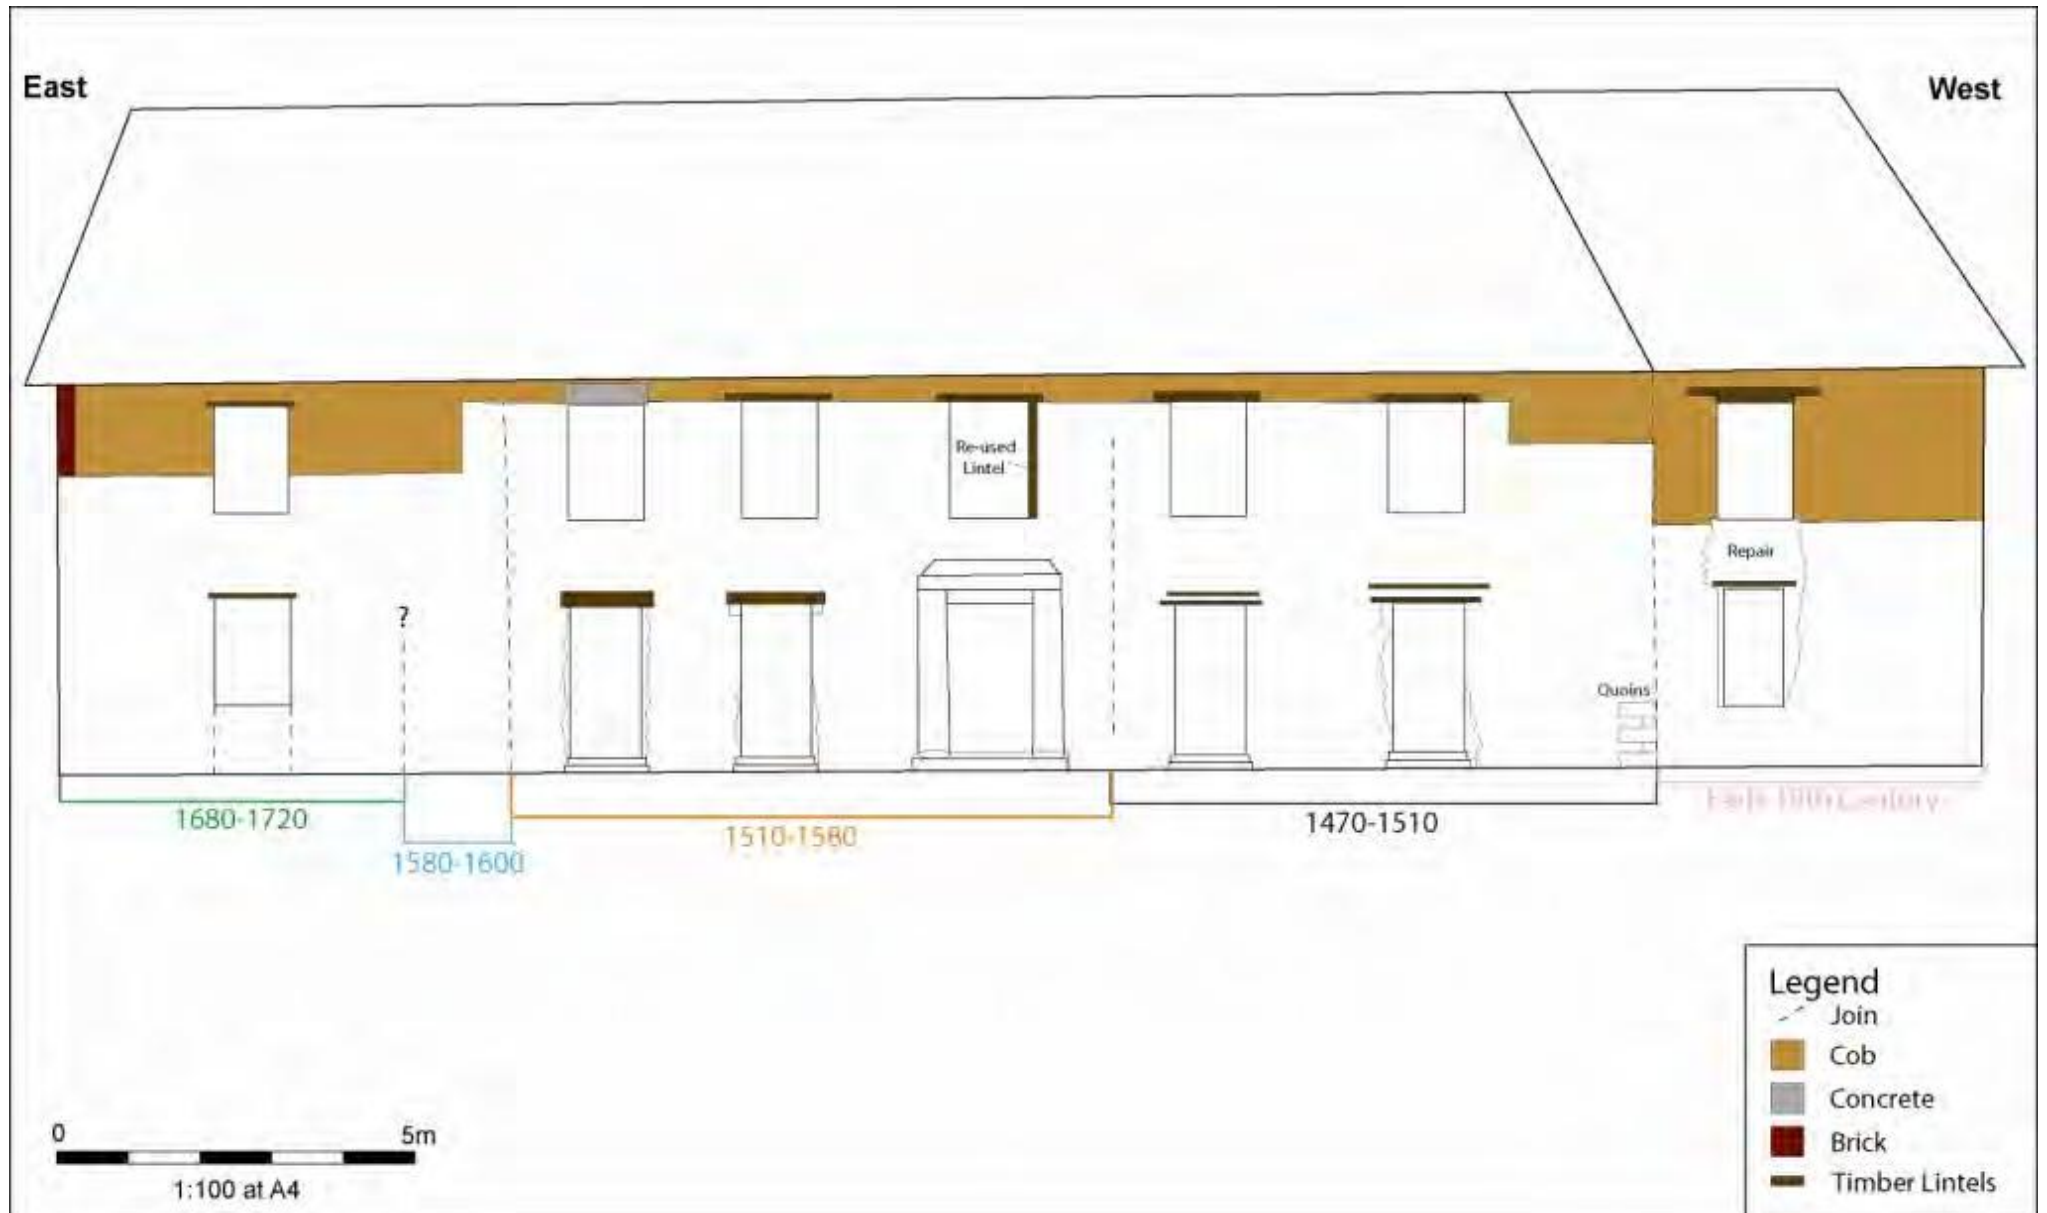
Figure 16: Details of the front elevation revealed during the removal of render.

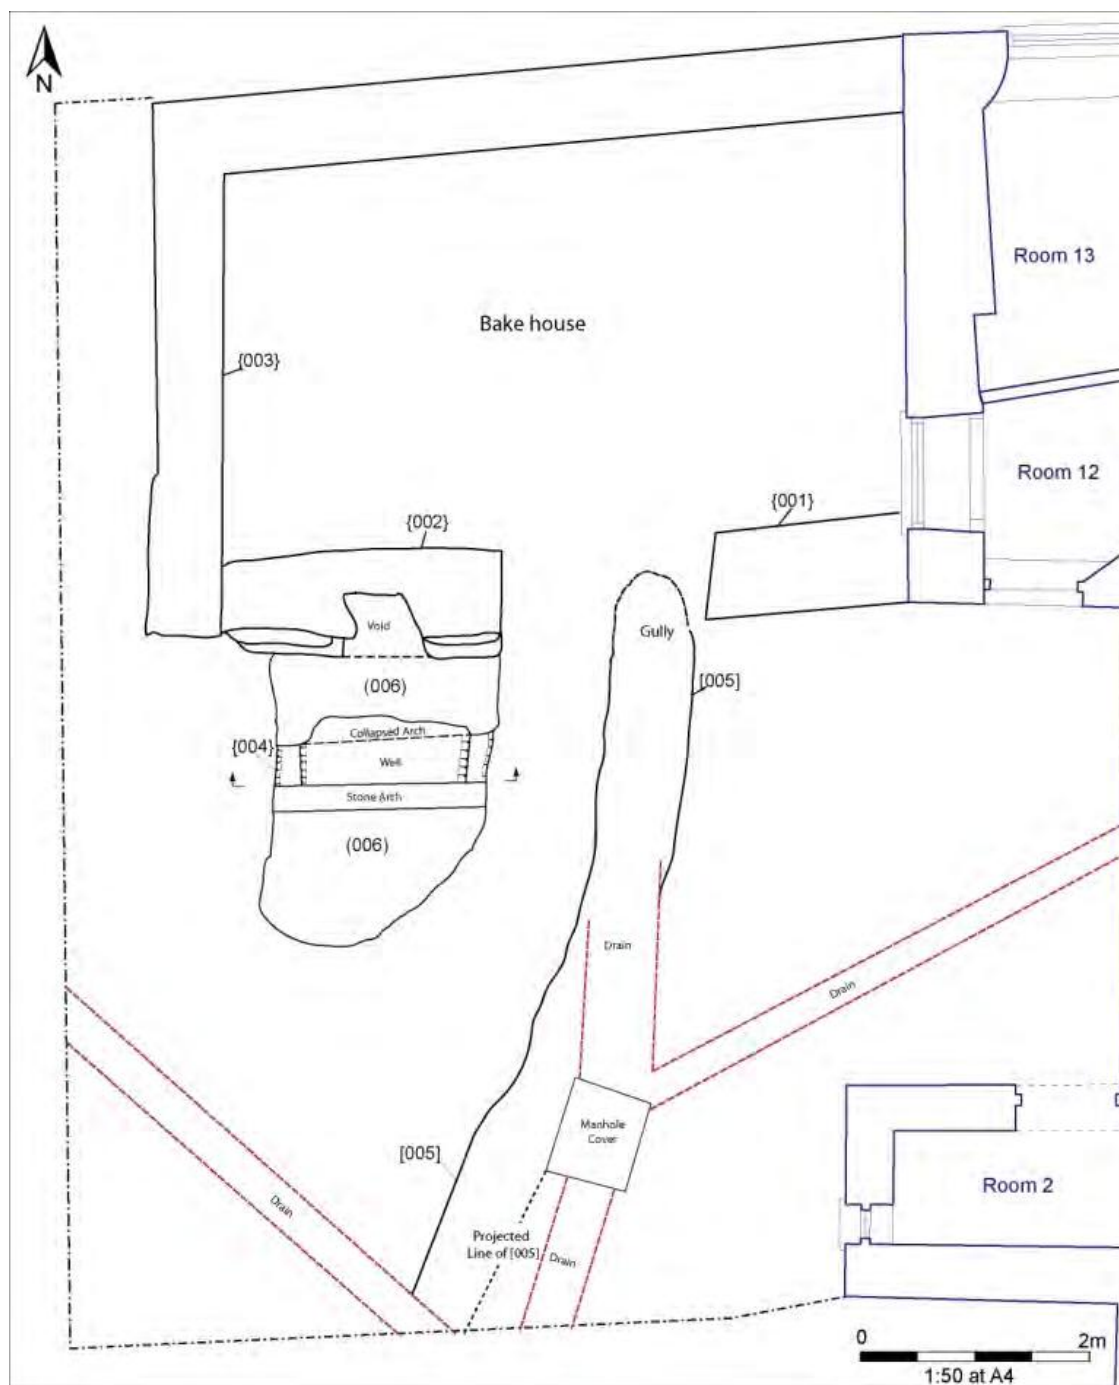
On the line of the south wall and abutting the west wall {003} of the bake house are the remains of incomplete footings of a wall {002} of slightly different construction from the rest of the bakehouse. It is primarily constructed from roughly coursed large (c.0.5m) angular stones with a dirty white lime mortar. The wall {002} clearly post-dates the bake house and survived only as a single or double course of stones which ran for 2.5m from east to west. The wall was 0.2m high at its highest, 0.7m wide at its eastern end and thinning to 0.65m at the western end. There is ragged gap of 0.5m in width cut into the footing of the wall (leaving a single course) 0.7m from its eastern end (near the bake house).

Figure 17: Trench 1, the area of the Bake House.

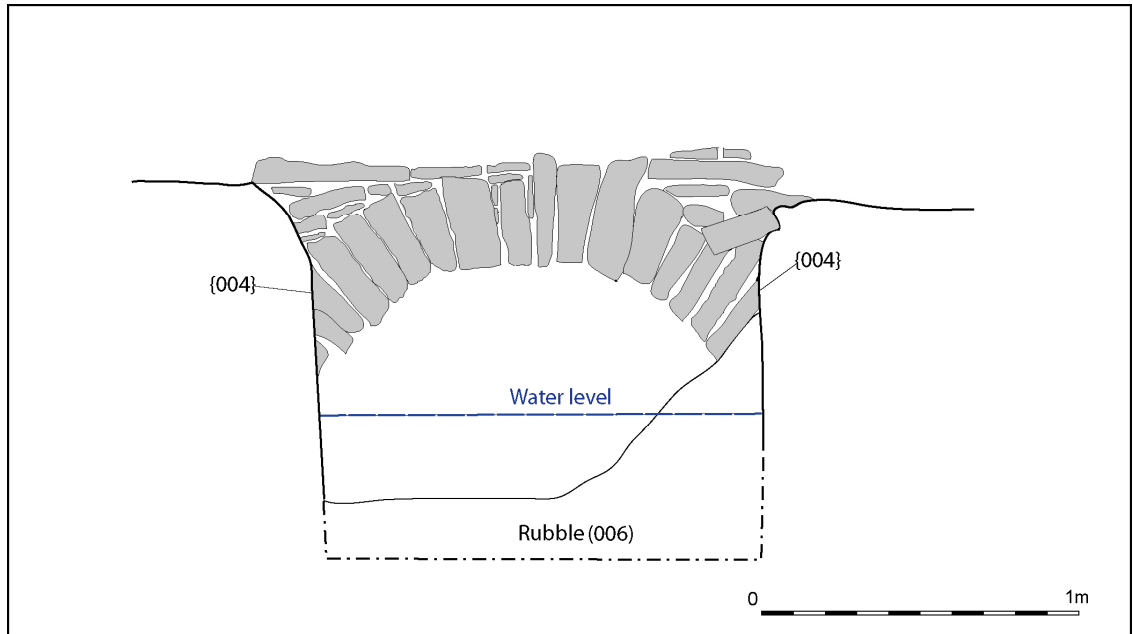
South of the western end of the bakehouse was a well {004} with a 1.8m circumference and 1.35m deep (Figure 18). The well and the area south of the bakehouse were covered by 0.2m of 20th century rubble (006). The rubble layer also sealed a slight 0.1m deep, 0.6m wide gully [005] which ran south south-west for 7m from the south wall of the bake house. The gully contained a loose mid-brown fill (007), which included some demolition debris and 20th century pottery and glass.

Figure 18: The north facing section through the well {004}.

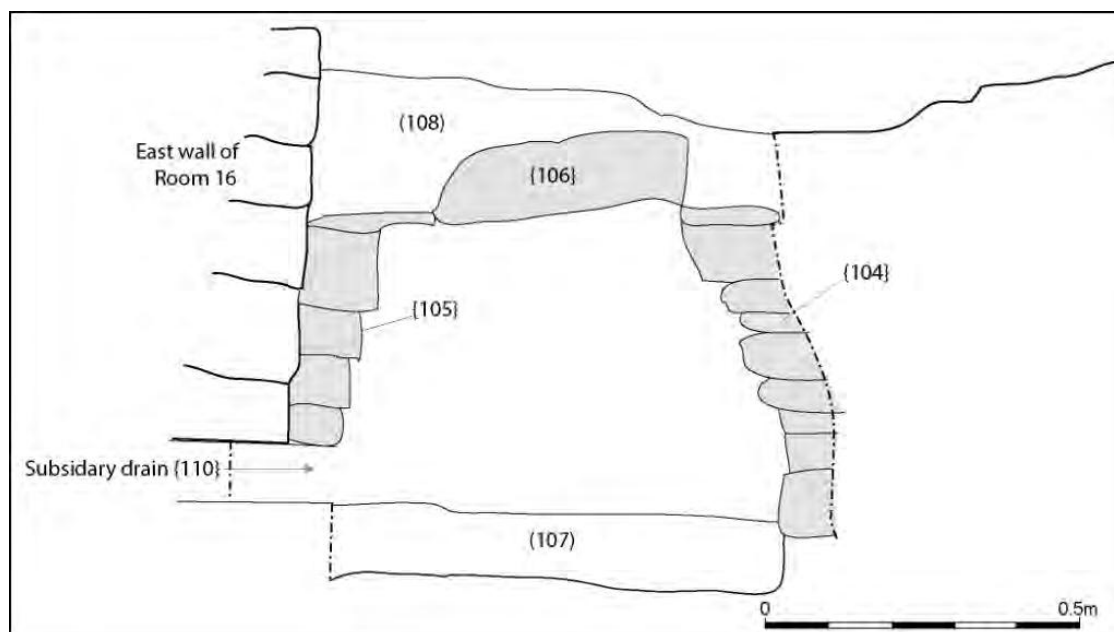
To the south-east, a further part of the culvert/drain demonstrated two phases of build (Figure 19). The north-east wall {104} had fairly vertical, internally faced base courses which then became corbelled until they met a horizontal capstone {106}. There were some handmade bricks within this wall and all components were covered with a brownish lime mortar. The wall of the culvert to the south-west {105} was effectively vertical with lower courses appearing to be dry-laid, the upper bonded with a hard creamy white lime mortar. The differing builds of the two walls suggested a blocking off of the drain, although when the fill (107) was removed, a small channel {110} which would have permitted a more limited flow at the base of {105} was revealed at the base of the north-east wall of the building.

Figure 19: South-east facing section of the culvert.

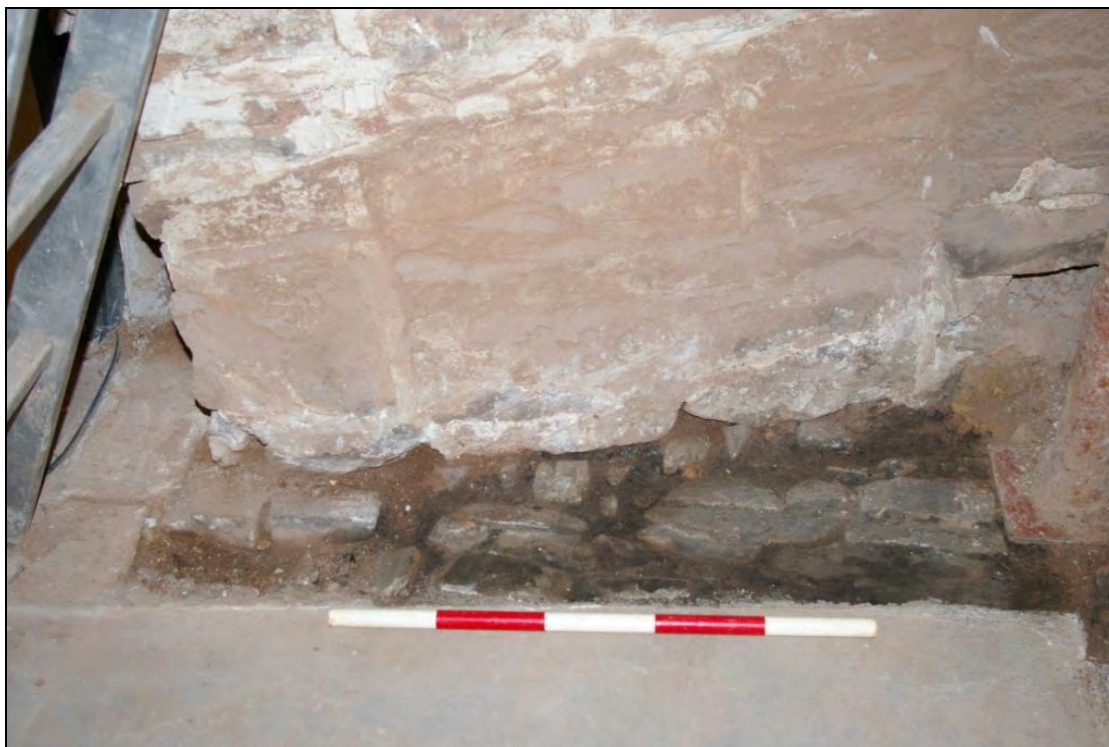
Beneath the foundations of the early 19th century walls to the east and south of R17 there were also traces of another (different?) cobbled surface (204). This surface extended beneath the western wall plinth {203} under the staircase in R10 (Figure 20). It is slightly lower (0.05m) than the other cobbled layer (201) and appears to have been cut into the compact red-brown silt-clay (202), rather than sitting upon this deposit as found with (201). The very limited surviving traces of this cobbling make the relationship between the two floors unclear, what is apparent however, is the relationship with the surviving part of wall {203} as the cobbled layer (204) clearly goes beneath it, while the other surface (201) abutts this wall.

Figure 20: Cobbles (204) extending below {203}, viewed from the east (0.5m scale).
