# BARNS at HIGHER AYSHFORD FARM BURLESCOMBE DEVON

Results of a Desk-Based Assessment  
&  
Historic Building Recording

Report No.: 130128  
Date: 28/01/2013  
Authors: C. Humphreys  
E. Wapshott  
T. Green

**Location:** Barns at Higher Ayshford Farm  
**Parish:** Burlescombe  
**District:** Mid Devon  
**County:** Devon  
**NGR:** ST 049152

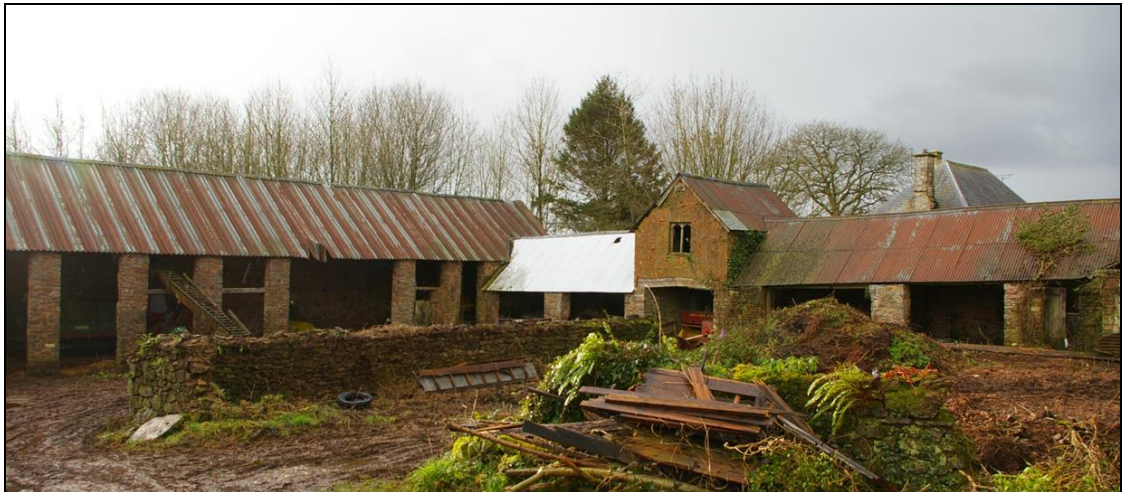
Figure 6: Buildings to the south-west of the courtyard, viewed from the north-east.

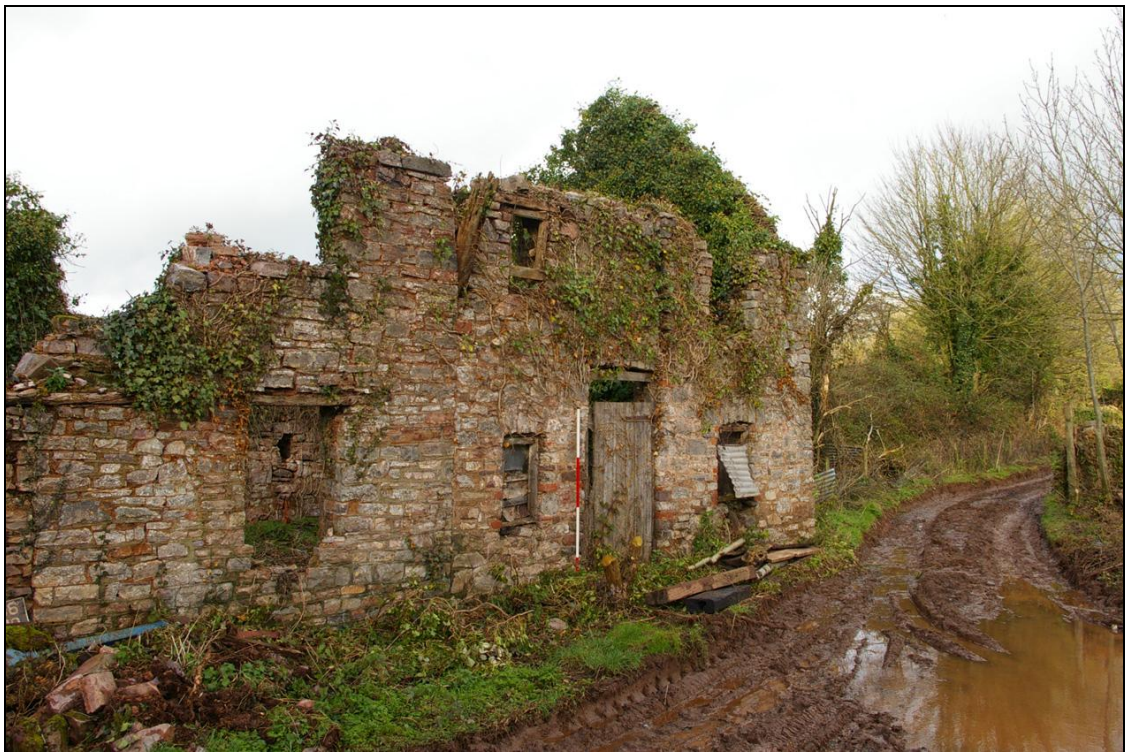
The eastern part of the range is a ruined, roofless stone-built two storey building of rubble stone construction (Figure 7); the gable to the east and the front wall to the south both appear to be later additions to the wall to the north. The south wall contains two small window openings to either side of a central doorway, all with stone segmental arches. These openings have deep splays, patched with brick, with pegged timber window frames and timber lintels. The doorway has brick and stone quoins, a pegged door frame and timber lintel. Above the ground floor windows are a pair of loading doors.

Only parts of the first floor and the roof structure (as described in the listing) survive and much of the detail has decayed due to prolonged exposure to the elements. There is no internal partitioning surviving between Building 1 and Building 2.

Figure 7: The south elevation of buildings 1 and 2, the former Stable Block, viewed from the south-west (2m scale).

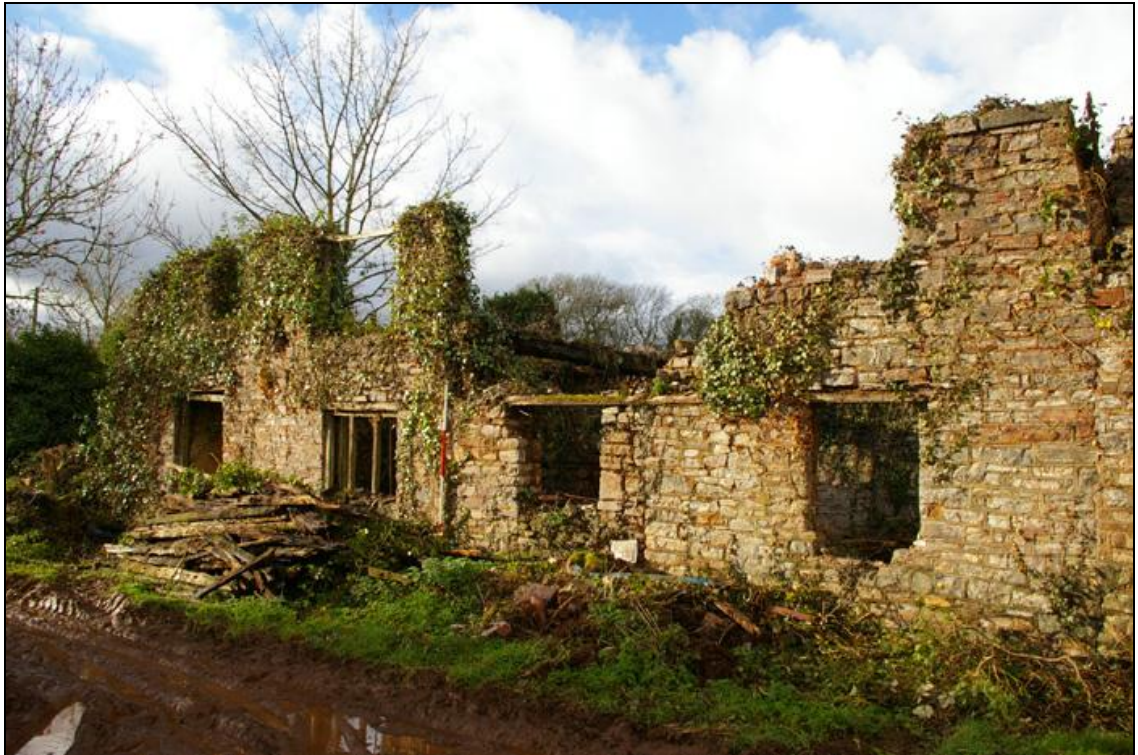
The ground floor openings in the south wall consist of a door opening with a narrow timber lintel at the western end and a wide window to the east. Parts of the chamfered timber window frame survive; with pegged joints and two timber mullions forming three lights with diamond set iron glazing bars. Timber ledged shutters survive in part. The first floor has a pair of loading doors. There are shallow splays to the windows and loading doors at the western end. The centre of the south wall has partly collapsed at first floor level (see Figure 8).

Figure 8: The south elevation of Buildings 2 & 3, viewed from the south-east (2m scale).

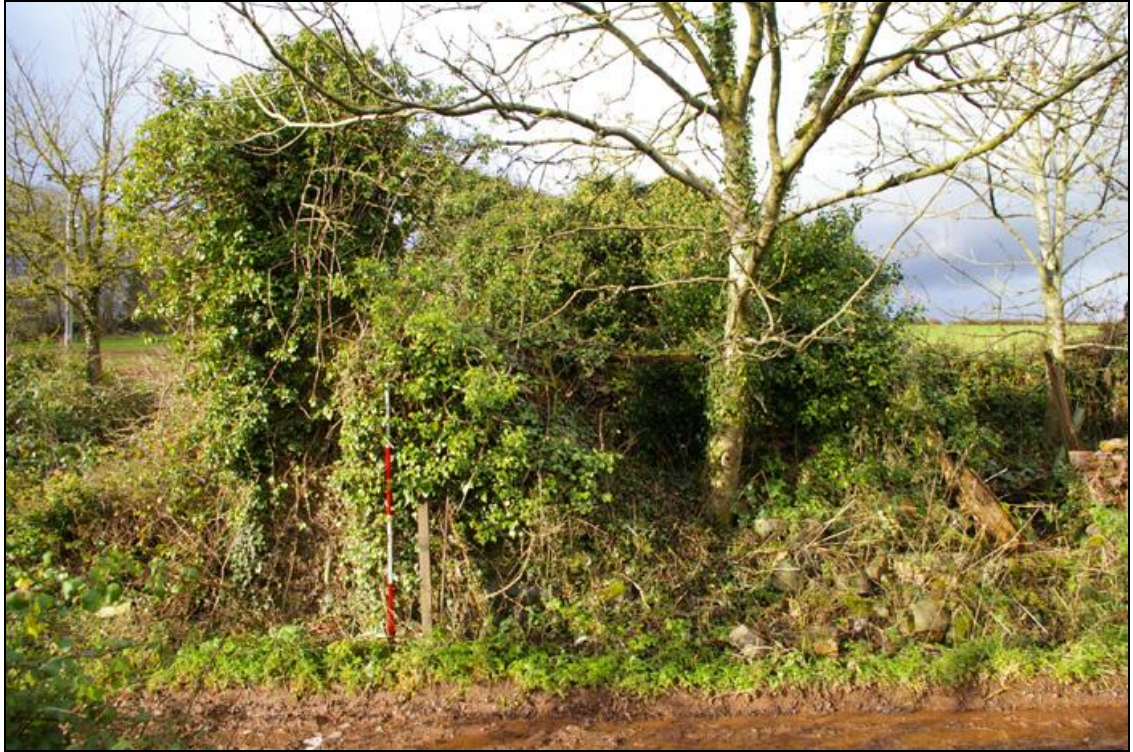
large stone perimeter wall. There is a clear build line to the east between the remains of the south wall of Building 3 and the adjoining south wall of Building 2.

Elements of a roof structure survive within the rubble and debris that fills the building; possibly including the remains of a jointed cruck truss blade.

Figure 9: The south elevation of Building 3, viewed from the south (2m scale).

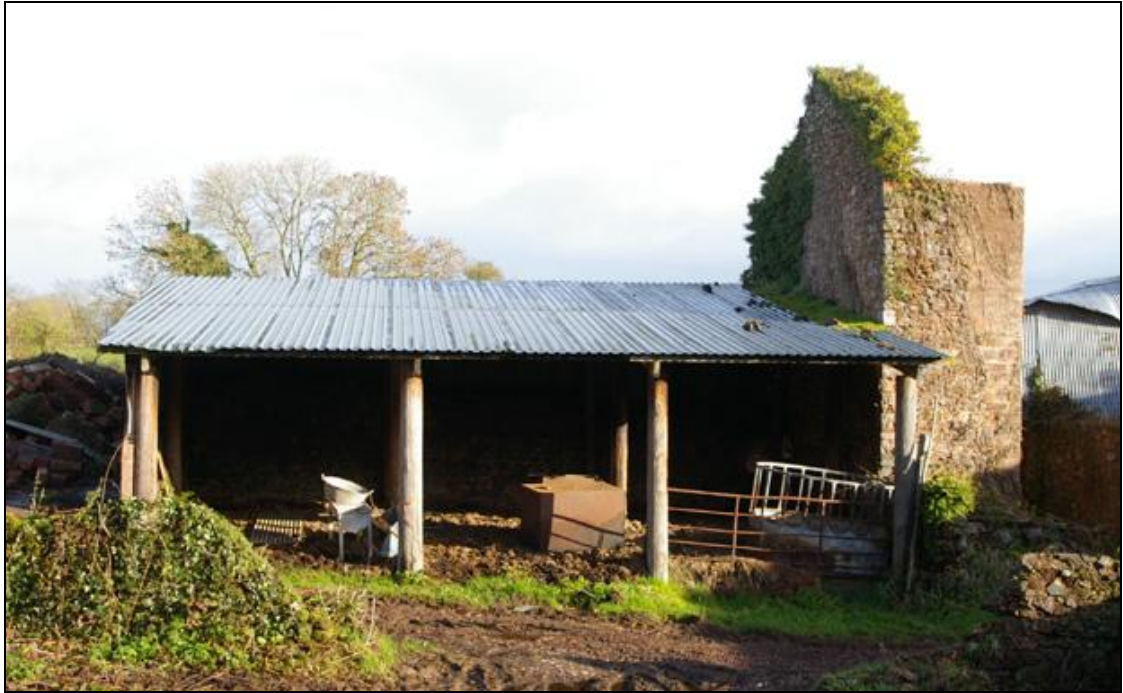
A one and a half storey 20<sup>th</sup> century open-fronted pole barn positioned in the centre of the east side of the courtyard, built up against the substantial perimeter stone wall to the east and abutting Building 5 to the south. To the north of the pole barn is a demolished concrete block building and an area of raised concrete surfaces. The pole barn is constructed of re-used telegraph poles, with a concrete block wall to the north, with corrugated sheeting upper portion and the north wall of Building 5 providing the southern side, it is open to the courtyard (Figure 10). The roof structure is timber with corrugated iron sheeting. The substantial perimeter wall which forms the east side of this building is of fine quality coursed tightly-packed faced stone blocks in an earthen bond. There is several lime mortar and cement bonded elements of rubble stone repair to the wall. The wall runs down to the north wall of Building 5, where it has been truncated; elements of the internal face of this substantial stone wall c. 1-1.5m in width, have collapsed revealing a densely packed stone core with heavy earthen bonding.

Figure 10: The west elevation of Building 4, abutting Building 5 to the south, viewed from the west.

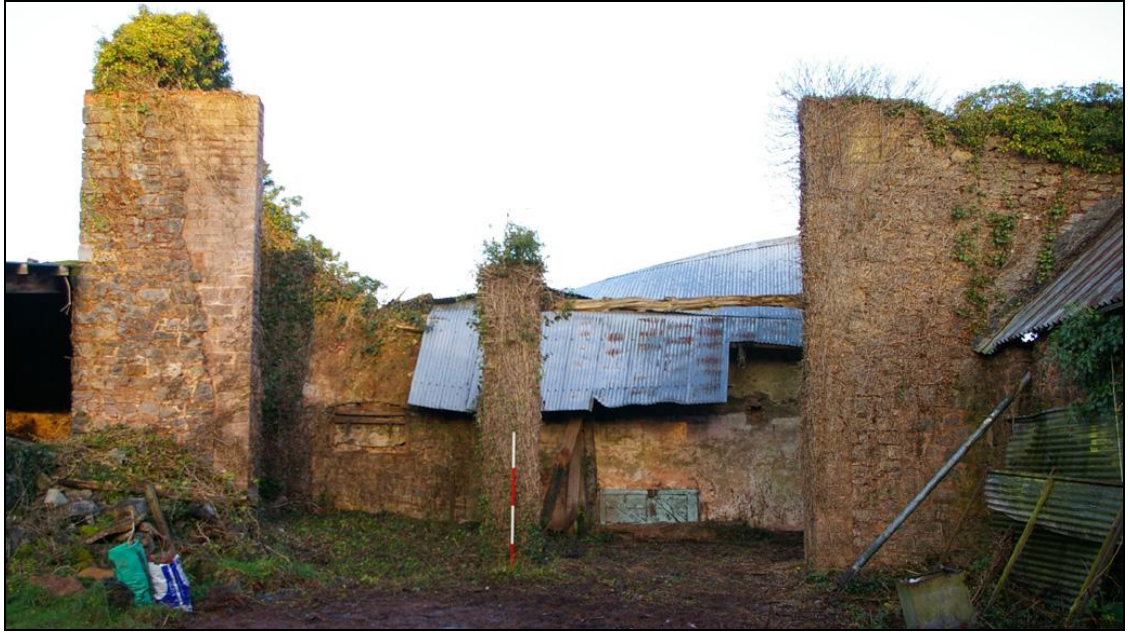
The building has lost most of its western wall, to the farmyard side, with two large openings now framed with concrete block repairs (Figure 11). At the southern end of this wall at ground floor level, giving access to Building 6, are two doorways with pegged timber frames with heavy timber lintels and a third opening, adjacent to the opening to the farmyard, that has been blocked with concrete blocks (Figure 12). The central doorway has a brick threshold, with a door of even width planks with strap hinges and an iron bolt. The door to the south has random width planking with strap hinges and evidence of a timber latch. A large stub of wall projects into the interior of the building between this pair of doorways.

Figure 11: The open west elevation of Building 5, showing the central partition wall, viewed from the west (2m scale).

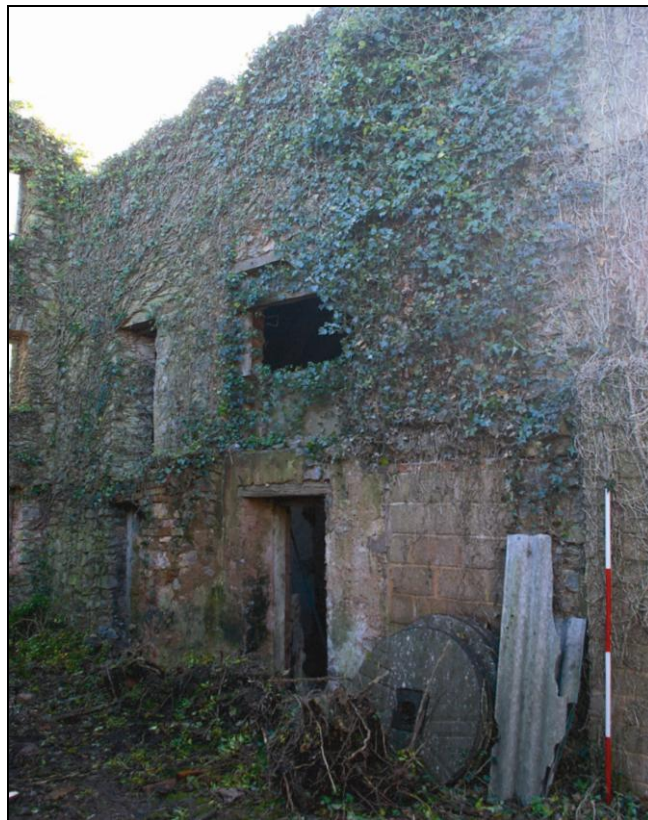
Figure 12: The west wall of Building 5, showing openings into Building 4, viewed from the north-east (2m scale).

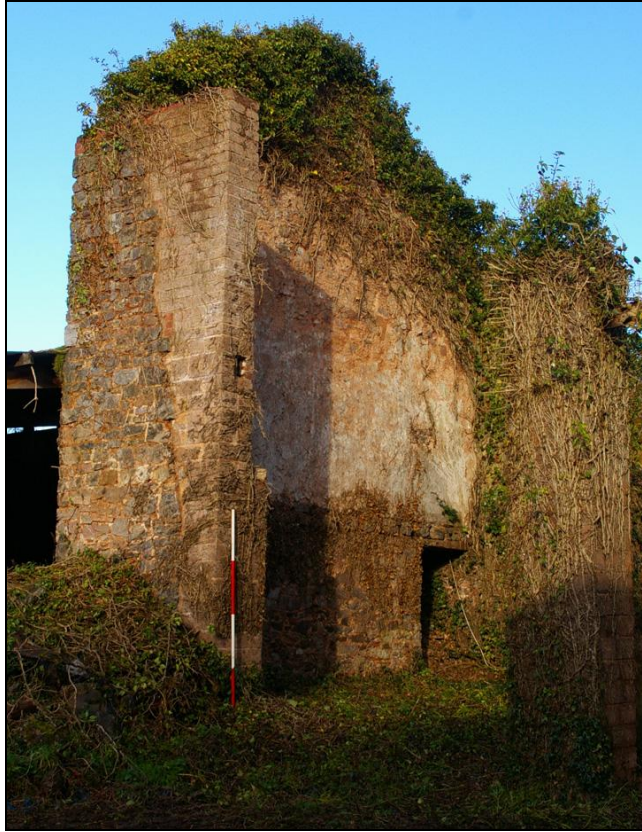
The rubble stone northern gable wall stands to three storey height with surviving internal plaster to the first floor with one opening, a narrow doorway, in the ground floor against the

east wall (Figure 13). This doorway has a large timber lintels and a brick threshold but is partially obstructed by a pillar of the adjacent Building 4.

Figure 13: The three storey north gable of building 5, viewed from the south-west (2m scale).

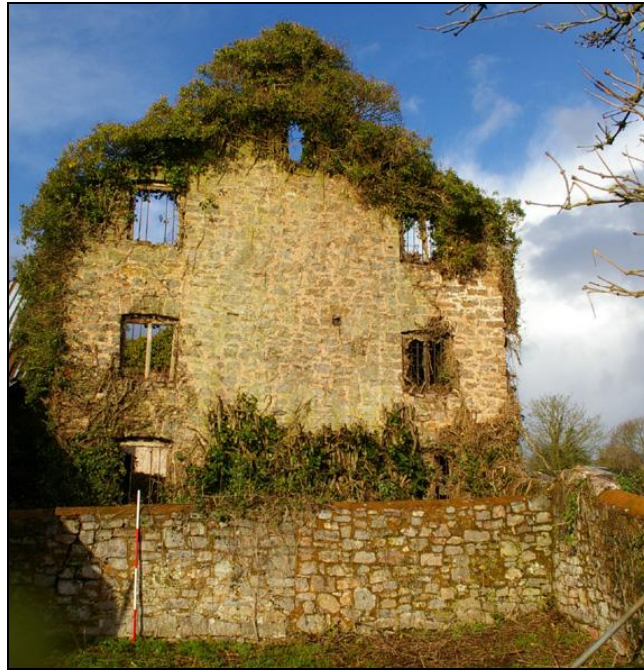
The south gable wall is of a stone rubble construction with a heavy use of lime mortar. There are six symmetrically placed window openings, two to each storey and one small opening to the gable apex; the windows are graded in height, getting smaller as the storeys rise (Figure 14). All the openings have rough segmental stone arches with chamfered pegged frames, timber lintels and sills. The windows are two light, with a central chamfered timber mullion and iron glazing bars. On the ground floor in the centre of the wall is a square opening with timber framing and a double flat segmental brick arch. This has a boarded timber shutter. Either side of the opening are timber lined alcoves, above which is a long narrow timber lintel with four small sockets; this is presumably the fittings for the mill wheel which was situated in the adjacent wheel pit

Figure 14: The south elevation of Building 5, with wheel pit, viewed from the south (2m scale).

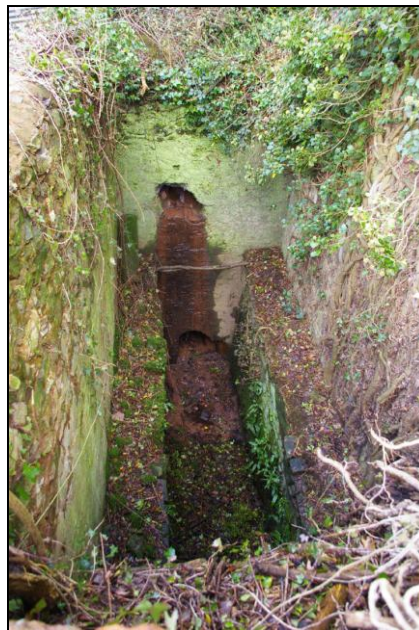
The wheel pit is against the south gable of Building 5 (Figure 14), and is bounded to the south, east and west by rubble stone walls in a lime mortar, showing some repairs and rebuilt sections (Figure 15).

Figure 15: The view into the wheel pit.

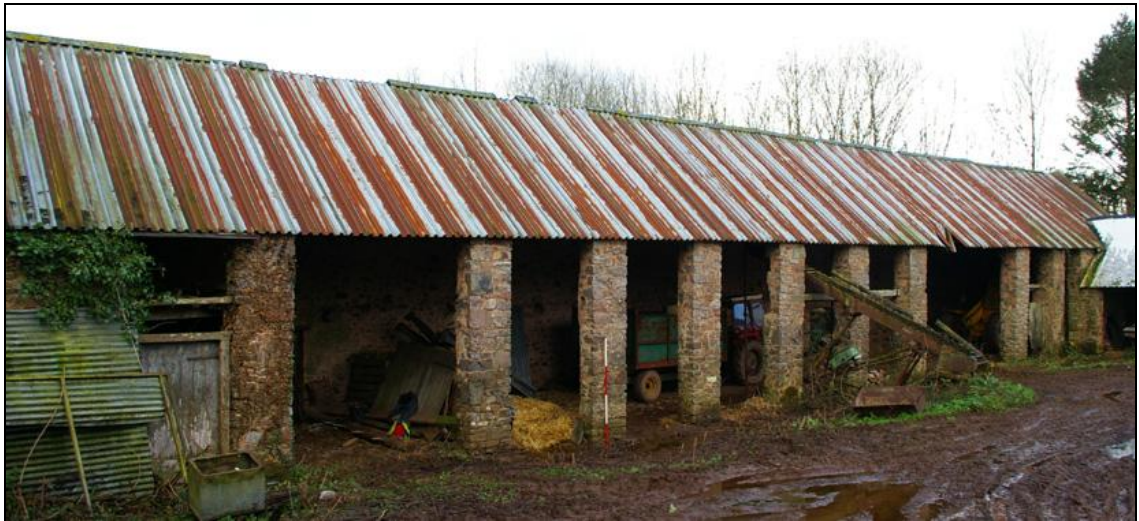
The pillars also supported the large elm floor joists which carried the plank floor of the loft/feed store; these too have been cut off, with only stubs remaining in some pillars or in the south wall. The western end of the north wall is solid where building 6 and building 7 adjoin, there is a small door opening in the wall against the west gable-end, with a narrow timber lintel and plank door, ledged to the rear, with strap hinges. The south wall is rubble stone heavily mortared to its internal face. The rubble stone western gable has a small window opening or air vent in the apex, with steep sloping sides and set with a timber pegged frame.

Figure 16: The eastern end of Building 6, viewed from the north-east (2m scale).

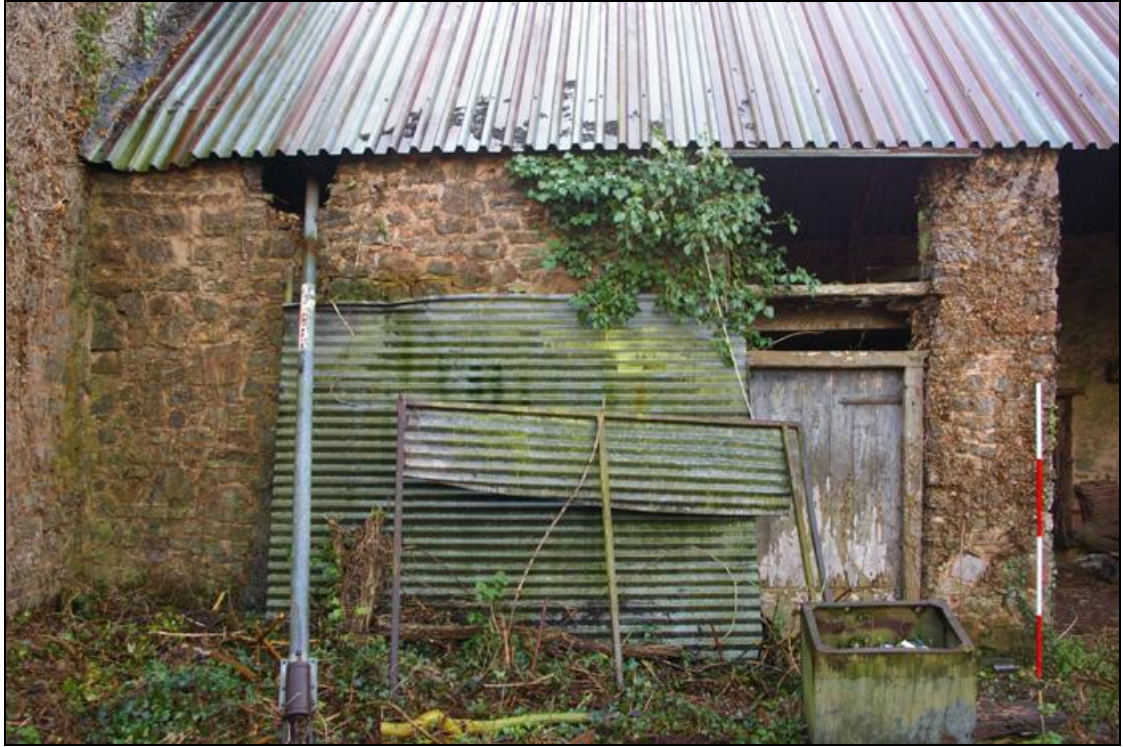
There is a stone partition to the east end of the linhay forming two compartments (Figure 17). One to the east is full height and has been converted to a grain store, with plastered walls and loft above, with fixed grain bins. The compartment has a door to the north into the courtyard and one to the west into Building 6; both doors are plank, ledged to the rear in pegged timber frames. Surviving cobbled floors can be viewed down the length of the building. The roof structure is formed of (13<sup>1</sup>) scissor trusses, with pegged mortice and tenon joints to the apex and spiked joints to the truss blades and scissor struts, the ends of which are turned over on the rear face (Figure 18). There are tie-beams as well as scissor struts for added strength and three sets of modern purlins to each side. The trusses rest on timber pads built into the wall to the south and on pillars to the north; there is no surviving ridge pole and the roof is of replacement corrugated iron sheeting.

Figure 17: The north elevation at the eastern end of Building 6, viewed from the north (2m scale).

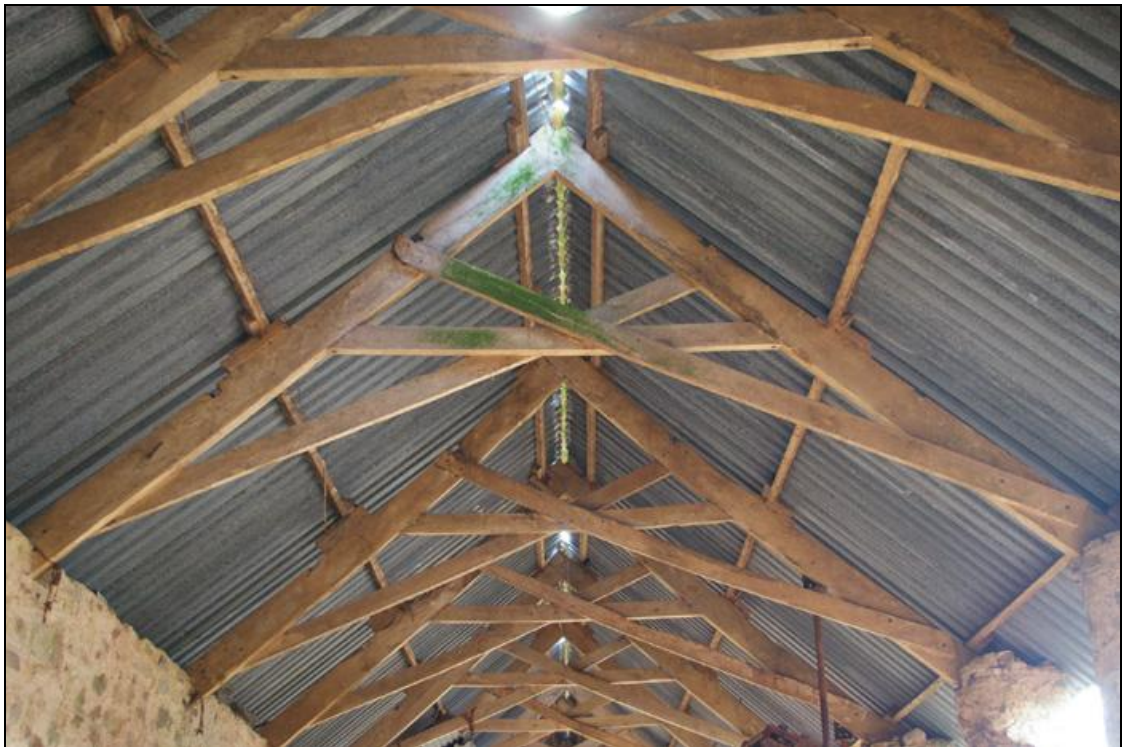
Figure 18: The roof structure of Building 6, showing the scissor brace trusses, viewed from the east.

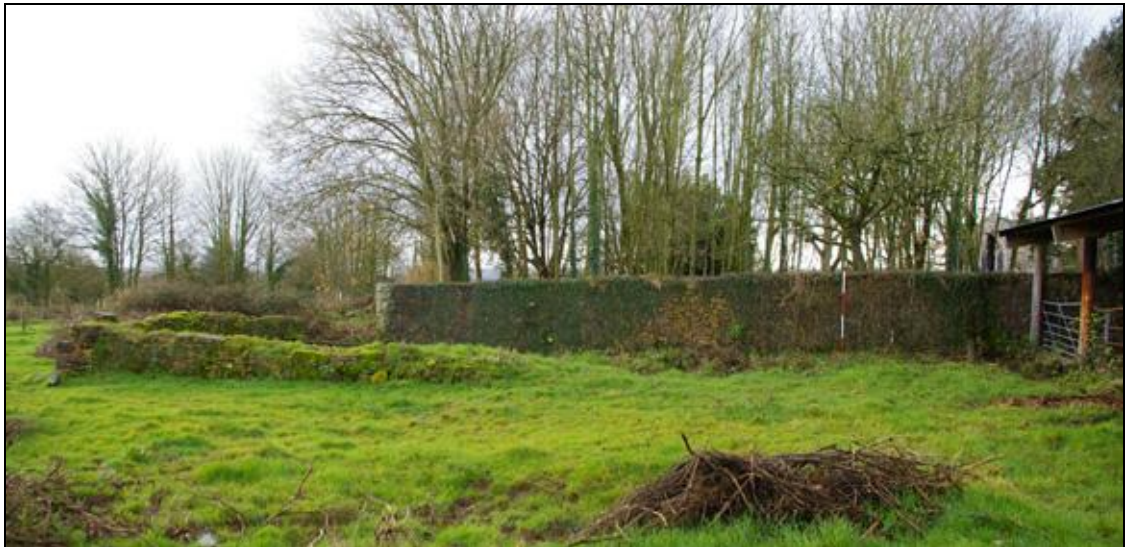
To the south of the Building 6 is a grassed area that is enclosed by stone walls to the east and south, with a later garden wall to the west side. The east wall is of fine quality coursed stone, with faced blocks in an earthen bond, the west is a semi-coursed rubble stone in a lime mortar. There are a number of partially demolished walls or ruins beneath the grass, which run parallel to the outside walls. This wall to the south is a largely fine quality structure of coursed faced blocks, in an earthen bond, *c.* 1m-1.5m wide. The wall to the east turns on a right angle to form a square enclosure, contiguous with the south wall (Figure 19). To the east side the wall has been heavily repaired around the gateway, patched with concrete blocks to the north face and rebuilt partially in rubble stone; these repair slightly obscure the angle of the eastern half of the south wall, making it off-set from the opposing west side of the gateway and the curving profile of the possible defences is truncated by the repairs. To the west side of the gateway/entrance the wall curves out, forming a wide semi-circular section of wall, *c.* 3m wide in diameter, with a wall thickness of *c.* 1m-1.5m. The internal face of this curve appears splayed and straighter and there is a significant amount of grassed-over rubble within the structure. There is a large stone built shaft which could be a drain or culvert which may have been within the curving structure, however damage to the wall and its eventual truncation here make confirming a relationship hard. An integral section of stone wall of the same construction runs north from the western edge of the gateway/entrance, framing or walling in the opening.

Figure 19: Remnants of walls; south of Building 6 viewed from the south-east.

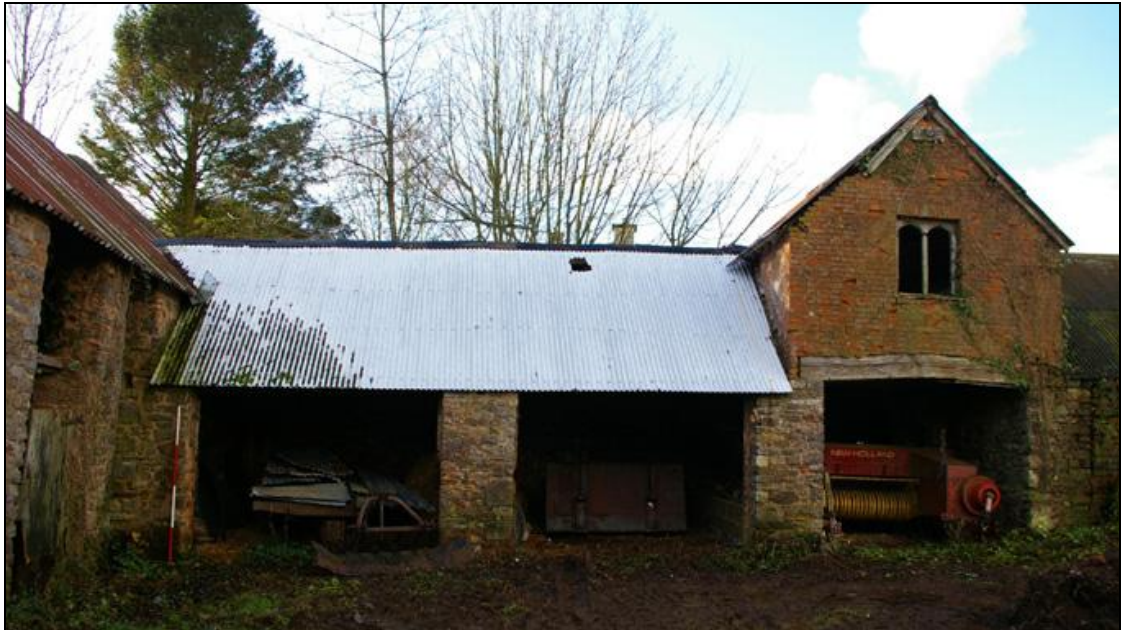
beam which is socketed into the central stone-built pillar bracing the building. There are two sets of modern purlins to each pitch of the roof which is covered with corrugated plastic. The floor appears to be of stone cobbles.

Figure 20: The east elevation of Buildings 7 & 8, viewed from the east (2m scale).

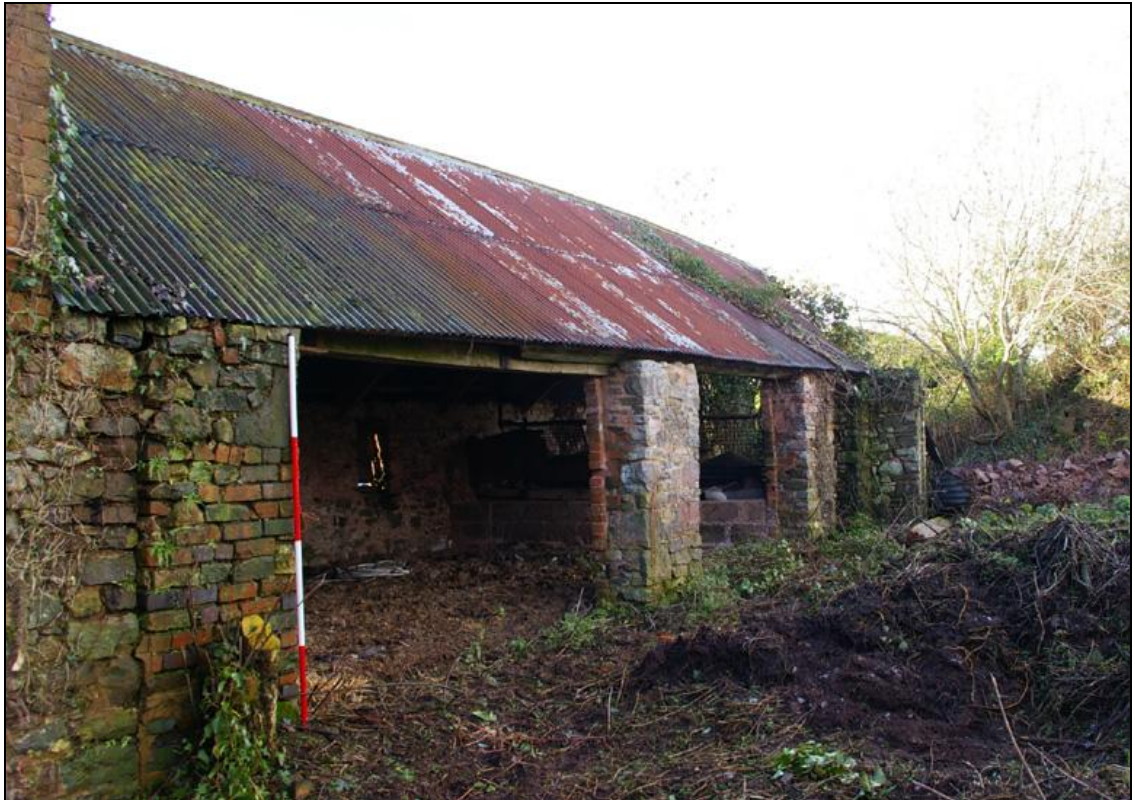
The west (rear) wall is of rubble stone construction, built up against the stonework of building 8, with heavy use of lime mortar; the interior face of the wall has been white washed, some of which survives. There is a small window opening to the southern end of the wall, with deeply splayed reveals and a timber frame that is set with iron pintles and an iron looped catch. A larger window opening to the centre of the wall has straight sides, timber lintel and chamfered frame, it also has iron pintles and an iron looped catch similar to that to the south.

Figure 21: East elevation of Building 9, viewed from the southeast (2m scale).

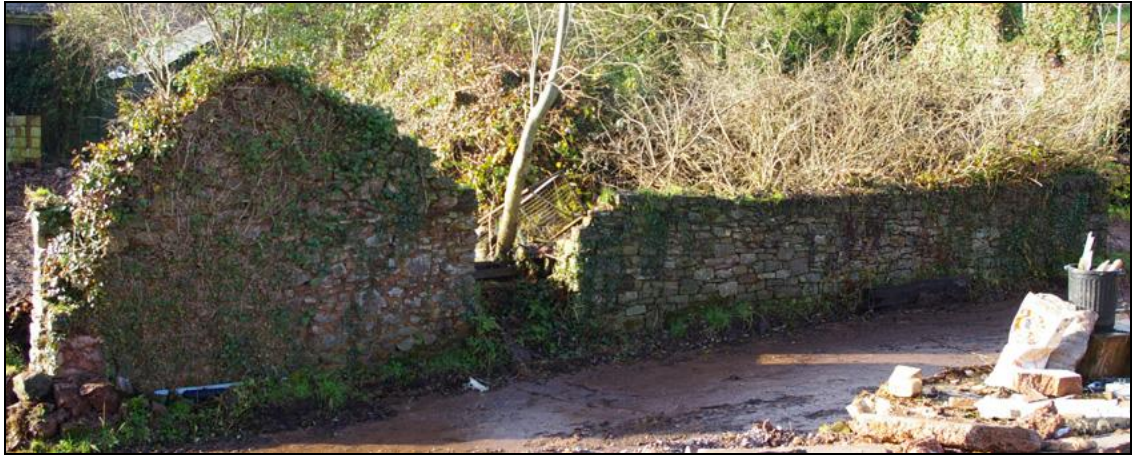
The surrounding area is enclosed by a truncated L-shaped rubble stone 19<sup>th</sup> century wall, forming an inner yard to. Within this area is evidence of a cobbled surface. Immediately adjacent to the remains of the ruined building stands a single-storey rubble stone gable wall of a further building, which would have stretched to the west within this inner courtyard.

Figure 22: Ruins of Building 10, viewed from the east.
