BARNS at WAYBROOK COTTAGES ALPHINGTON DEVON

Results of a
Historic Building Assessment

Report No.: 130711
Date: 11.07.2013
Authors: D.Laing-
Tregrove

South West Archaeology Ltd. was instructed by Kim Dodge of CSA Architects to undertake an historic building assessment of former agricultural buildings at Waybrook Cottage, Alphington, Devon, prior to the potential development of the site.

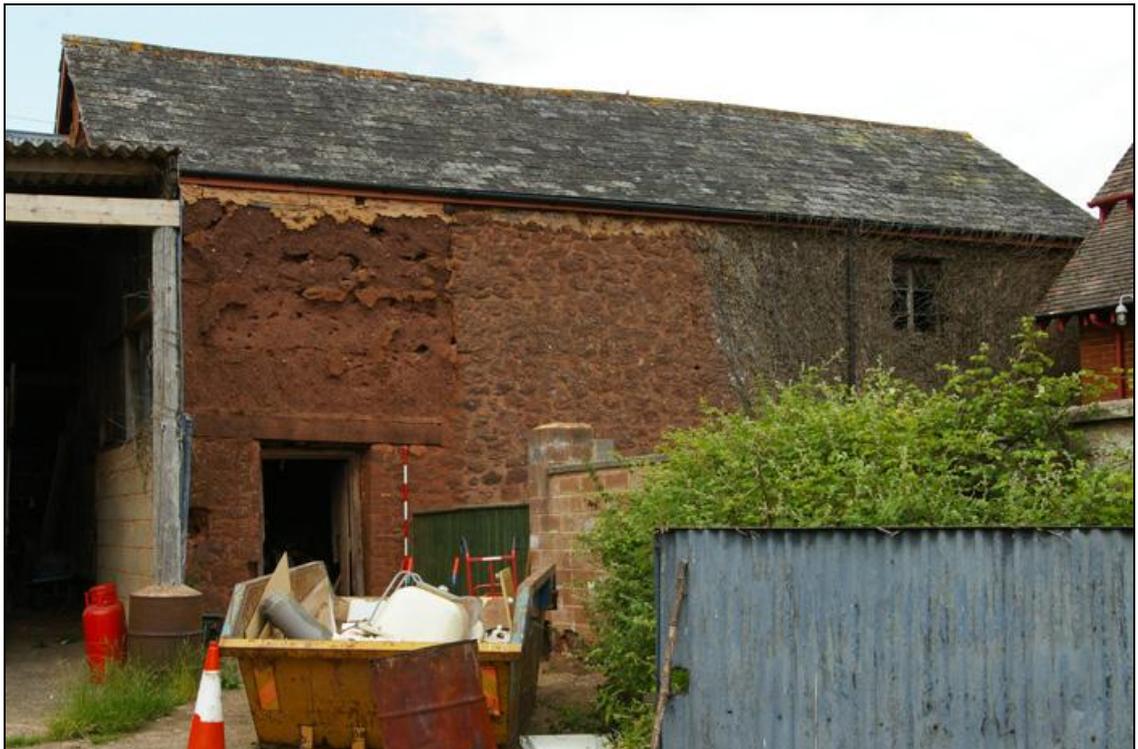
Figure 6: The south-east elevation of Building 1 (B1), viewed from the south (2m scale).

The south-east elevation has three phases represented, to the south is a cob section, above the only ground floor door opening into the building which is positioned at the south west end, allowing access into the former farm yard, with rubble stone facing around the opening, and with brick jambs (Figure 2). To the north of this a section of wall appears to have been rebuilt in rubble sandstone in creamy lime mortar, with possibly earlier rubble stonework to the north end. There are two windows to the north in the south-east elevation, one at ground floor level

and one above at first floor level; both contain ramshackle modern casements and the elevation is very overgrown with ivy. To the north-west the elevation is also very overgrown and the ground rises sharply to the north (Figure 7). There is a small roofless former rubble stone building built up against the north end of the north-west elevation and to the south of this the ground is built up from the north to form a walkway to the first floor door opening at the north end. This door was locked at the time of the survey and the upper floor of the building not accessed.

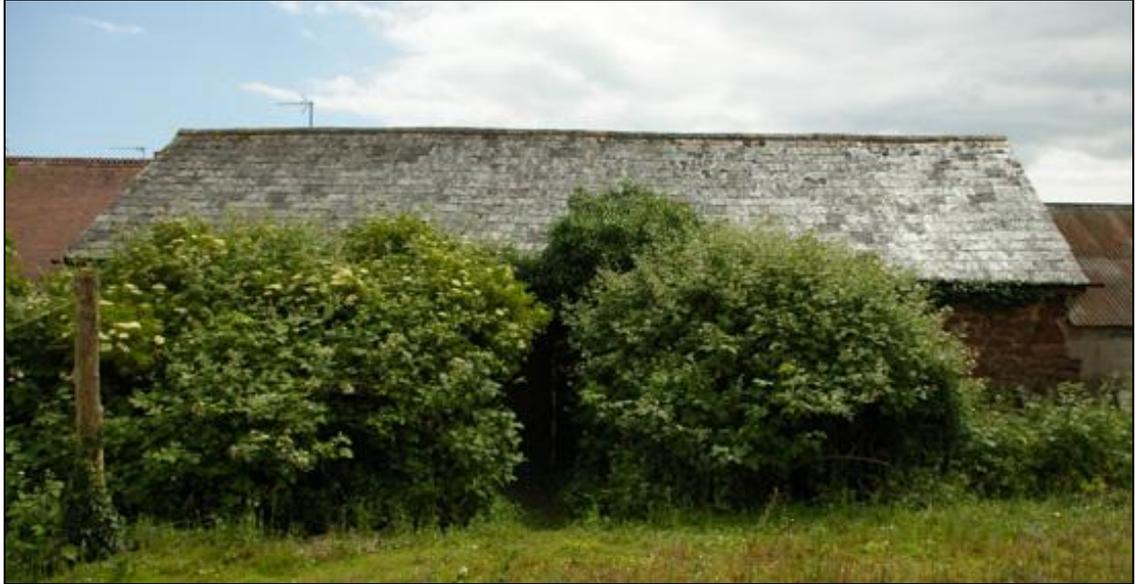
Figure 7: The rear north-west elevation of B1, with a gap in the vegetation to the first floor door opening, viewed from the north-west.

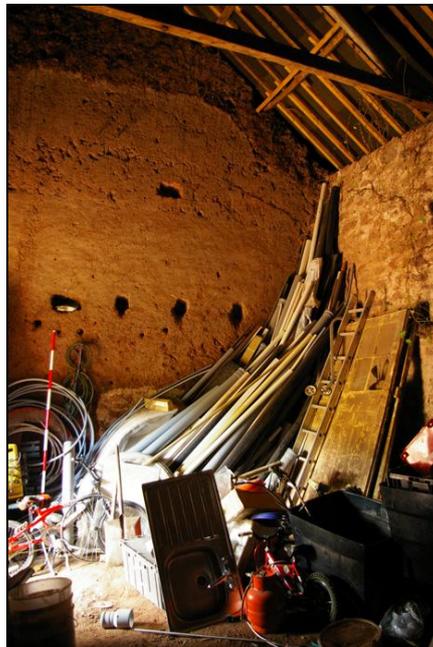
Figure 8: The interior south-west gable wall of B1, viewed from the north (2m scale).

The interior of the building is partitioned into two compartments, open to the roof to the south-west and with a first floor to the north-east (upper floor not accessed), although the southern end of the building was formerly floored and joist holes still remain at first floor level in the south gable (Figure 8). The floor of the compartment to the north is cobbled with small stones and it is lit by the window opening in the south-east wall. This has splayed reveals to the upper portion but the wall is reduced in width and disturbed beneath.

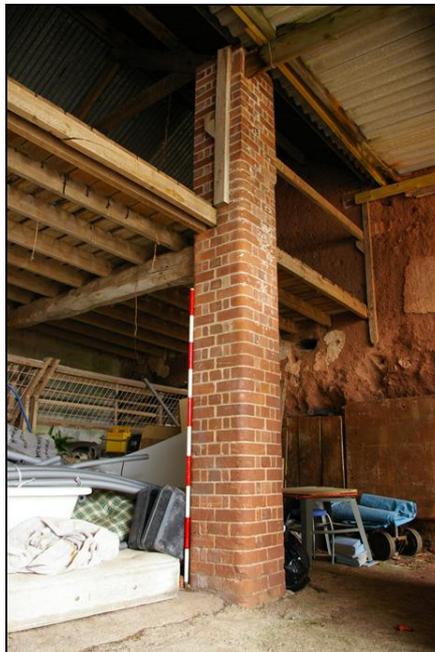
Figure 9: Brick pillar supporting the floor and roof at the north end of B2, viewed from the south (2m scale).

The linhay is built up against the south gable of B1 to the north, is open to the east with the floor and roof supported on brick pillars (some now removed), and with a modern sheet metal and timber open fronted extension with a single pitch roof to the east, projecting into the former yard. The west wall is concrete block, except at the south-west end where a small single storey sheet metal shed abuts the linhay (Figure 10). Here, to the interior, the west wall is of rubble stone construction and probably part of an earlier structure. The flooring within the Linhay is cement and it is raised to the north with timber troughs and hay racks against the length of the rear wall. To the south end, against the sheet metal shed, the wall is constructed of a mix of timber, brick and metal sheeting.

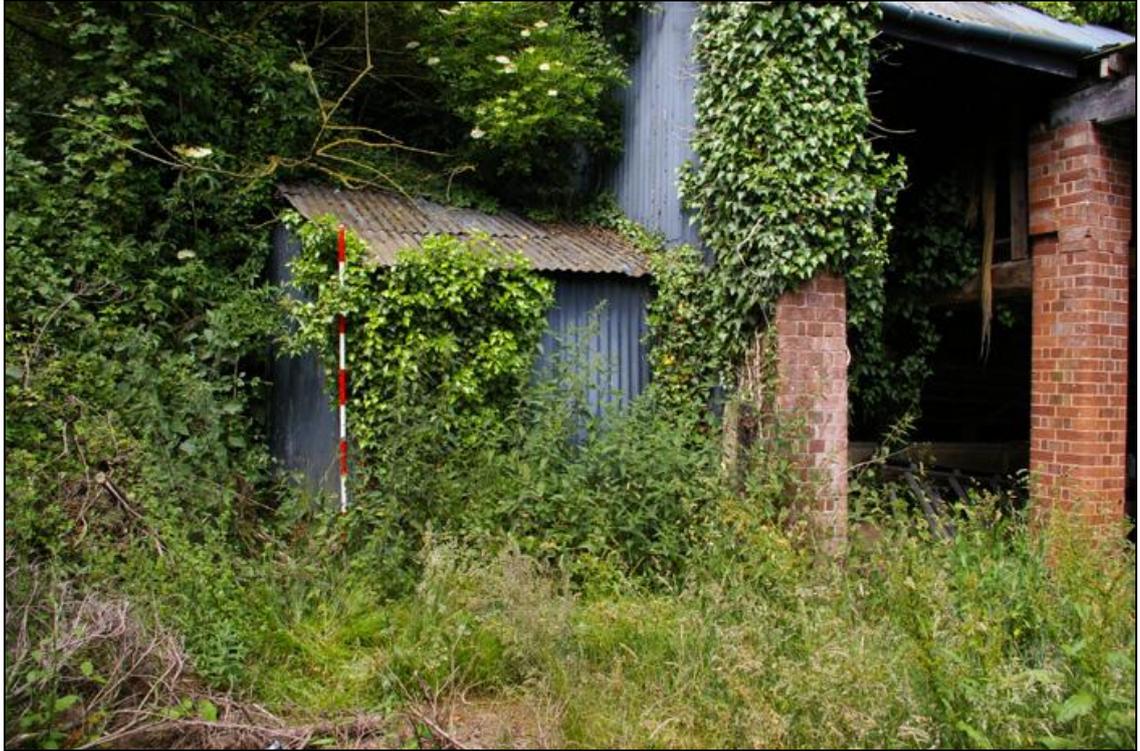
Figure 10: The single storey lean-to at the south-west end of B1, viewed from the south (2m scale).

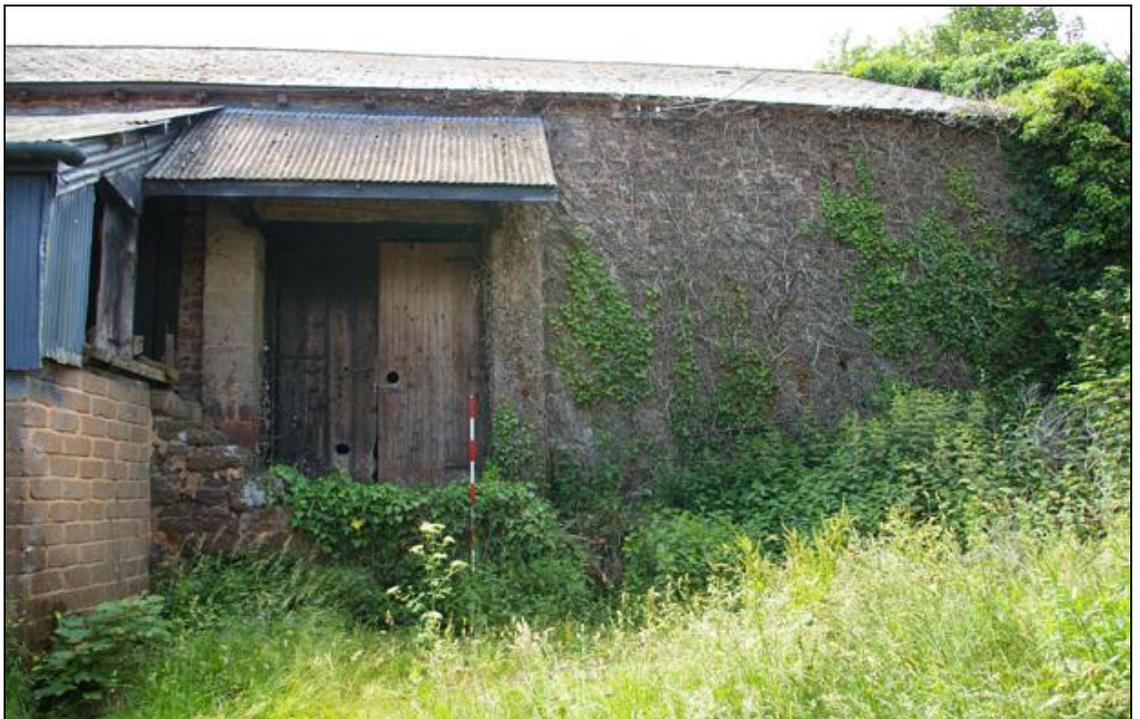
A large eleven bay, semi coursed rubble sandstone Threshing Barn built into the slope at the western end and slightly into the slope to the south-west, with opposing double doors to north and south, to west of centre, and with a pitched slate roof, which was re-slatted in the late 20th century (Figure 11).

Figure 11: The west end of the north elevation of Building 3 (B3), viewed from the north (2m scale).

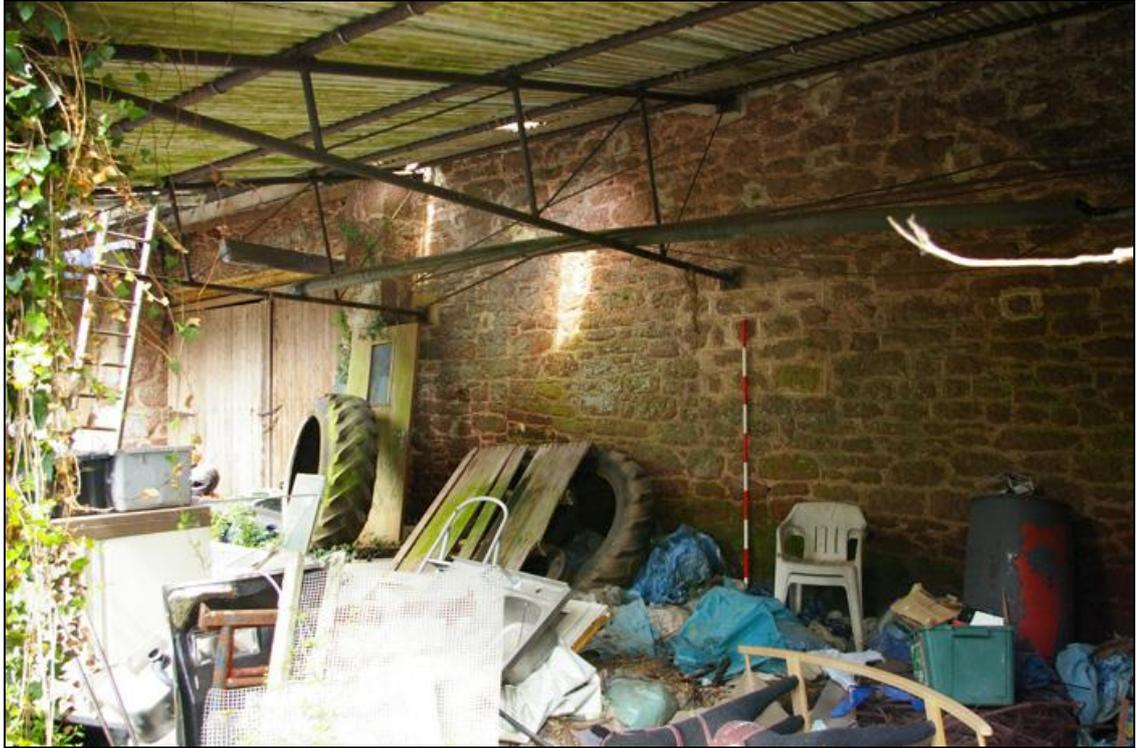
Figure 12: The exterior south wall of B3, within a mid to late 20th century lean-to, with south doors to the left, viewed from the east (2m scale).

The doors to the north are accessed via cement and sandstone steps built up against the north elevation, the opening has a slated pentice roof and projecting cheeks, as to the south. The opening to the south has been widened during the 20th century (Mr D White *pers com*) and the western cheek appears to have been moved slightly further to the west and most of the earlier pentice roof removed at this time. To the south there are also a couple of extensions, to the west a modern garage, erected in the late 20th century, and to the east a single storey lean-to resting on brick pillars, as to B2, but with mid 20th century metal framing fixed to the wall of the barn to the north and resting on the pillars to the south (Figure 12). No clear indications of any earlier structures on this elevation were noted during the survey; however there is a small blocked rectilinear opening within the south wall which may have related to machinery associated with a former horse engine on this elevation. The west gable is very overgrown and the large loading door in the centre was only just visible within the vegetation at the time of survey. To the east the gable wall continues to the south as a retaining wall against the raised ground surface to the rear of the barn. This wall has been built up in modern brick and cement and topped with metal sheeting forming a single storey east wall to the lean-to to the west.

To the interior the wall to the east of the south door is reduced and ragged. A loading door was also forced into the western gable during the mid-late 20th century and the floor, that slopes quite steeply down to the east at the east end, was cemented. The floor steps down at the east end to the level of a ground floor door opening in the east end of the north wall; this appears correct and not a later insertion. To the west there are slit windows to north and south, to the east there is a large window opening at first floor level in the south end of the east gable wall, now containing a modern two light casement but with a slightly waney lintel above which appears contemporary to the build (see Figure 9). There is a blocked opening in the south wall to the east with a timber lintel remaining.

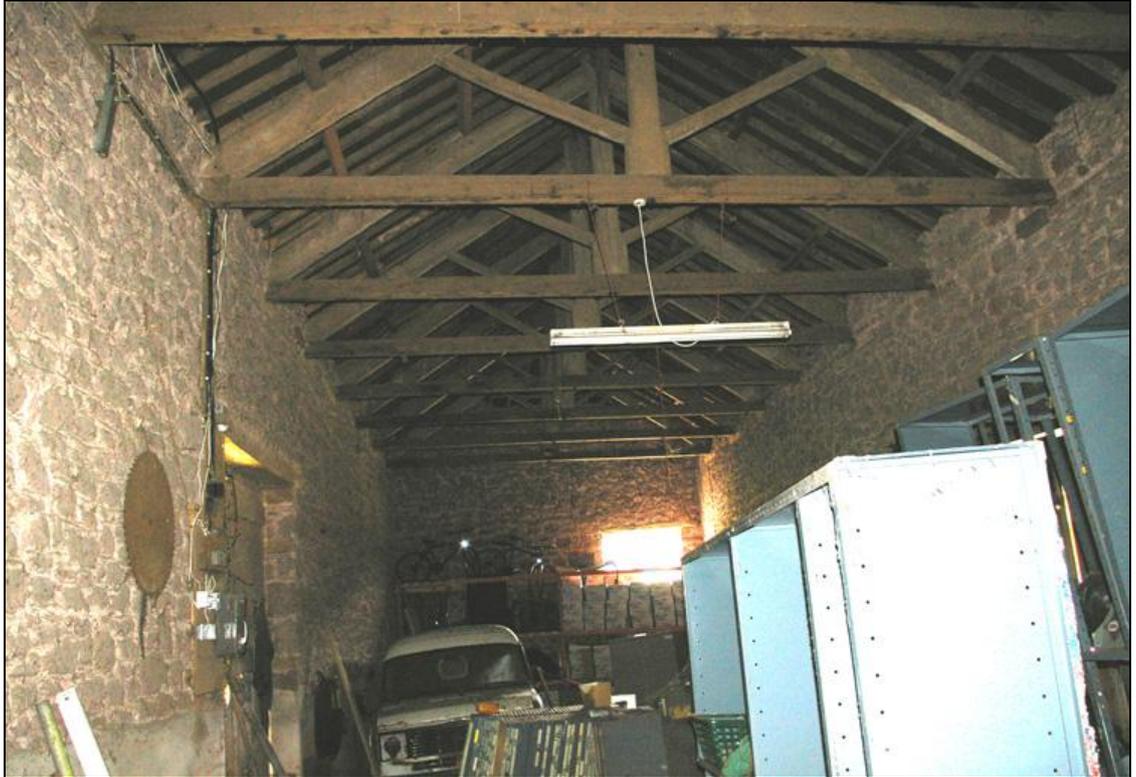
The barn appears to be of a single phase of build and the roof structure to the interior is a single phase king post roof (see Figure 13), bolted to the underside of the collars and set on timber pads into the wall (roof structure as B1).

Figure 13: The interior south-east end of B3, showing king post roof structure, north doors and window opening in the east gable, viewed from the north-west.

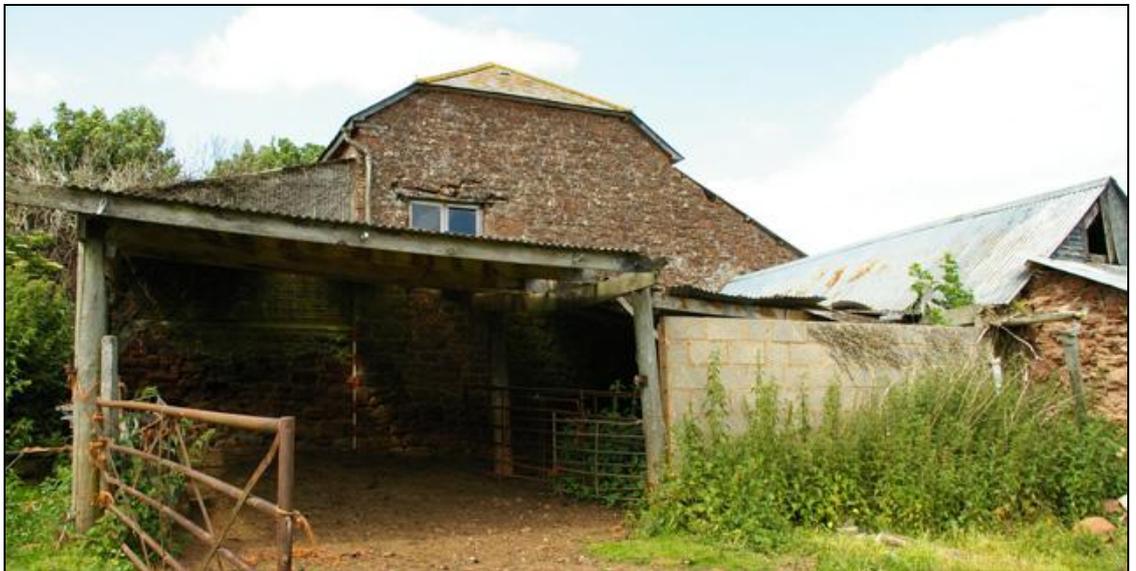
Figure 14: The east wall of Building 3, with roof of B4 to right, viewed from the east (2m scale).

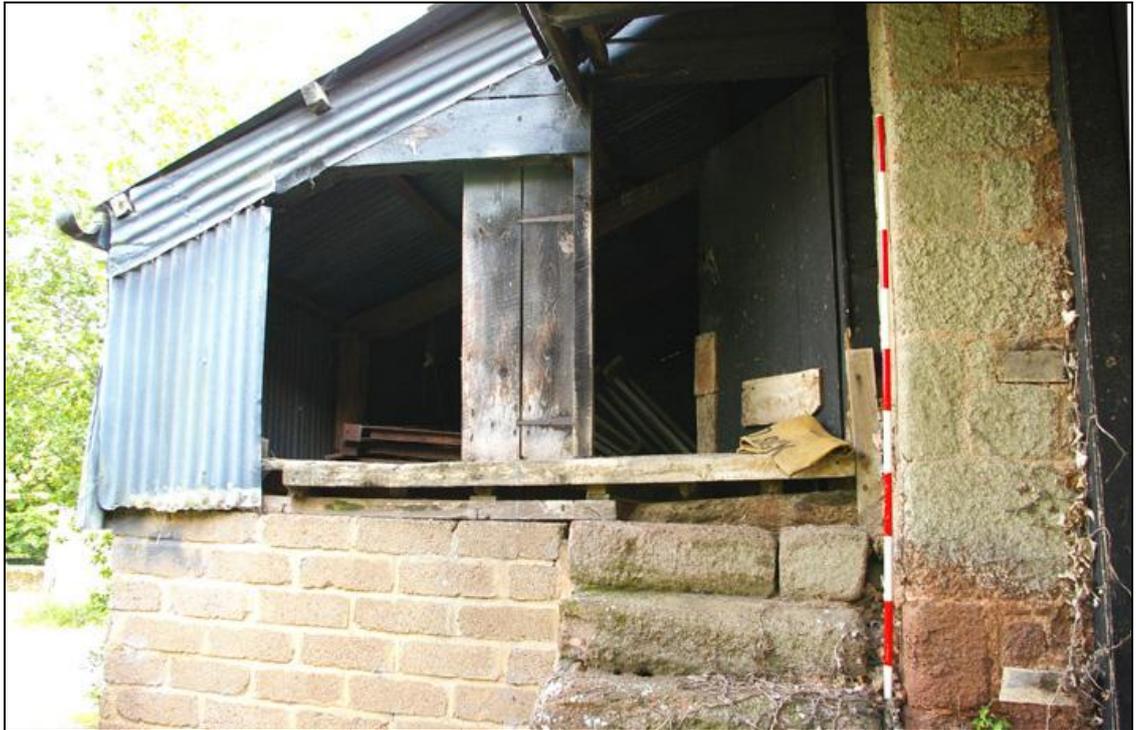
To the exterior the stepped plinth up to the north door continues up to the east to the first floor level of a small two storey open fronted linhay built up against the north wall to the east of the door (3a). The steps up pass in front of the eastern cheek of the door opening, and the first floor level of the linhay has a single pitch sheet metal roof sloping down to the north and is closed to the yard (north), again, with metal sheeting (Figure 15).

Figure 15: Exterior first floor north elevation of B3a, viewed from the west (2m scale).

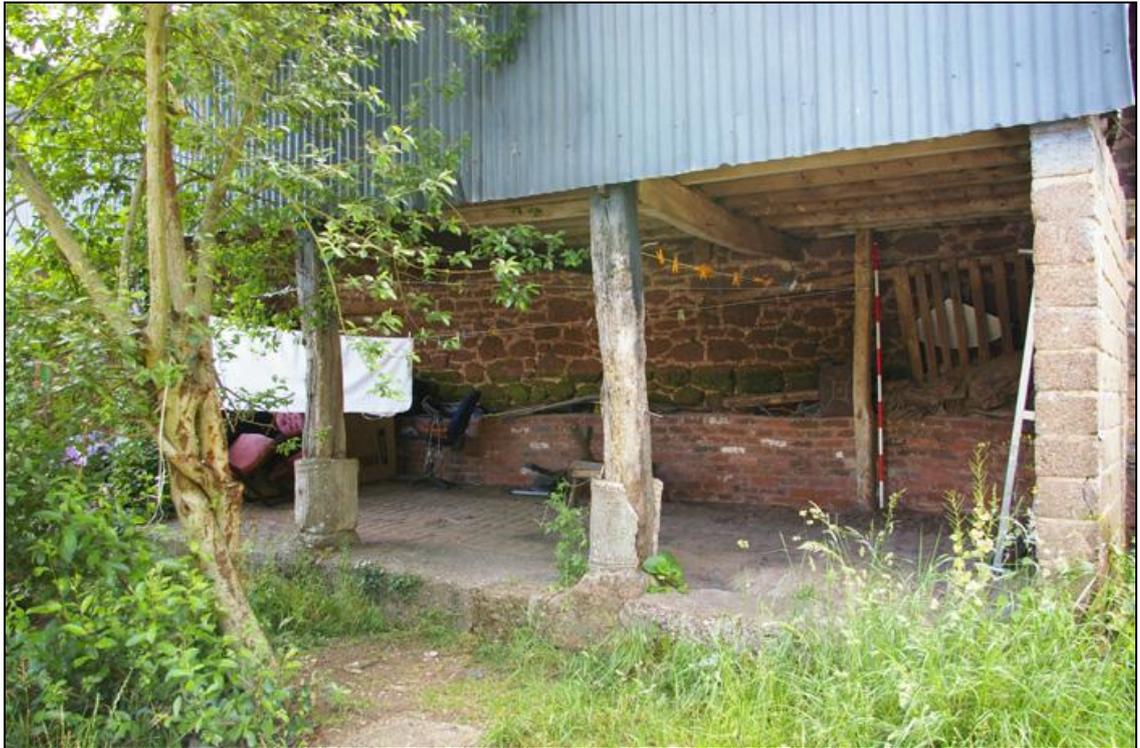
The Linhay structure is supported to the north on three timber posts, with timber floor joists notched into the sides and set into the barn wall to the south (Figure 16). The upright posts and the joists have carpenters marks on the eastern faces, comprising a row of circular depressions in the wood, numbering from 1 to 4 (Figure 17). One of the joists has been replaced by an RSJ and seemingly there was formerly a forth post and joist in the position of the block wall at the west end. The roof timbers above at first floor level are set into the wall of the barn to the south and rest on the tops of the upright posts to the north. The floor of the linhay is raised from the surface of the yard and the front edge is now covered with cement but appears to be composed of local sandstone as elsewhere. To the interior the floor is mainly of brick (all marked 'J MASON') to the centre, but with cobbles to the south between the bricks and brick feeder troughs built against the wall. The ceiling has an open slot open above the troughs to tip fodder down from the first floor loft. The floor is set at a lower level to the east presumably to access the door at that end.

Figure 16: The north front of Building 3a – Linhay, viewed from the north-west (2m scale).

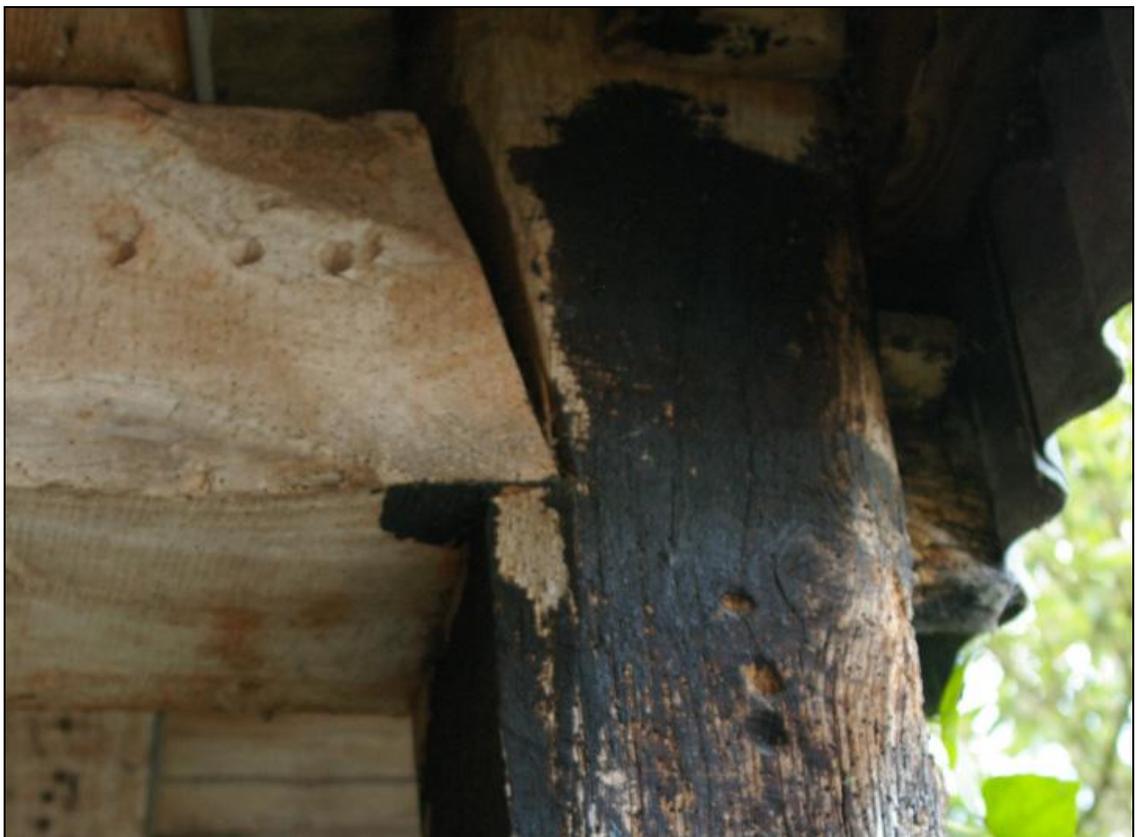
Figure 17: Detail of the carpenters marks on the posts and joists within B3a, viewed from the south east.

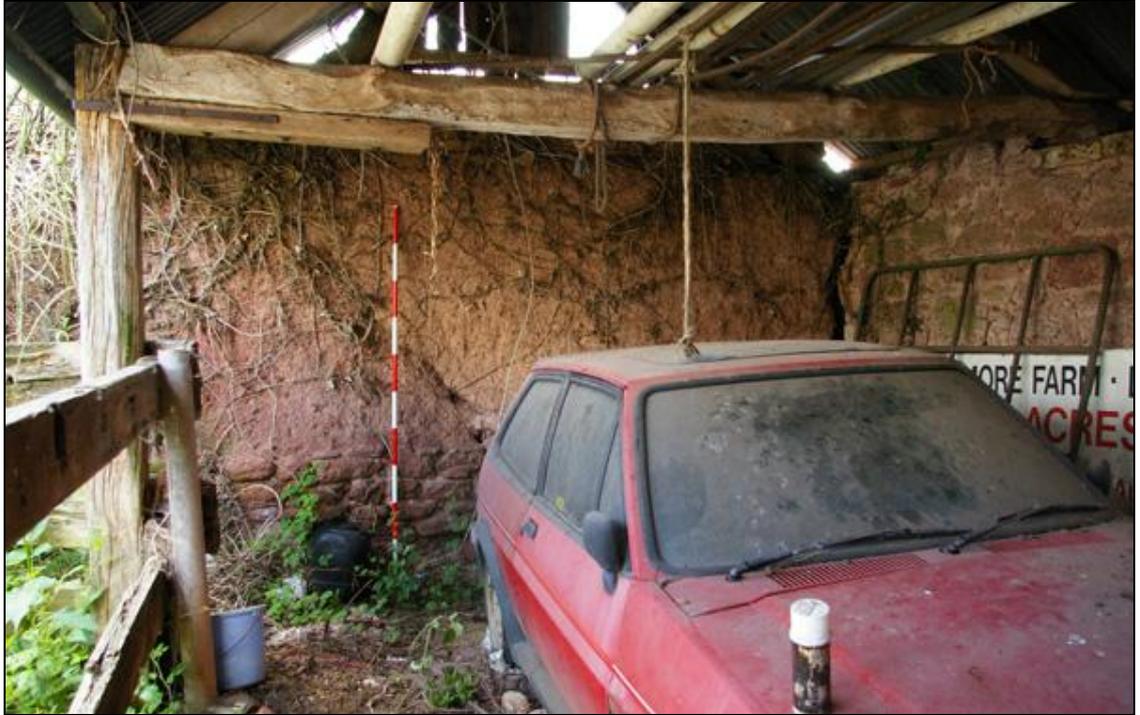
A further open fronted single storey 4 bay building constructed within the space between the Linhay to the west and the Piggery (B5) to the east (Figure 18). With the western portion partitioned off (Figure 19), with timber planking and with a feeder trough at this end appearing to service the yard to the north rather than the interior of the building.

Figure 18: The south-east end of B4 abutting the wall of B5, viewed from the north-west (2m scale).

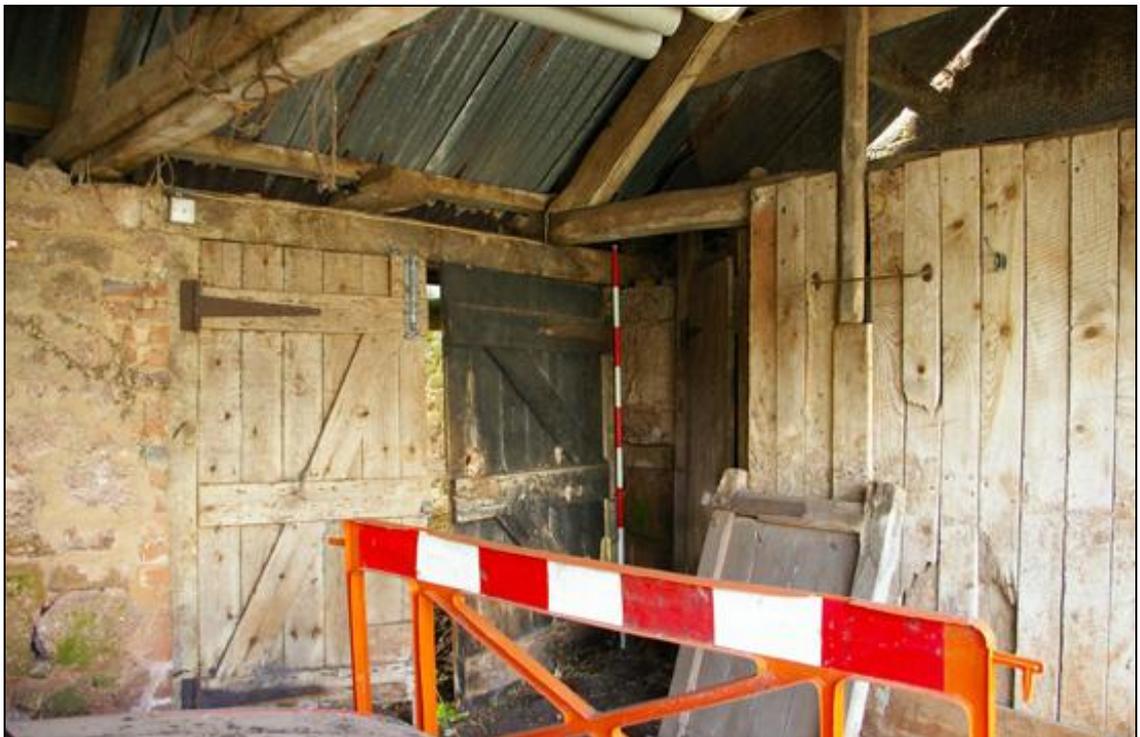
Figure 19: The door openings to the exterior and into the compartment at the north-west end of B4, viewed from the south-east (2m scale).

There are a pair of doors in the south wall that open to the field to the south (Figure 19), now a roofed pen. The wall to the south is rubble sandstone as elsewhere, and appears to abut the east wall of the Barn at the western end. The relationship between this wall and the south and west walls of the Piggery (B5) is unclear, as the masonry within the corner and along the exterior of the south wall of B5 has partially collapsed as well as being subject to previous brick repair within the south-east corner of B4. The wall may have formerly closed the yard between the Barn and the Piggery (B5) as the remaining masonry appears to be contemporary with the Barn to the west. The jamb to the east of the opening in this wall has been repaired in brick – the opening may therefore have been widened. The roof structure is a simple A-frame, nailed and tied with metal strips at the apex and to the purlins above, and with nailed collars. The floor is solid but not visible and is uneven. The timberwork and structure are of little merit.

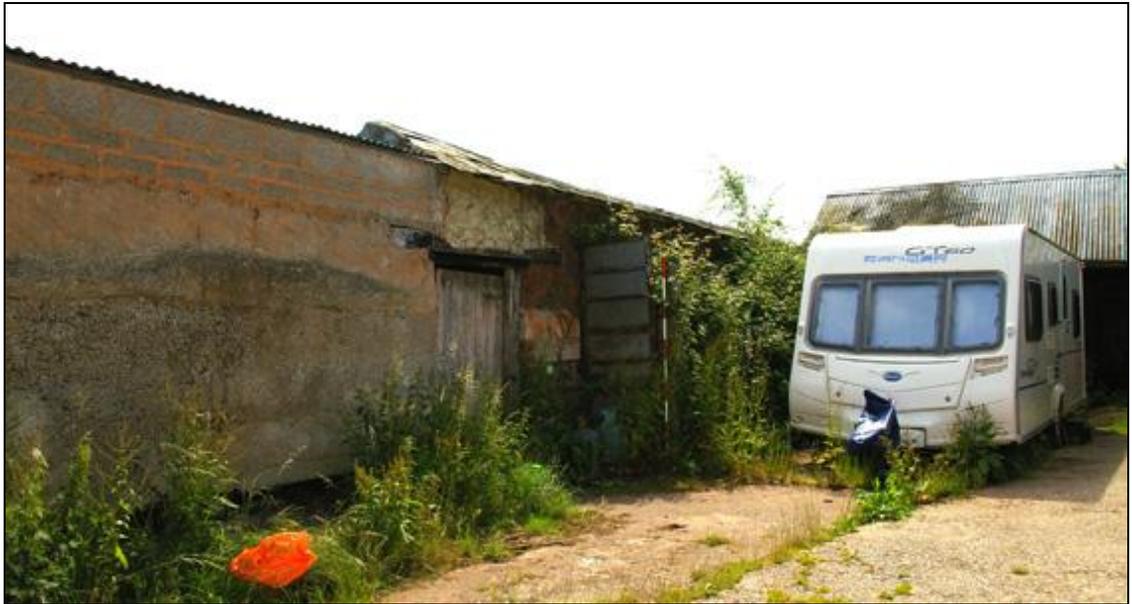
Figure 20: The exterior west wall of Buildings 5 and 6, viewed from the north (2m scale).

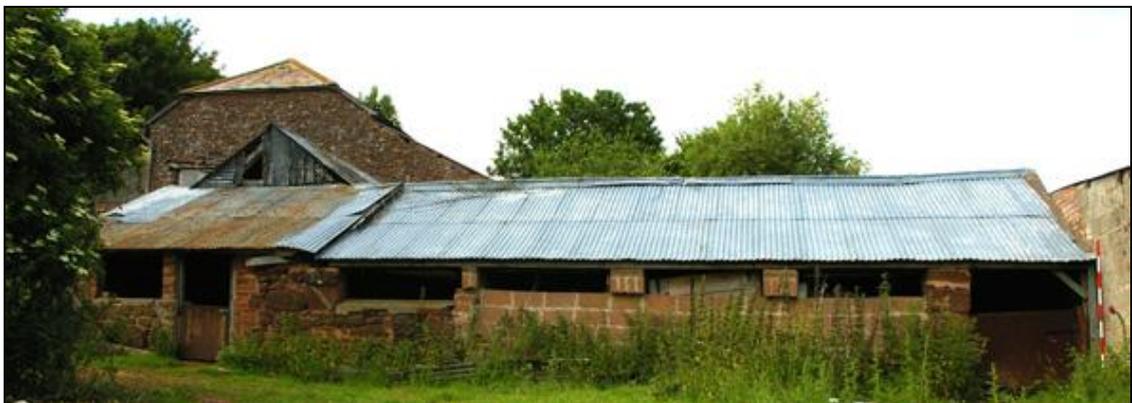
Figure 21: The entire east elevation of the Piggery (B5), viewed from the east (2m scale).

B5 is comprised of a cob wall, on a rubble sandstone plinth against the yard to the west, containing no visible openings, and a rubble sandstone wall to the south, partially collapsed (Figure 22). Dwarf walls to the east with wide window openings to the upper part and formerly rubble stone pillars between with door openings. Most of this elevation has been rebuilt in concrete block but some masonry remains to the west, with brick repairs around the openings. Now with a sheet metal roof and haphazard roof structure (Figure 21).

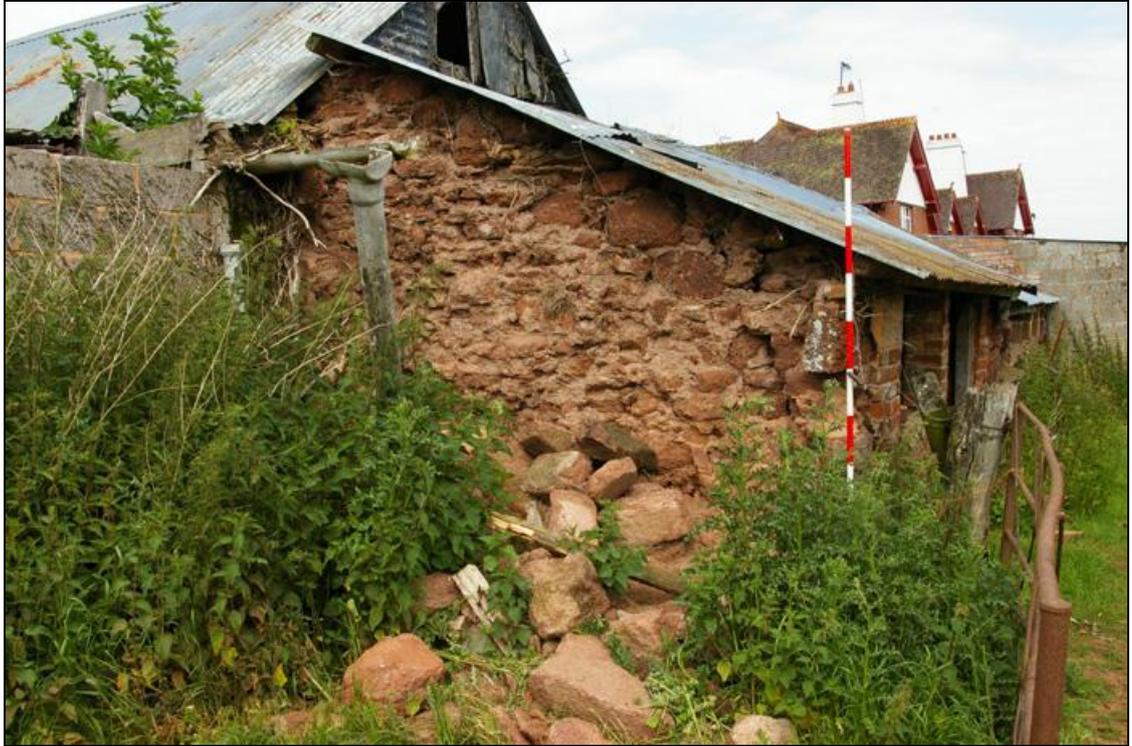
Figure 22: Exterior south wall of B5, viewed from the south (2m scale).

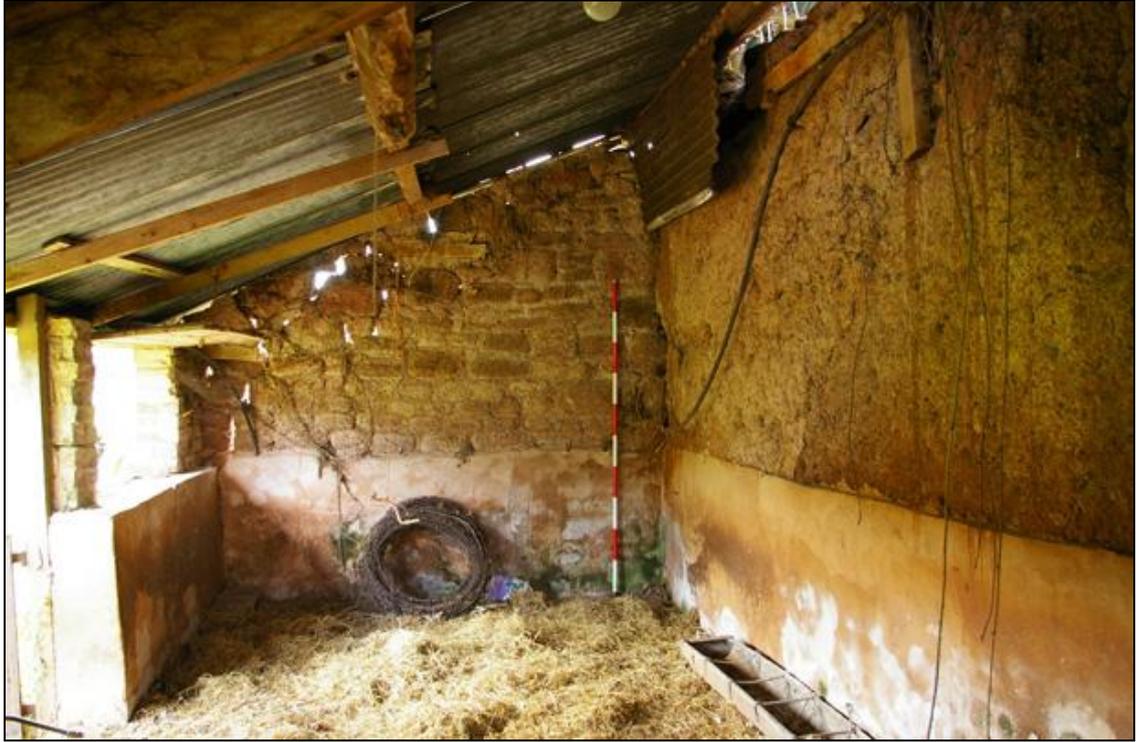
Internally, the building is now divided into two compartments by a concrete block wall with a door at the east end, cut at an angle to the top to fit under the slope of the roof. The south-western compartment has been used as a stable (Figure 23) and the northern compartment is used for storage and has a cement floor. To the north end, against the north wall of Building 6, there is a corridor through from east to west with half height rubble stone walls to either side, built up to the north with brick and concrete block, and to the south of the corridor with timber planks, there are door openings to each end of the corridor into the yard and field to the east.

Figure 23: The interior south compartment of B5, viewed from the north (2m scale).

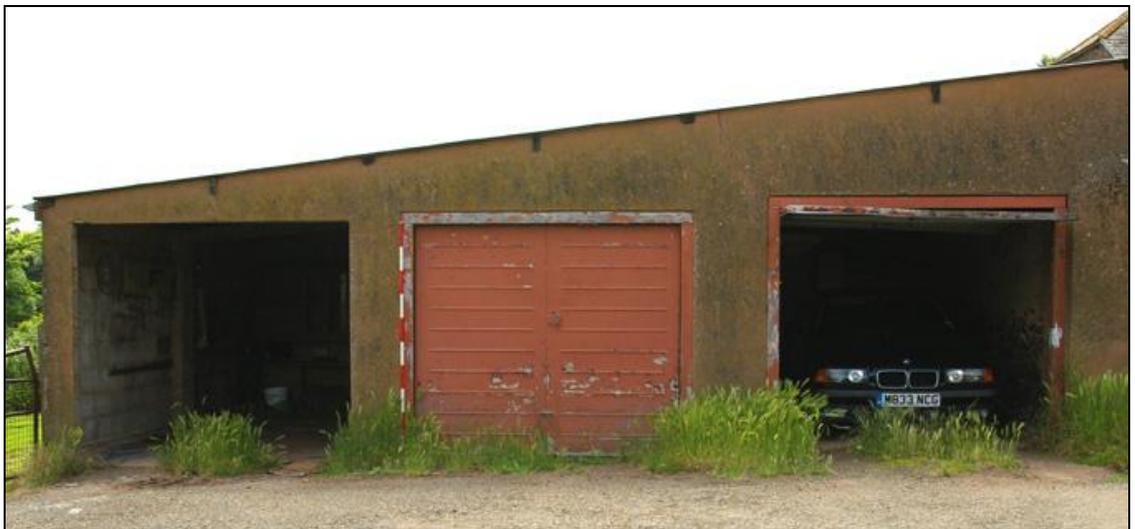
Now comprising three garages (Figure 24), the only historic element is the western compartment, constructed of cob on a rubble sandstone plinth and with walls aligned with the Piggery (B5) to the south. The two eastern compartments, built of concrete block, were apparently added in the mid-late 20th century (Mr D. White *pers com*). The single pitch roof slopes down to the east and the timber structure is modern with a sheet metal covering. The south wall to the rear of the historic element has been built up from the sandstone plinth with brick and concrete block against the corridor at the north end of B5. The east wall has a small opening blocked with concrete block, which may have been forced through (Figure 25). This compartment may formerly have functioned as a cart shed but few clues remain to its original usage.

Figure 24: The exterior north elevation of B6, viewed from the north (2m scale).

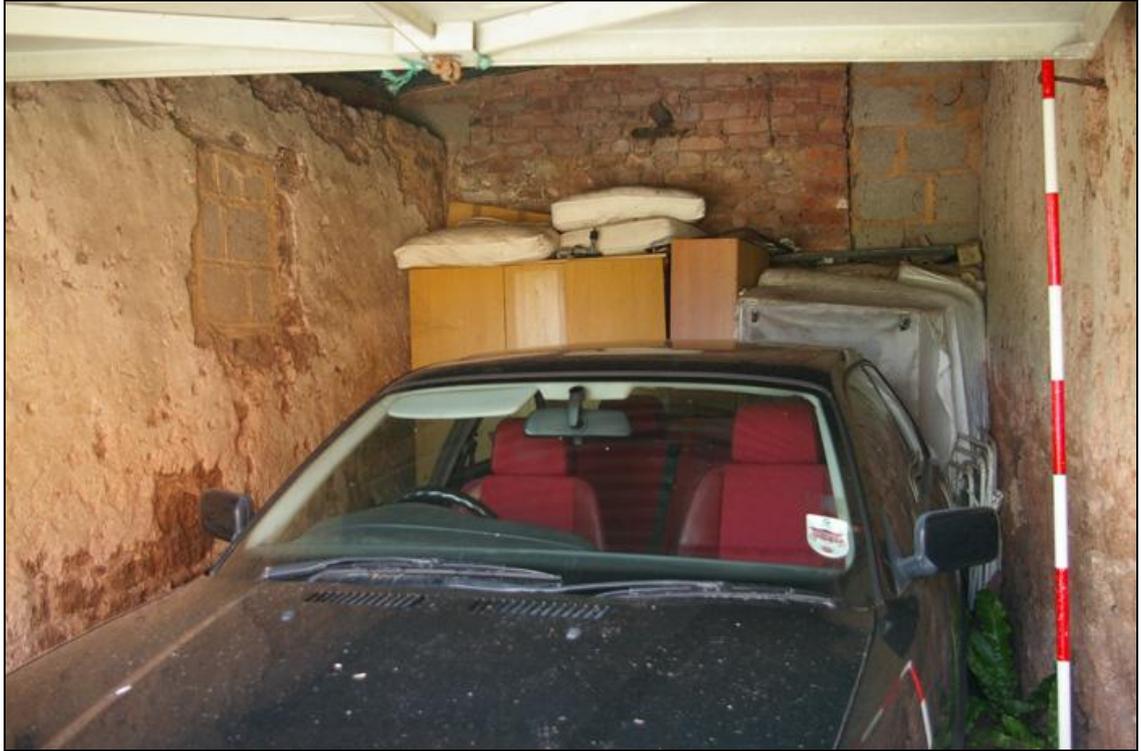
Figure 25: The interior of B6; the north-western garage compartment, viewed from the north (2m scale).

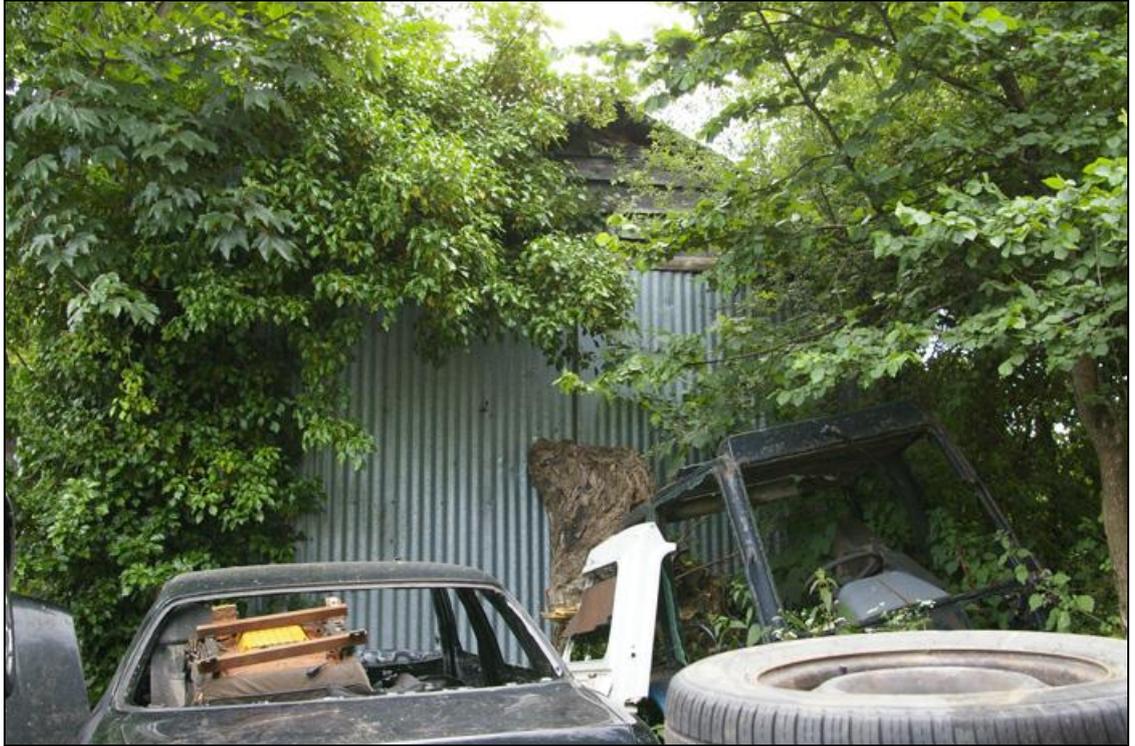
Also located within the upper area of the site, a long shed constructed of modern metal sheeting (Figure 26). The building was not accessed because the doors at the north end were closed with a large tree trunk resting against them. However, to the west of the building in Waybrook Lane it was noted that there appears to be a very overgrown stone wall against the road, which could possibly be the west wall of an older structure incorporated into the current modern building (Figure 27).

Figure 26: Building 8, viewed from the north-east.

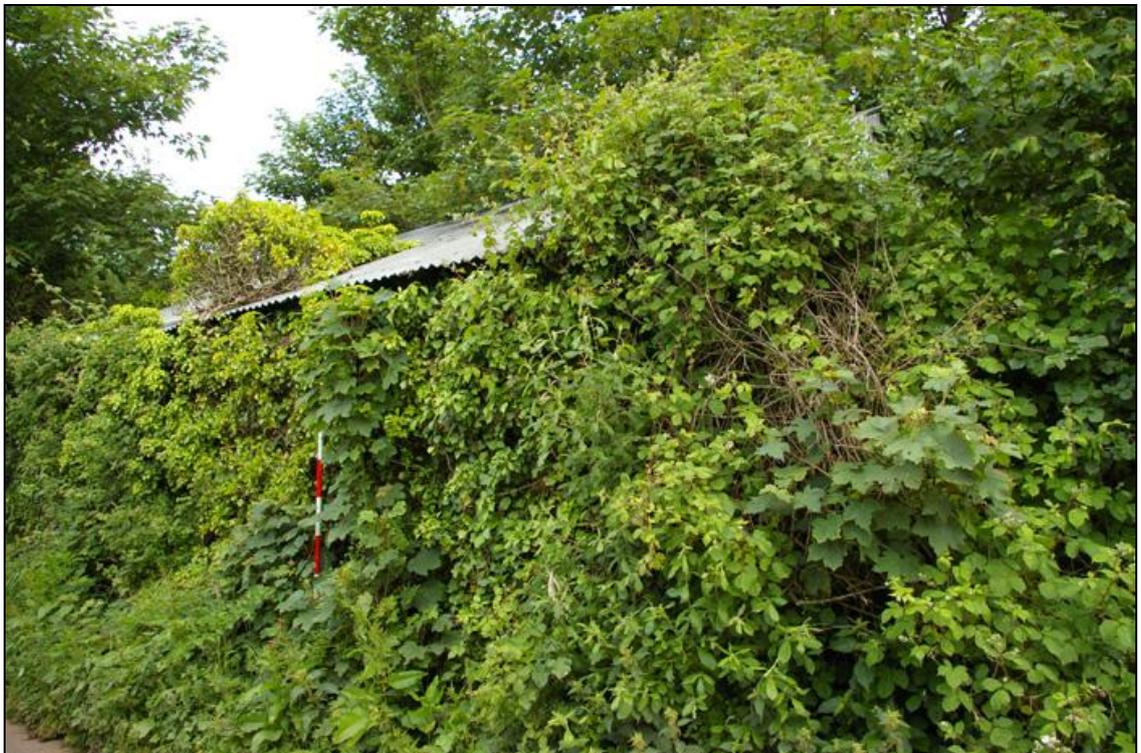
Figure 27: The overgrown sandstone wall of, or against the west wall of Building 8 (2m scale).

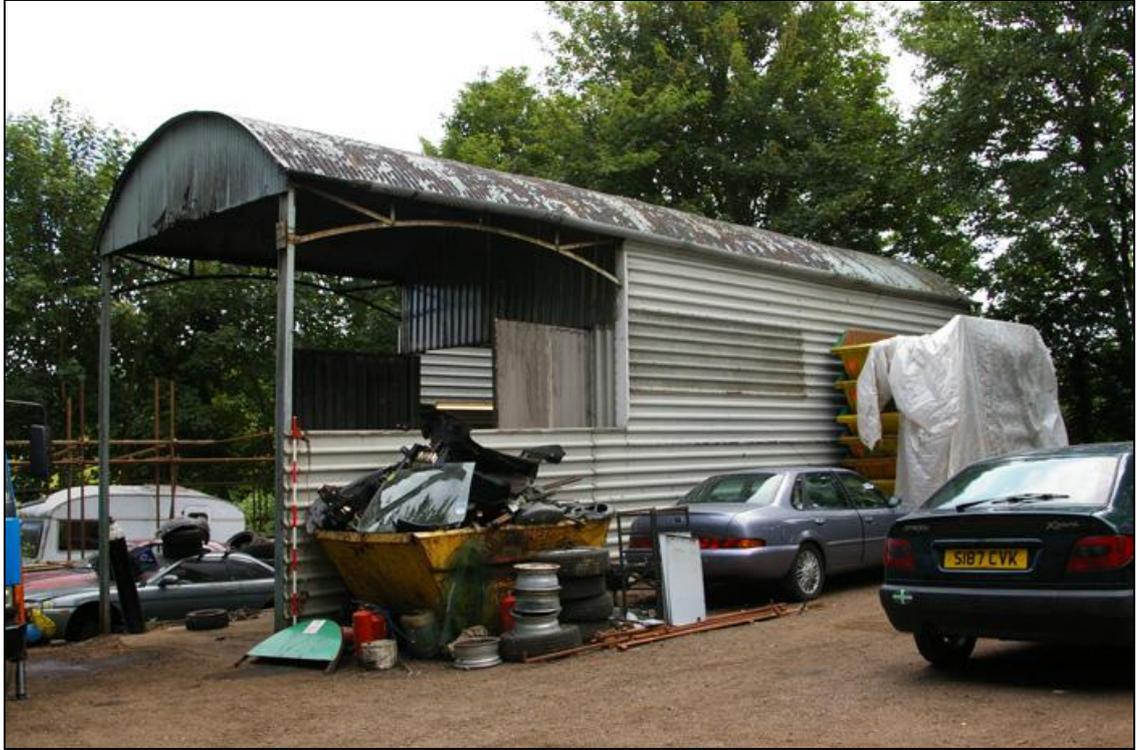
A modern Dutch Barn clad in late 20th century metal sheeting, with no evidence of any earlier structure (Figure 28).

Figure 28: Building 8, viewed from the north-east (2m scale).
