LANDEWEDNACK WINDMILL  
WINDMILL FARM LANDEWEDNACK  
HISTORICAL ASSESSMENT & BUILDING SURVEY  
JUNE 2013

D. Laing-Trengove  
130807  
07.08.2013

## **Historical Assessment & Building Survey**

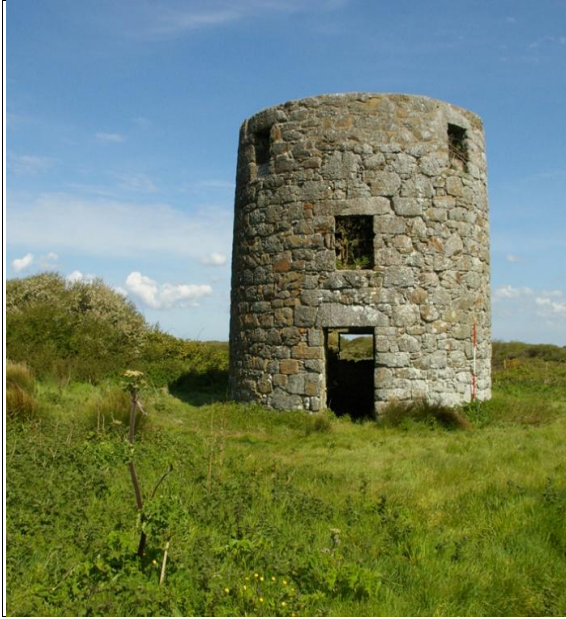
Figure 2. The windmill viewed from the south, showing the opposing door openings and south, east and west window openings (2m scale).

There is a window opening at first floor level over the south door and above at second floor level to east and west (Figure 2). There is also a forced window opening just to the west of the north door at first floor level, apparently knocked through and utilised during the Second World War, with insubstantial timber lintels and frame, now propped up with rough timber logs and with the disturbed wall above now failing and with modern pinkish cement repairs (Figure 4).

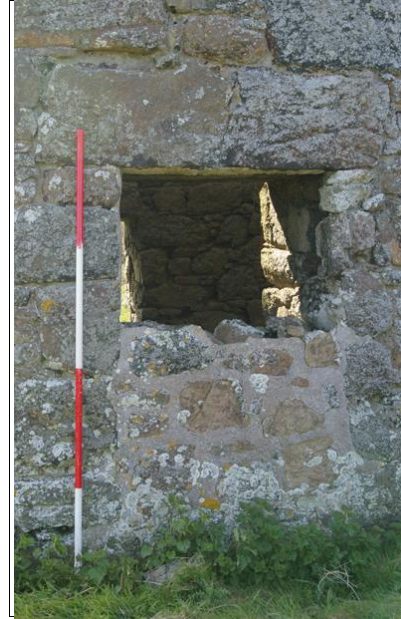
Figure 3: The partially blocked north door opening, viewed from the north (2m scale).

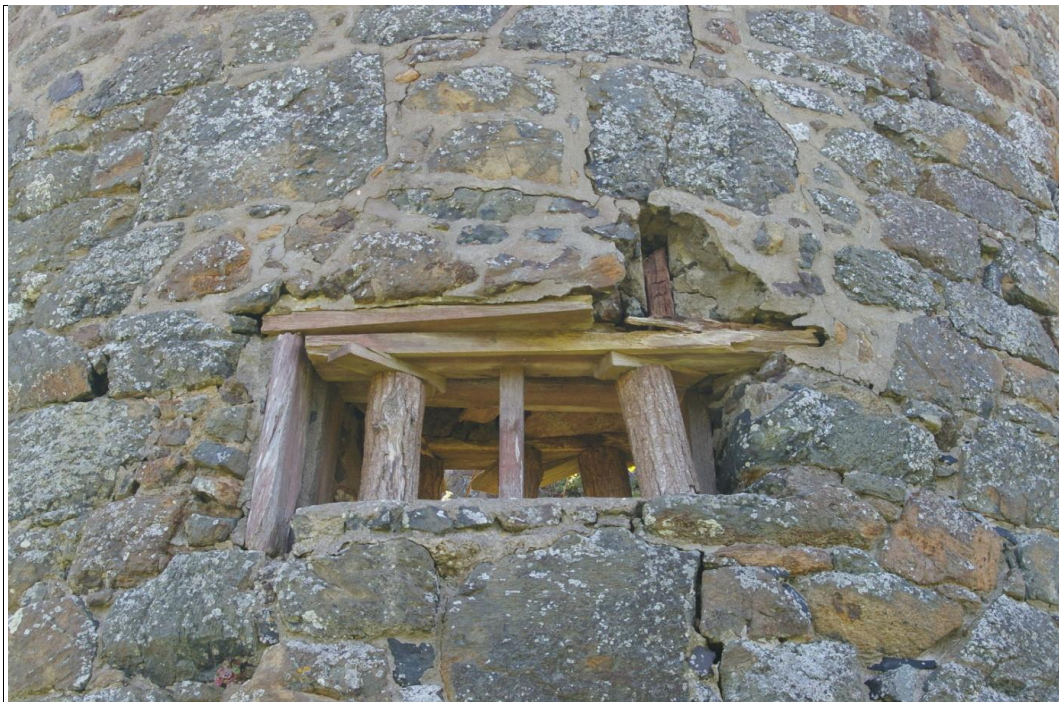
Figure 4: The forced WWII window opening to the north, with modern cement repairs above and to the upper wall, viewed from the north.

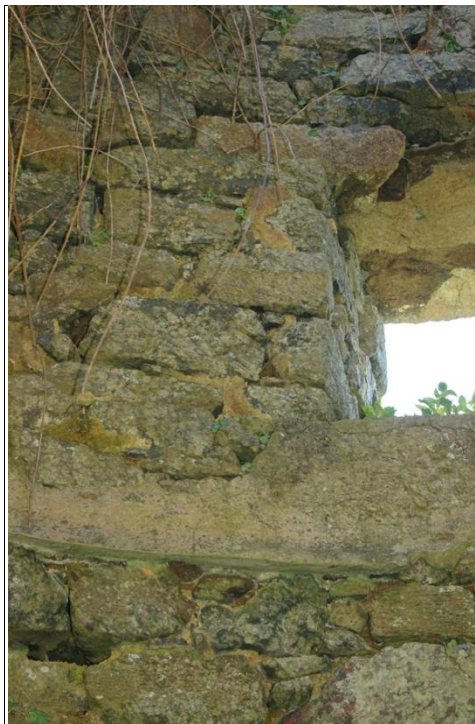
Figure 5: The small patched of former clay plaster remaining on the wall to the east of the south first floor window (with modern cement below), viewed from the north.

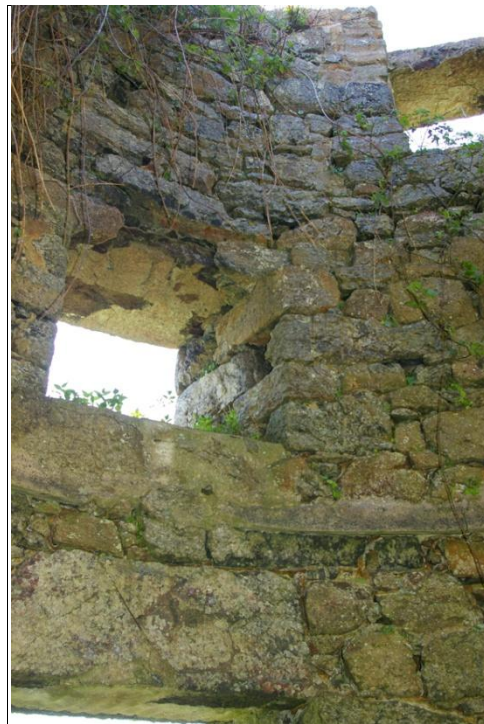
Figure 6: The south window, with cement to the lintel and sill, with cement former floor level below and the west window with (reset?) lintel above.

The upper limits of the tower have been re-pointed and at least partially rebuilt; the change in build is particularly visible around the two upper window openings. To the interior the lintels of these east and west windows are now single slabs, not set flush with the internal face of the wall (see Figure 6 - top right). The reveals of the western window are not splayed and are ragged, suggesting that they are recent or have been rebuilt.

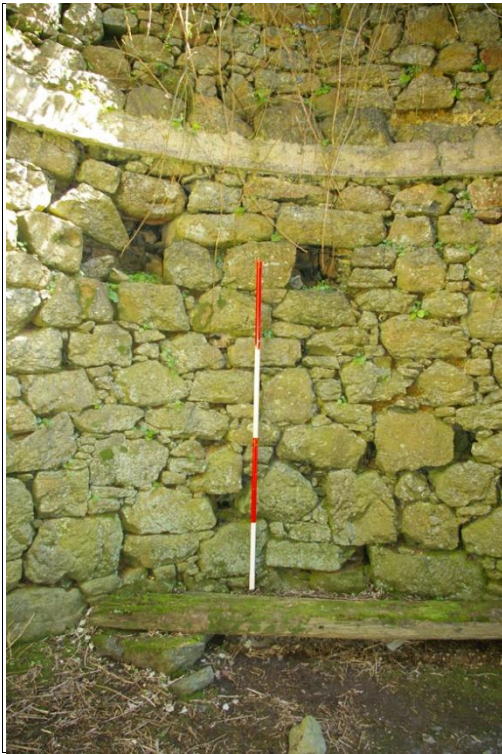
The interior lintel of the door to the south has cracked and been repaired with concrete, there is also some modern cement pointing to the reveals of the opening and a line of cement mortar adhering vertically down the sides of the opening just to the north of the exterior face; marking the position of a former doorframe. The wall to the east has two cavities within the interior face of the masonry just below the level of the lowest (first floor) ledge. These do not appear associated with any former internal workings however, and they may simply be where stones have been removed or the wall has partially collapsed.

Figure 7: The cavities in the east wall, viewed from the west (2m scale).

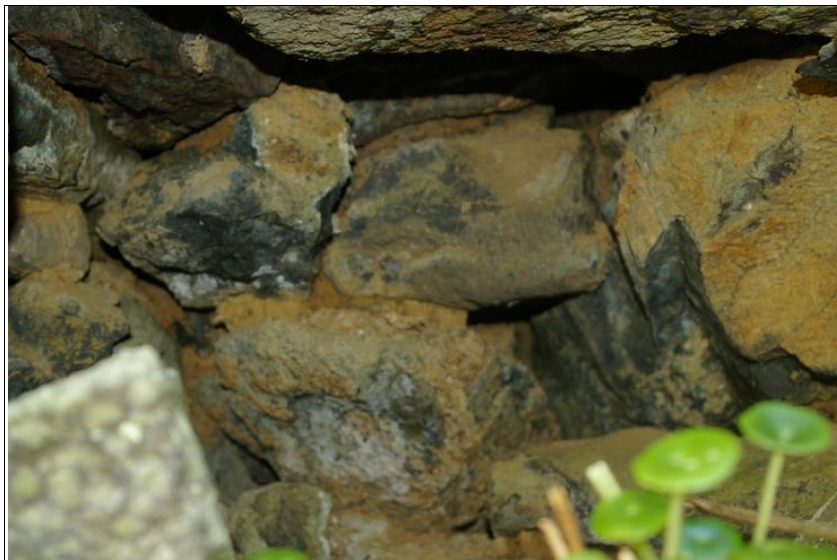
The majority of the structure, with the exception of the modern (20<sup>th</sup> century) repairs, appears to be bonded with orange earth/clay. This can be seen both between the masonry of the exterior and the interior, including within the core of the wall where masonry has been removed or collapsed to the north-east (Figure 9). The main body of the structure as it stands today would therefore appear to date from a single period. The earth bonding of the walls suggests that this is probably the original structure first noted in the late 17<sup>th</sup> century, for, if as the records suggest the structure was rebuilt during the late 18<sup>th</sup> century (see section above), one could perhaps expect a stronger mortar to be used, probably containing lime. The rebuilding in this instance may simply refer to the reinstatement of the timber sails and windshaft onto the top of the remaining tower structure. The robust size and thickness of the walls gives these tower structures a particular durability, and where allowed to remain an increased longevity. It is therefore likely that this extant structure dates from at least the 17<sup>th</sup> century.

Figure 9: The interior of the cavity within the north-east section of wall, viewed from the south-west. Note the orange earth bonding.

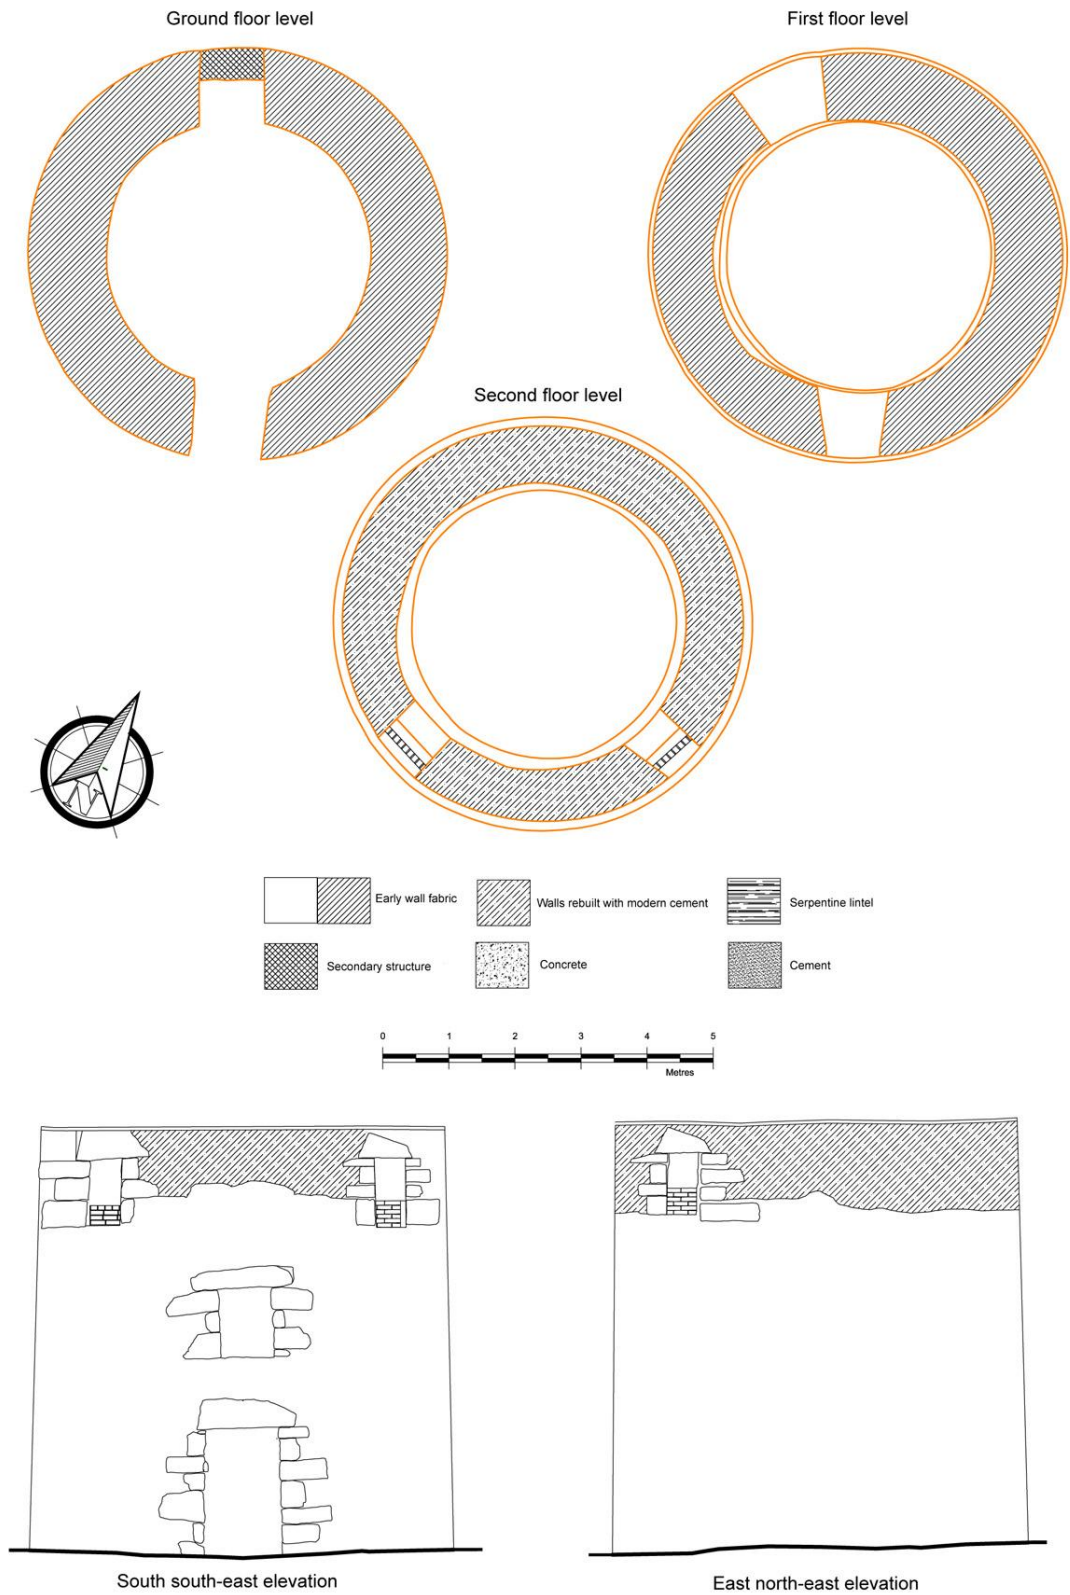
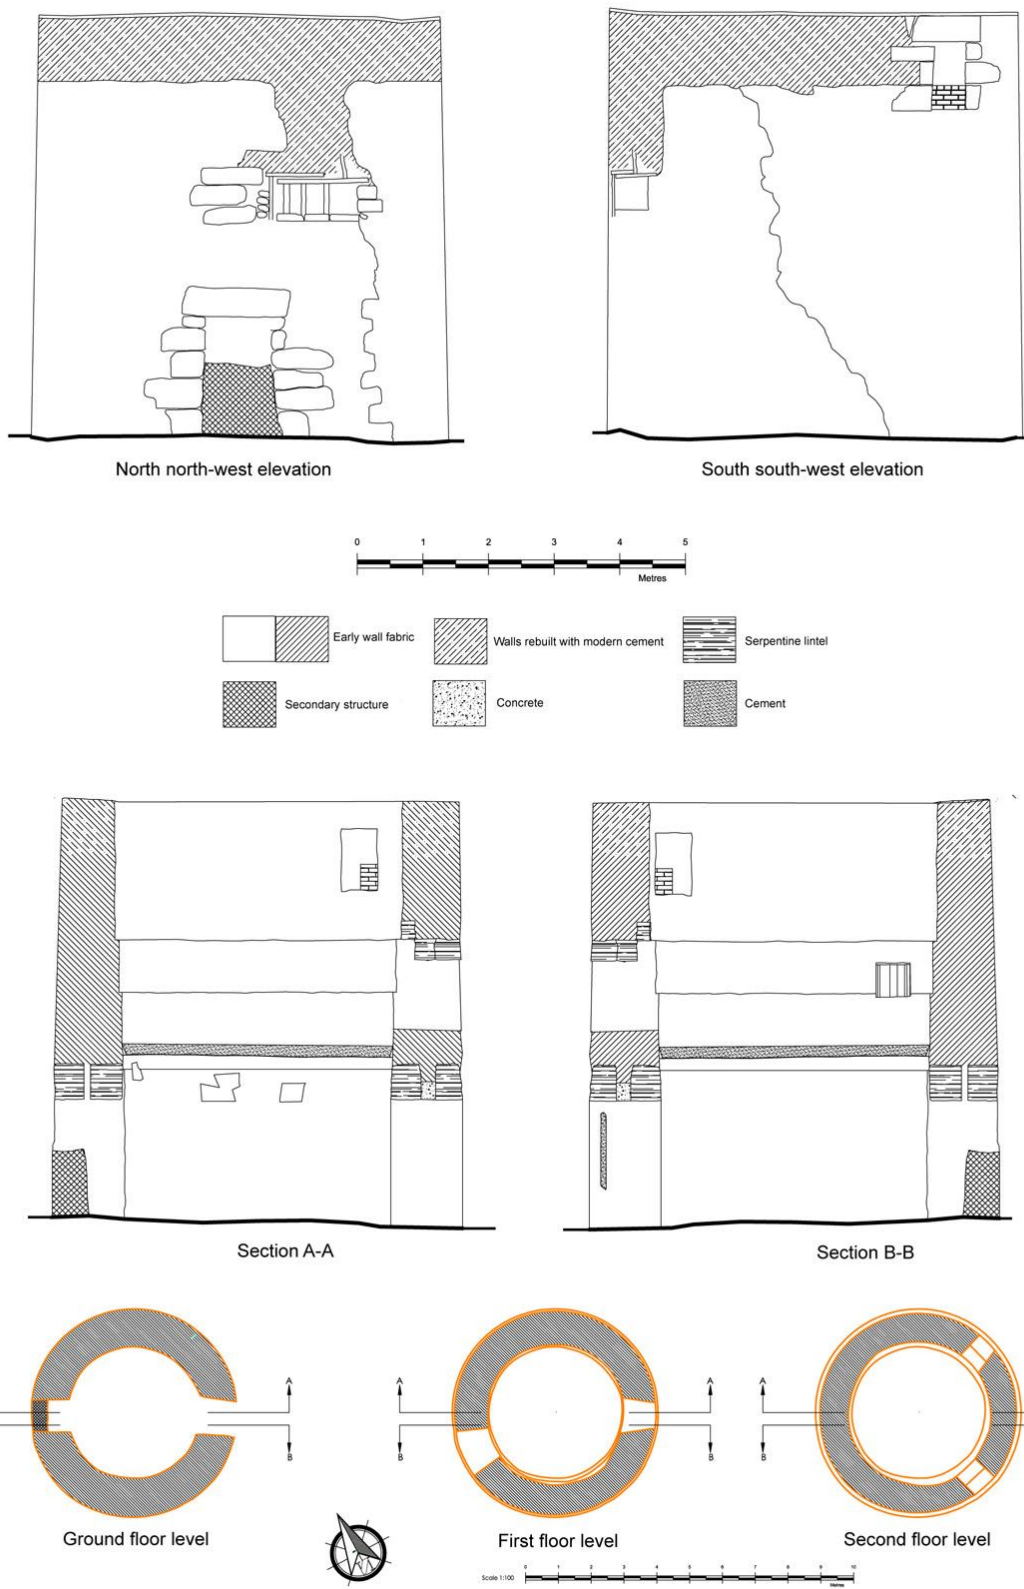
The interior walls are mostly un-pointed and the masonry bonded with earth/clay. The interior may formerly have been plastered with the same material, as there are small patches adhering to the masonry of the upper levels and this appears to be the same in colour and consistency as the bonding within the walls at ground floor level (Figure 5). There are traces of modern cement to the window openings and a cement ring around the interior at first floor level, where a floor was inserted during the Second World War (Gary Ratcliffe *pers. comm*) (Figures 5 & 6). The walls also step back forming ledges, indicating possible former floor levels or ledges to support the former interior machinery (see Figures 13 & 14).

It was not possible to identify more than three phases of construction or repair within the building, two of which are modern (see Figures 13 & 14). The earliest cement repairs or additions to the structure appear to date to the WWII use of the tower, these include the inserted window to the north, a ring of cement probably formerly associated with an inserted floor at first floor level and concrete and cement repairs to the openings. The later, 1970-80s repairs are clearly visible at the top of the
