WHEAL MARTYN CHINA CLAY MUSEUM

SITE GAZETTEER & CONDITION SURVEY

APRIL 2013

Author:	D. Laing-Trengove
Report No.:	130529
Date:	29.05.2013

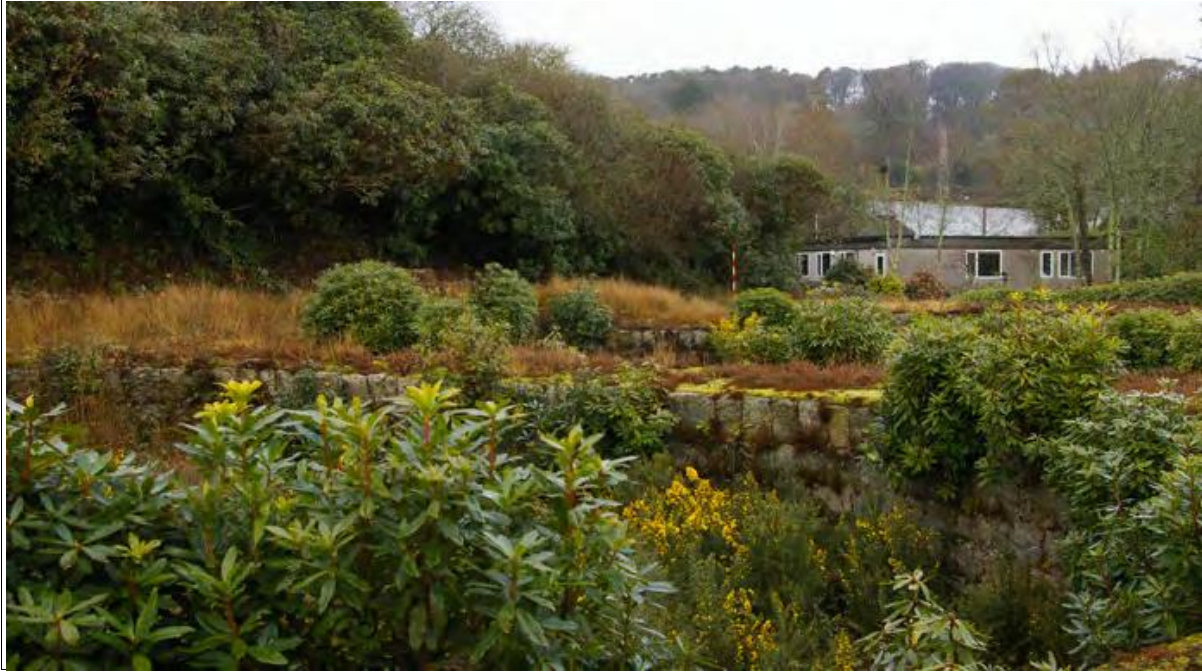
Figure 2.

CAPTION: The central and northern settling pits, viewed from the south-east. (2 meter scale)

CONDITION 2013: In a poor condition but the structures are relatively sound. The removal of rhododendrons and gorse is most urgently required. There is lots of rabbit activity on the platform although no burrows were observed. The bank to the south-west also requires clearance of rhododendron and scrub.

RECOMMENDATIONS 1999: *Consider vegetation removal and consolidation works where required. As one of the Scheduled Monuments on the site, these pits are at risk through root penetration and damage if the vegetation is left unchecked. They are an extremely important historic feature relating to the Gomm works, and should ideally be part of the access and interpretation policy for the site.*

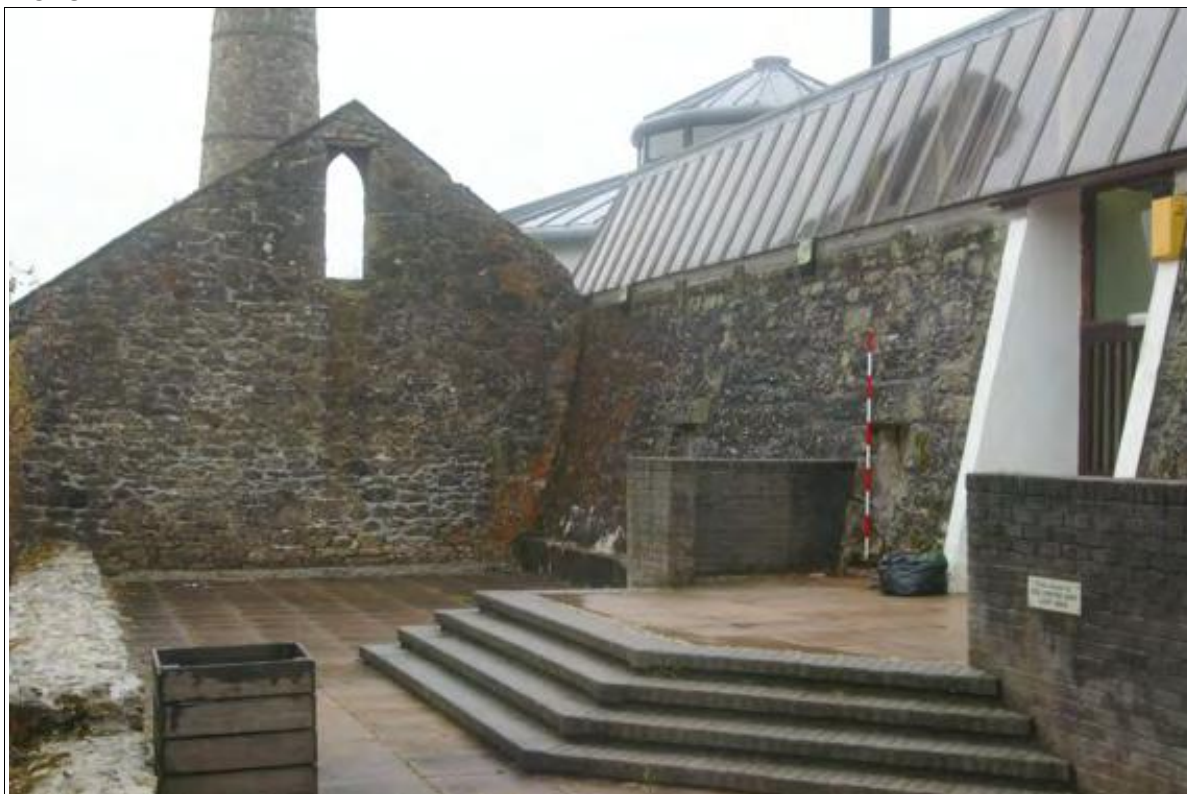
**Figure 3.**

CAPTION: The south end of the east wall of the Gomm settling tank, and south gable of the kiln pan to the east, viewed from the north. (2 meter scale)

CONDITION 2013: A modern conversion (as 1999 comments above).

RECOMMENDATIONS 1999: *Adaptive re-use of the settling tank has to some extent diminished its value for interpretation, and makes it difficult to view the monument as a whole. While one appreciates the reasons for this re-use, in the long-term the Museum and its Trustees might wish to consider an alternative strategy to the development of this area, which would take into account the greater historic significance of the Gomm kiln as opposed to its Wheal Martyn counterpart.*

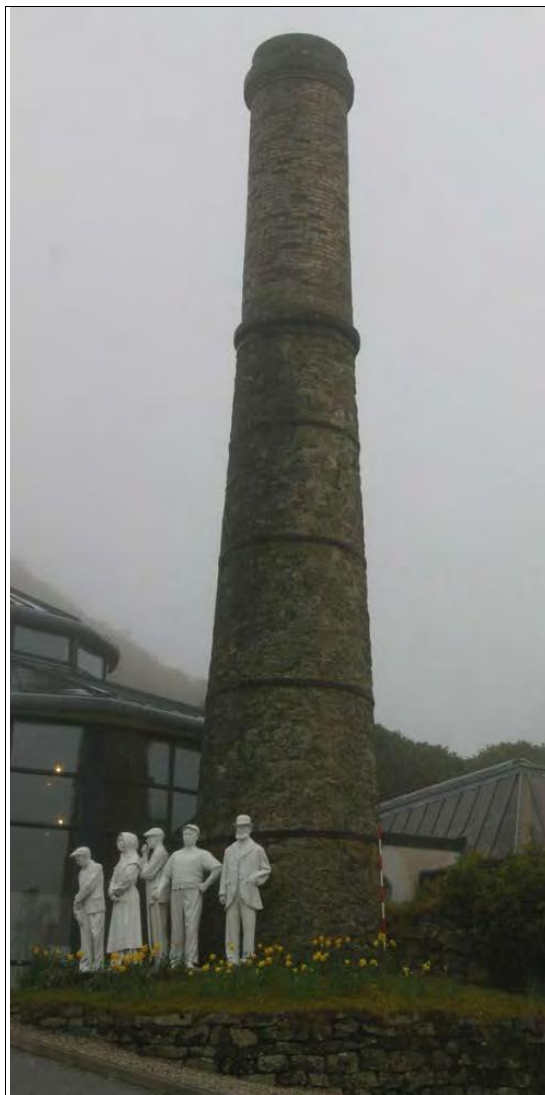
**Figure 4.**

CAPTION: The Gomm kiln chimney stack (3) viewed from the east. (2 meter scale)

CONDITION 2013: In good condition, with only a small amount of ivy growth and some small cracks to the north.

RECOMMENDATIONS 1999: *The stack would appear to be in good structural order. Suggest inspection by a structural engineer and vegetation clearance at regular intervals.*

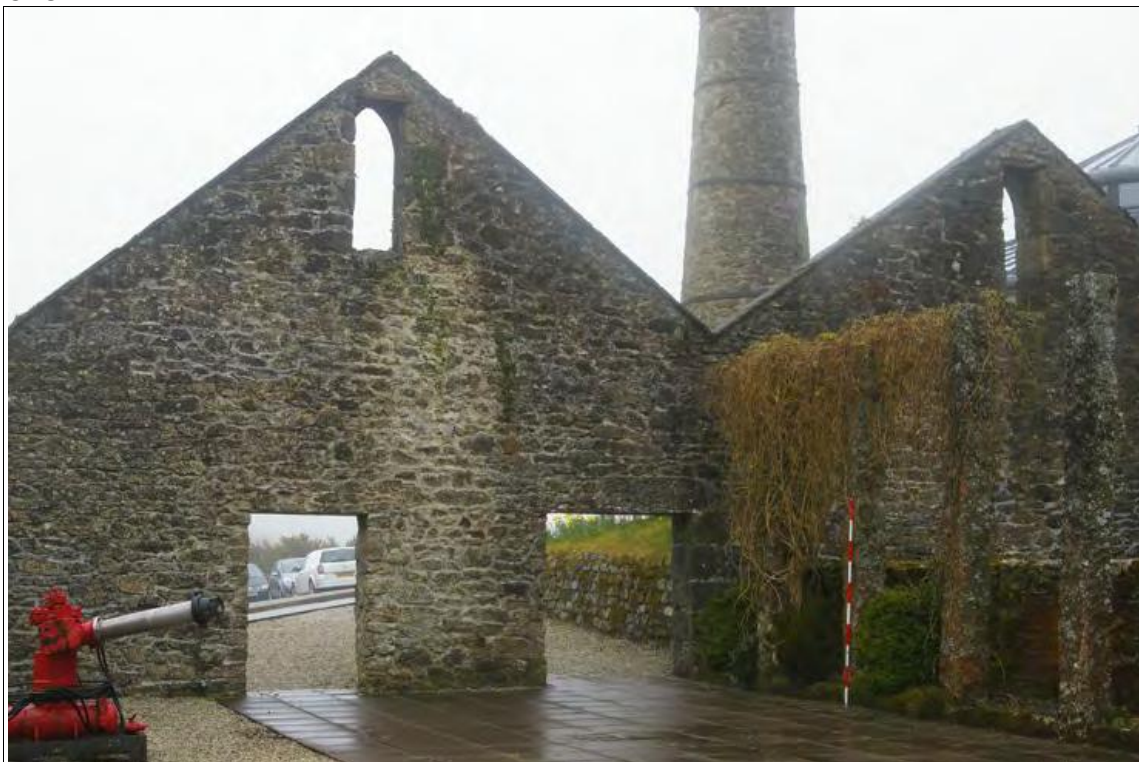
Figure 5.

CAPTION: The south gables of the kiln pan and linhay, with the central roof supports, viewed from the east. (2 meter scale)

CONDITION 2013: The overall condition of the remaining structure is good and has been well maintained. There is at present no *in situ* interpretation of the building or its significance for visitors, and any further extension or conversion could detract from the historic importance of these buildings.

RECOMMENDATIONS 1999: *At present, almost no use is made of the Gomm Kiln for interpretation of the china-clay process or as an exemplar of the development of the pan-kiln as a monument class. The associated settling pits at the rear (1) are inaccessible. It forms a display area for some artefacts and its settling tank (2) serves as the Museum entrance, shop, AV theatre and restaurant. Further adaptive re-use of the pan and linhay areas is proposed as an option for the development plan. This report suggests that perhaps other options should also be explored which would re-assess the Gomm kiln as probably the most important single monument on the site and offer alternative solutions for its display and conservation.*

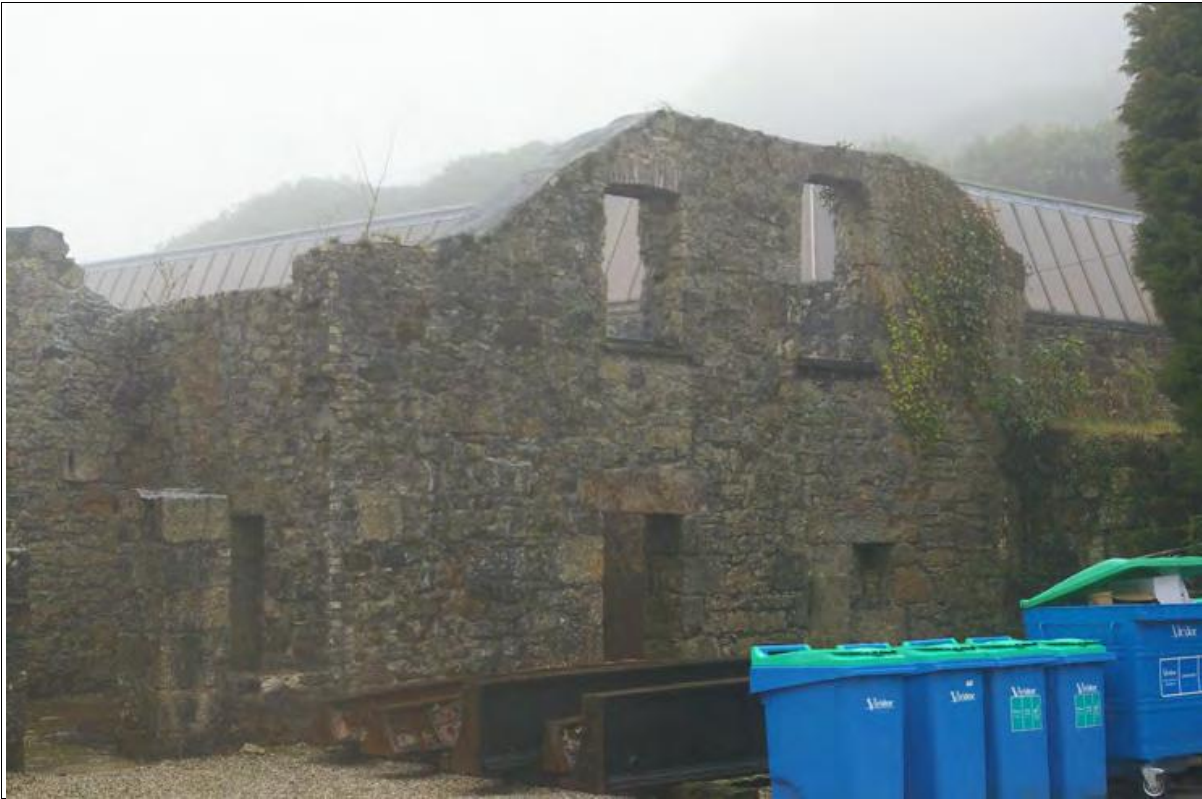
Figure 5.

CAPTION: The additional rooms adjacent to the former furnace room, viewed from the north-east. (2 meter scale)

CONDITION –2013: The structure is in a fair condition, but with some vegetation growth to the interior, the exterior walls and wall tops.

RECOMMENDATIONS 1999: *This feature of the Gomm kiln is very unusual and perhaps represents an opportunist re-use of the structure during a period when the Gomm works was disused. It should be conserved in situ.*

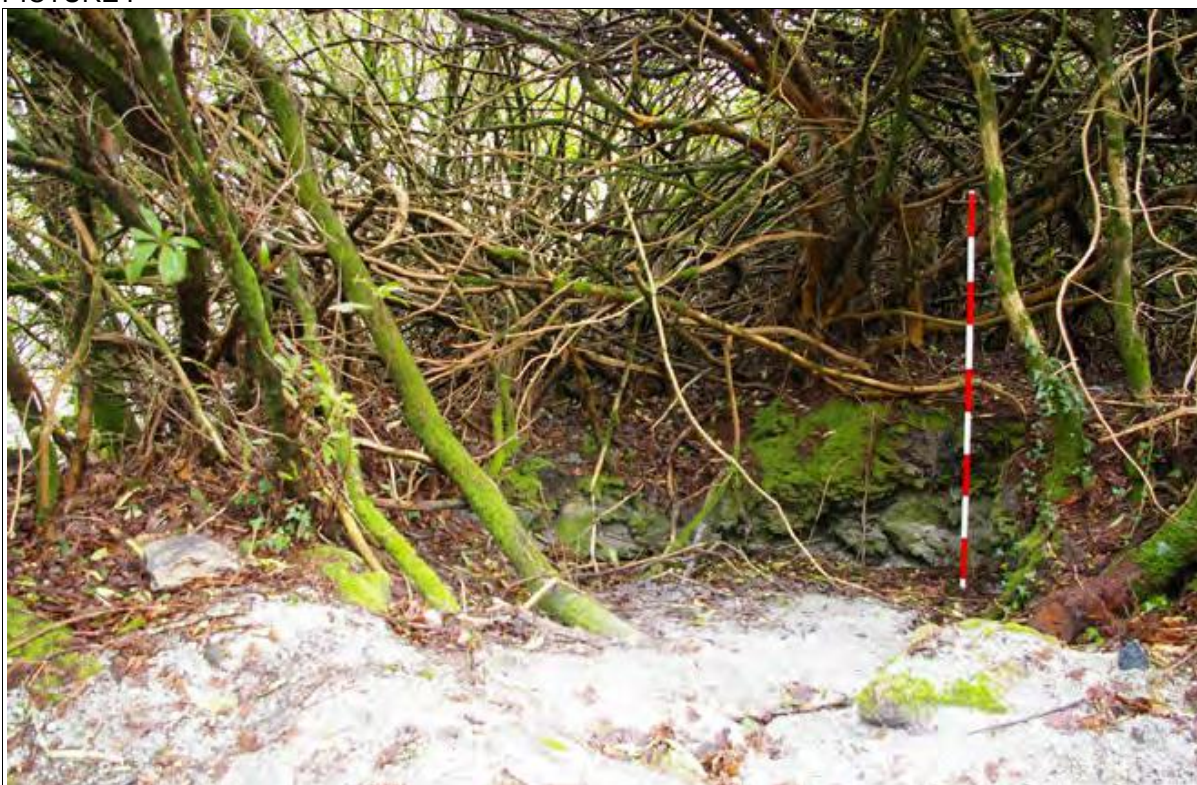
Figure 6.

CAPTION: Remaining north and east walls of tank (9), viewed from the west. (2 meter scale)

CONDITION 2013: Very poor condition, very overgrown.

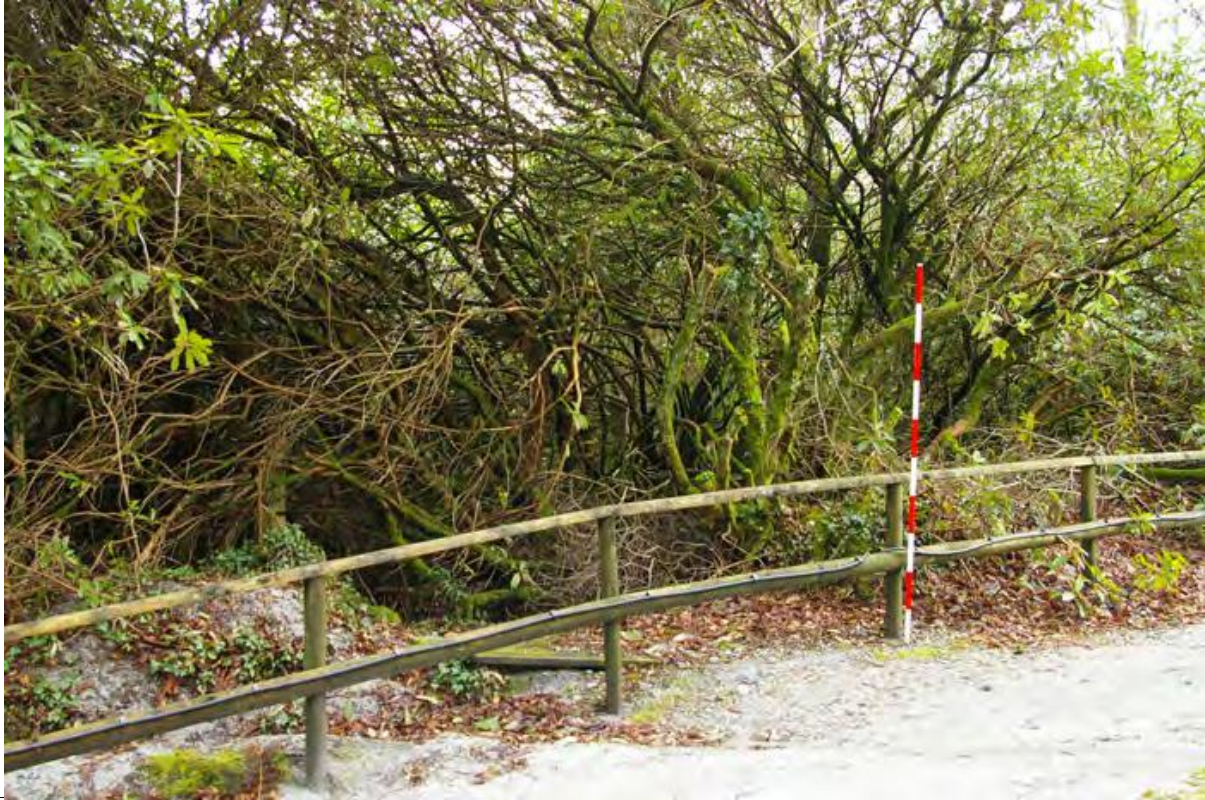
Figure 7.

CAPTION: Possible former position of tramway (10) (central depression to left of scale), viewed from the west. (2 meter scale)

CONDITION 2013: Very poor condition.

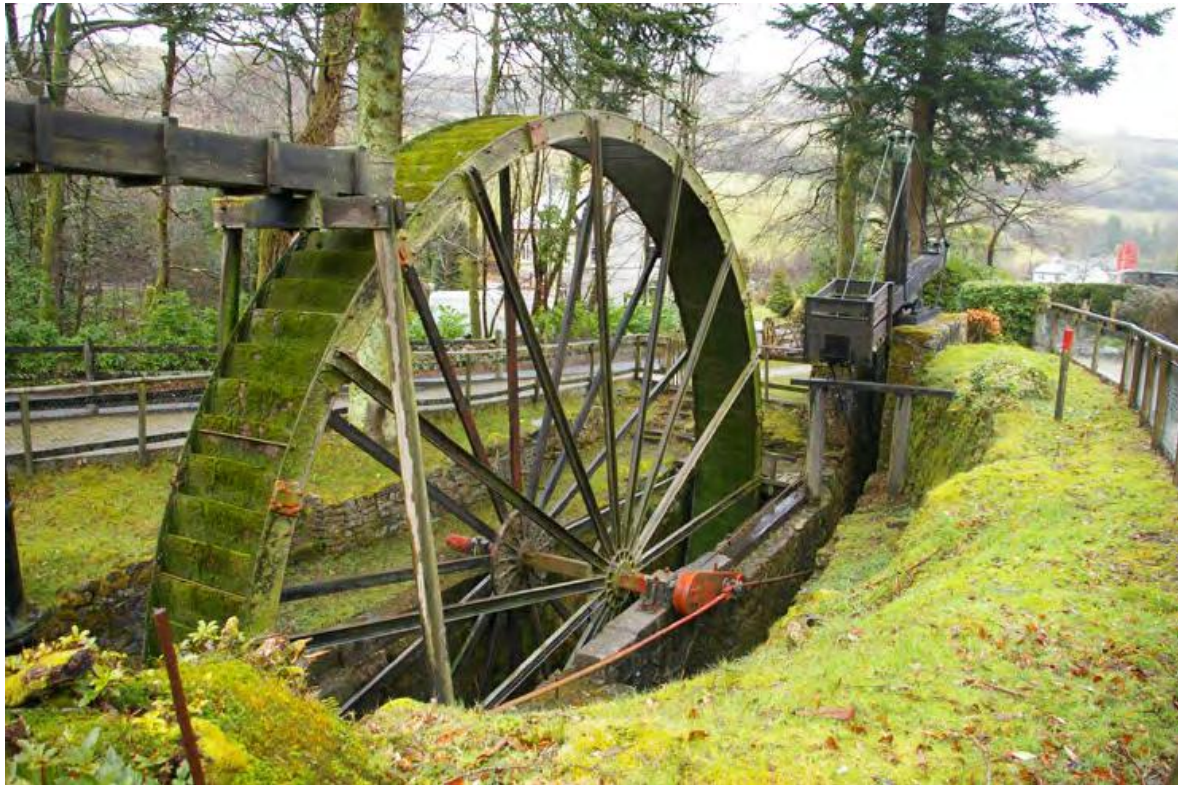
Figure 9.

CAPTION: The waterwheel (12) viewed from the north-west. (2 meter scale)

DESCRIPTION 2013: As 1999 description above, with some modern cement repairs to upper of the wheel pit; the wheel is working from April.

CONDITION 2013: The condition of the wheel is basically sound, although the wheel itself could benefit from clearing and moss removal.

RECOMMENDATION 1999: *The wheel is worked during the summer season and appears to be basically sound. Maintain and repair as required.*

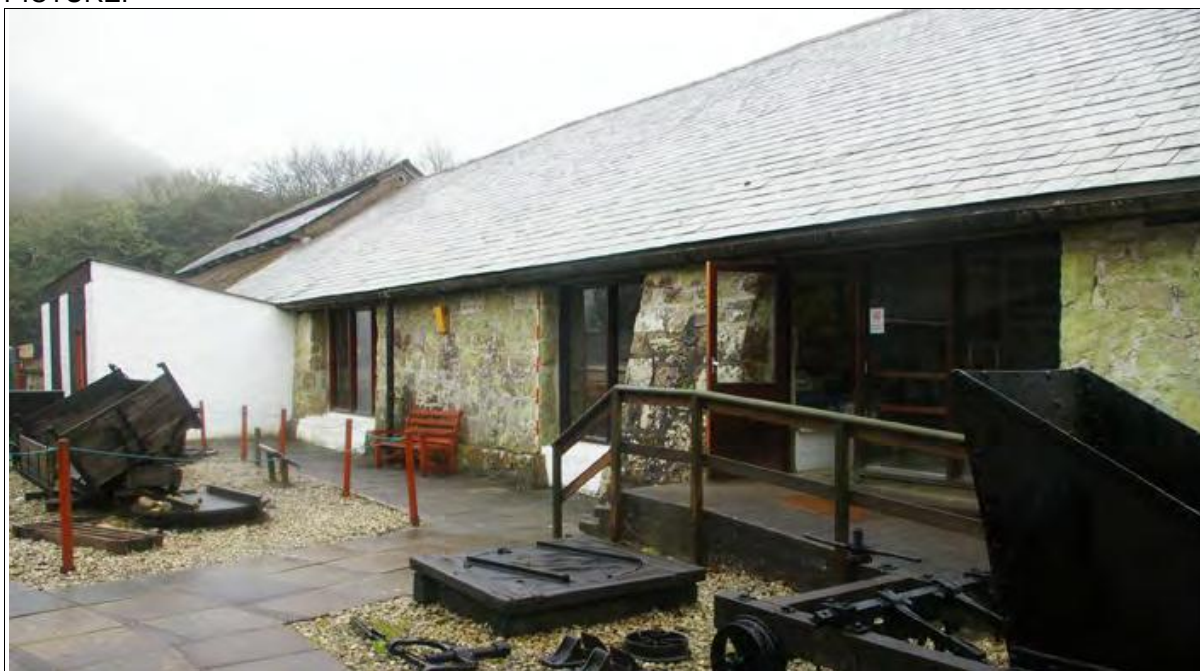
Figure 10.

CAPTION: The front (east) wall of the linhay of the pan kiln (13), viewed from the north. (2 metre scale)

CONDITION 2013: The building appears in a good condition, but is not improved externally by the modern extension to the east.

RECOMMENDATION 1999: *The internal use of the kiln for display and presentation both of the china-clay process and artefacts is well-judged and successful. It is essential that the full length of the pan is retained in its present form to preserve the integrity of the building in terms of its original function. Maintenance of the building is demanding both of resource and skill, but is crucial for the future as so few pan-kilns survive with their roof structure intact. Suggest removal of the blockwork addition at the front, to allow a proper appreciation of the frontage of the kiln.*

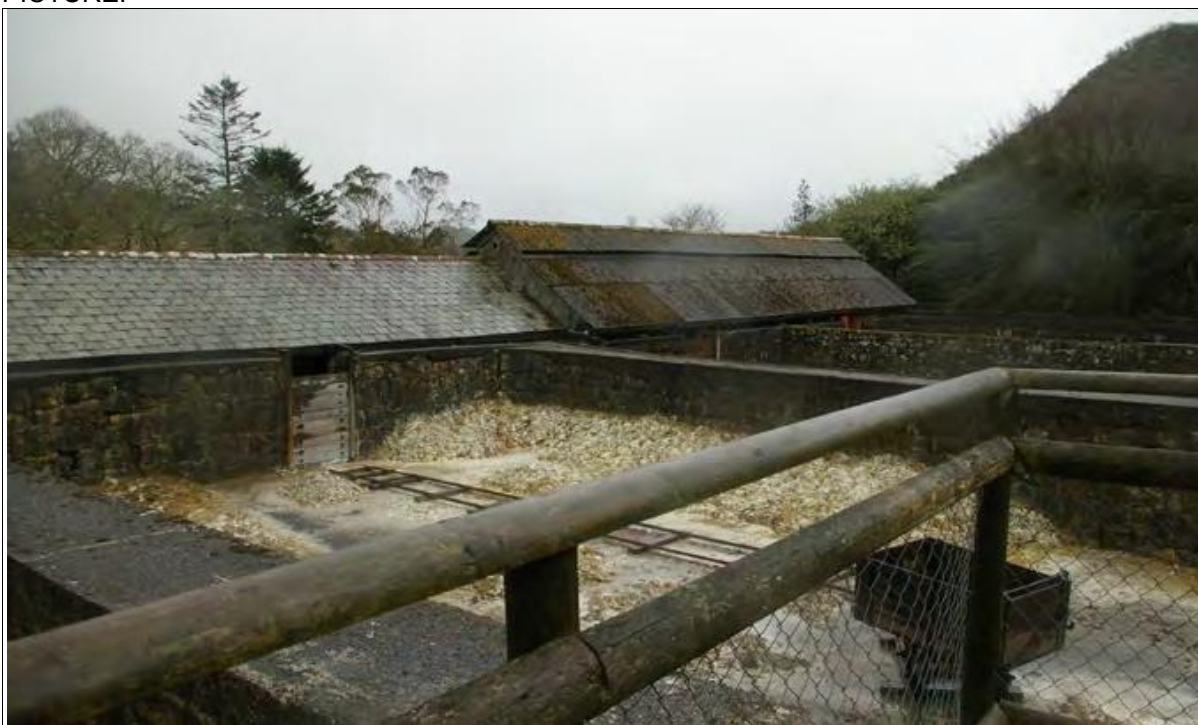
Figure 11.

CAPTION: Tank (13.1)

CONDITION -2013: Condition is good. The tank appears structurally sound and the cement capping to the wall tops has prevented vegetation growth without significantly altering the structure.

SIGNIFICANCE: Of high significance. This structure sits within the Scheduled area, is in good condition and is a useful feature in terms of illustrating the former workings.

RECOMMENDATION 1999: *Maintain using traditional techniques and materials.*

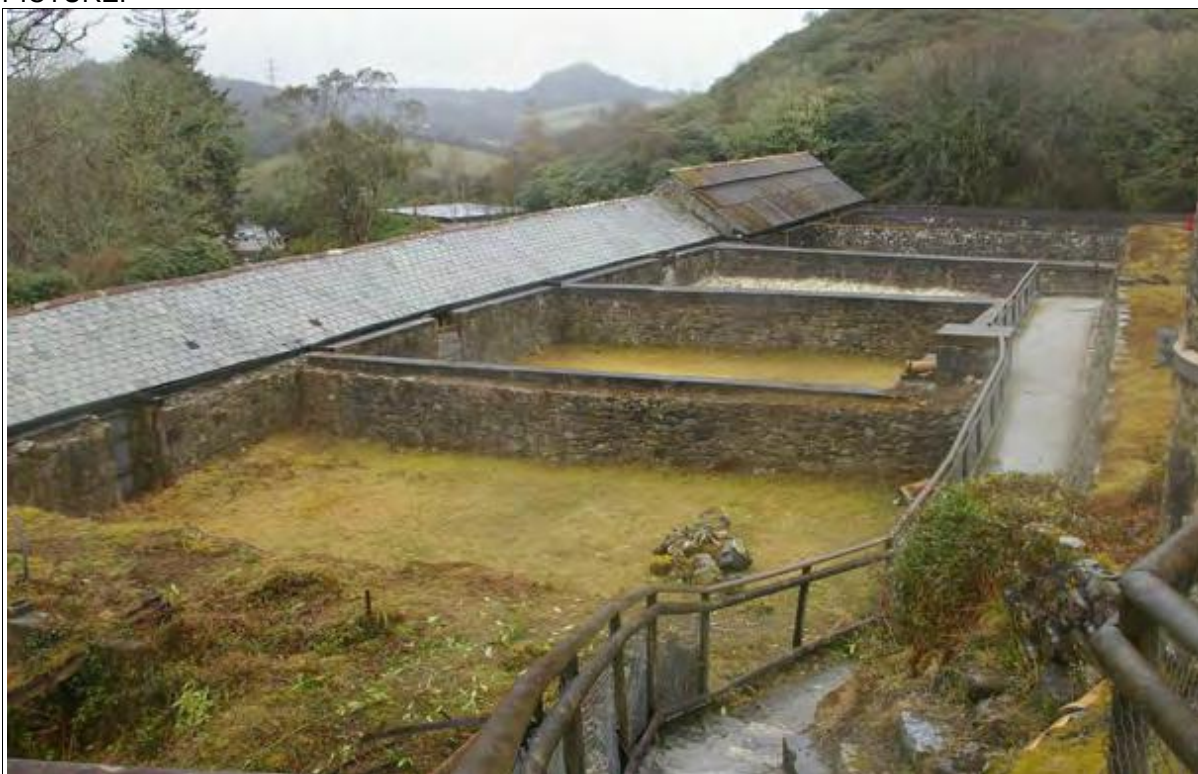
Figure 12.

CAPTION: Tank 13.2 (grass floored, in background), viewed from the north.

CONDITION 2013: In good condition. The interior has grown over with grass, which could be cleared and the tank floor revealed. The structure has no use at present but is only accessible from the kiln. The cement on the wall tops has prevented any vegetation growth.

SIGNIFICANCE 2013: Of moderate to high significance. Within the Scheduled area of the Wheal Martyn works and one of a number of tanks on the site, but in a less good condition than 13.1.

RECOMMENDATION 1999: *Maintain using traditional techniques and materials.*

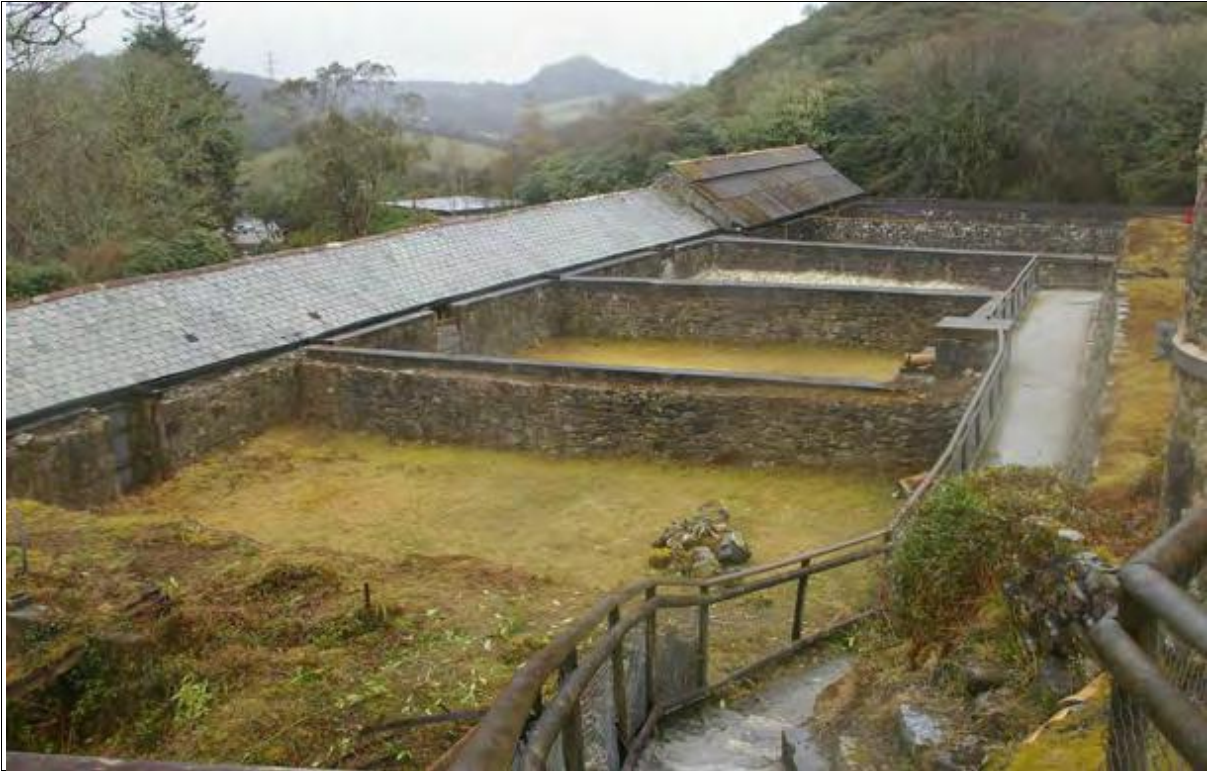
Figure 13.

CAPTION: Tank 13.3 (grass floored, in foreground), viewed from the north.

CONDITION 2013: Generally good, although the floor is grassed over and the wall tops have some vegetation growth that could be removed.

SIGNIFICANCE: Of moderate to high significance. Within the Scheduled area of the Wheal Martyn works and one of a number of tanks on the site, but the condition is less good than tanks 13.1 and 13.2.

RECOMMENDATION -1999: *Maintain using traditional techniques and materials.*

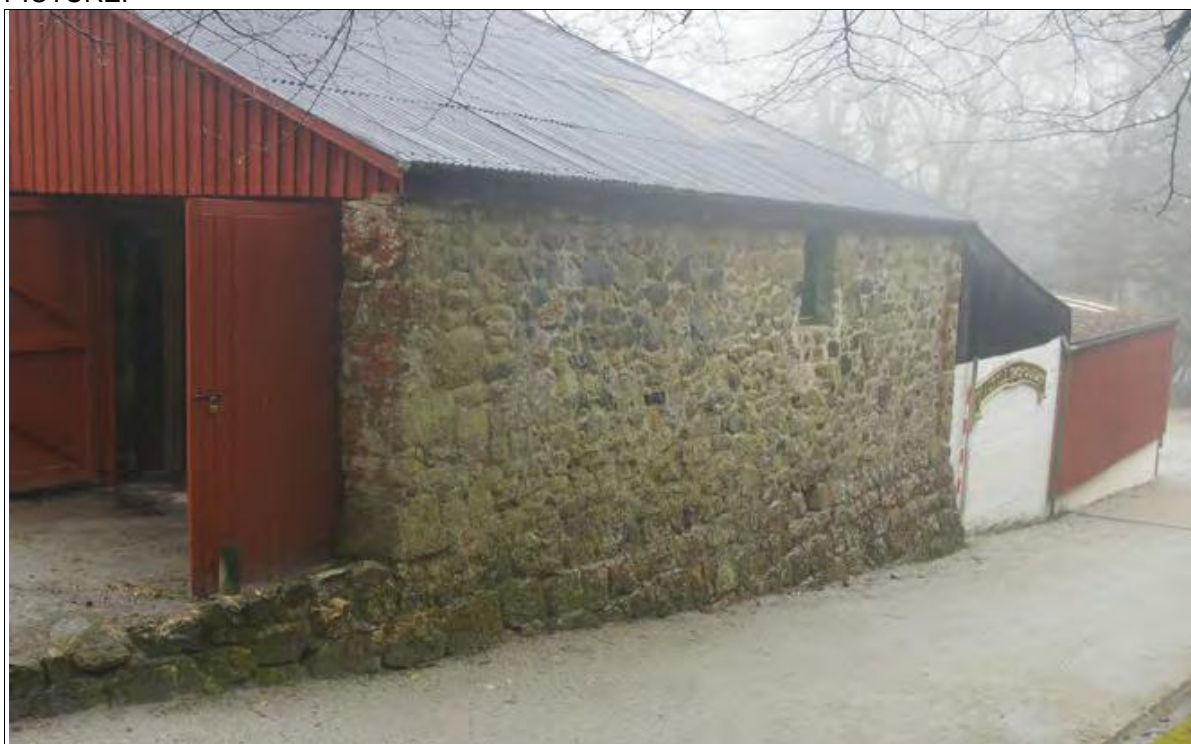
Figure 14.

CAPTION: The south elevation of the furnace room of the pan kiln (14), viewed from the west.

RECCOMENDATION 1999: *Maintenance of the building is demanding both of resource and skill, but is crucial for the future as so few pan-kilns survive with their roof structure intact. Suggest replacement of the corrugated asbestos roof sheets with slate.*

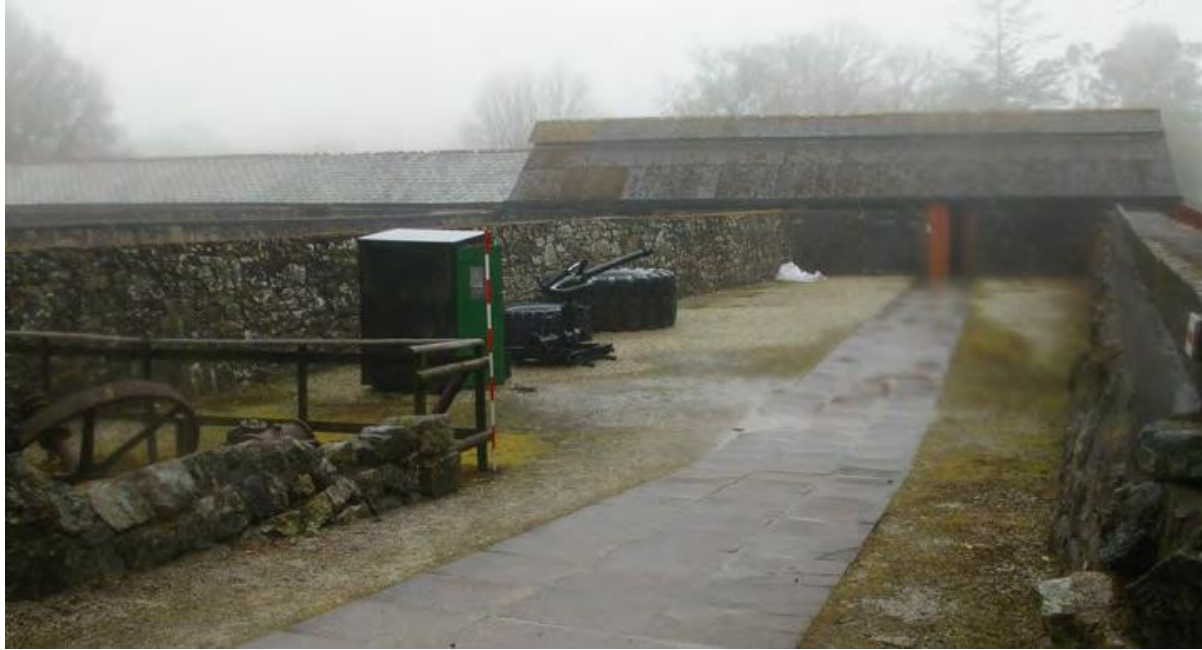
Figure 15.

CAPTION: The tank (14.1), viewed from the west.

CONDITION 2013: The south wall face is very irregular and the stability of the structure appears questionable at the western end of the south wall - could benefit from addition of mortar pointing? The tank is partially open at the west end and removal of this end wall may explain the ragged nature of the south wall here.

RECOMMENDATION 1999: *Maintain using traditional techniques and materials.*

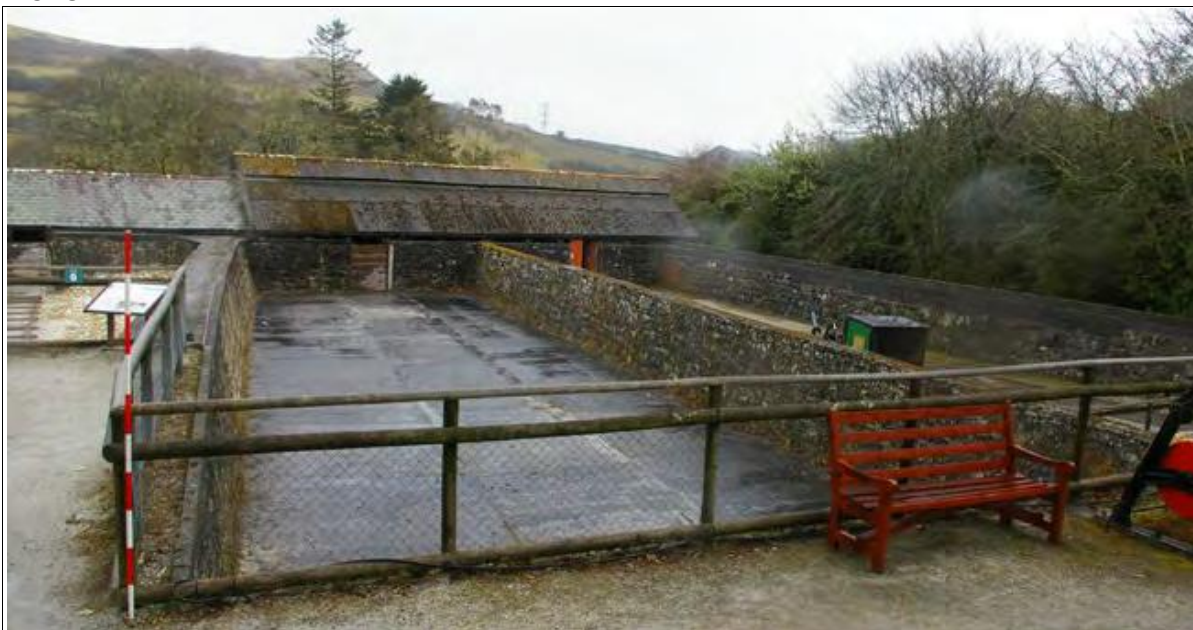
**Figure 16.**

CAPTION: The tank, viewed from the west.

CONDITION 2013: In good condition.

SIGNIFICANCE 2013: Of high significance. Within the Scheduled area of the Wheal Martyn works, one of a number of intact tanks on the site, but in very good condition therefore of high significance.

DESCRIPTION 1999: *A rank at the rear of the Wheal Martyn kiln (14), in place by the time of the 1907 OS mapping. Granite built and with a cement floor.*RECOMMENDATION -1999: *Maintain using traditional techniques and materials.*

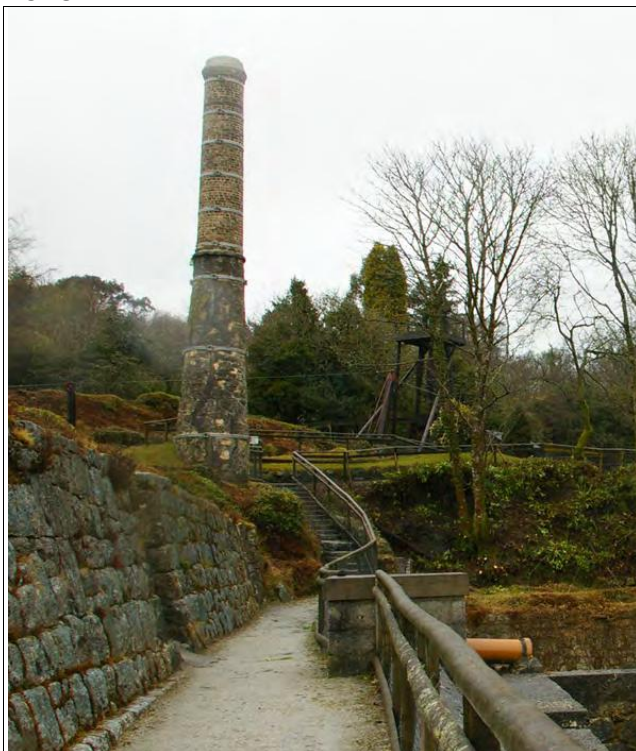
Figure 17.

CAPTION: The chimney (16), viewed from the south.

CONDITION -2013: The vegetation has been cleared and the structure appears sound, with replaced galvanised metal bands.

RECOMMENDATION -1999: *Remove vegetation and have the stack examined by a structural engineer*

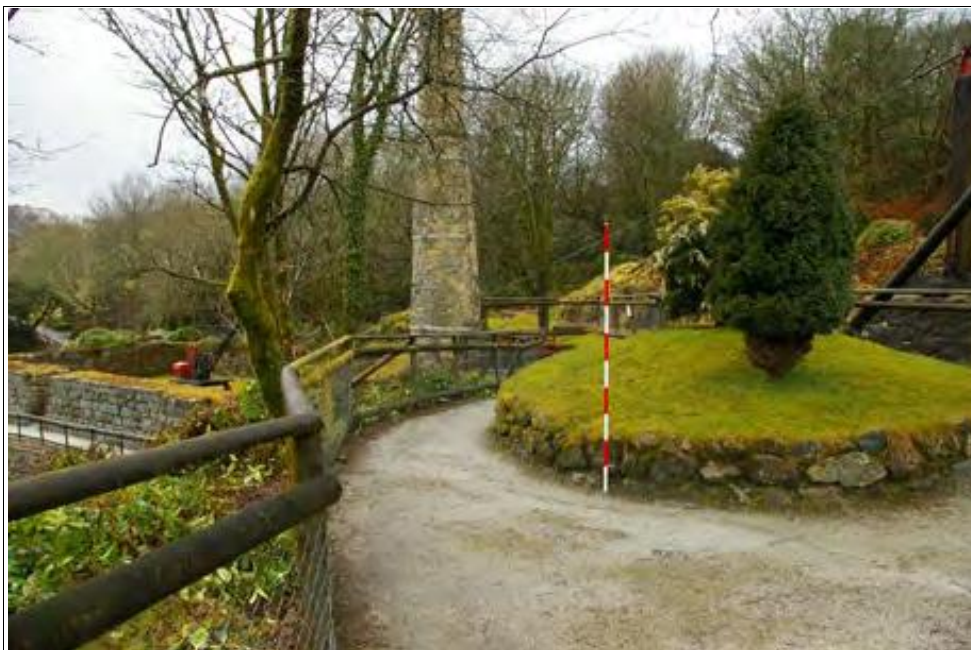
**Figure 18.**

CAPTION: Approximate former location of chimney (16), viewed from the north-east.

CONDITION 2013: As 1999 above, although at the time of the survey area (18) – to the left of the location photographed - was being cleared of vegetation.

RECOMMENDATION 1999: *Consider re-construction of this stack in the long-term.*

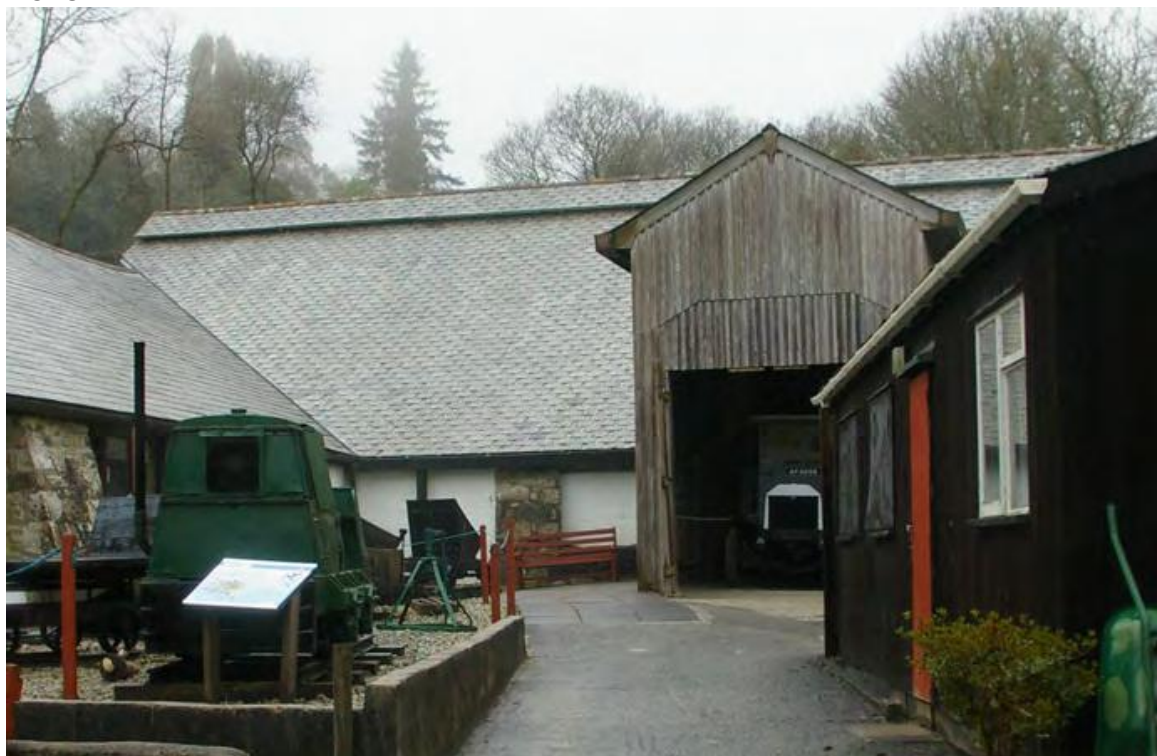
**Figure 19.**

CAPTION: The south elevation of the Mica dry (17), viewed from the south.

CONDITION 2013: The building appears generally sound but would require some clearance in the area of the pan. The roof structure is in very good condition.

RECOMMENDATION 1999: *Maintenance of the building is demanding both of resource and skill, but is crucial for the future as so few pan-kilns survive with their roof structure intact. Forward plans should consider the options for public access and re-use of the pan area. In this context it would be vital to avoid internal sub-division of this space, so that the original intent and form of the building may be appreciated.*

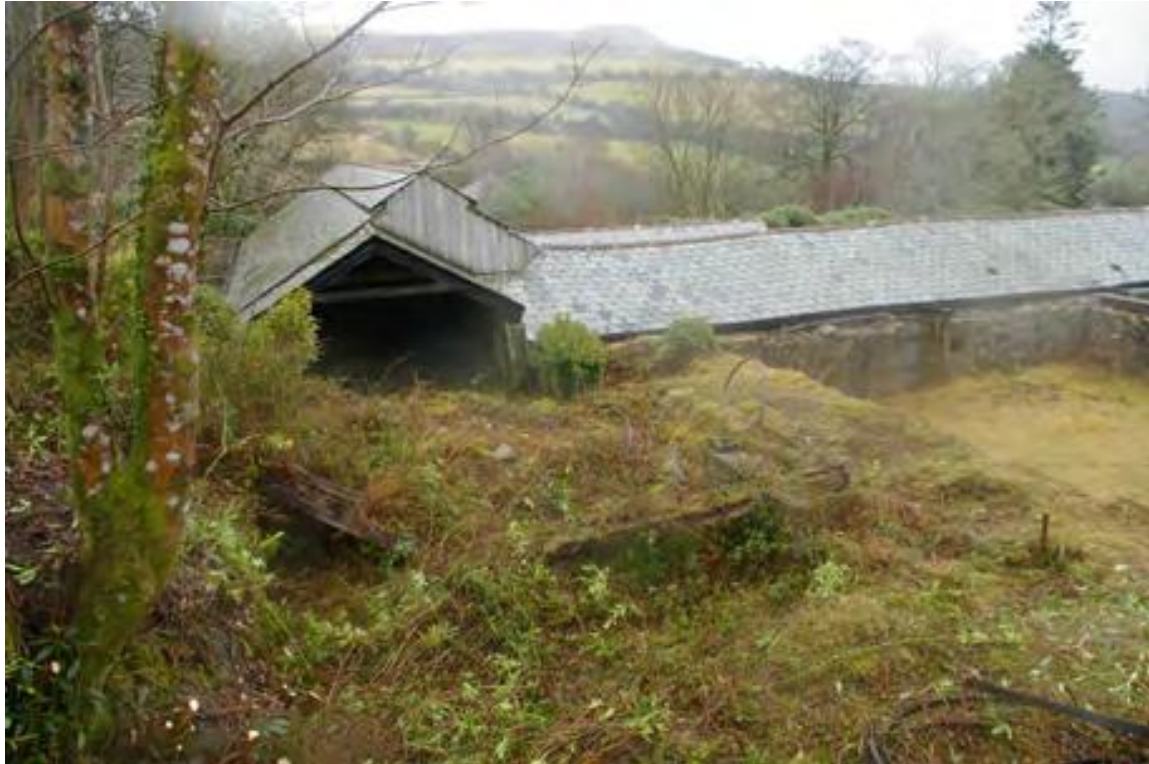
Figure 20.

CAPTION: The pan/tank (18) during partial clearance, viewed from the west.

CONDITION 2013: Very poor. The area should be cleared of vegetation and any clearance or removal of rubble etc should be undertaken by or with an archaeologist in attendance so as to understand the feature in relation to the mica dry.

RECOMMENDATION 1999: *Clear vegetation and some debris to enable part of the floor area to be excavated to test the function of this feature. In the long-term consider options for adaptive re-use of the structure.*

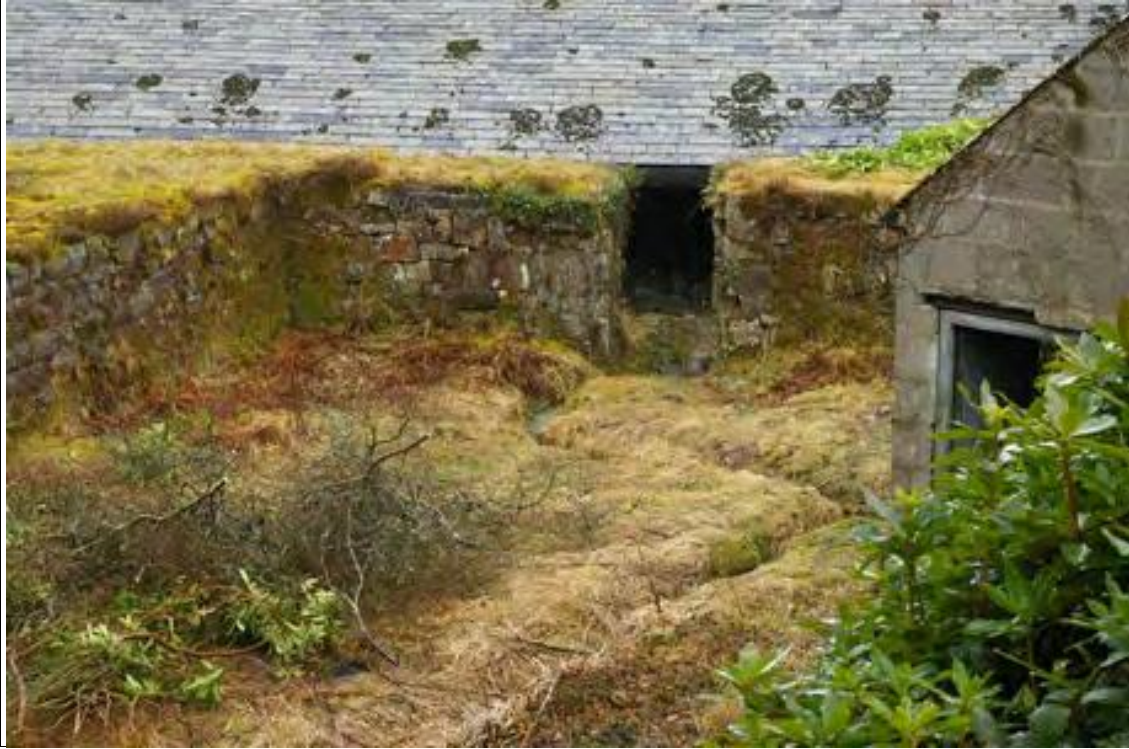
Figure 21.

CAPTION: The settling tank, interior south and east walls, viewed from the north-west.

CONDITION 2013: See above, although the walls are generally sound. Vegetation needs clearing and water either rerouting or channelling.

SIGNIFICANCE: Of moderate to high significance. Located within the Scheduled area and closely associated with the mica dry (17) with its partner tank (20), however the condition of this tank requires improvement.

RECOMMENDATION 1999: *Maintain using traditional materials and techniques. Consider options which would allow public access.*

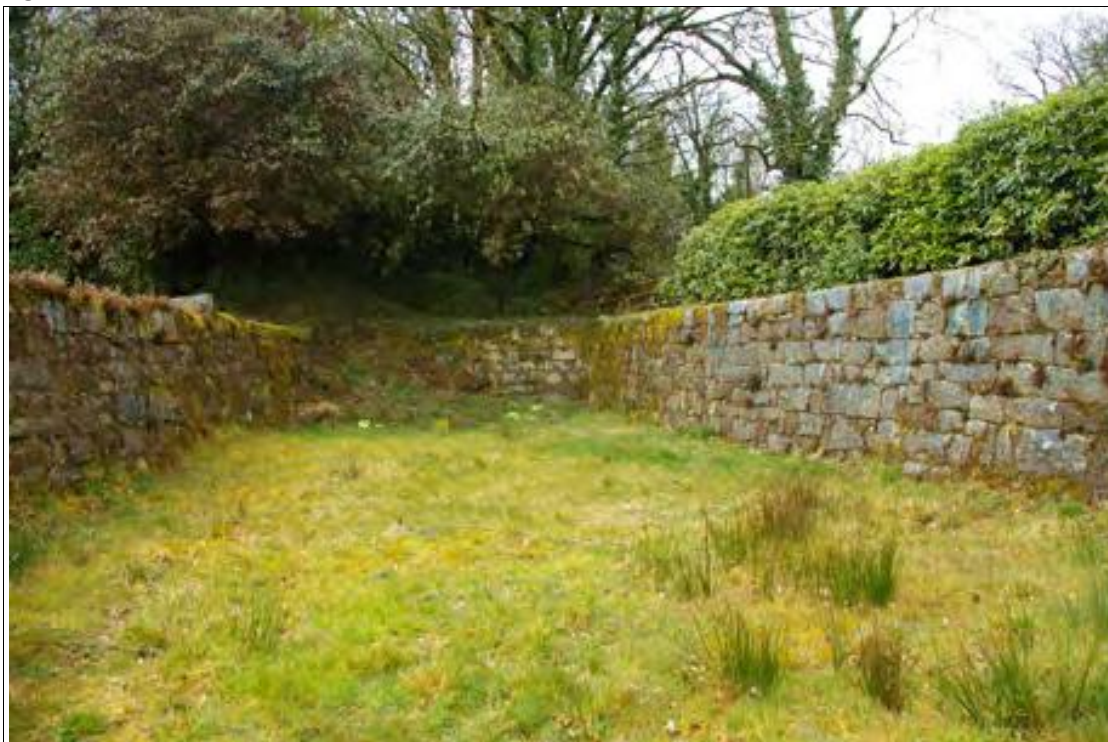
**Figure 22.**

CAPTION: The settling tank (20), viewed from the south.

DESCRIPTION 1999: *One of a pair of settling tanks serving the Mica Dry (17). Trapezoidal in plan, granite-built, and with a single hatch door facing the kiln. Cleared of vegetation and in good condition.*RECOMMENDATION 1999: *Maintain using traditional materials and techniques. Consider options which would allow public access.*

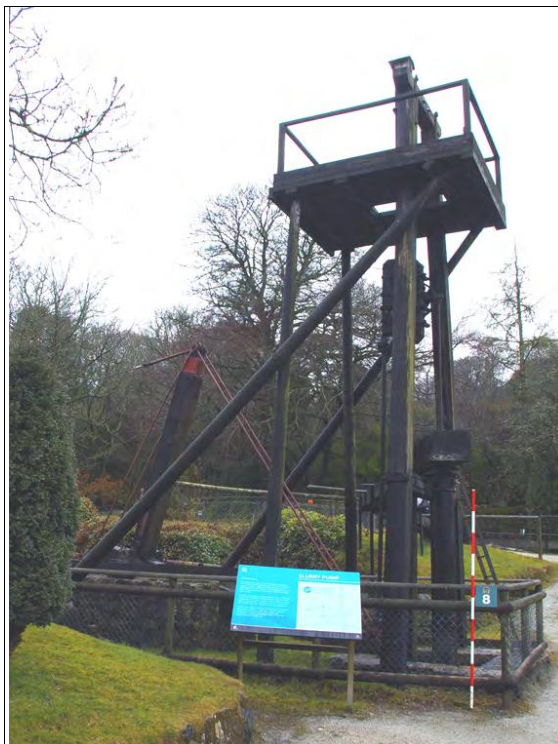
**Figure 53.**

CAPTION: The slurry pump (57), viewed from the south-east.

SIGNIFICANCE 2013: Of high significance as a distinctive mechanised feature of the site, within the scheduled area.
