## **Devon County Council Historic Environment Record**

| Civil Parish & District:<br>Instow, North Devon | National Grid Reference<br>SS 4797 3097 | | Number: | |
|--|---|--|---|--|
| Subject: A pipe trench excavation for drainage improvements and repair of the south Transept of St John's Church, Instow. Photo attached? YES | | | | |
| Contractor's reference number/code: ISJ13 | | Dates fieldwork undertaken: 4 <sup>th</sup> & 8 <sup>th</sup> October 2013 | | |

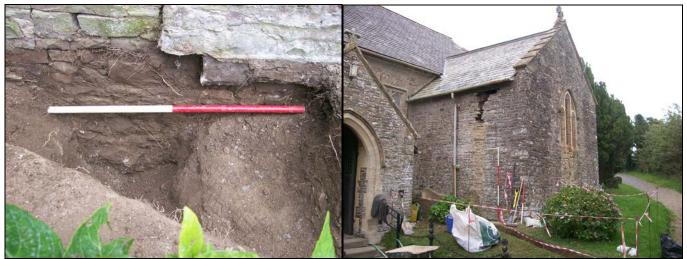
A meter wide inspection pit was excavated below the crack in the exterior of the west wall of the south transept (see Figures 1, 2, 5). The crack was proven not to extend into the foundation, which were in-situ. Therefore the crack is the result of the wall coming away at its top as opposed to subsidence at the foundations. The crack appears to follow the line of an old repair or extension to the south end of the south transept wall, evident in the wall being slightly wider at this point, or at least not flush, particularly noticeable in the footings (Figure 2).

Figure 1: Footings immediately beneath repair, viewed from the west (1m scale).

Figure 2: South transept; showing crack, repair and pipe trench, viewed from the south-west (2m scale)

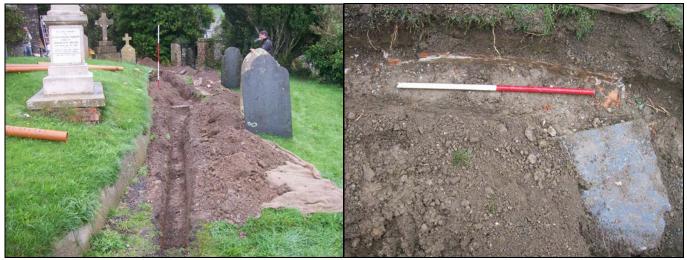
The pipe trench was 0.30m wide and at least 0.30m deep along its entire length (see Figures 3, 5). The stratigraphy revealed was; Topsoil (100), 0.16m thick, a mid brown-grey, friable sandy-silt; Subsoil (101), variable depth, a mid yellow-grey brown, friable sandy-silt with frequent grit and small sub-angular to sub-rounded stones, occasional slate, charcoal and bone fragments; Natural was made up of a shillet rock seen in the field north of the church and at one point (in the south-east corner of the pipe trench) only 0.45m below present ground level.

Two graves were revealed half way along the southern part of the pipe trench, aligned east-west (see Figures 4, 5). The earlier grave was brick lined, the bricks being 0.22×0.11×0.07m and hand-made. It was bonded with lime mortar and its interior was rendered with mortar. Its walls were straight at the head end but slightly curved along its length. These graves are generally sealed and reused. This one had been backfilled and cut by a grave of the same construction style, although with straight sides. The later grave was still sealed by slate slabs bonded with mortar, although removal of a loose slab revealed the grave to be hollow and intact. The pipe trench was diverted to skirt around the south of this grave and cut the backfill of the earlier grave. As the later grave is beneath the existing footpath about 1m of it was uncovered and reinforced lintels laid across it in case of collapse in the future. The two plans of the churchyard (from the Early 19<sup>th</sup> and Early 20<sup>th</sup> century respectively) do not show these graves, however comparable grave types such as those noted by SWARCH at Kentisbury church, Devon, were used up unto at least 1901, although the bricks and mortar would seem to indicate an 18<sup>th</sup>-19<sup>th</sup> century date.

Figure 3: South part of pipe trench, viewed from the west (2m scale).

Figure 4: Graves revealed in pipe trench, viewed from the north (1m scale)

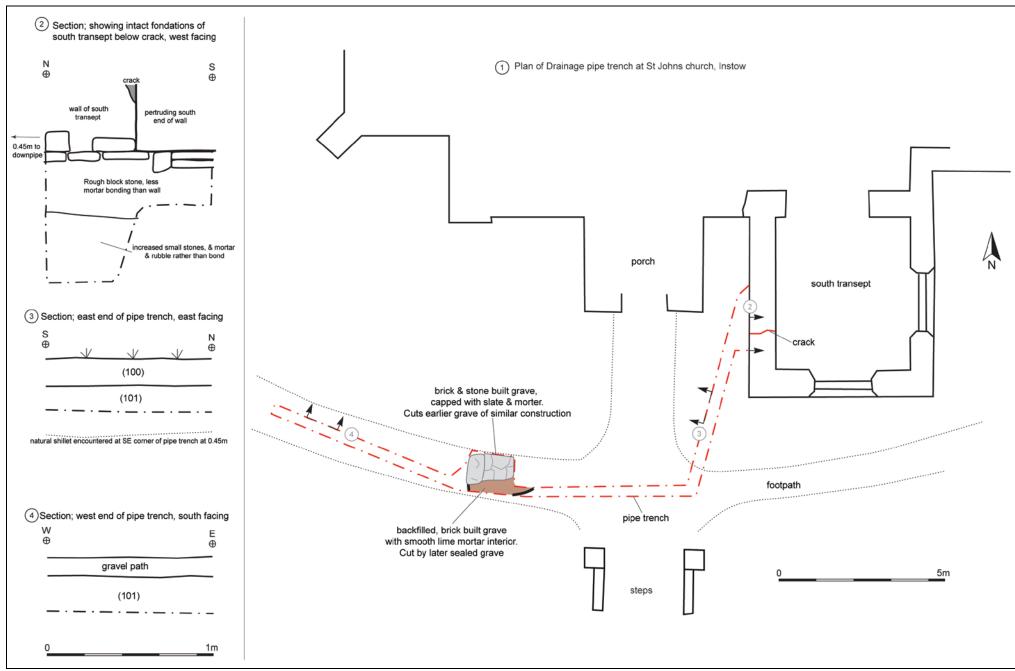
Figure 5: Site drawings; Plan and sections. Section drawing numbers (2-4) correspond to grey-scale numbers on plan (1).
