HOAR OAK COTTAGE LYNTON & LYNMOUTH DEVON

Results of Historic Building Recording
&
Archaeological Monitoring

Report No.: 130815
Date: 15.08.2013
Authors: Dr B Morris
T Green

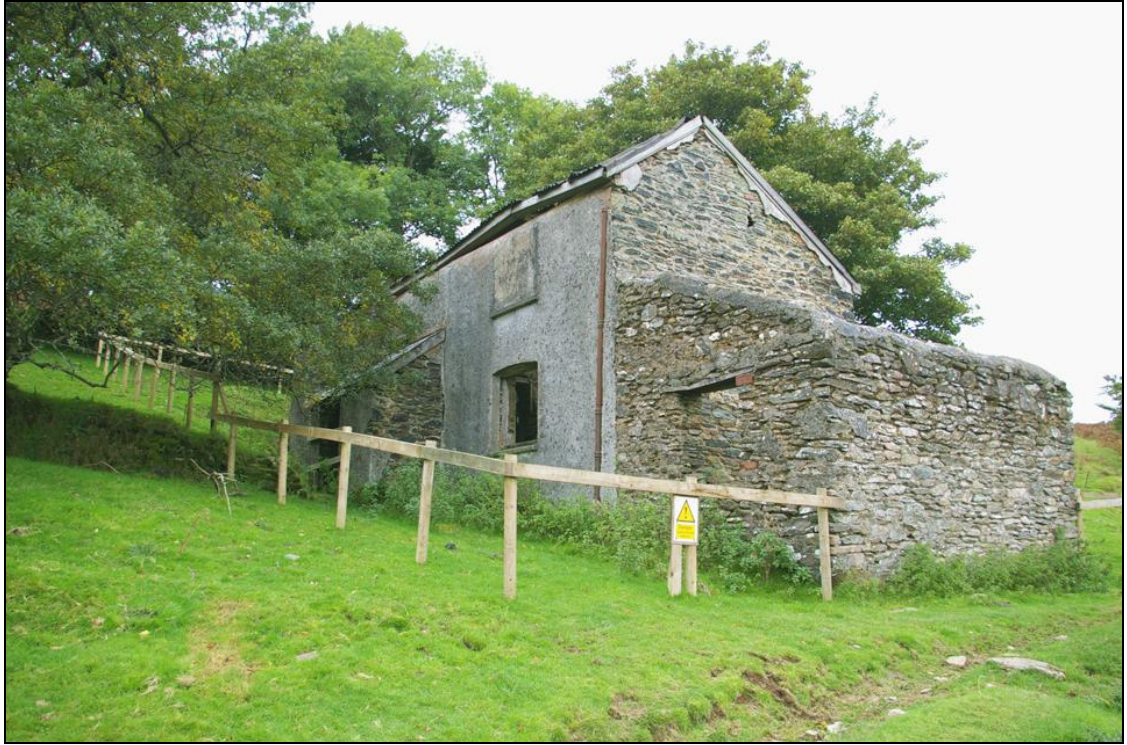
Figure 6: The cottage, viewed from the south-east, prior to works starting.

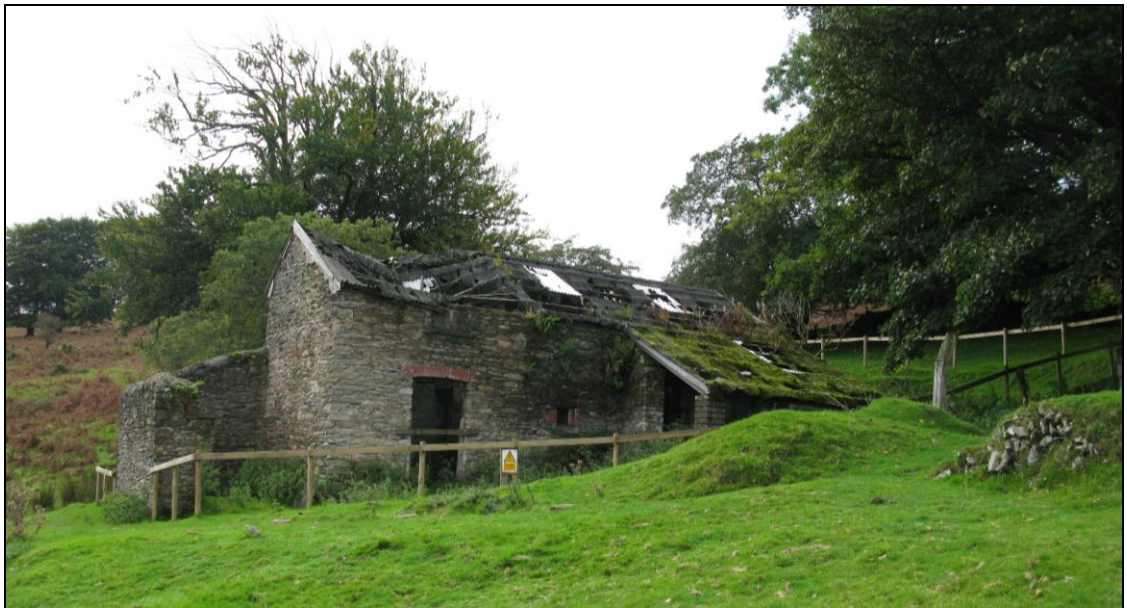
Figure 7: Hoar Oak Cottage, viewed from the north-east, prior to works starting.

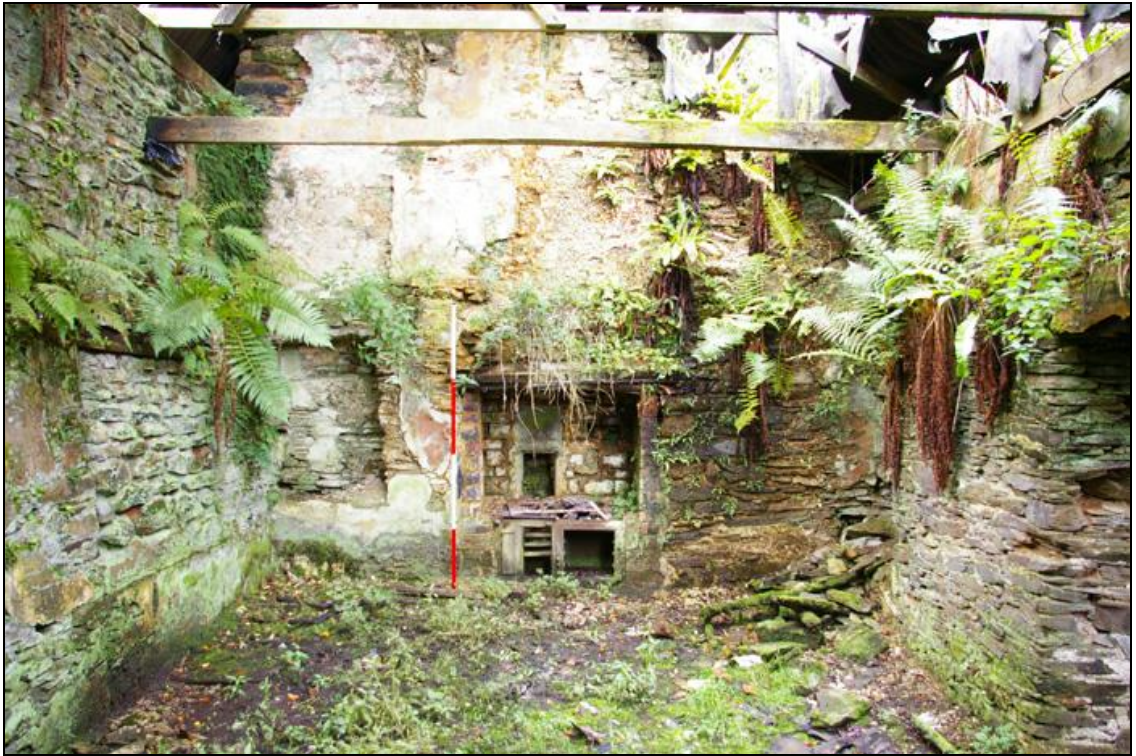
Figure 15: The interior of Hoar Oak Cottage (R1), viewed from the east (scale 2m).

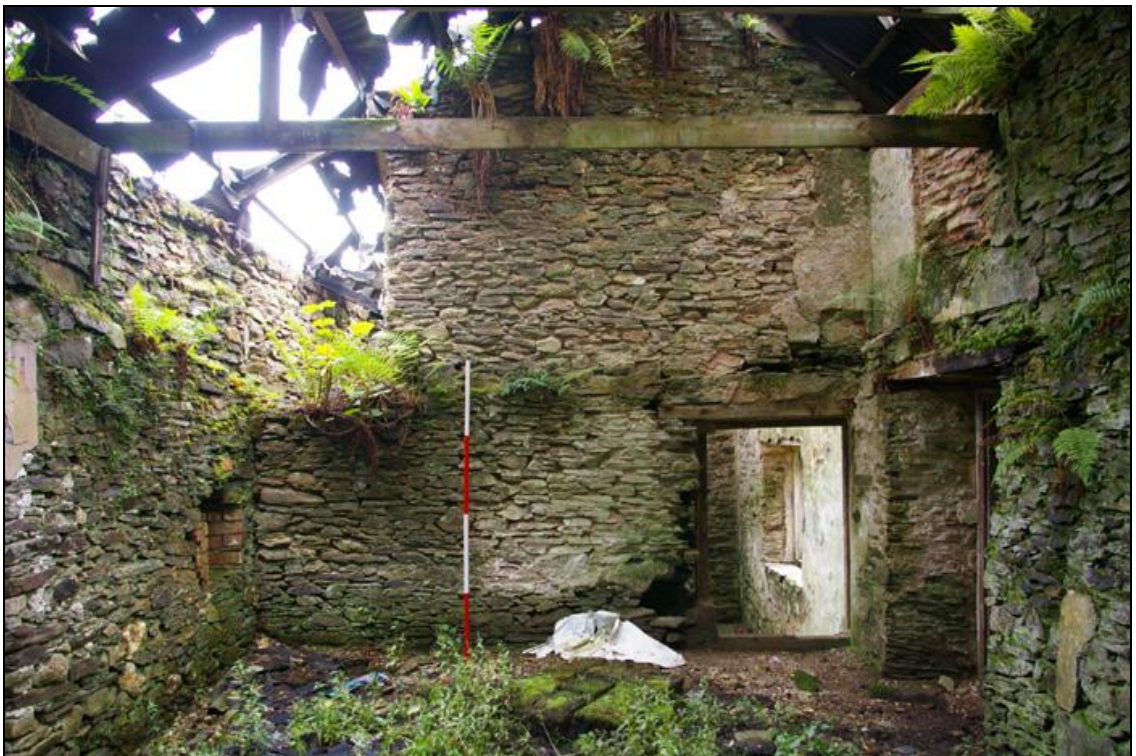
Figure 16: The interior of Hoar Oak Cottage (R1), viewed from the west (scale 2m).

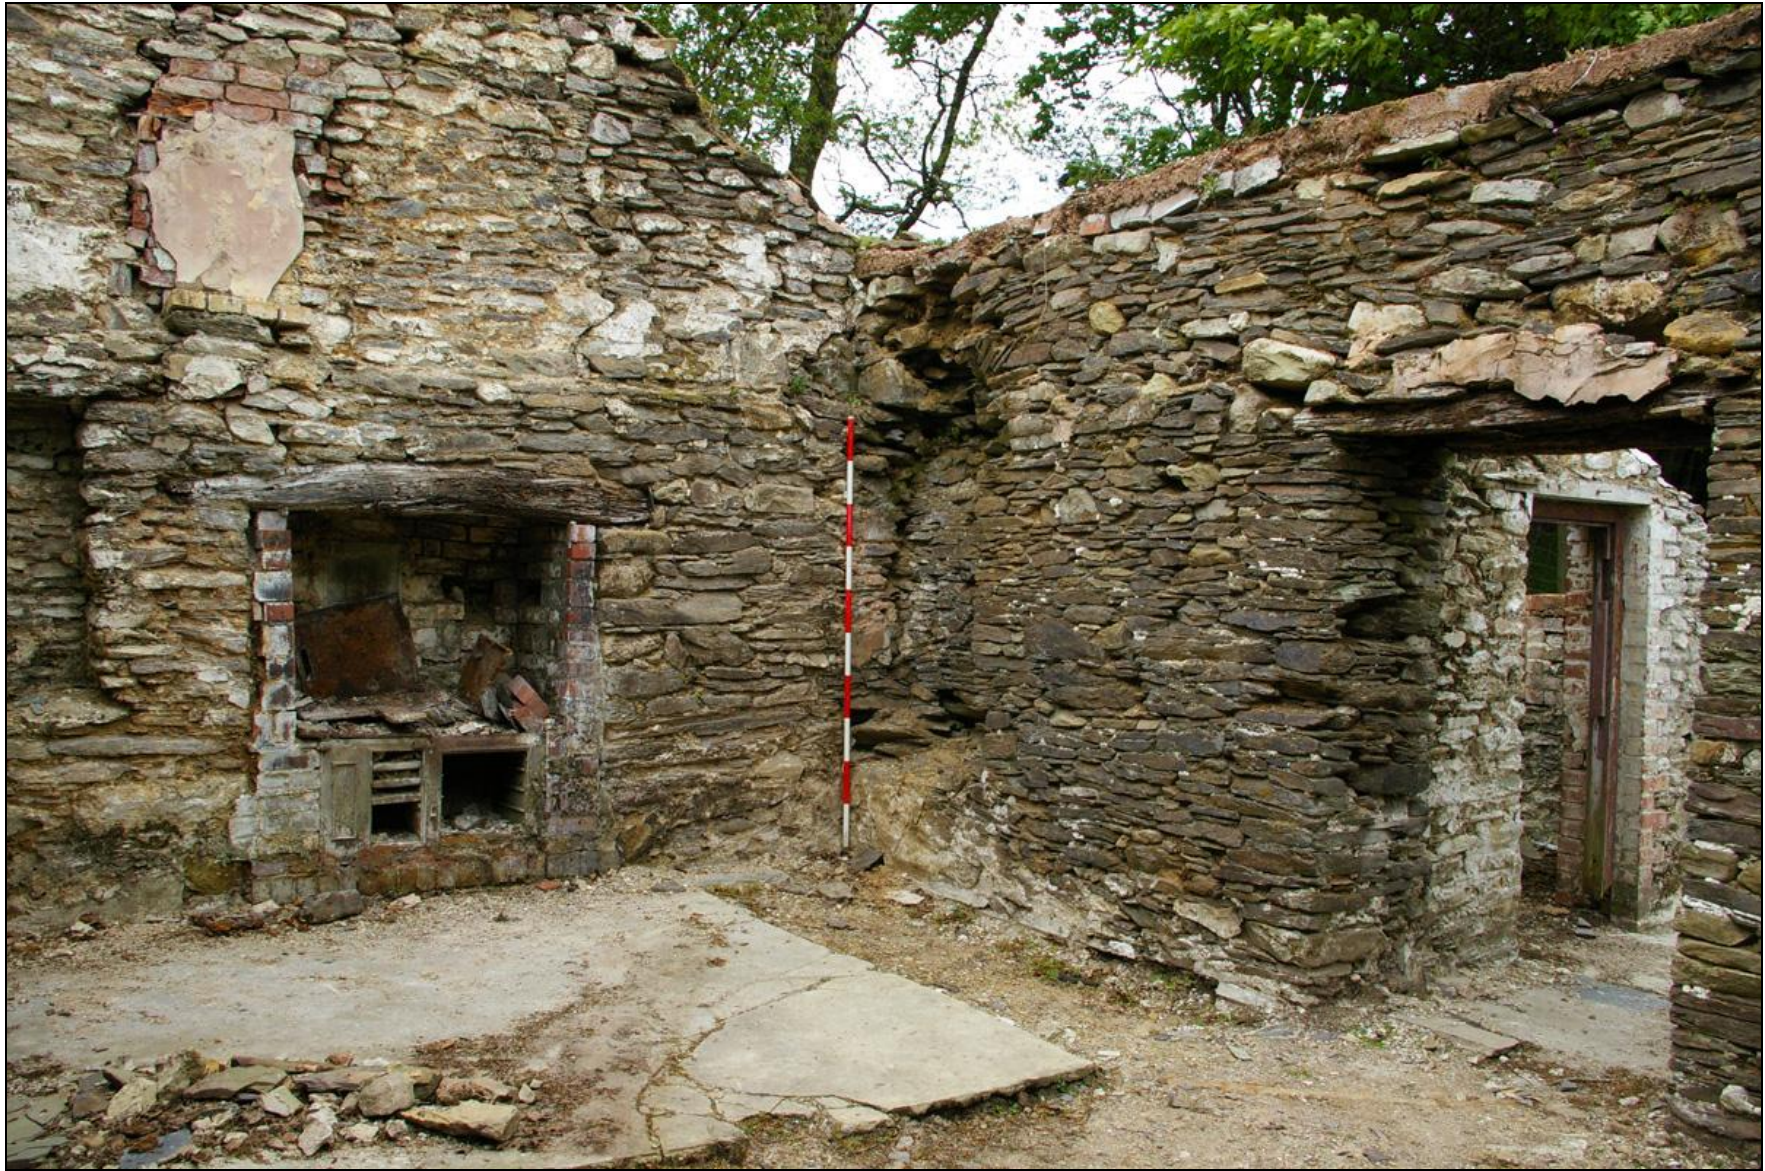
Figure 23: Room 1, north-west angle (scale 2m).

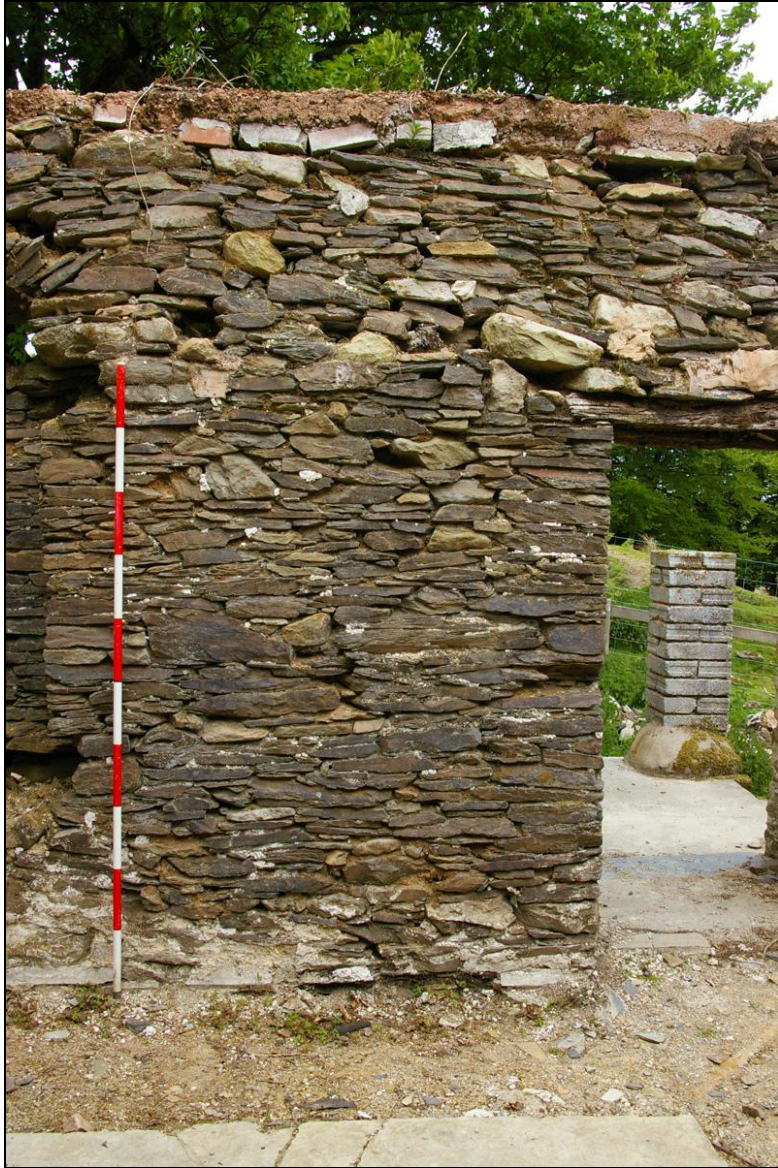
Figure 24: Room 1, north elevation, western end, showing the clear difference between the Phase 1 (lower) and Phase 2 (upper) stonework (scale 2m).

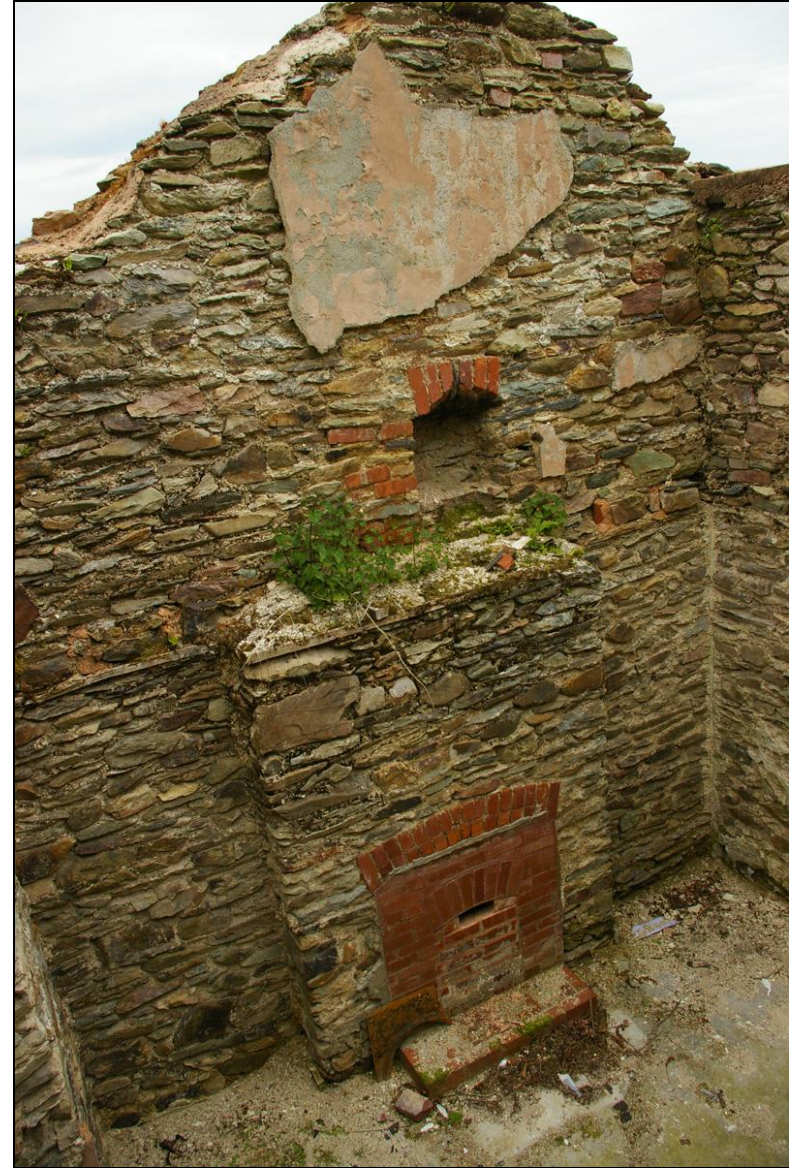
Figure 25: Room 2, from above, showing the fireplaces in the eastern gable (scale 2m).

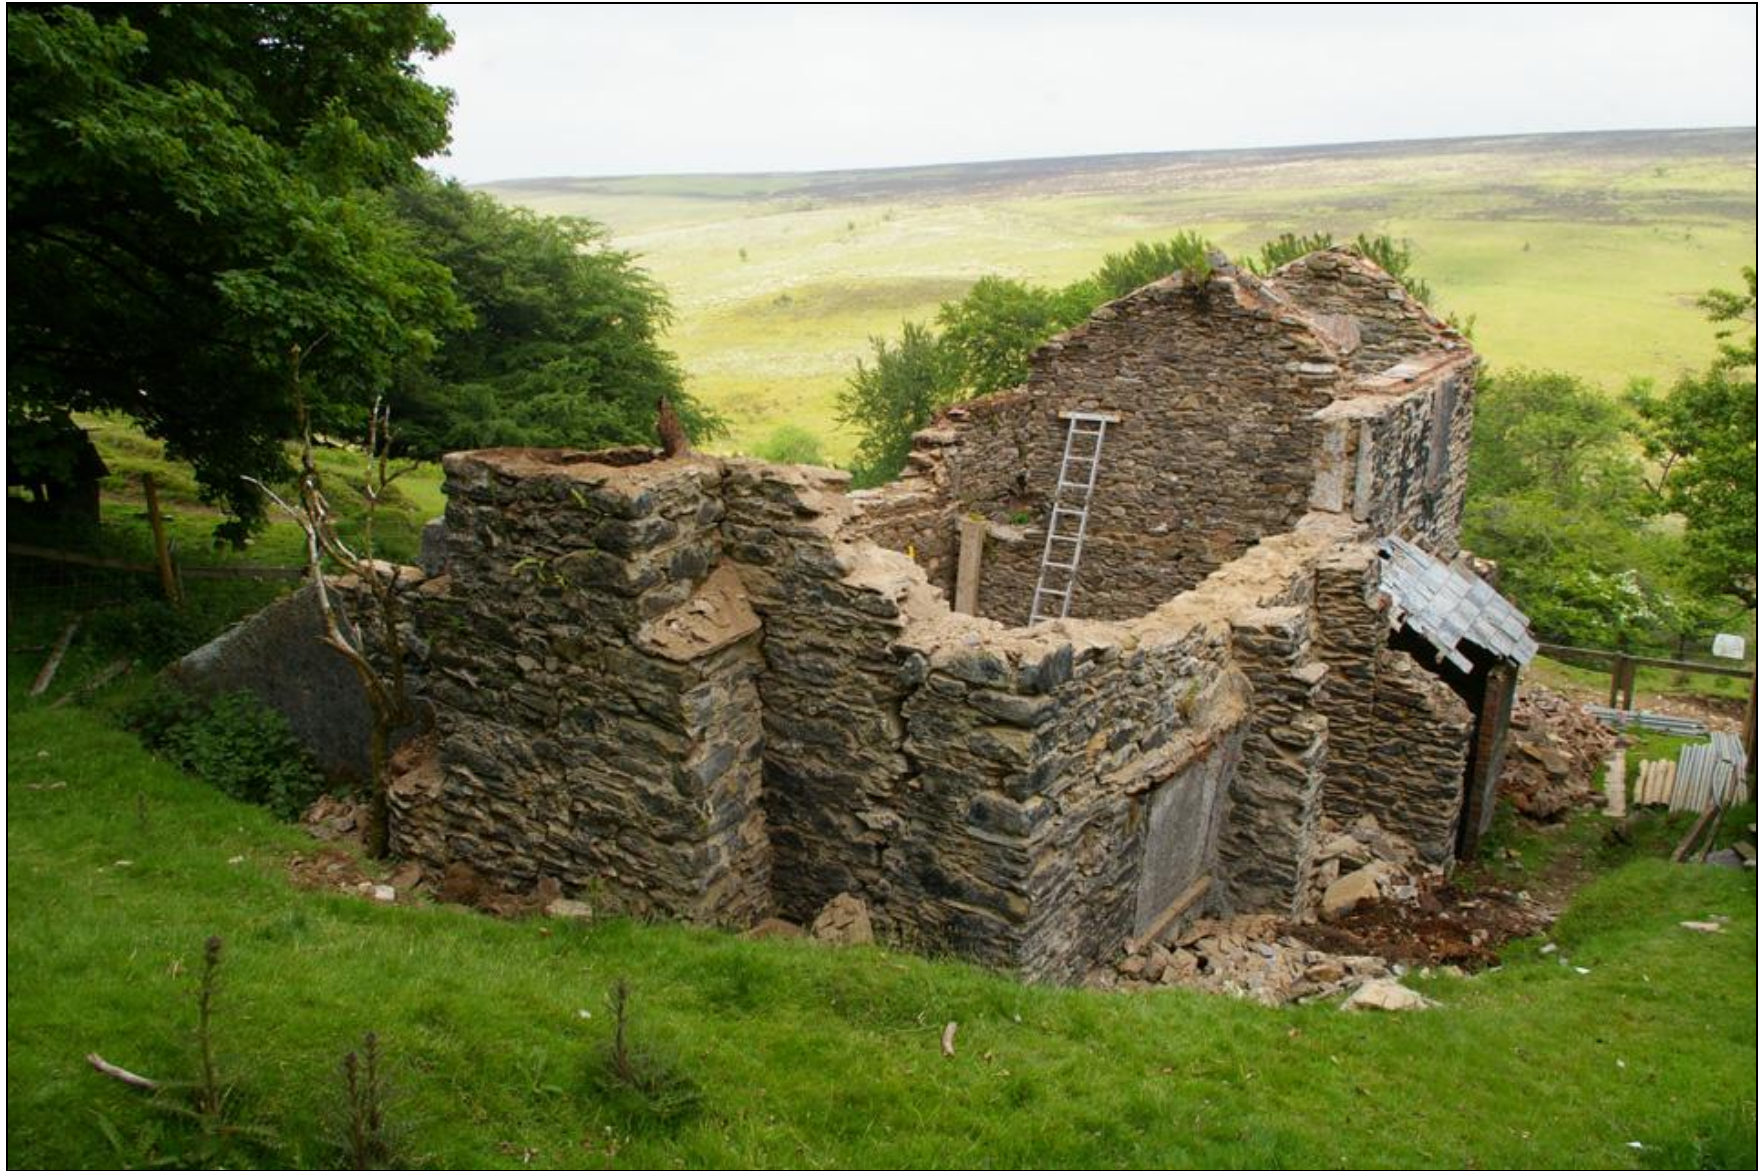
By 2010, the structure had deteriorated further; the Onduline roof had failed and some of the walls had become unsafe. The ENPA took the decision to remove the roof, clear the detritus and reduce and repair the walls. This work was undertaken in 2013.

Figure 26: Hoar Oak Cottage, following the reduction of unstable masonry; viewed from the south-west.
