# COOMBE FARM BRIXTON DEVON

Results of Historic Building Recording  
& Dendrochronological Analysis

Report No.: 140227  
Date: 27.02.14  
Authors: B. Morris  
C. Humphreys  
E. Wapshott

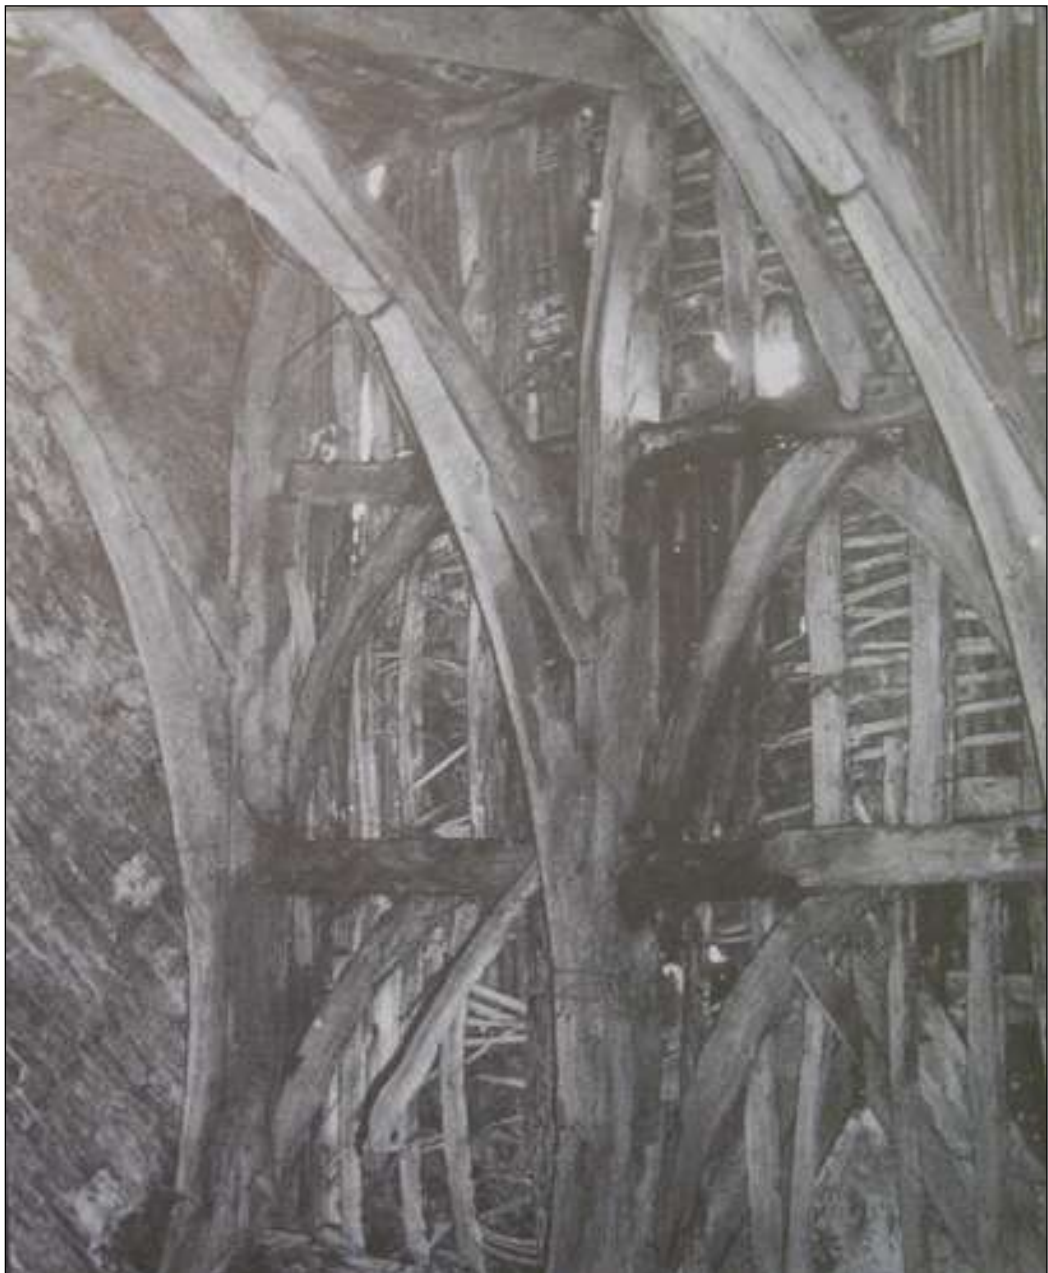
Figure 18: The original roof of the Great Barn, the western truss-blades at the southern end, viewed from below and to the north-east. This photo was published in Langdon (1995), and shows the 15<sup>th</sup> century arch-braced roof was in a poor state of repair by the early-mid 20<sup>th</sup> century.

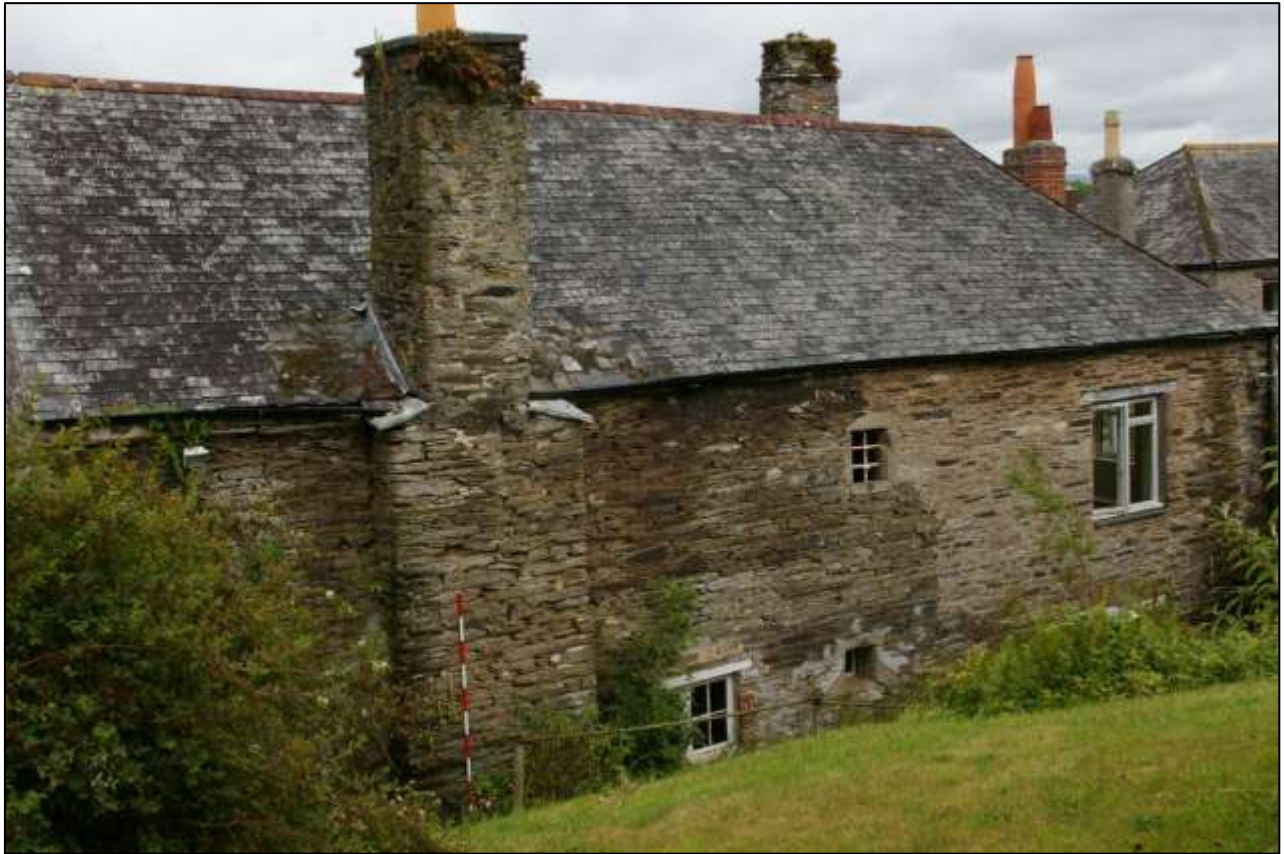
A coursed rubble and partly-dressed slate-stone elevation under a recent slate roof, the eastern part has been rebuilt in the 19<sup>th</sup> century. There is a large structural crack at the eastern end of the elevation, running from ground to eaves height; this appears to mark the eastern side of the rebuilt section. To the west, the change of build is less obvious, but appears to incorporate a vertical joint.

Figure 58: The south-facing elevation of the 15<sup>th</sup> century block; viewed from the south-west, looking north-east (scale 2m).

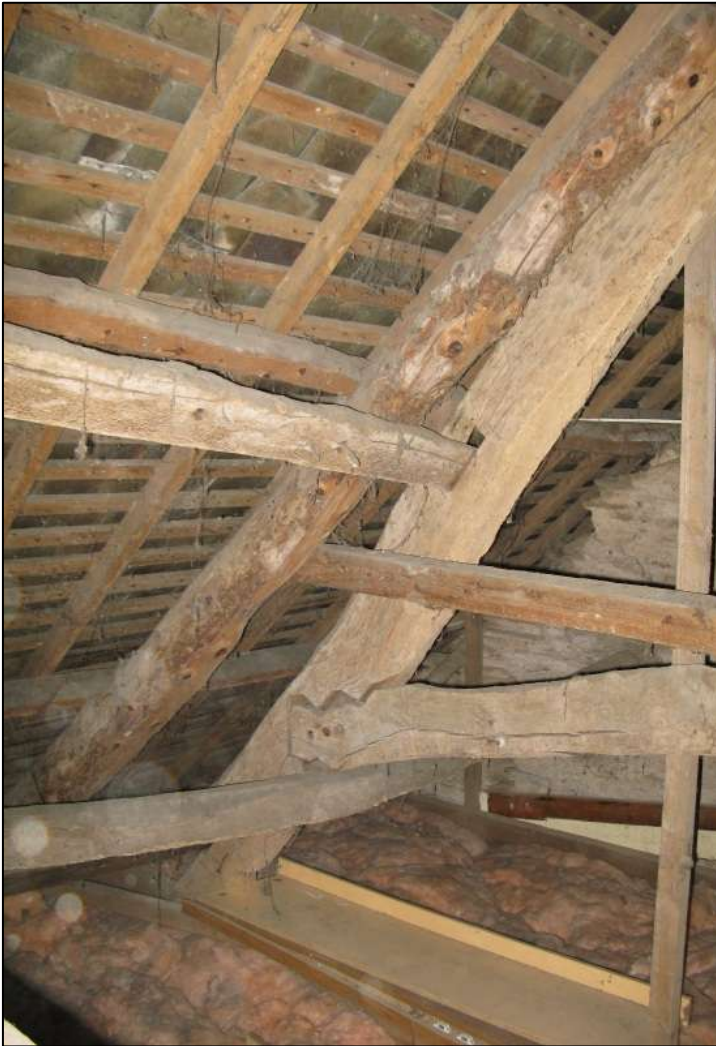
Figure 77: Detail of failing Truss H; viewed from the north-west.
