BRYNN MILL ROCHE CORNWALL

**Desk-Based Assessment &
Historic Building Recording**

Report No.: 140422
Date: 22.04.14
Authors: Martin Watts

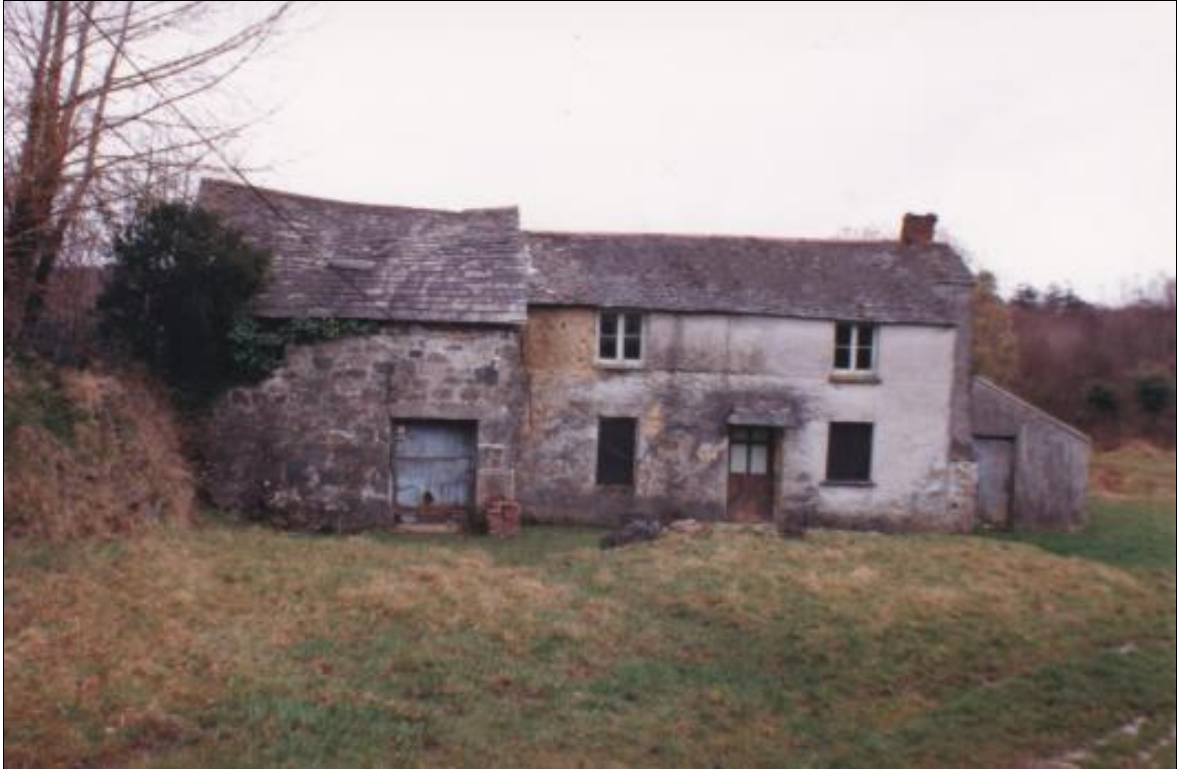
Figure 6: South-west elevation of the Cottage and Mill in 1988.

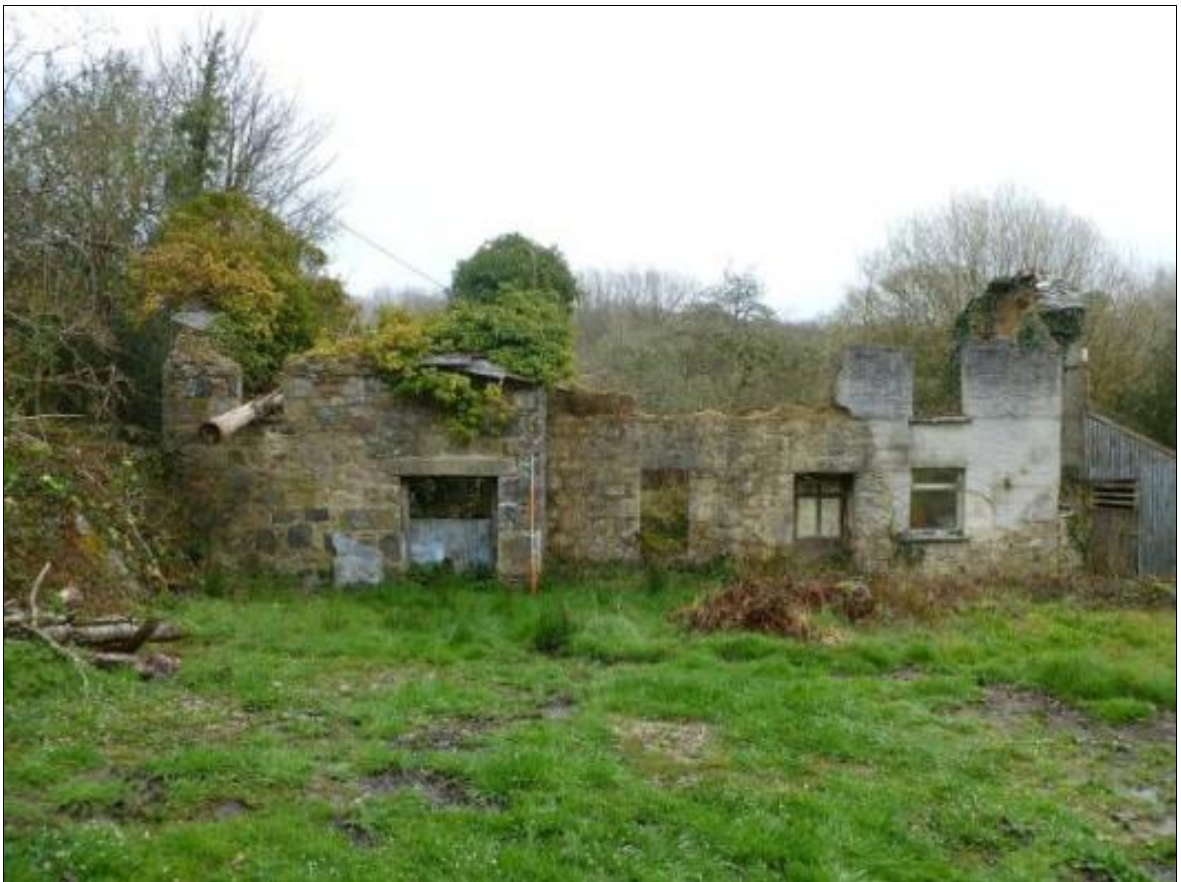
The south-west elevation is of rubble stonework with two openings: with a wide ground-floor stable door in a timber frame under a granite lintel and a small first-floor window. The door opening has dressed quoins, including a granite stone with a domed back to the right of the door. This appears to be reused and its shape suggests it may have been cut from a millstone blank. The first floor window opening has a slate cill, but the window frame has gone and there is a tree lying through the opening.

Figure 7: South-west elevation of the Cottage and Mill in 2014.

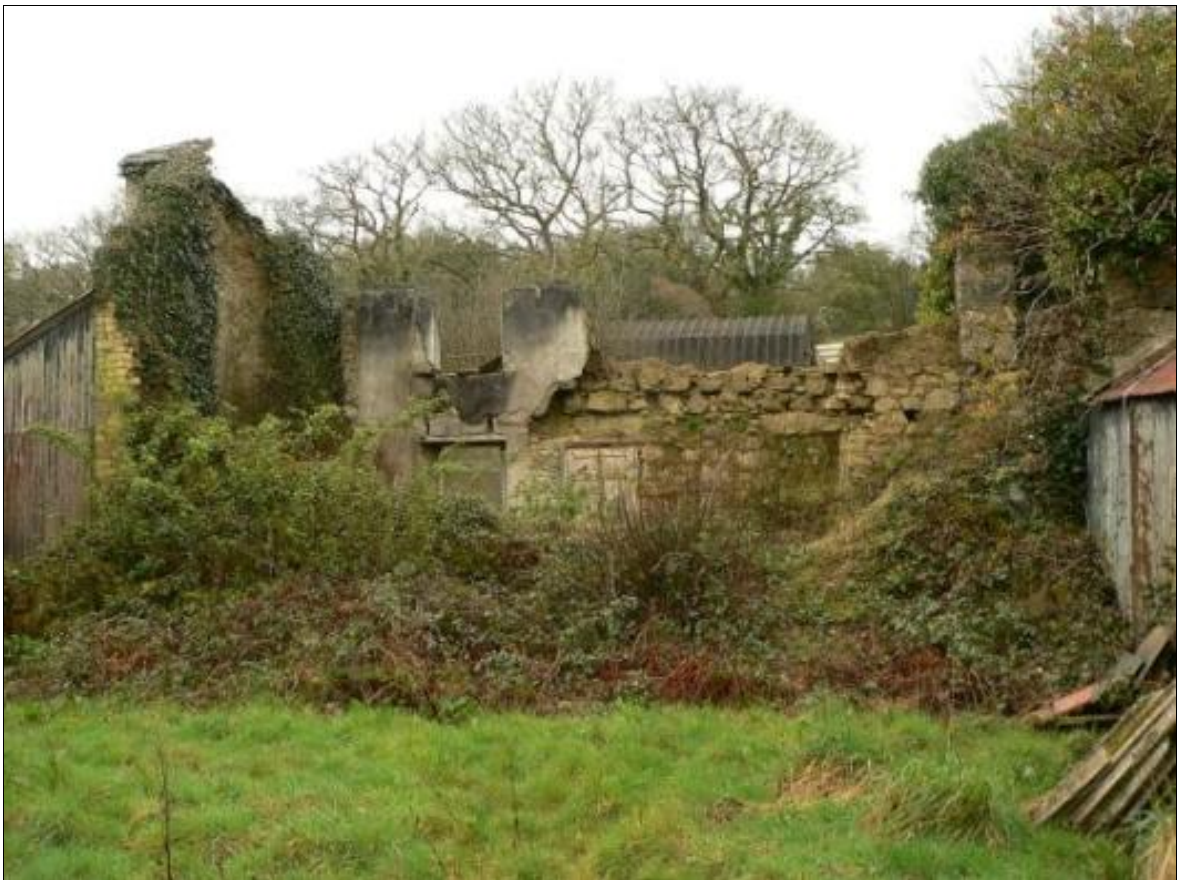
The north-east elevation of the mill is largely obscured by ivy and the corrugated iron shed which extends to the east. Within the shed the mill wall can be seen to be of rubble stone with a doorway under a granite lintel and single leaf vertically-planked timber door. This door opened outwards, into the shed, and as the opening has splayed reveals internally; it appears to have been a window opening subsequently enlarged for a door. The 1980s survey drawings show a first floor window in this wall, but this is no longer visible.

Figure 9: North-east elevation of the Cottage and Mill in 2014.

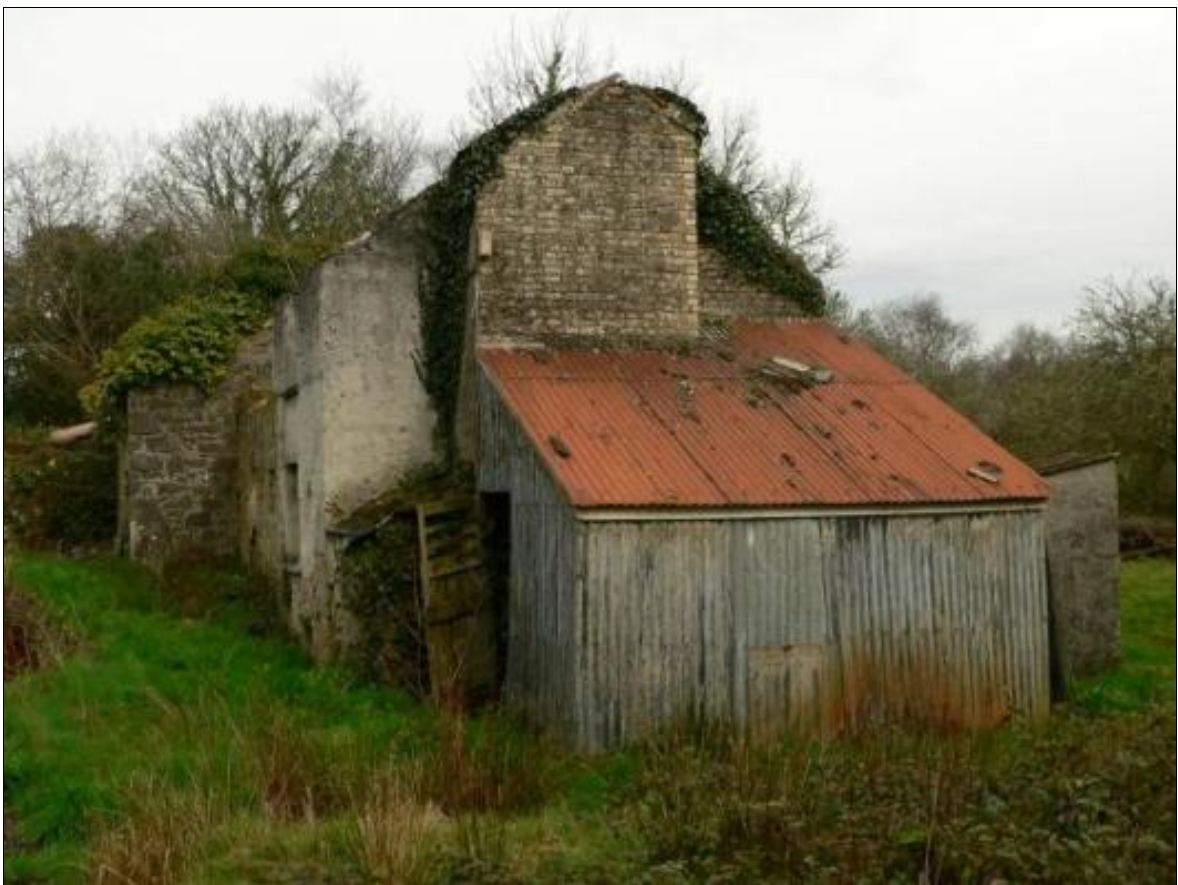
Figure 11: South-east gable elevation of the Cottage in 2014.

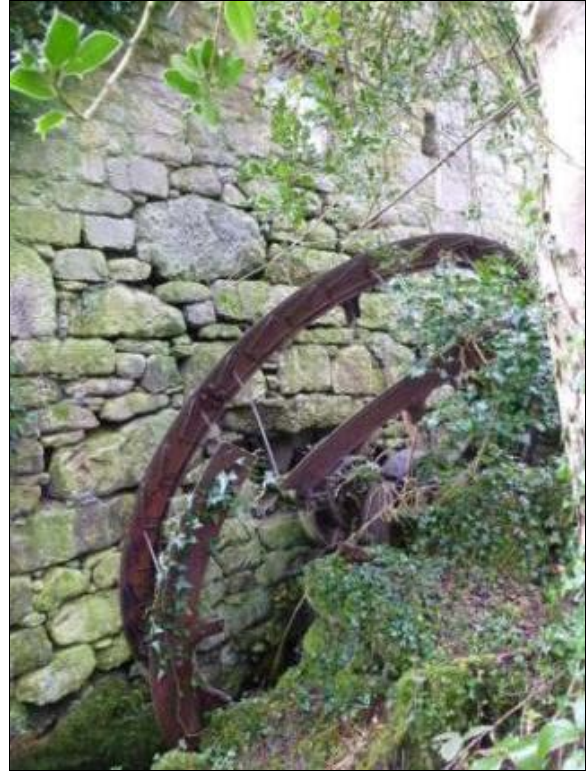
Figure 13: [right] The waterwheel in 2014.

The waterwheel was overshot and would have been fed from a timber launder that projected beyond the masonry wall at the upstream end of the wheelpit. Only the cast-iron shrouds of the waterwheel remain, leaning at a precarious angle to the north. The outer shroud ring is broken at one point and has a short section missing, but otherwise the castings appear intact. The shroud castings carry the embossed inscription OATEY. & C^o WADEBRIDGE in a bold sans serif face (see above). The wheel was about 3.7m overall diameter by 0.75m overall width. The shrouds, which form the rings of the wheel, are made up of six sections each side, the sections being joined end to end midway between the arm positions with a cover plate and four bolts. The number 6 is cast on the cover plates and shrouds. There would have been two sets of six timber arms, all of which have rotted away, as have the timber buckets and sole boards. The shroud sections having integrally cast flanges to locate the bucket and sole boards and there are three cross-tie rods between each pair of sections. There would have been 42 buckets, each formed of two boards, and sole boards, the ends of which were located between two flanges around the inner circumference of the shrouds. The timber arms were bolted to projecting plates cast integrally with the shrouds and their inner ends were housed and bolted into pockets in heavy cast-iron centres or naves. The naves are about 0.76m in diameter and were wedged onto the timber wheelshaft, of which some decayed vestiges remain. The outer end of the wheelshaft has a cast-iron cross-tail gudgeon and two gudgeon rings. Its journal (bearing) ran in a bronze bearing set in a granite block. This appears to be still in place on the pit wall, but is now obscured by overgrowth.

The heritage value of Brynn Mill has been much diminished by the treatment of the site over the last 25 years or so, with the introduction of a number of large caravans and improvised shelters at the expense of maintaining the original buildings on the site. The loss of the roofs and upper floors of the mill and adjoining cottage has resulted in the almost complete reduction of these buildings to ground floor level. The walls of the mill still stand to eaves level and it would appear feasible to repair, rebuild and re-roof the mill and cottage to their earlier appearance. However, while many of the iron elements of the mill machinery are likely to have survived under the rubble and debris, it is considered that the remains of the working parts of Brynn Mill are now so decayed and fragmented as to be beyond any meaningful historical or economic restoration. The cast-iron shrouds and naves of the waterwheel are basically intact, however, and could be salvaged.

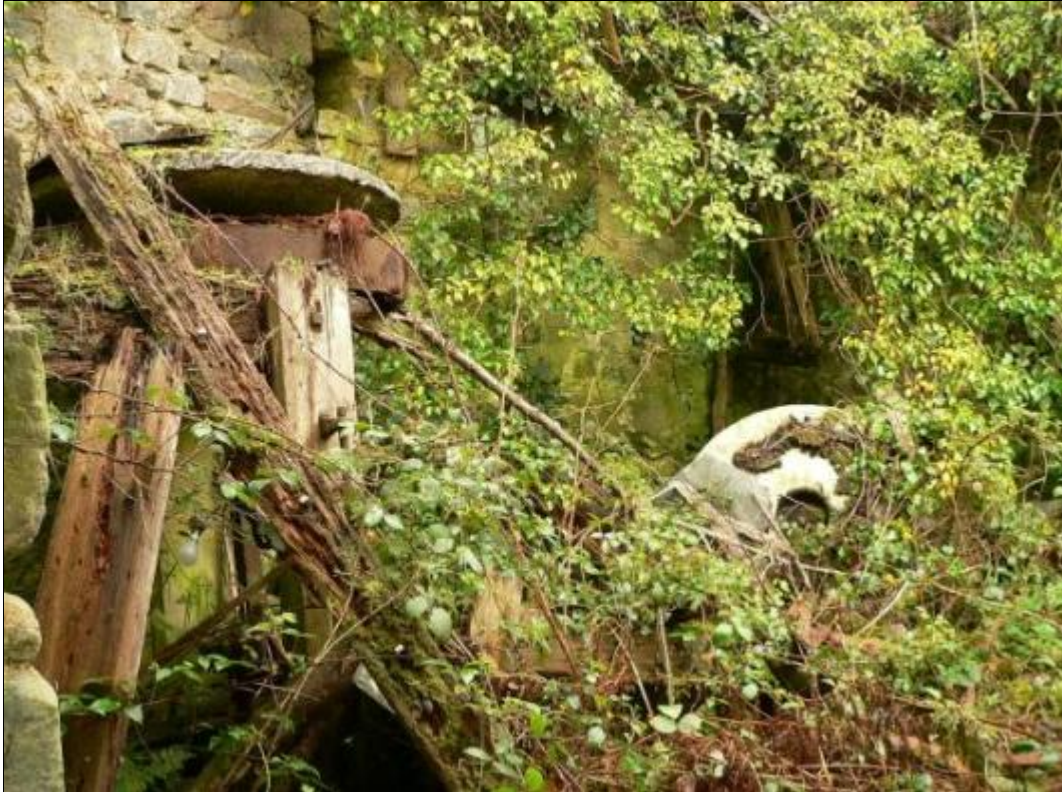
The upstream millstones are precariously balanced on the remains of the hurst, but are in about their original working position. Only a short section of the softwood front beam (bressummer) survives, to which the vertical front bridge post is notched and bolted. This post is of oak, sparingly converted from a small tree, 0.21m wide by 0.12m thick. The bridge tree, which spans horizontally between the front and rear bridge posts, carries the foot bearing of the millstone spindle. It is 0.15m wide by 0.17m deep, with a central tenon at its outer end which projects through a long mortise in the front bridge post, and to which the tentering adjuster is fixed. This is a vertical iron screw with a captive spanner. Alteration of the tentering screw adjusts the elevation of the millstone spindle, and thus the gap between the millstones whilst working, to control the texture of what is being milled. The upstream millstones consist of a worn granite runner stone with a domed back and a bedstone which has been bound with a 0.15m deep iron hoop and has a decayed plaster backing. The face of this stone was not clearly visible, but it appears to be granite. The hoop and backing appear to have been added to a worn stone to increase its working life.

Figure 17: Remains of the hurst (left) and fallen millstones, from the west.

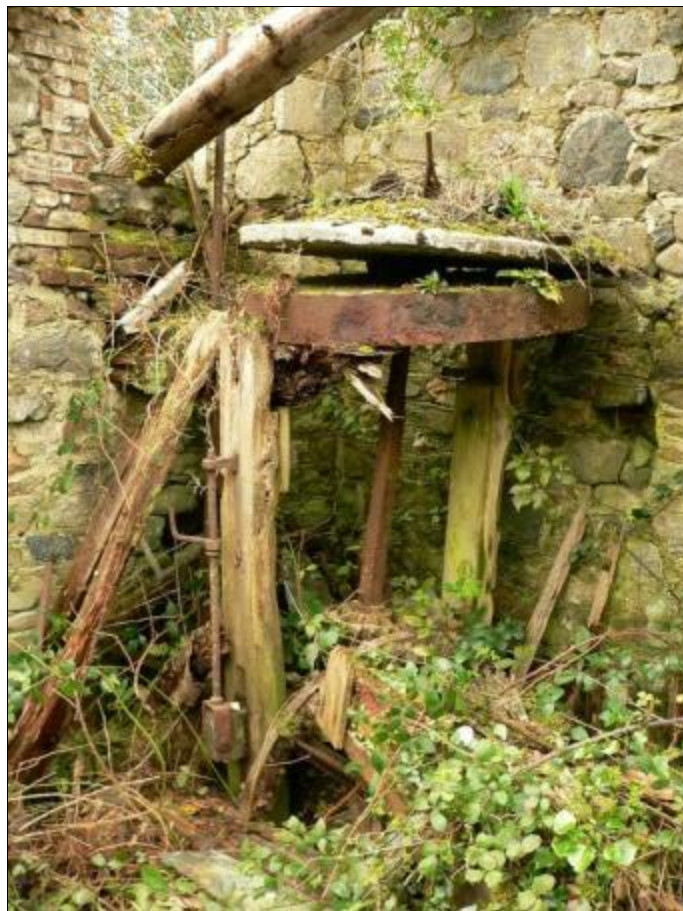
Figure 18: Remains of the hurst and upstream millstones.

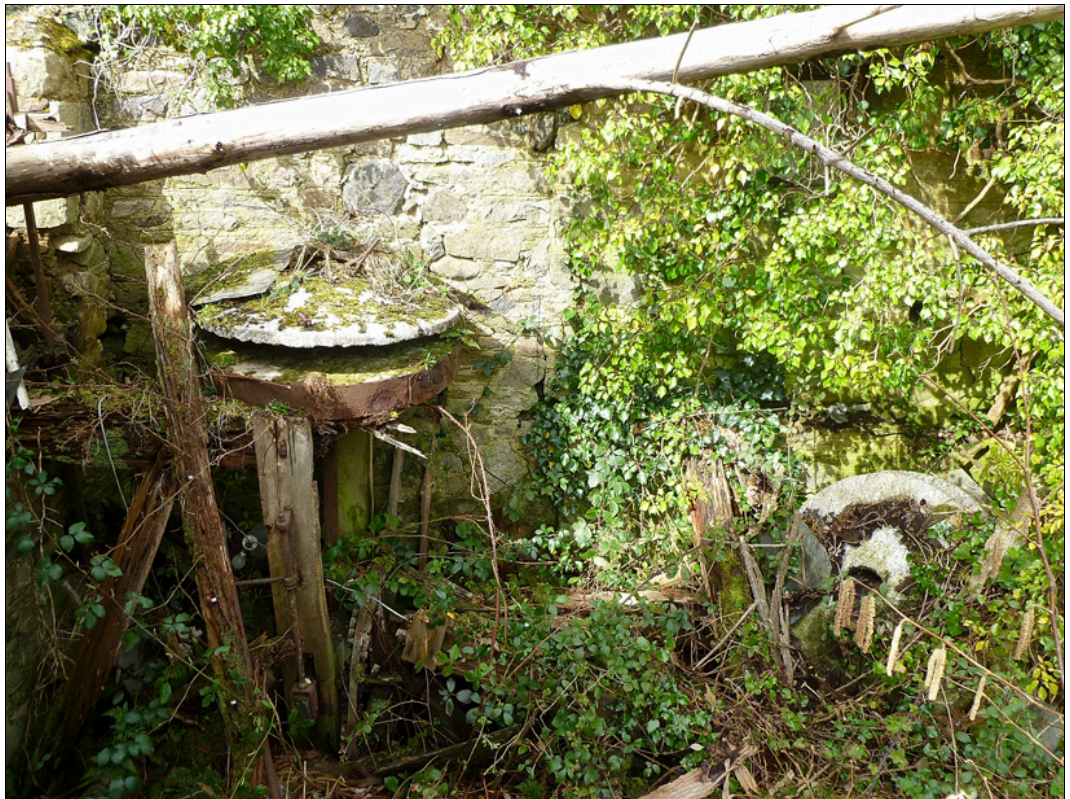
Remains of the hurst, showing the collapsed downstream millstones.

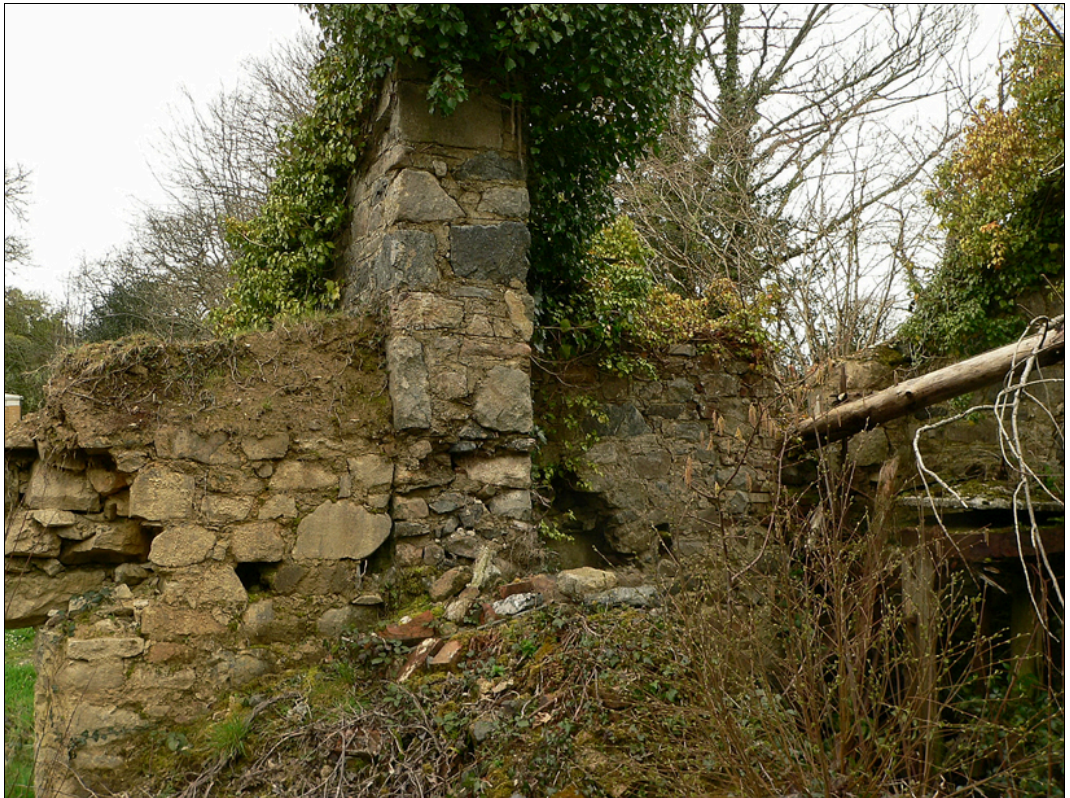
The internal dividing wall between the mill and the cottage is now reduced to a low level. Its base is of rubble stone, which appears to have originally extended up to first floor level with lighter construction above. On the western side the wall stands to eaves level, with dressed stone quoins used in the return at former first floor level. This may have formed one side of a doorway into the mill, or is simply the limit of the extension of the mill building.

The (now collapsed) partition between the Mill and the Cottage, viewed from the south-east. Note the Cottage walls about the Mill, and the probable presence of a door between the two at first-floor level.

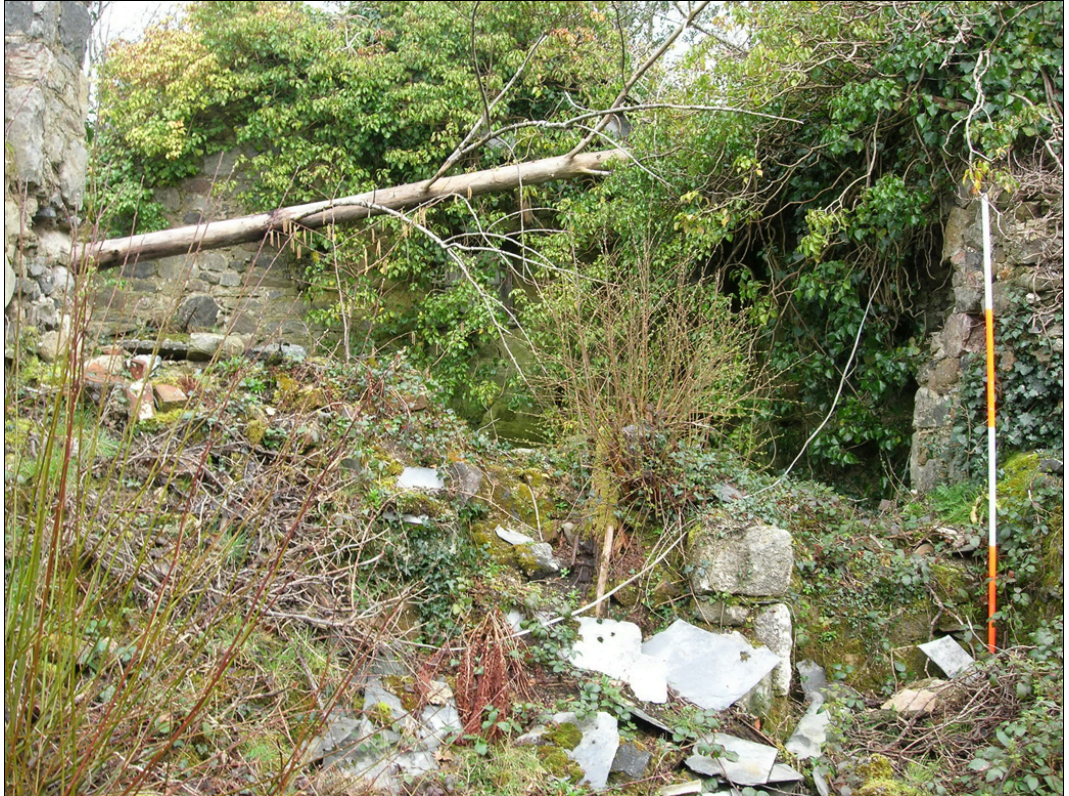
The collapsed wall between the Mill and the Cottage, viewed from the south-east.

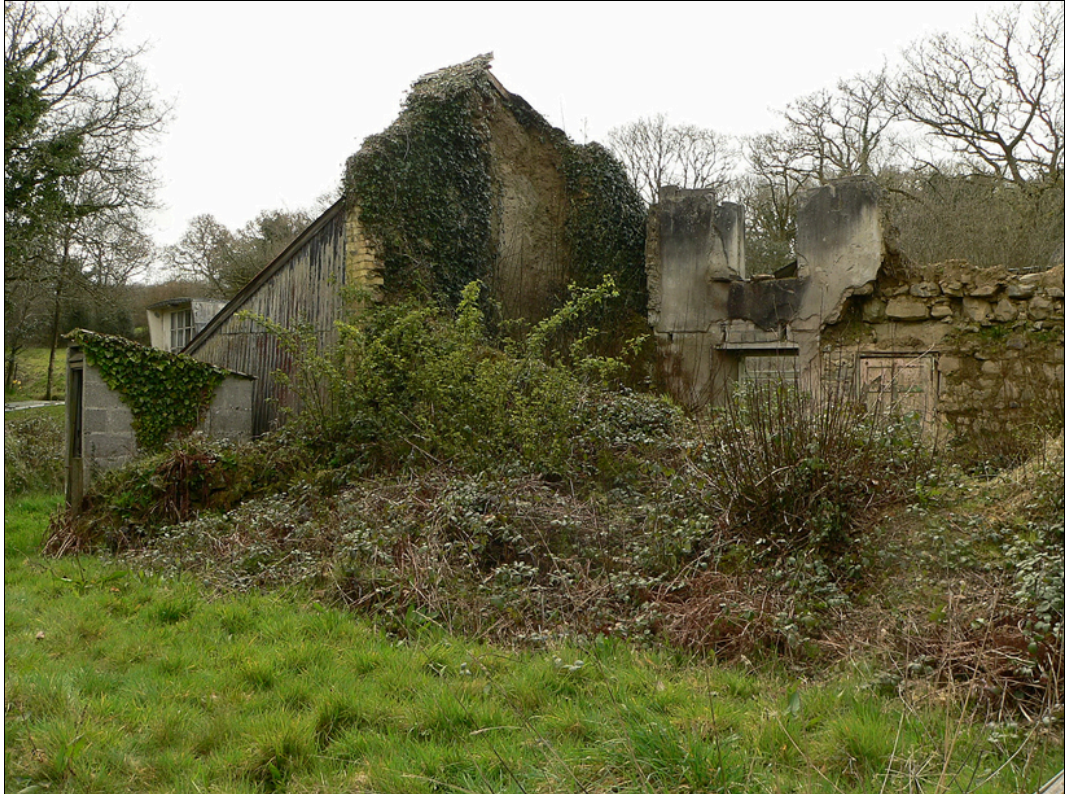
The collapsed north-east (rear) wall of the Cottage.

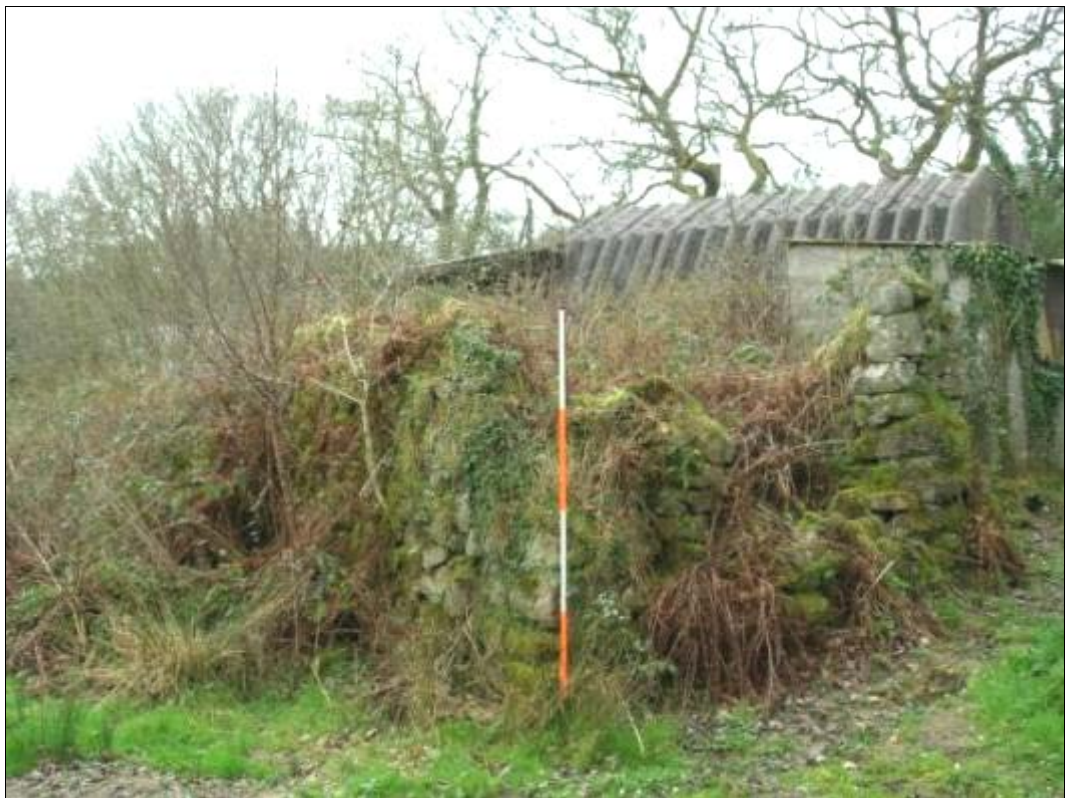
To the west of the mill and cottage are the overgrown remains of the rubble stone walls of some small outbuildings built into the slope. These were not closely investigated; they appear to have been ancillary buildings, probably for animals, forming an essential part of any smallholding. A photograph taken in 1988 shows some of these buildings in a more intact condition.

The remains of the outbuildings in 2014.

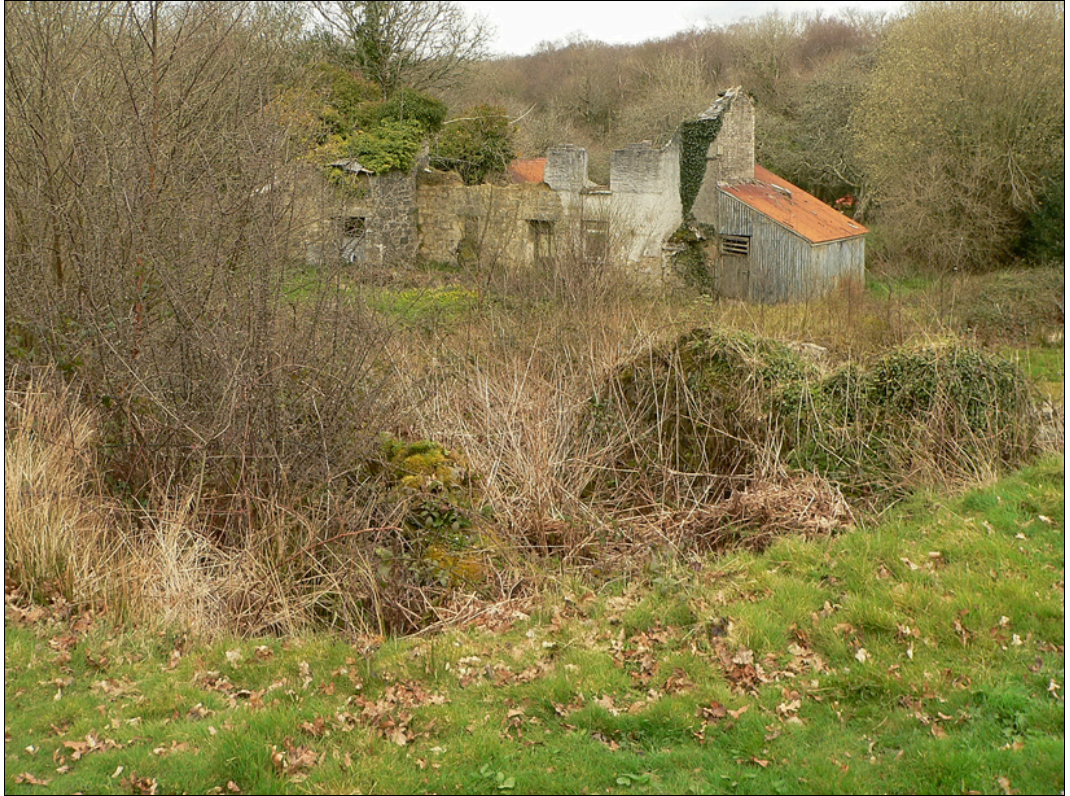
One of the collapsed outbuildings, from the south.
