## Devon County Council Historic Environment Record

<b>Civil Parish &amp; District:</b> South Brent, South Hams, Devon	National Grid Reference SX 69622 60257		Number:	
Subject: Archaeological monitoring and recording at St. Petroc's Church, SouthPhoto attached? YESBrent, DevonProvident St. Petroc's Church, South				
Planning Application no: N/A		Recipient museum: N/A		
OASIS ID: southwes1-196893		Museum Accession no: N/A		
Contractor's reference number/code: SBS16		<b>Dates fieldwork undertaken:</b> 5 <sup>th</sup> & 14 <sup>th</sup> December 2016; 11 <sup>th</sup> January 2017

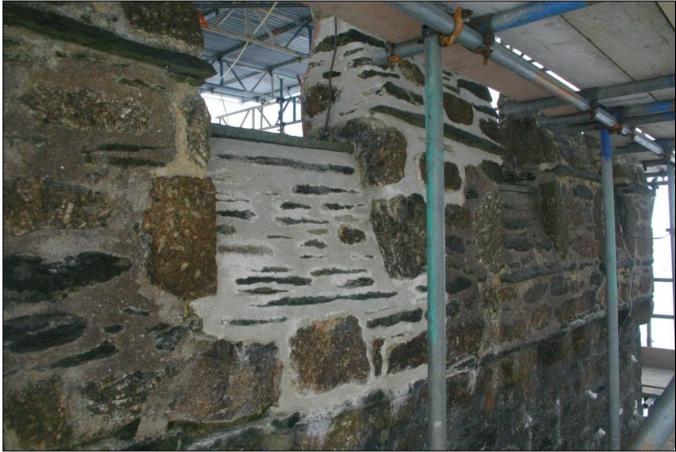
During works the top of the tower has been rebuilt, with the west and south sides and the north-east corner carefully deconstructed; each stone numbered and then replaced exactly. The heavy cement mortar was removed and repointed in a lime mix. The upper part of the merlons, rebuilt in the 19<sup>th</sup> century required restoration. The 19<sup>th</sup> century roof behind the crenellations was exposed by the works, constructed of massive pine scantling, but rotten. This was replaced like for like. The 19<sup>th</sup> century shale infill of the crenels was recreated by the builders to seal the 19<sup>th</sup> century raised roof level. The bells are supported on a 19<sup>th</sup> century iron/steel frame and the floors are all of 19<sup>th</sup> century timber. Some large, angled sockets at the upper level suggest a more complex bracing timber structure occupied this tower (a spire?) before the 19<sup>th</sup> century works, which created the present flat roof.

Figure 1: The top of the tower during consolidation works.

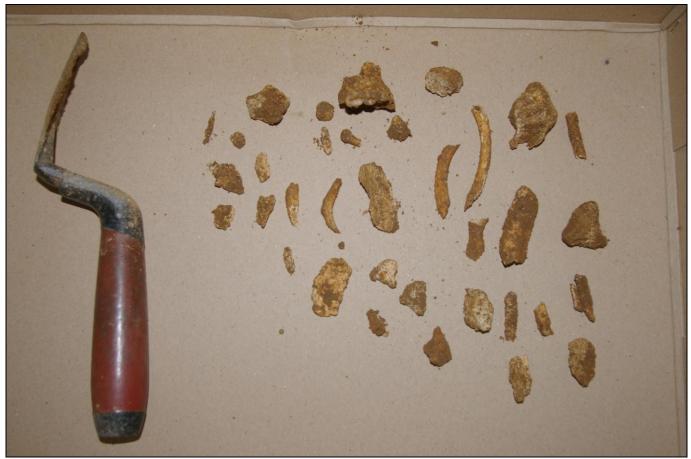
Figure 3: Fragments of human bone recovered from tower wall.
