BEASLEY WEIR DULVERTON EXMOOR NATIONAL PARK WEST SOMERSET

Results of Historic Building Recording

Report No.: 150202
Date: 02.02.15
Author: B Morris

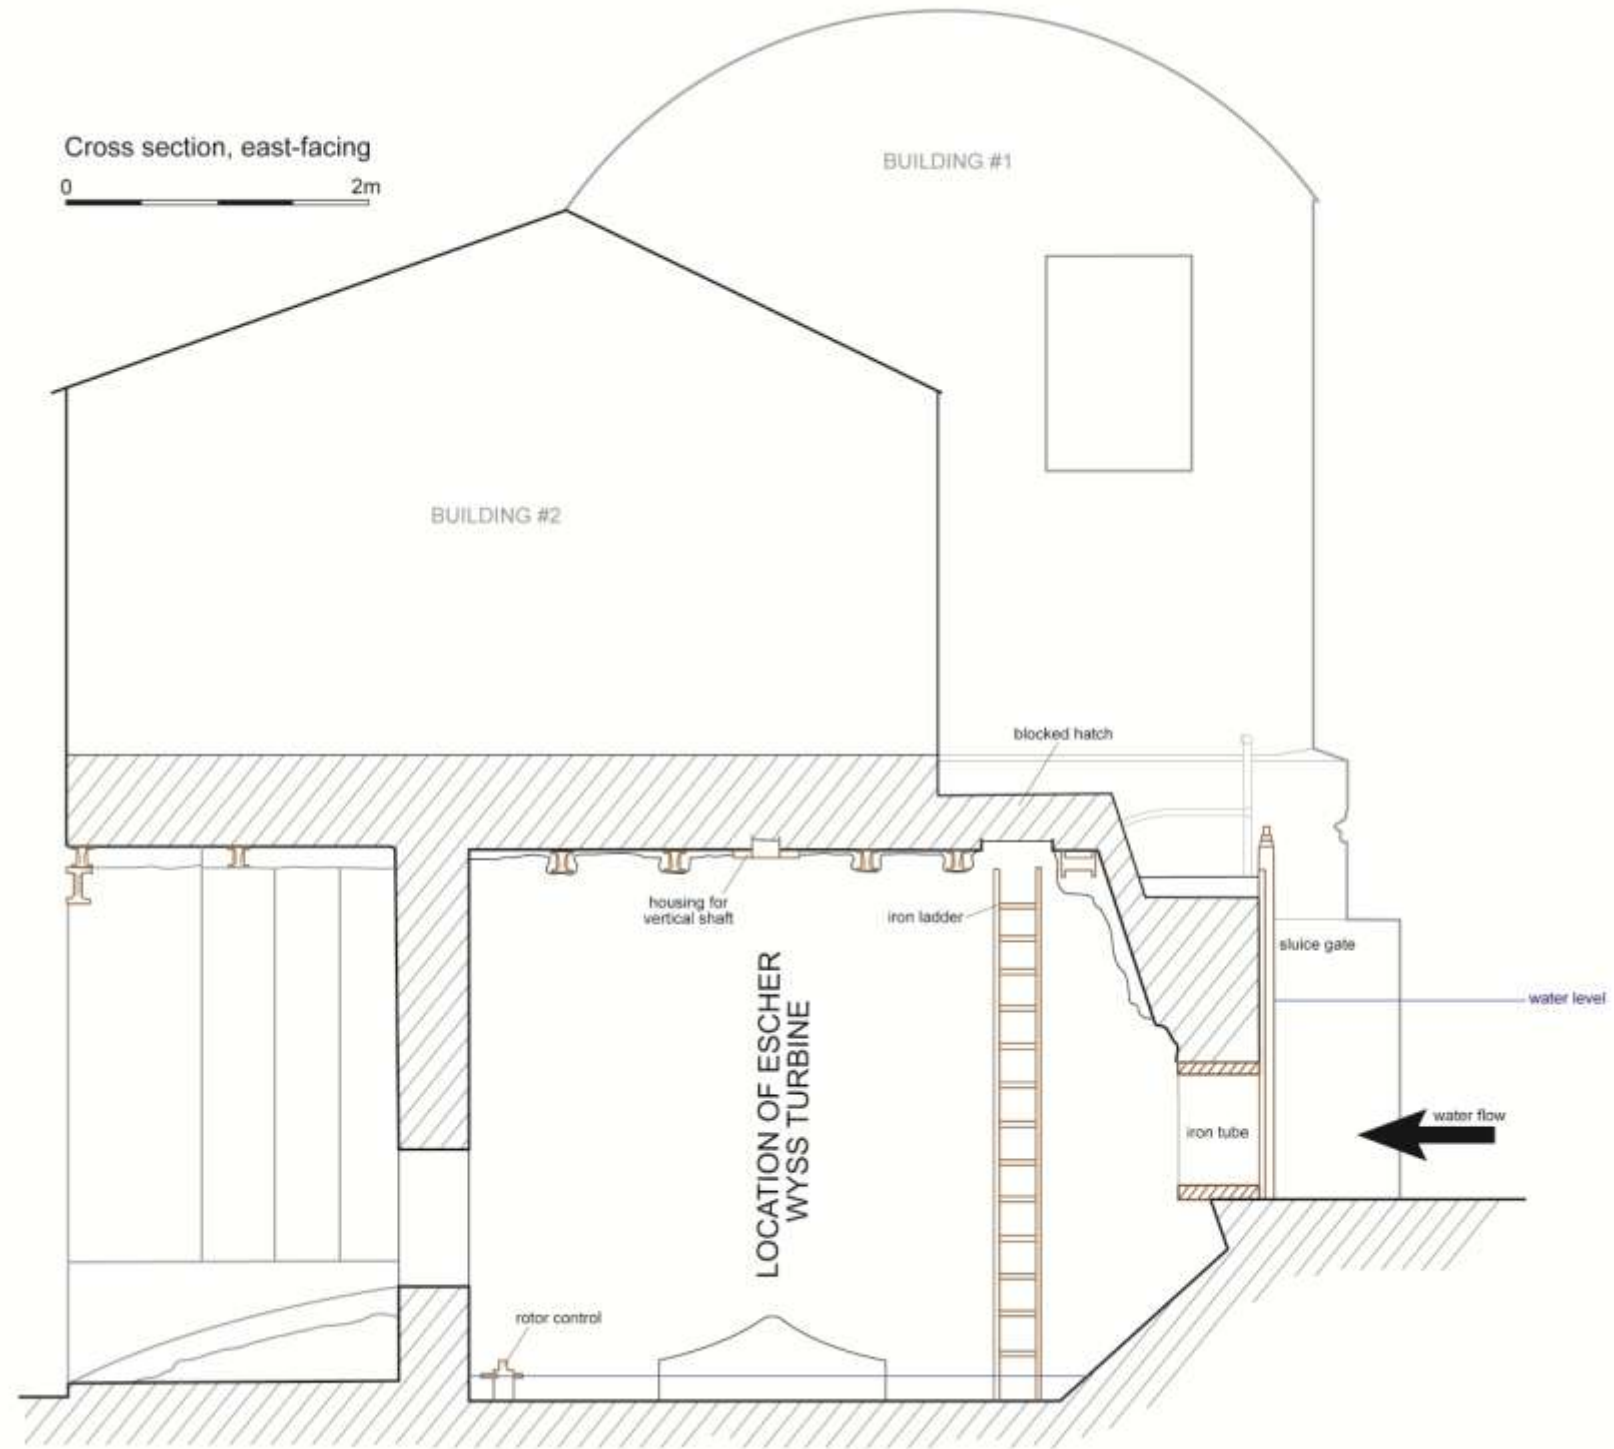
Figure 13: Cross-section through the Phase 2 turbine chamber with Phase 4 sluice gate.

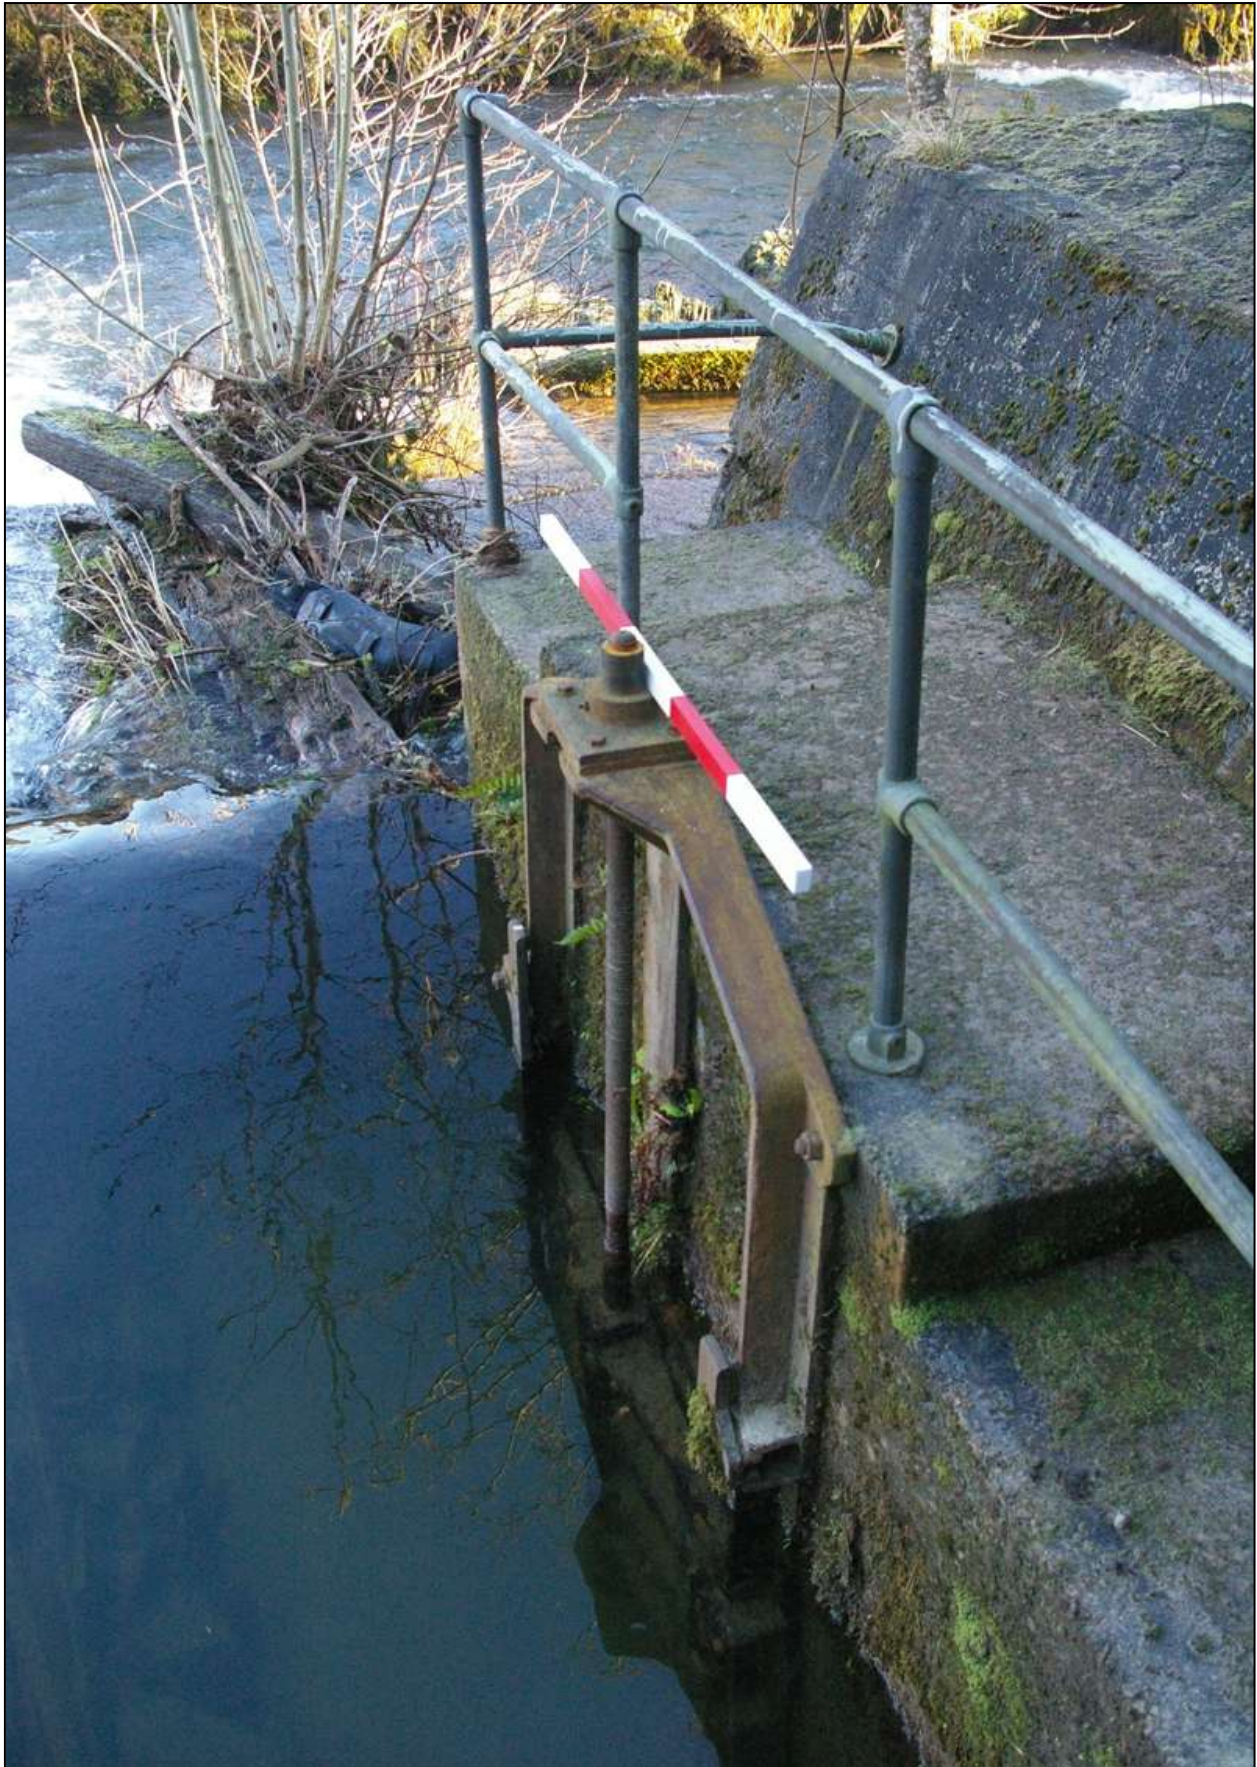
Figure 31: Detail of the FARRER sluice gate at the eastern end of the north elevation; viewed from the north-west (scale 1m).

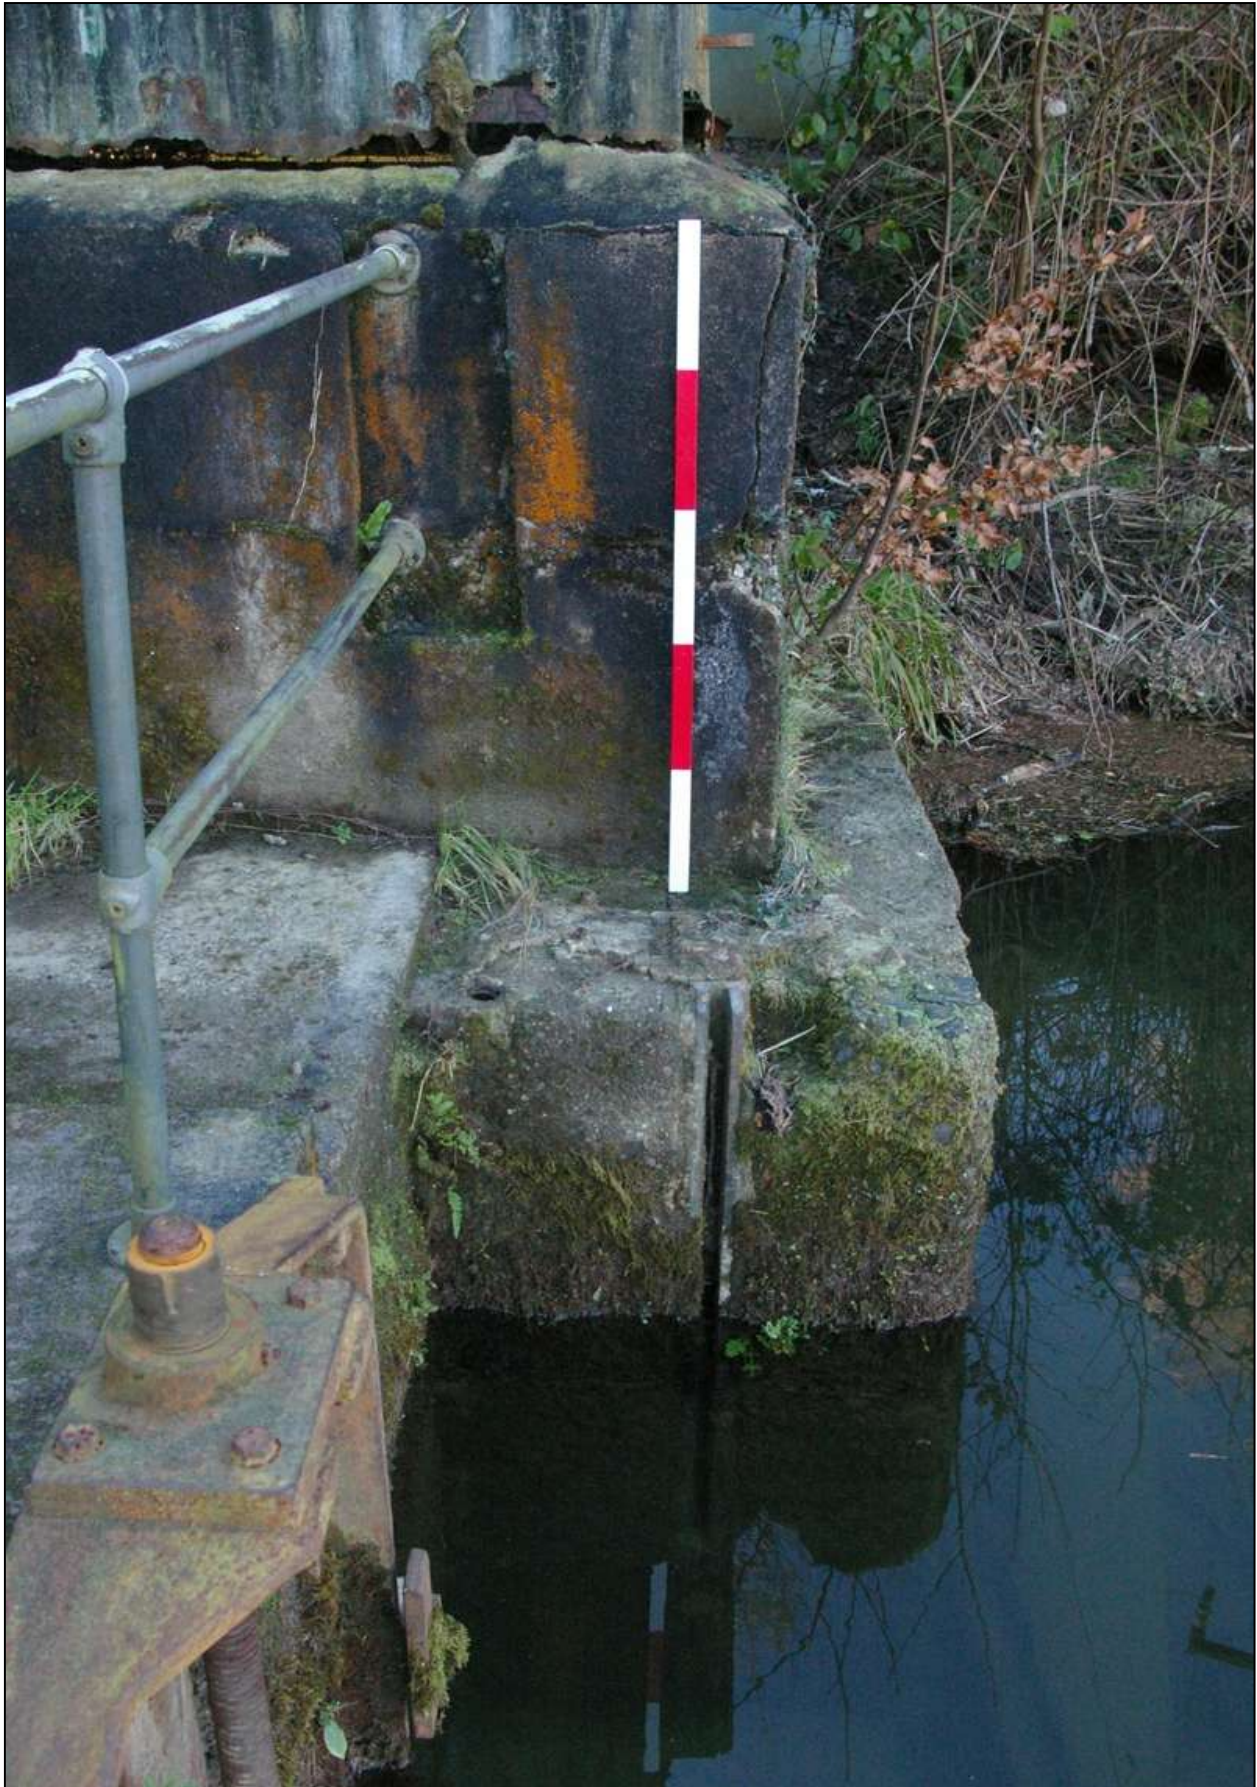
Figure 33: North-east angle of B1, showing the former sluice gate slot; viewed from the east (scale 1m).

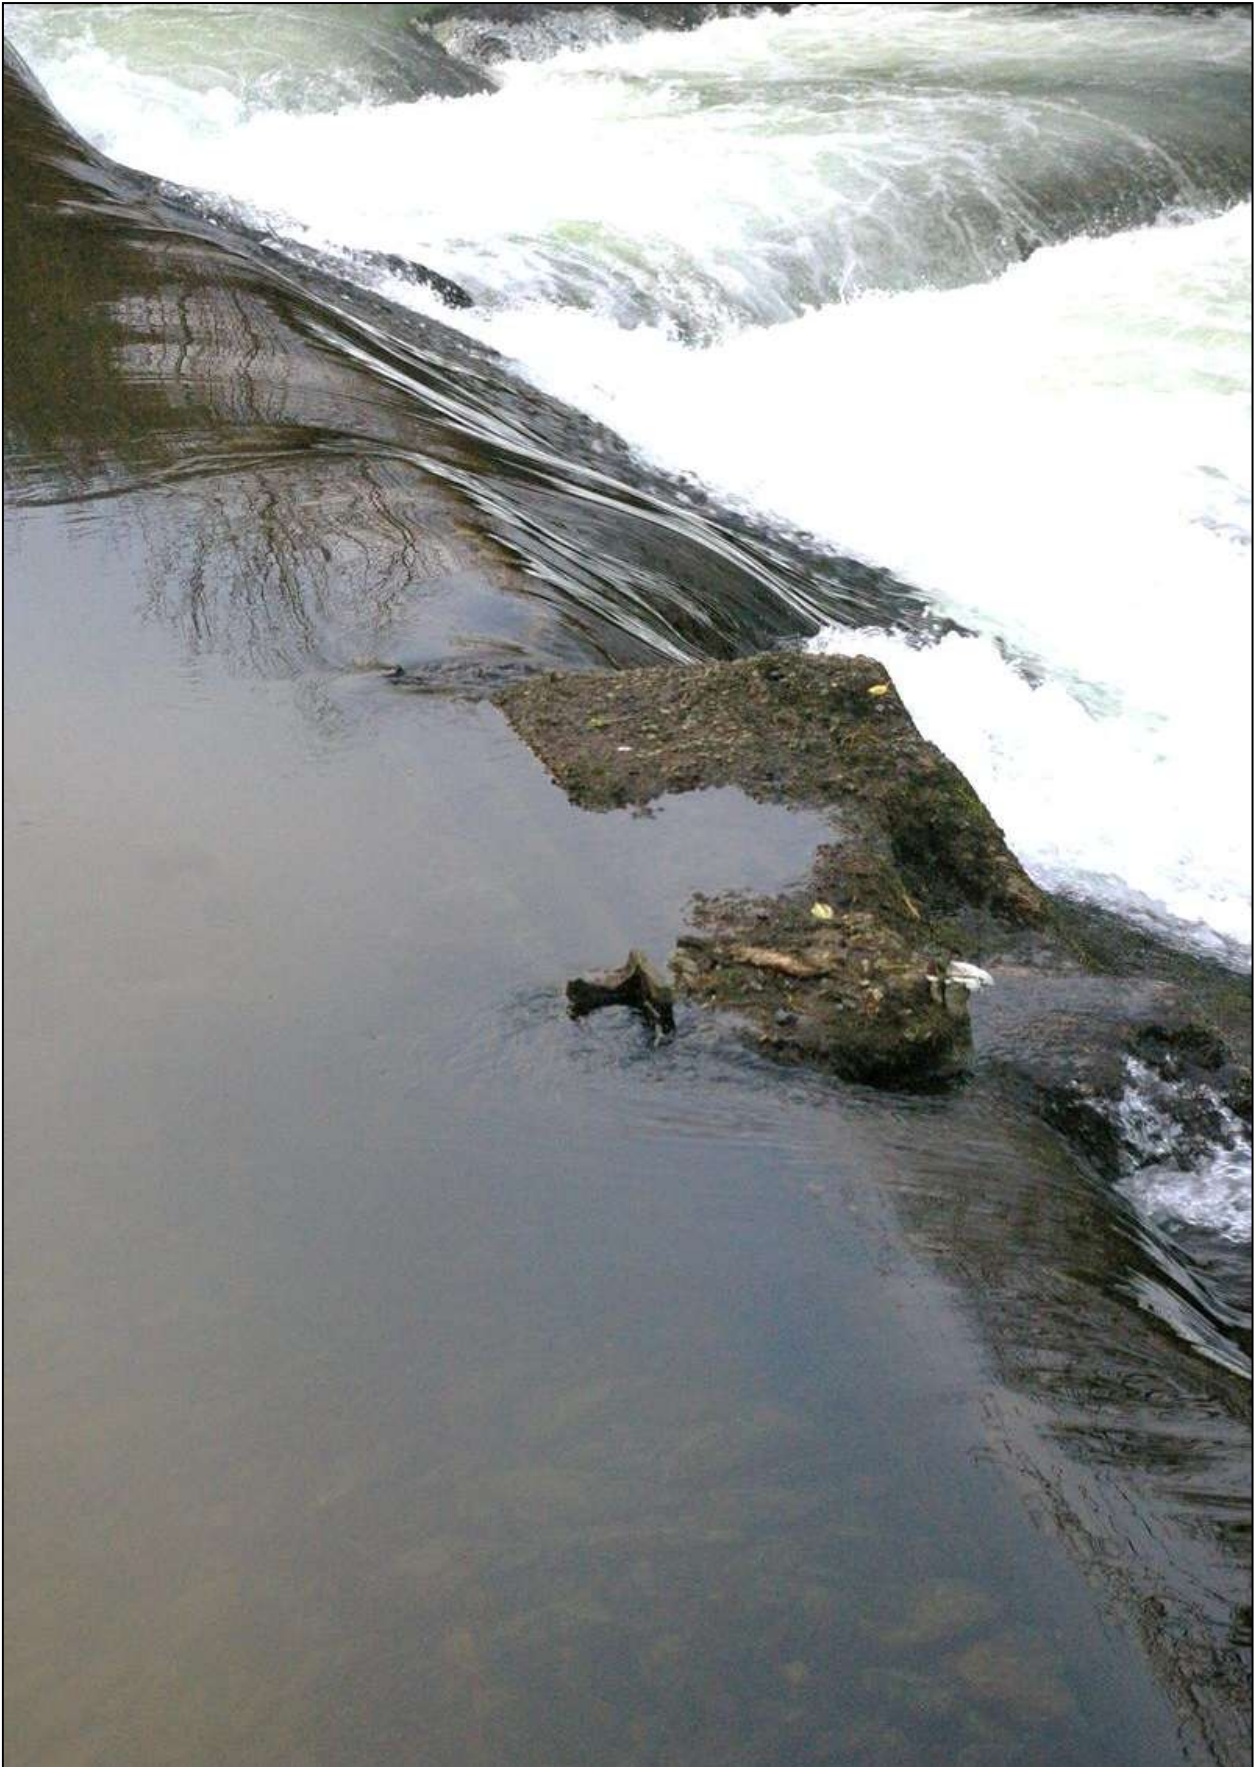
Figure 40: Detail of the weir, showing the possible broken stubs of iron fittings and a possible sluice gate; viewed from the south (no scale).

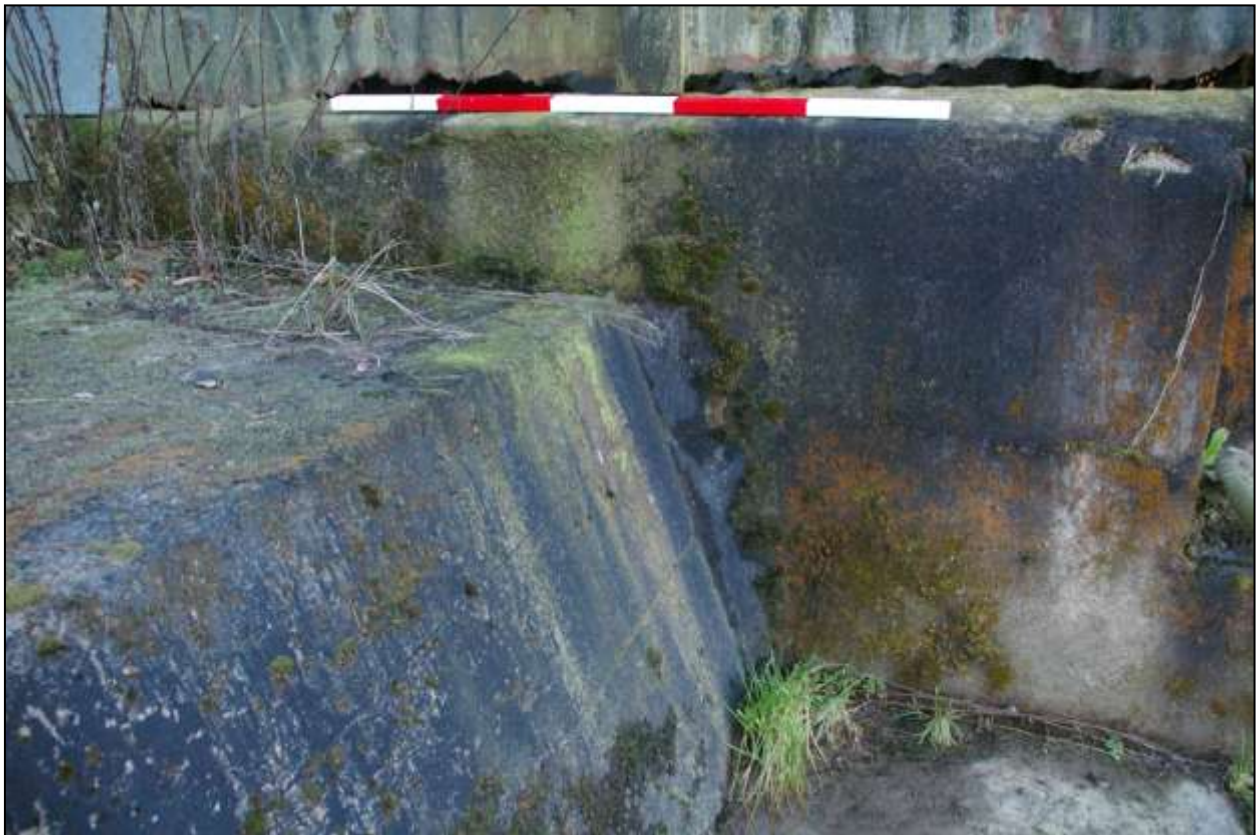
Figure 42: Base of the east elevation of B1, showing rebuilt sloping concrete front; viewed from the east (scale 1m).

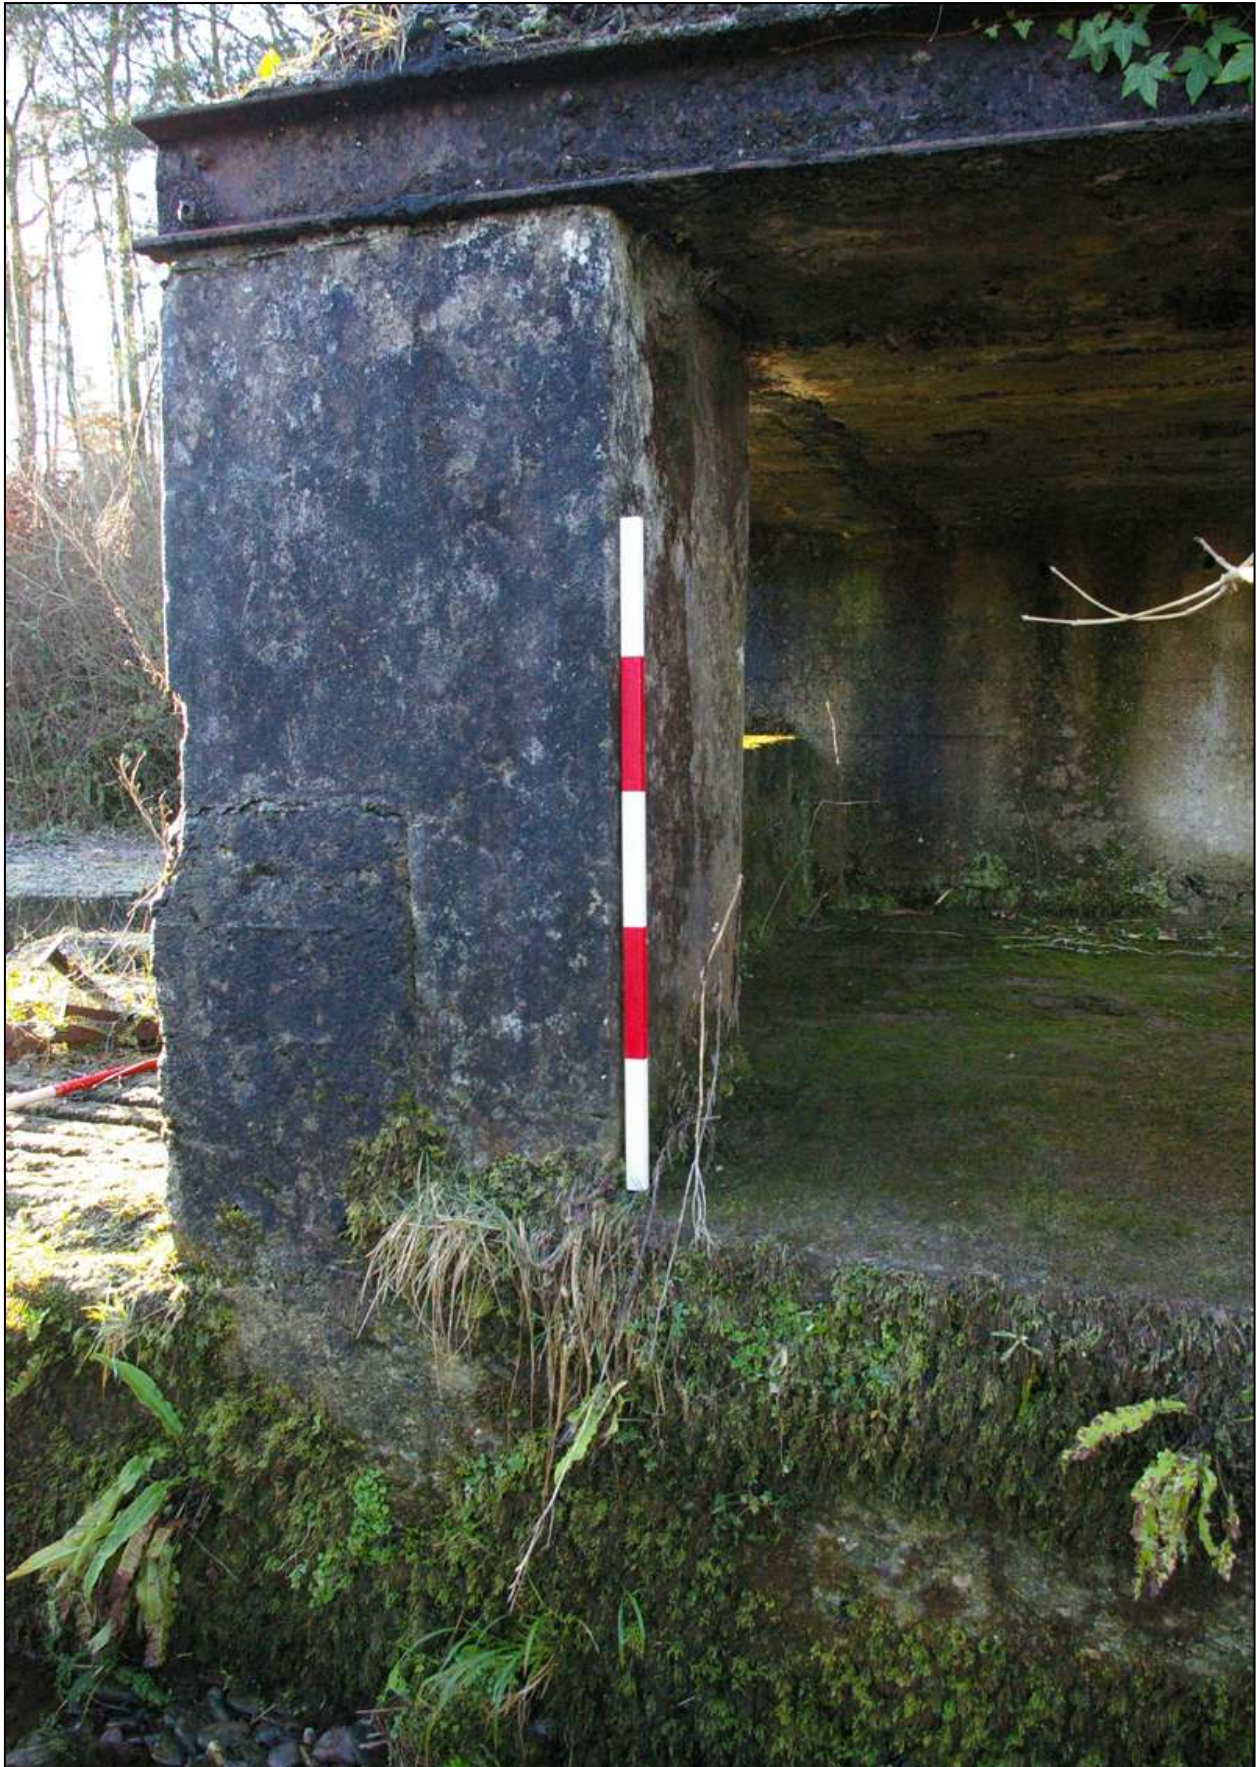
Figure 60: Detail of the east face of the south pillar, showing it built over and around the southern wall of the spillway; viewed from the east (scale 2m).

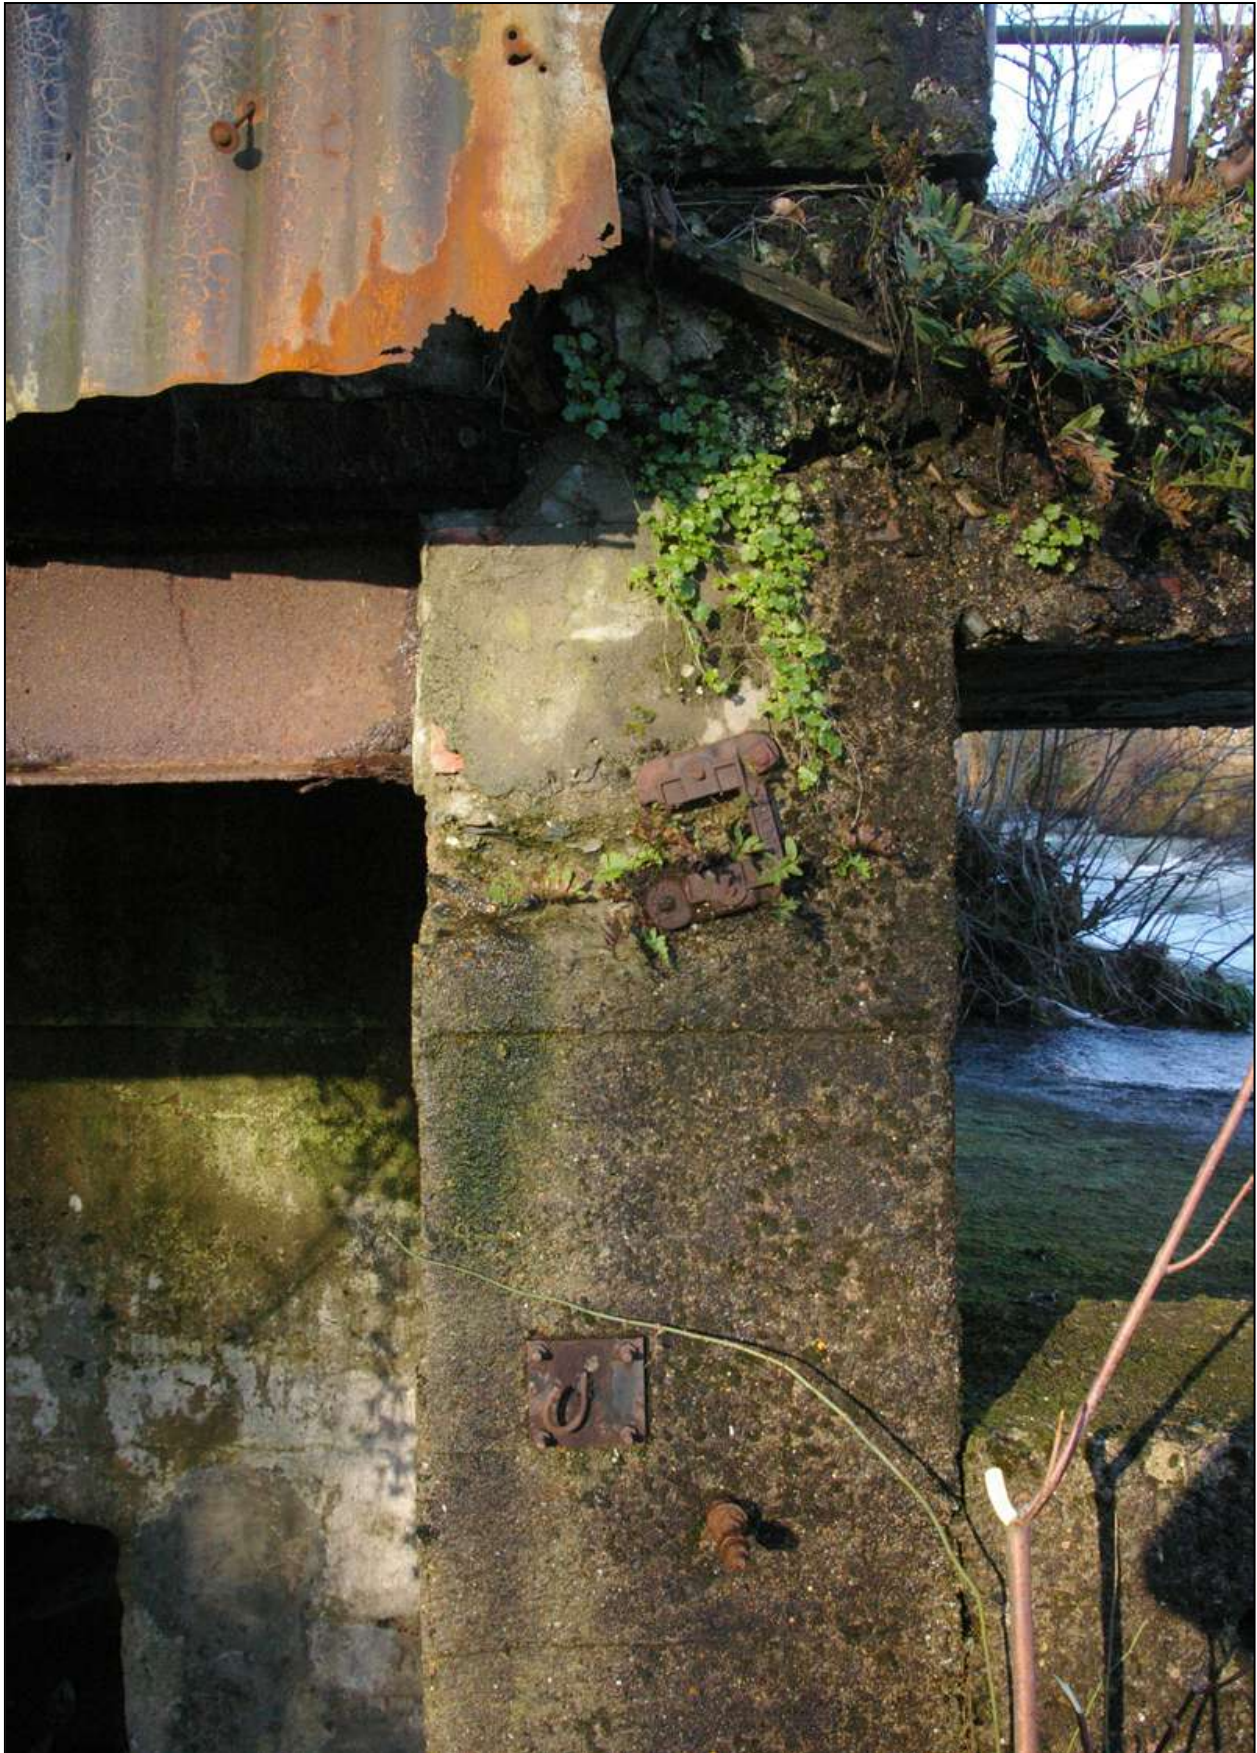
Figure 70: The south face of the east wall of the turbine chamber, showing the later iron fittings and inserted iron girder; viewed from the south (no scale).

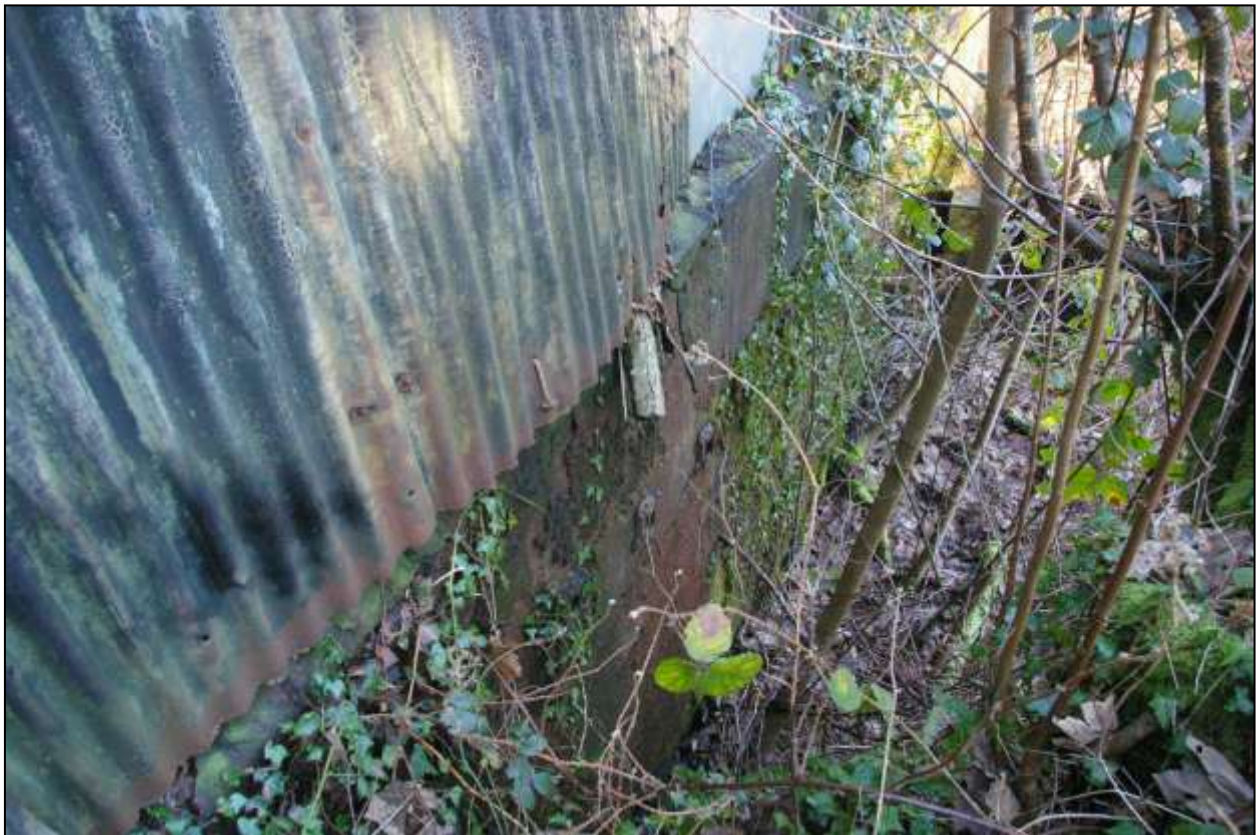
Figure 72: The base of the south elevation of B1 where the ground level steps down; note the DOULTON brackets in the wall. Viewed from above and to the south-west (no scale).

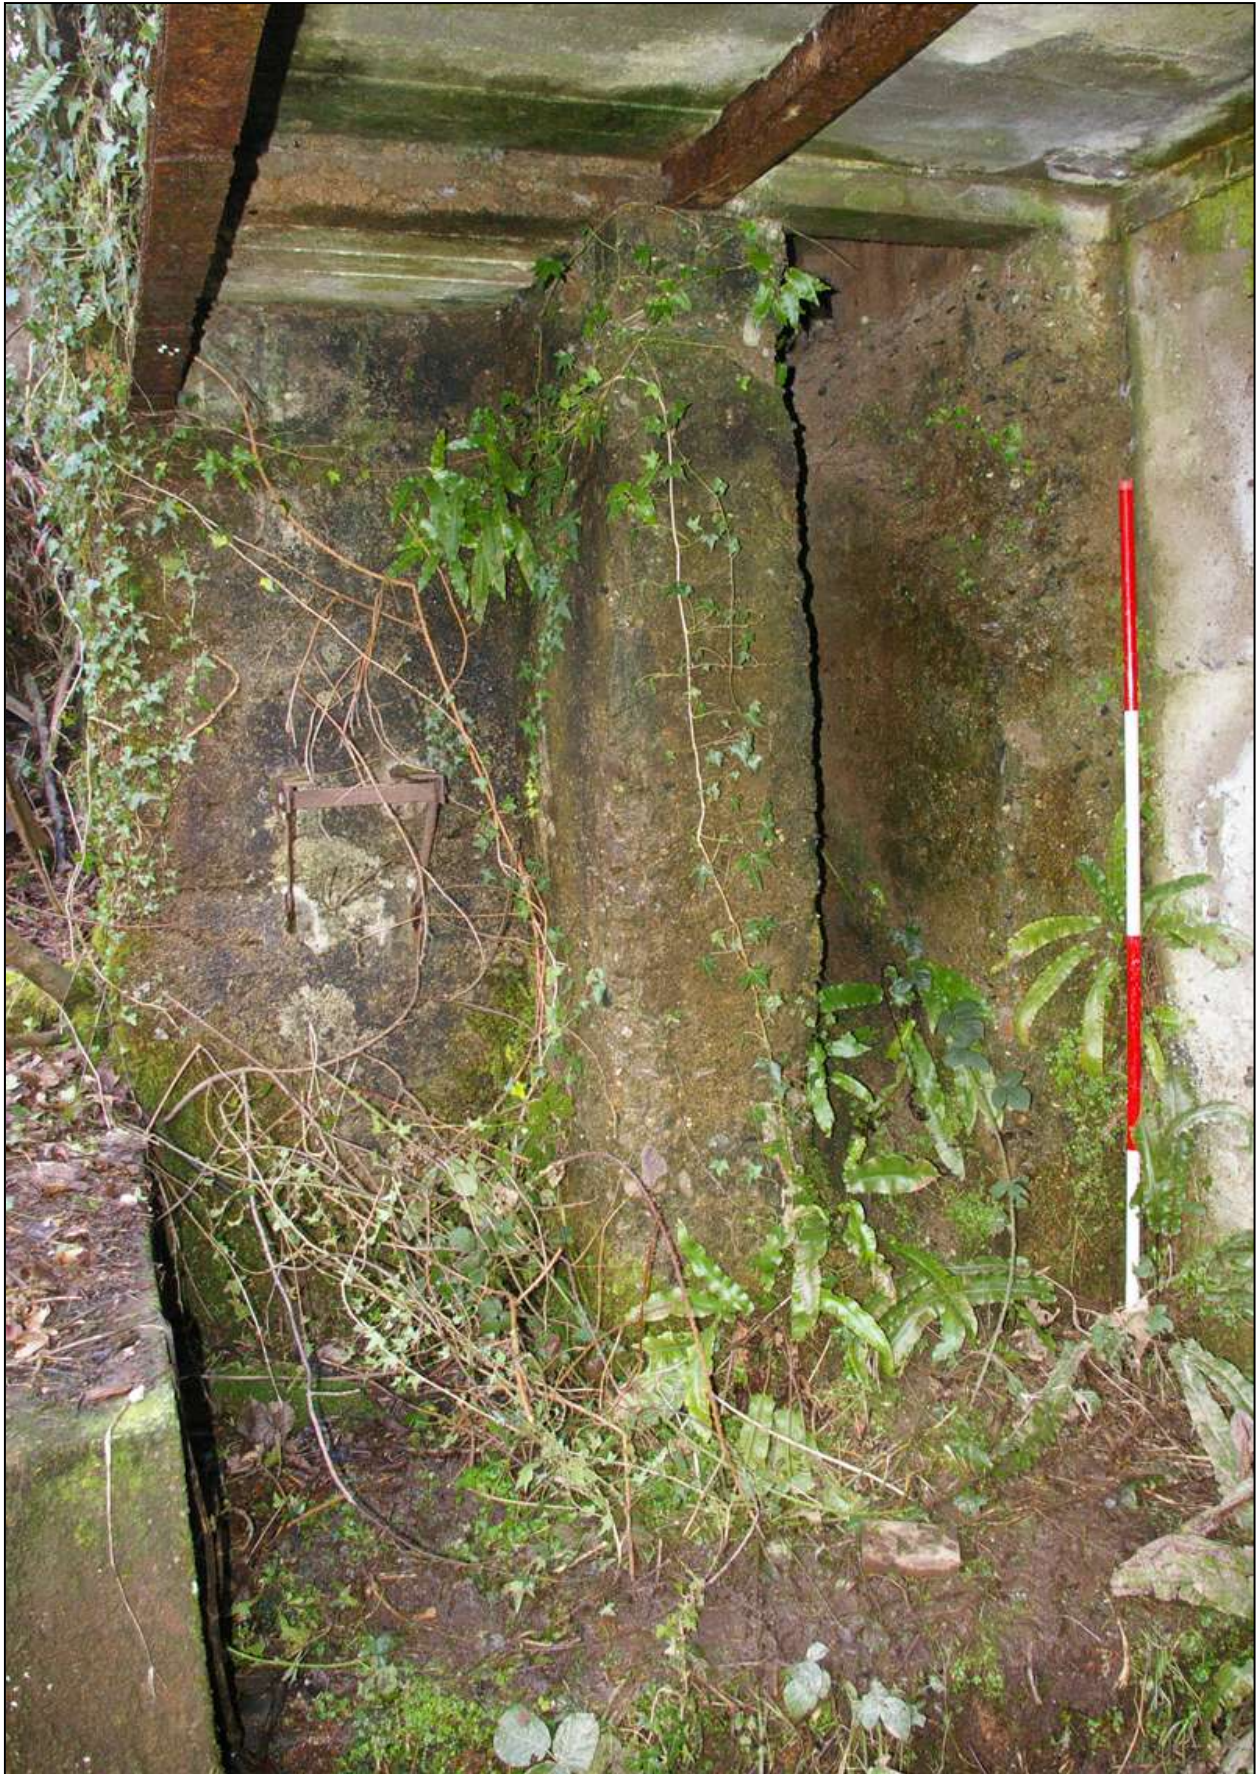
Figure 80: The west wall of the turbine chamber, showing the potentially earlier mass concrete plinth; viewed from the south-east (scale 2m).

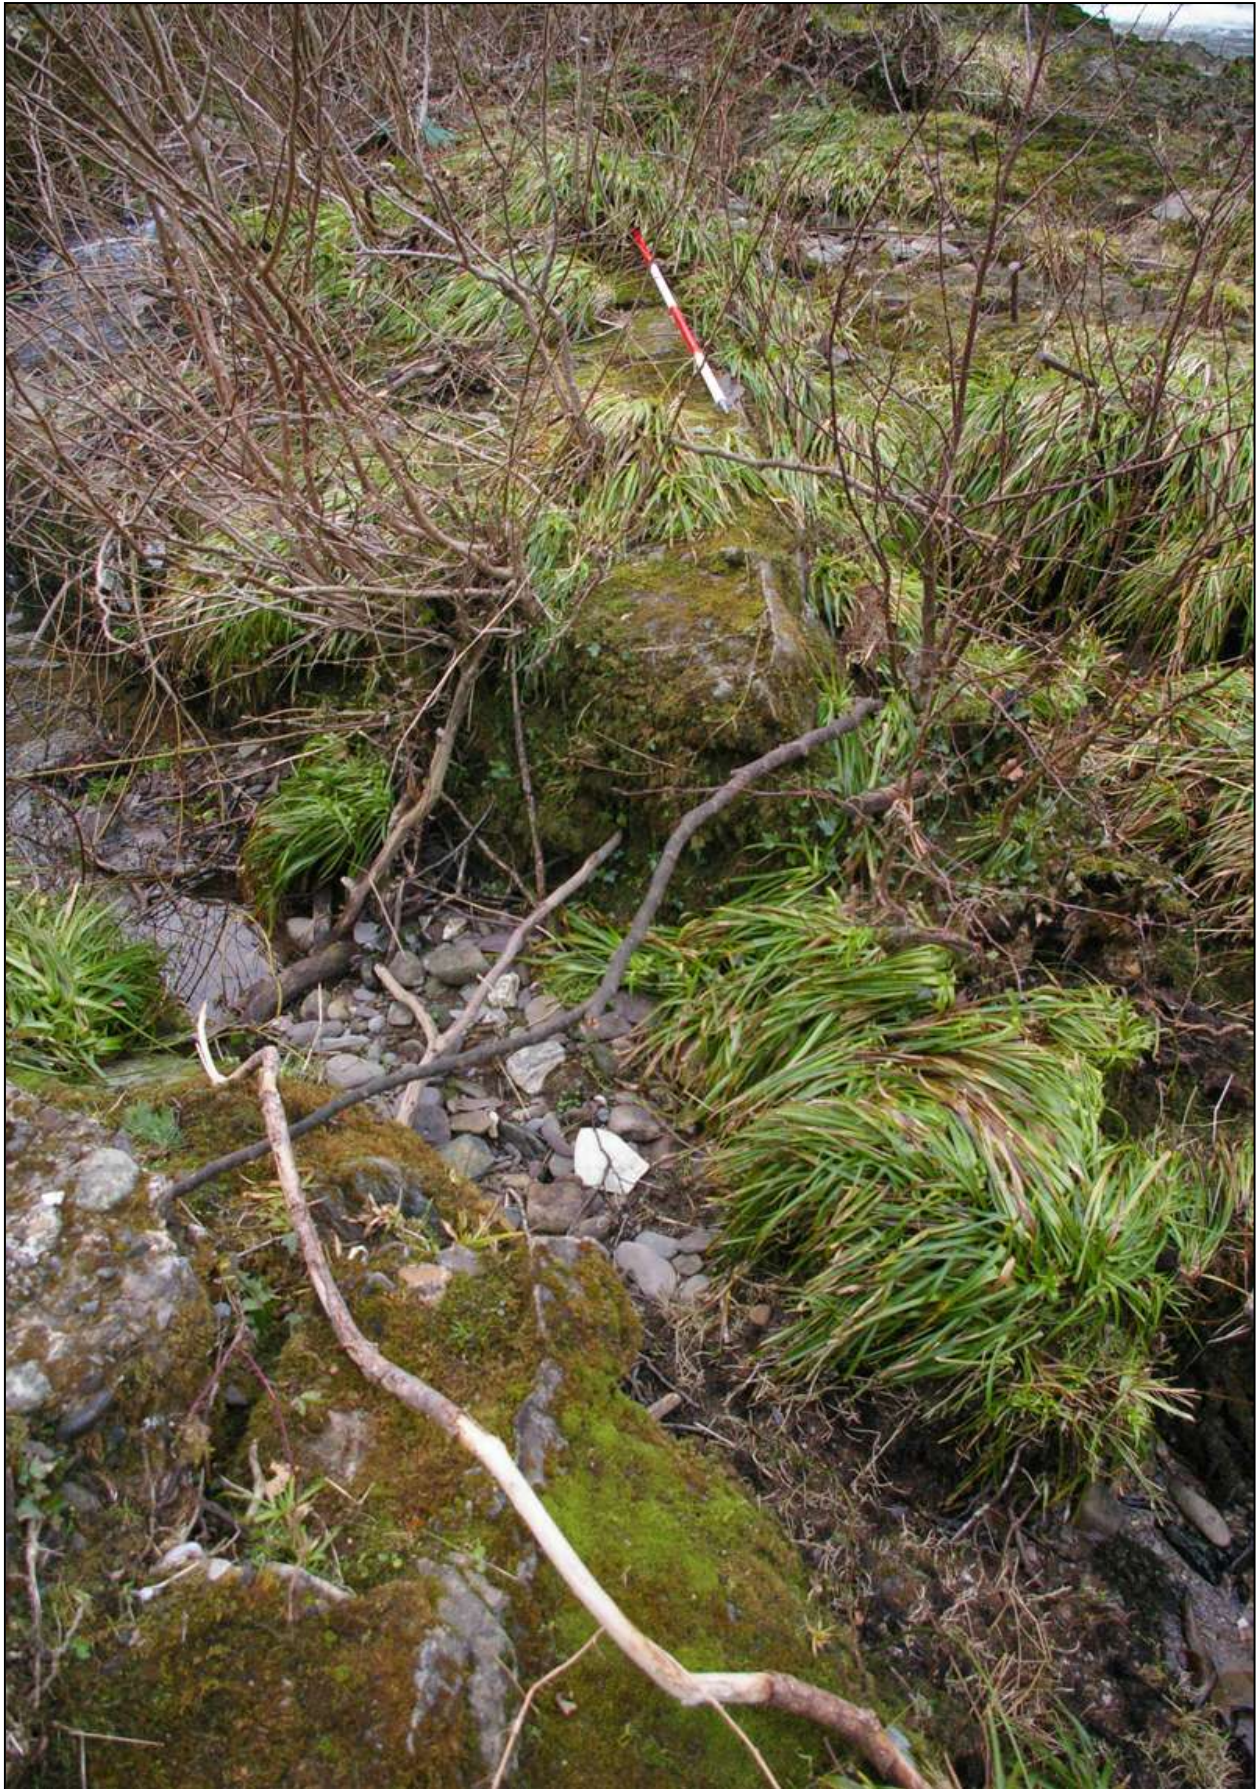
Figure 111: Wall 1, showing it cut by Leat 2; viewed from the south-east (scale 2m).

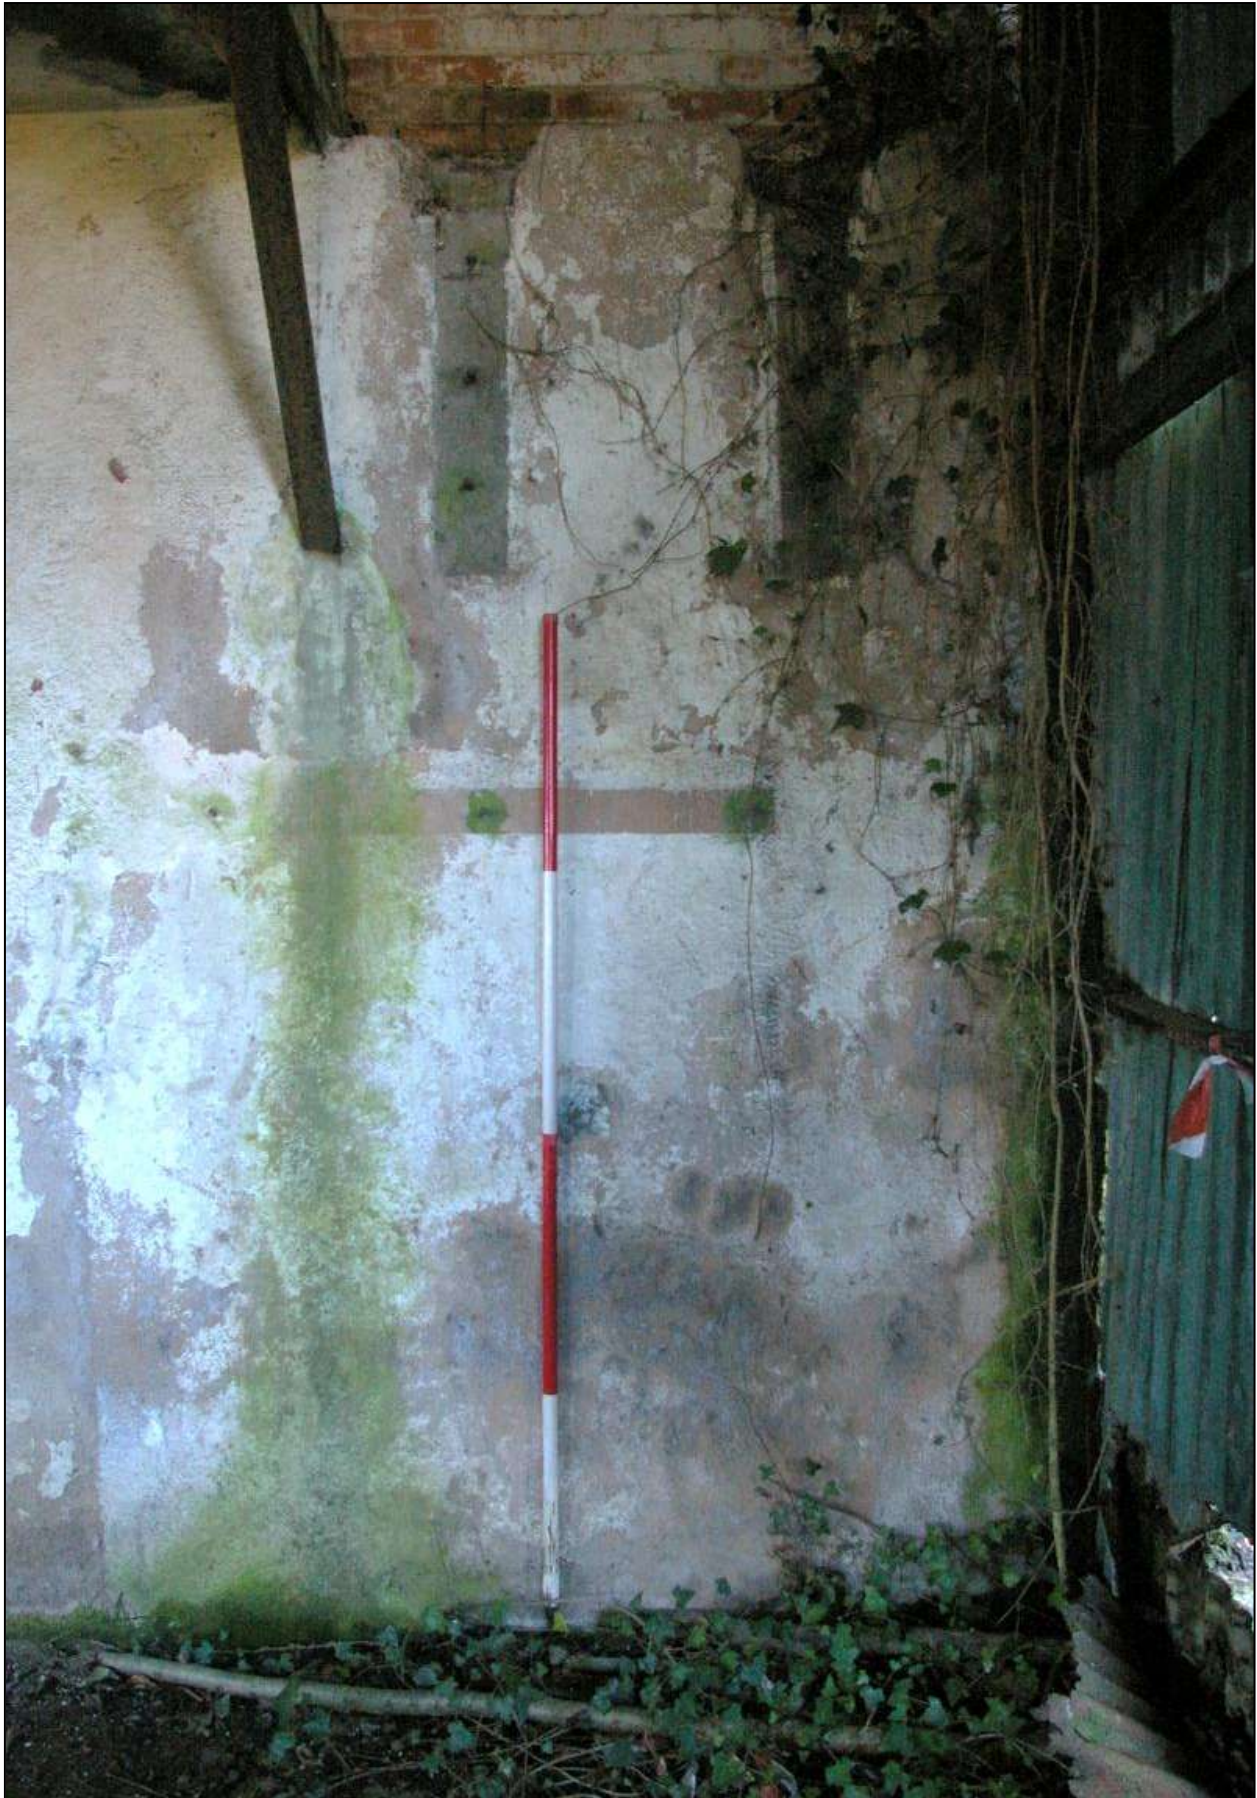
Figure 117: Scars on the west wall of B1, viewed from the east (scale 2m).
