TANTONS HOTEL, RIVERSIDE FLATS AND HAMPTON TERRACE, BIDEFORD DEVON

Results of a Historic Building Assessment

Report No.: 141101
Date: 01.09.2014
Author: C. Humphreys
E. Wapshott
J. Bampton

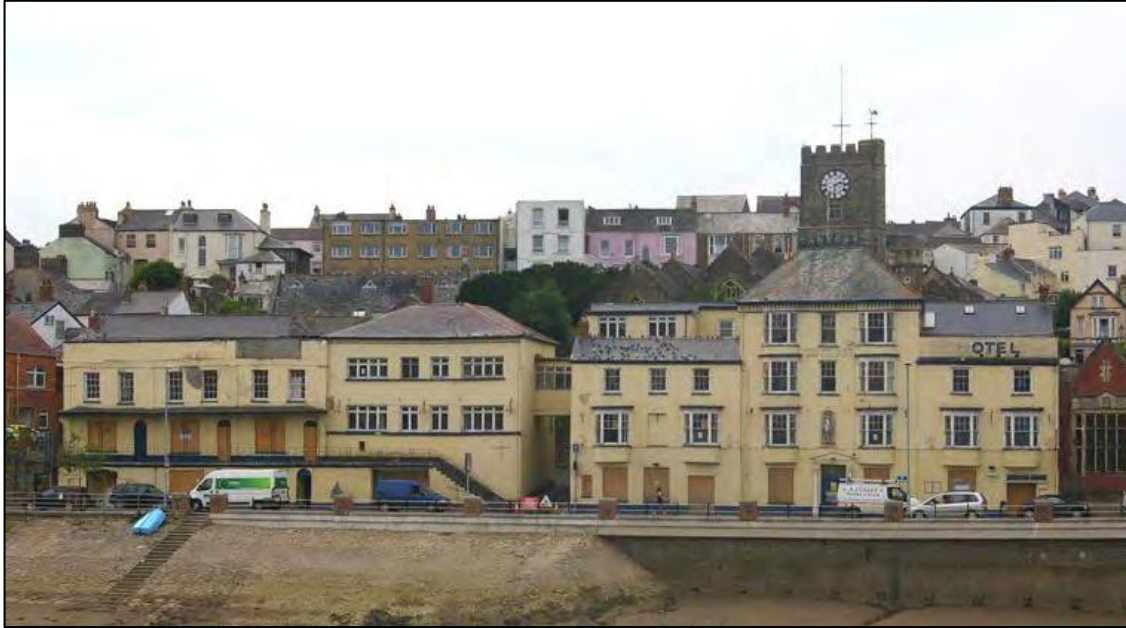
The east elevation forms the principal front of the building. A central range, with hipped slate, flat-topped roof, decorative railings and flag pole, is set back from two slightly projecting asymmetrical wings to the north and south, with pitched slate roofs. The whole is rendered and painted in cream with blue detailing, with cast iron guttering and downpipes.

Figure 3: East elevation of the Tantons Hotel, Riverside Flats and Hampton Terrace, from the east.

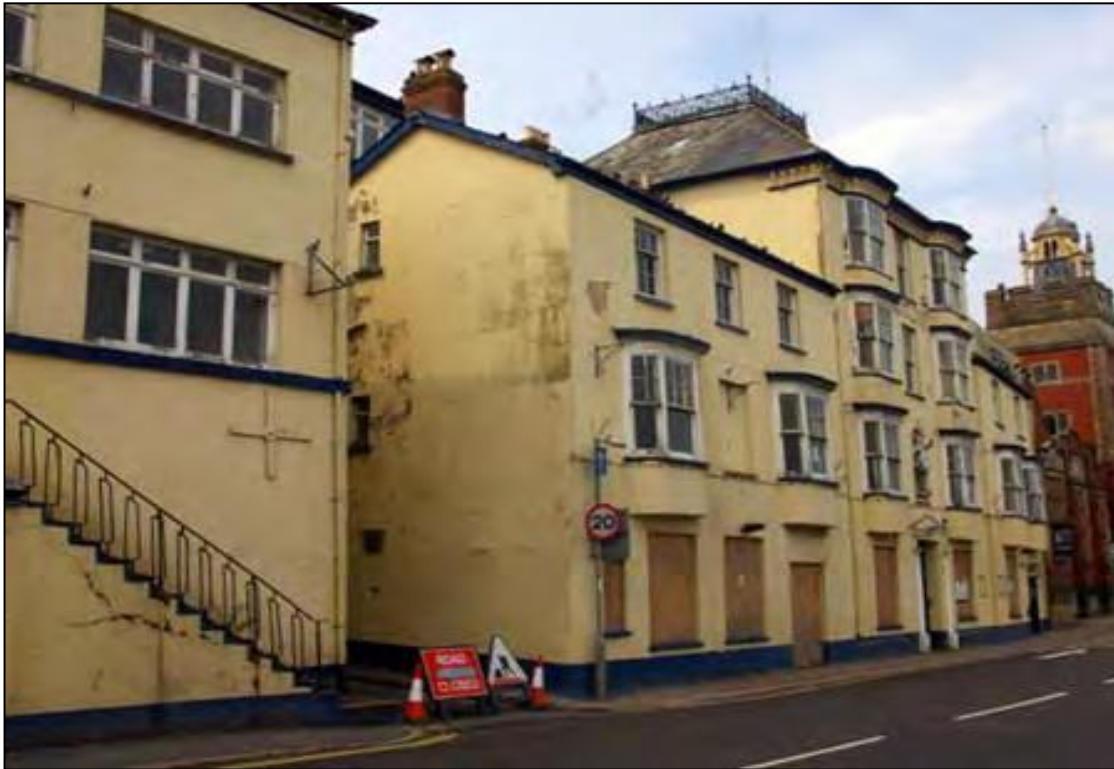
The south elevation is of three storeys to the east, rising to a gable, with gable end chimney stack and painted barge boards. Three small narrow hopper casement windows have been forced into the gable.

The south elevation of the rear range is of four storeys, under a flat roof with painted bargeboards. The corridor link enters the elevation at the second floor to the east. The elevation is fenestrated with a range of off-set single sash windows to the first, second and third floors, with an additional three-light window to the east, on the first floor. Three large blocked openings occupy the ground floor. This elevation is set into the slope to the west.

Figure 4: The south elevation of the main hotel building, from the south east.

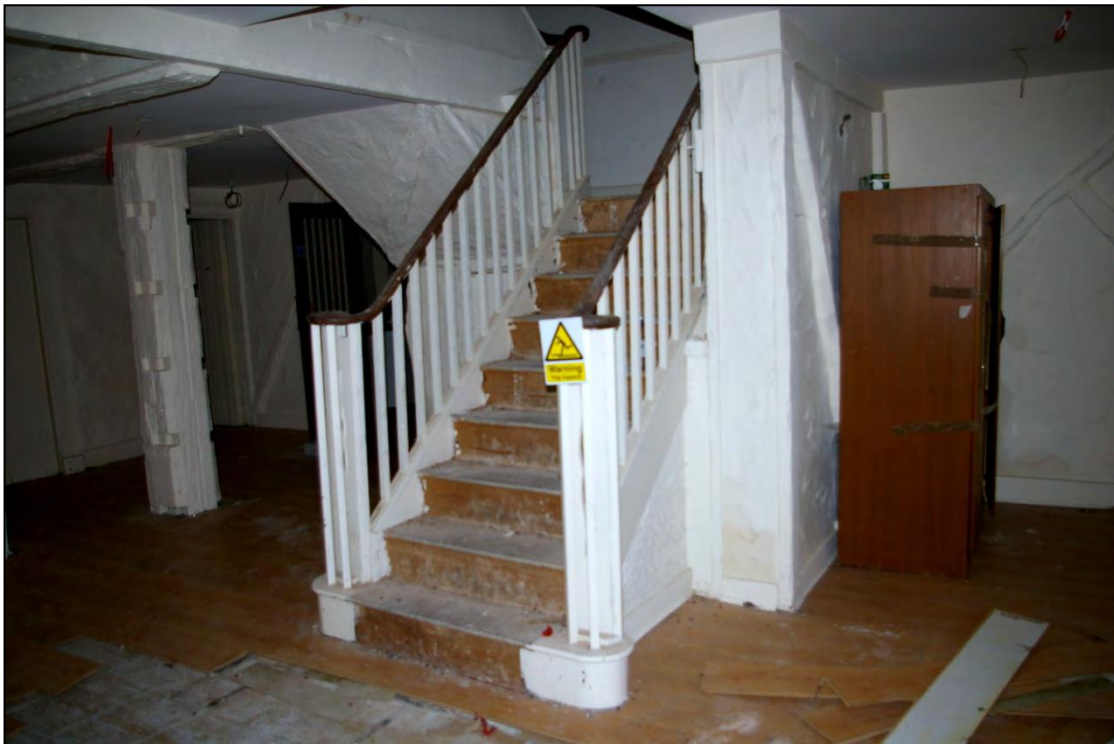
The ground floor has been significantly altered in the 20th century. A central reception hall with stairs and lift to upper floors and private office, to the south two dining/function rooms with a small bar, to the north a large bar and seating area and to the rear range, service kitchens. Beams, reused from other sources, have been inserted into the structure within false ceilings, to create an 'olde worlde' look, obscuring the 19th century high ceilings and plaster cornices in several rooms. The windows in the east elevation are late 19th century sash windows. The lower flight of the main staircase has been altered; the curving polished wood handrail appears correct, but has been reset in its current position.

Figure 5: The staircase within the ground floor reception hall, room 2, from the south-east.

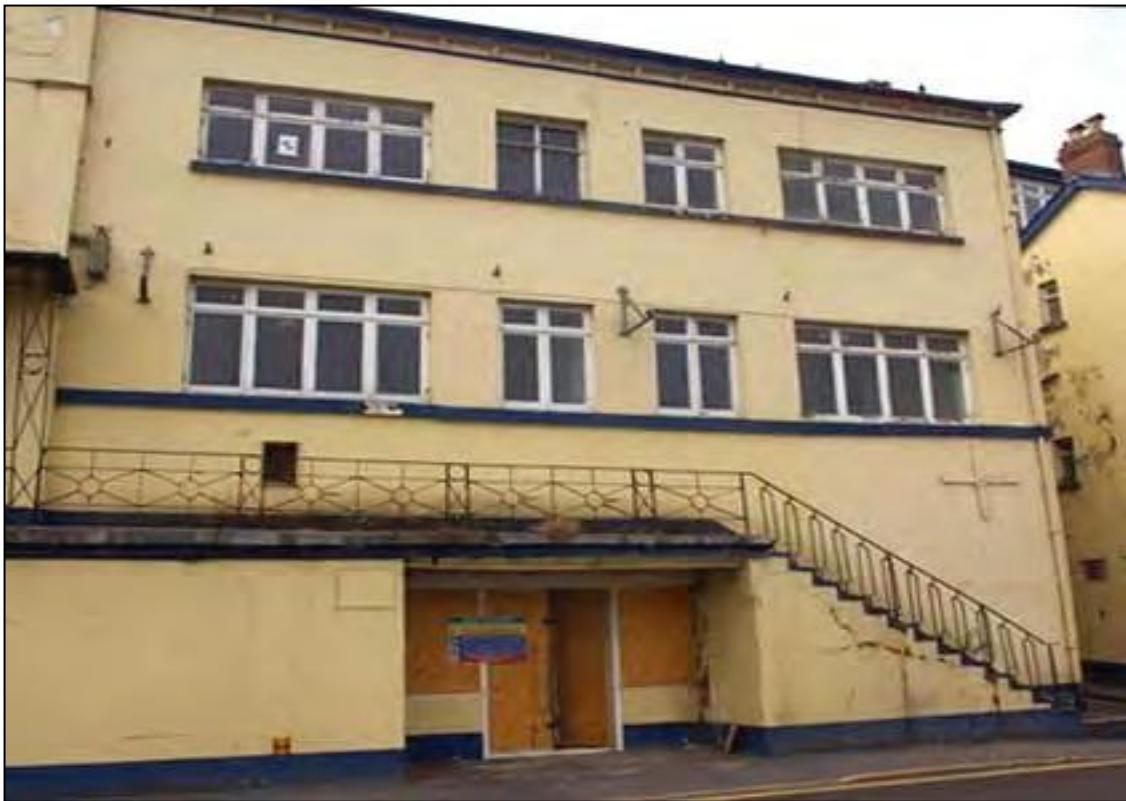
This structure is not DoE Listed and comprises a rendered two-storey building of rubble stonework construction under a slate roof, with red terracotta ridge tiles. The building is almost exclusively fenestrated with mid-20th century timber casement windows with shallow bead moulding, many with surviving brass window furniture, such as screw latches. There is one modern replacement window in the front (east elevation), on the second floor. The building is accessed via the second storey corridor link from the main hotel building to the north. There is a blocked former fire escape leading from the first floor out onto Lower Meddon Street to the west (Figure 10). In the post-war period the building was heavily remodelled; designed to create extra room-space for the hotel business.

Figure 10: Riverside Flats; viewed from the east.

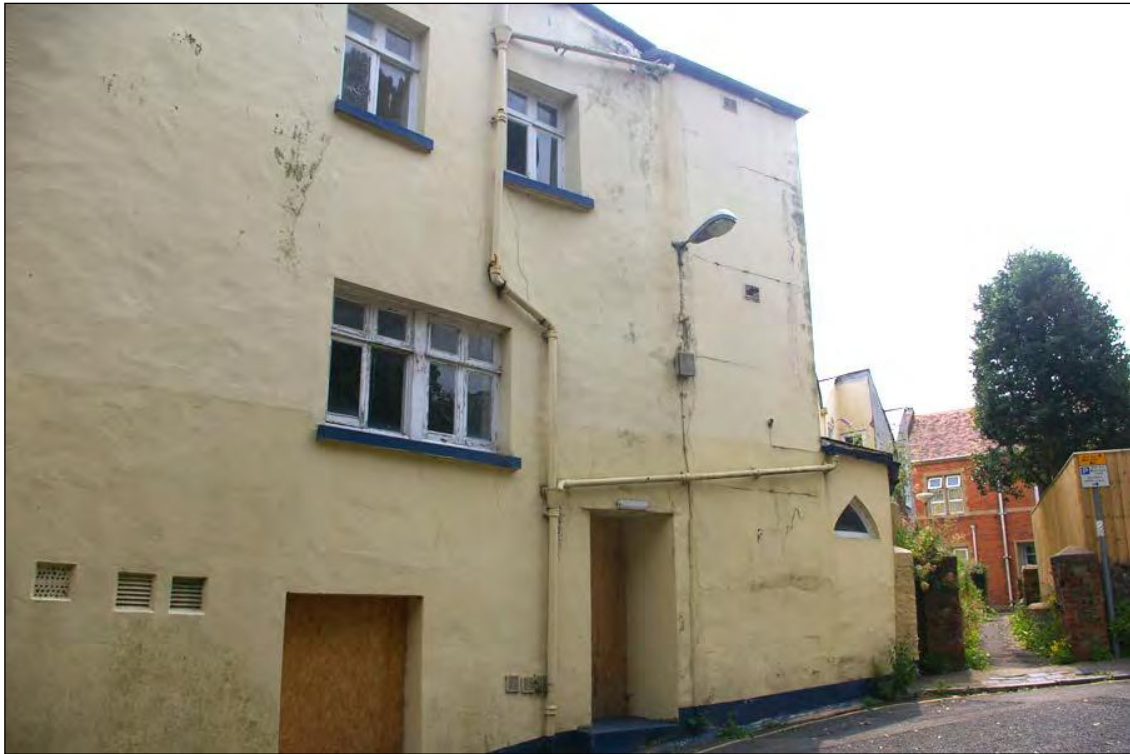
The ground floor of the building is of several phases of mixed stone rubble and is set back into the hill-slope to the west. The front wall of the ground floor appears to have been significantly altered in the mid 19th century, to allow for access to the raised terrace along the east side of Hampton Terrace. The large double opening may be an enlargement of a 19th century opening (Figure 10). The exterior wall to the west is heavily rendered but may represent the part survival of a retaining wall to the road or hill-slope. At some point in the 20th century, the north-east corner of the building appears to have been 'squared off'; the older stone structure reduced and possibly partially rebuilt, to allow for cars to use Lower Meddon Street.

Figure 11: North side of Riverside Flats; viewed from the north-east.

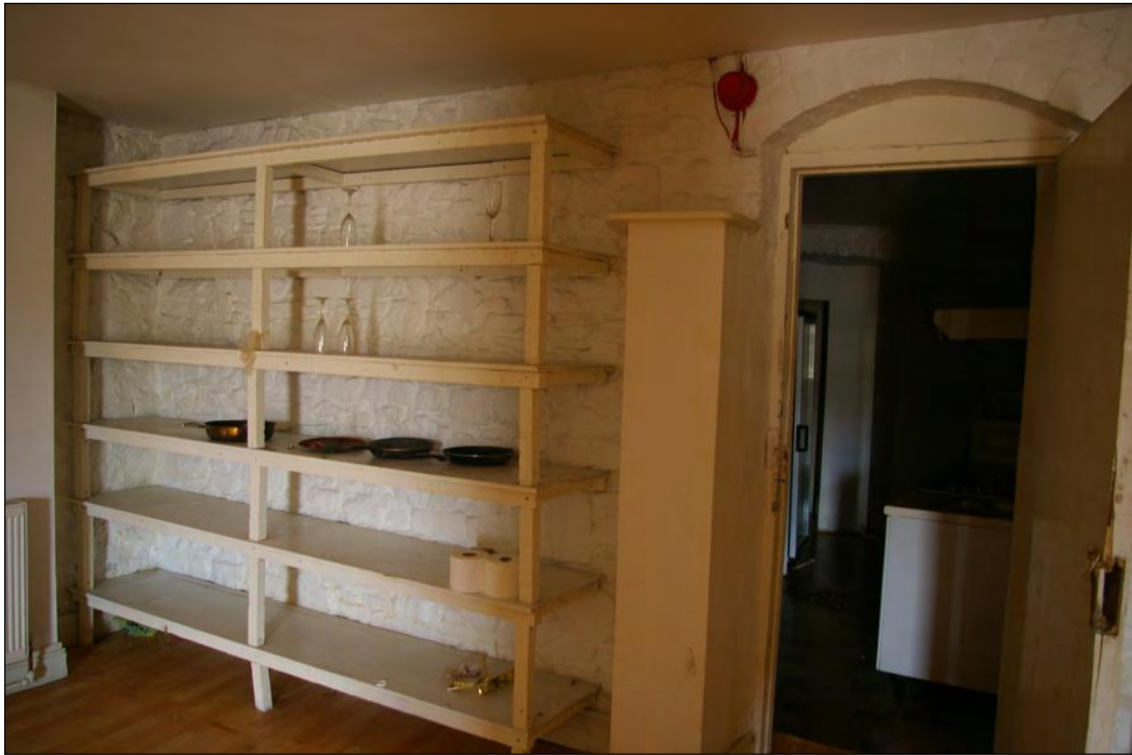
Figure 12: Narrow segmented brick archway door from Room 1 to Room 2; viewed from the east.

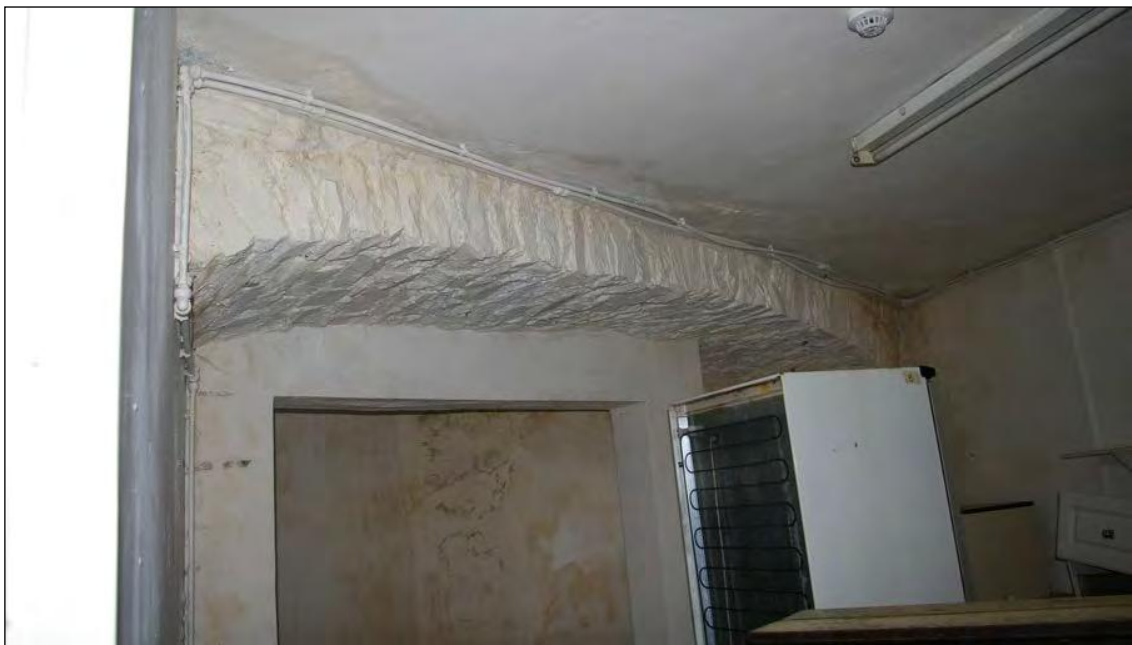
On the ground floor (Figure 4) the building comprises one large open area (R1) (Figure 9) with an enclosed stone-built room in the south-west corner (R2) of rubble construction and a modern partitioned bathroom (R3) inserted against the west wall. The most significant feature which survives within this ground floor space is the west wall, which encompasses the substantial remains of a stone built retaining wall. Room 2 is connected to Room 1 by a narrow segmental brick arched doorway in its east wall (Figure 10). Another doorway, in the south wall, appears forced; this links to the attached building (Hampton Terrace) to the south. Within the retaining wall which forms the west side of the stone room, there is a large segmental arch which appears to brace the rear wall of the building (Figure 11). The arch is very large and of fine quality stonework. The space beneath this arch is boarded, suggesting there may be further blocked space behind. This arch may be associated

with some form of cellar storage running back into the hill-slope. The west wall may represent the partial survival of a former garden/enclosure wall, or perhaps less likely, the remains of an earlier building.

Figure 13: Room 2, large segmental archway; viewed from the east.

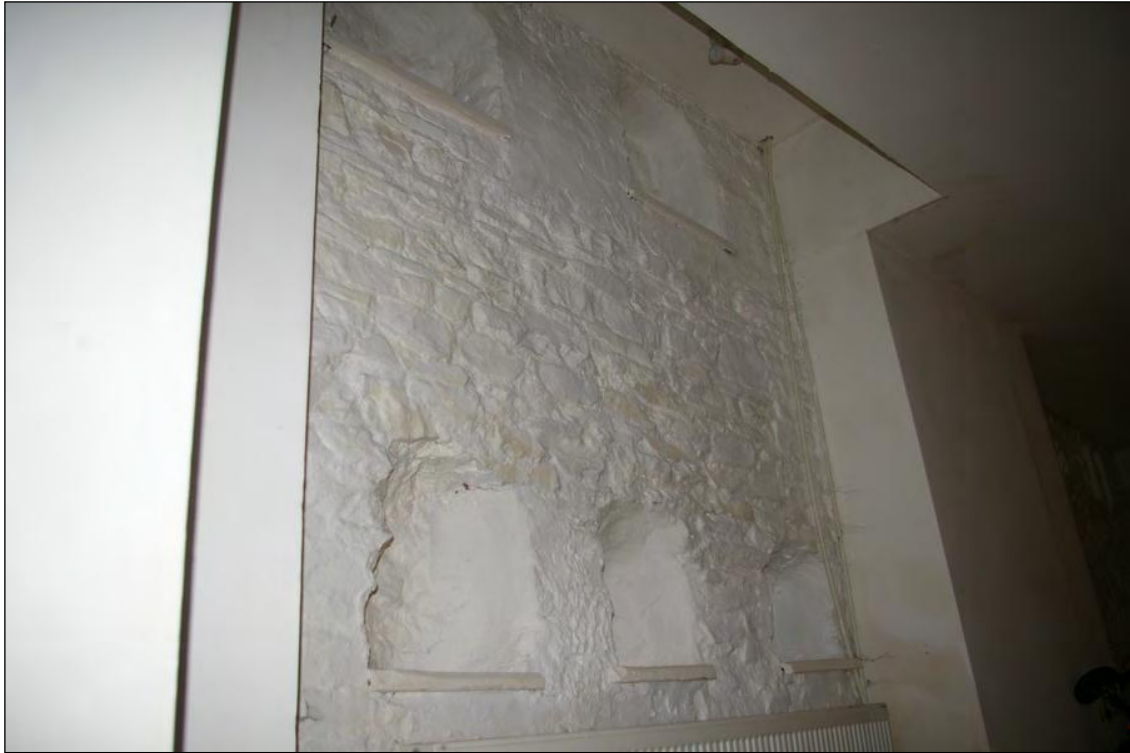
into a former loading door opening. The northern wall of Room 1 incorporates a group of five small alcoves (Figure 12), of similar size and form, which look like 'bee-boles'. These alcoves are set higher than the current first floor level within the 20th century building. In the north wall are two shallow wide boxed in areas which are matched by similar projections in the south wall. These may either be blocked chimney stacks or supports for chimney stacks. The southern projections appear to be more solid than those in the north wall, although are markedly similar in dimensions and appearance.

Figure 14: 'Bee-hole'-type alcoves in the north wall of Room 1; viewed from the south-west.

Set in the northern wall, and partially higher than the current first floor level, there is a group of five small alcoves of similar size and form that give the appearance of 'bee-boles'. If these are indeed bee-boles then this area would have formerly been open, and may represent an earlier phase than the buildings themselves, perhaps the partial survival of a garden wall.

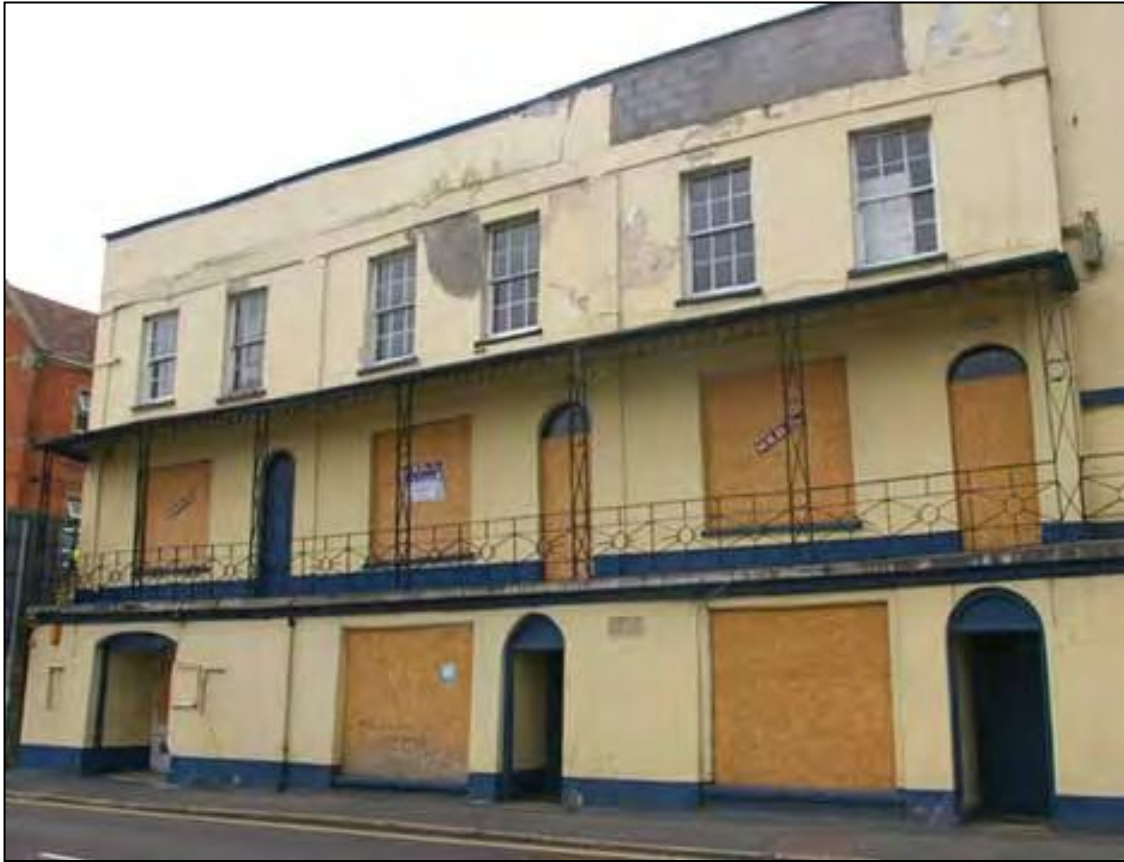
The building is built of stone rubble, rendered to the south and east sides, under a slate roof. It has received extensive 20th century alterations, converting the three individual townhouses into hotel accommodation. The front (east) elevation of the building is symmetrical, of classical proportions, typical of the early to mid-19th century style. Each of the three units is divided by a flat pilaster, formerly with simple moulded capitals of which only that to the north survives. The roof is hidden by a plain raised parapet above a six window symmetrical second floor window range. The inner four second floor windows are typical six over six pane sashes, hornless and of early to mid 19th-century date, contemporary with the construction of the building. The two outer sash windows to

the north and the south are six over six pane, horned sashes, later 19th or possibly early 20th century in date.

Figure 15: Hampton Terrace; viewed from the north-east.

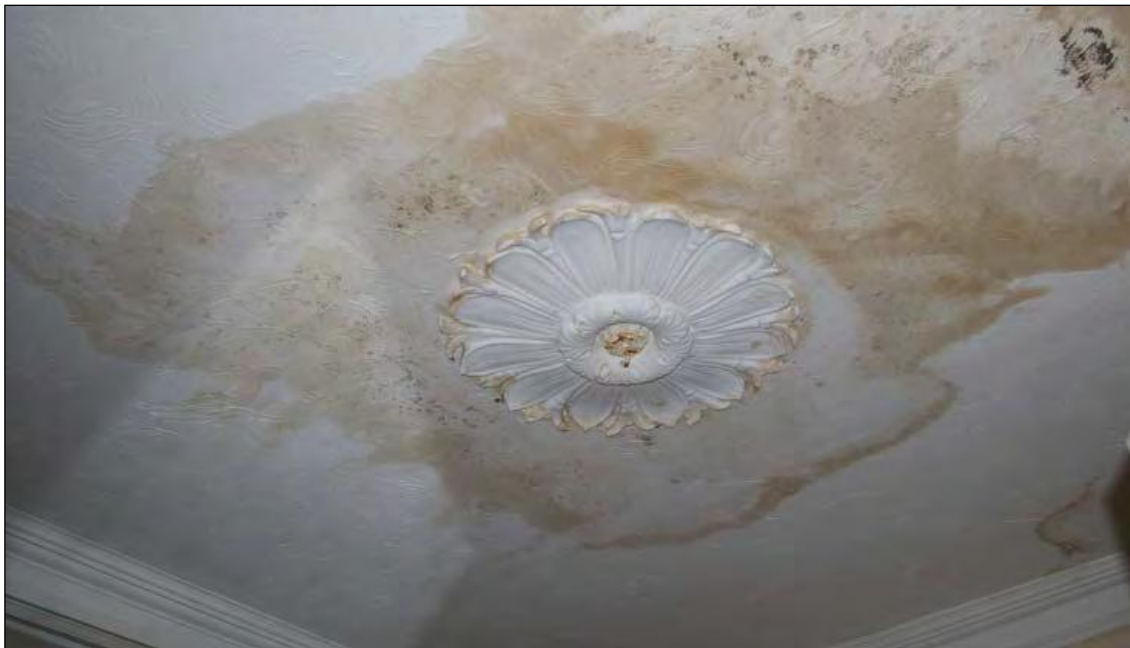
The central house of the terrace, No. 2, survives with significantly more historic features intact than the other houses. The hallway retains its original moulded plaster cornice and the large front reception room, retains both its moulded deep skirting and a deep moulded plaster cornice to the ceiling; there is also an additional later 19th century elaborate plaster ceiling rose (Figure 18). The original stair to the second floor also survives in this house, with stair plate and bead-moulding to either side; it has been altered at second floor level. Of note in the southern house is Room 87, a kitchen, with a wide, tall open fireplace built into a stone chimney stack in the south wall; designed to hold a 'range' with a surviving simple beaded skirting of early to mid 19th century date (Figure 19). A 19th century cupboard built into the side of this fireplace also survives.

Figure 18: Plaster ceiling rose in the reception room of No.2 Hampton Terrace.
