LANGDON COURT HOTEL WEMBURY DEVON

Results of a Desk Based Appraisal,
Historic Building Appraisal & Impact Assessment

Report No.: 150107
Date: 07.01.2015
Authors: E. Wapshott
S. Walls

SWARCH were commissioned to undertake appraisal and impact assessment of the cellar at Langdon Court Hotel, Wembury, Devon. *Langdon Court Hotel is a Grade II* Listed house set within a registered park and garden and with a number of other Listed buildings located in close association.*

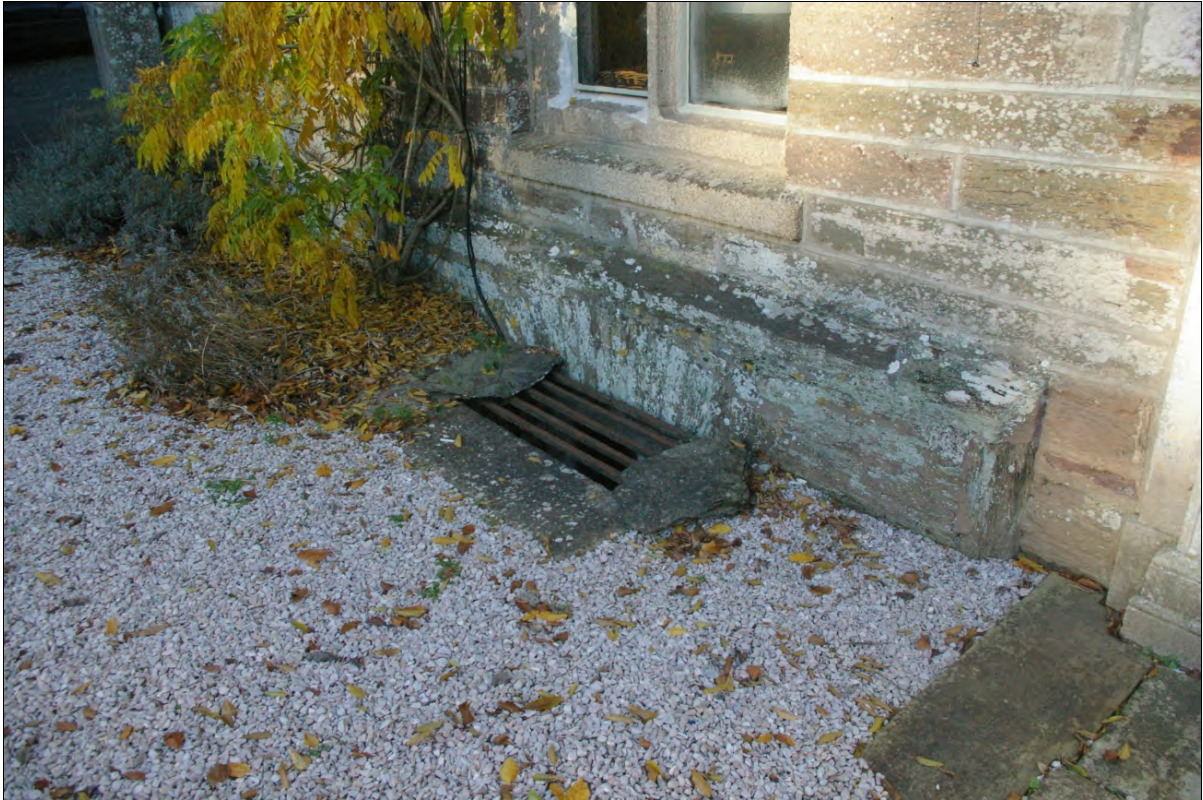
Detail of one of the light wells, with the segmental arch within the plinth; from the south-east.

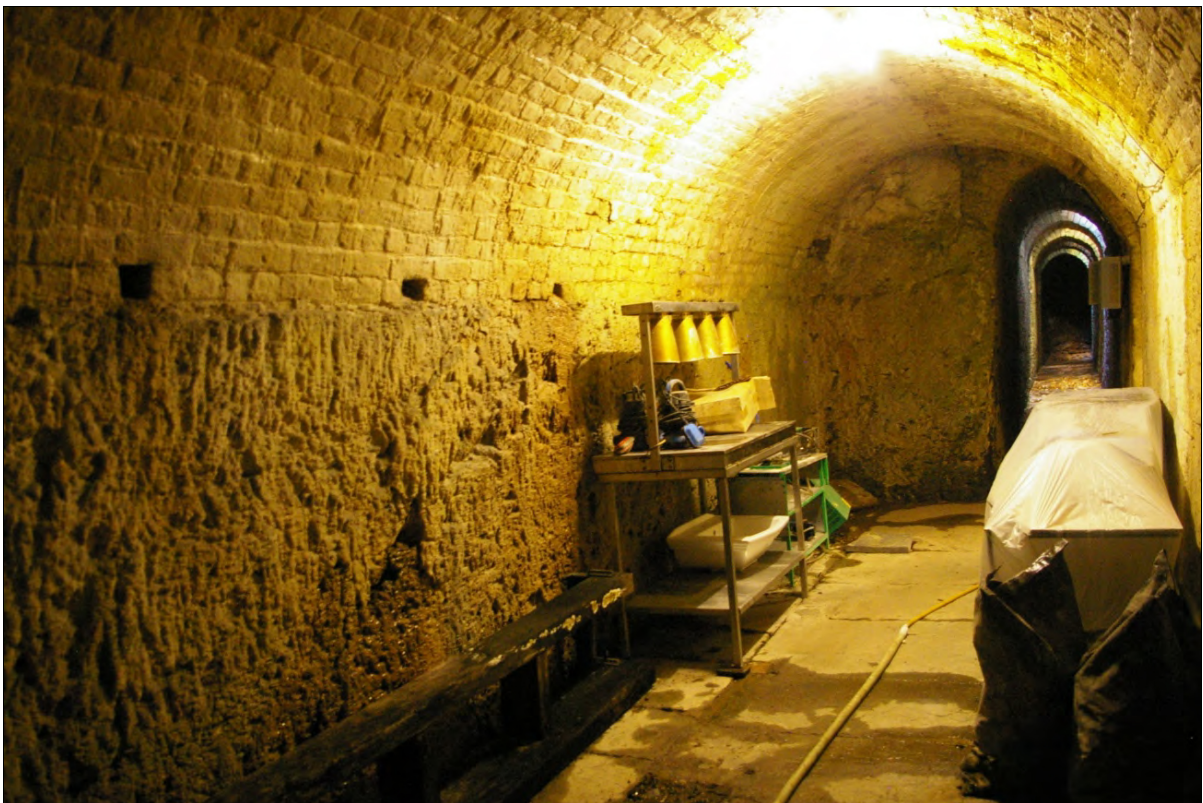
View of the south wall, cut out of the bedrock, within the vault in Area 4; from the north-east.

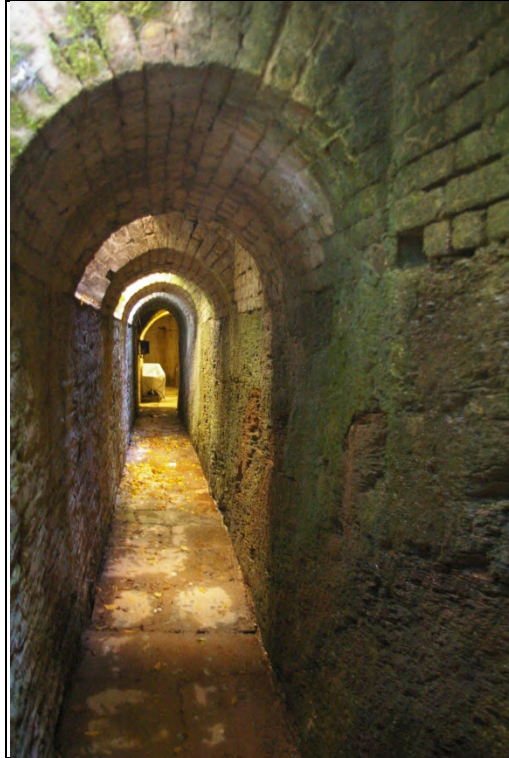
View down the drainage/air vent tunnel in Area 4; from the east.

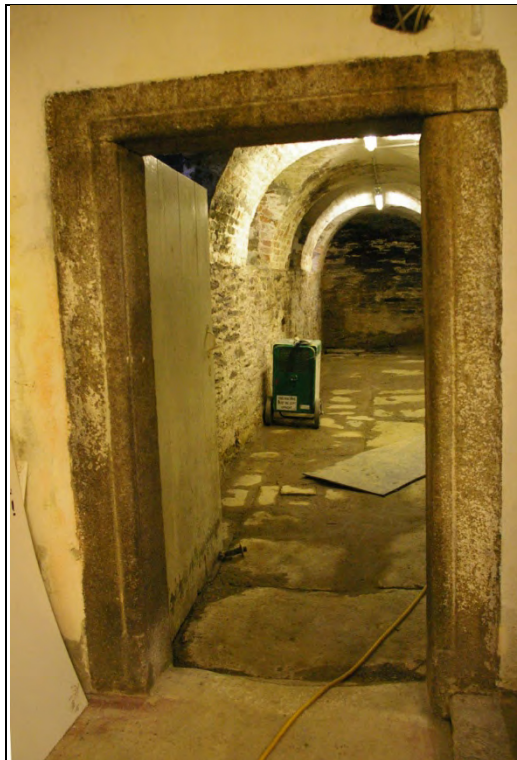
View through the granite moulded doorway between Areas 2 & 3; from the east, north-east.

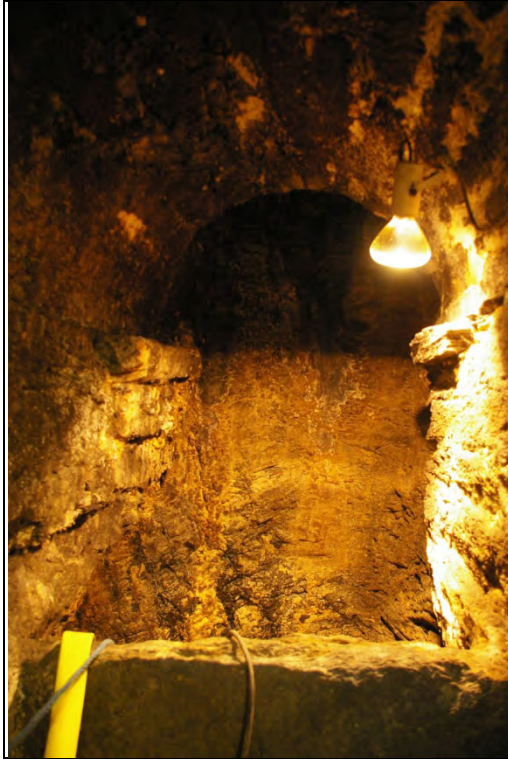
The well is especially interesting as it may be the earliest feature on the site, perhaps dating back to the medieval period and the earlier buildings. The bedrock around the well may have been altered to fit with the 18th century layout of the cellar. It is more likely that the well is contemporary with the re-building of the house, but an earlier origin should be considered a possibility.

View into the stone cut well shaft; from the south.

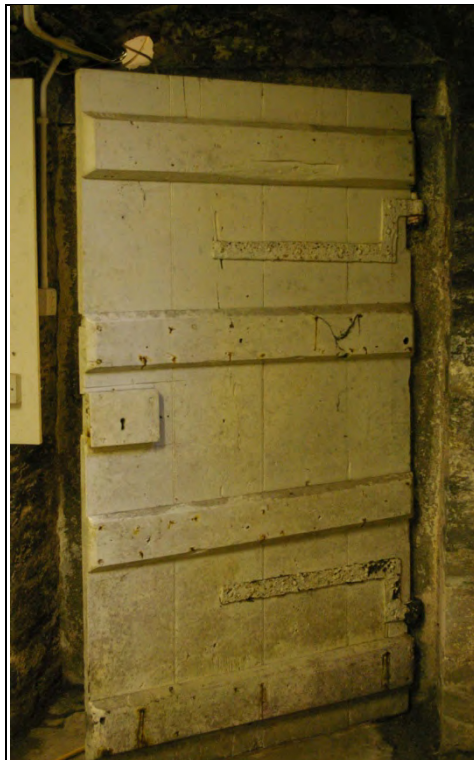
Detail of the secure 19th century plank door; from the west.

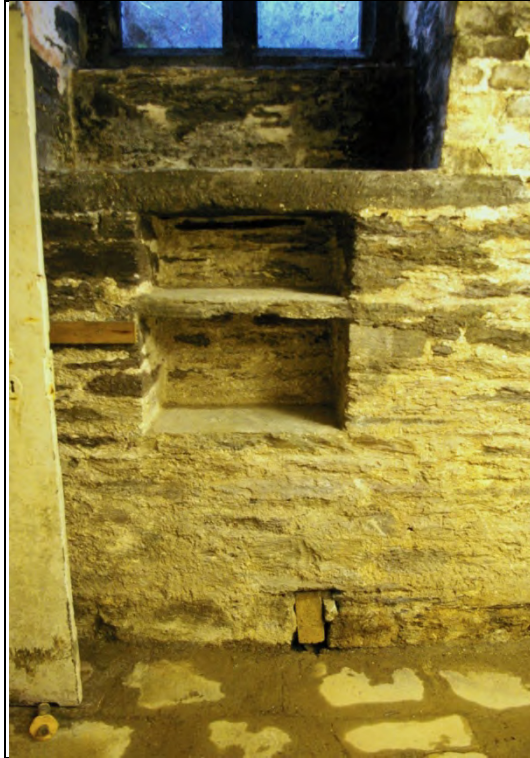
The keeping place in the south wall under the first window; from the north.

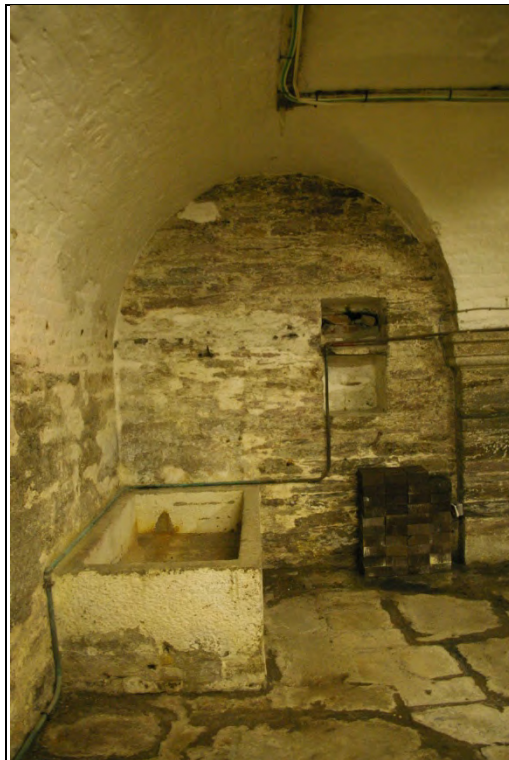
The east wall of the wine cellar, with keeping place and stone trough; from the west.

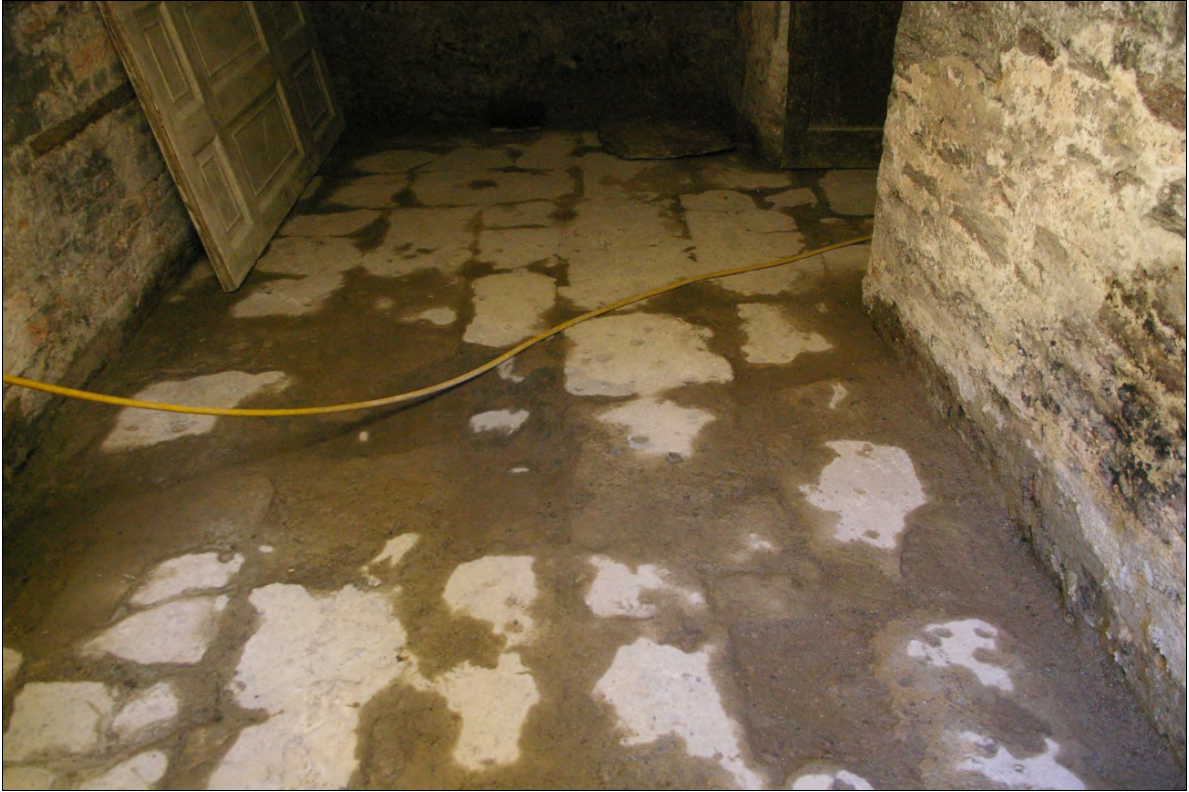
The stone slab floor in the lobby of Area 1; from the west.

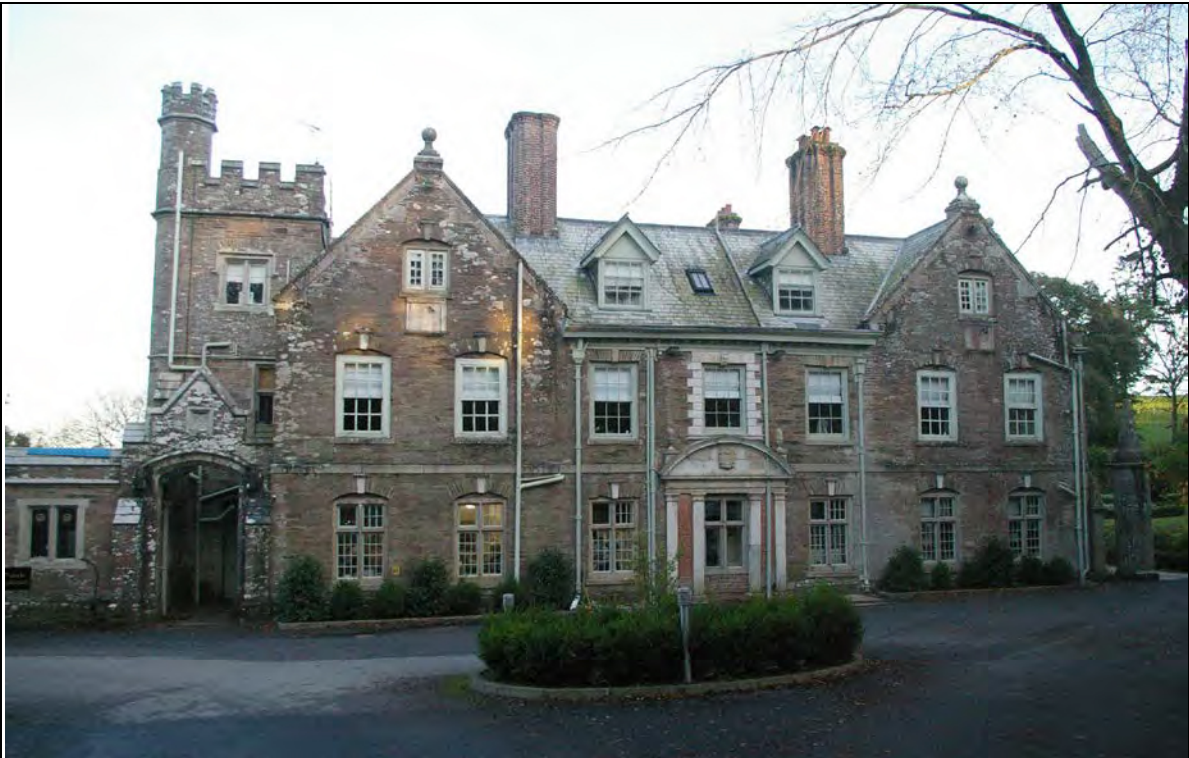
To the west elevation the coal hole is set into the ground, immediately south of the central doorway in the west elevation; the blocked delivery chute is set to the north. Both are framed in granite slabs slightly proud of the surface. As on the south elevation however, this does nothing to distract from the symmetry of the facade.

The west elevation of Langdon Court; from the west-north-west.
