BRICK HOUSE ST. NEWLYN EAST CORNWALL

Results of a Historic Building Assessment

South West Archaeology Ltd. report no. 160506

By N. Boyd & E. Wapshott
Report Version DRAFT01
29 April 2016

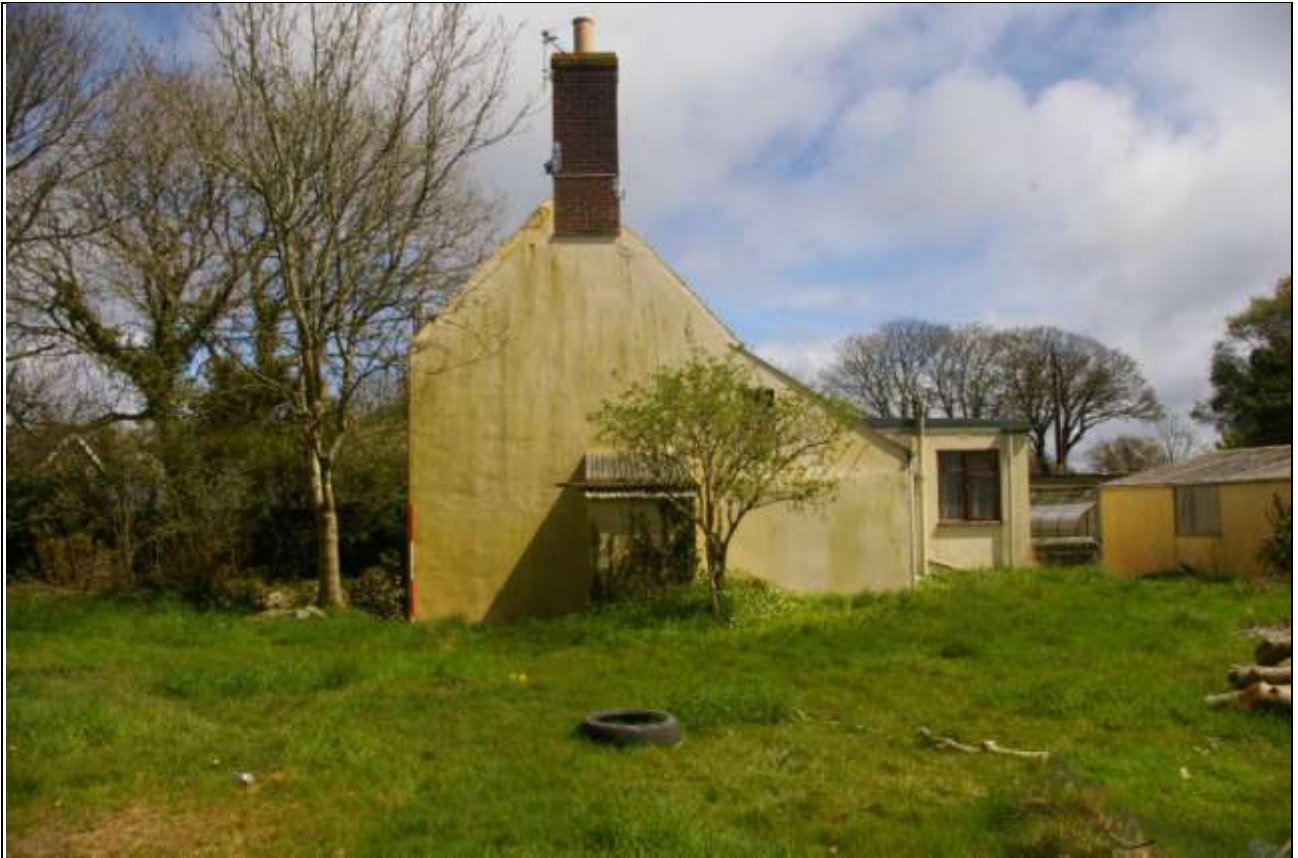
Concrete blocks can be seen in the west elevation of the main farmhouse which is heavily rendered and there may have been some strengthening works or repairs needed here. The upper part of both chimney stacks and the southern part of the west gable were completely rebuilt at this stage. The first floor within the farmhouse was also replaced, steel RSJs inserted to brace the building. This suggests that at some point in the 20th century the building may have fallen into disrepair, requiring more intensive renovations.

The west elevation of the farmhouse; from the west (2m scale).

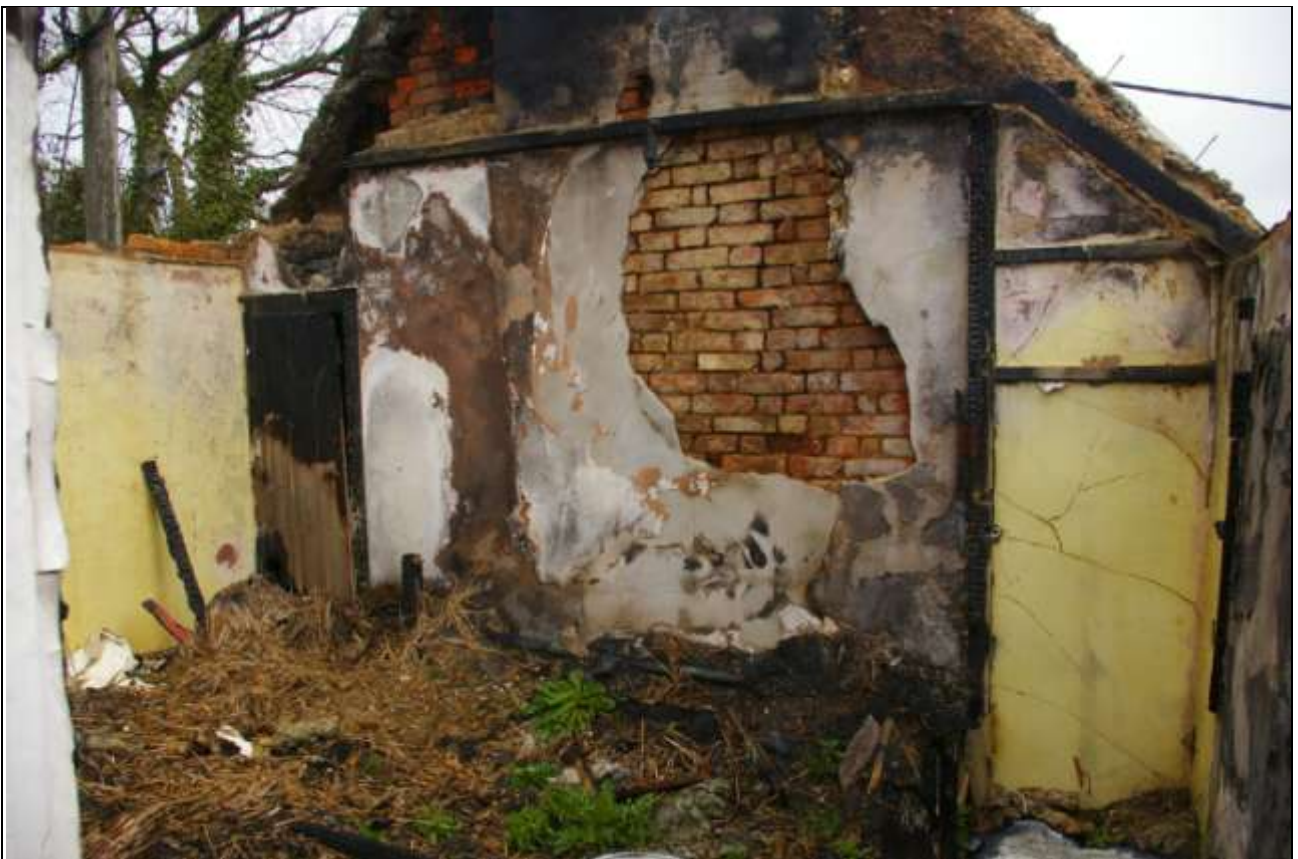
Room 12, the eastern chimney stack with small cupboard and surviving cob and lime plaster to the walls in places; from the south-west.

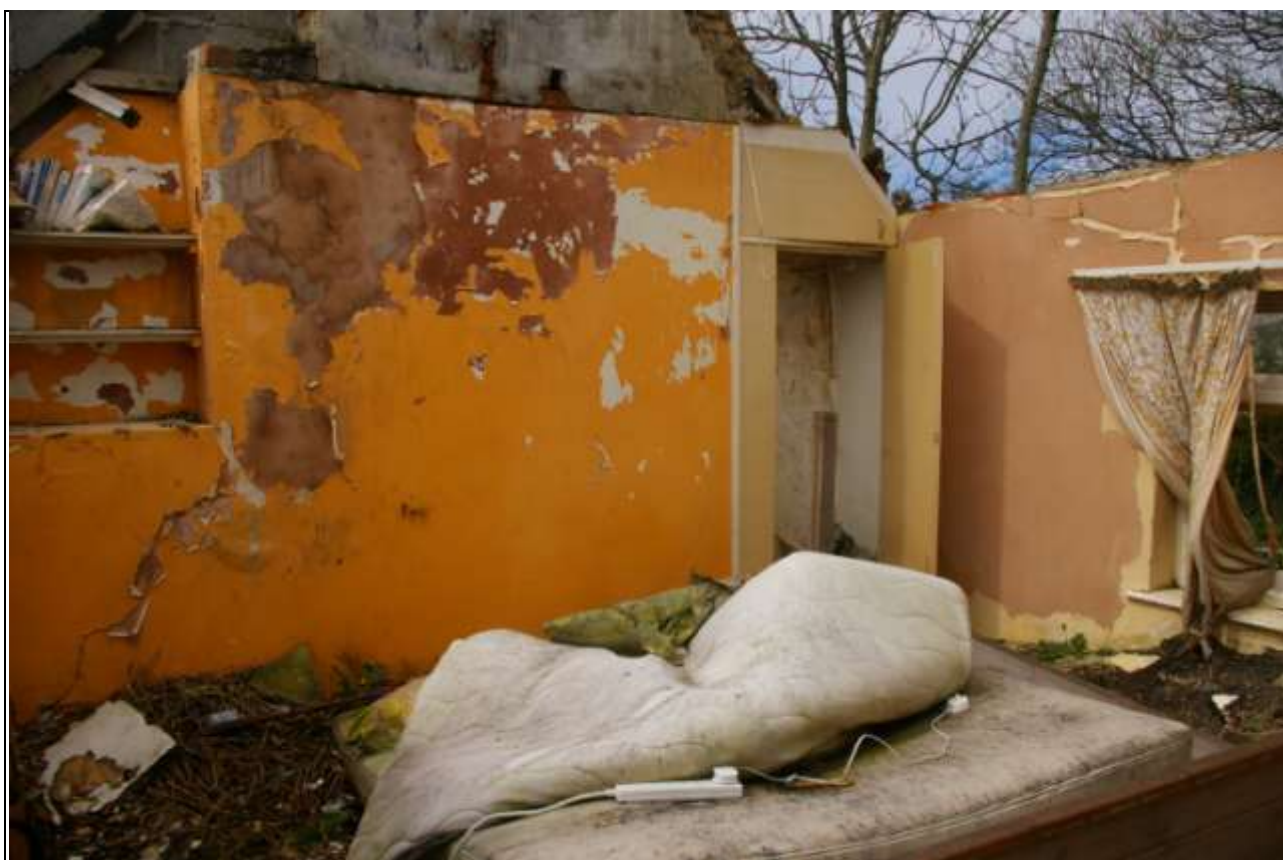
Room 14, showing the western chimney stack, possibly wholly 20th century in date, as much of elevation is rebuilt in concrete block, cupboard to north of stack, shelves to south may block a former window opening; from the east, south-east.

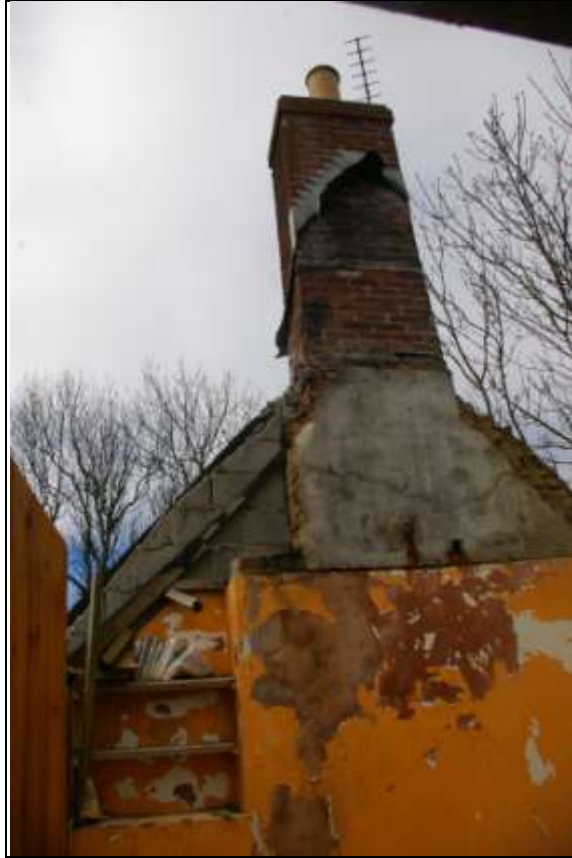
The western chimney stack, the upper shaft of which is wholly 20th century and much of the south part of the gable appears to have been rebuilt in concrete blocks; from the east, south-east.

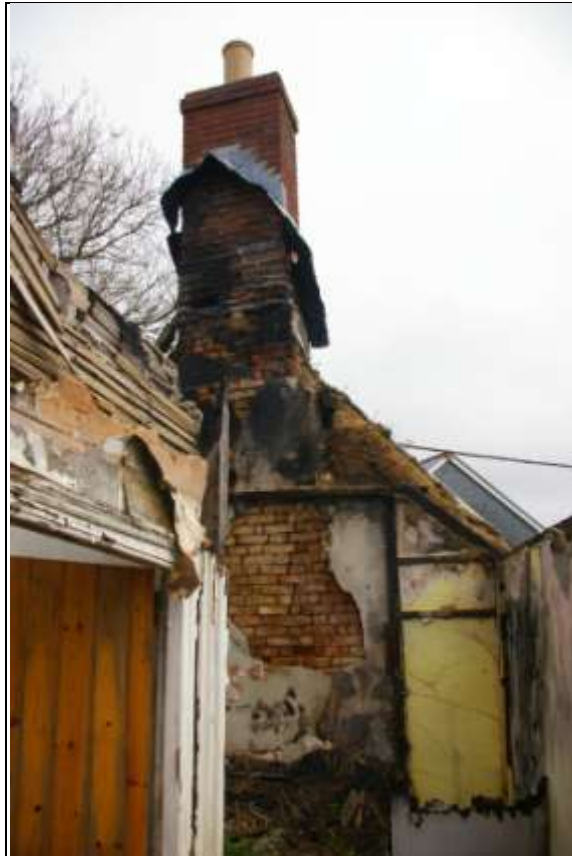
The eastern chimney stack, the upper shaft of which is in 20th century brickwork but the rest of which (and gable) all appears original, of historic brick and cob; from the west, south-west.

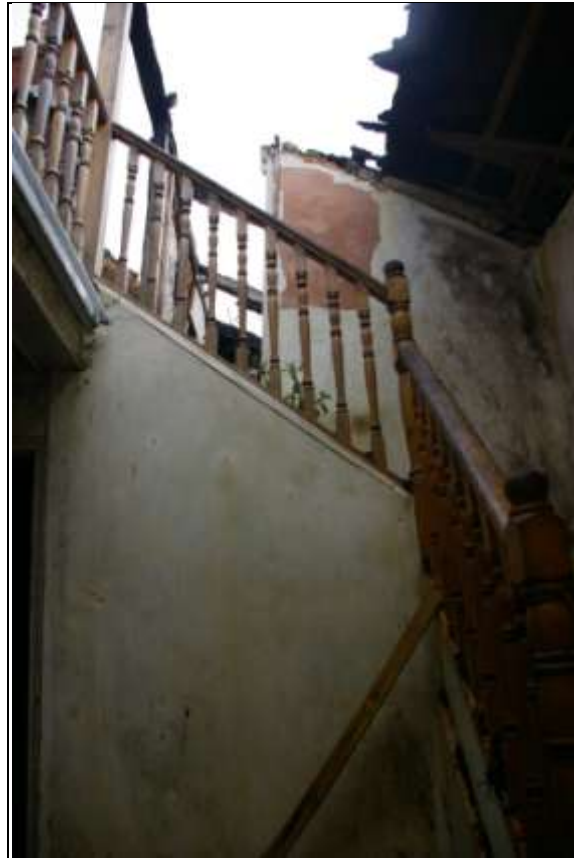
Room 2, the hallway, leading up to Room 11, the landing; showing the modern 20th century staircase and the lost roof; from the west.

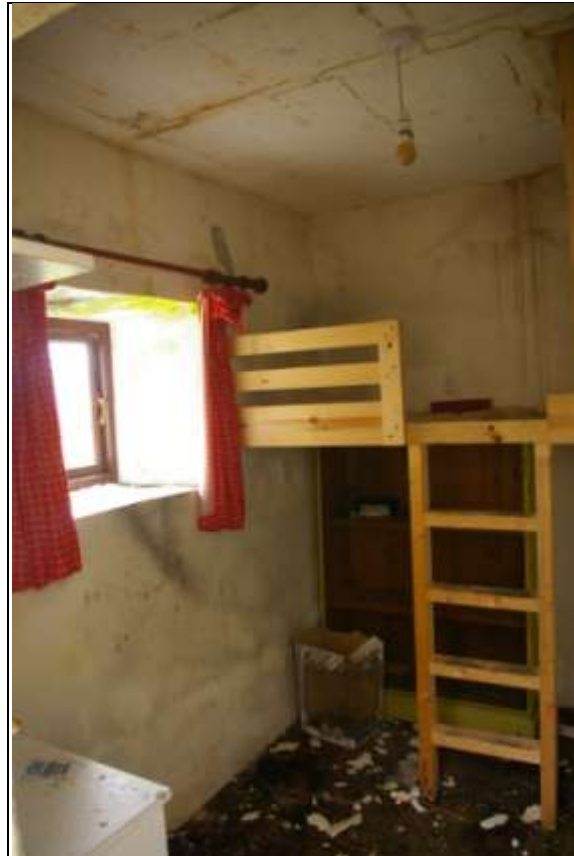
Room 7, wholly renovated and modernised, walls may have been partially replaced with concrete block in places; from the east, north-east.

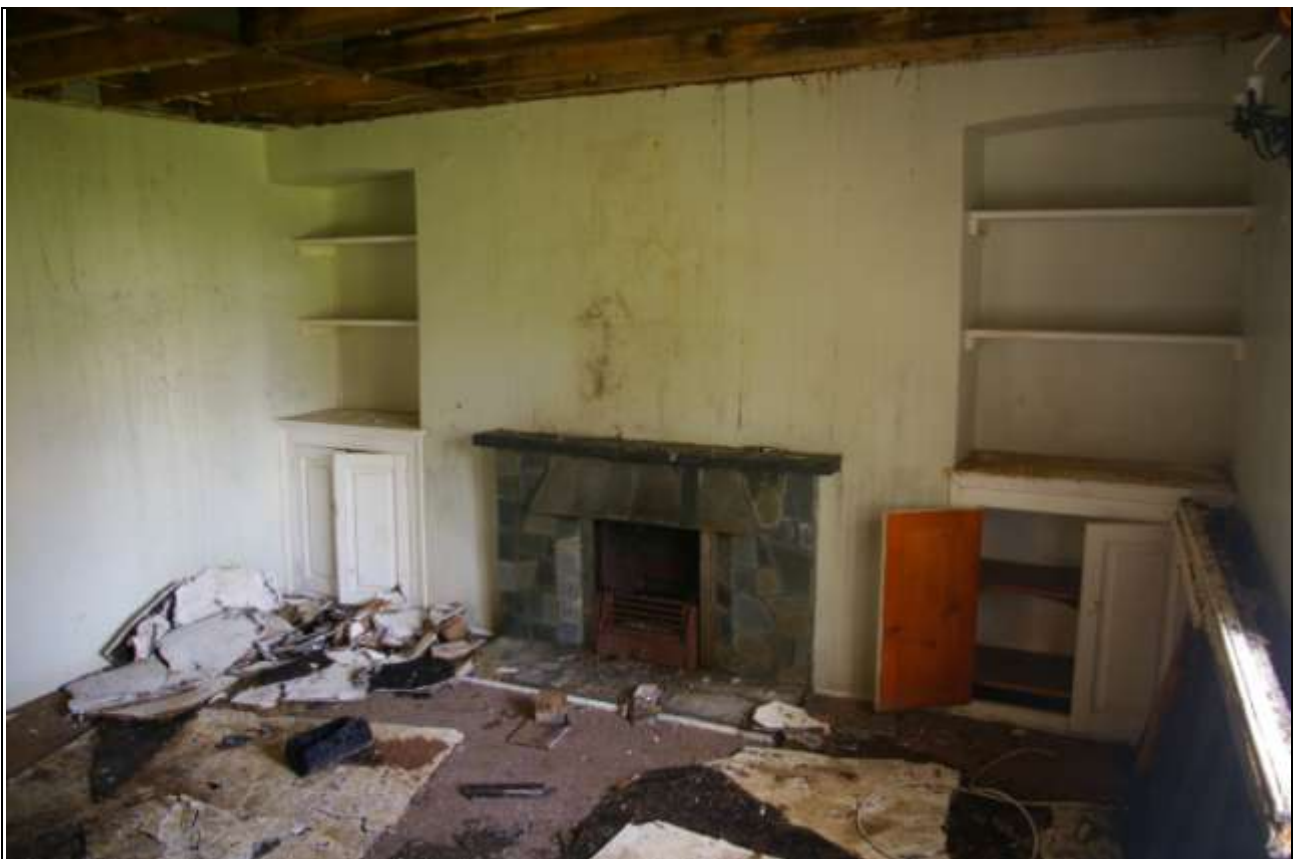
Room 1, showing modern fireplace within possibly replaced stack, ceiling is also 20th century, with steel RSJ inserted; from the north-east

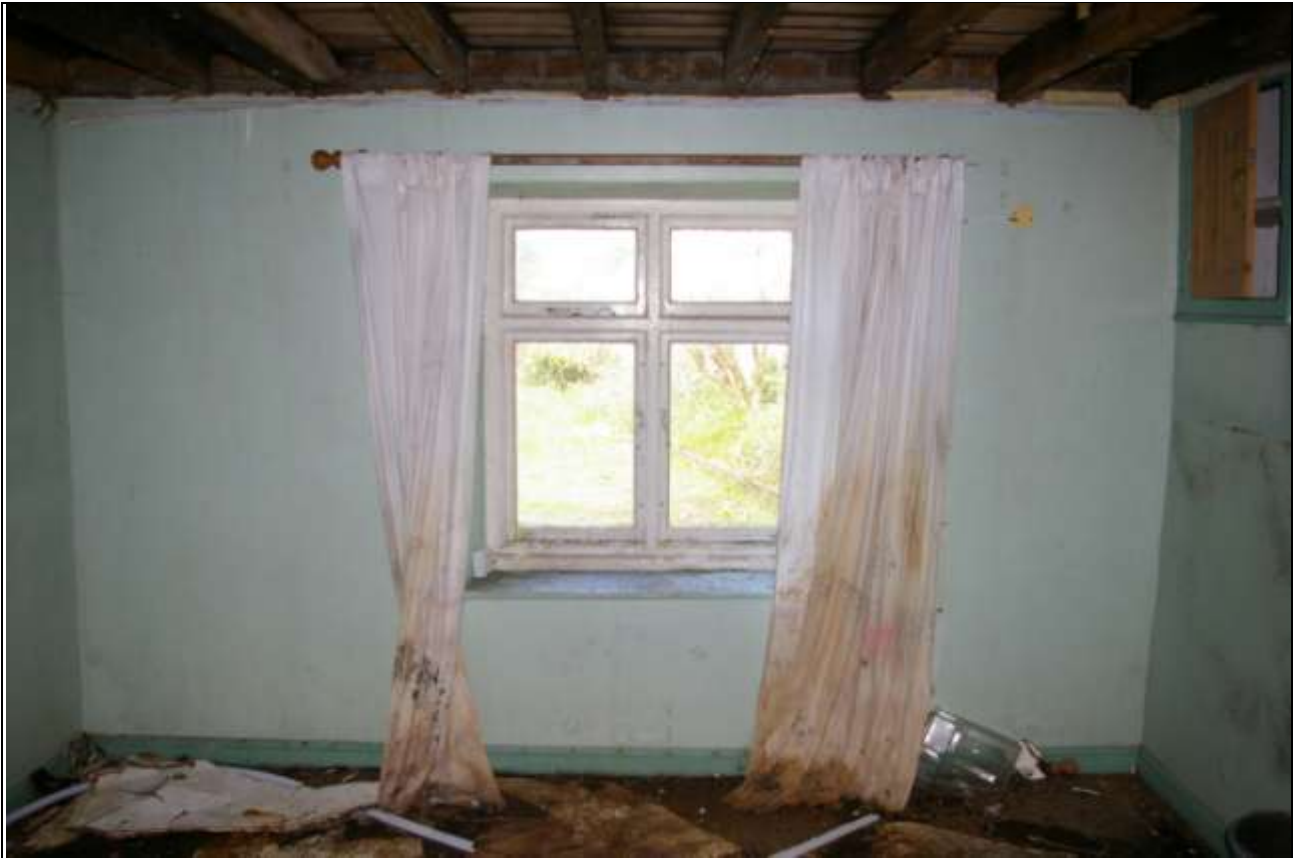
Mid 20th century replacement window in Room 3, also showing the 20th century ceiling with steel RSJ fitted; from the south.

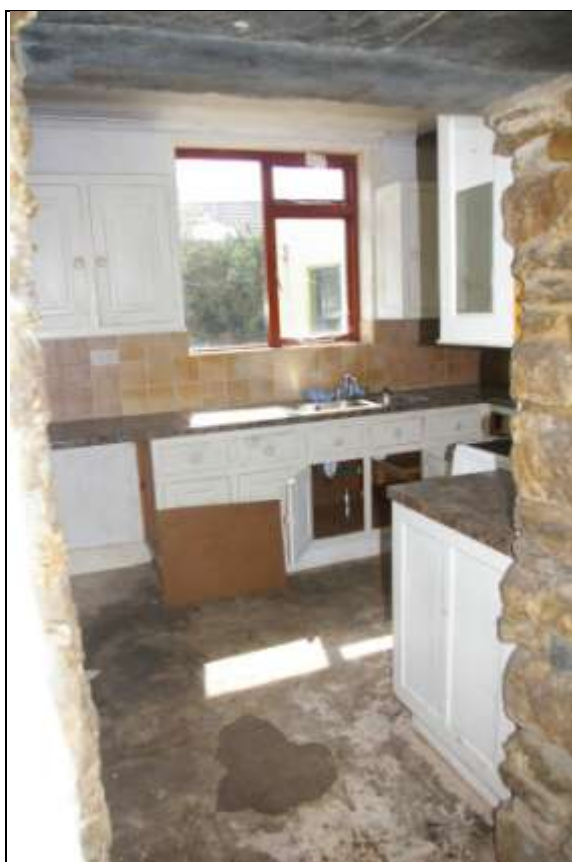
The modern kitchen (Room 5), viewed through the forced opening in the rear wall of the 19th century extension (Room 4); from the north, north-east.
