THE OLD FORGE MILL LANE, CHETNOLE DORSET

Historic Building Assessment

Report No.: 151226
Date: 26.12.2015
Authors: Colin Humphreys
E. Wapshott

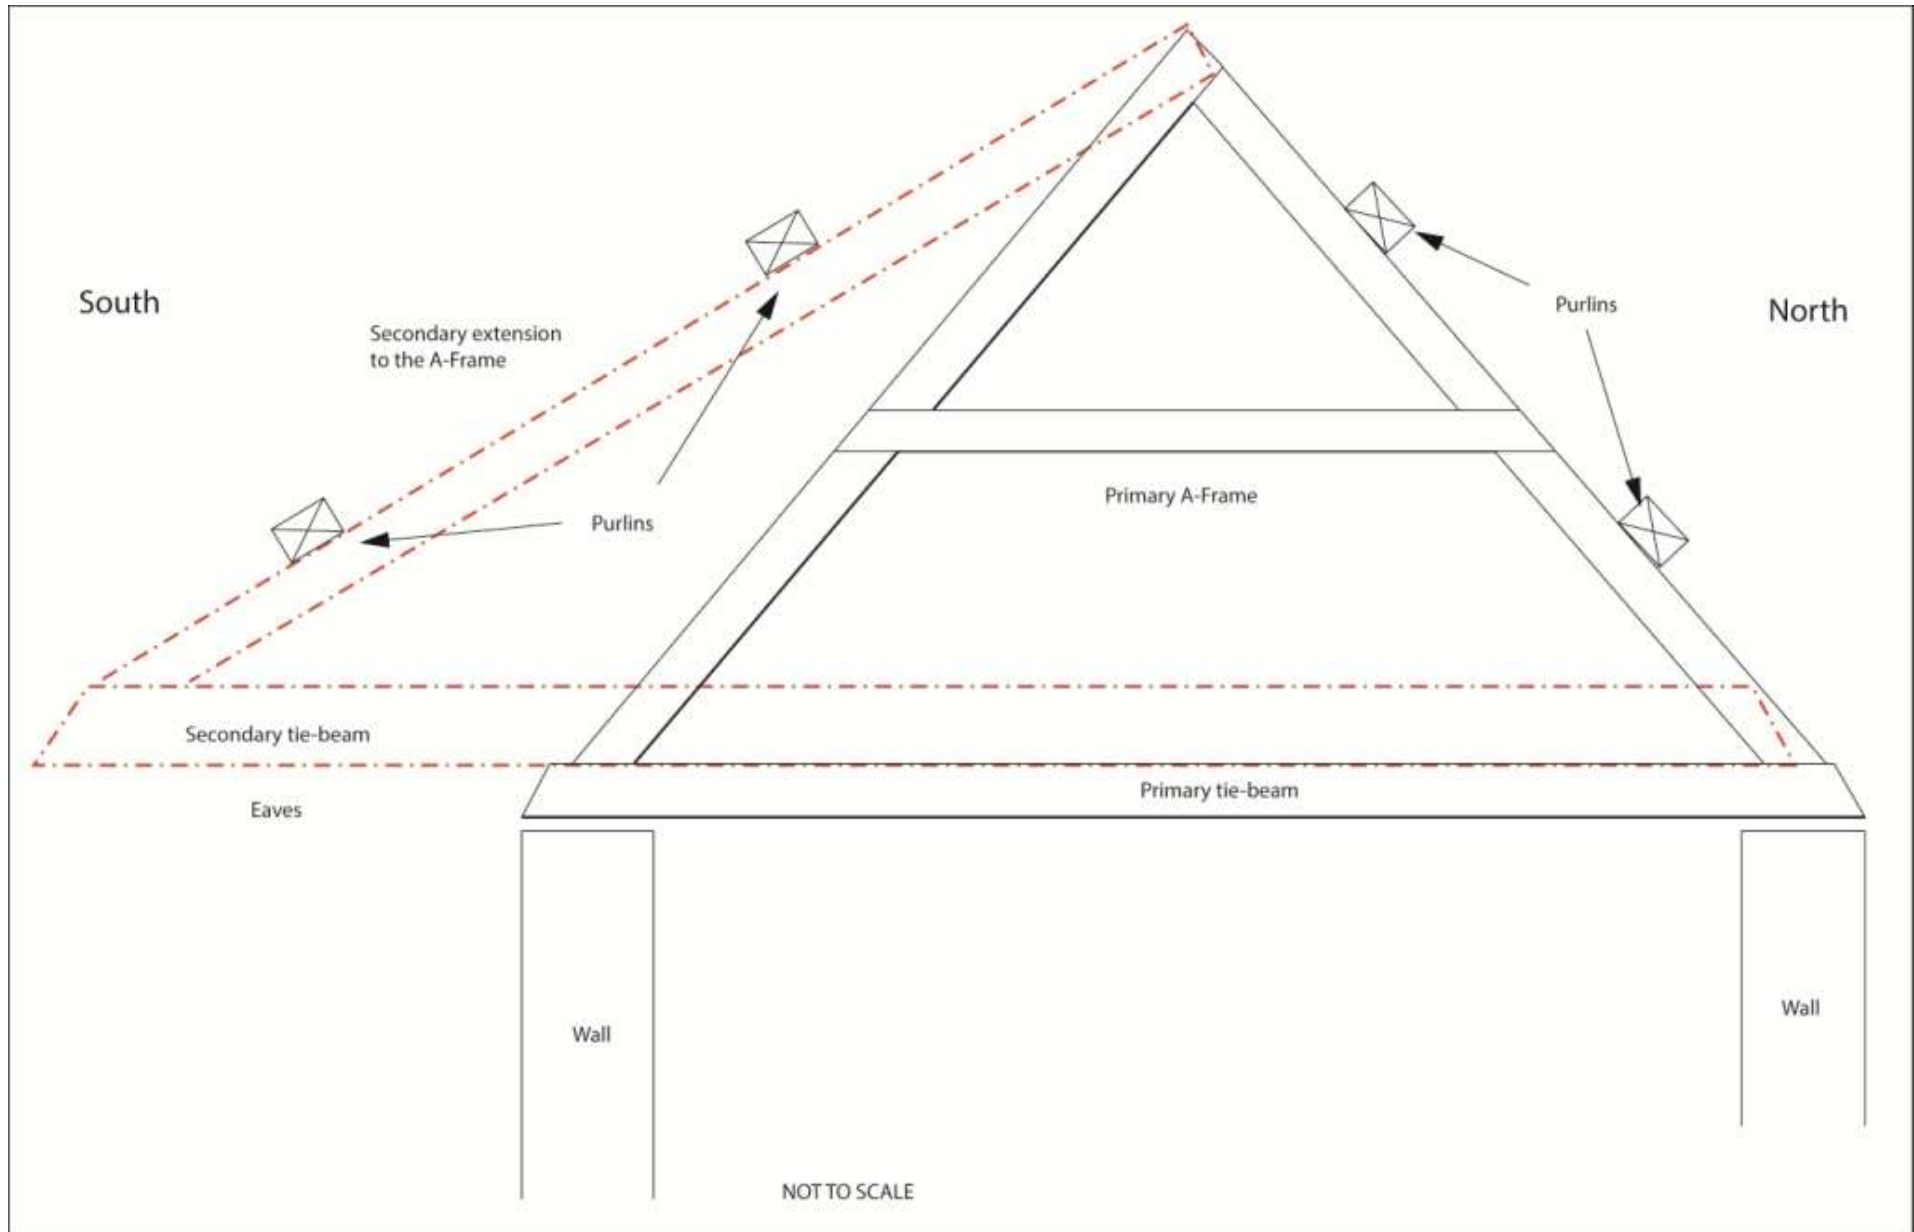
A secondary tie-beam is fitted adjacent and above each of the earlier A-frame tie-beams. This extends the full width of building and to the width of the new eaves and is spiked to the primary frame (see Figures 6 & 7). Mortice and tenoned in to this and face nailed to the apex of the primary A-frame is a single timber carrying a pair of purlins forming the roof pitch. Several extra timbers struts have been crudely fixed between parts of the major elements and may be later structural repairs. Each A-frame has had the same treatment.

Figure 6: Diagram of the roof structure showing the secondary elements that formed the deep eaves.

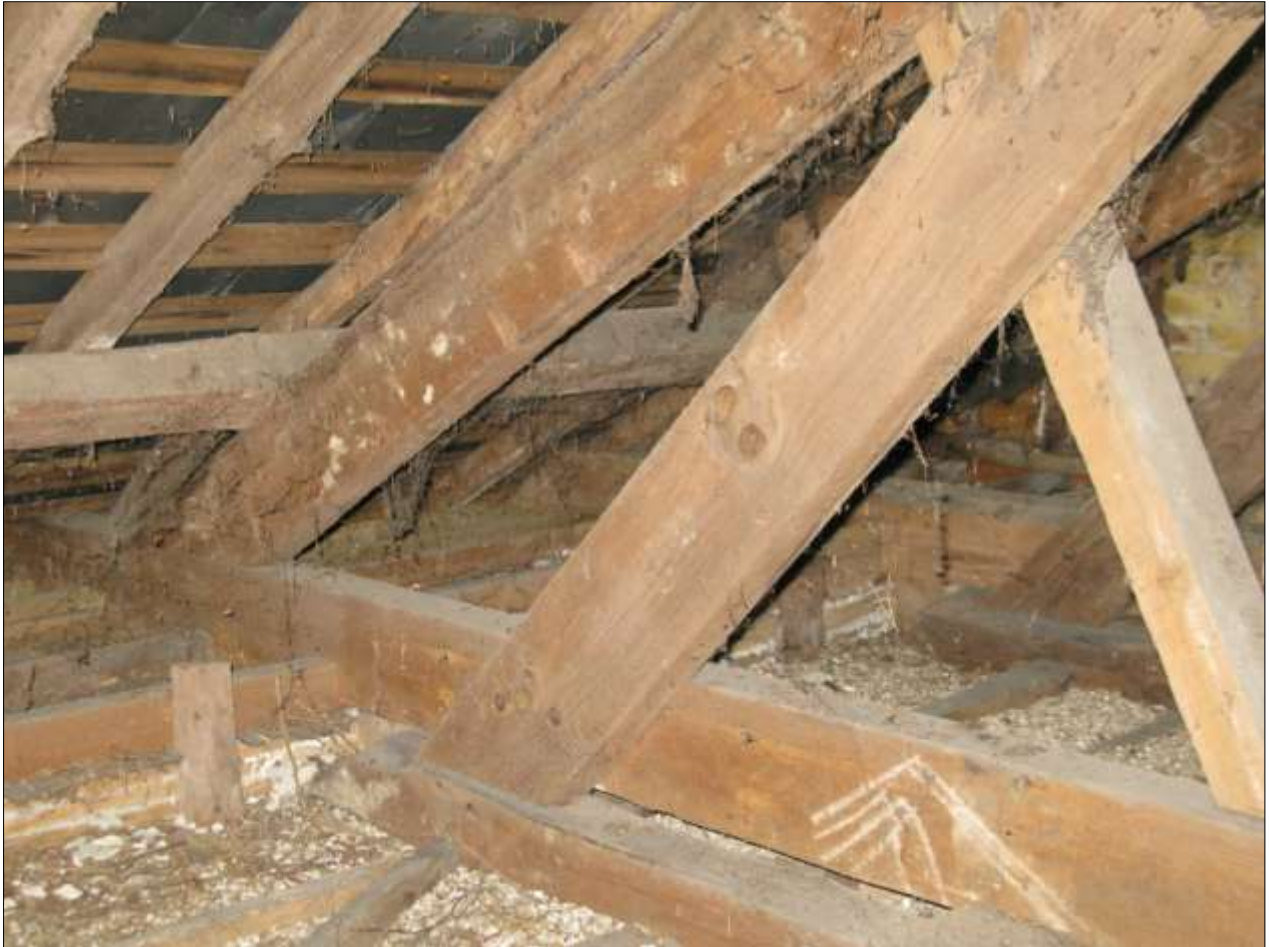
Figure 7: Truss showing the extra truss blade and secondary extended tie beam.

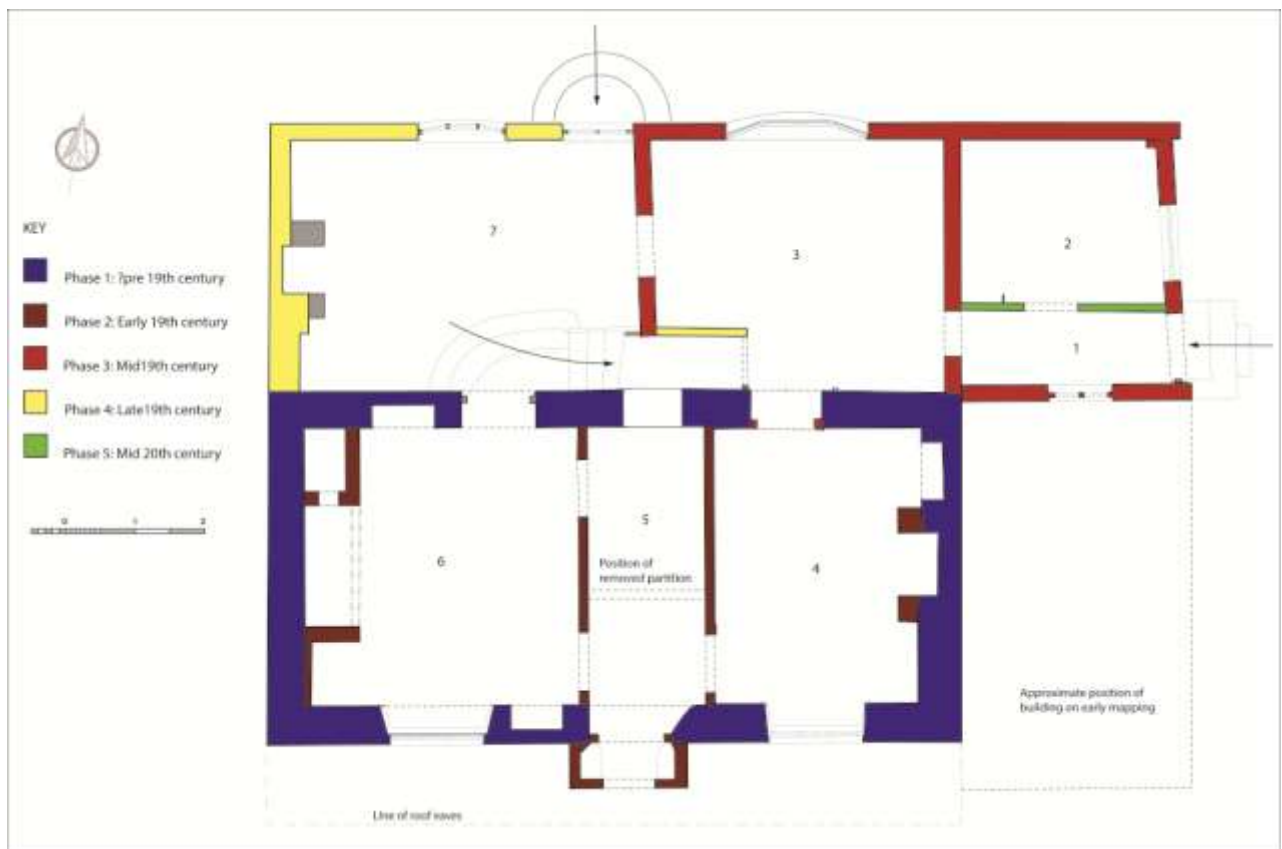
Figure 8: The Old Forge; ground floor phasing.

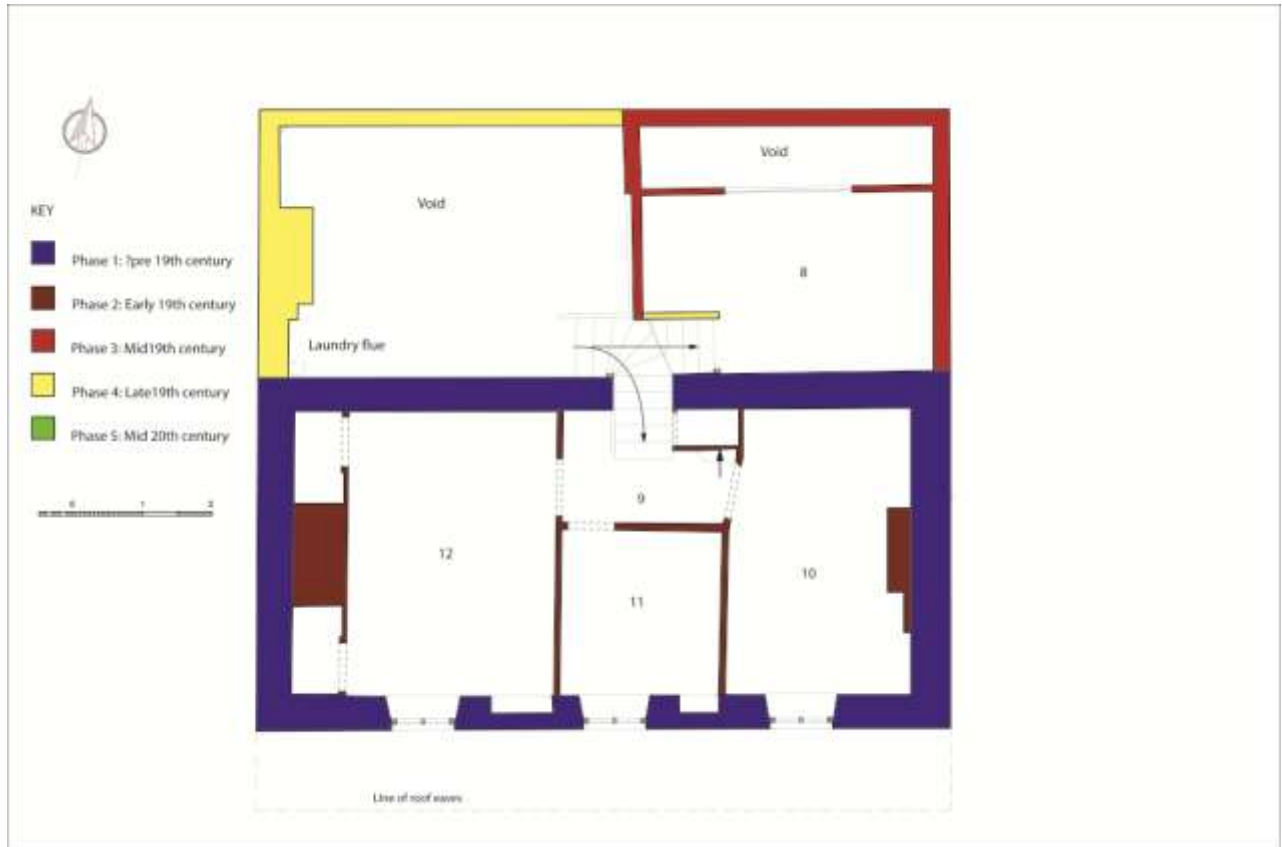
Figure 9: The Old Forge; first floor phasing.

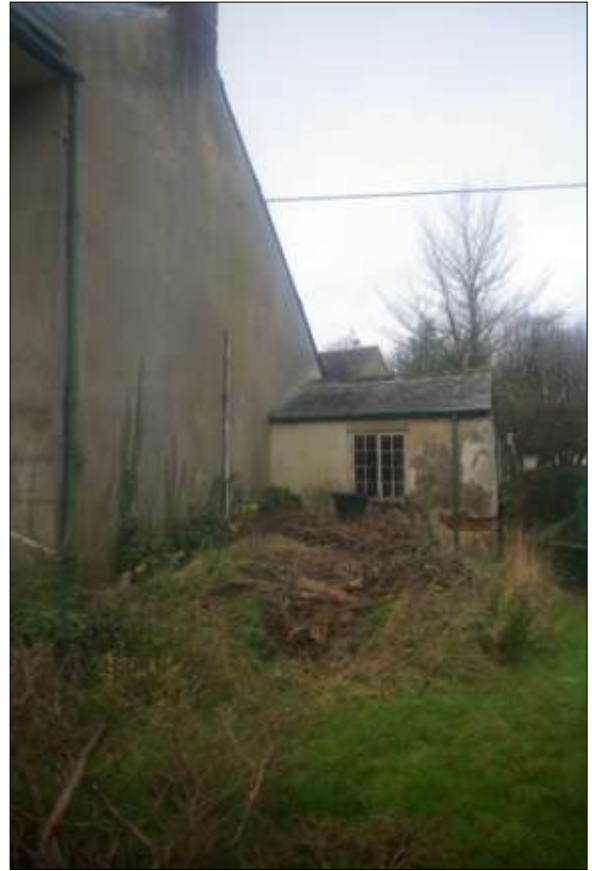
Elevation EAST		Description
Figure Numbers:		Fig 11
Fabric Description:		Stone elevation, patched with brickwork, rendered.
Roof Covering		Gable-end elevation, slate roof, timber barge boards.
Drainage/Guttering		Cast-iron guttering and down pipe.
Relationships:		Cohesive with the south, west and north walls, not with the brick extensions. This elevation is of first phase, abutted by the east elevation of the brick extension.
Significant Details:		A brick flue and blocked hearth occupies the space south of the stack, on the exterior of this elevation. This flue has been forced into the earlier stone structure and appears to have served an extension to the east which was demolished in the early 20 th century. Visible within the internal face is much timber lacing and patched brickwork, bracing the flue, which rises against the earlier stack. Did this flue serve the former forge, which is now lost?

Figure 11: Raised area (probable remains of a demolished extension) to the east of the house.

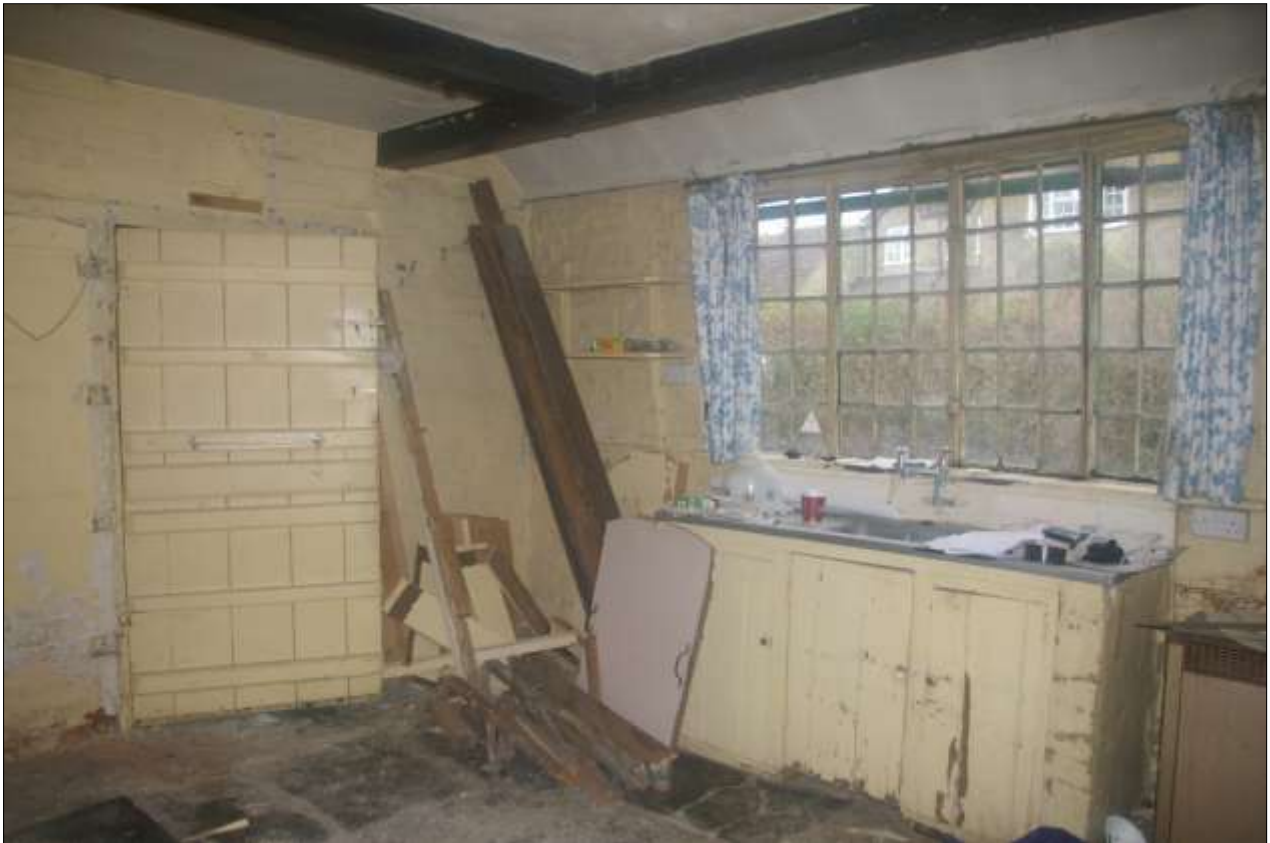
set, but all differ slightly in style and colour.
Interior – Room 3		
Description		
Function:		Kitchen, former dairy or service room extension.
Figure Numbers:		Fig 13
Walls:		The north, east and west walls are of brick, of single brick's width, painted internally, in cream. The south wall is the former rear wall of the stone building, formerly covered by lathe and plaster and painted, but the stonework is now exposed.
Floor:		Stone flagstone floor, set in a sand/lime mix. In good condition, with very large square slabs being used.
Ceiling:		Lathe and plaster ceiling, painted.
Opening – Doors:	2	Door to room 4 – four panel plain door, in wide beaded frame, brass door knob and large iron lock and key. The door is accessed via a short flight of steps, room 3, being lower in level than room 4. Timber handrail to right side of steps. Timber threshold to doorway. Door to room 7 – Uneven width plank boarded door, with bead moulding, with multiple, deep but narrow ledging bars. Formerly a stable door, but fixed shut, with added ledging bar, across join. Long tapering handmade strap hinges. Iron thumb latch and wood block lock, with large keyhole. Narrow plain timber frame.

Figure 13: Room 3 from the south east showing former external 'stable' door.

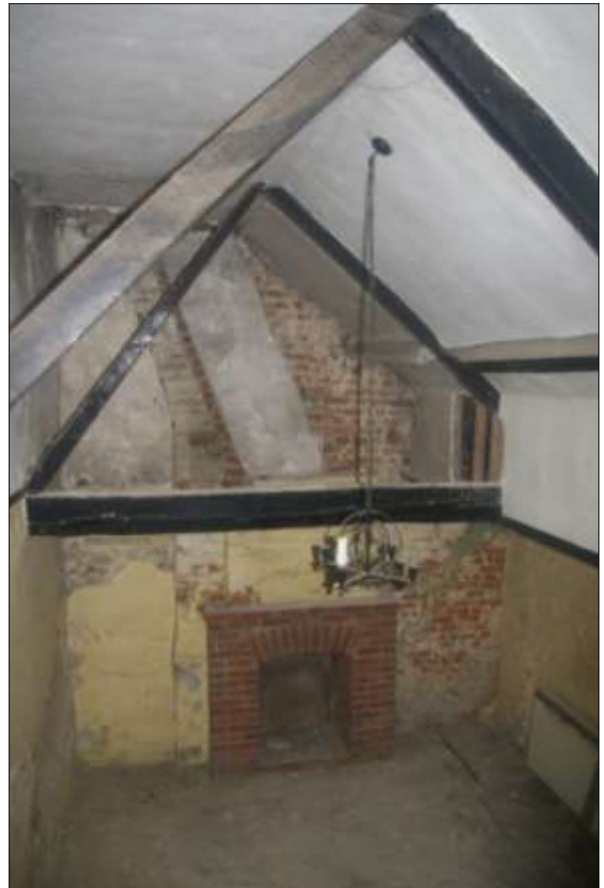
This feature may have been previously identified as associated with a former forge, but no evidence of that survives and the hood of plaster and timber would not have been for a forge.
Fireplace:		There is a large open hearth framed in mid 20 th century brickwork, on the west wall.
Comments:		This room may have previously been a small open yard, serving the dairy/service extension to the east, before being enclosed in the second phase of extensions. This may explain the worn nature of the floor and exterior doors seen serving this space in both rooms 3 and 6.
Interior – Room 8		Description
Function:		First floor store/loft.
Figure Numbers:		
Walls:		Stone wall to south, former rear wall of first building. Plastered and painted. The west wall is of lathe and plaster partition, with straw, painted. The east and north walls are part brick and part lathe and plaster, set into the eaves of the deep catslide roof over the extensions.

Figure 18: Room 7 viewed from the stair showing the scar of the laundry hood to the left of the fireplace
