Devon County Council Historic Environment Record

Civil Parish & District: Bere Alston, West Devon	National Grid Reference SX 43247 65000	Number:
Subject: Archaeological monitoring and recording on land adjacent to Weir Cottage		Photo attached? YES
Planning Application no: 0408/16/HHO	Recipient museum: Plymouth City Museum	
OASIS ID: Southwes1-262965	Museum Accession no: N/A	
Contractor's reference number/code: WQC16	Dates fieldwork undertaken: 21 st & 26 th September 2016

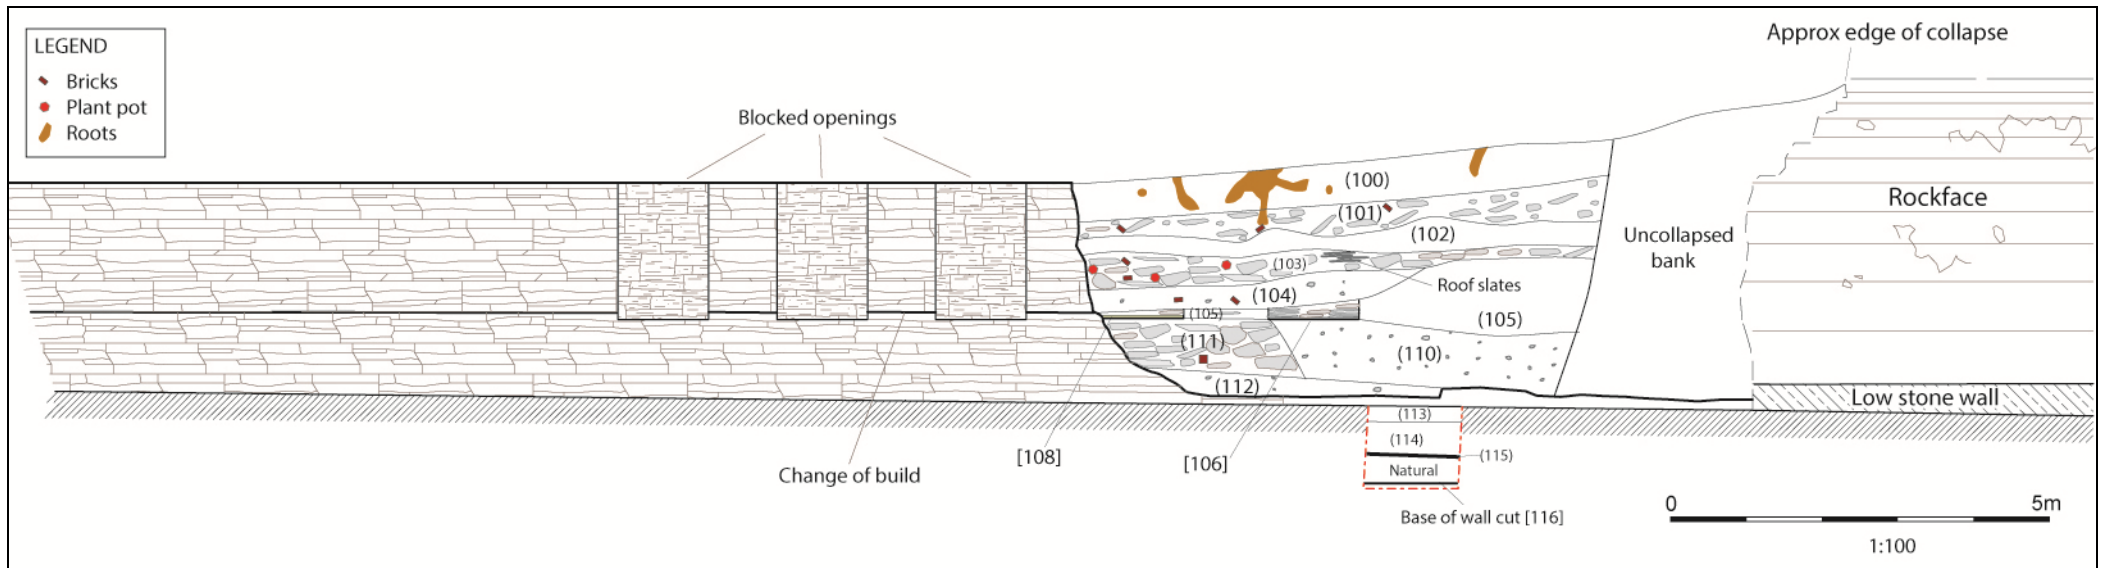
The stratigraphy behind the wall comprised of a series of layers ((100), (101), (102), (103), (104)) of rubble infill, rubbish and dark brown friable silts with heavy root intrusions c.1.4m thick, which had been backfilled up against the wall, probably in the 20th century. Infilling behind the raised wall, perhaps during garden landscaping for the property to the north, ultimately contributed to its collapse. These layers contained plant pot fragments, common bricks, industrial slipwares, the remains of an iron bucket and a few roof slates. Below layer (104) was a layer of relatively clean greyish-yellow friable silt-clay with occasional stones (105), this appears to have been cut into by two features [106] and [108]. These cuts represent traces of the subsequently infilled chutes/vents in the wall. Feature [106] was the more obvious of the two features, as it had a thin layer of coal surviving at the base of the cut, and had

Figure 2: Elevation/section showing the wall and deposits exposed behind, prior to grading.

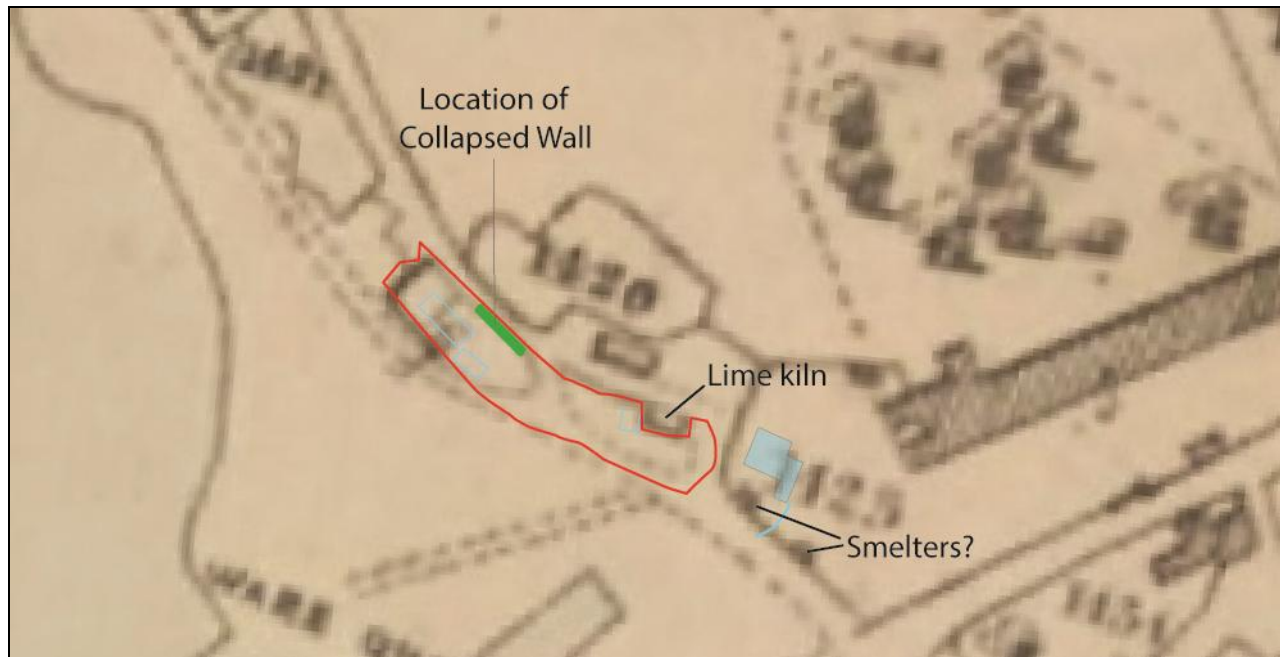
The former existence of a trackway which bisected the approximate location of the wall on the tithe map (see Figure 3) was not apparent in the exposed or scarped back section. The exact location was not identified in the scarped back section, which may suggest that it was located slightly further to the east than the collapse, perhaps obscured by the un-collapsed section of bank. The increasing thickness of deposit (105) may suggest that this relatively clean material had been used to backfill the track in the 19th century, and would suggest that the wall postdates 1840, although was in existence prior to the 1st edition map. It would appear likely that it was built following the demolition of the 'house' at the western end of the plot.

Figure 3: Extract of the Bere Alston Tithe Map, the approximate location of the site is bounded in red, with the present sheds and Cobblestone Cottage shown in blue.

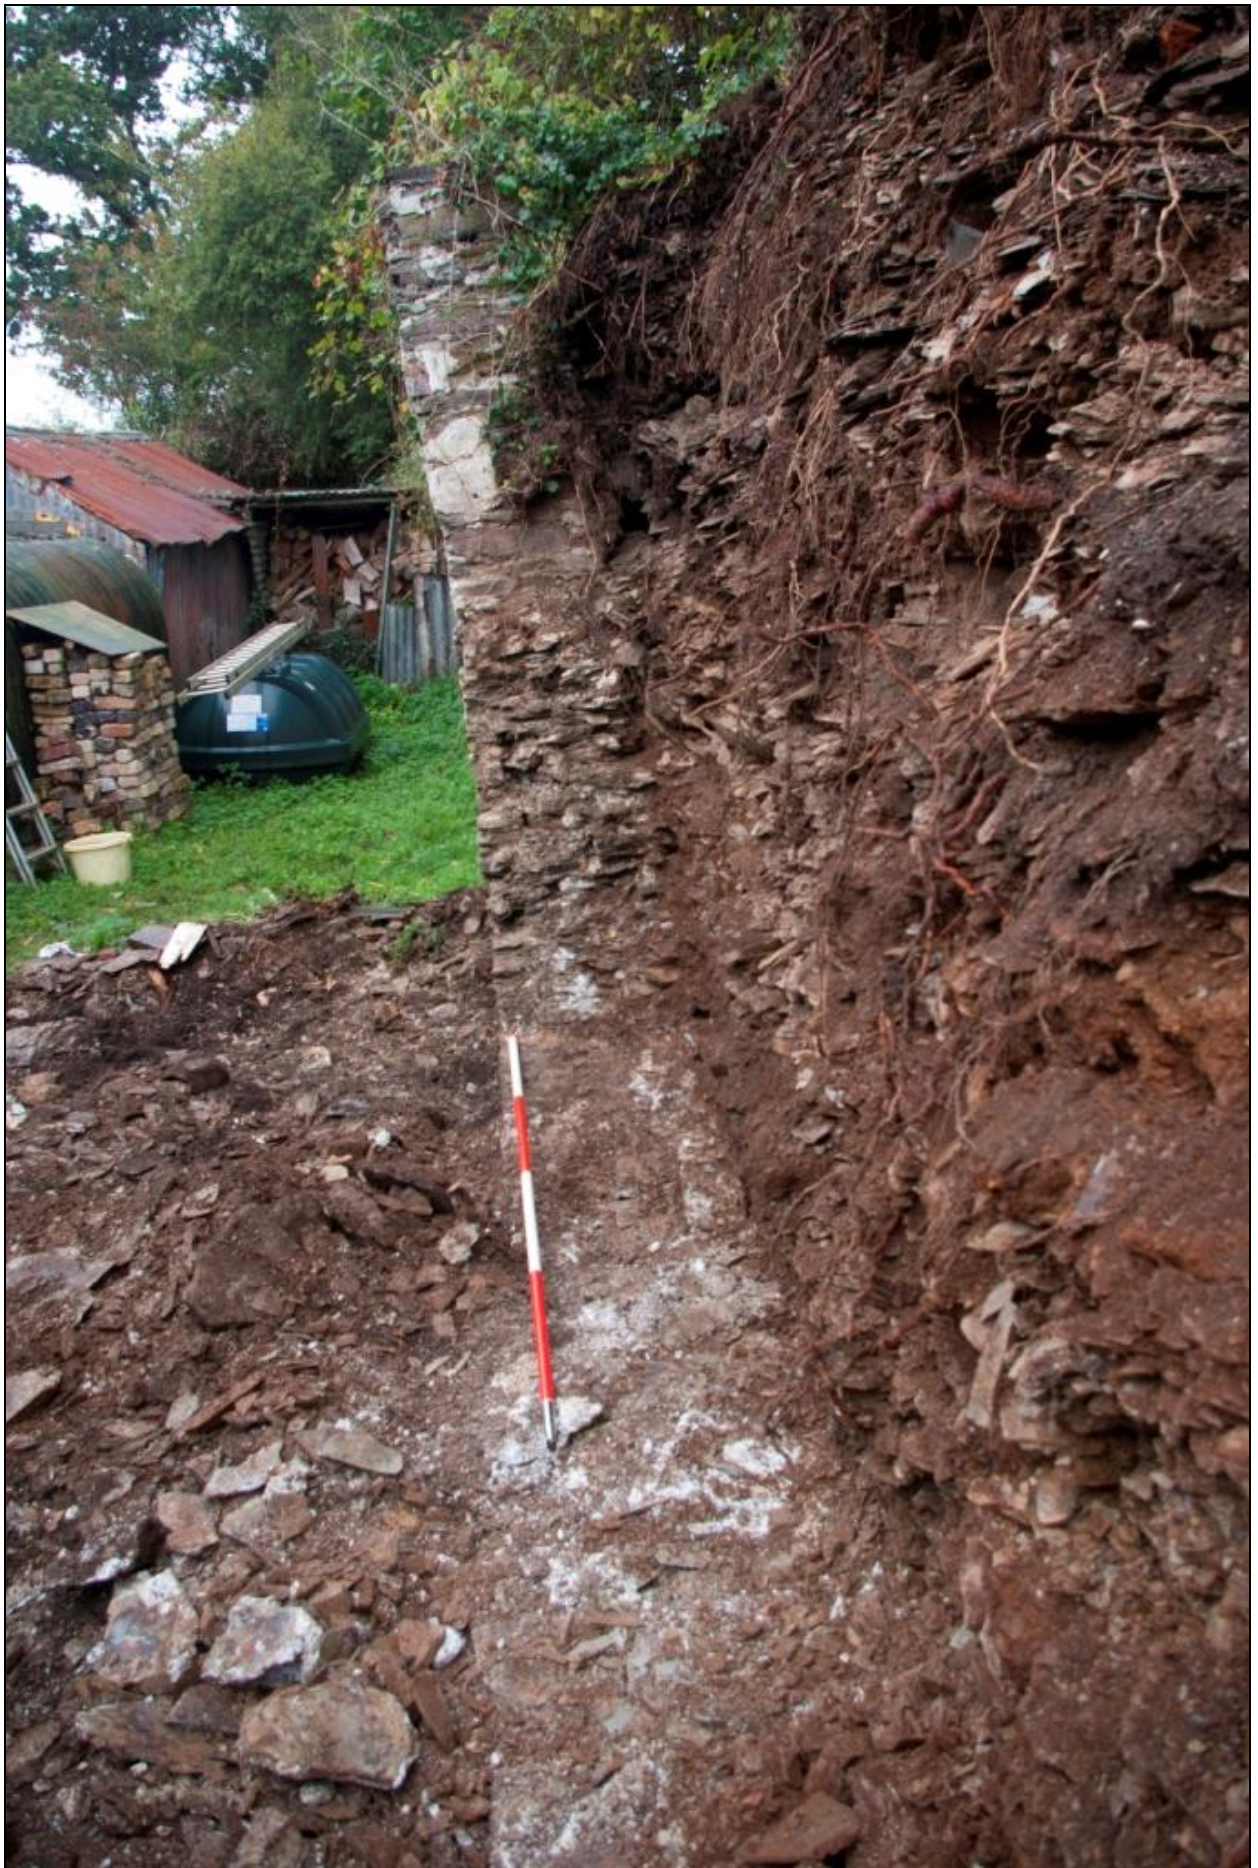
The retaining wall that had collapsed consisted primarily of a 20th century re-build of an historic structure. The footings of the historic (19th century?) wall survived beneath the collapse (see Figure 4). The historic wall appeared to be c.2.9m high, and consisted of three distinct phases of build in the surviving fabric to the west. The excavation of the sondage through the footing revealed that this extended c.1m in depth, with the ground within the proposal site having been raised by around 0.5-0.6m. The lower portion of wall (c.1.3m above present ground level; 2.3m in total) was of tightly packed and roughly coursed blocky stone with a very hard and clean white lime mortar with rare coal fragments. The clean nature of the lime bond perhaps indicative that it hadn't travelled very far, i.e. from the nearby lime kiln.

been packed with some stone, presumably at the point of infilling. Cut [108] was barely visible, and was largely demonstrated by the clear straight join apparent in the standing structure; this was subsequently removed due to the possibility of further collapse, as apparent in Figure 4.

Figure 4: Shot of historic wall footing (scale 2m). Note the lean on the remaining historic wall, the upper corner was removed prior to the rebuilding.
