# LAUNDRY COTTAGES PENROSE ESTATE PORTHLEVEN, CORNWALL

Results of an Interpretive Historic Building Survey

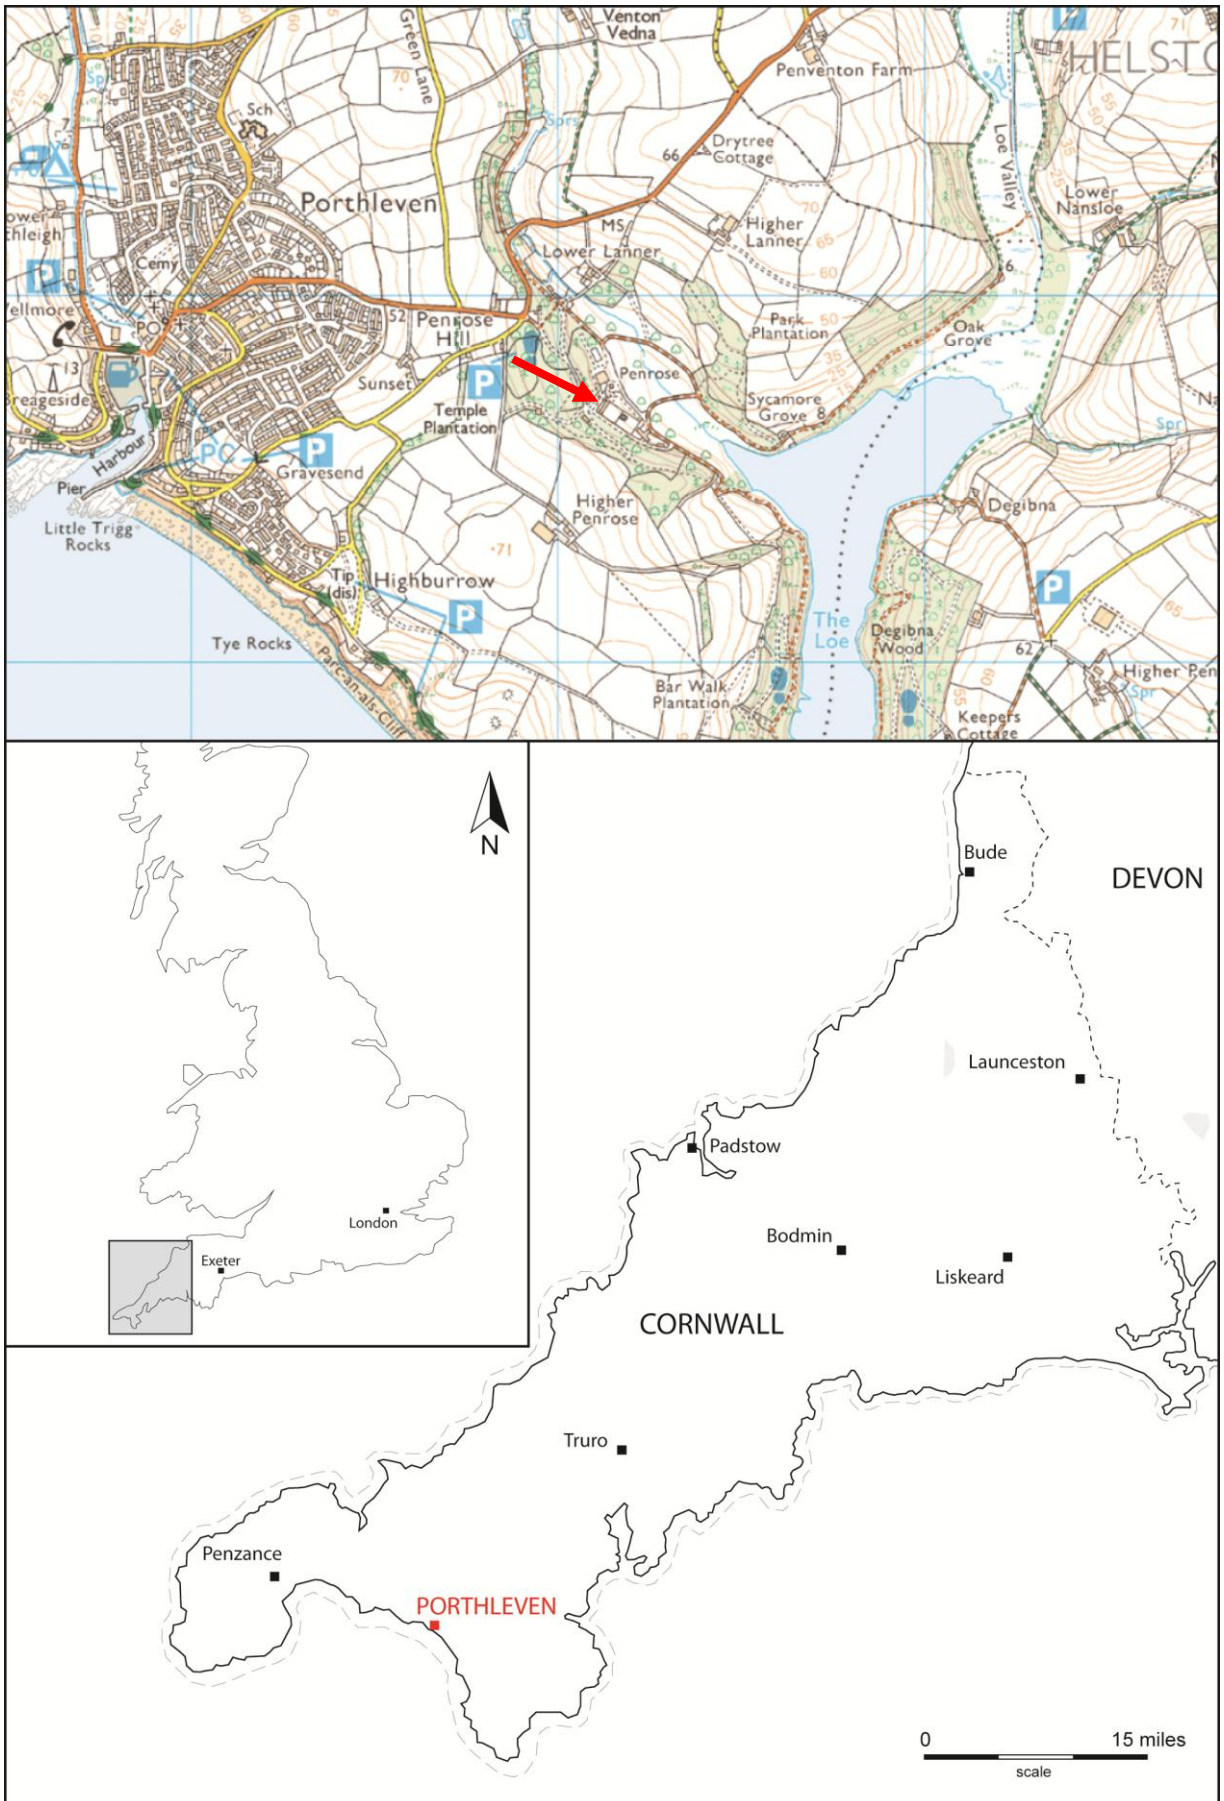
Figure 1: Site location (the site is indicated).

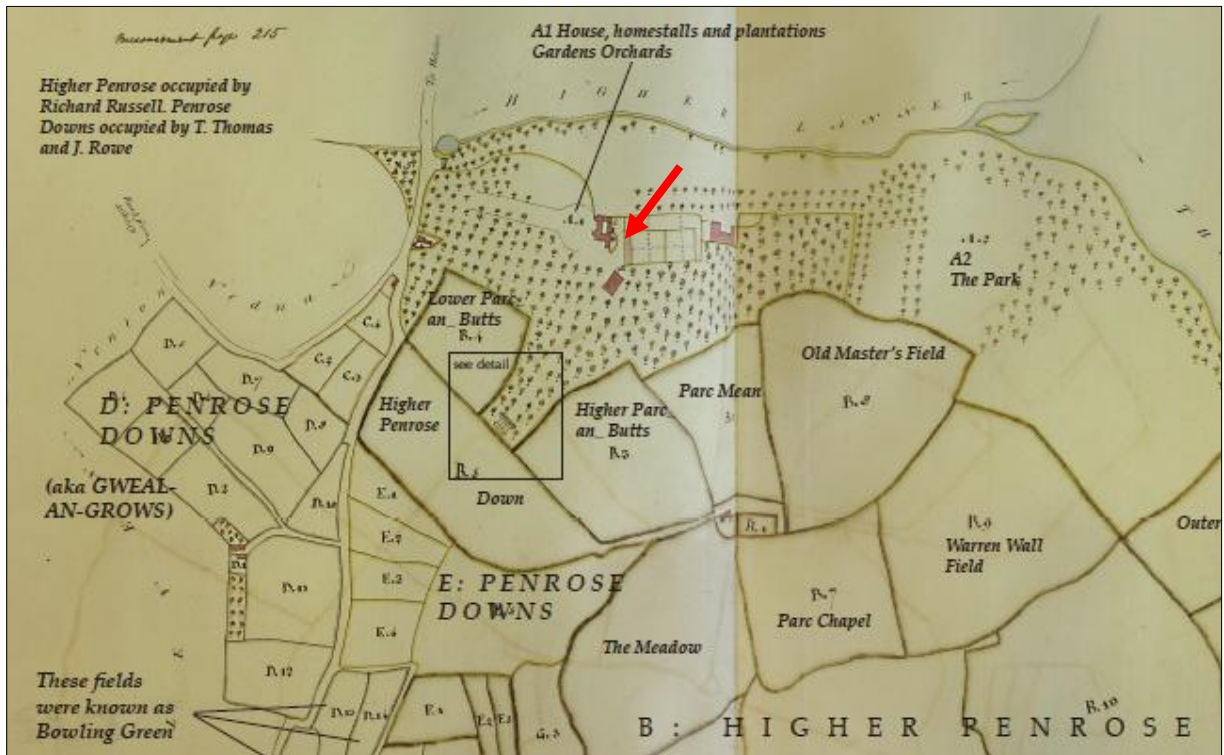
Figure 4: Copy of the Cove estate plan of 1788, from Nicholas Pearson Associates (the site is indicated with a red arrow).

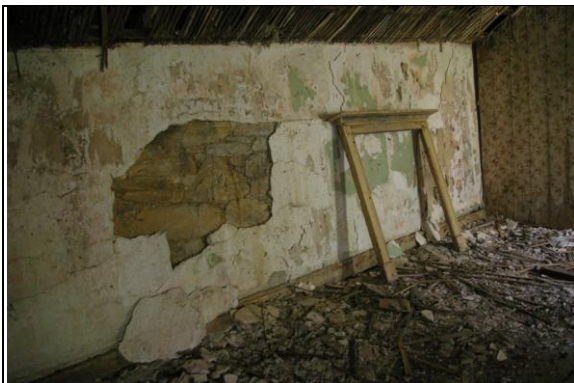
Figure 64: View of the plastered walls within Room I of Section 3 and the surviving but loose timber fireplace surround; from the north-west.

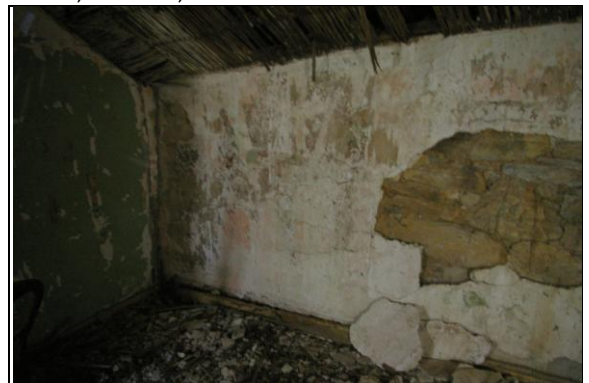
Figure 68: View to the north-east corner of Room I, Section 3; from the south-west.

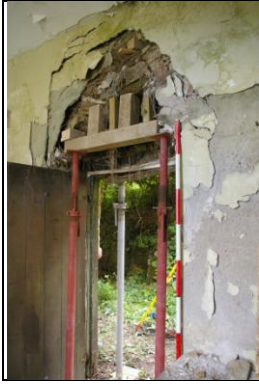
Figure 93: The failing doorway in the west wall of Room M, in Section 4; from the north-east.

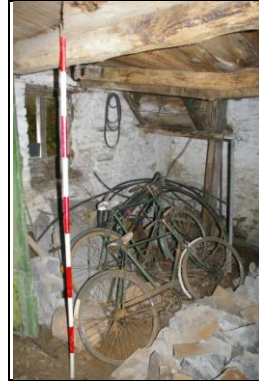
Figure 97: View of where the stairway from Room M is forced through the wall Room L; from the south-east.
