BLAGDON WHARF BARN BLAGDONMOOR WHARF HOLSWORTHY DEVON

Historic Building Recording & Archaeological Monitoring & Recording

South West Archaeology Ltd. report no. 170124

By E. Wapshott & N. Boyd Report Version 01 24th January 2017

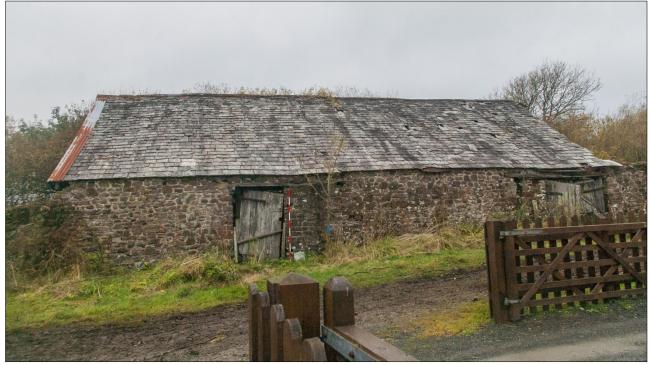
The south elevation of the warehouse; from the south-south-west (scale 2m).

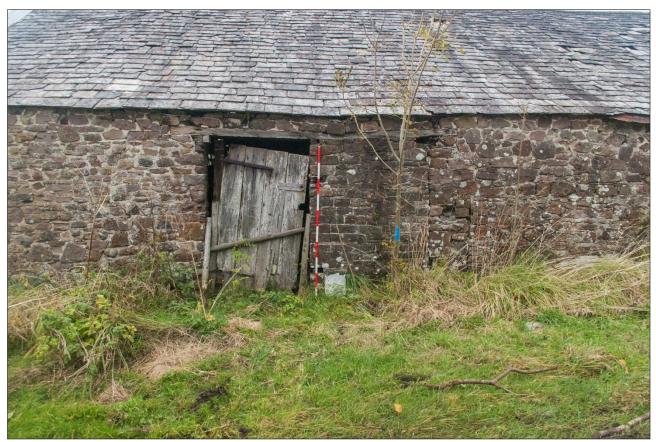
The west doorway in the south elevation showing the partly-blocked opening; from the south (scale 2m).

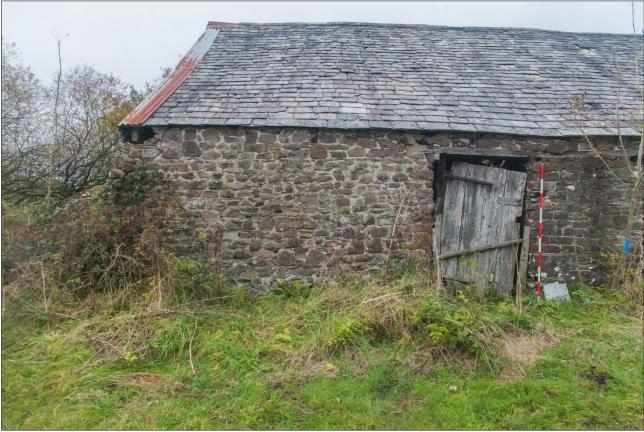
The west end of the south elevation showing the different phases of stonework; from the south (scale 2m).

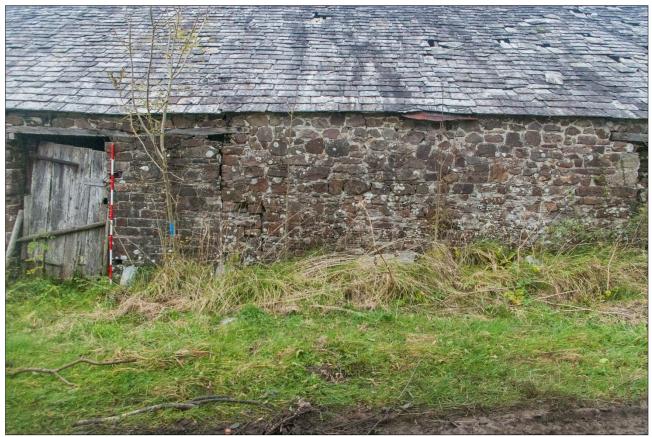
The central section of the south elevation, showing the different phases of stonework; from the south (scale 2m).

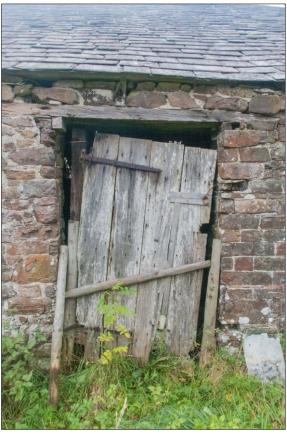
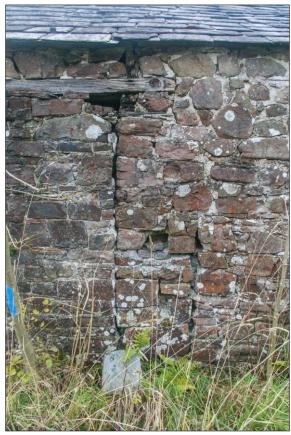
LEFT: Detail of the door to the west, south elevation; from the south. RIGHT: Detail of the blocking and two phases of build at the west doorway, south elevation; from the south.

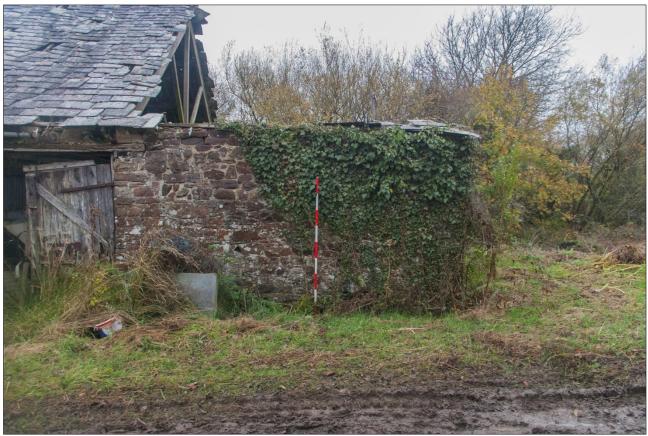
The partly-ruined east end of the elevation; from the south (scale 2m).

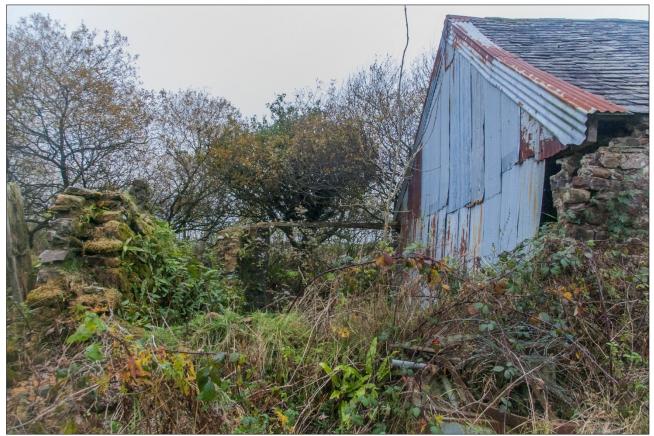
The west ruined end of the warehouse; from the south.

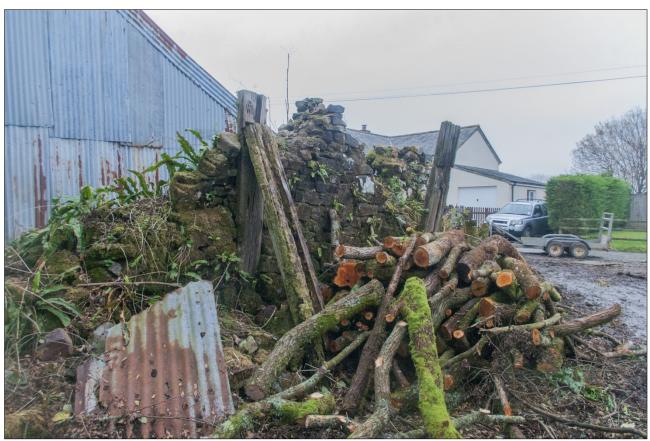
shaping. This elevation is abutted by and contains several large posts, like sleepers, bolted to the elevation, the function of which is unclear as so little of the building survives at this end.

The timber posts braced against the ruined west elevation; from the west.

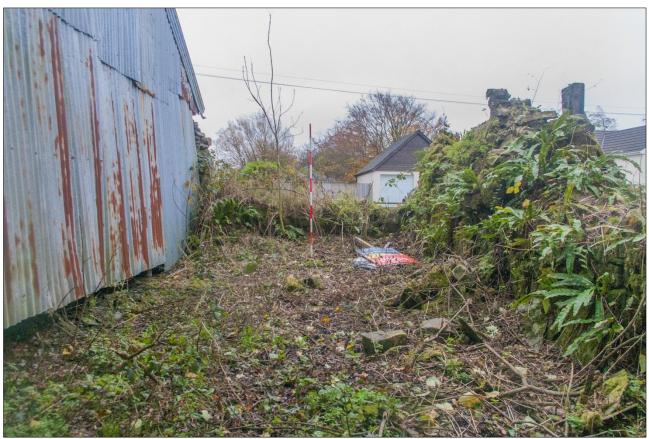
View into the ruined west end of the warehouse; from the north (scale 2m).

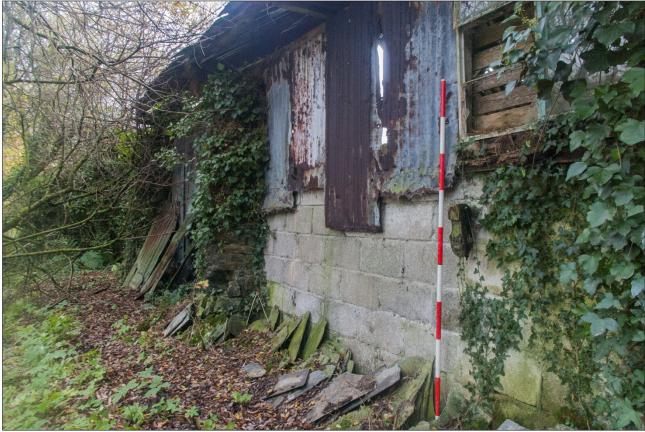
The east end of the north elevation, showing the infill concrete sections; from the north-west (scale 2m).

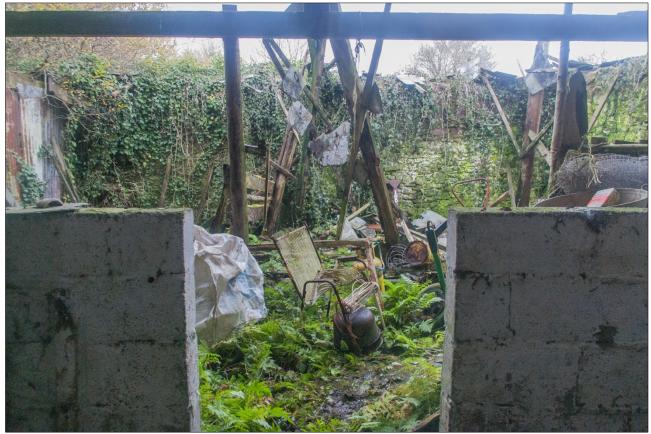
View of the east end of the warehouse where the hipped roof has failed; from the west.

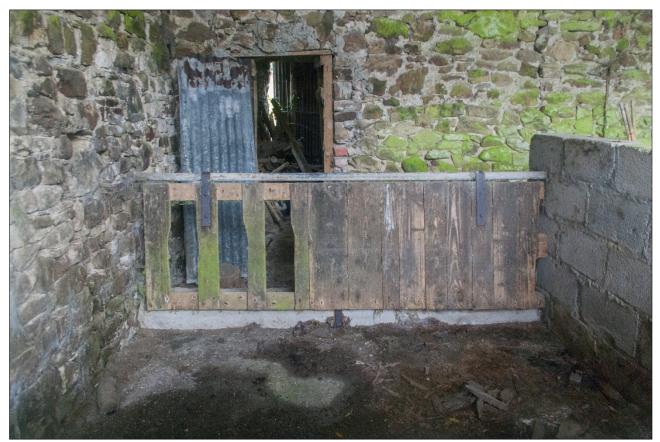
View of the forced doorway in the partition wall, leading to the western half of the warehouse; from the east.

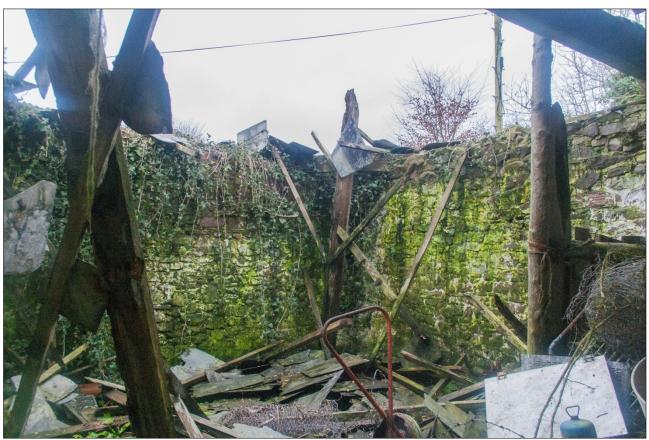
Detail of one of the hipped corners of the collapsed east end of the roof over the warehouse; from the north-west.

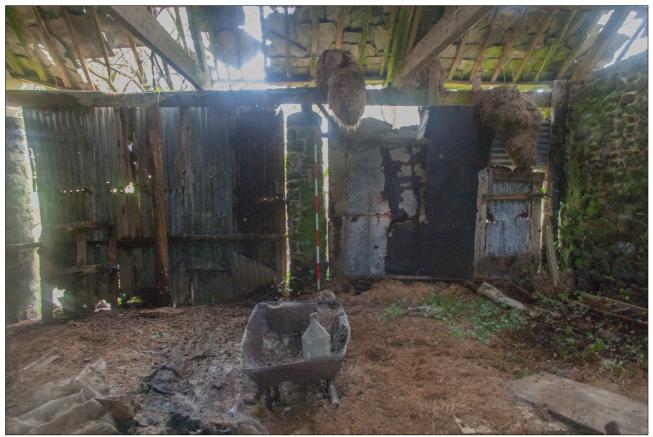
The north wall of the warehouse at the western end, showing corrugated iron sheeting infill; from the south (scale 2m).

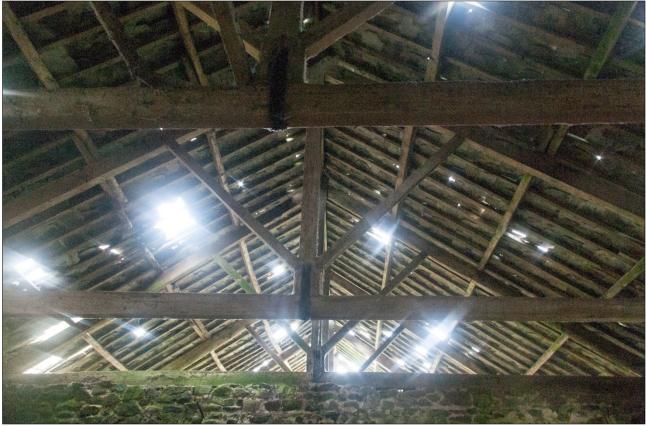
Detail of the roof trusses, showing three purlins to each pitch and the simple A-frame and king post trusses, with struts, bolted by straps, a mid or later 19th century roof; from the west.

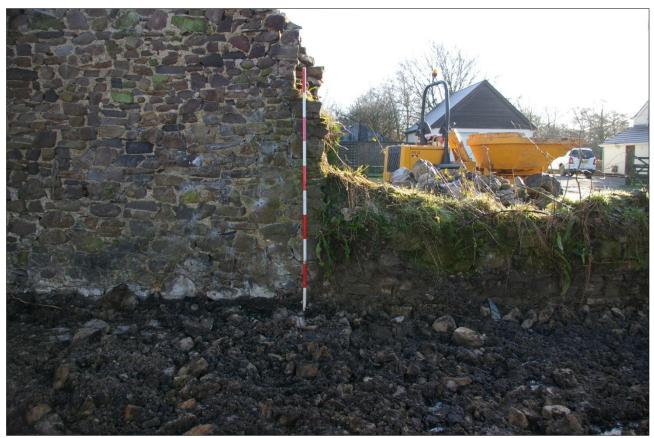
The end of the south wall with the clear build line to the west extension, now demolished; from the north (scale 2m).

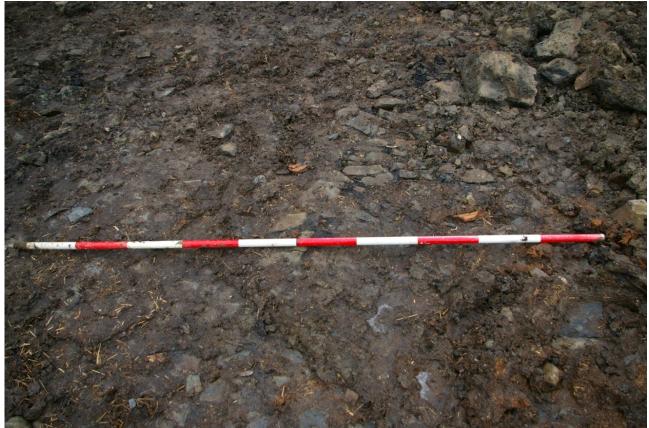
The original cobbled floor surviving to the north side of the west section of the warehouse; from the west (scale 2m).

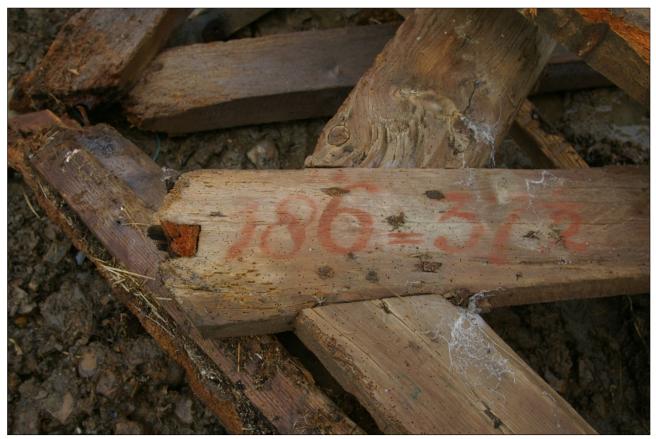
Detailed view of kingpost at apex, showing pegs, bolts, and graffiti; from the south.
