WHELMSTONE BARTON BARN COLEBROOKE MID DEVON DEVON

Historic Building Recording

Whelmstone Barton Barns, Colebrooke, Devon Historic Building Recording

By E. Wapshott & N. Boyd
Report Version 01
3rd January 2017

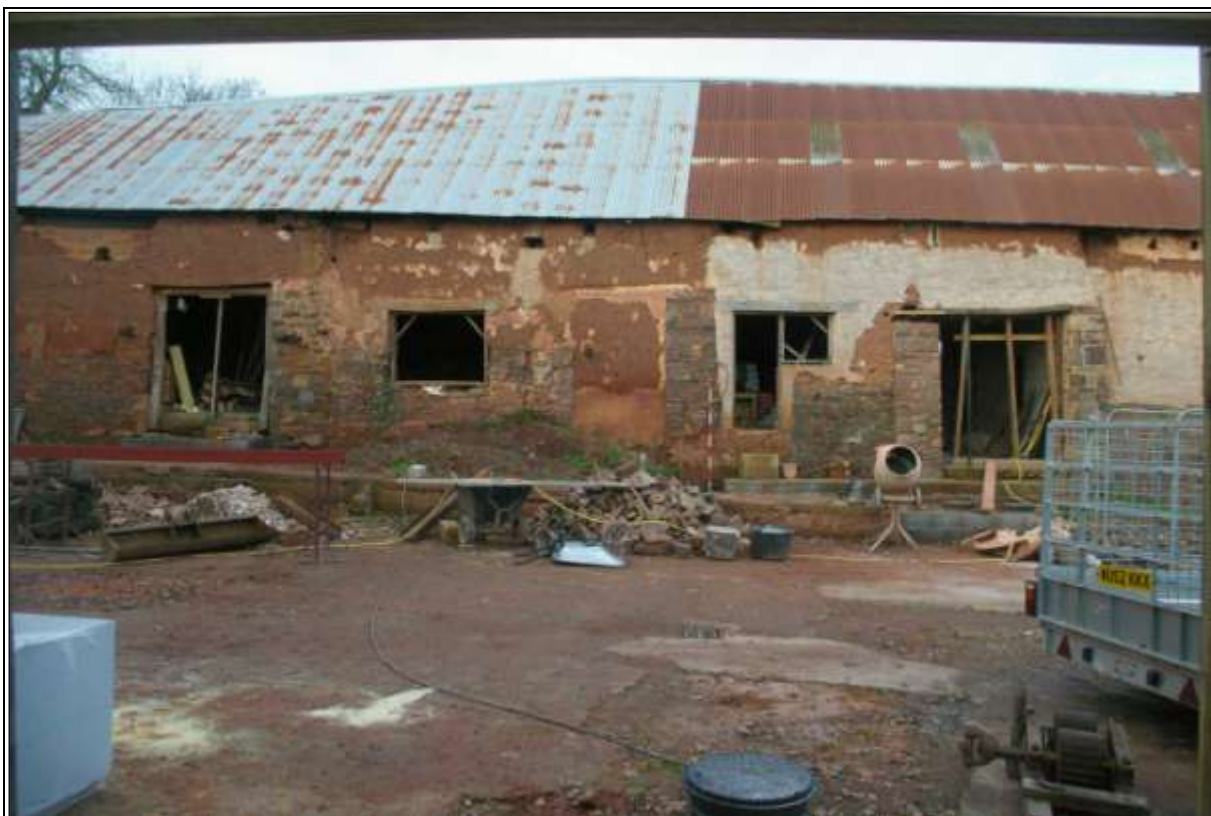
Figure 5: The central section of the south-east elevation of the main barn; from the south-east (2m scale).

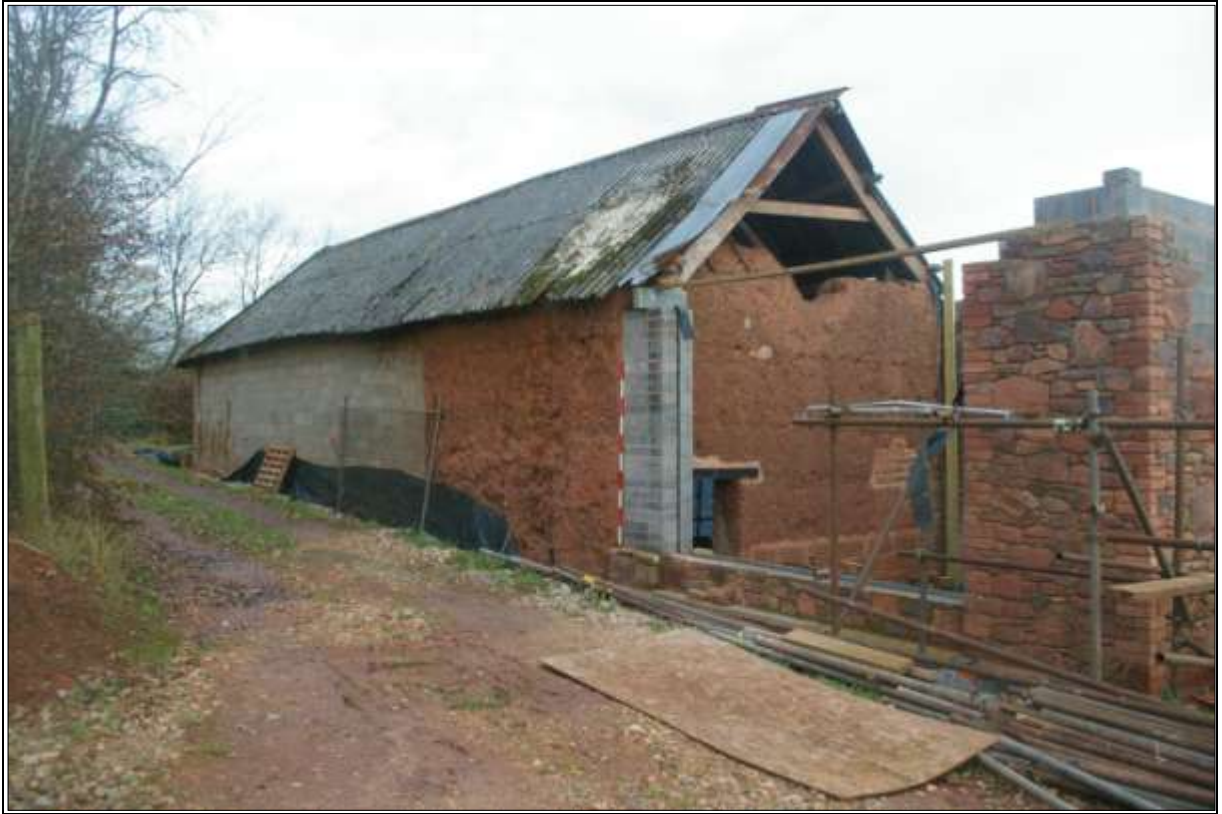
The Western Linhay survives to the southern end in cob, on a stone rubble base, open to the yard. Its gable end elevations have both been rebuilt in concrete block and a concrete floor was inserted at the same time. Internally, enough of the structure survived to retain its massive elm beams from the loft floor, with large square joist sockets. Four 17th century A-frame trusses also survive, very similar to those seen in the southern extension of the Barn, but with more 19th century intervention. Some large purlins and pegged rafters can also be seen either *in situ*, or reused within the roof structure. The linhay is defined in appearance by its open front, dominated by massive oak posts which had been tarred to protect from the weather and stood on large dressed stone pads. One *in situ* post survived to the eastern end of the linhay, with a mortice and tenon socket into the massive loft floor beam and again with a socket to carry the end of the truss blade. Some of the other posts were structurally unsound and have been removed and stored in the barn during works. These have initials and the date 1928, when the set of posts were renewed. This linhay appears to have been an animal byre on the ground floor, with loft above for feed storage. No evidence of troughs survives, but there is evidence of sockets for a partition at the western end in one of the massive loft beams and a further partition at the south-eastern end. There may have been a feed channel along the long, rear south-western elevation. This linhay is being converted into a dwelling.

Figure 6: The south and west elevations of the western linhay, surviving in cob to the south end but largely rebuilt in concrete block sometime in the 20th century; from the south (2m scale).

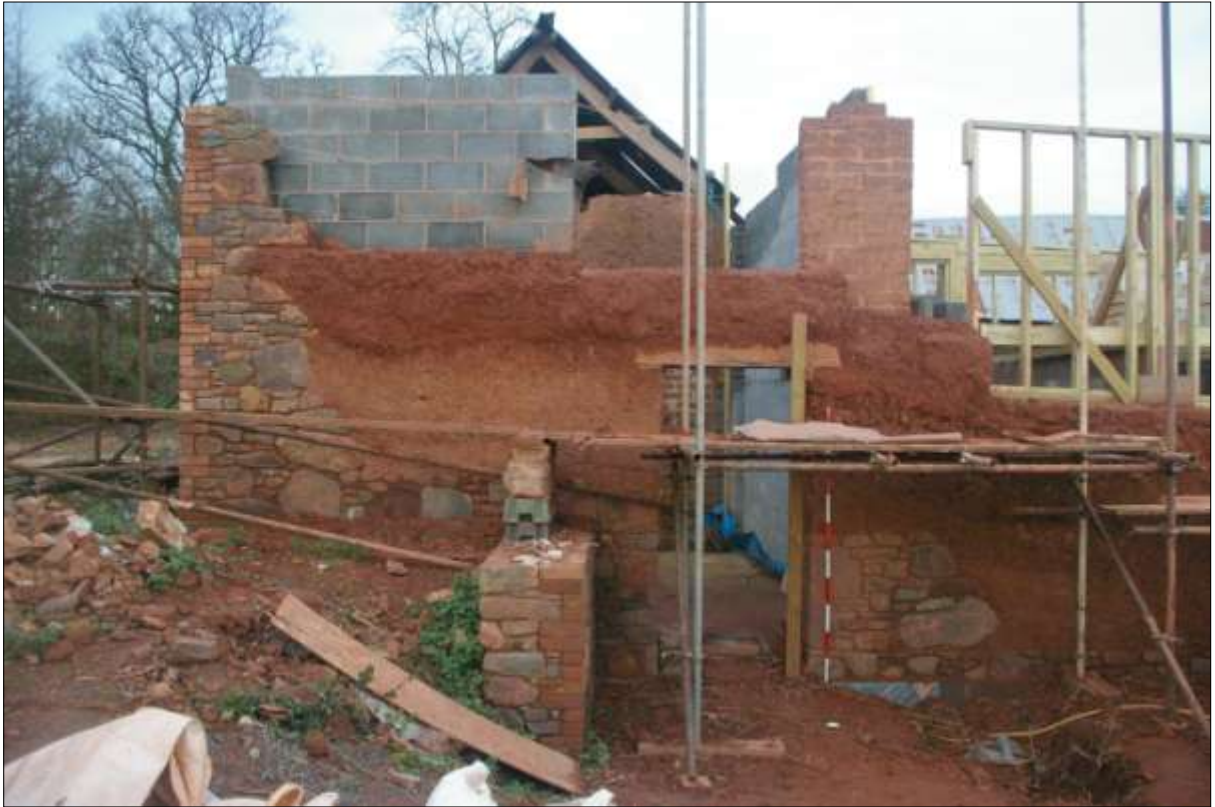
To the south of the Western Linhay was an adjoining corner structure, which linked it to the next linhay (the Southern Linhay). This structure was wholly ruinous, with piles of stone and cob and collapsed roof trusses, it was partially standing at the time of the Keystone Survey (Cox and Thorpe 1996). At this time of this survey, the building was in the process of being re-built from the clues provided by the remains. It had a later 19th century A-frame roof, one truss of which survives on the south-east end of the western linhay, where it extends the historic hipped gable out to link with the corner building. The building had doors leading into the ground floors of both linhays and a large, ground floor opening in its south wall. This would suggest a root house, with a tipping door for carts and easy access to the feed channels of the adjacent byres. All the (ground floor) openings have been retained in the newly rebuilt structure, which is a mix of handmade cob blocks and rubble stone. This building is being incorporated into the accommodation of the new dwelling being developed within the Western Linhay.

Figure 7: The original structure here had largely collapsed but the remains were suggestive of a possible 19th century extension for a root house, to serve the linhays and byres; from the south-west (2m scale).

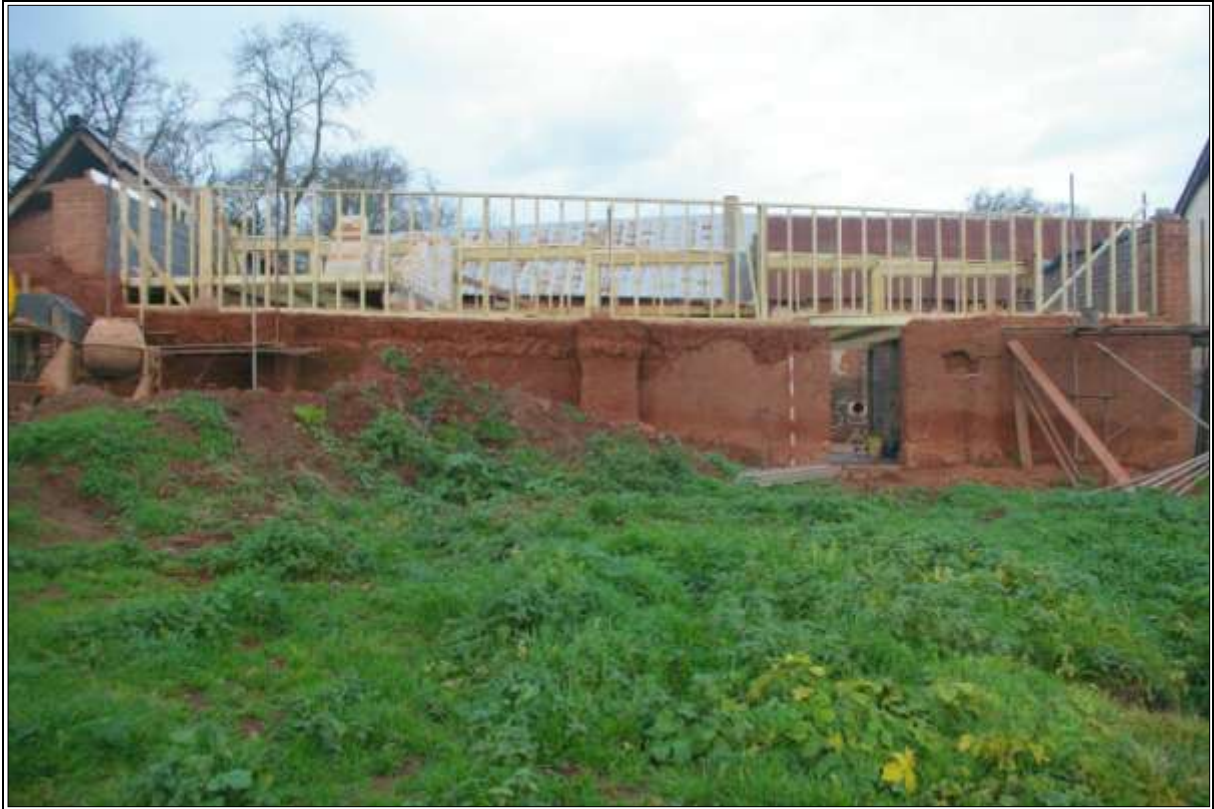
The upper part of the long south-east elevation and part of the north-eastern gable end wall have been recently rebuilt in cob blocks. The rest of the structure has been repaired; new green oak posts will replace those lost on the open front, the upper walls are being rebuilt in timber and will carry horizontal plank cladding. This linhay had a concrete slab floor and partition walls dividing it into smaller compartments, as it will be used for storage for the adjoining residences, with a bat roost in the tallet.

Figure 8: The southern linhay, showing the rebuild with the collapsed cob; from the south-east (2m scale).

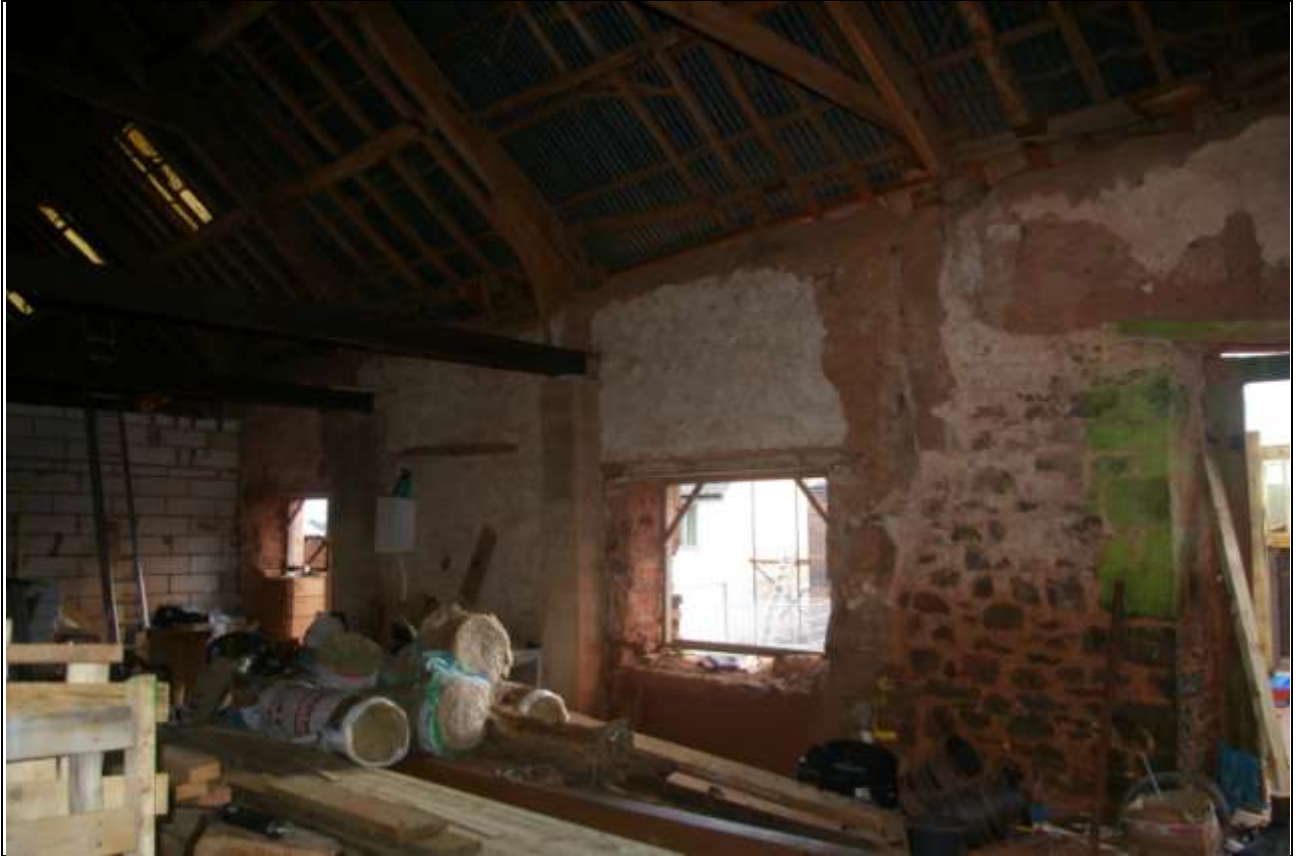
The main open area of the barn towards the north, already partially divided for conversion; from the west.

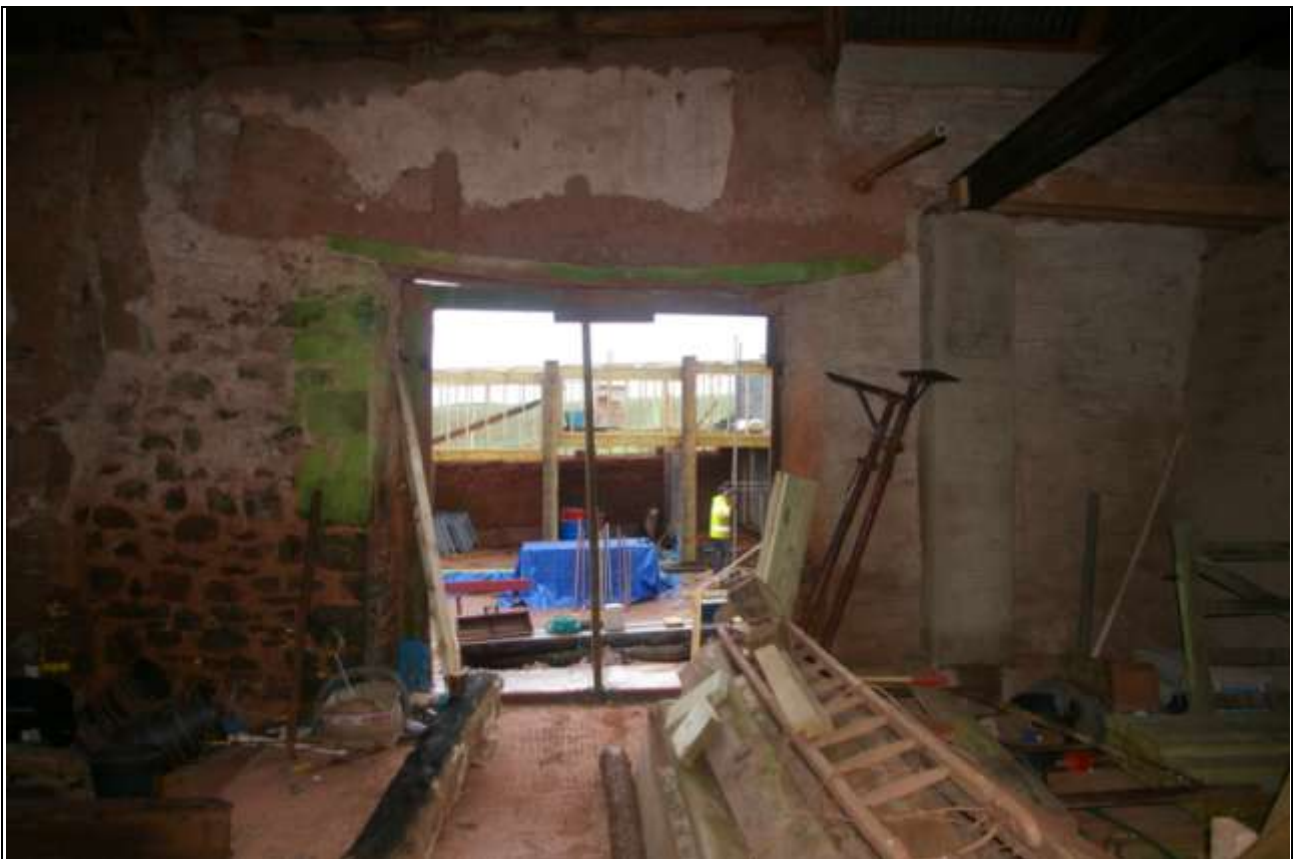
The large barn opening in the south end of the south-east elevation, with rebuilt stone sides, typical 19th century timber lintel and door frame, with chamfered sides; from the west, north-west.

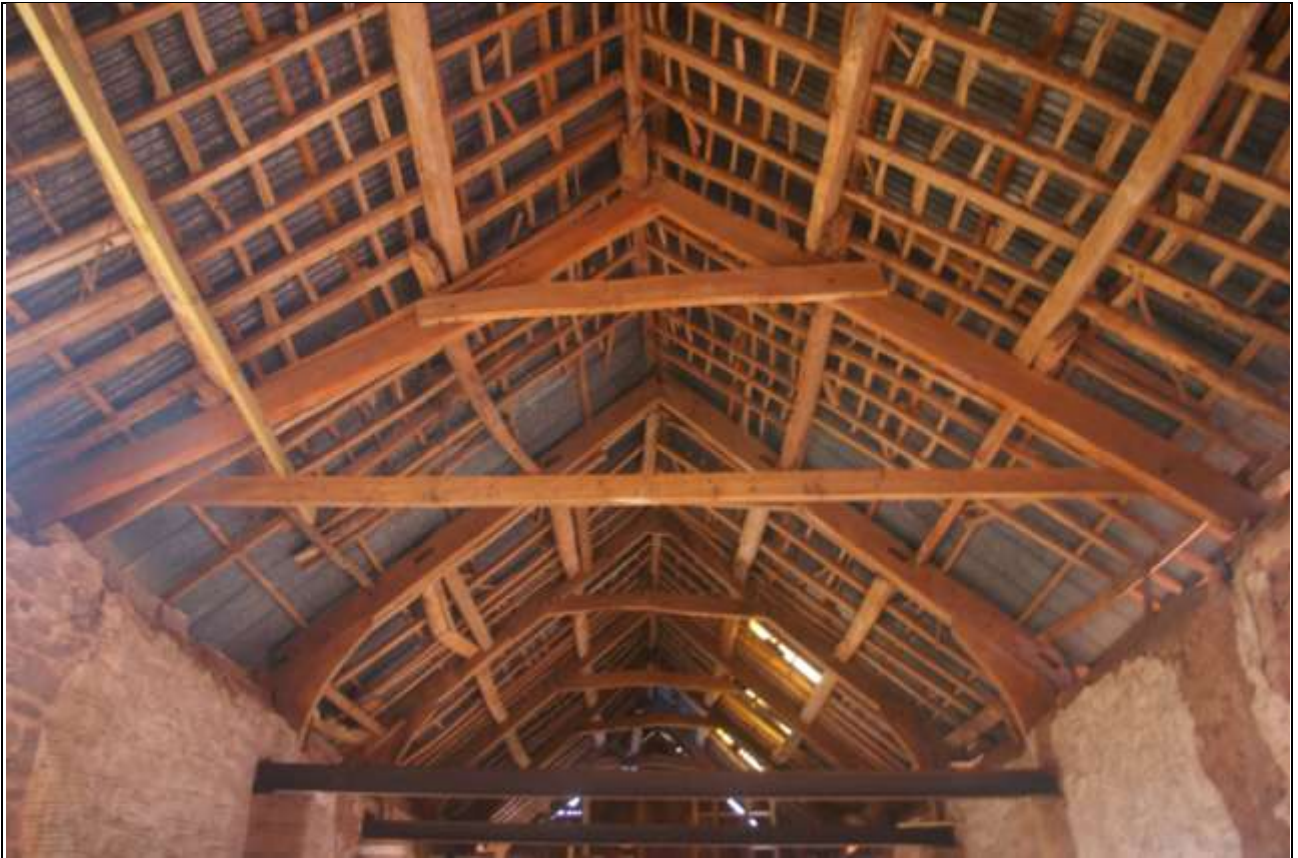
One of the later trusses to the south end of the barn, probably later 17th or early 18th century in date, showing how they have been patched and repaired at a later date.

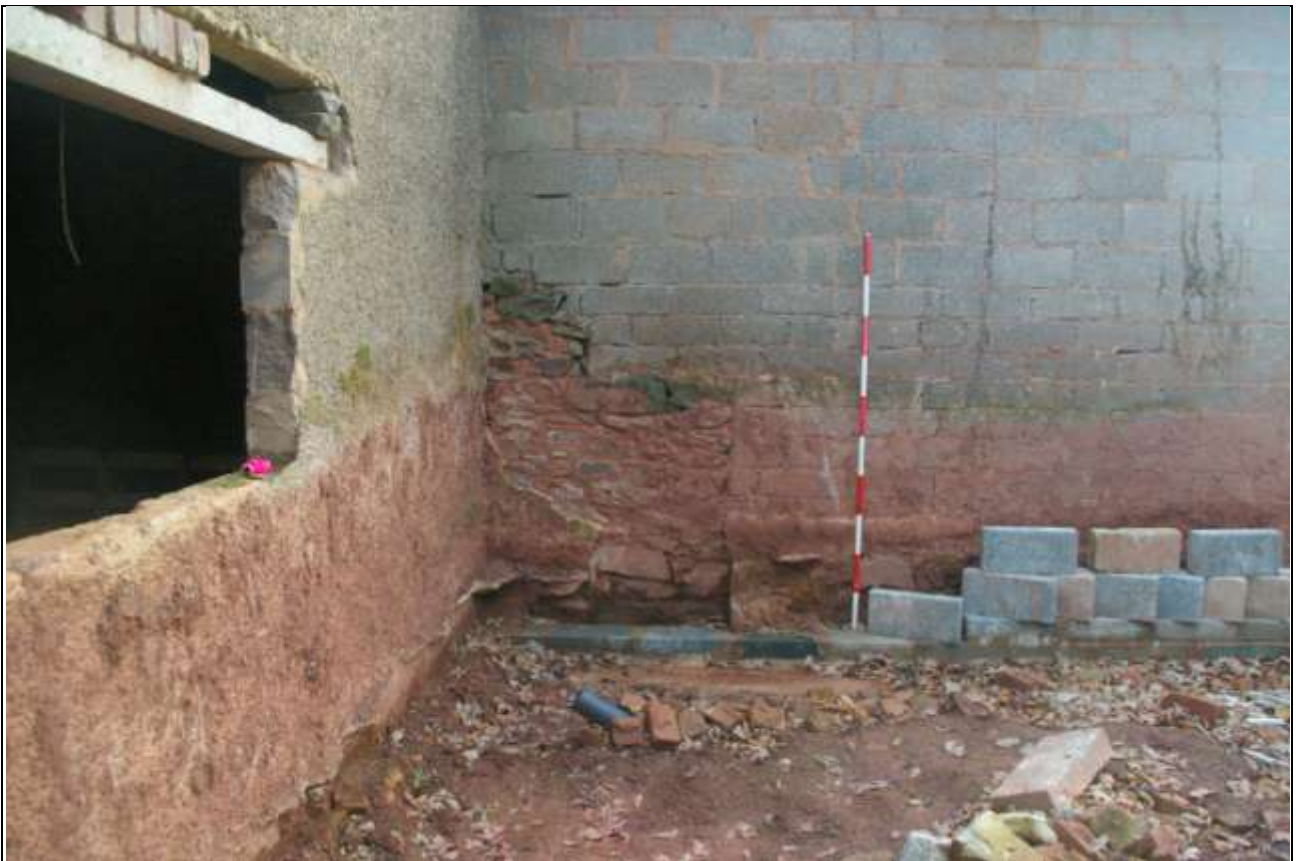
The barn and western linhay where they adjoin, showing the barn has been slightly truncated during rebuilding; from the west (2m scale).

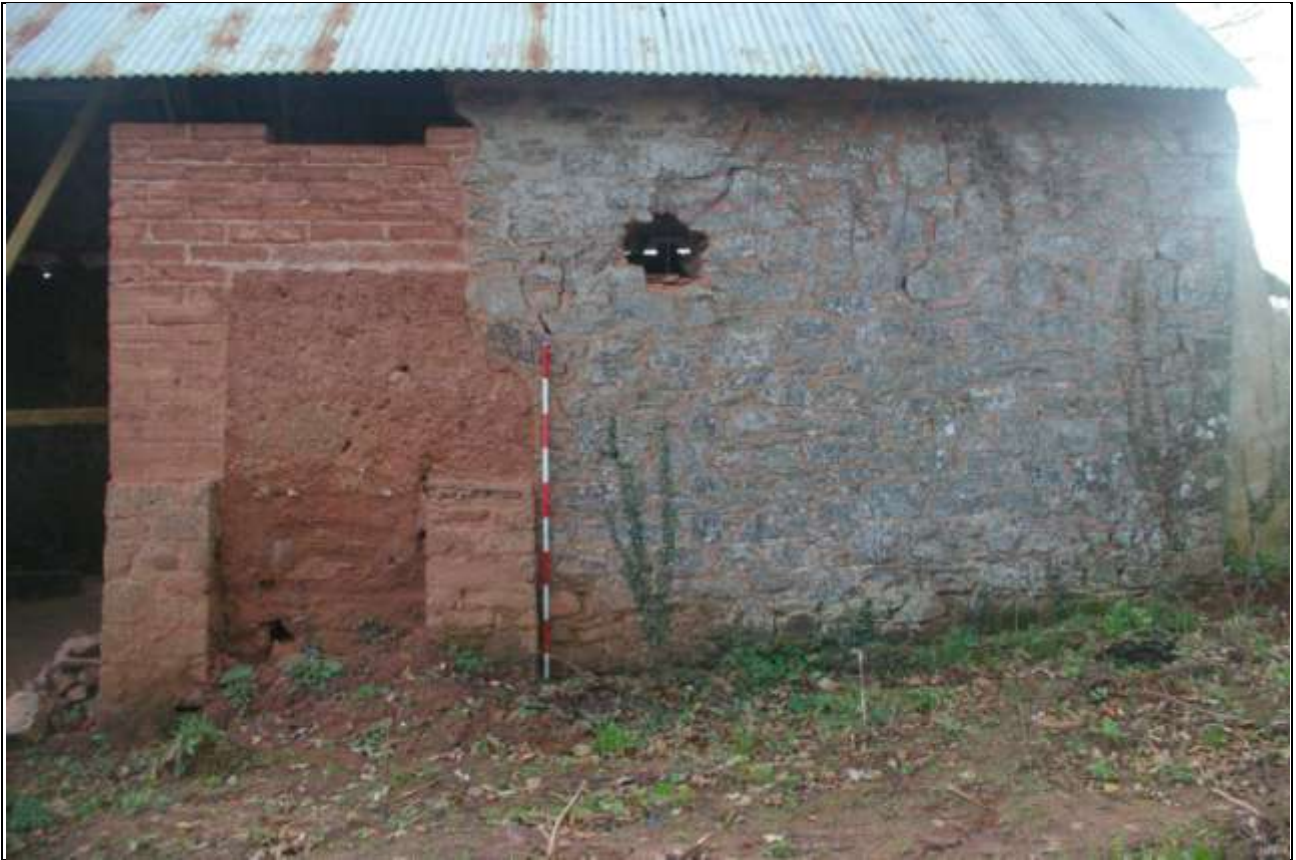
The south end of the barn, later 17th or 18th century, showing a 19th century rebuild; from the north-west (2m scale).

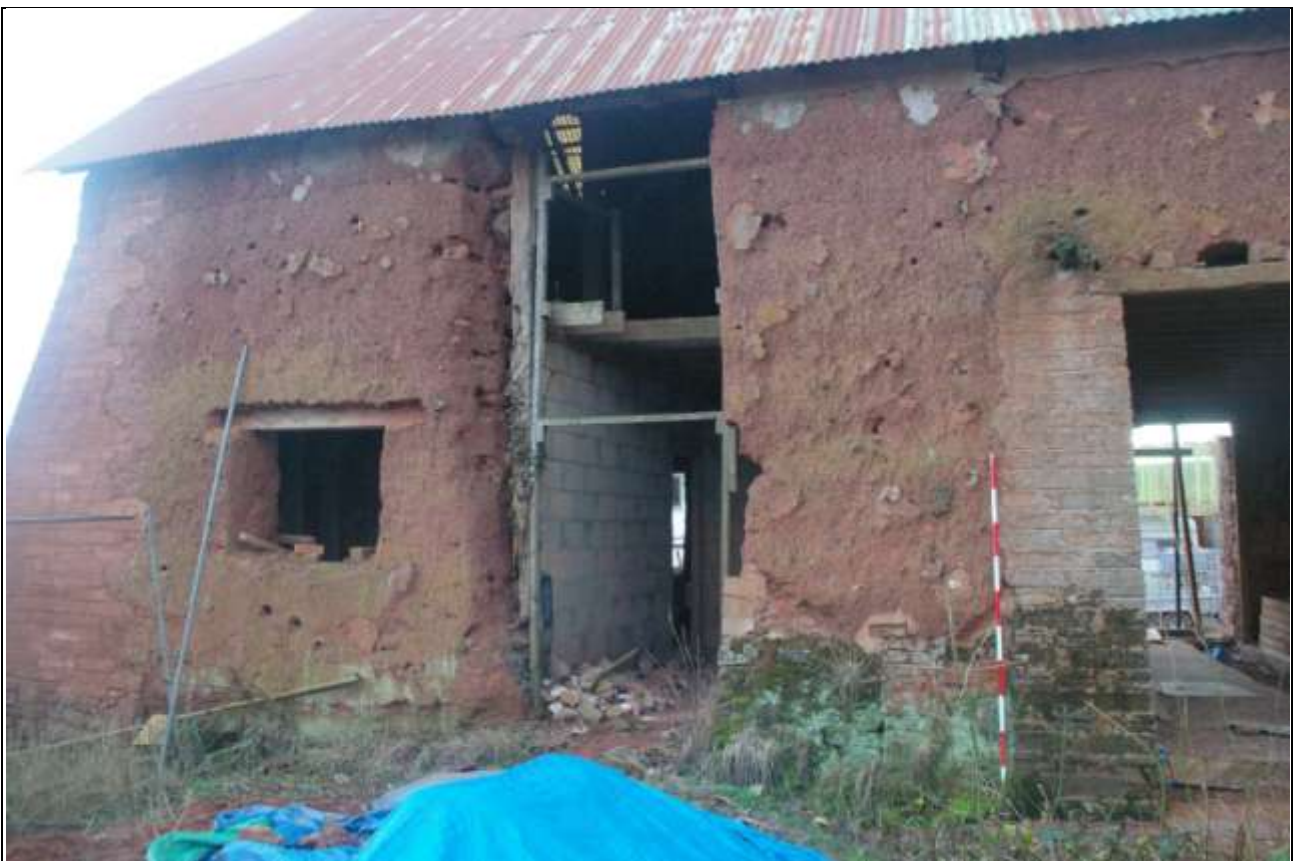
The previous owner had attempted to convert this building to a dwelling and had forced large openings into the walls of the barn, causing structural issues. The main historical (17th century) openings we see today are a large pair of opposing threshing doors to the north end, which have a heavy chamfered lintel, and a pair of narrower (width and a half) opposing doors towards the south end, also with heavy chamfered lintels. A small window at eaves height in the north-west wall, adjacent to Truss 5, is built within a raise in the cob, suggesting that it is also a 17th century addition.

The north-west elevation of the barn, showing the forced openings undertaken by the previous owner; from the west (2m scale).

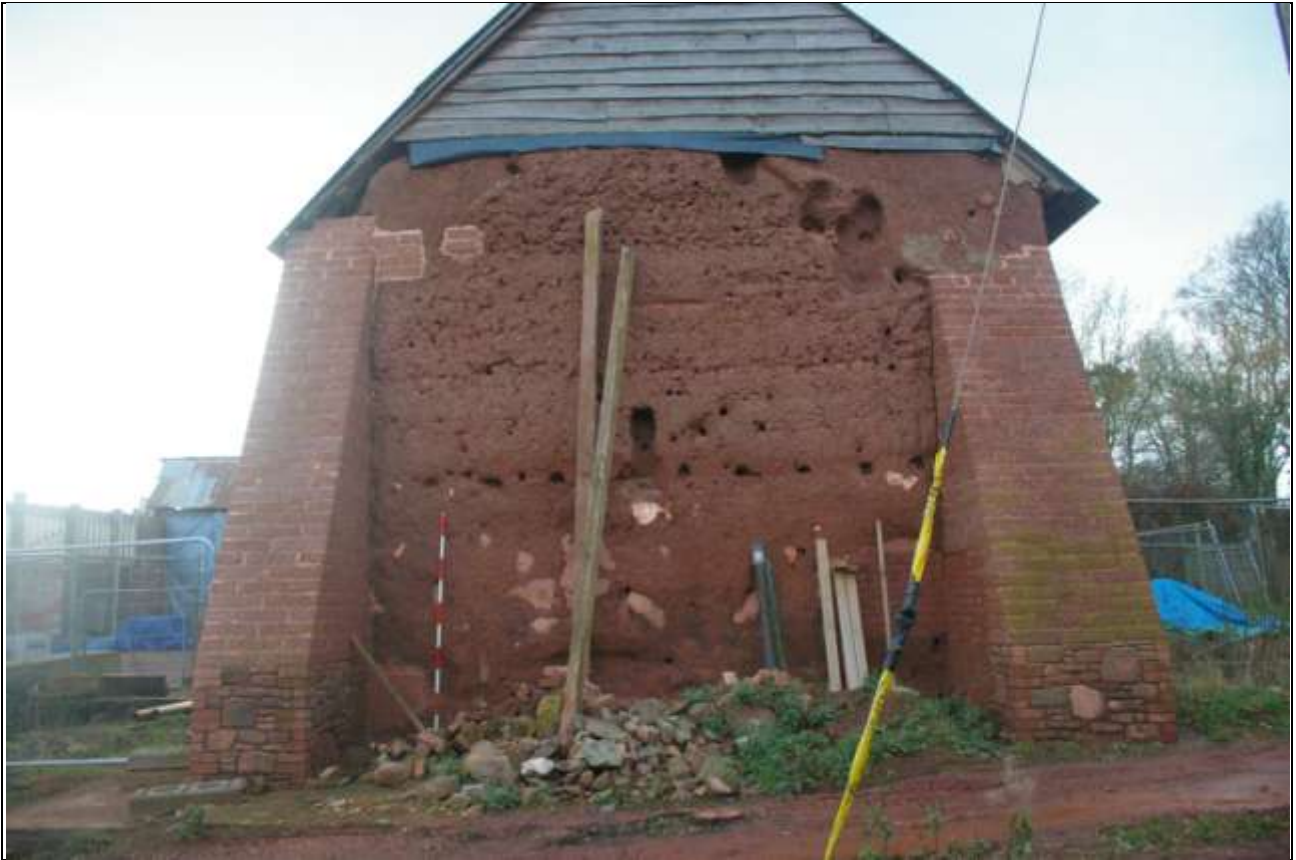
The north-east end of the barn, with poor condition original cob and newly rebuilt cob buttresses; from the north-north-east (2m scale).

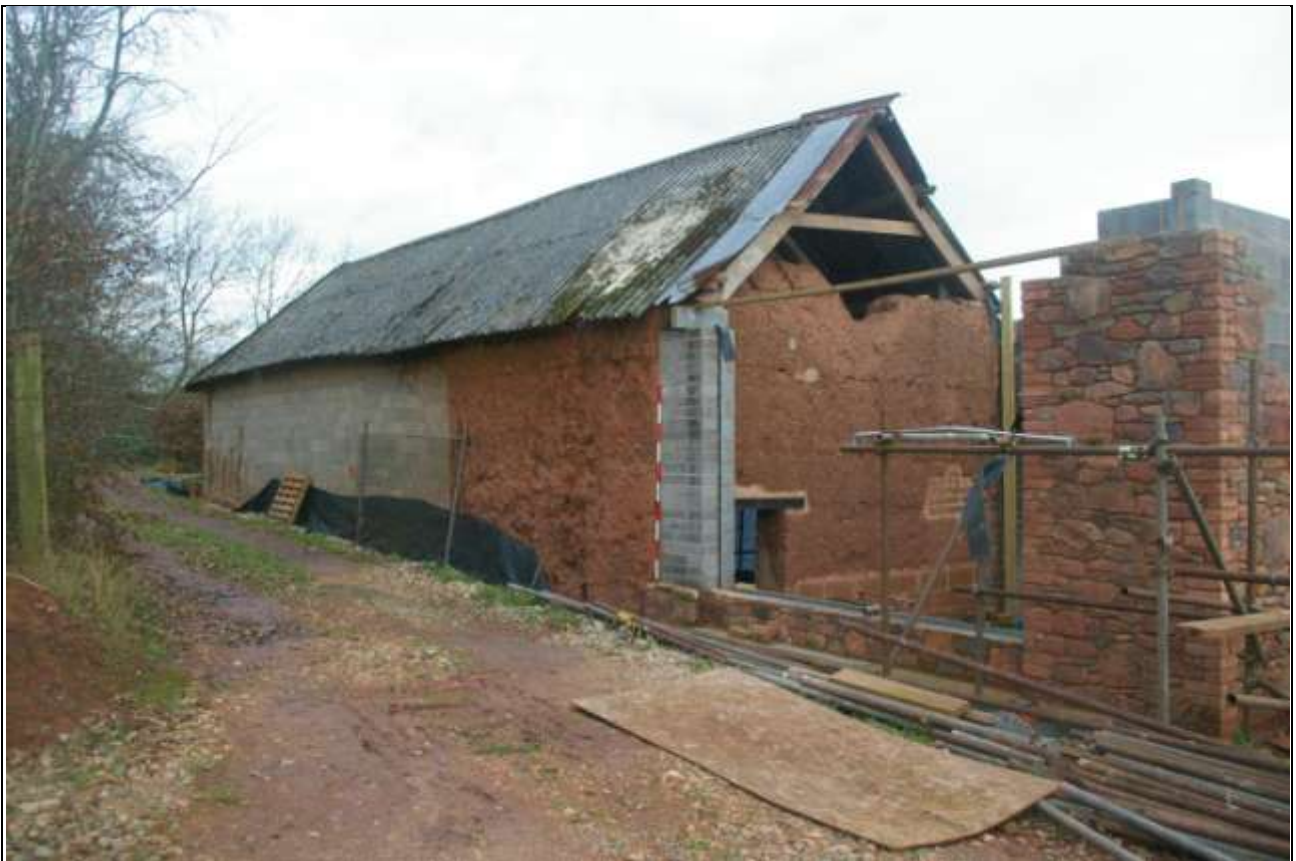
The south-west elevation the west linhay, surviving cob on a stone plinth to the south end and base, but largely rebuilt in concrete block sometime in the 20th century; from the south (2m scale).

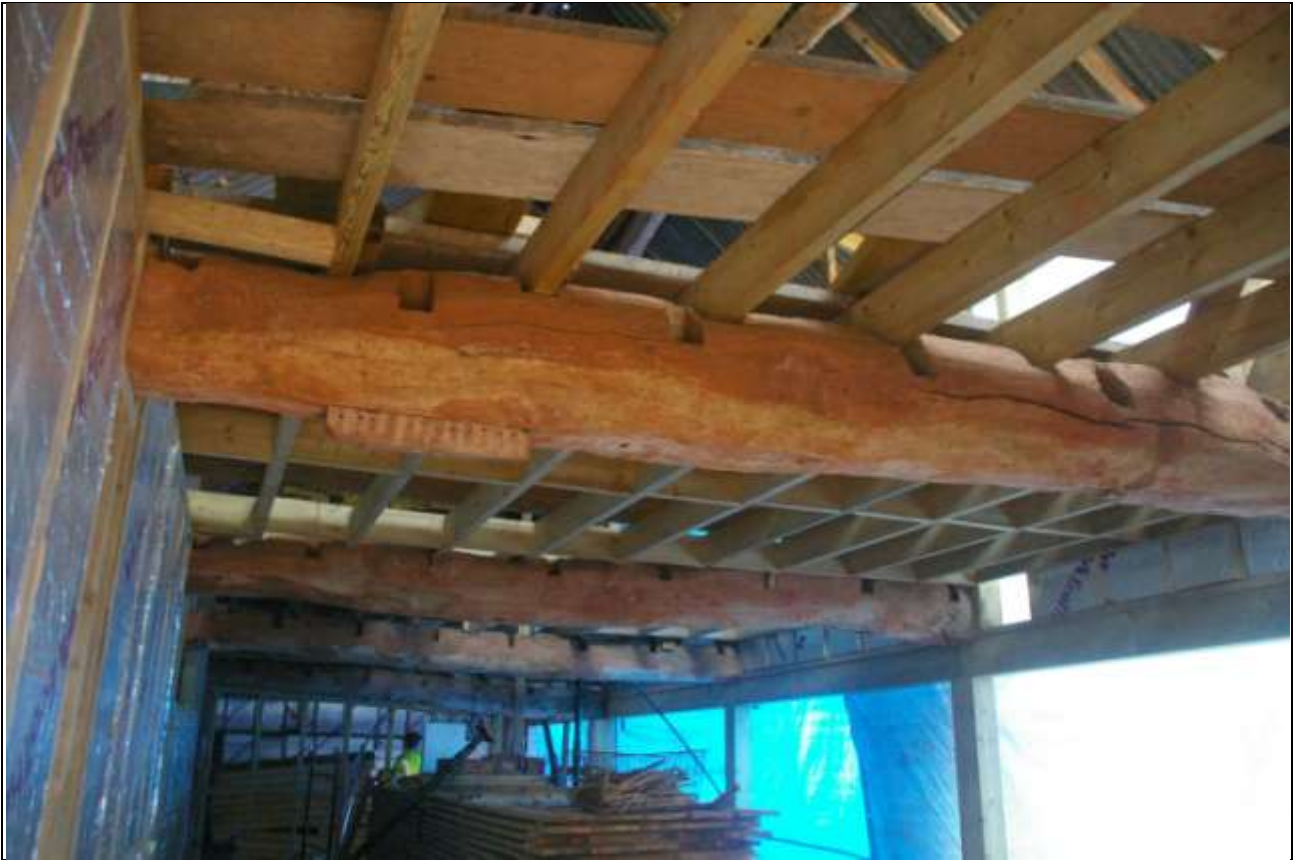
The conserved and reset elm loft beams in the west linhay, incorporated into the new secure first floor; from the south.

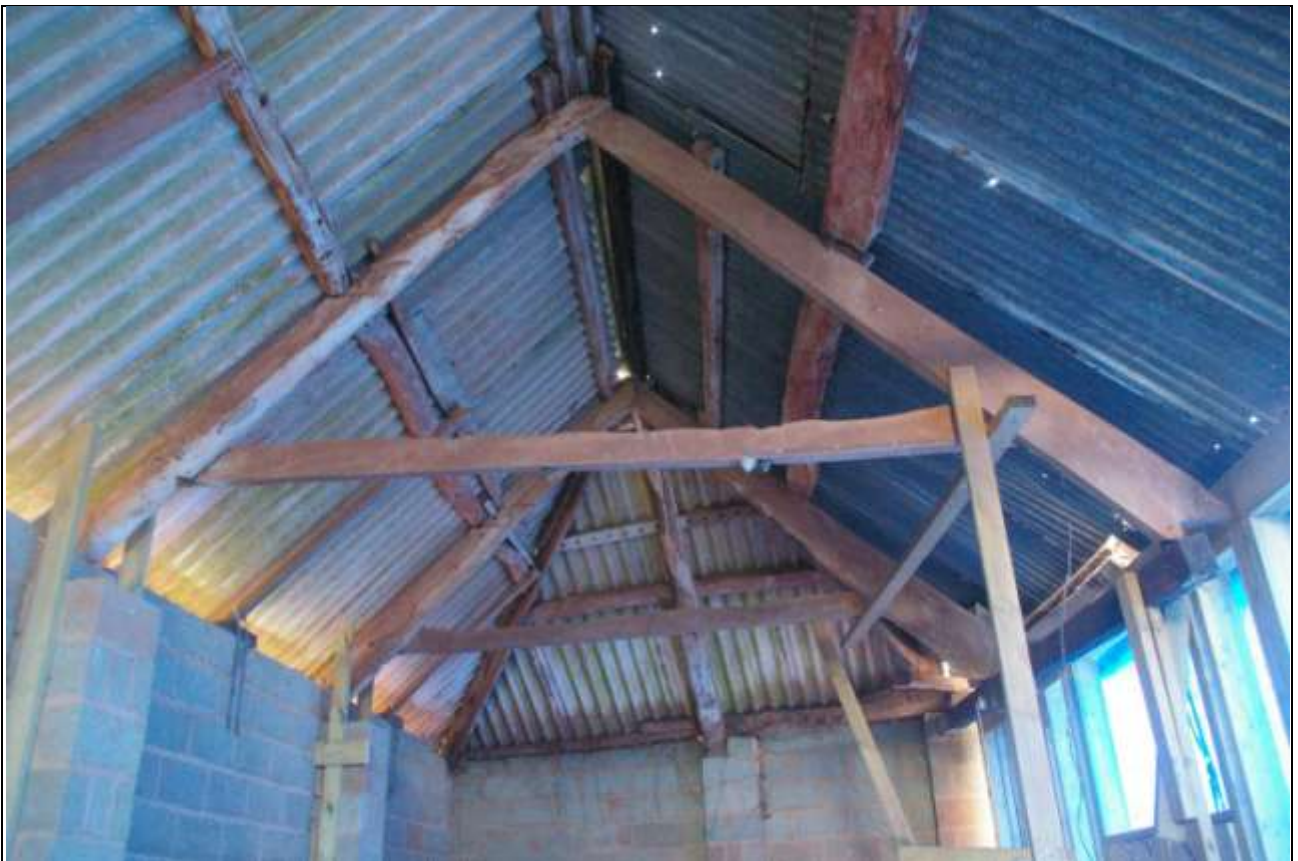
The western end of the west linhay roof, showing the hipped structure and first truss. The roof has been overhauled in the 19th century; from the south-east.

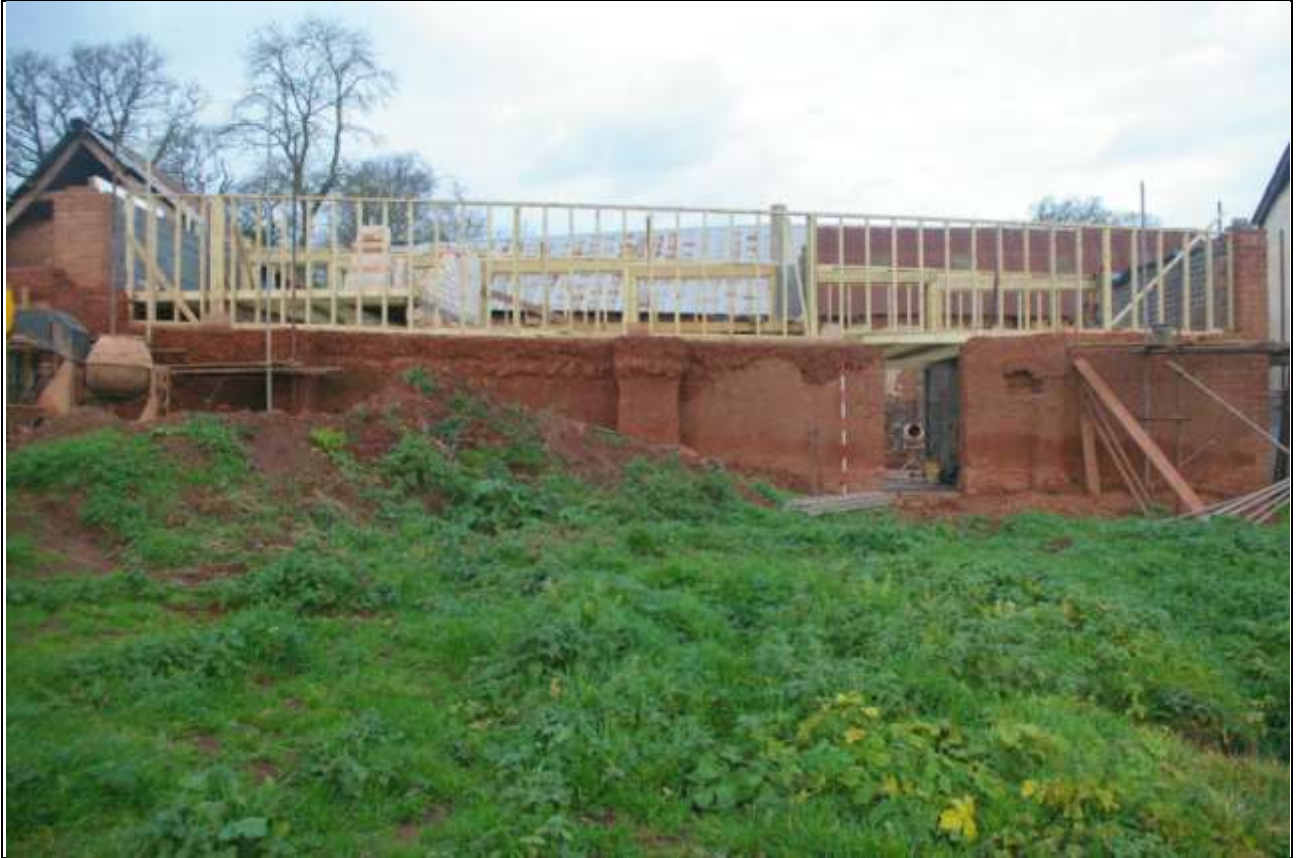
The east corner of the south linhay, rebuilt in handmade cob blocks, using collapsed cob from the site, also showing the restored historic cob south-east wall; from the south-east (2m scale).

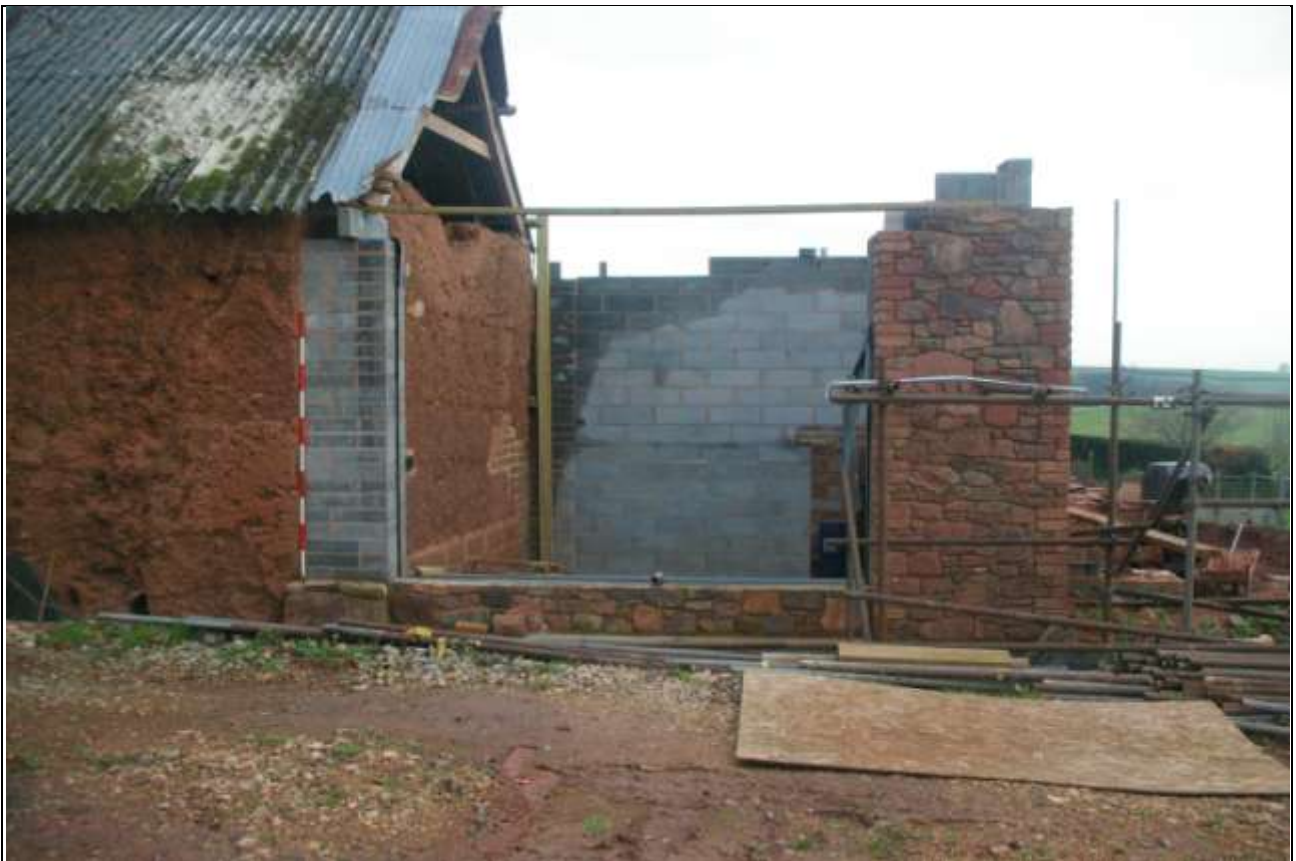
The rebuild of the root house, where the linhays adjoin; from the south-west (2m scale).
