COLEHAYES BARN
OTTERTON
EAST DEVON
DEVON

Desk-Based Assessment & Historic Building Recording

Colehayes Barn, Otterton, Devon Desk-Based Assessment & Historic Building Recording

By E. Wapshott & N. Boyd
Report Version 01
12th April 2017

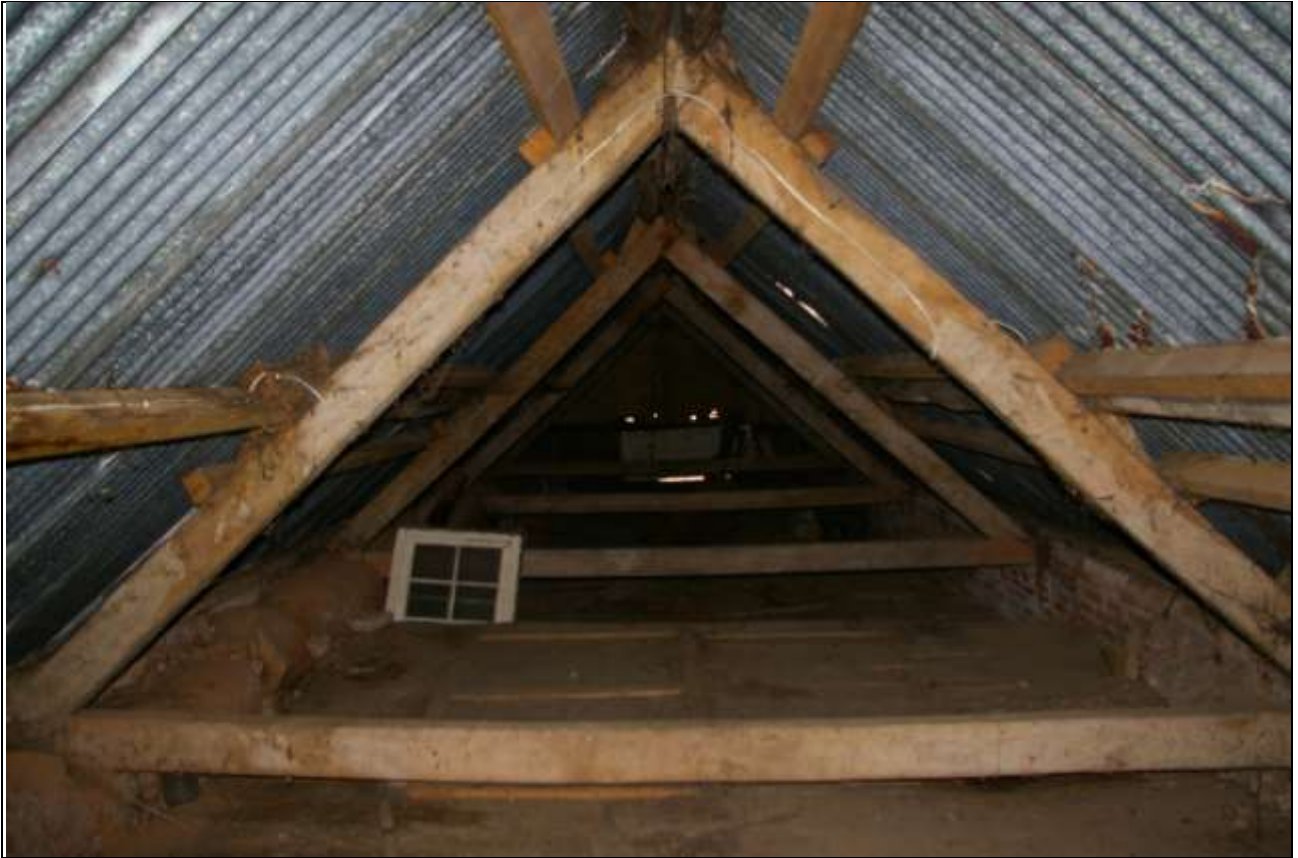
The roof is corrugated metal sheeting, now rusted, but dating to the 1920s/1930s. It was painted in camouflage pattern during the Second World War. This corrugated roof rests on timber A-frames, with nailed joints, overlapping at the ridge, with double ridge poles and a pair of lightweight overlapping purlins to each pitch. This roof structure is of 1920s/1930s date and is contemporary with the corrugated sheeting. This roof was installed after a devastating fire in this between-war period. The late medieval roof survives to the east end, associated within the historic cob walls. The upper element of the crucks were burned beyond repair, however, the base of the crucks survive within the cob walls, rising to side joints which project above the cob walls. This identifies the roof as of later medieval form, a side-jointed cruck roof. Two pairs of base crucks survive to the east end, one of better condition survives to the south side. This would appear to make a 4-bay barn, but the cob wall survives beyond this and the stone rubble base further, indicating this was a larger structure. No historic smoke blackening was viewed, which means it is likely that this building was not heated.

View of the roof structure from the east.

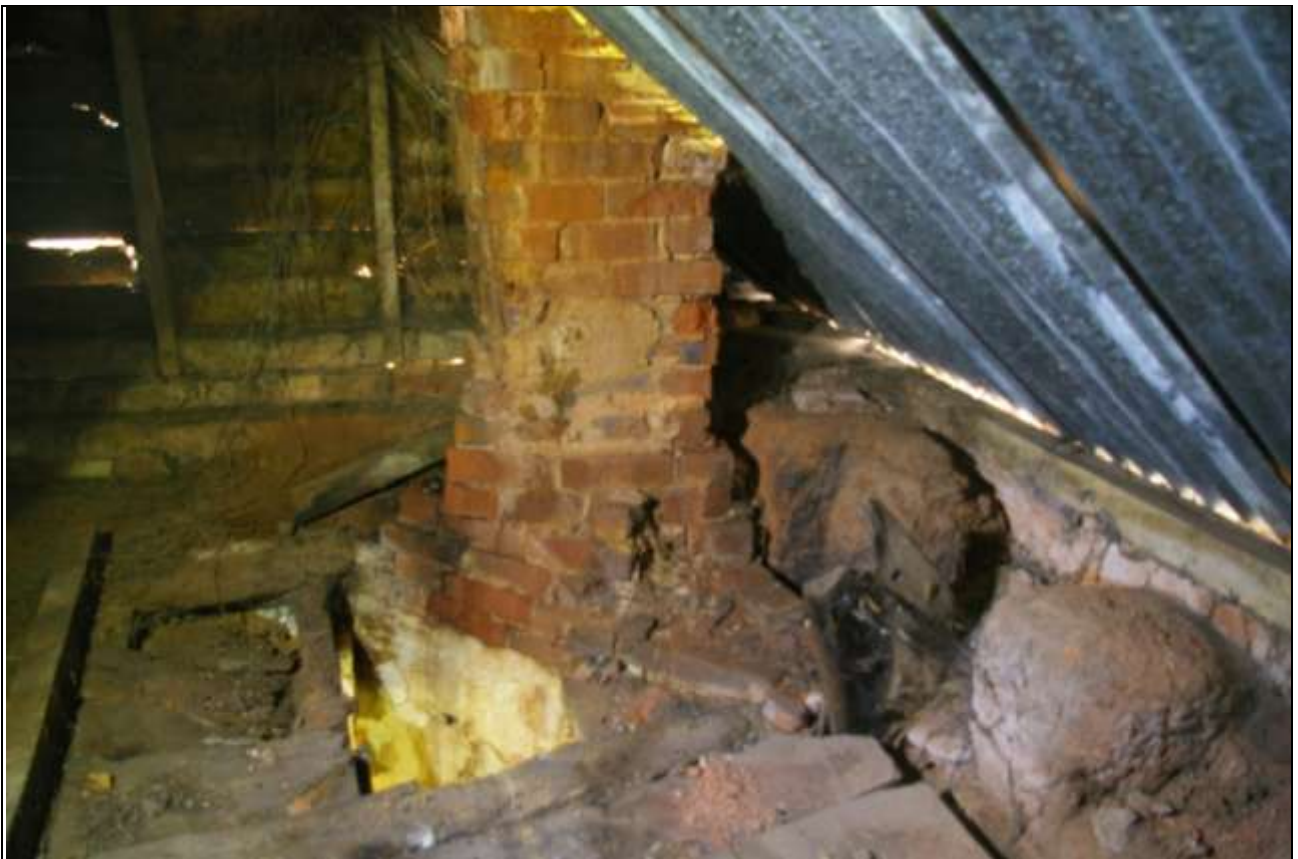
Brick stack, serving fireplace inserted into the room at the east end; from the west, north-west.

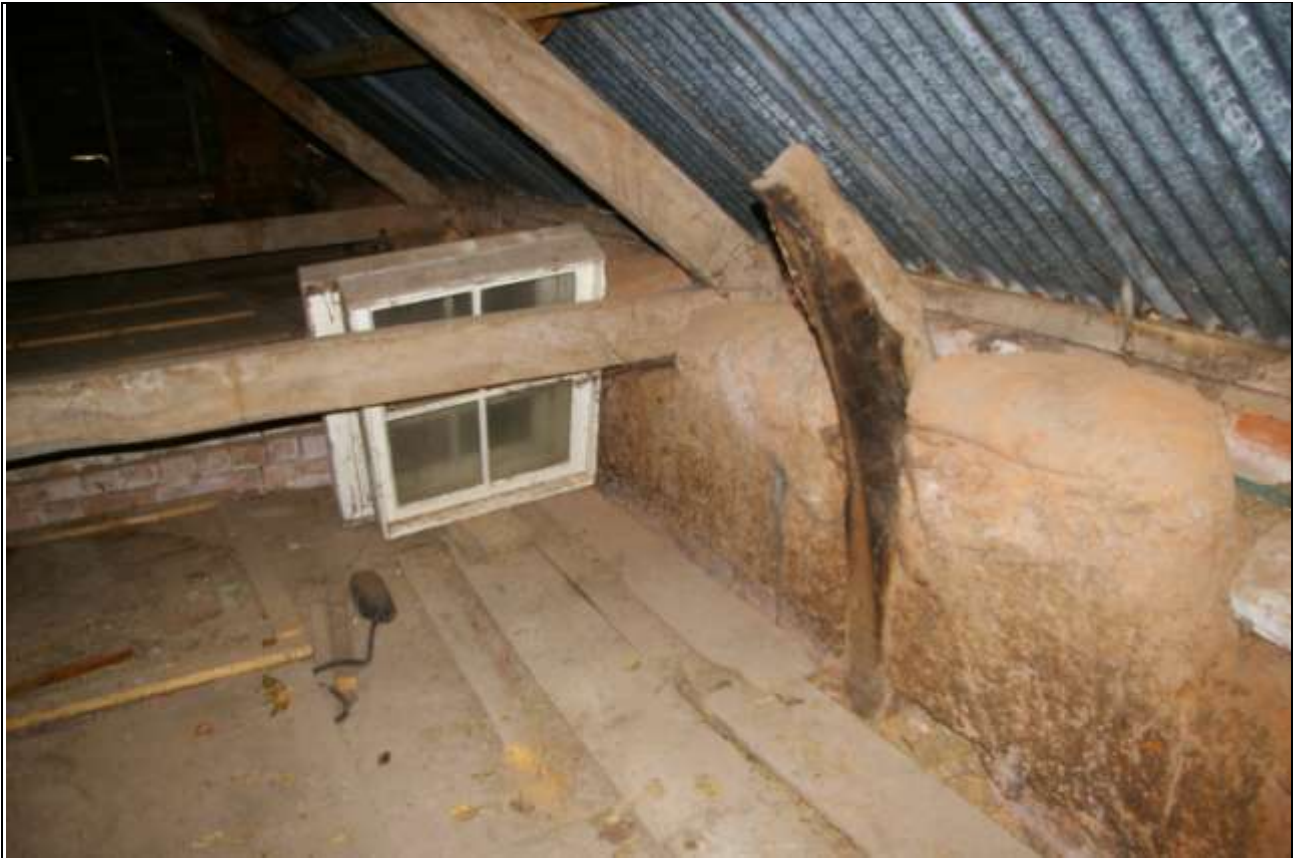
The 'east' end of the barn is of heavy cob walls, on a rubble stone base and dates to the late medieval period, likely to be c.1600 or earlier. This cob building has the remains of side-jointed cruck trusses in the top of its main elevation walls. The upper crucks were lost in a fire of the 1920s/1930s; many of the cruck trusses have some element of black smoke-staining from this fire.

The best preserved base cruck as it rises smoothly into the joint, showing the smoke-blackening from the fire which destroyed this roof; from the north-west.

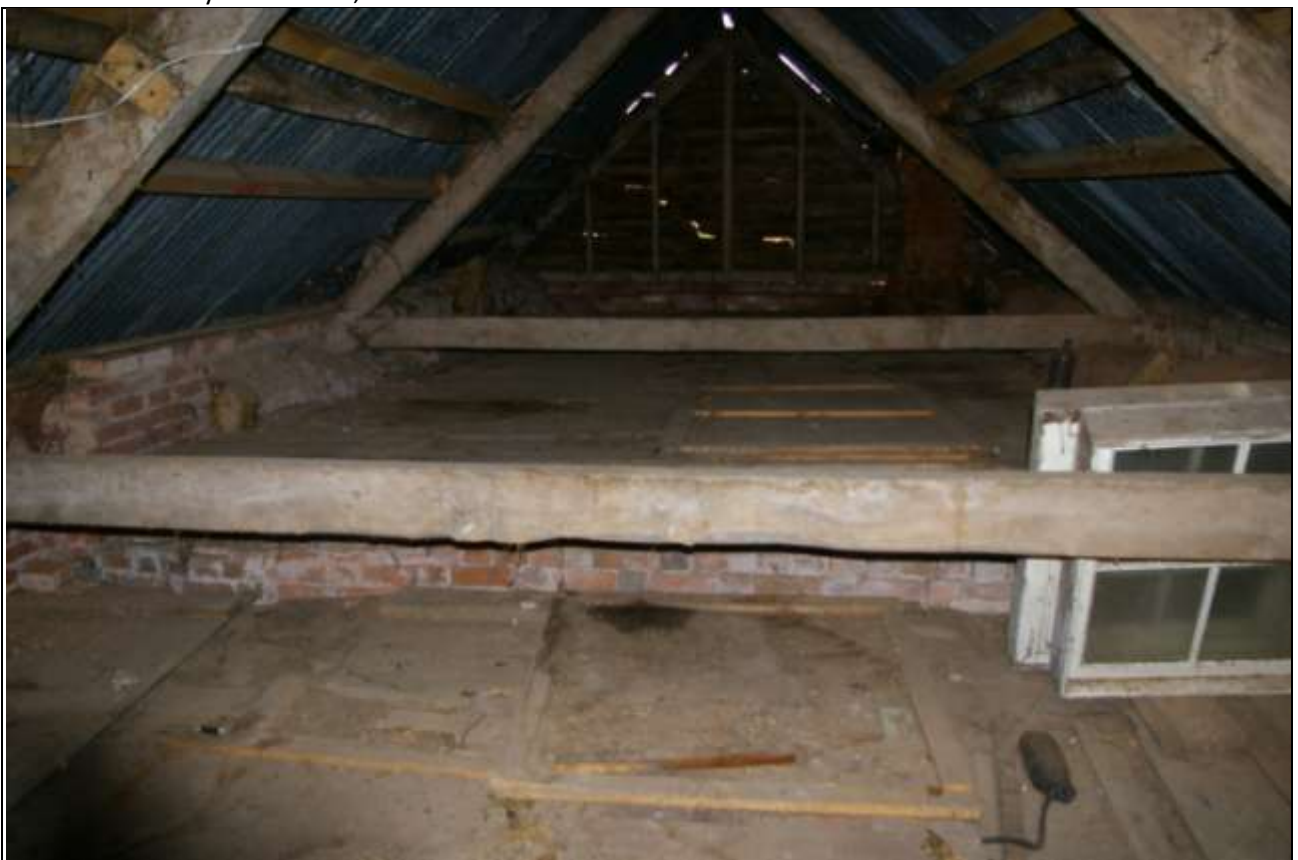
The raised section of loft to the east end, also showing two pairs of the base crucks to the east end; from the west.

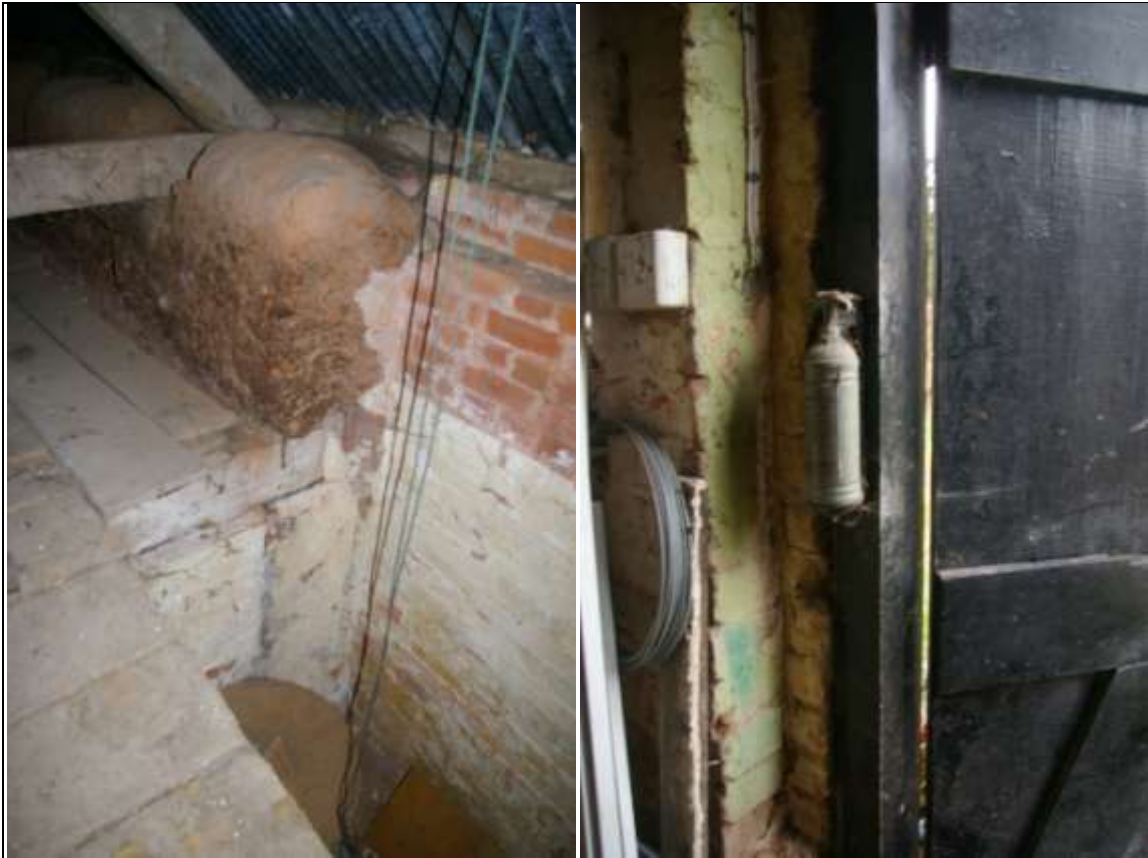
Left: The join between cob and brick on the south wall; from the north-west.

Right: The early 20th century fire extinguisher, attached to the door frame in room 4; from the south, south-east.

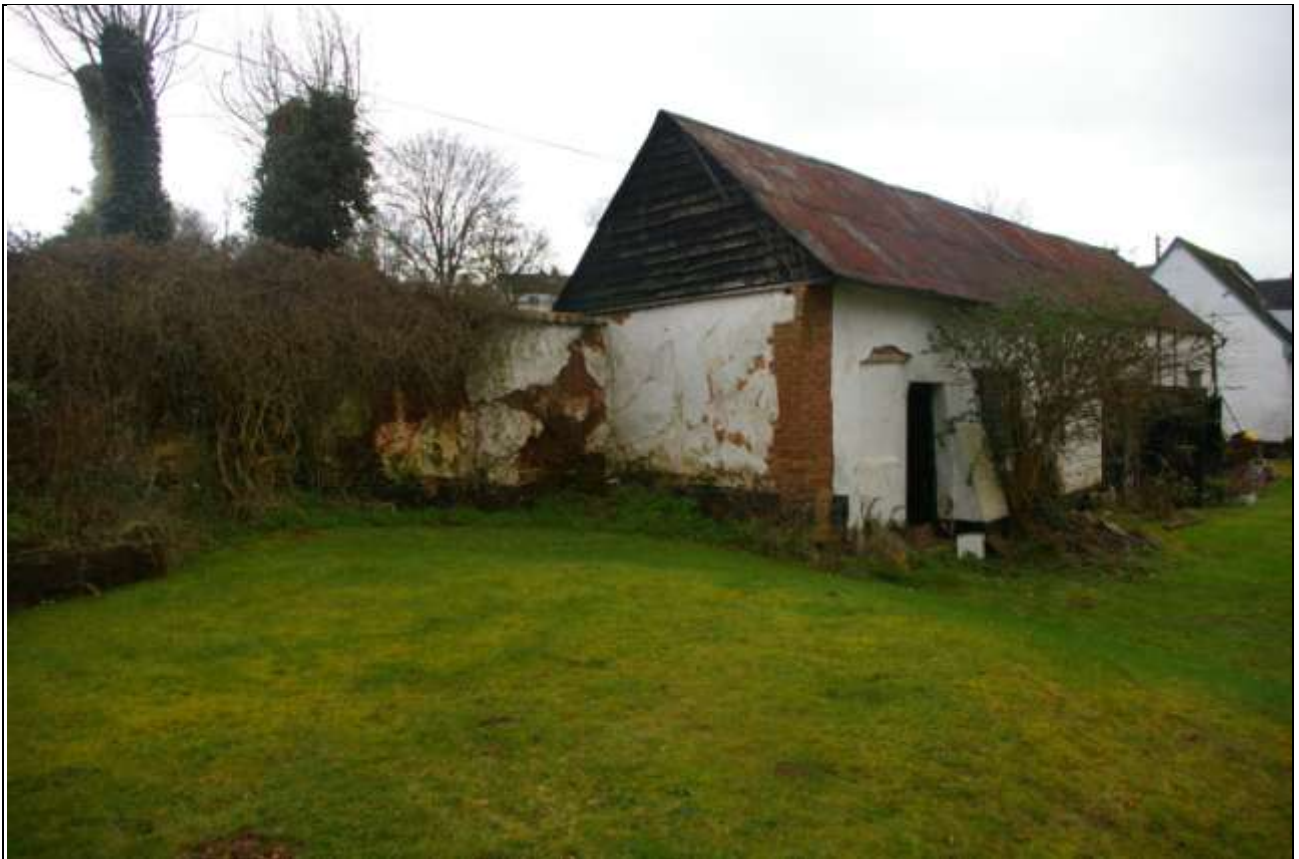
Exterior view of the barn and adjacent historic walling; from the north-east.

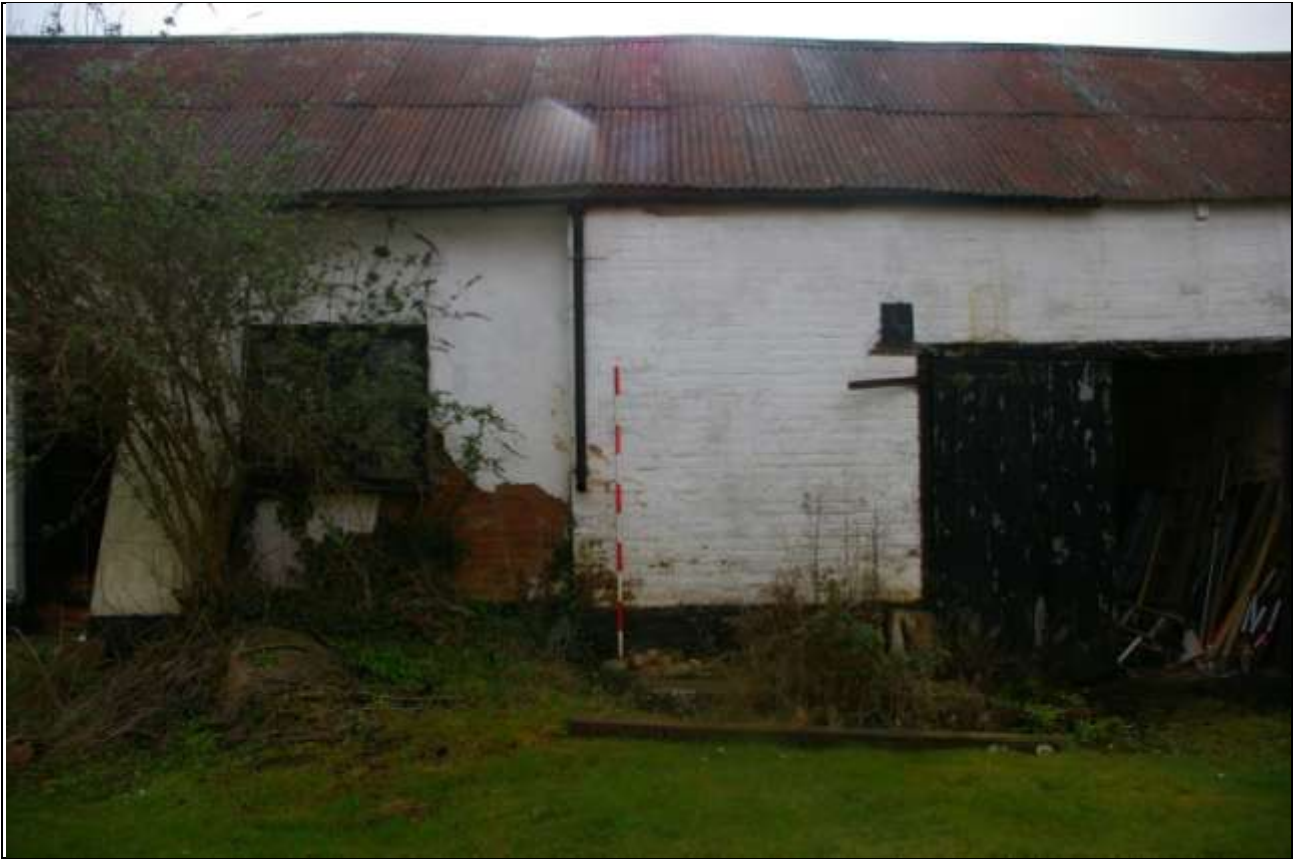
The north elevation is built of cob to the east end, which sits back, relieved from the rest of the elevation, with a large cob and brick buttress bracing the wall. This section of historic cob walling has a blocked window, central doorway and a large, three-light window. The majority of the north elevation projects slightly forward, of brick build, a mixture of Garden Wall bond and Stretcher Bond. The elevation at this western end is dominated by two double openings with boarded doors, with another three-light window to the west end.

The north elevation, showing the older cob to the east and the brick to the west; from the north.

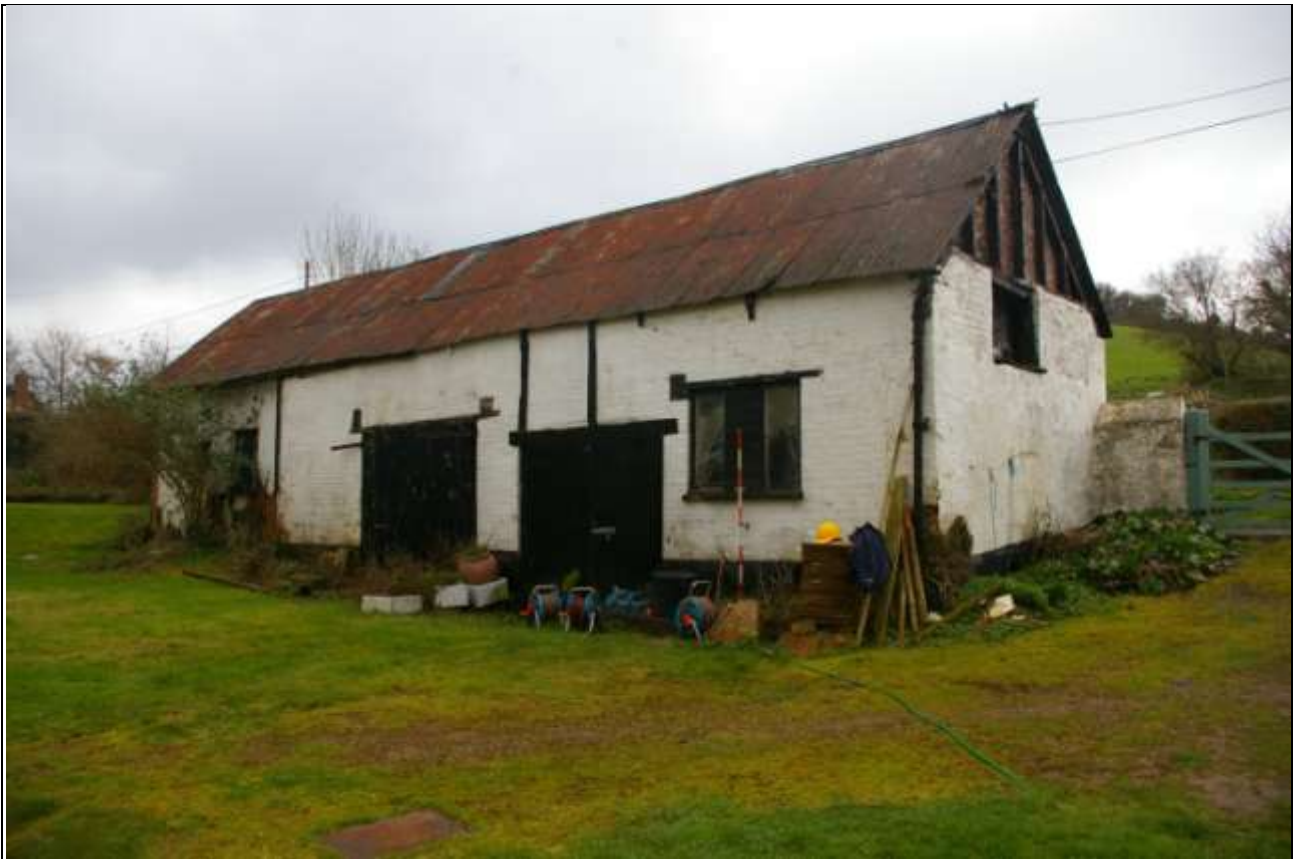
The north and west elevation of the barn; from the north-west.

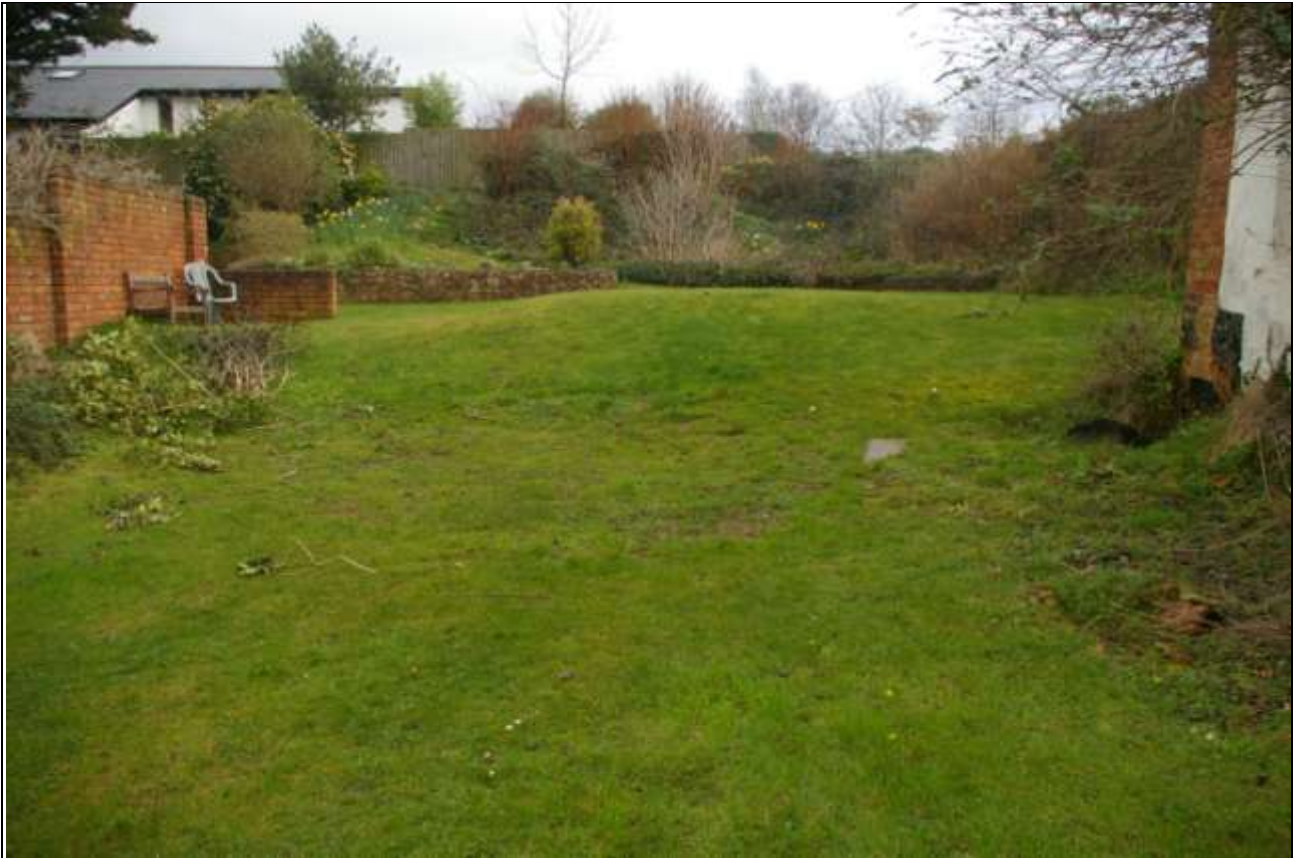
The terracing/undulations in the garden, where the adjacent buildings have been demolished; from the west.

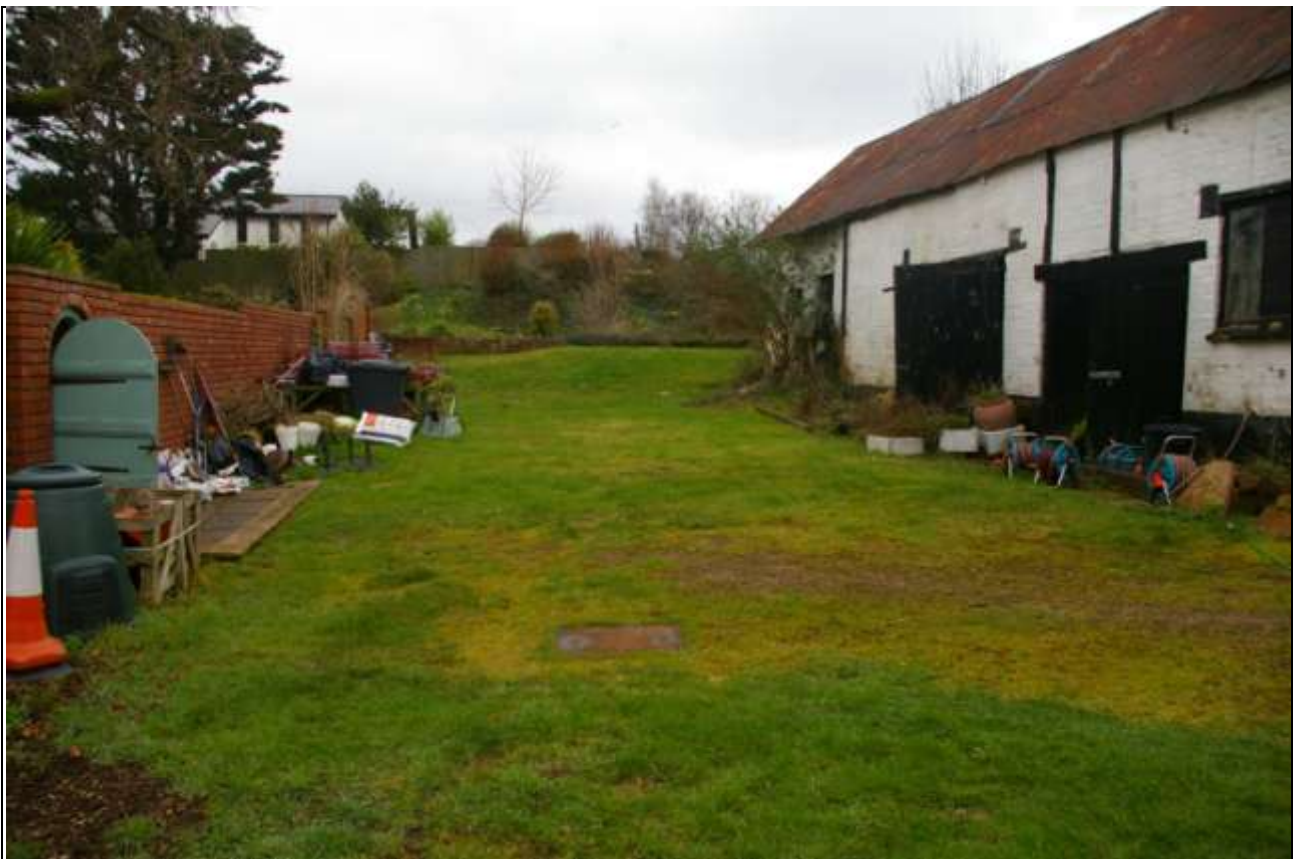
The grass to the north of the barn, which was historically a cobbled yard, the cobbles now piled at the eastern end of the barn; from the west.

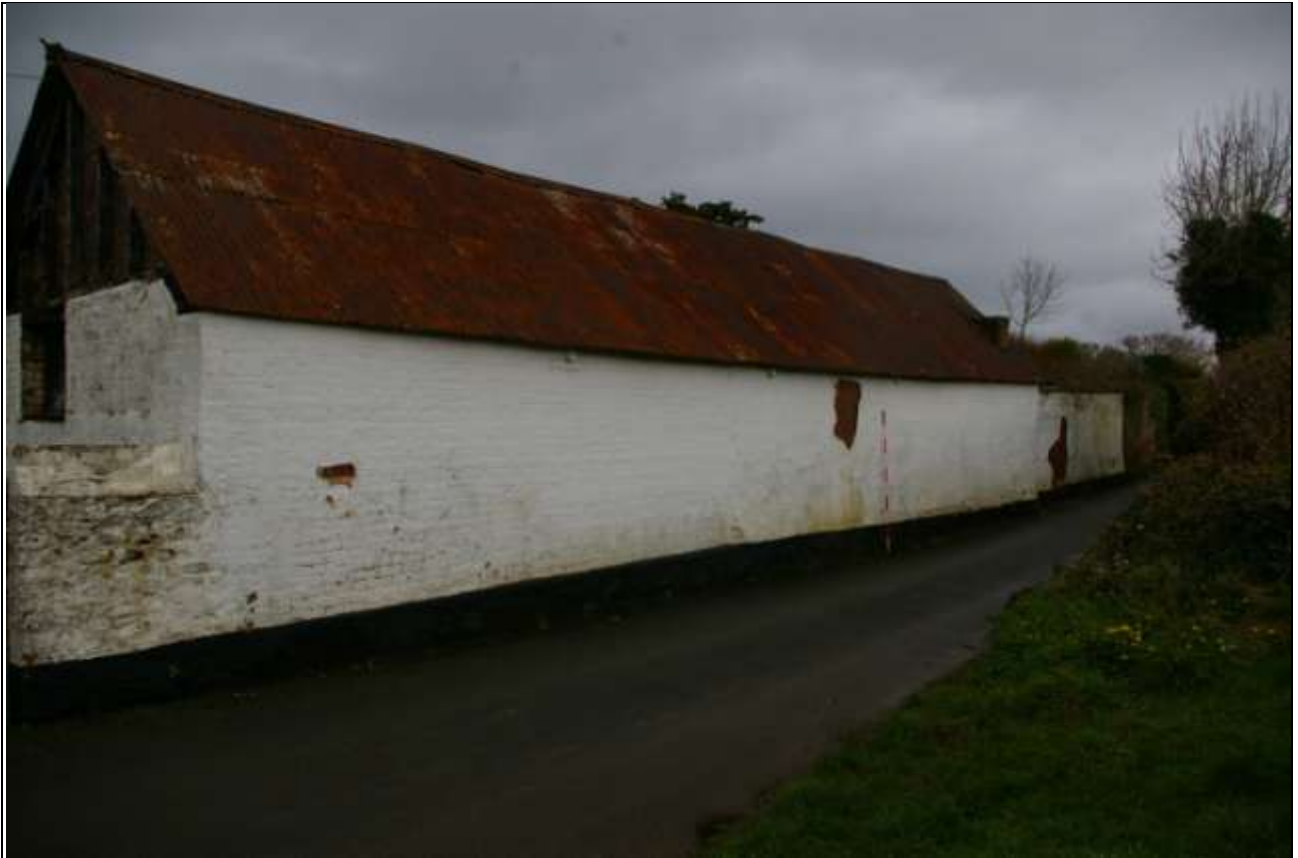
The south elevation is of cob of a rich red-brown colour, built on top of a rubble stone base. The west end of the south elevation is of English bond brickwork. The elevation is now blind, but there is clearly a blocked window to the east end.

The south elevation along Behind Hayes Lane; from the south-west.

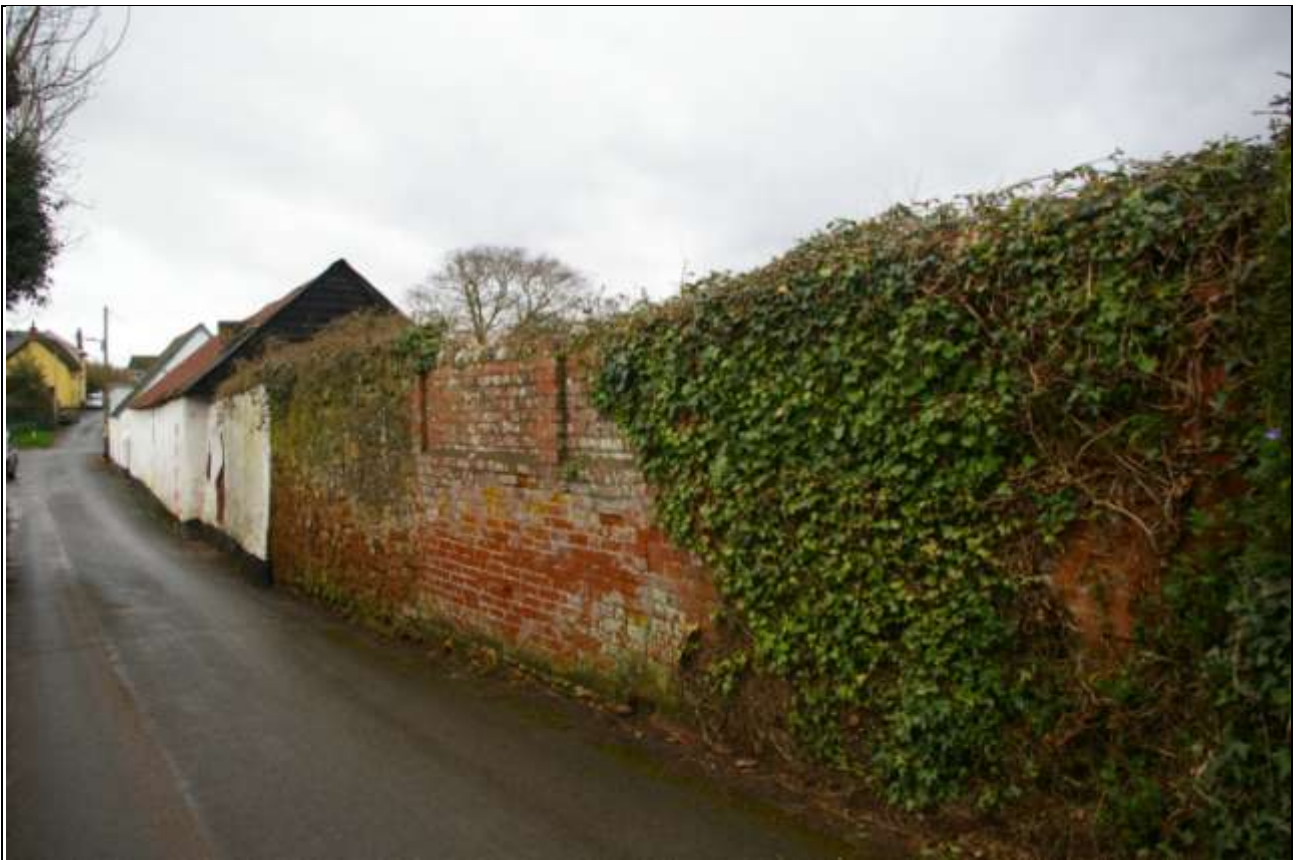
View along the phases of brick, dressed stone blocks and cob of the historic walling along Behind Hayes Lane; from the east, south-east

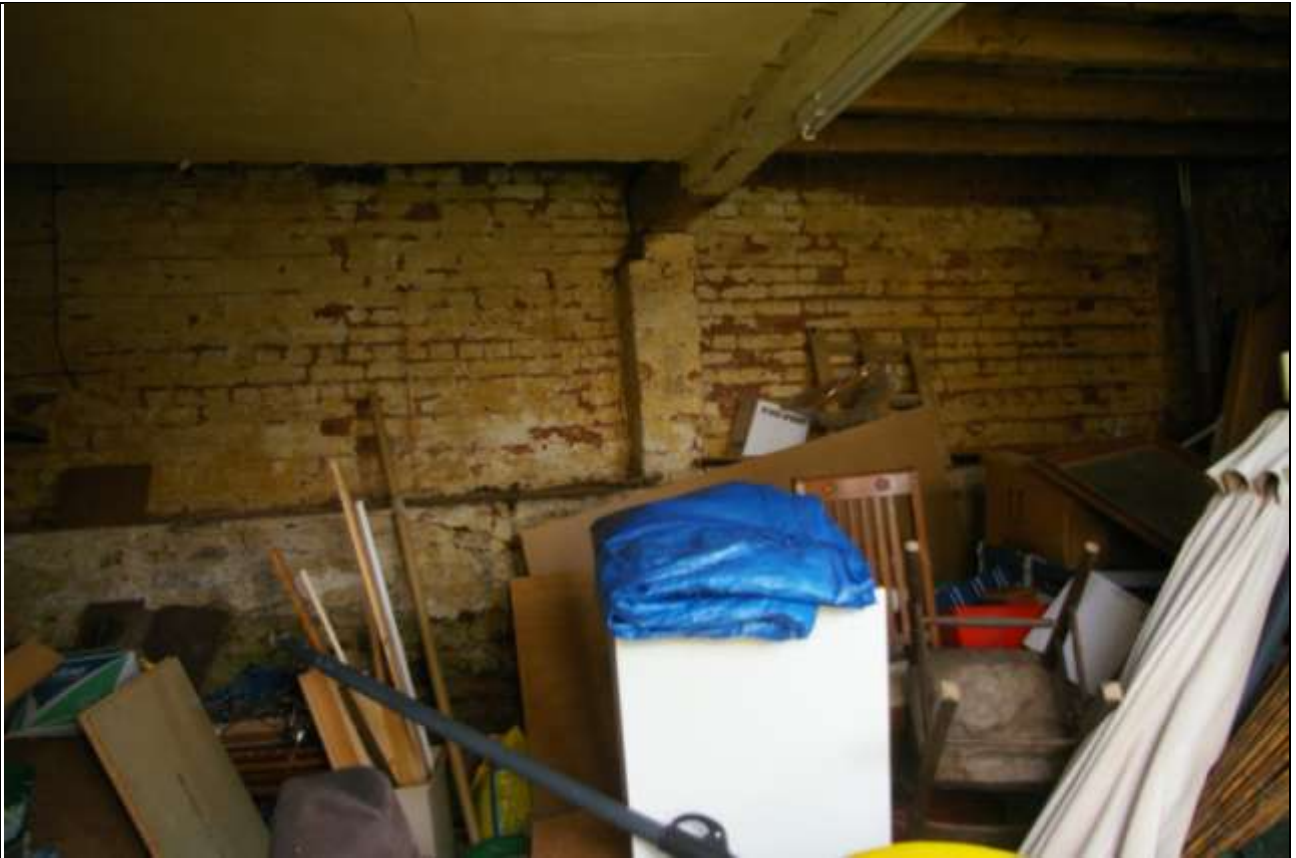
The south interior wall to the west end of the barn, showing the English Bond brickwork; from the north.

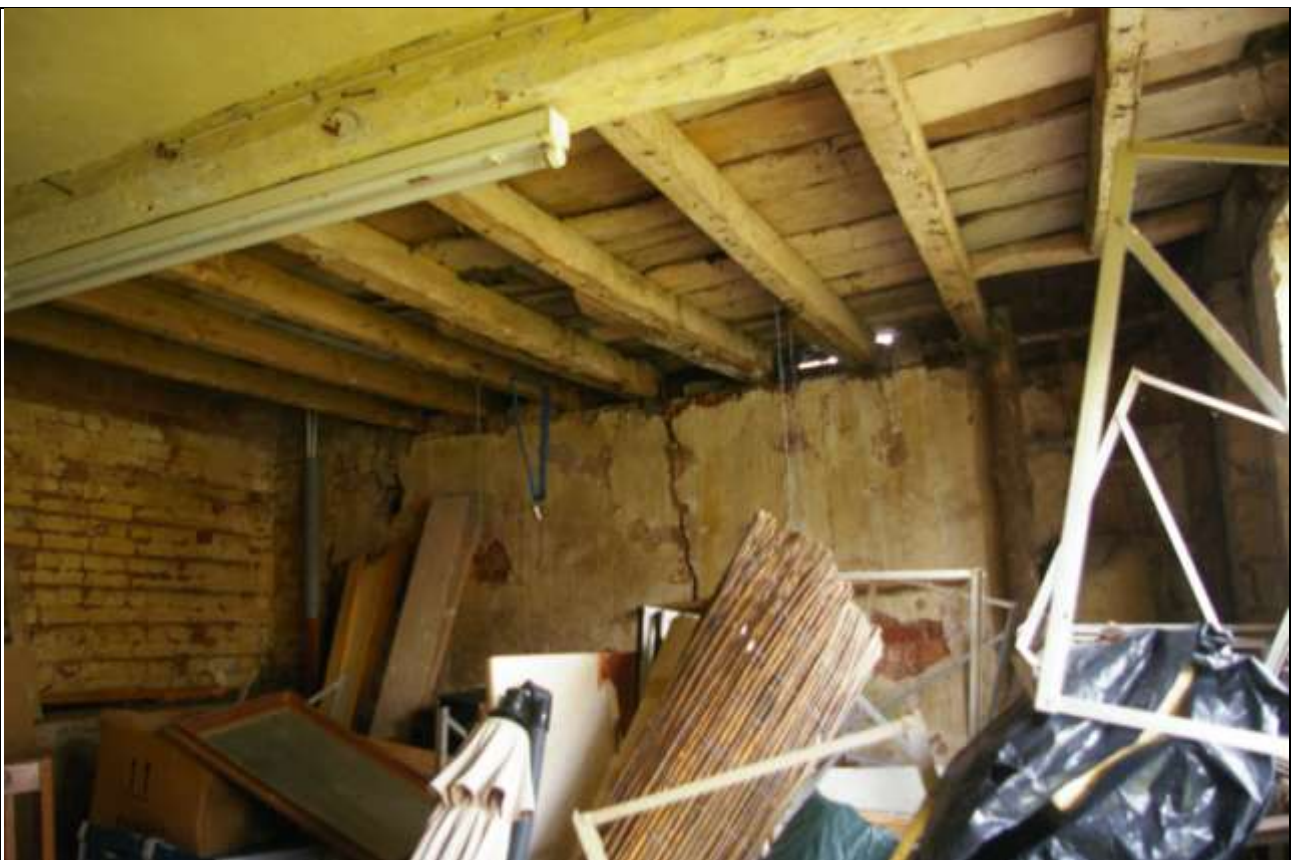
The brick west wall of the barn, showing the plaster on the inner face and heavy 19th century beams and joists to the loft floor; from the east, north-east.

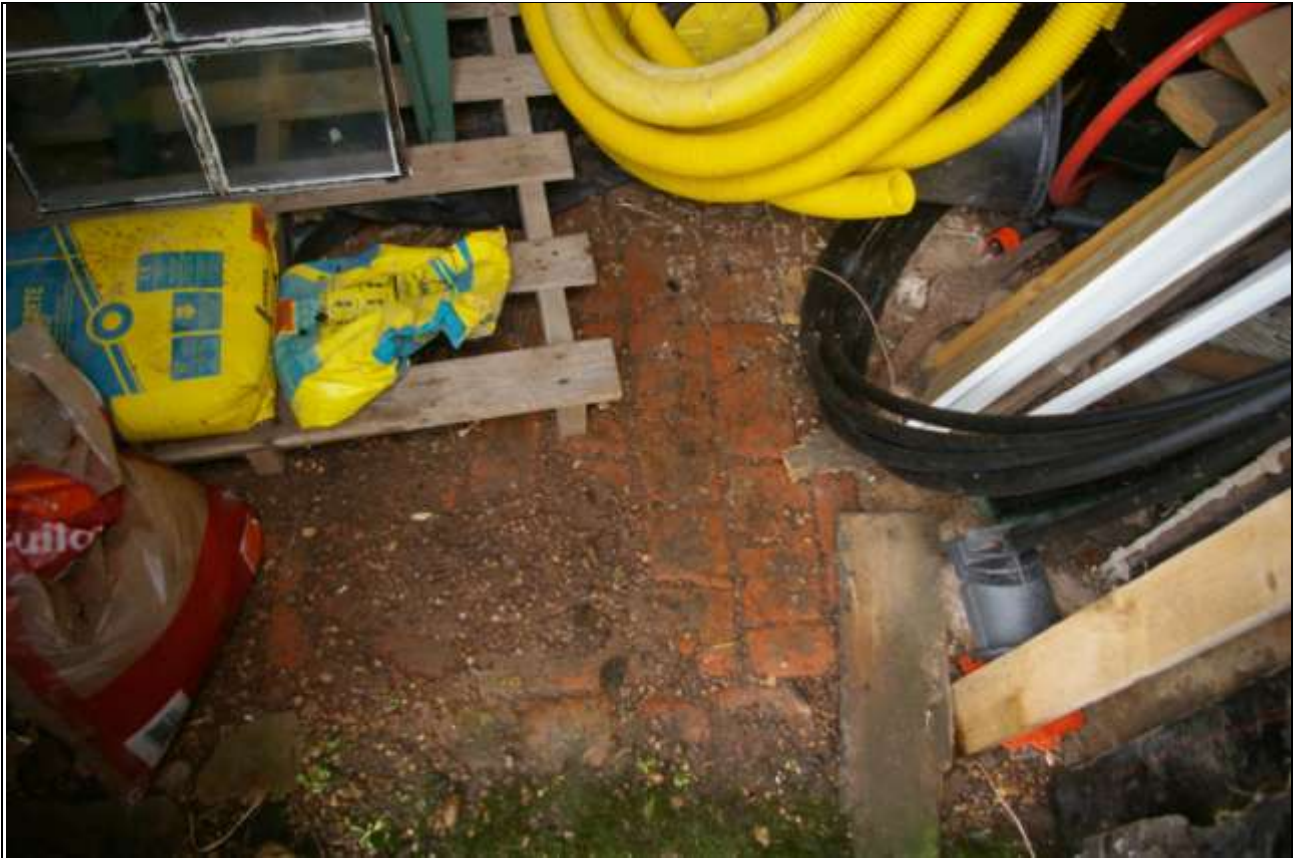
The brick pavers in the west end; from the north.

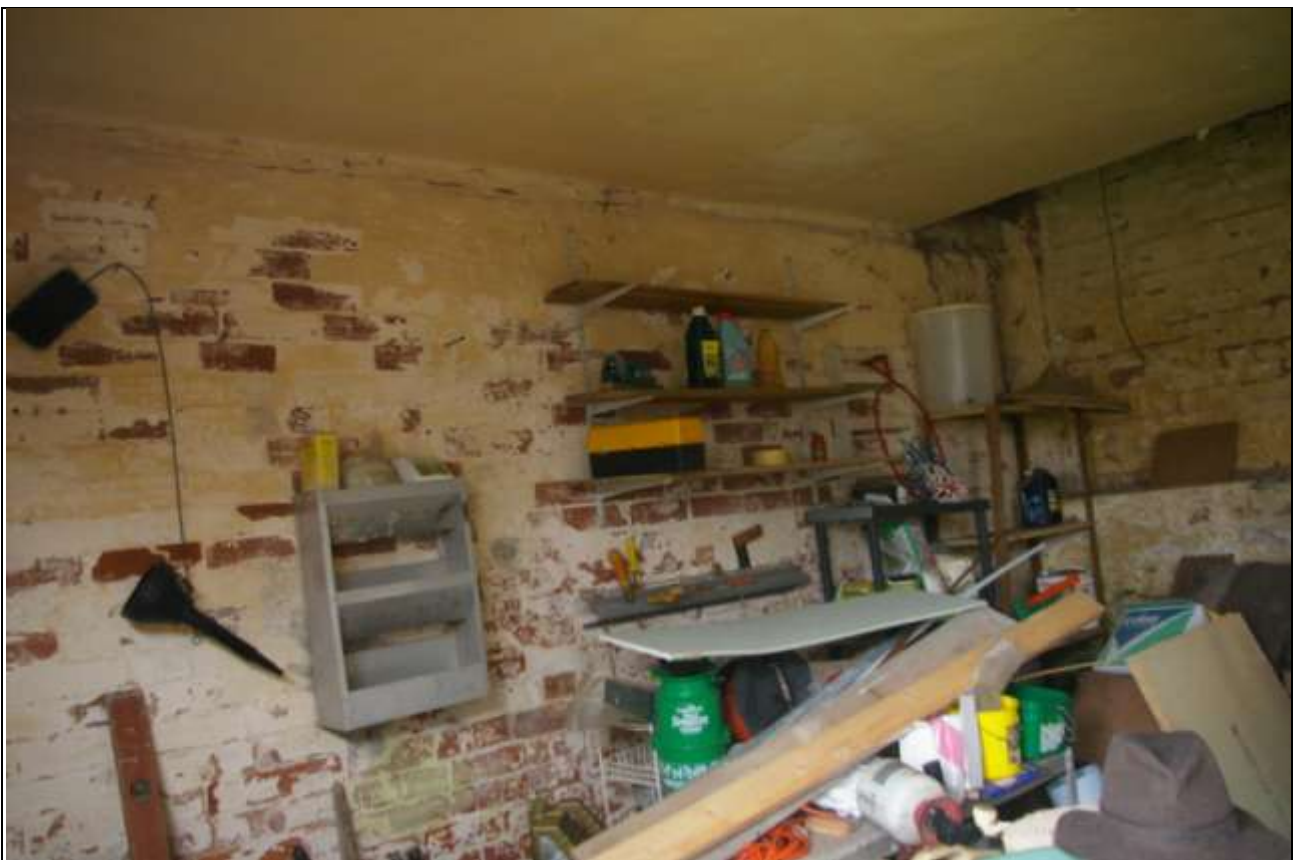
The brick partition wall, clearly not tied into the exterior walls, of Stretcher bond, possibly a later addition; from the north-west.

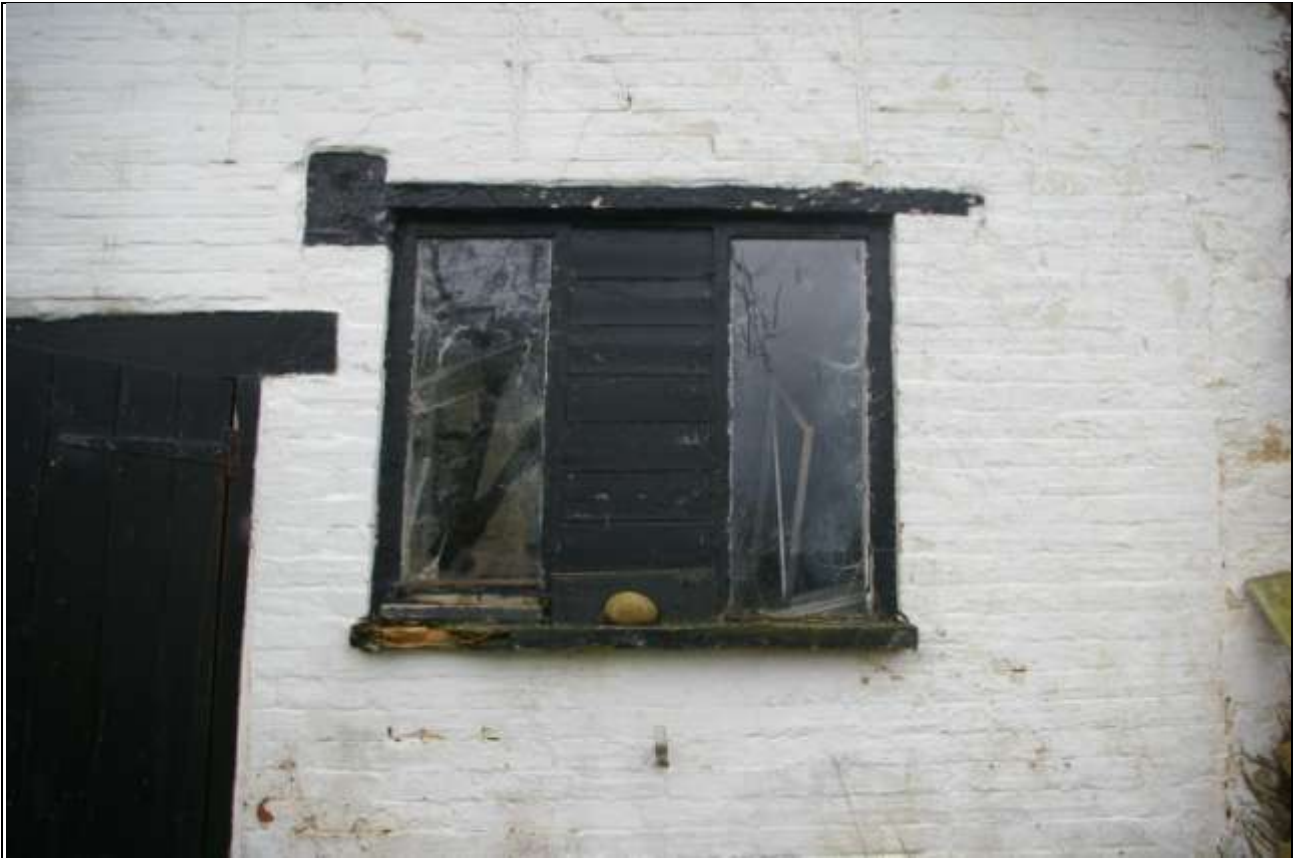
The three light window to the west end of the north elevation; from the north.

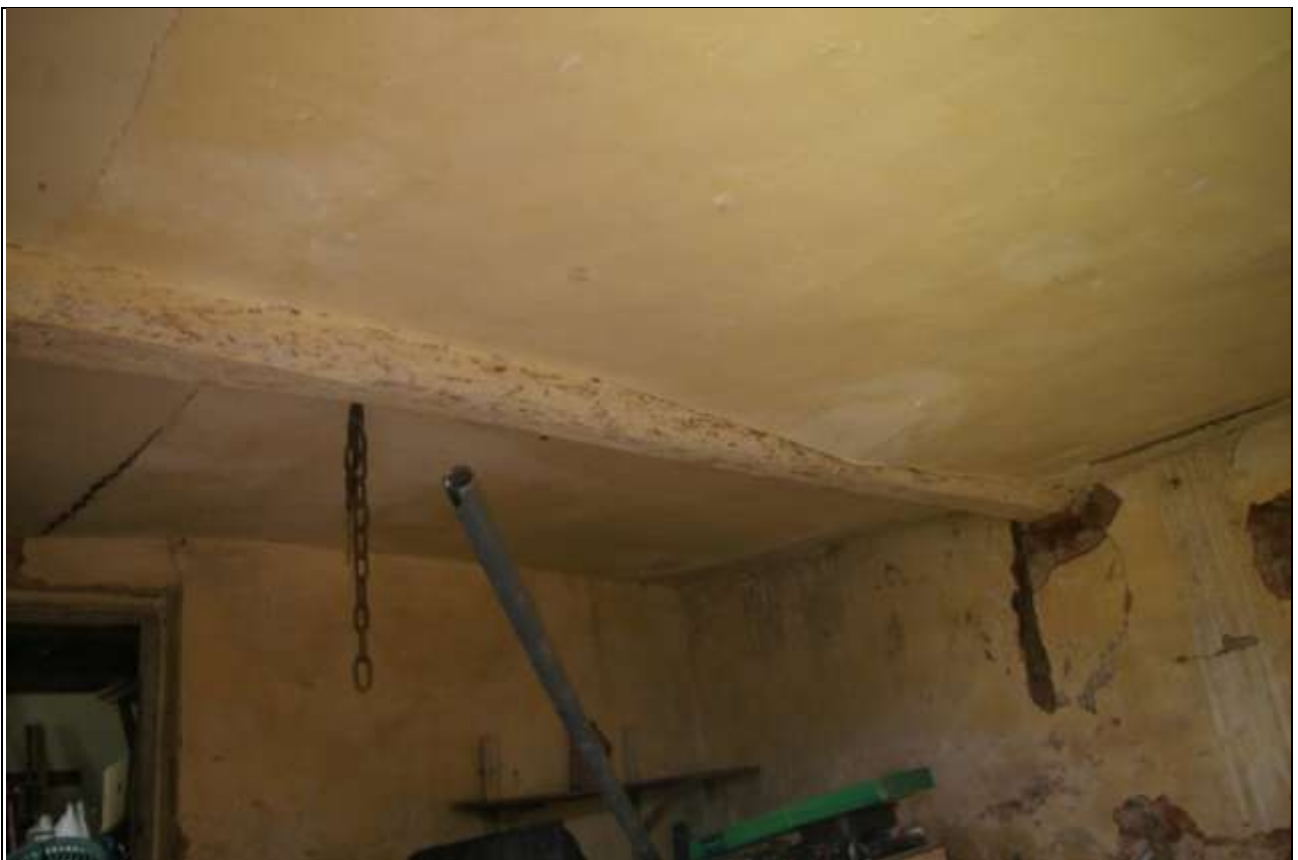
The ceiling beam in room 4, has a narrow chamfer, with run out stops, the base cruck can be seen in the wall to the east side of the beam; from the north-west.

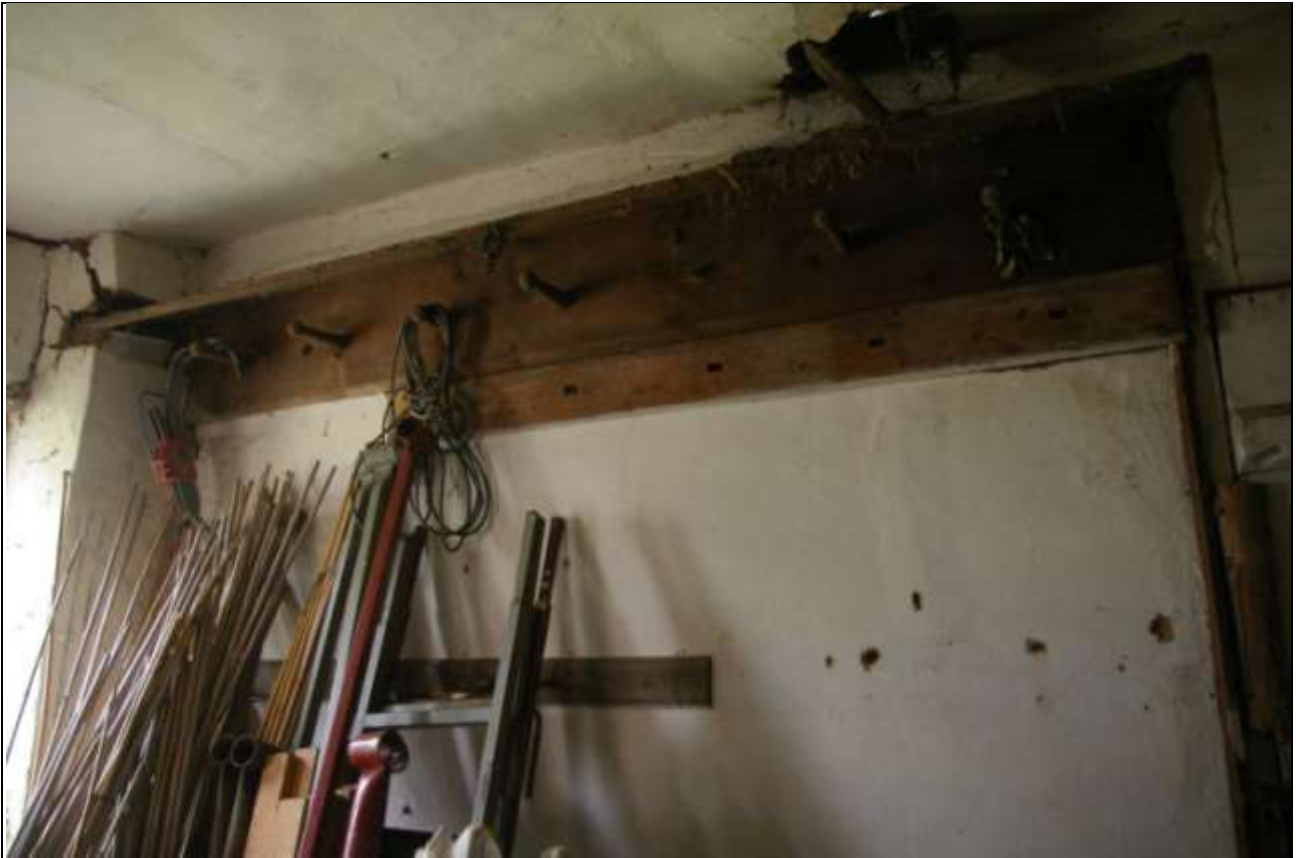
Detailed view of one of the planks, bolted to the wall, with turned pegs, for reins or harness; from the south-west.
