COLEHAYES BARN
OTTERTON
EAST DEVON
DEVON

Desk-Based Assessment & Historic Building Recording

Colehayes Barn, Otterton, Devon Desk-Based Assessment & Historic Building Recording

By E. Wapshott & N. Boyd
Report Version 01
12th April 2017

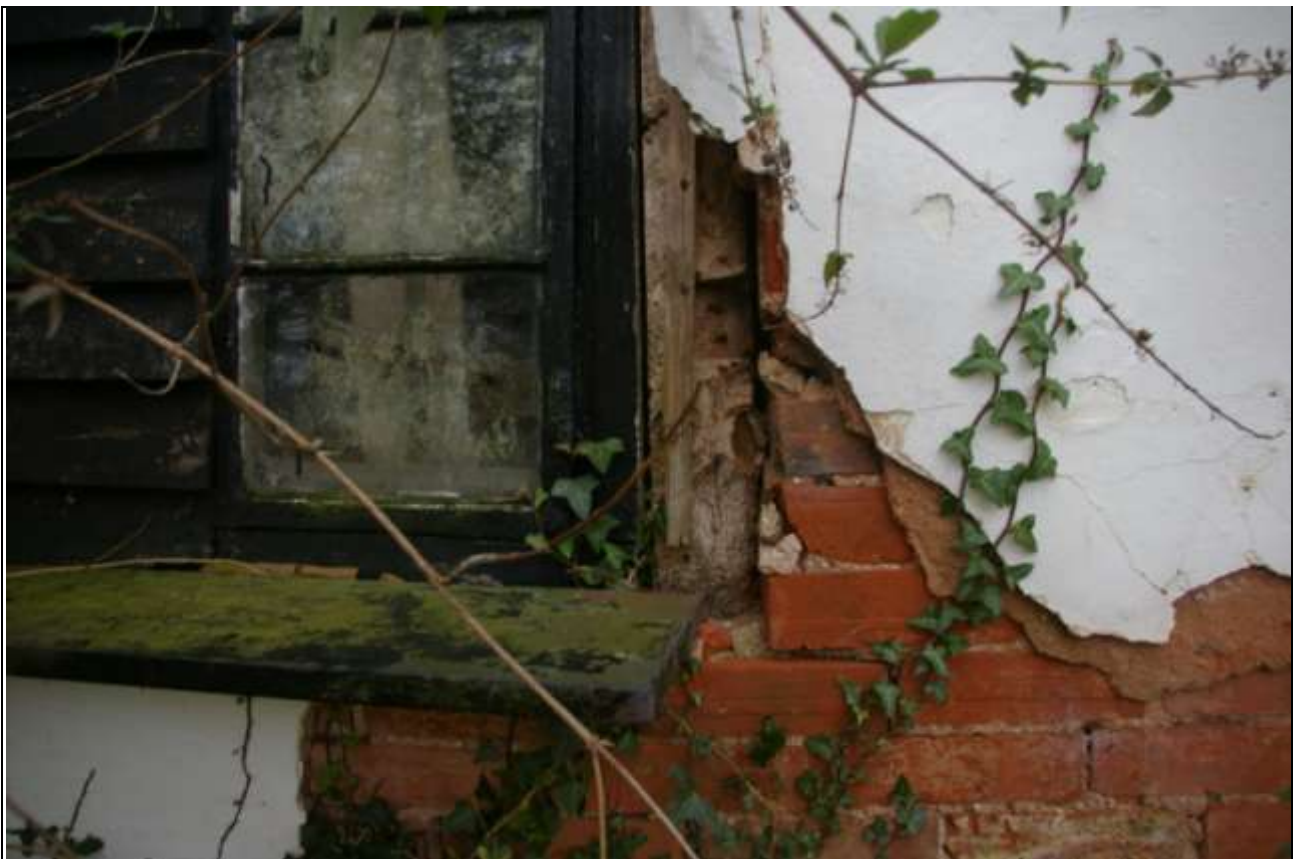
The heavy timbers which line the opening to the window in room 2; this may be the back of the heavy base cruck; from the north.

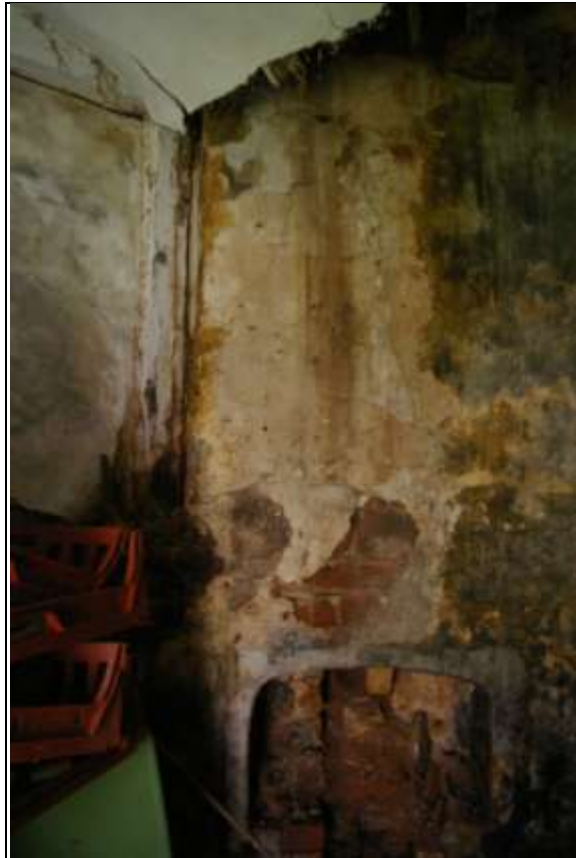
The brick stack and fireplace in room 1; from the north

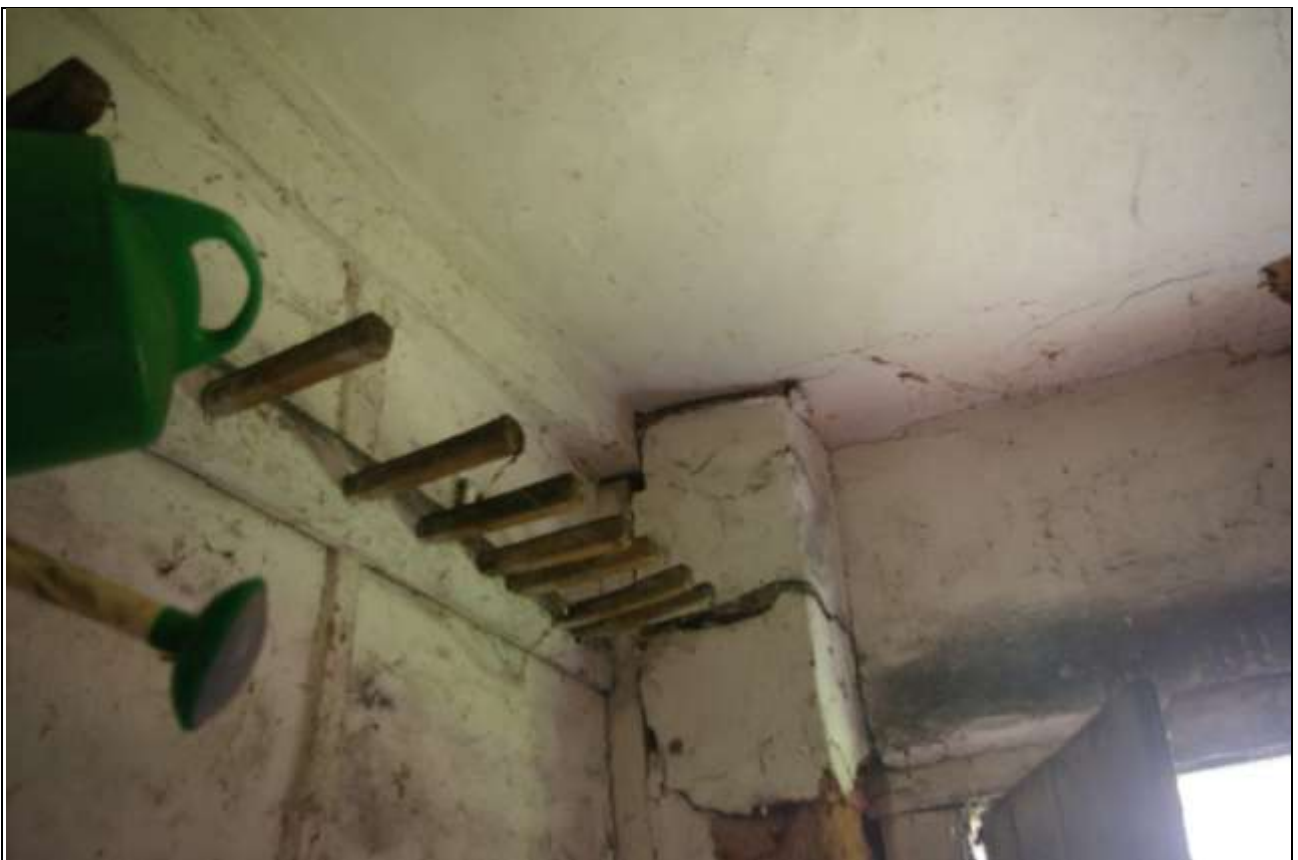
The heavy beam over the partition between room 1 and 2, showing its wide adze cut chamfer and run out stops. Also showing one of the narrow planks and long crude sets of pegs; from the south, south-east.
