MORETON HOUSE, BIDEFORD, DEVON

Results of a Desk-Based Study
&
A Historic Building Assessment

Report No.: 150429
Date: 29.04.2015
Authors: Humphreys, C.
Wapshott, E.
Hosegood, V.

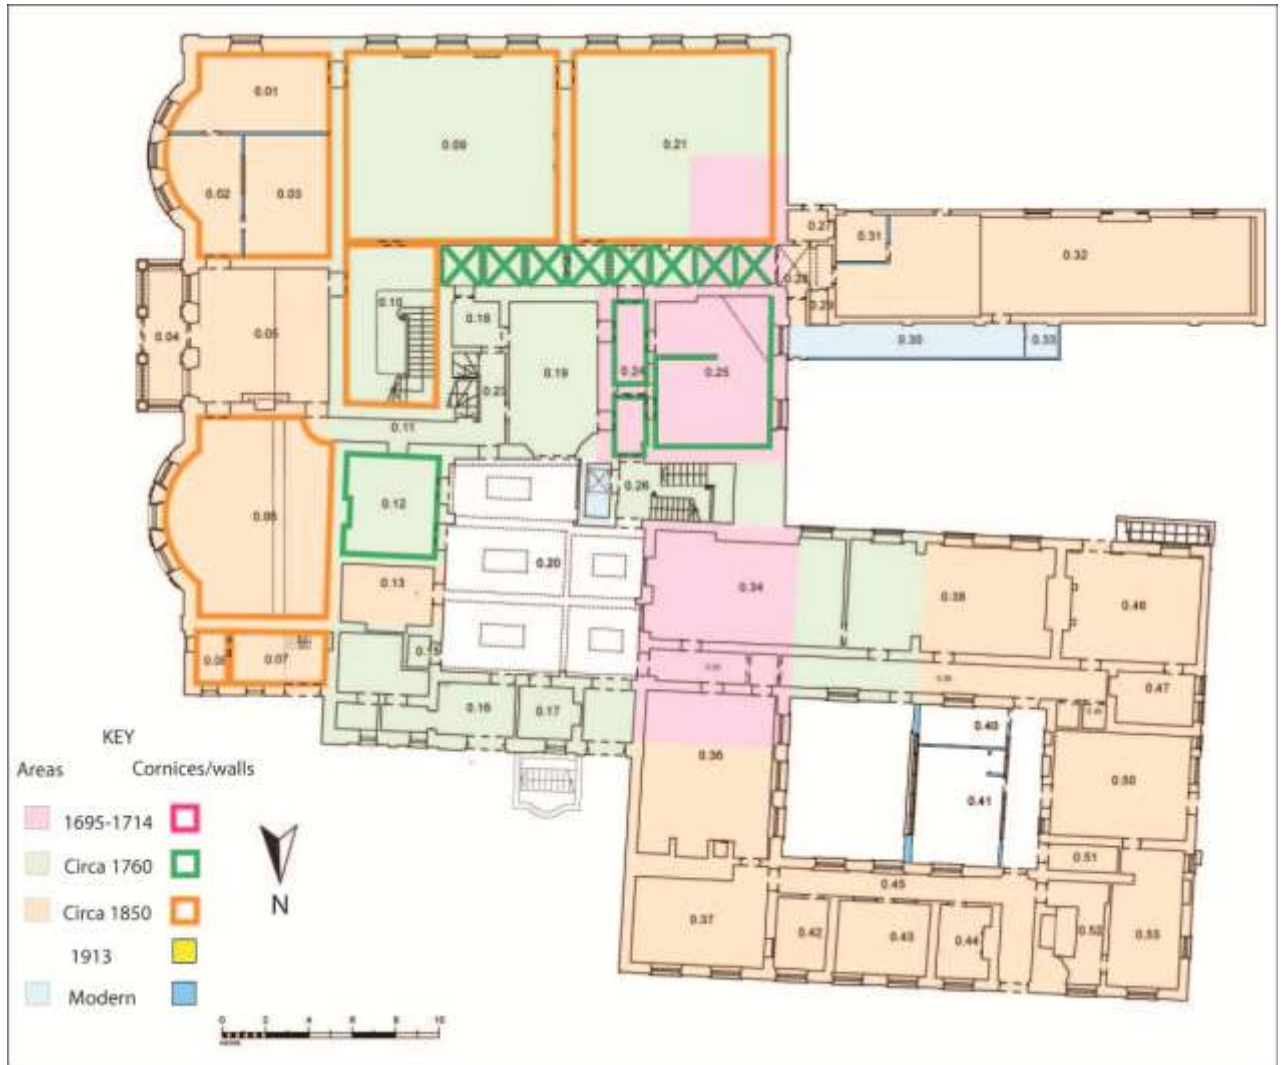
Figure 8: Phased ground floor plan.

3.3.1 Late 17th century (pink on plans)

Evidence for this period survives in the western part of the building and appears to demonstrate that the earlier structure consisted of at least two blocks (*note the misalignment*) the gap between subsequently filled-in with a stair in the 18th century. The size of the 17th century building is unknown however, the only description or depiction is a mid 18th century date painting of the house by John Jewel which shows 'a grand house of three stories'.

3.3.2 18th century (green on plans)

Daddon house was significantly enlarged during this phase with a large block containing the principal first floor reception rooms added to the south of the complex.

3.3.3 19th century (yellow on plans)

The house was again enlarged and elaborated. A large range was built to the east, abutting the former exterior east wall. This range created additional reception rooms and a more formal entrance, with porch. A new main stair, to serve this east range was inserted into the rooms in the former east wing of the 18th century house and the earlier stair removed.
