# **PYNE FARM BLACK DOG WASHFORD PYNE DEVON**

Results of a Desk-Based Appraisal & Historic Building Assessment

South West Archaeology Ltd. report no. 160623

By Colin Humphreys Emily Wapshott  
Report Version FINAL  
23<sup>rd</sup> June 2016

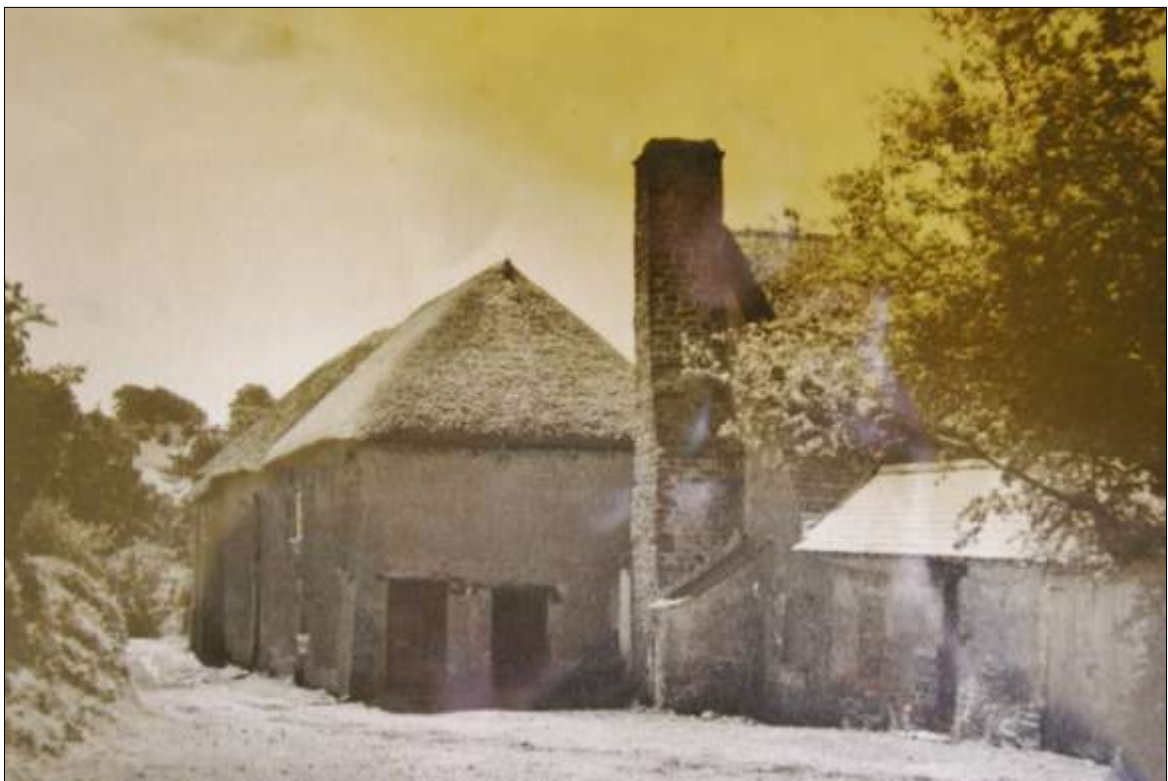
#### 3.1 Fig 5.

This photograph shows the barn from the bridleway to the north-west, and clearly demonstrates the construction and style of the building that was extant at the time of the DoE listing. The building is of two storeys with a thatched roof, hipped to the north. A pair of doorways can be seen in north end of the ground floor; presumably one was connected to the farmhouse via the link shown on the mapping. In the west elevation openings can be seen in the ground and first floor and towards the southern end the cheeks for the threshing barn doors are clearly visible. The pair of openings to the north may be painted and glazed but this is not certain.

Figure 5: Photograph of the north end of the east range; probably 1950's. Taken from the north.

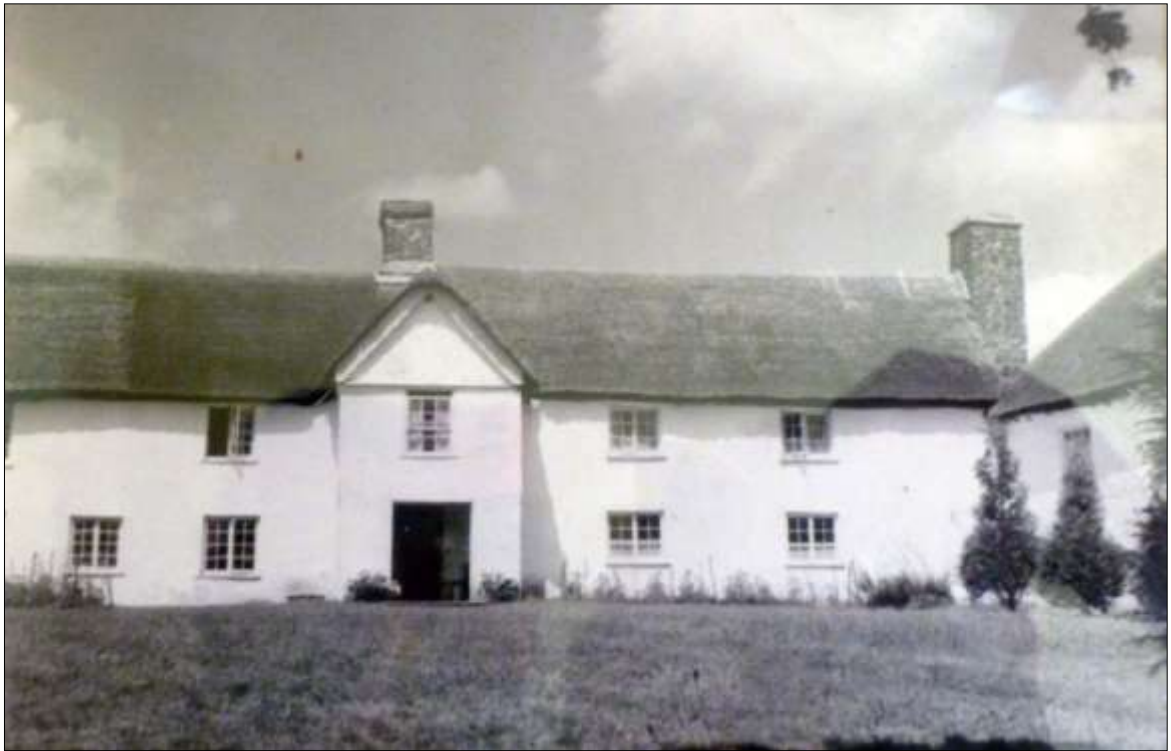
#### 3.2 Fig 6.

This shows that the northern end of the east range was used for domestic purposes.

Figure 6: Photograph showing the north end of the east range; probably 1960's. Taken from the south.

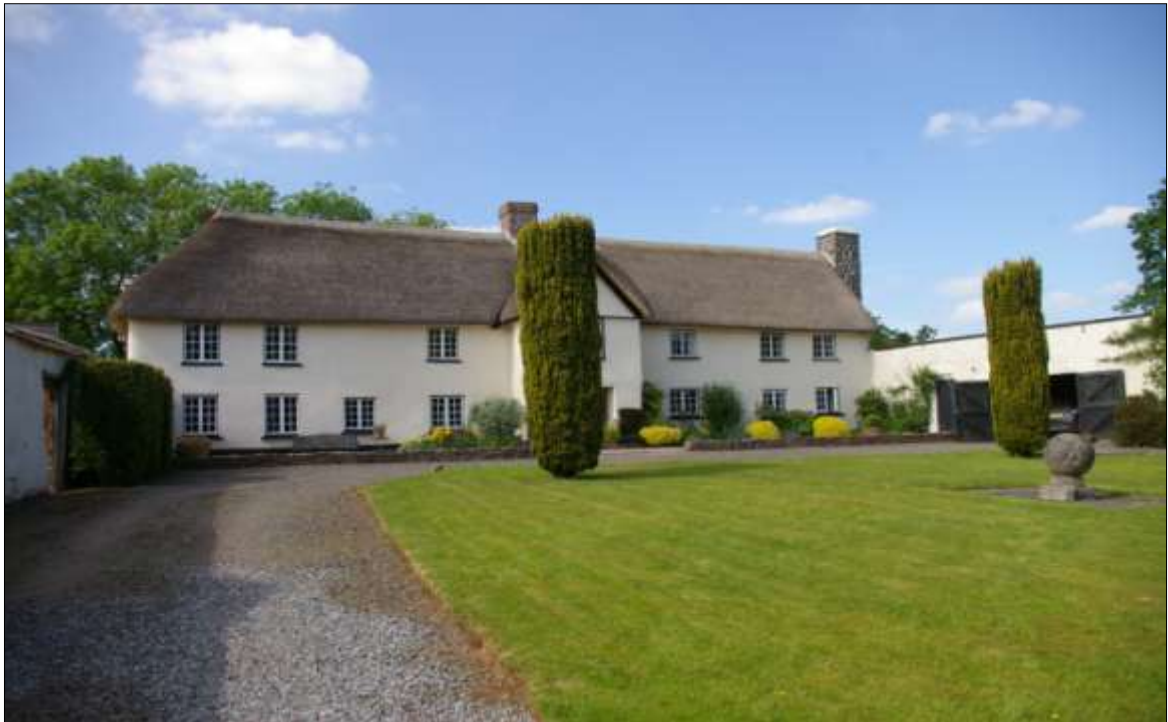
Figure 7: The farmhouse viewed from the south-west.

Long, south facing, two storey farmhouse with a central porch. Thatched roof, hipped to the west with three chimney stacks; one central with a brick upper section, a large stone stack against the east gable with a projecting oven and a smaller stack to the rear of the west part of the building, mostly constructed of brick. The walls are of cob construction on a stone base with a modern cement render and modern synthetic paint. The asymmetric layout of the window openings illustrates the development of the building, although many of the casements are modern replacements with modern sills.

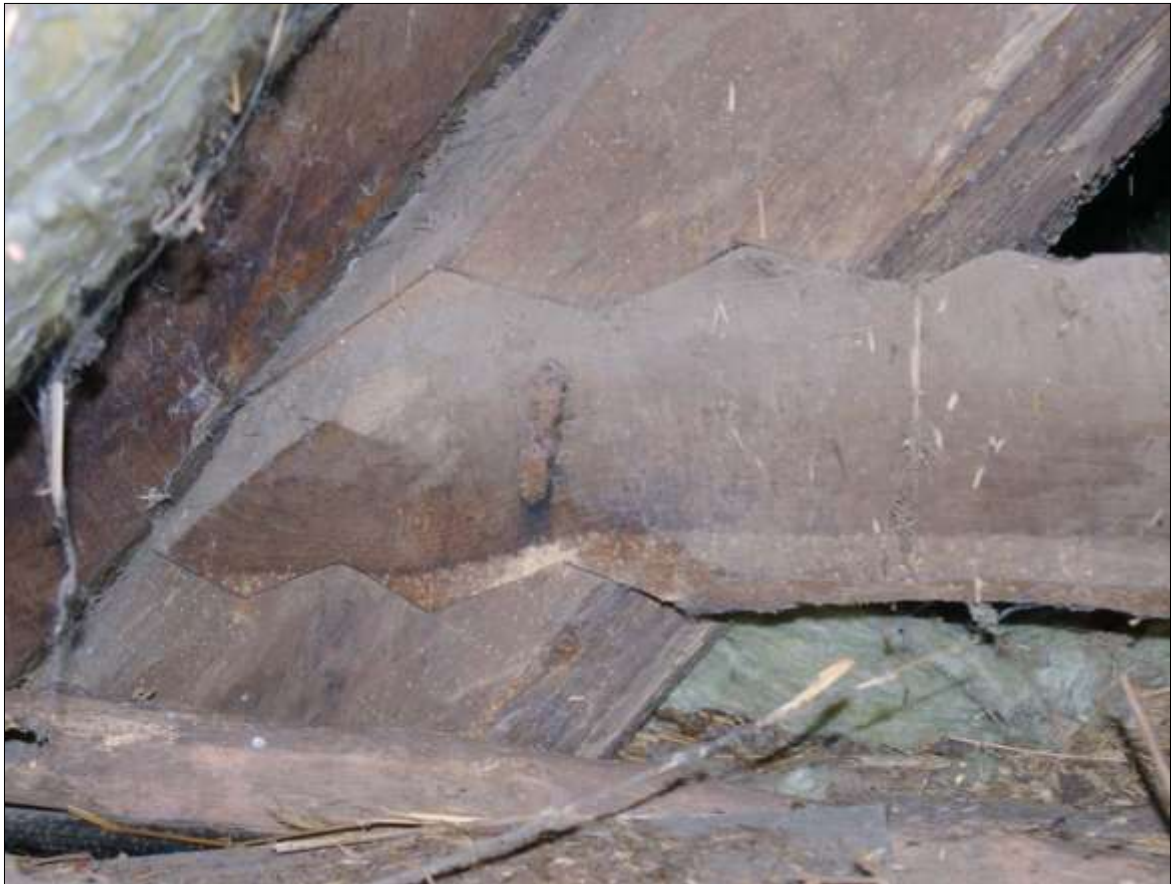
Only the area to the east of the chimney stack was inspected at the time of the survey. This consisted of a single oak A-frame with steep pitch, the principles half-lapped at the apex and the collar half-lapped and notched to each principle and fixed with a single iron spike (fig 8). There is a pair of purlins to each pitch on the back of the principles with crude 'in the round' rafters pegged to the purlins.

The chimney stack is unrendered in the roof space and the purlin to the north has been relieved around the stonework, possibly demonstrating the later insertion of the stack. The foot of a truss blade can be seen in the corridor (16). This is truncated by the chimney stack, again suggesting an inserted stack. The equivalent truss blade to the south is missing; the whole of the upper part of the porch having been rebuilt in the late 20<sup>th</sup> century.

Figure 8 Detail of collar joint with truss blade over central section.

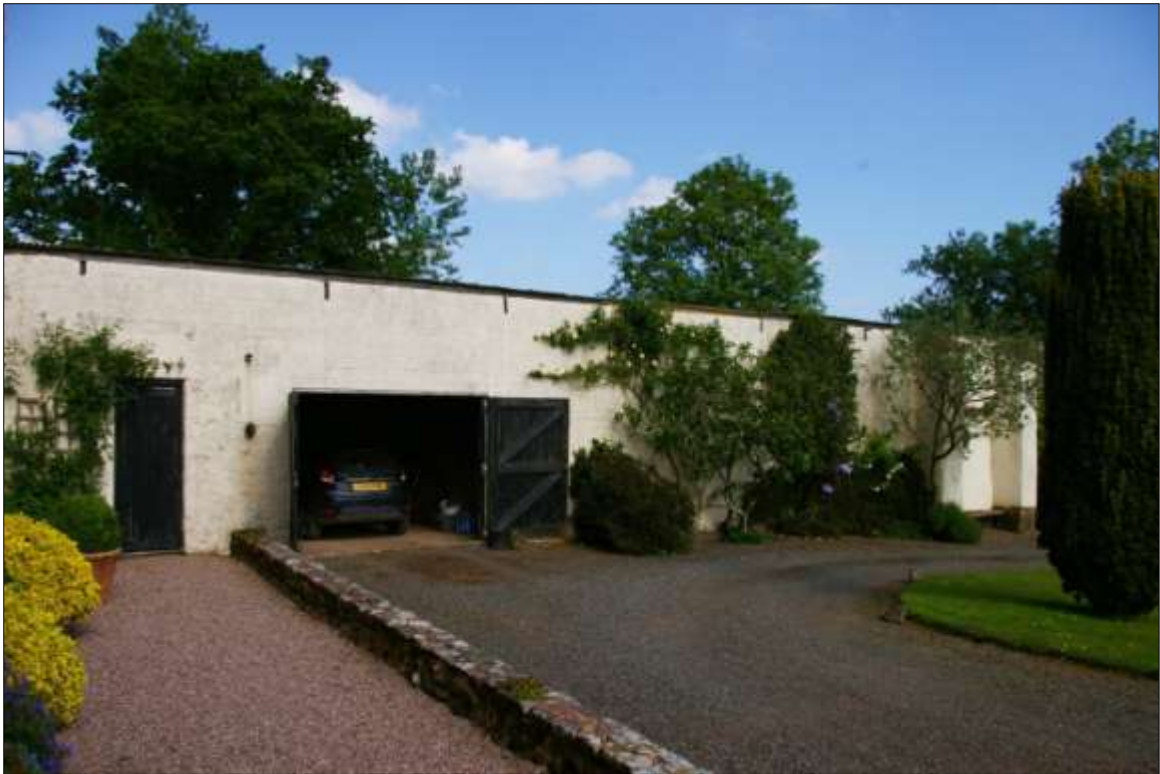
Figure 11: The barn range to the east of the house; viewed from the north-west.

This is a composite of barn structures, forming a long range, which has developed southwards down the slope. It is attached to the south-east corner of the farmhouse. The building forms the east side of the front courtyard, facing the former lane on its east elevation.

In the latter part of the 20<sup>th</sup> century the whole of this range suffered from neglect and poor repair and much of the historic structure was replaced with poorly constructed concrete blockwork. None of the historic roof structure survives; the former pitched, thatched roof (fig 5) having been replaced with mono-pitched corrugated iron.
