# THE EAST BARN, SHIRCOMBE FARM, BROMPTON REGIS, EXMOOR SOMERSET

Results of a Desk Based Appraisal,  
Historic Building Assessment & Archaeological Monitoring

Report No.: 141001  
Date: 01.10.2014  
Author: E. Wapshott  
V. Hosegood

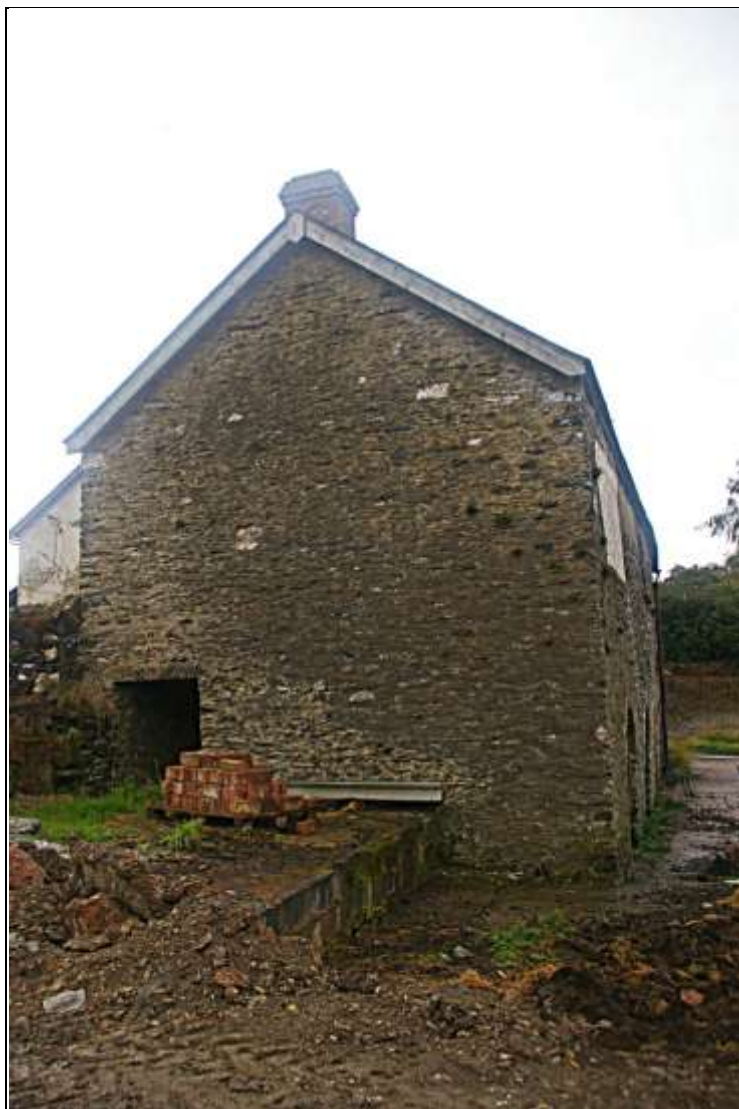
The west elevation is a gable end with new timber barge boards, using modern pine planks. The elevation has been heavily repointed to the south with cement (Figure 7). One small door opening occupies the base of the wall to the north side, providing access to the former feed passage. This has a flat segmental stone arch, supported with a steel girder and concrete internal lintels. There is patching in cement render and pointing around this reconstructed opening. This elevation is abutted by the concrete block remains of a 1960s shed which has been demolished.

Figure 7: The west elevation of the East Barn; viewed from the south-west.

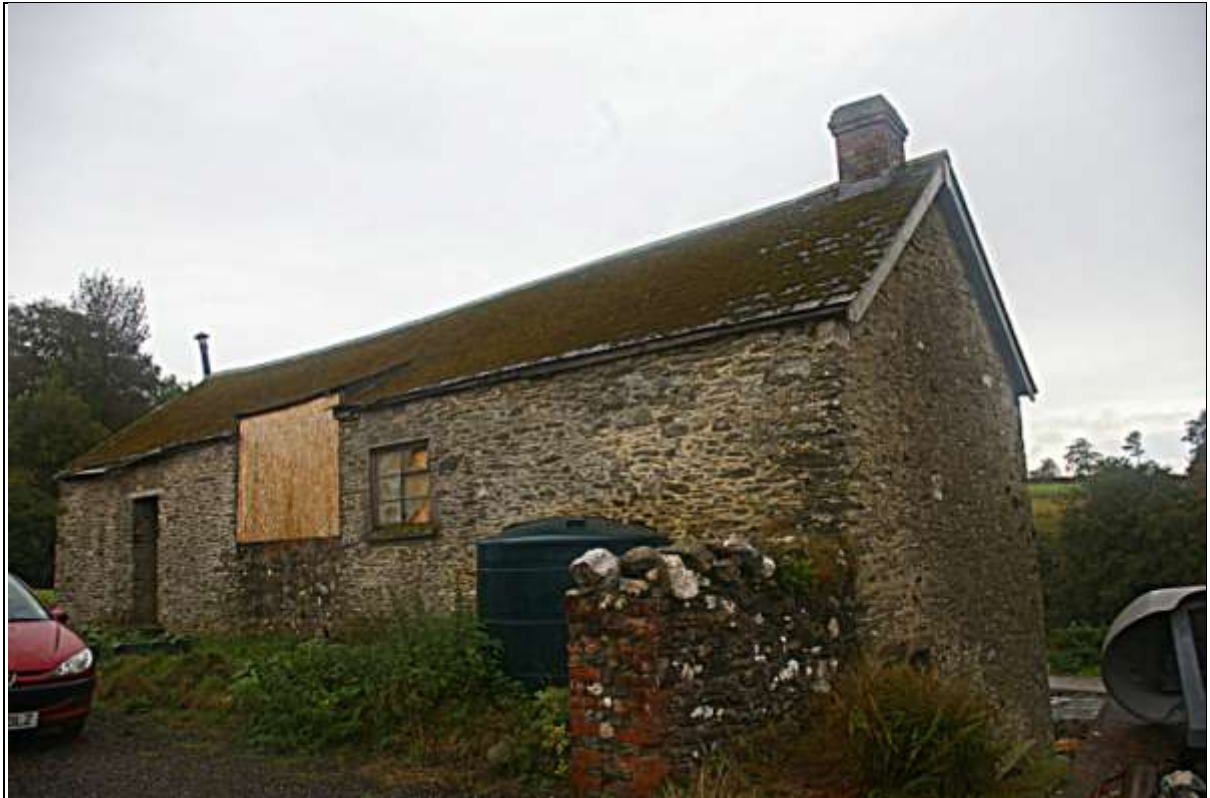
The north elevation of the barn is of single storey height, providing access to the first floor. The elevation has three openings (Figure 8). From west to east, these include: a metal 'Critall' window set in a forced opening; to the centre, a large boarded 'Somerset' or wall dormer, which breaks the line of the eaves and which is set into a blocked double-width door opening and to the east, a narrow doorway set into a partly blocked/partly forced window opening. The doorway has a narrow timber lintel and timber threshold and frame, with a 20<sup>th</sup> century plank door, having a decorative cast iron handle. The elevation is abutted by a short section of stone and quartz walling to the west end, with brick detailing. A short section of modern guttering survives to the east. A section of surviving cobbled surface, of approximately 2m width, runs almost the length of the elevation from the western end and stone built steps lead to the 20<sup>th</sup> century doorway to the east.

Figure 8: Shot along the north elevation; viewed from the north-west.

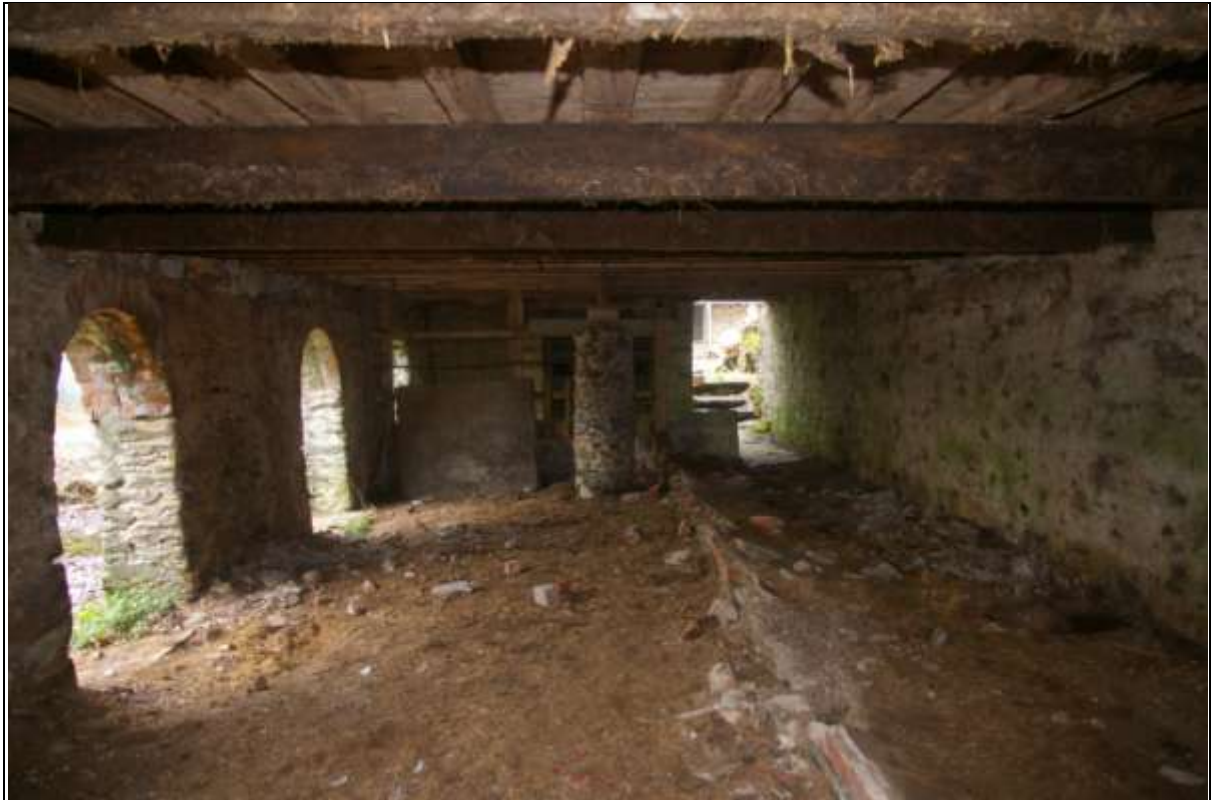
The first floor above can be seen to be supported on two main phases of (replacement) joists, set in the much larger square-built sockets of the original beams. The joists in places are merely resting on loose bricks, stacks of broken slate or shards of concrete block and similar. The joists to the west are of modern form, narrow and fine, but closely positioned for support. Unusually narrow floorboards lie directly on the back of these joists. The joists to the east are set on edge and are very deep, but narrow, possibly having been reused from another structure. These have a further set of joists laying on their backs, of large flat pine beams, some retaining bark, set on their sides. Modern even width planks overlay these joists, forming the floor to the first floor.

Figure 9: The ground floor interior of the East Barn; viewed from the east.

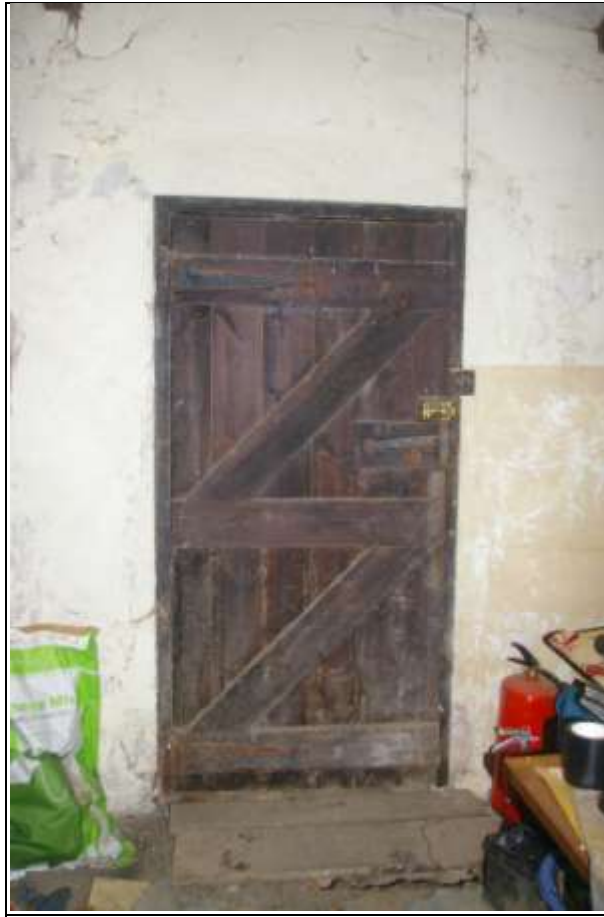
Figure 10: The doorway through the north elevation, which provides access to the first floor; from the south.

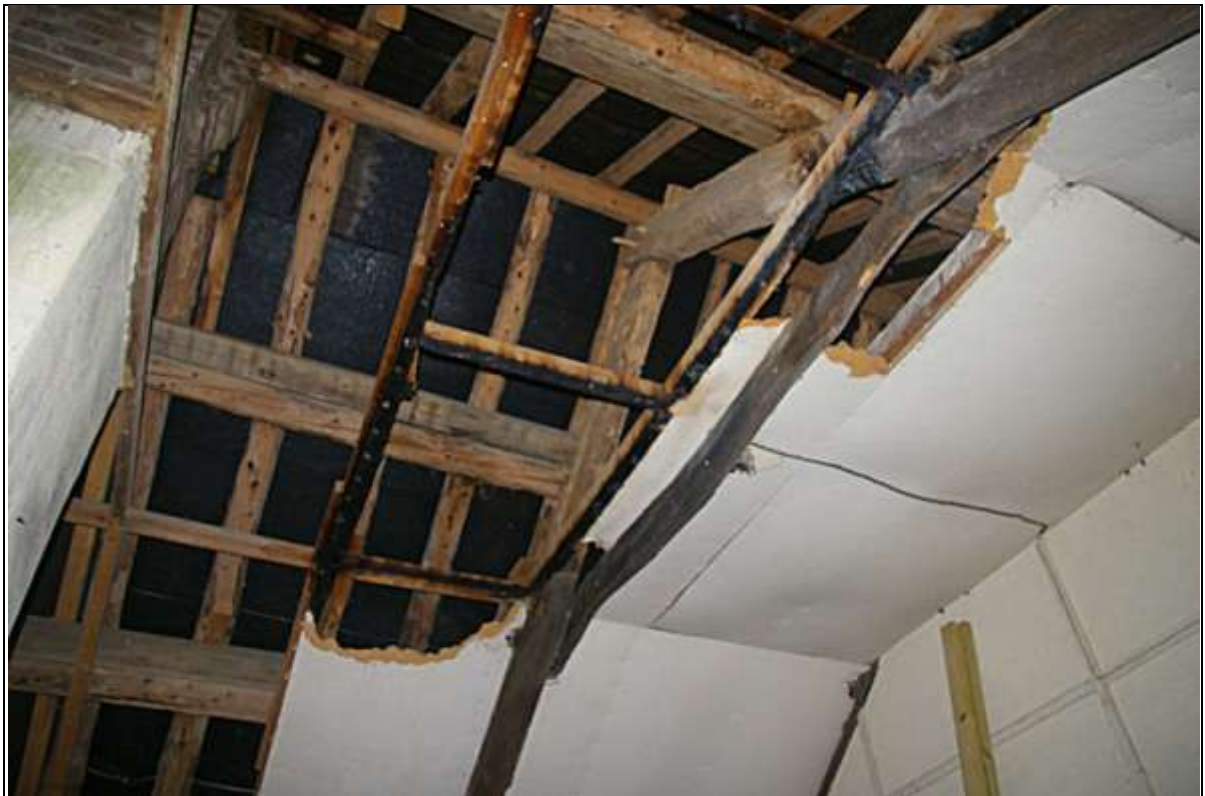
The majority of the roof structure was obscured by the chipboard ceilings on the initial site visit; however these had collapsed in places providing some view of the trusses above (see Figure 11). The roof is seven bays, with six A-frame trusses. There is a pair of purlins to each pitch which are unusually large in size and roughly chamfered, some of the purlins overlap. The majority of the purlins are set directly on the back of the truss blades, a few purlins, are shallowly set into the back of some of the truss blades. Irregular numbers of rafters frame each bay and lie on the back of the purlins. The truss blades, purlins and tie beams are in part roughly chamfered, many of the rafters are 'in the round', or partly 'embarked', some are partly chamfered. The trusses sit on a wallplate. The truss blades overlap at the single ridge pole, which is set on edge. The truss blades are pegged at the ridge pole, the tie beams bolted to the truss blades.

Figure 11: The roof structure; from the south-south-west.

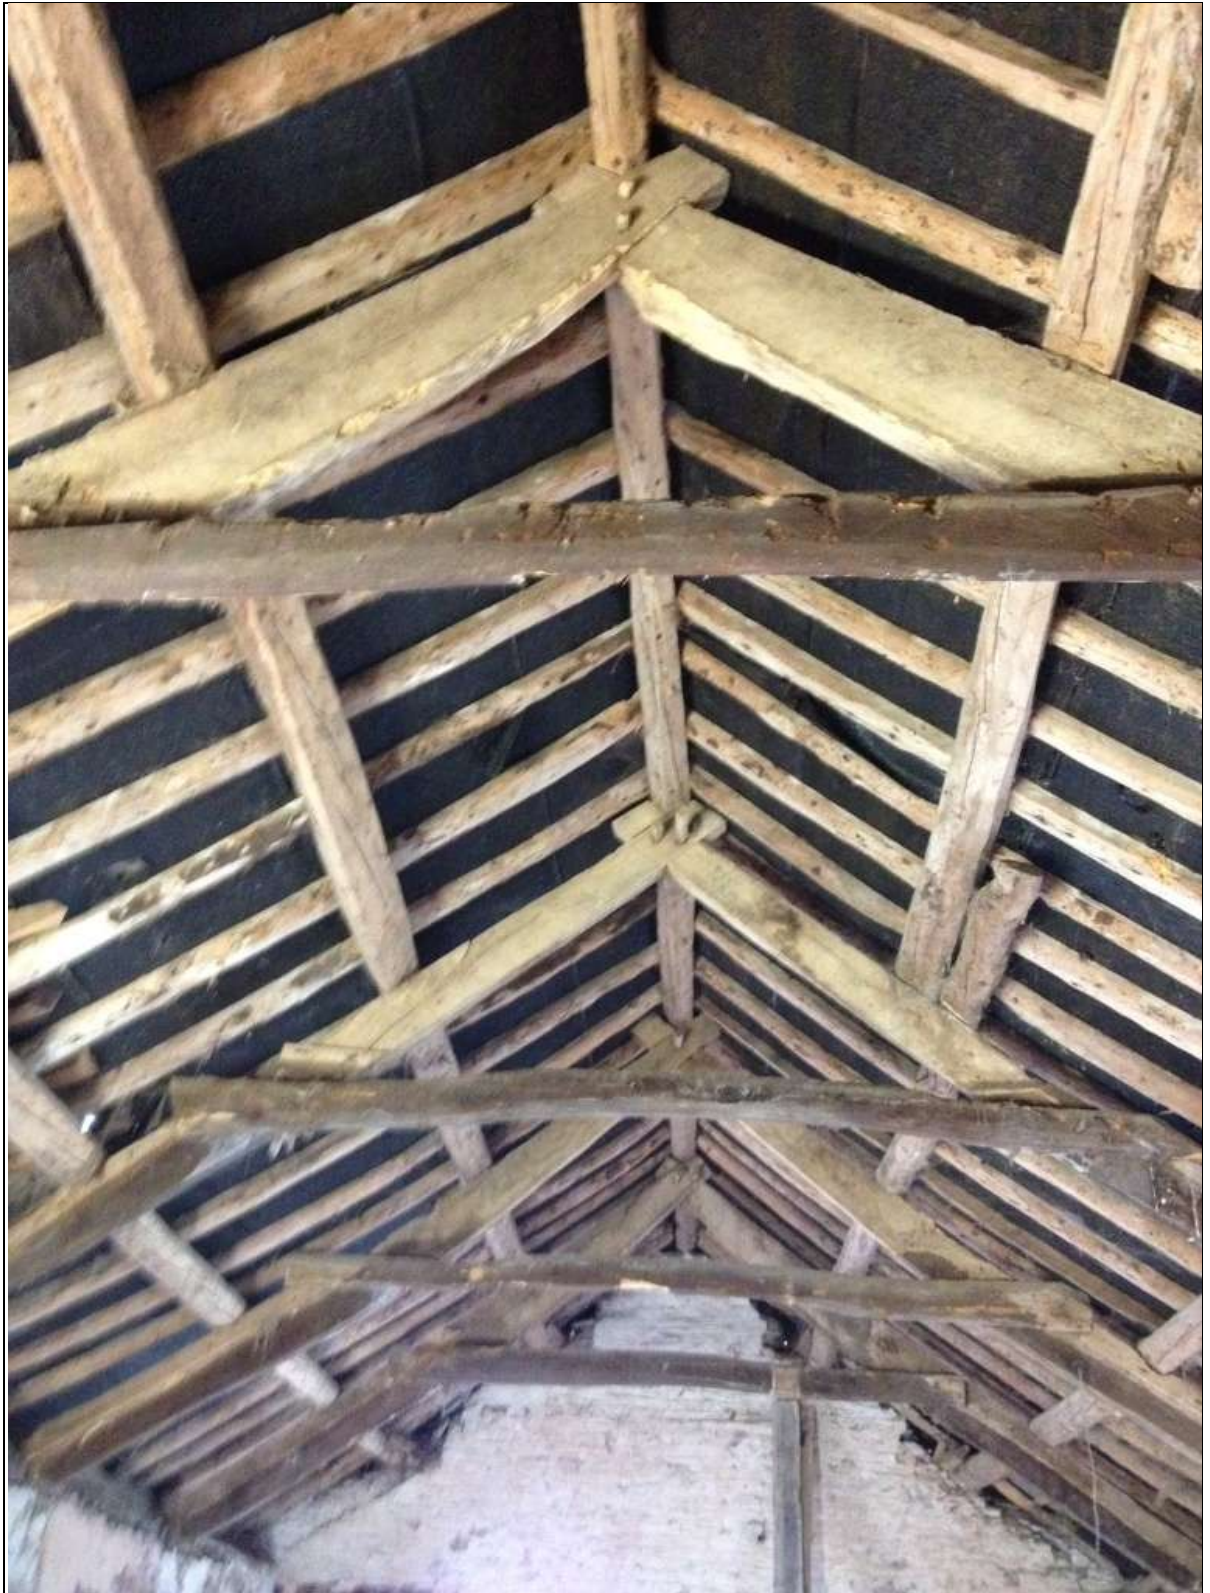
The roof is seemingly contiguous with the construction of the barn in the mid-19<sup>th</sup> century, but heavily repaired in places. The truss blades overlap at the ridge, with spiked joints. The ridge pole is

heavy and set on edge (Figure 12). The trusses have raised collars, with bolted joints. Where rafters survive they appear to be very heavy, and some roughly cut or in the round, others have been replaced with modern timber.

The bank barn suffered from several decades of deterioration in the later 20<sup>th</sup> century and the roof has suffered from water damage and damp ingress. The roof is of little historic interest, or architectural value, in its own right.

Figure 12: Shot of the roof following the removal of the plaster ceilings.

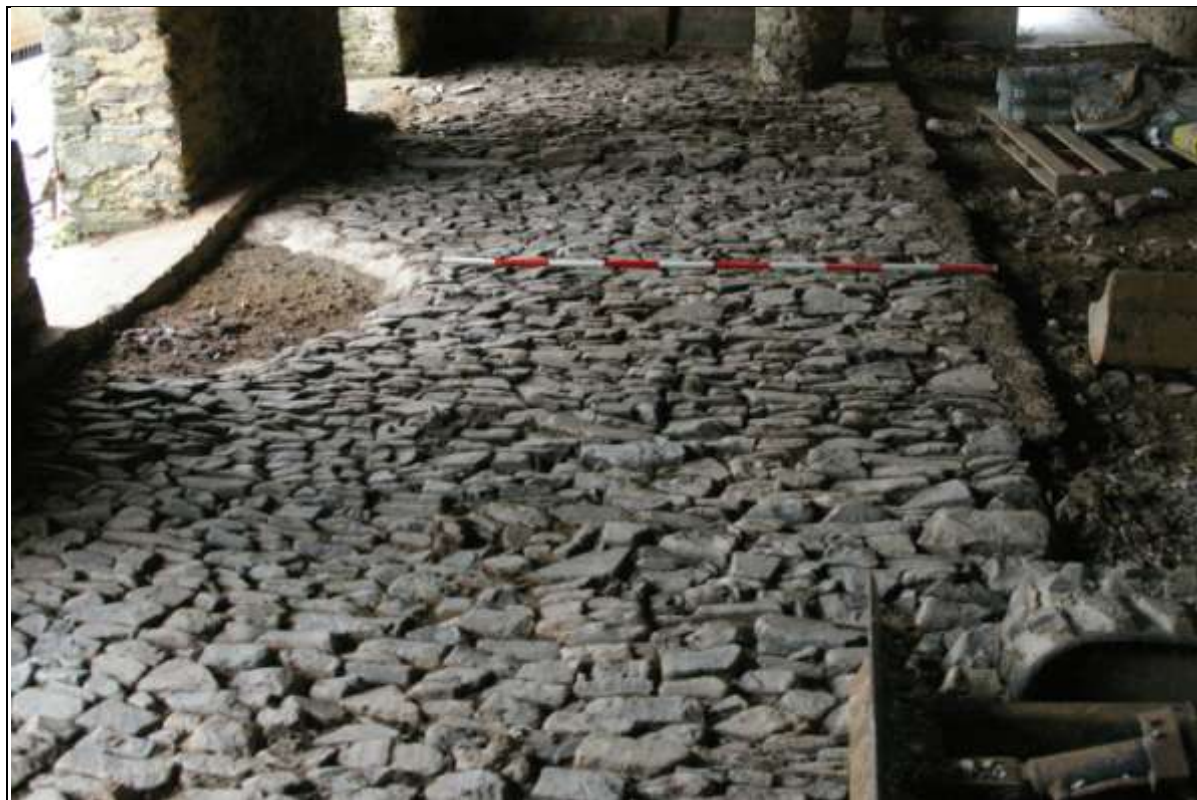
Figure 13: The cobbled floor following power-washing; viewed from the east.

The cobbled floor has been cleared since the previous visit, and is made up of rough cut and irregularly sized slatestones. The floor slopes to the south, the cobbles laid approximately north to south. The slope may aid in drainage of the floor, with no formal built drains visible.

The cobbles are of questionable craftsmanship, loosely set, of irregular size, unfaced and poorly fitted. The cobbles may represent a late 19<sup>th</sup> century replacement of an earlier floor. Smaller, dressed cobbles, scattered within the current floor may have been salvaged from a previous floor, but could as likely have come from elsewhere. The existing cobbled floor is in juxtaposition with the smart brick segmental arches which access the space. Although largely built of rubble, care has been taken, in general, with the barn, to create a statement building close to the main farmhouse. The farmhouse follows a similar pattern, in that more care was put into its exterior appearance than the quality of the interior build and layout.

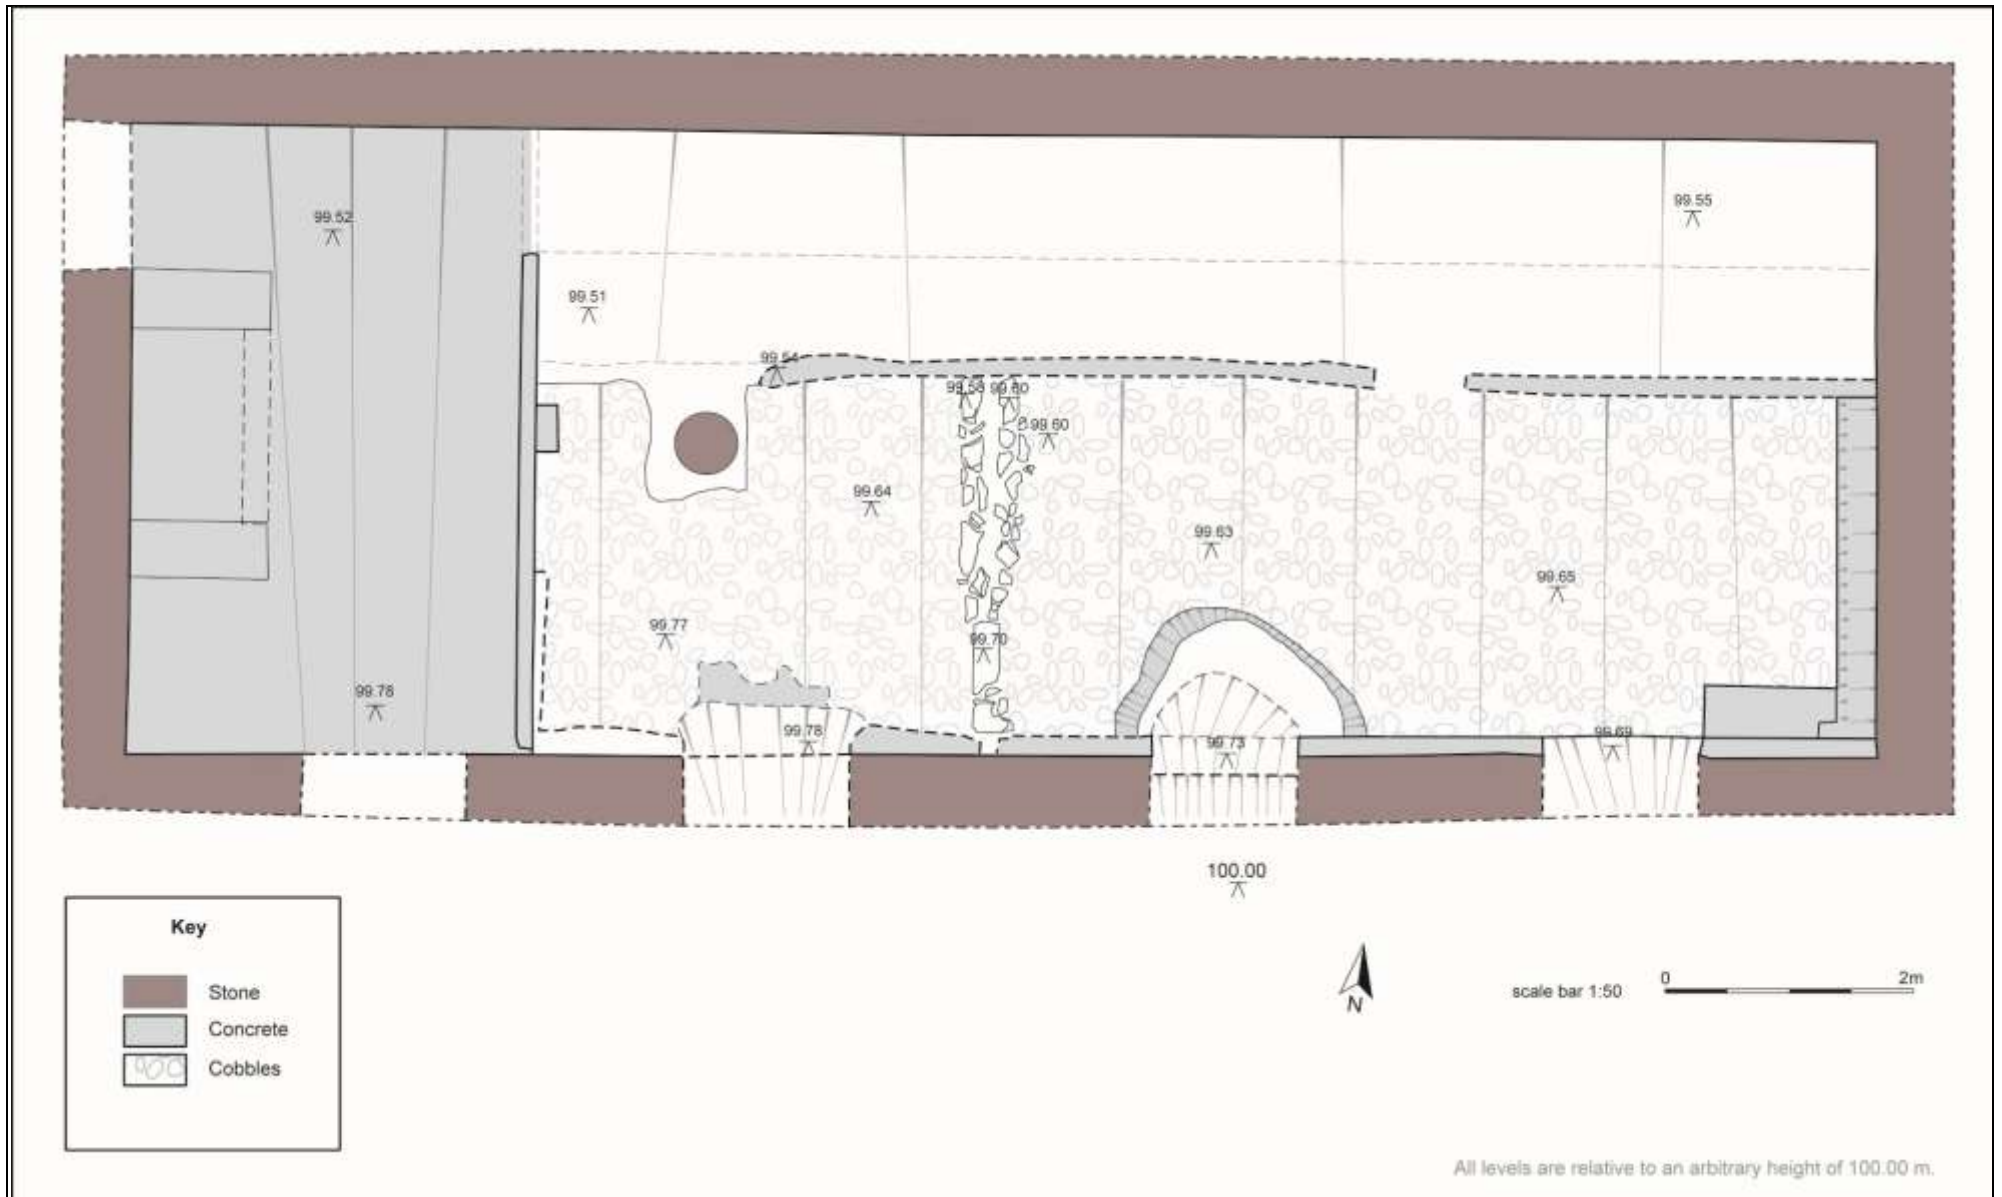
Just inside the eastern central archway is a semicircular hole (c.1.5mx1m). A large stone pillar has been inserted to support the ceiling in the north-west corner of the cobbled floor. The eastern end of the floor has been concreted over, forming a sloping area where 20<sup>th</sup> century plumbing for a water supply has been inserted. Areas of the floor also appear to have been patched with larger irregular blocks of stone. The cobbles no longer retain any of their bond material, with many being very loose.

Figure 14: Plan of the ground floor of the bank barn, with cobbled floor and features indicated.

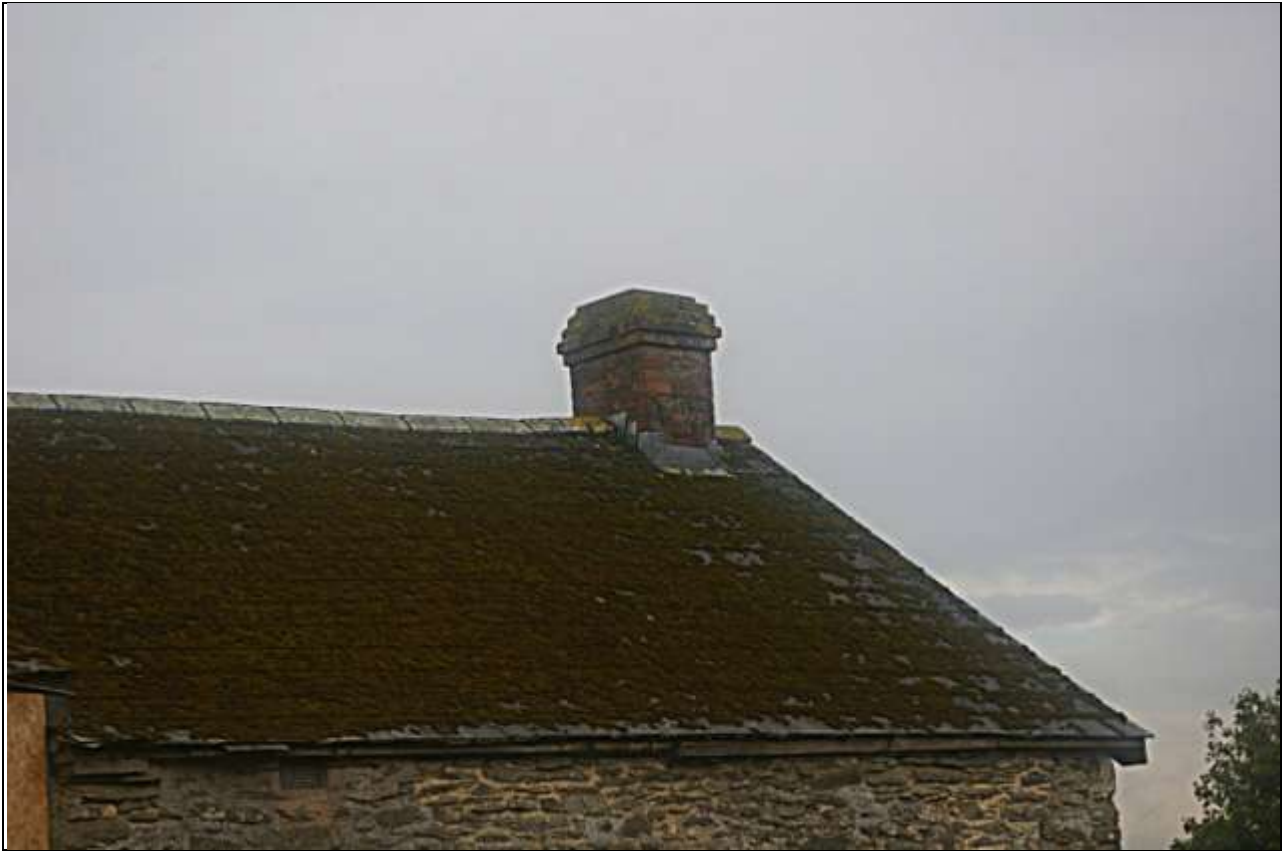
Detailed view of the repaired brick stack; from the north-east.

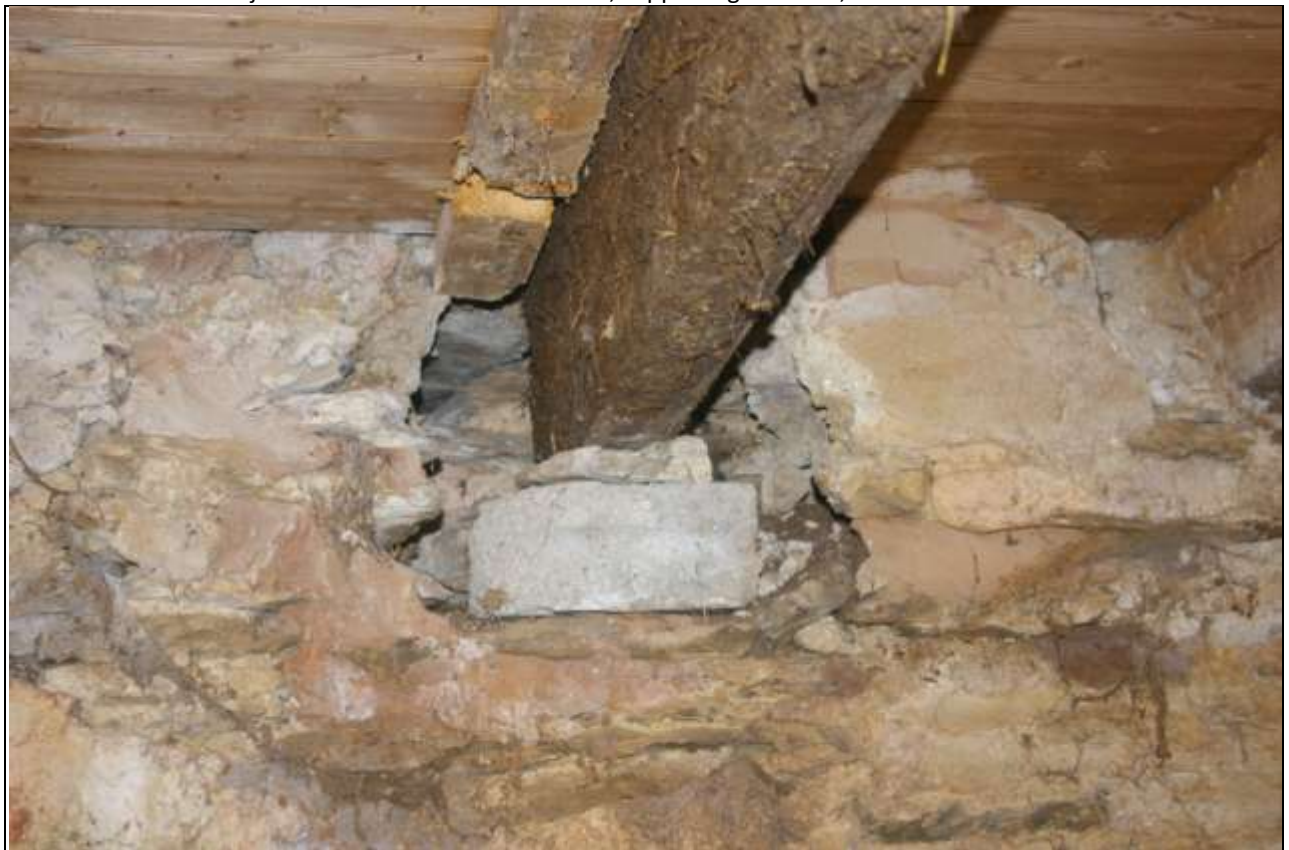
Detail of one of the joists to the east end, resting on a loose stack of rubble and a concrete block.

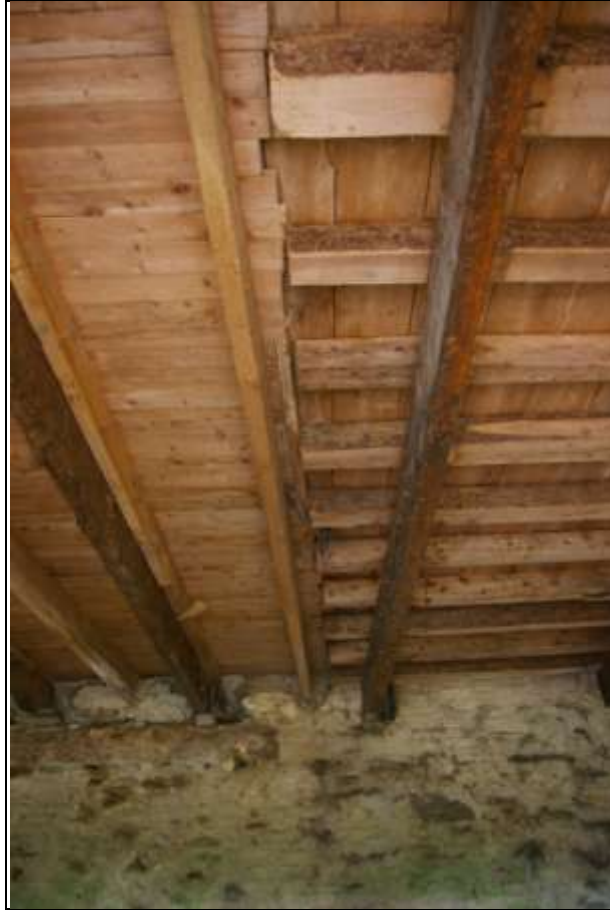
The rough join between the two types of flooring; from the south.

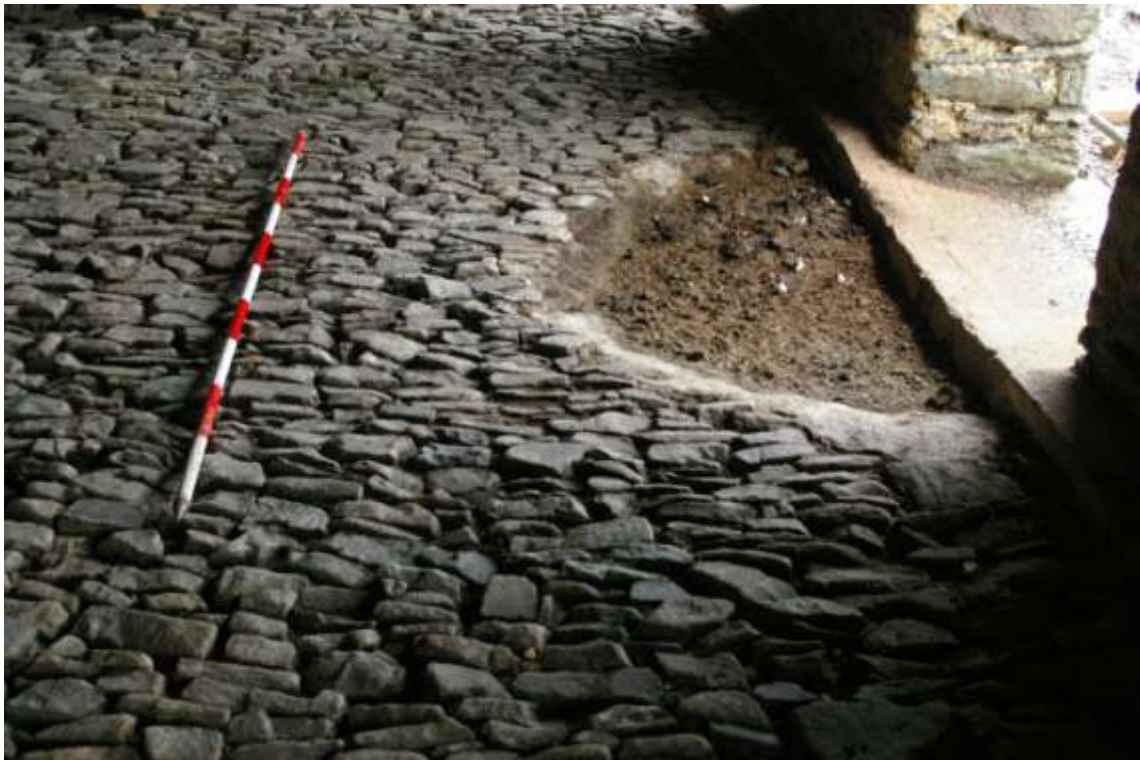
The semicircular hole, with 2m scale; from the west.

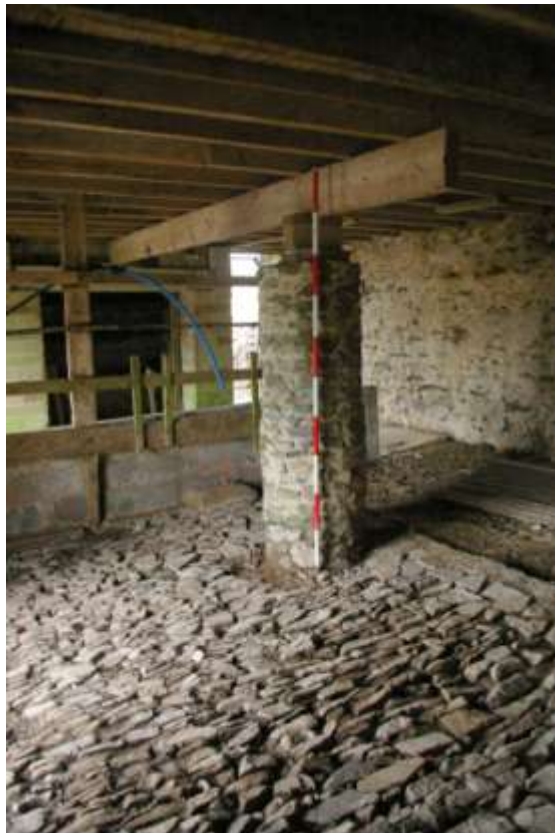
Stone pillar, forced into the cobbled floor, with 2m scale; from the south-east.

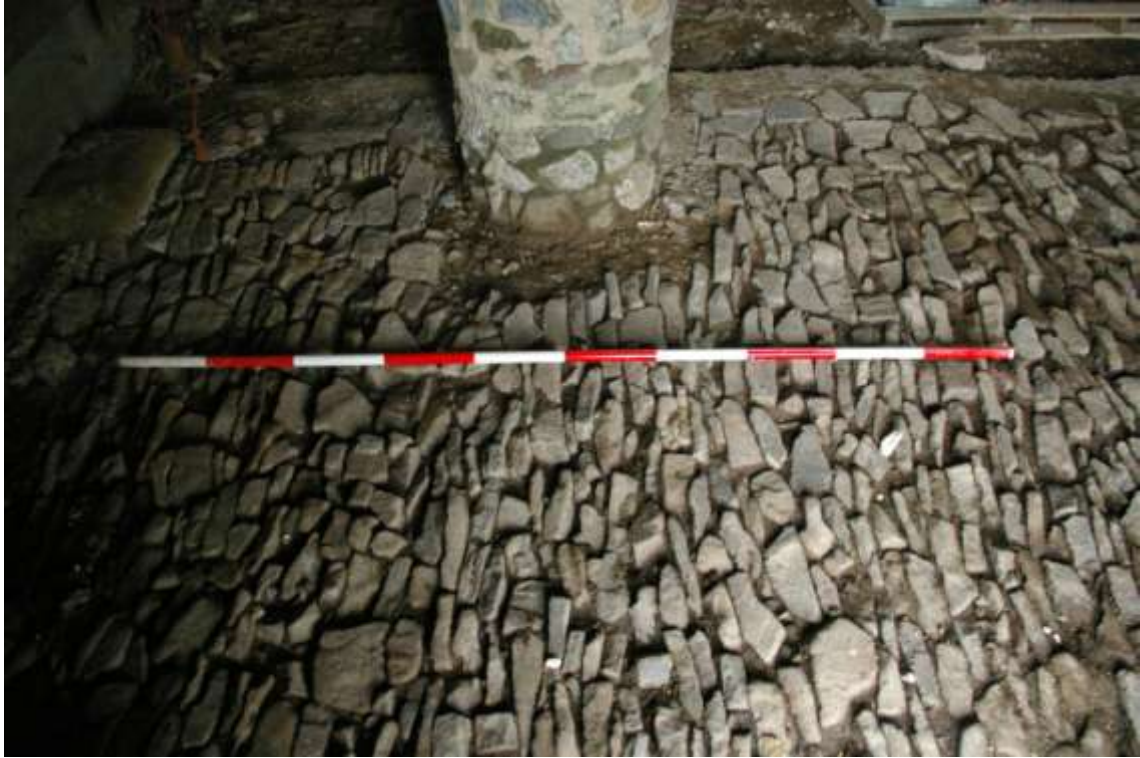
Damaged section of floor with stone pillar inserted; from the south.

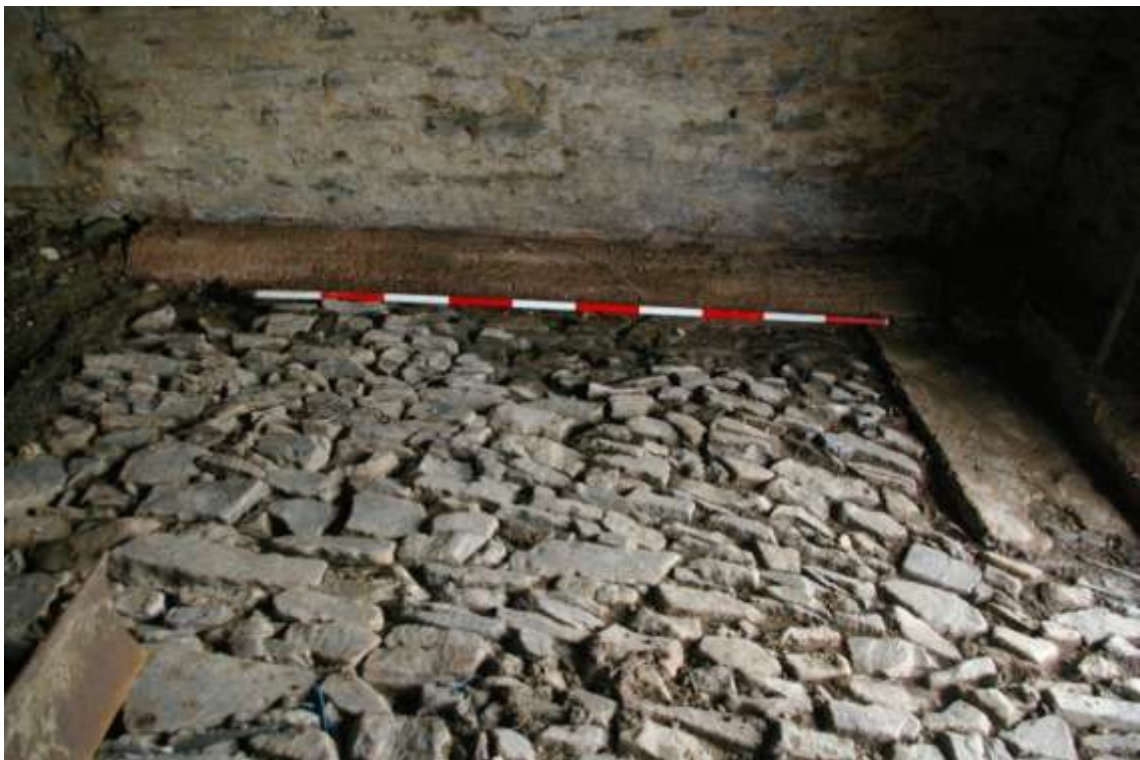
The concreted end of the cobbled floor to the east, with 2m scale; from the west.
