Dartmouth Castle, Dartmouth, Devon – Emergency Plaster Recording

South West Archaeology Ltd. 21.11.2016

Project Background

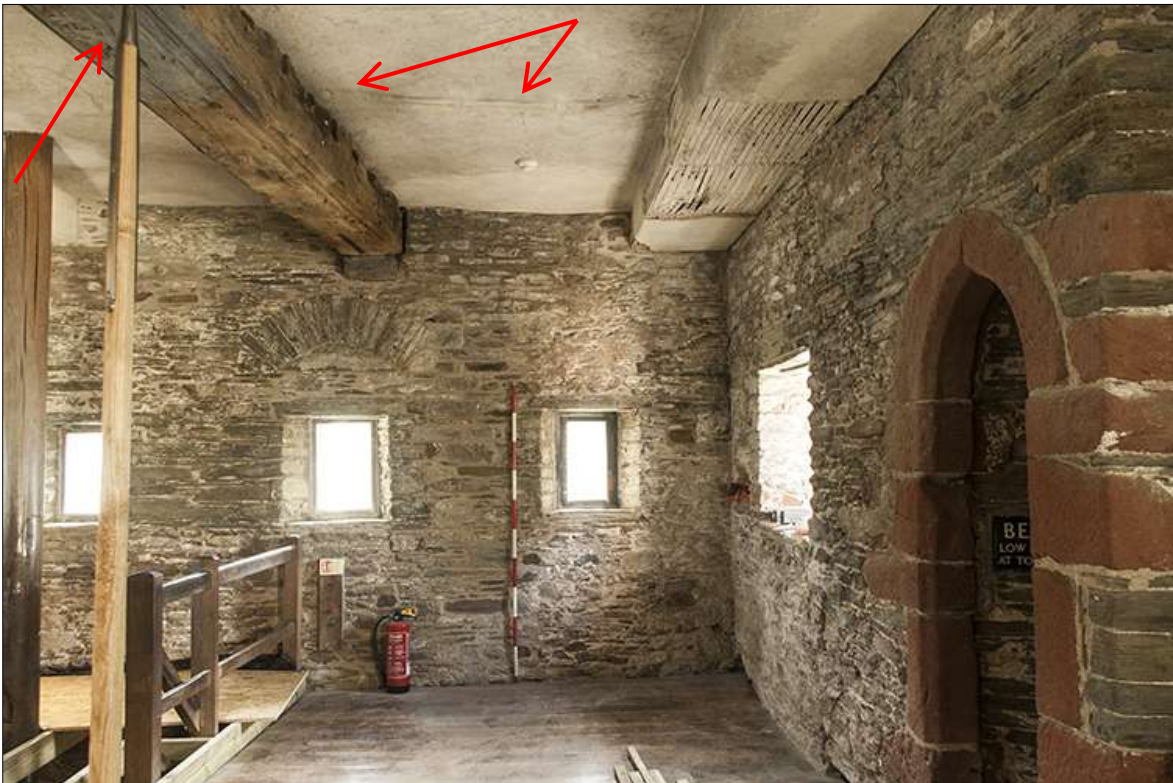
Figure 3: 5991 The south side of the tower; viewed from the south west (scale 2m). The grey paint on the moulded oak beam and partition marks are indicated.

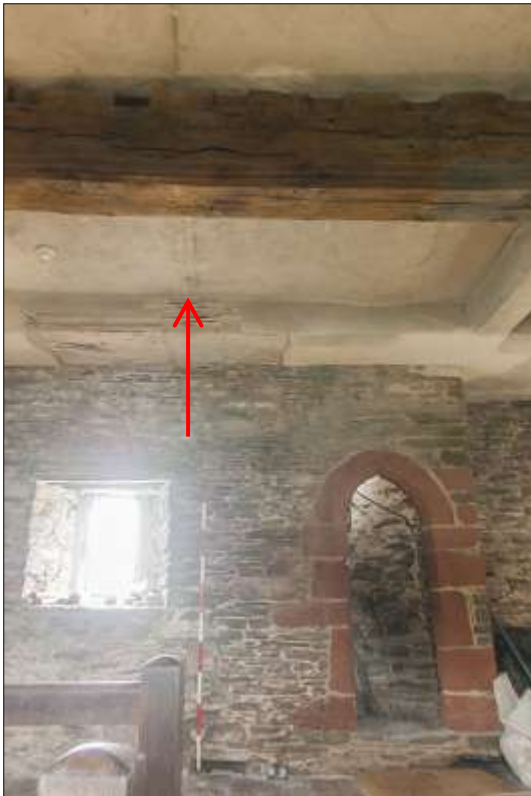
Figure 4: 5999 The south-east wall of the tower; viewed from the north-west (scale 2m). The partition marks are indicated.

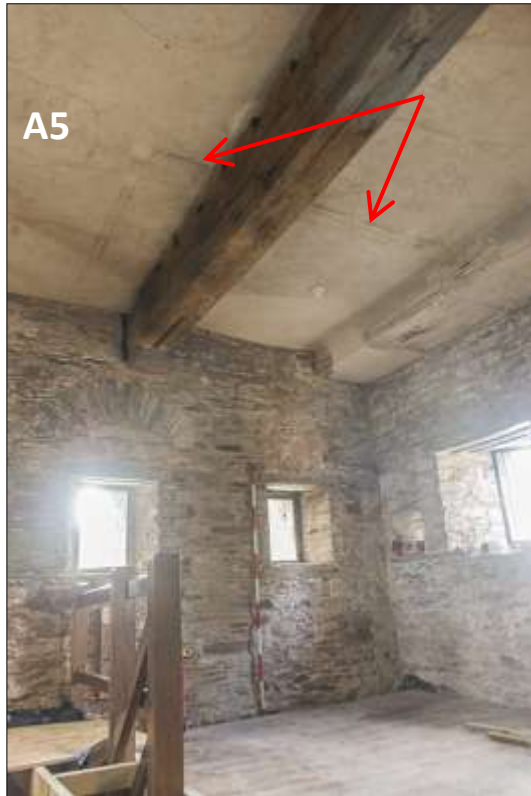
Figure 5: R5997 The south-east corner of the tower; viewed from the north-west (scale 2m). The partition and scratch marks are indicated.

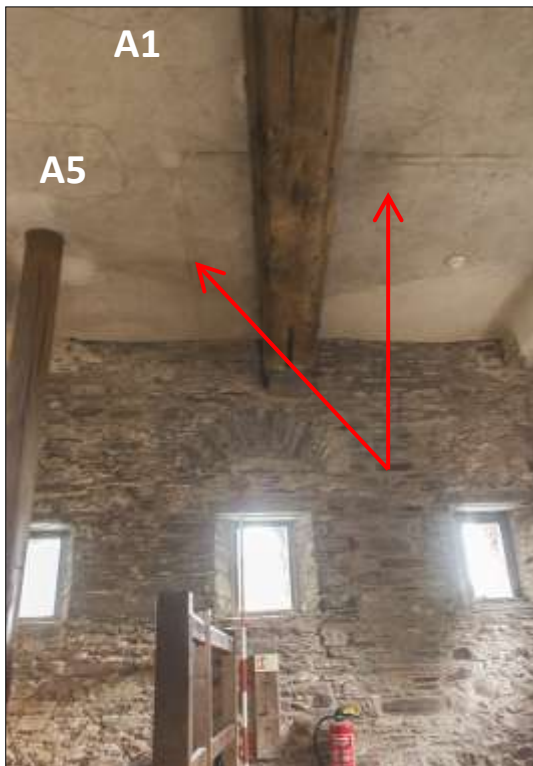
Figure 6: L6001 The north-east wall of the tower; viewed from the south-west (scale 2m). The partition and scratch marks are indicated.

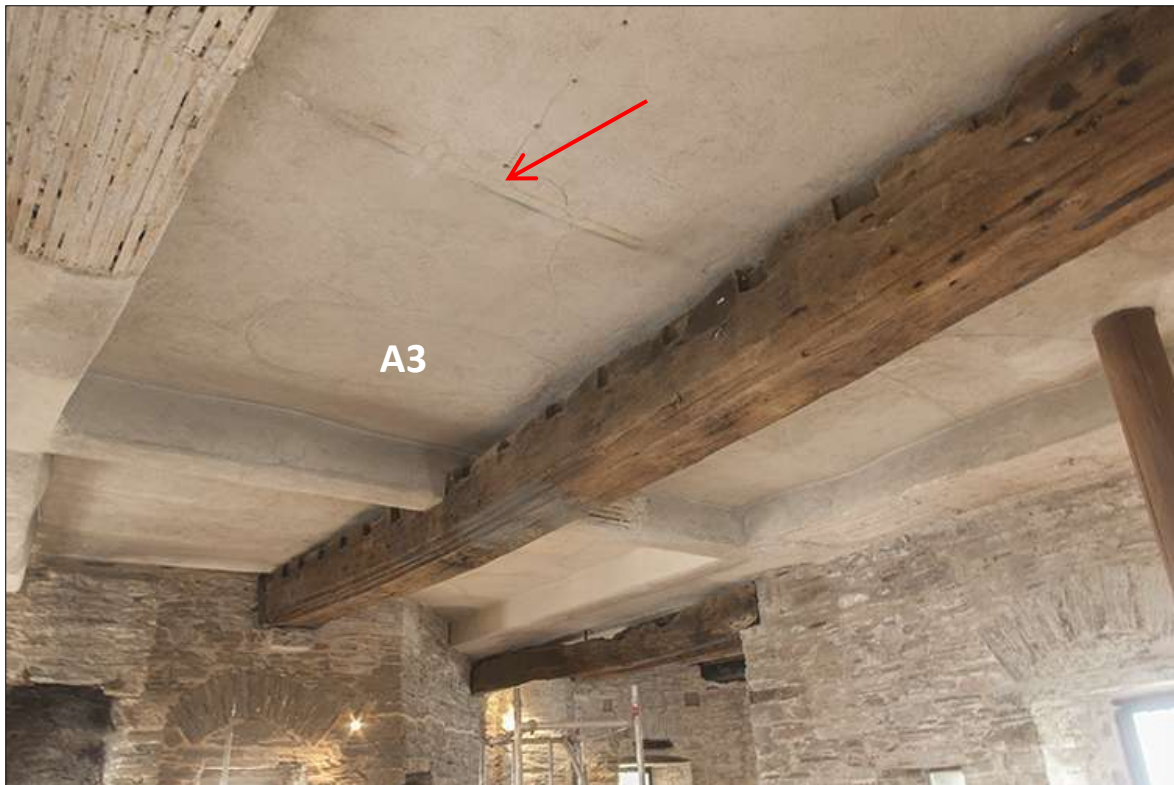
Figure 10: 6012 The ceiling of the north-western half of the tower; viewed from the south-east. The partition and scratch marks are indicated.

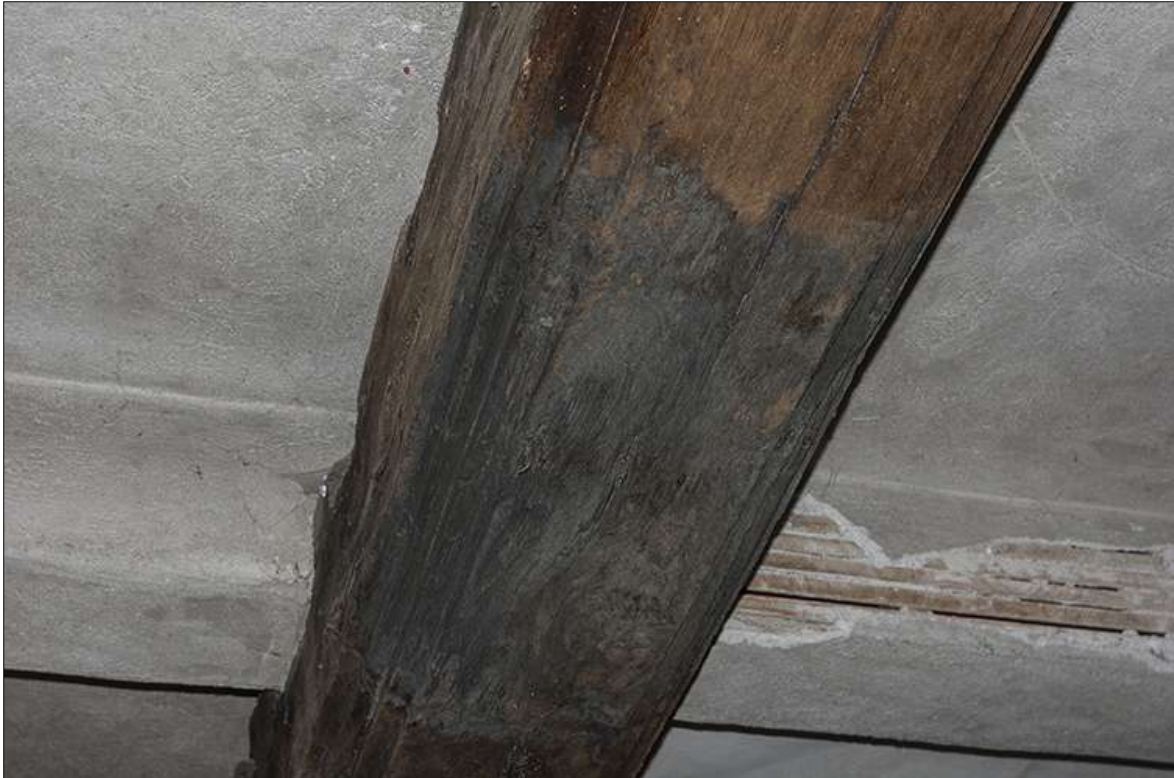
In the south-east corner there is a partition mark on the ceiling consisting of two bands of paint, one green/grey and one ochre yellow. The marks define a sub-square partition to the south-east corner, running from the south wall to the central historic beam, running under the beam and then back to the east wall. Both paint bands are slightly less than 20mm wide. A wide strip of grey paint is visible to the west on the surviving oak beam, suggesting that at some point most of the room had been painted in a grey and green colour scheme, typical of the 19th century, to which the original marks might be dated. The location of this paint – in the middle of the central beam – would suggest the presence of a prop prior to the replacement of the ceiling.

Figure 12: 6011 Detail of the grey paint on the original moulded oak beam, which appears to correspond with the re-established partition marks on the ceiling; viewed from the south-east.

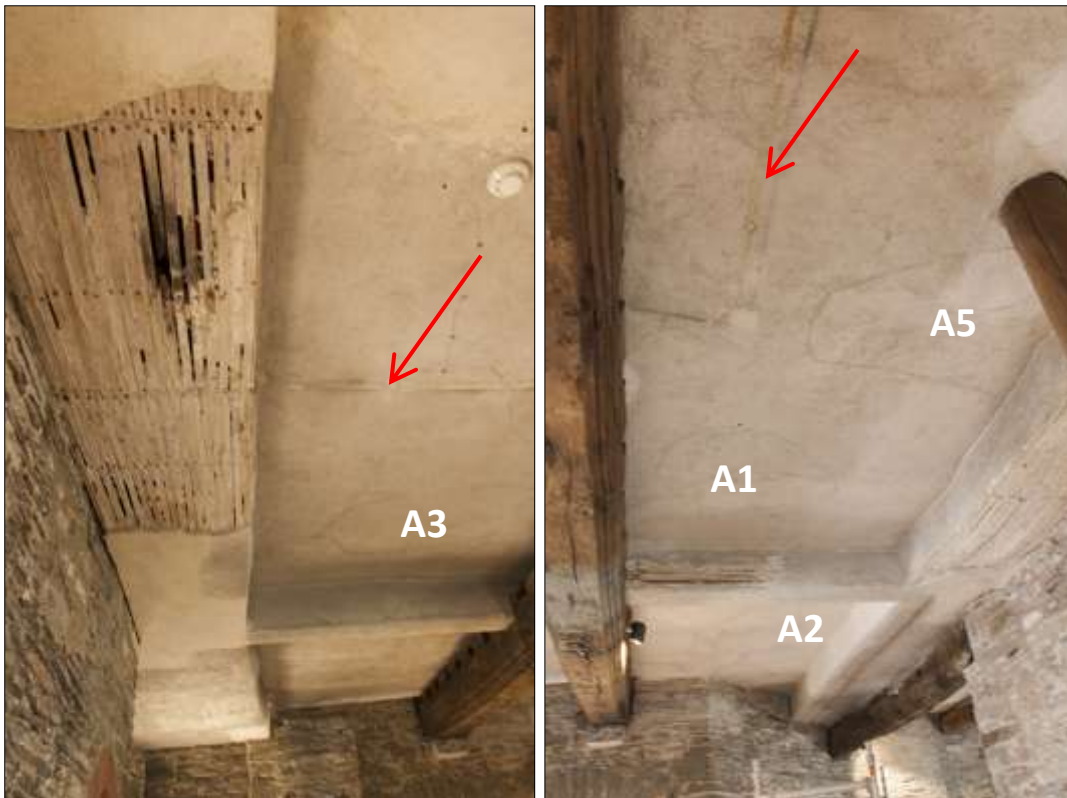
Figure 13: L6017 The ceiling of the southern part of the tower; viewed from the north-east. The partition and scratch marks are indicated.

Figure 14: R6019 The ceiling of the northern part of the tower; viewed from the north-east. The partition and scratch marks are indicated.

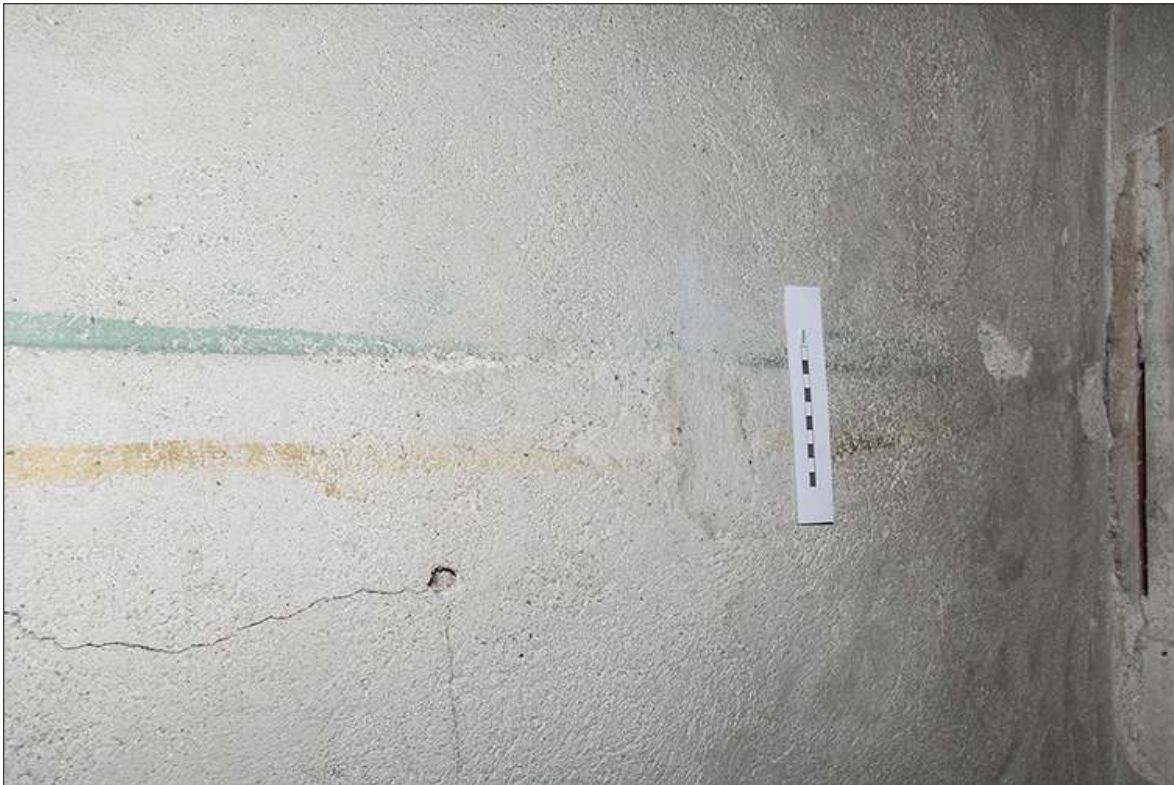
Figure 15: 6041 Detail of the partition marks south of the moulded oak beam; viewed from the north-west (scale 10cm).

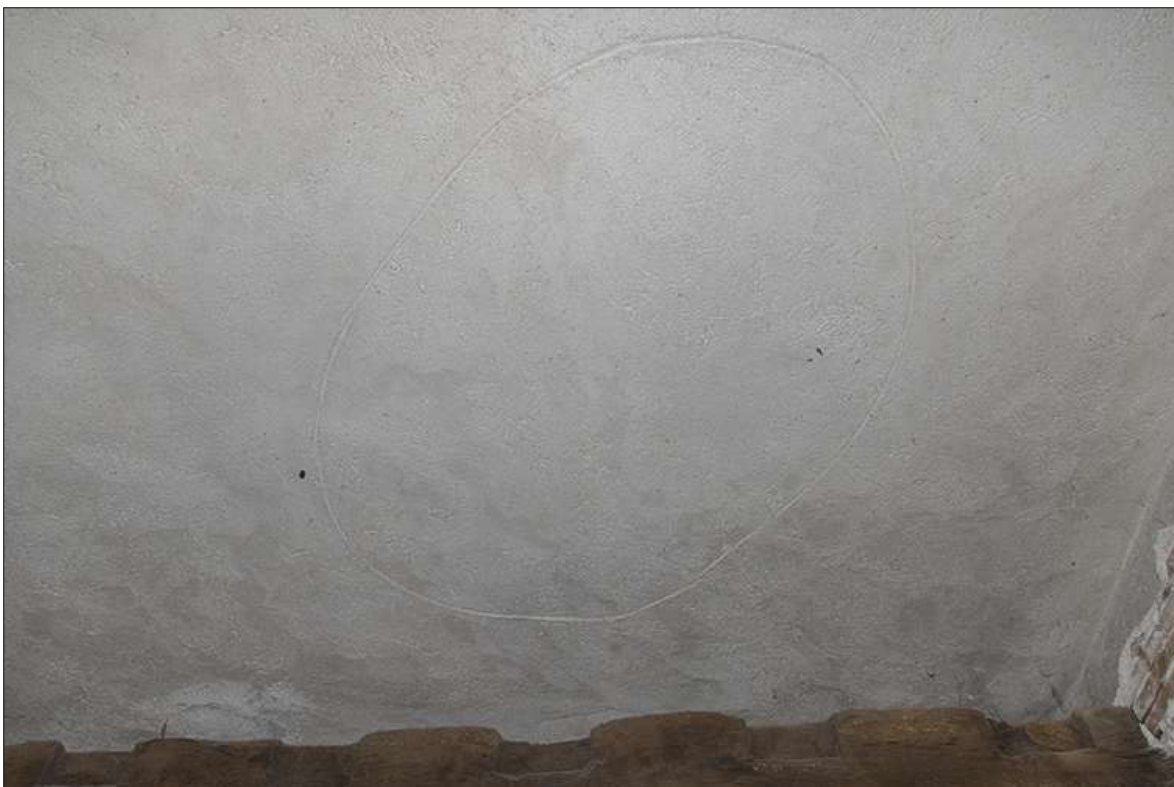
Area 1: The marks include some smoothed areas and an area of scratches, possibly where a tool may have been pulled or dragged through the plaster when damp.

Figure 16: 6045 Area 1 scratch marks; viewed from the north.

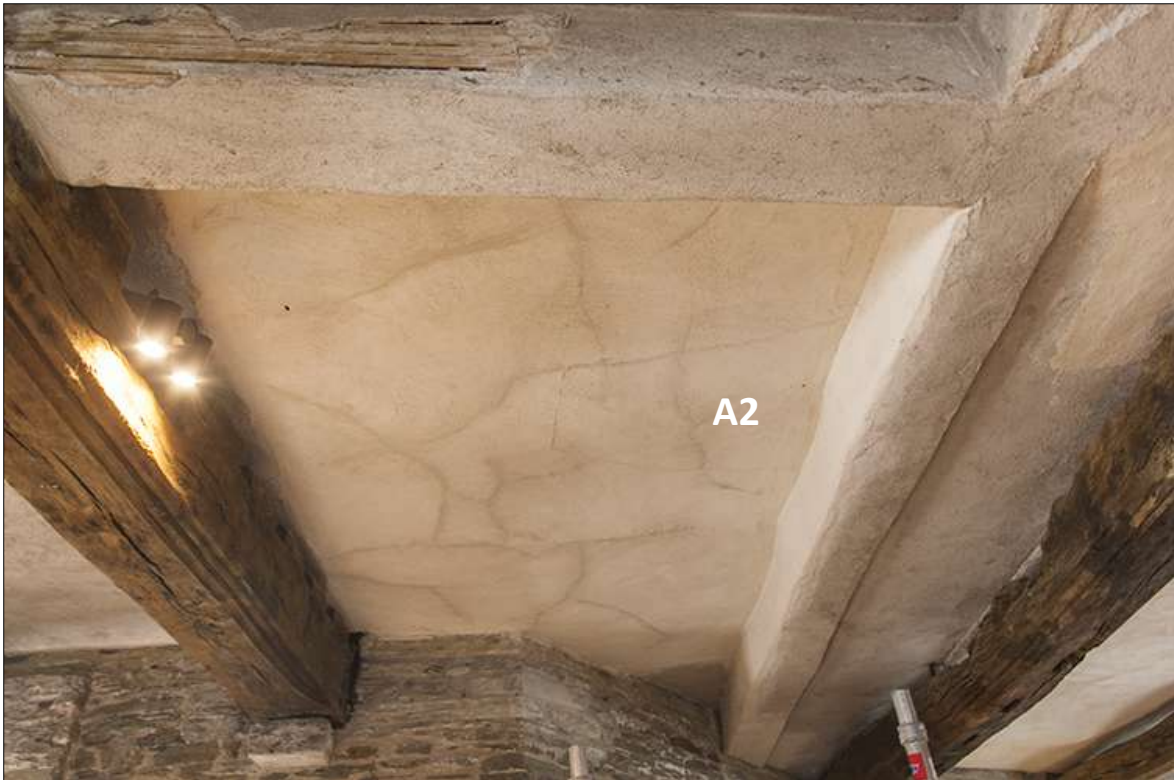
Area 2: The marks include smudges and scratches in the plaster.

Figure 17: 6020 Area 2 scratch marks; viewed from the north east.

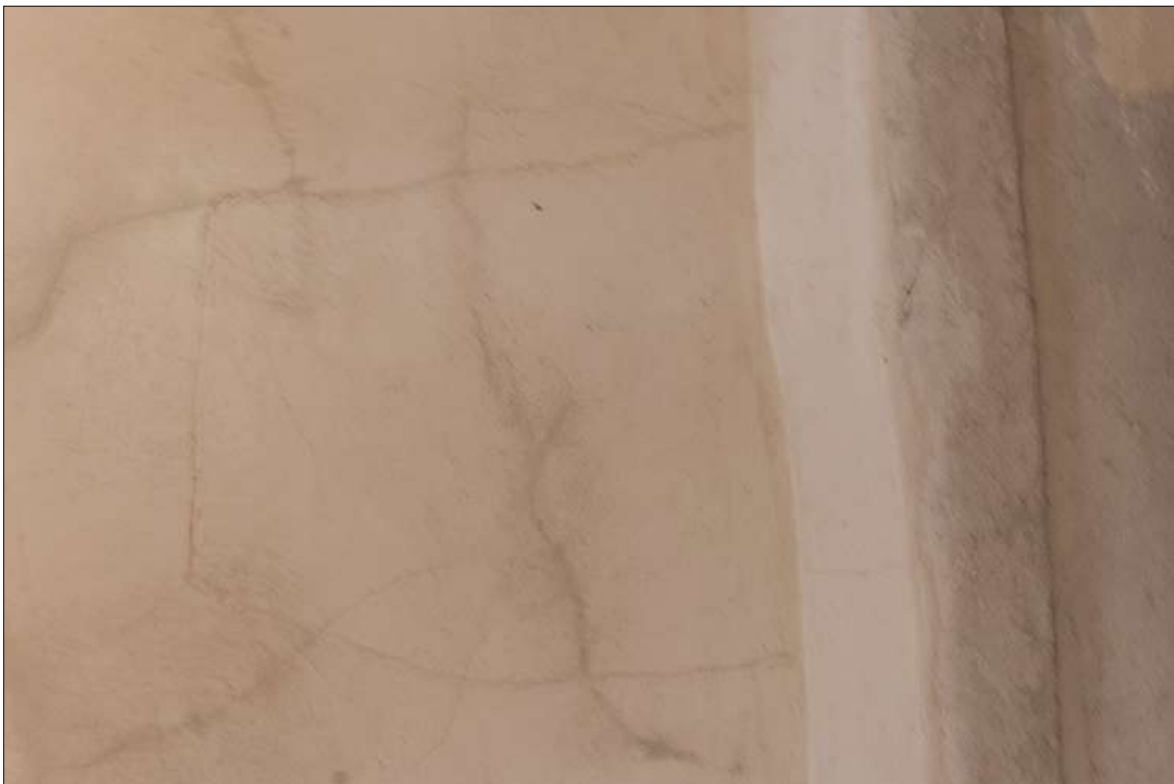
Figure 18: 6094 Area 2 scratch marks; viewed from the east.

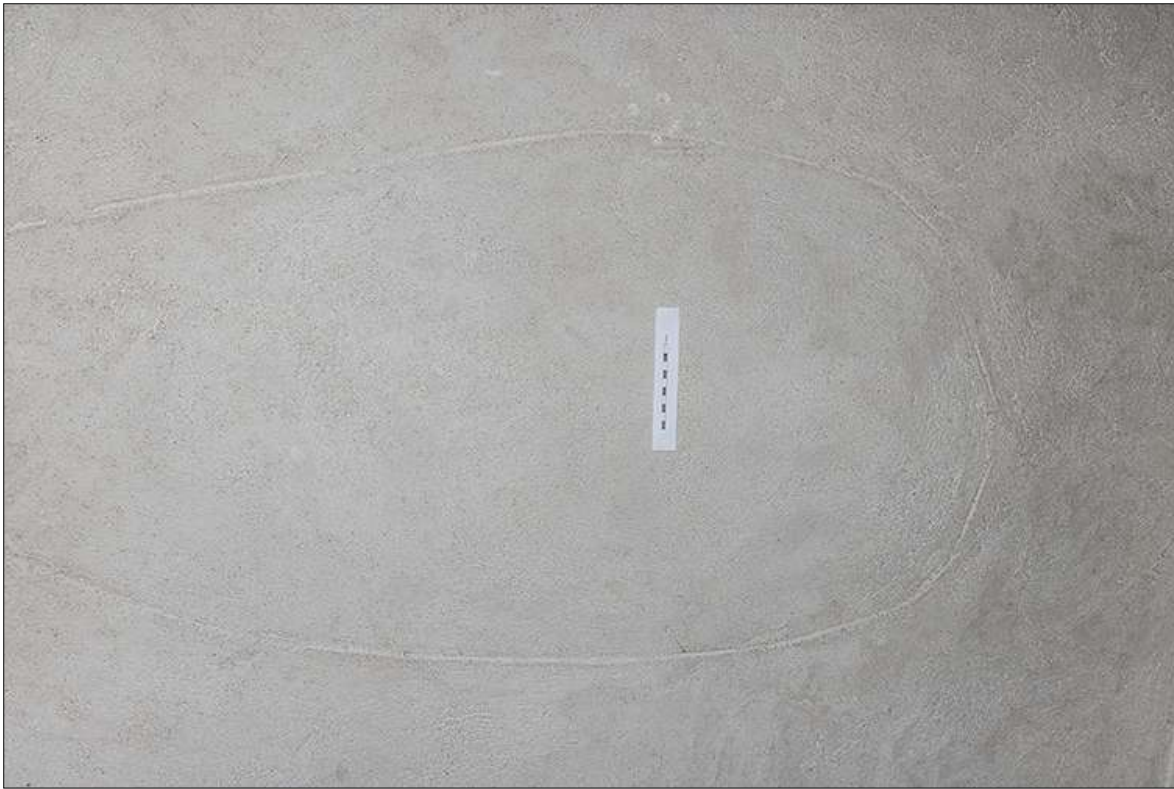
Area 3: The marks are located above the entrance to the stair turret. This area contains smoothed areas and a definite finger mark. There is a slight smooth indentation that might represent a hand or palm print.

Figure 19: 6079 Area 3 scratch marks; viewed from the west (scale 10cm).

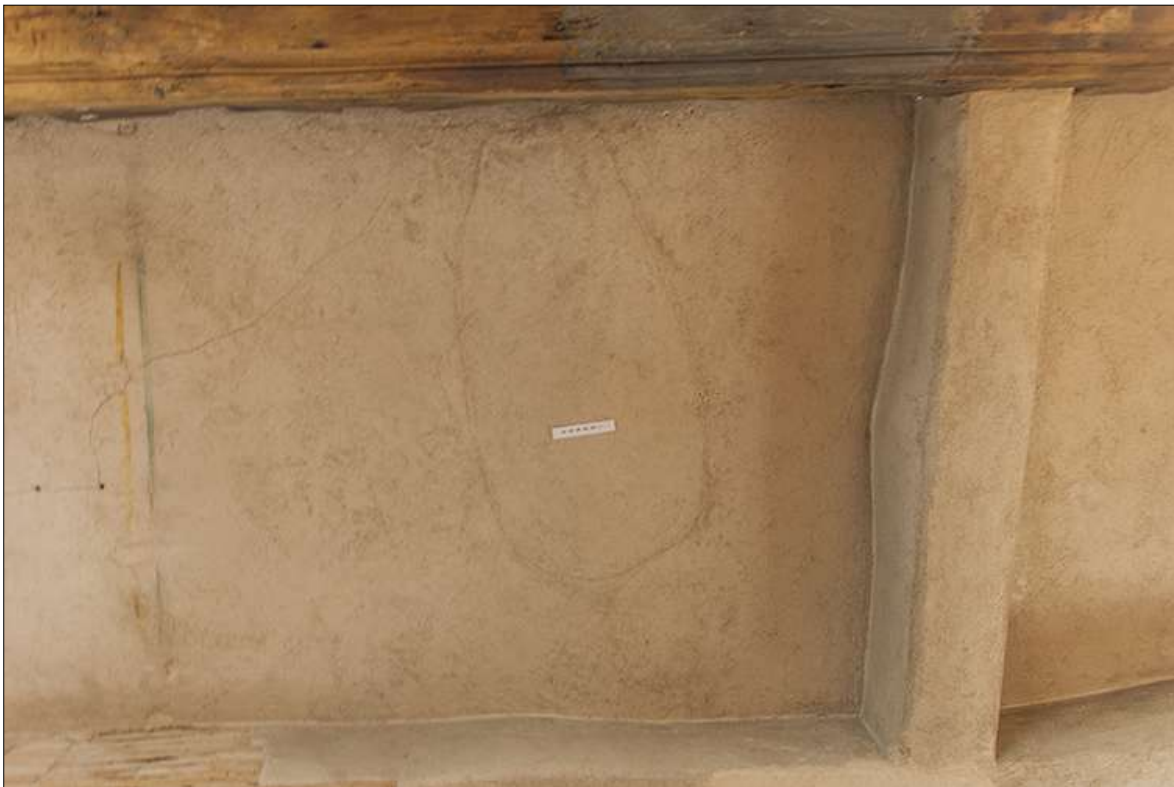
Figure 20: 6027 Area 3 scratch marks; viewed from the south (scale 10cm).

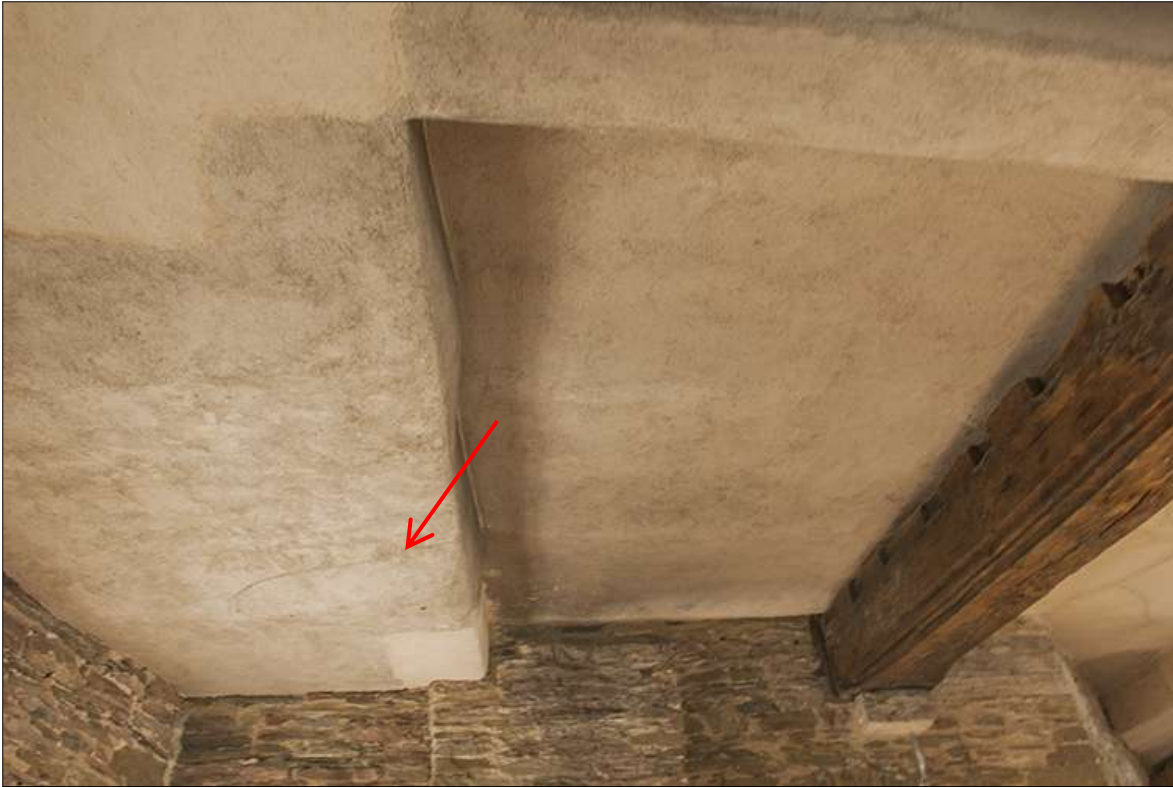
Area 4: These marks are on part of the lime plaster encasing one of the steel RSJs that runs along the south wall. The marks consist of three finger holes. On the west wall adjacent to this area is the remains of the hooded fireplace and there is a window opposite within the south wall.

Figure 21: 6021 Area 4 scratch marks (indicated); viewed from the north-east.

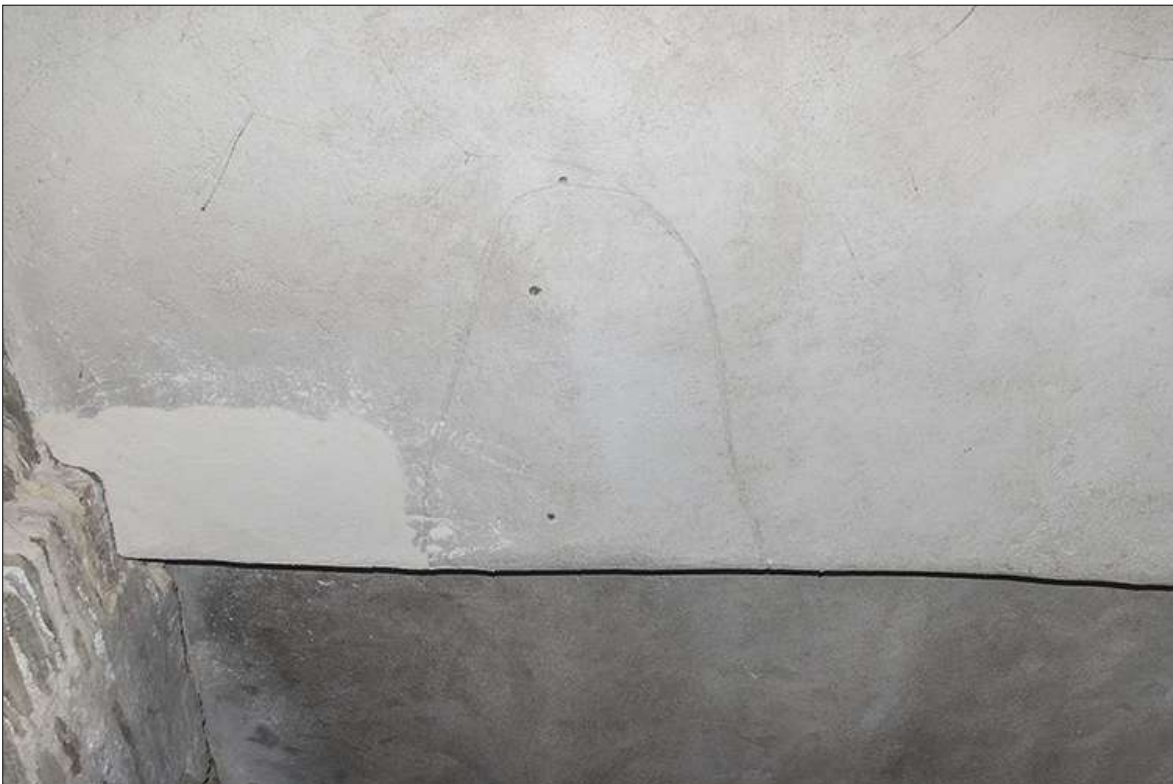
Figure 22: 6050 Area 4 scratch marks/finger marks; viewed from the south.

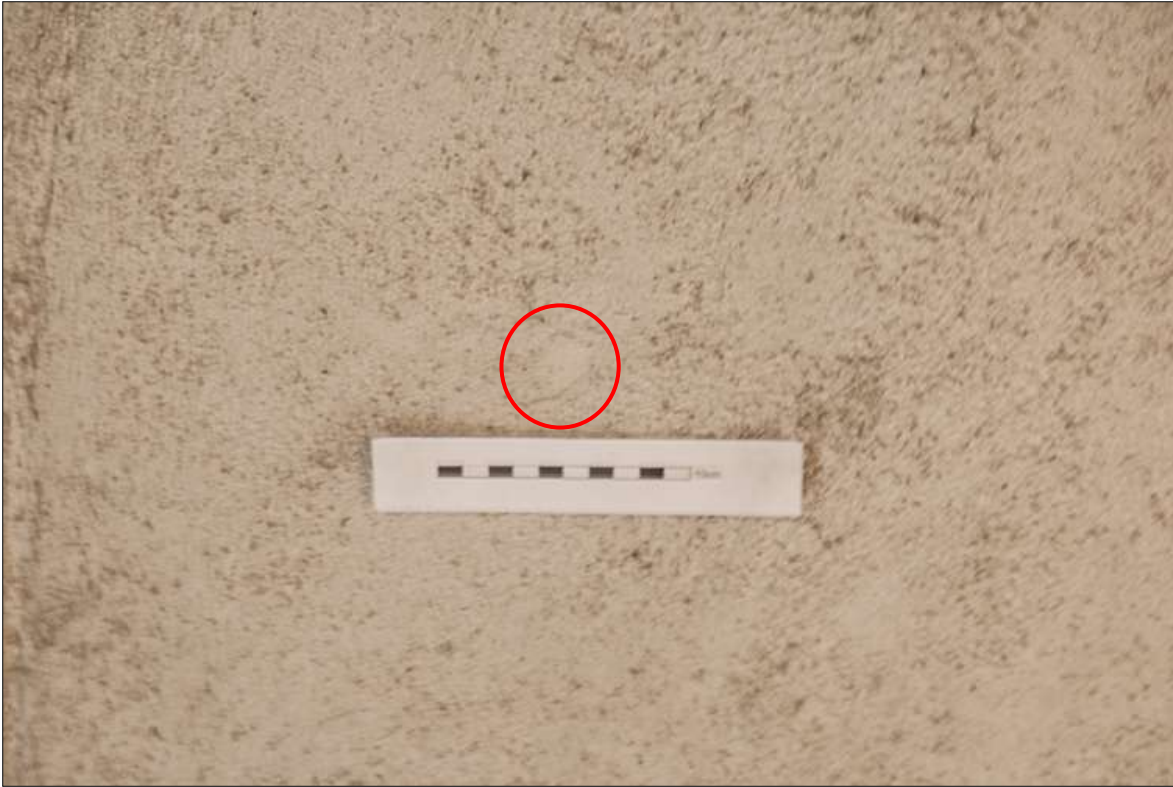
Figure 23: 6084 Area 4: detail of fingerprint (indicated) (scale 10cm).

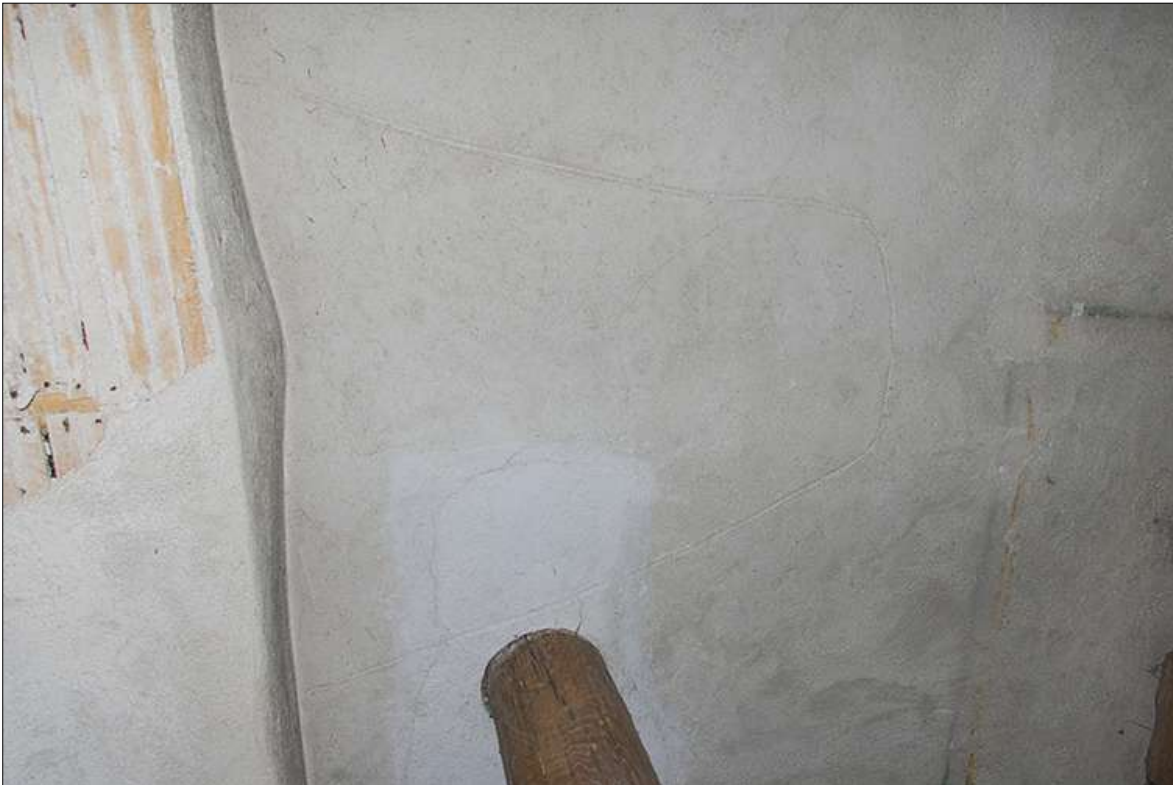
Area 5: These marks are in the north-east corner, now over the modern access steps. There is some scratch or drag marks and several smoothed areas.

Figure 24: 6051 Area 5 scratch marks; viewed from the west.
