# CLEEVE FARM BARN IVYBRIDGE SOUTH HAMS DEVON

Historic Building Recording

South West Archaeology Ltd. report no. 170613

By E. Wapshott & N. Boyd  
Report Version 02  
13<sup>th</sup> June 2017

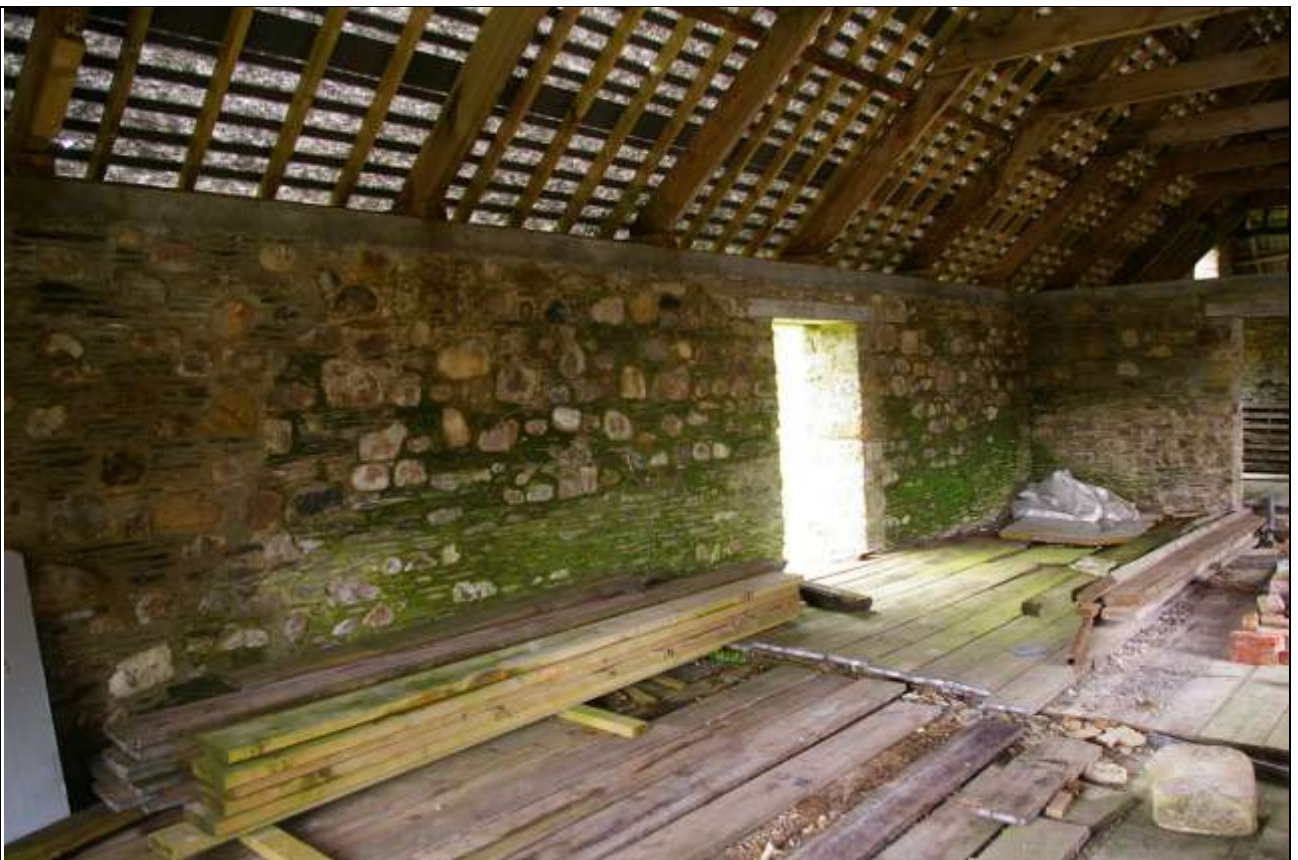
FIGURE 15: INTERIOR FACE OF LONG WEST WALL, AT LOFT HEIGHT, SHOWING MODERN CONCRETE RING BEAM; FROM THE SOUTH-EAST.

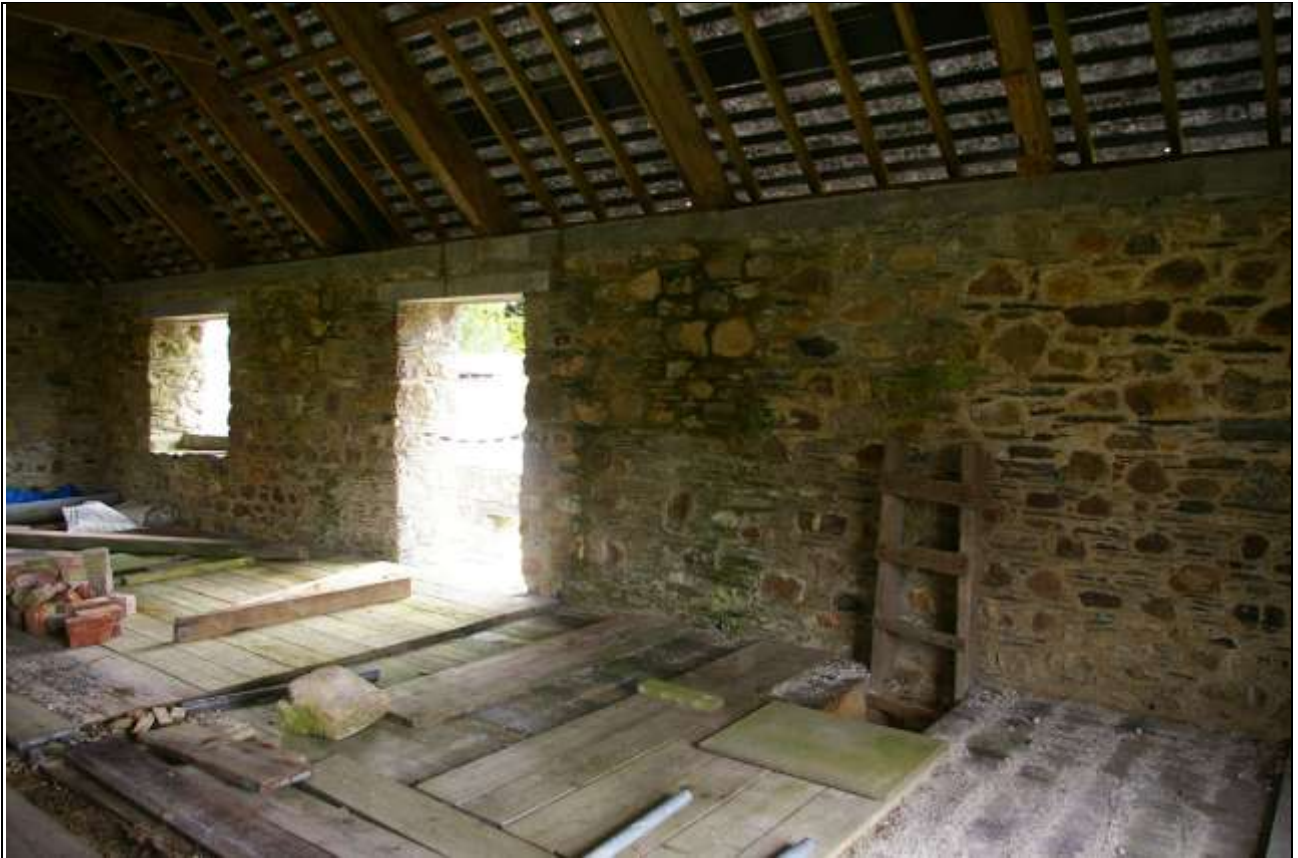
FIGURE 16: INTERIOR FACE OF THE LONG EAST WALL, AT LOFT HEIGHT, SHOWING MODERN CONCRETE RING BEAM; FROM THE SOUTH-WEST.

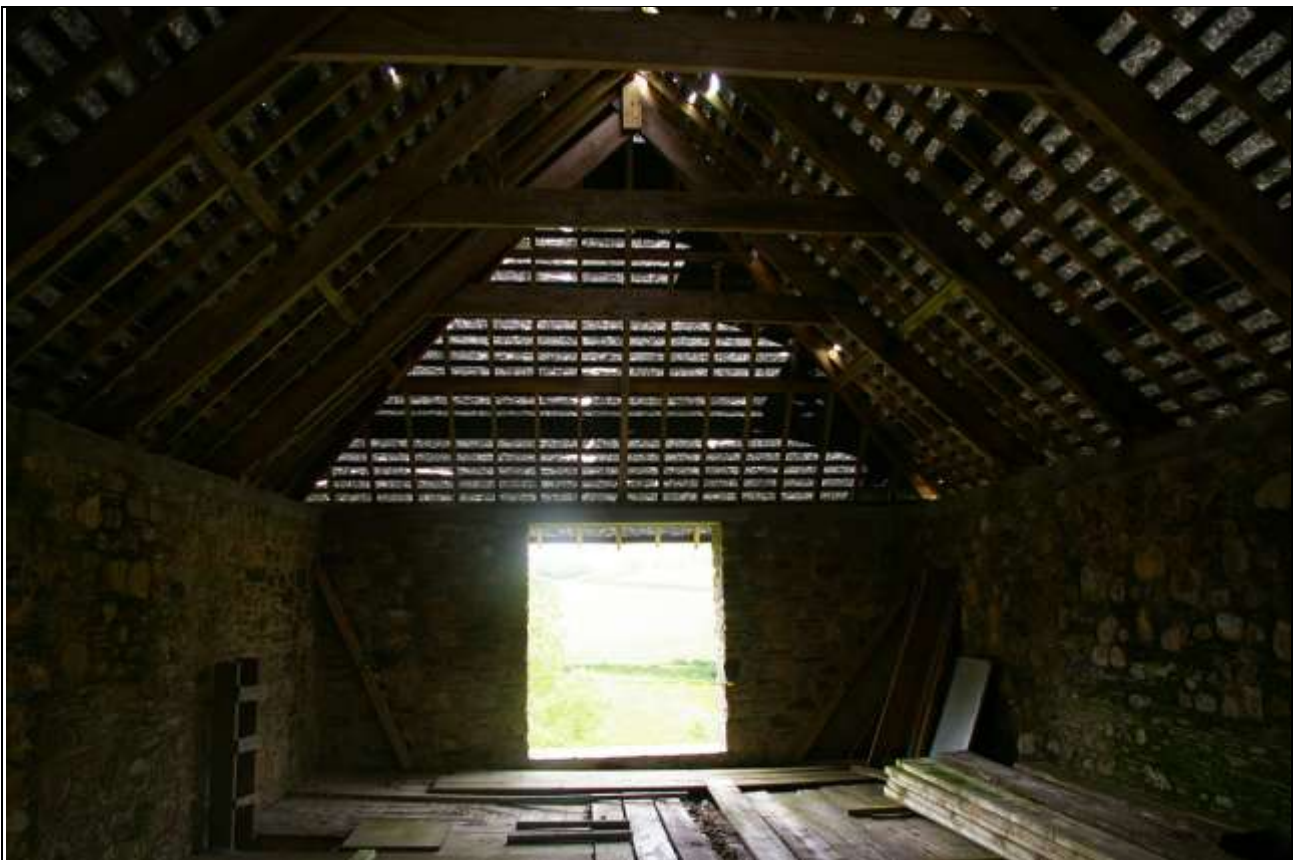
FIGURE 17: BARN A, VIEW TO THE NEWLY FORMED OPENING IN THE SOUTH END AND HIPPED ROOF; FROM THE NORTH.

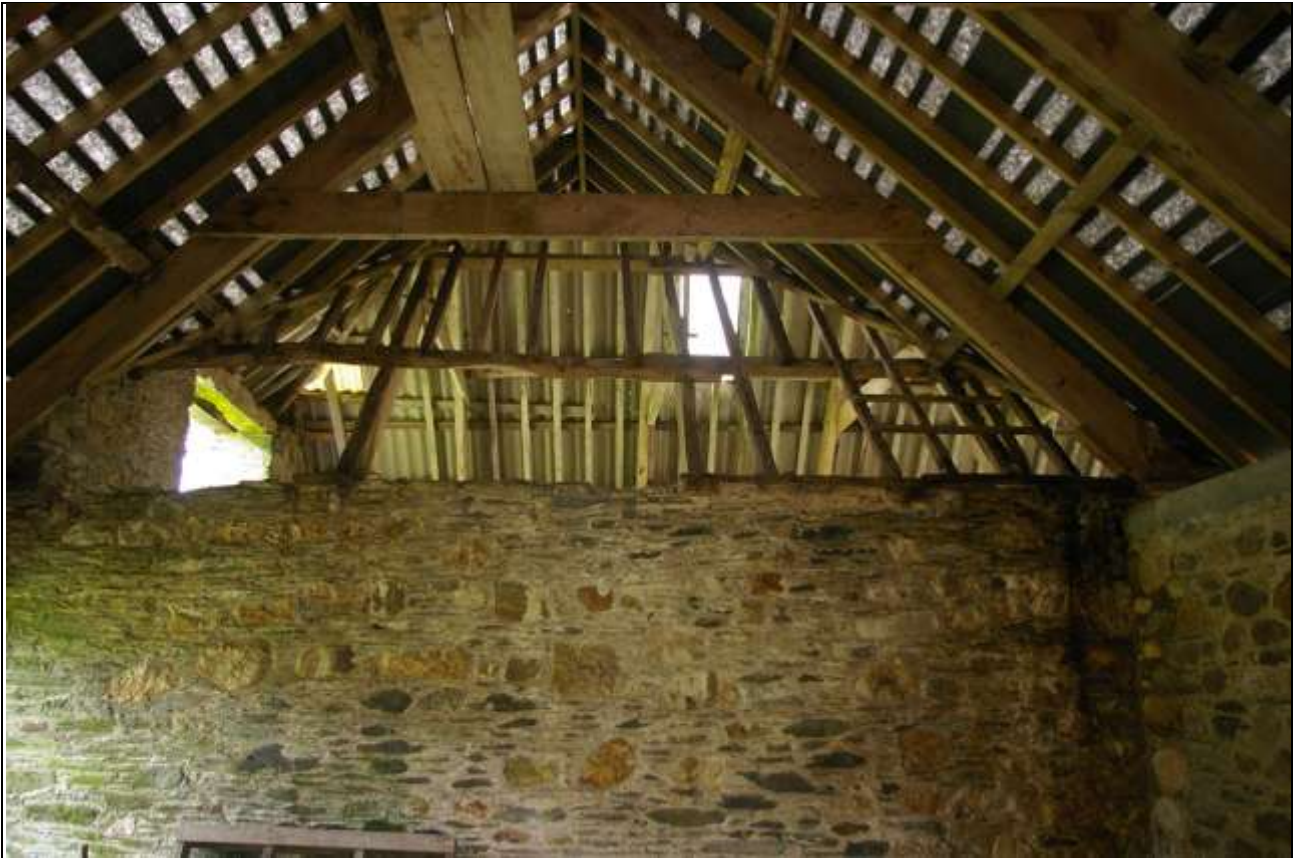
FIGURE 18: THE ARRANGEMENT OF ROOFS TO THE NORTH END, WHERE THE HISTORIC ROOF OF BARN B WAS CLEARLY SEALED AND NOT CONTIGUOUS WITH BARN A, SUGGESTIVE OF AN ORIGINAL LOWER ROOF HEIGHT FOR BARN A. THE MORE MODERN CURRENT ROOF IN BARN A AWKWARDLY ABUTS THAT OF BARN B; FROM THE SOUTH.

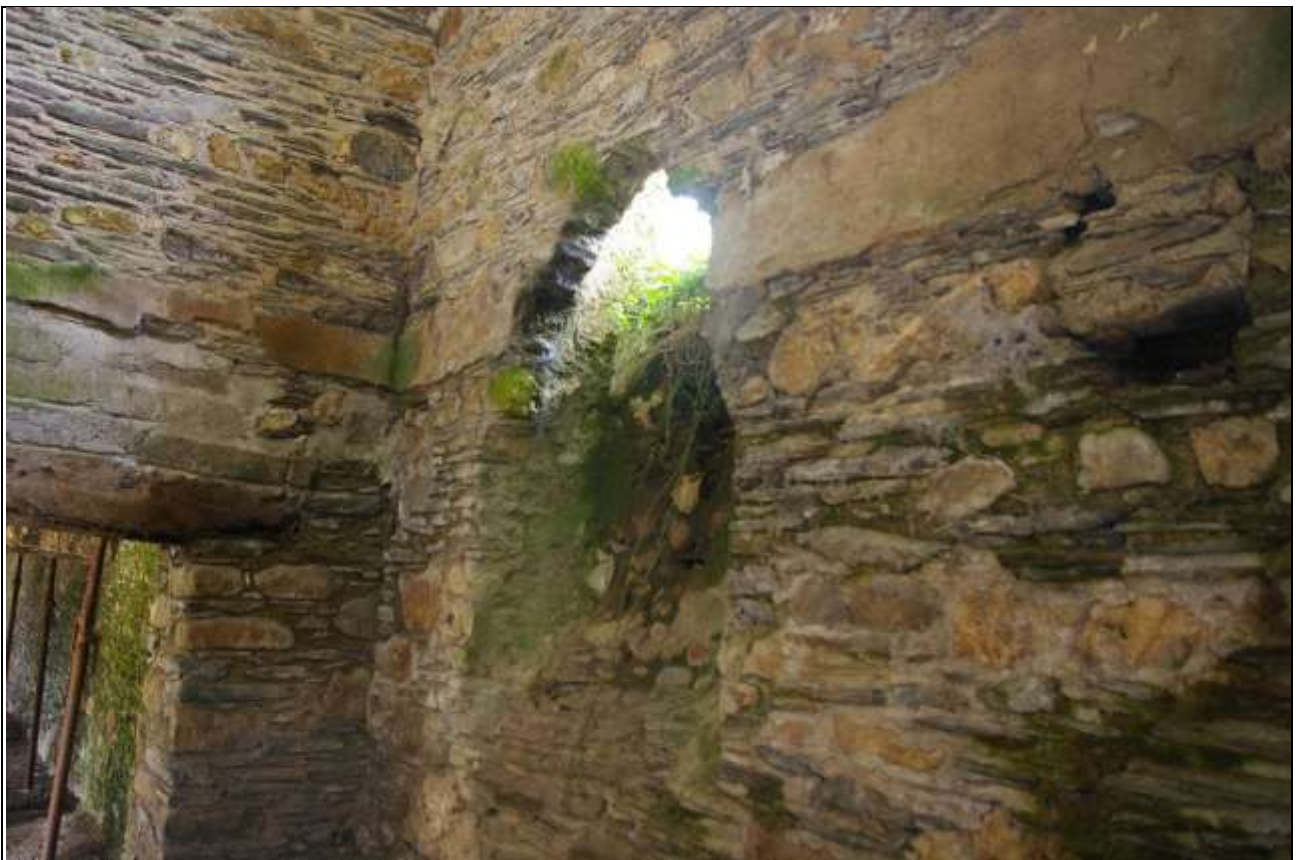
FIGURE 43: THE FORCED OPENING IN THE WEST WALL OF BARN B; FROM THE NORTH-EAST.

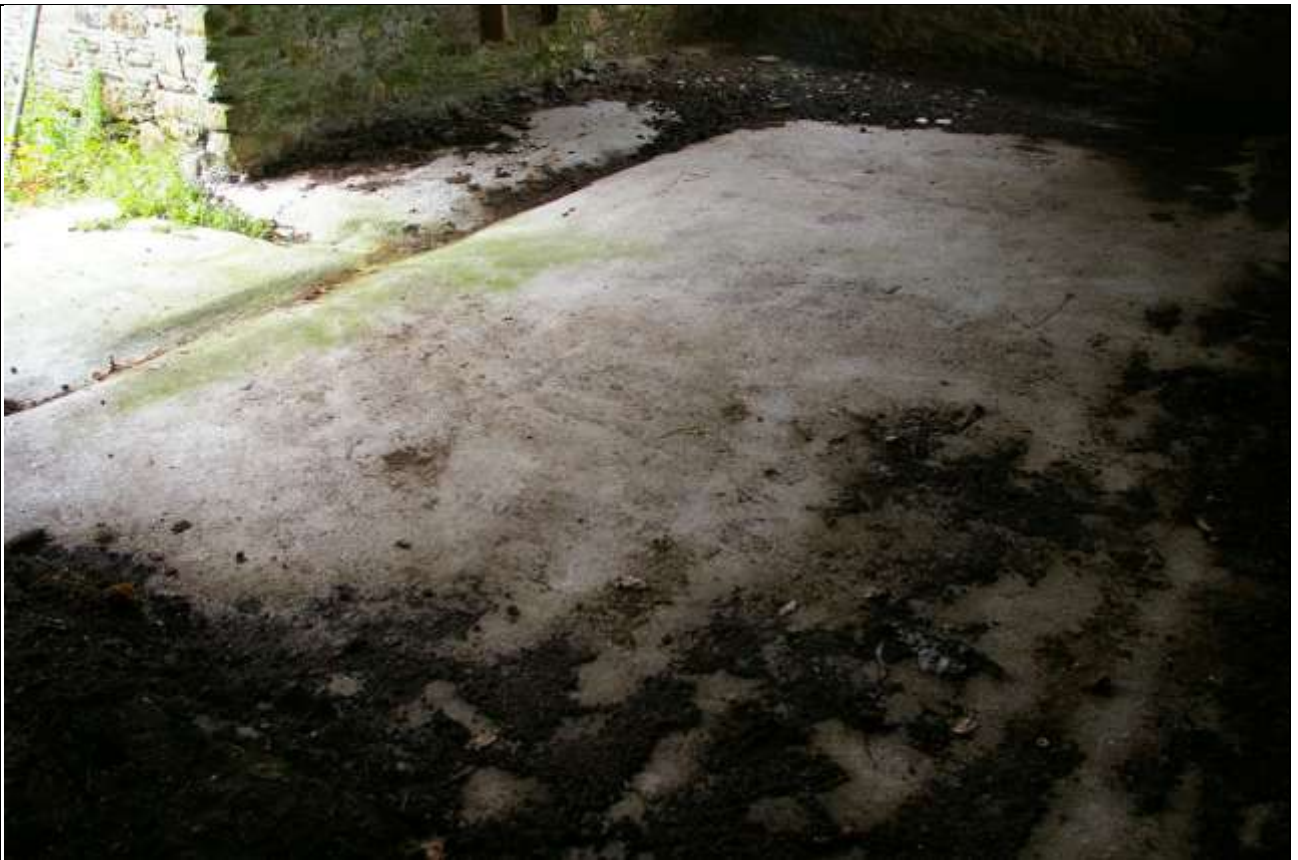
FIGURE 53: THE FLOOR IN THE LARGE SOUTH COMPARTMENT OF BARN A, COBBLES, COVERED BY A THIN LAYER OF CONCRETE, WITH DRAIN TO EAST SIDE; FROM THE NORTH-WEST.

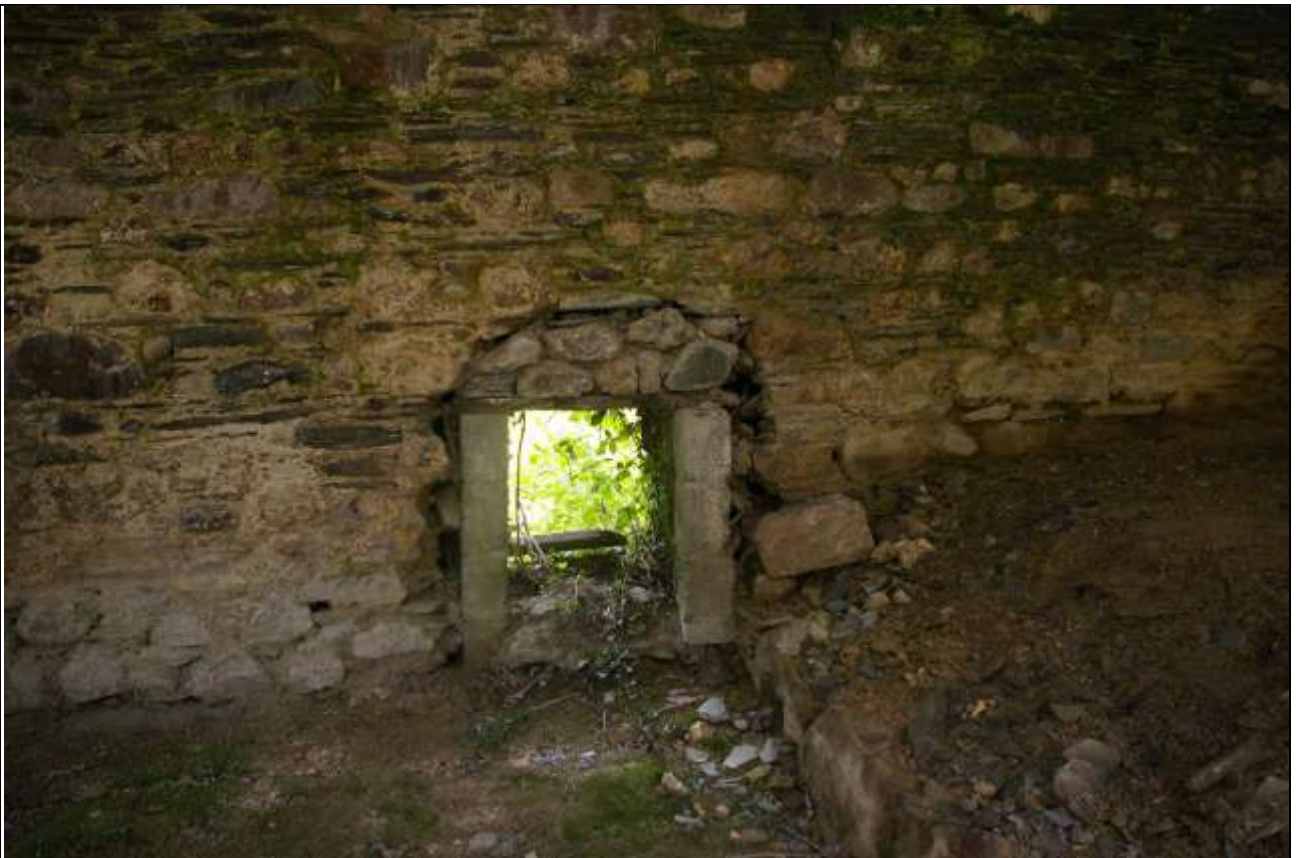
FIGURE 63: A FORCED OPENING IN THE SOUTH WALL OF BARN C, WESTERN END; FROM THE NORTH-NORTH-EAST.

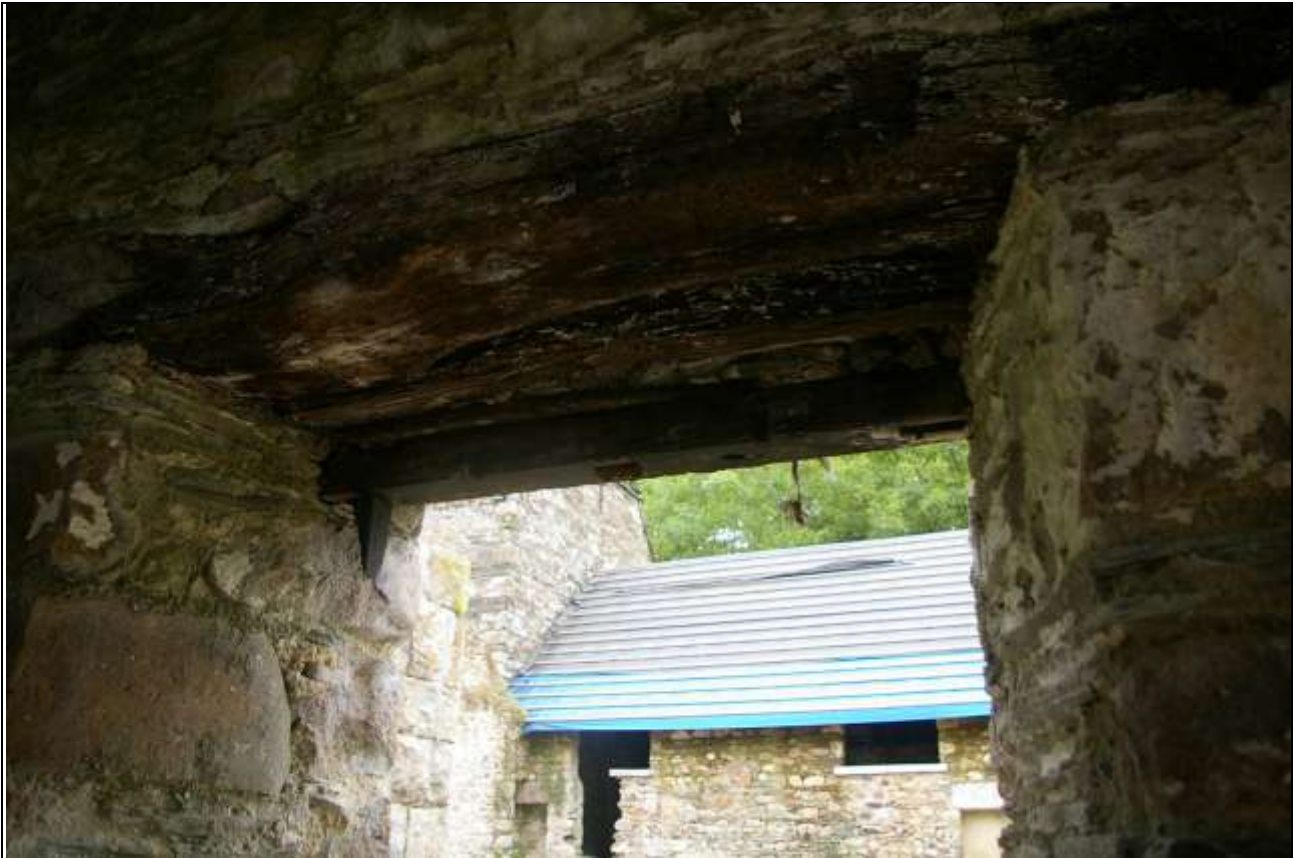
FIGURE 70: DETAIL OF SURVIVING LINTEL AND WINDOW FRAME WITH BROKEN TIMBER SQUARE GLAZING BAR; FROM THE SOUTH-EAST.

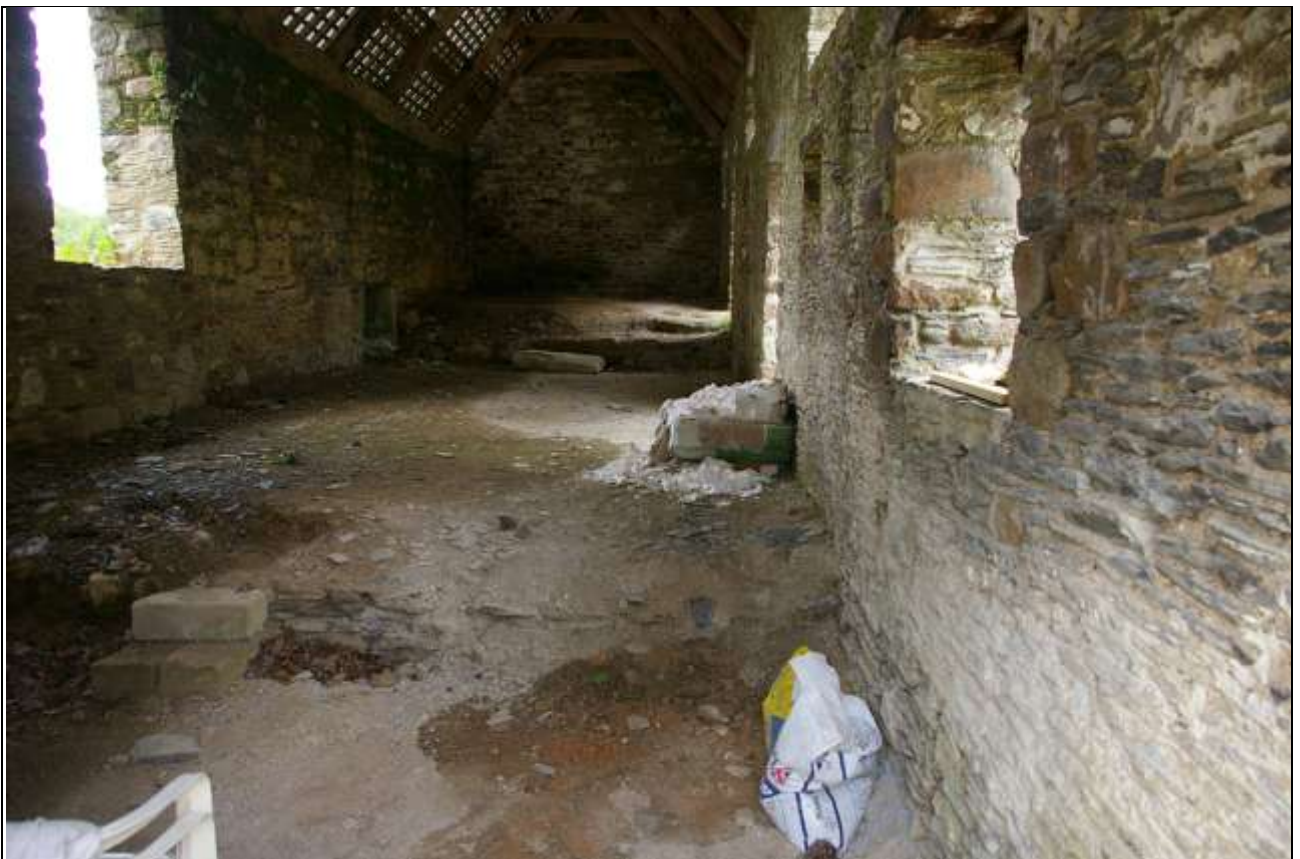
FIGURE 71: VIEW OF THE INTERIOR SPACE OF BARN C, STRIPPED OUT, AS VIEWED FROM DOOR IN EAST ELEVATION.

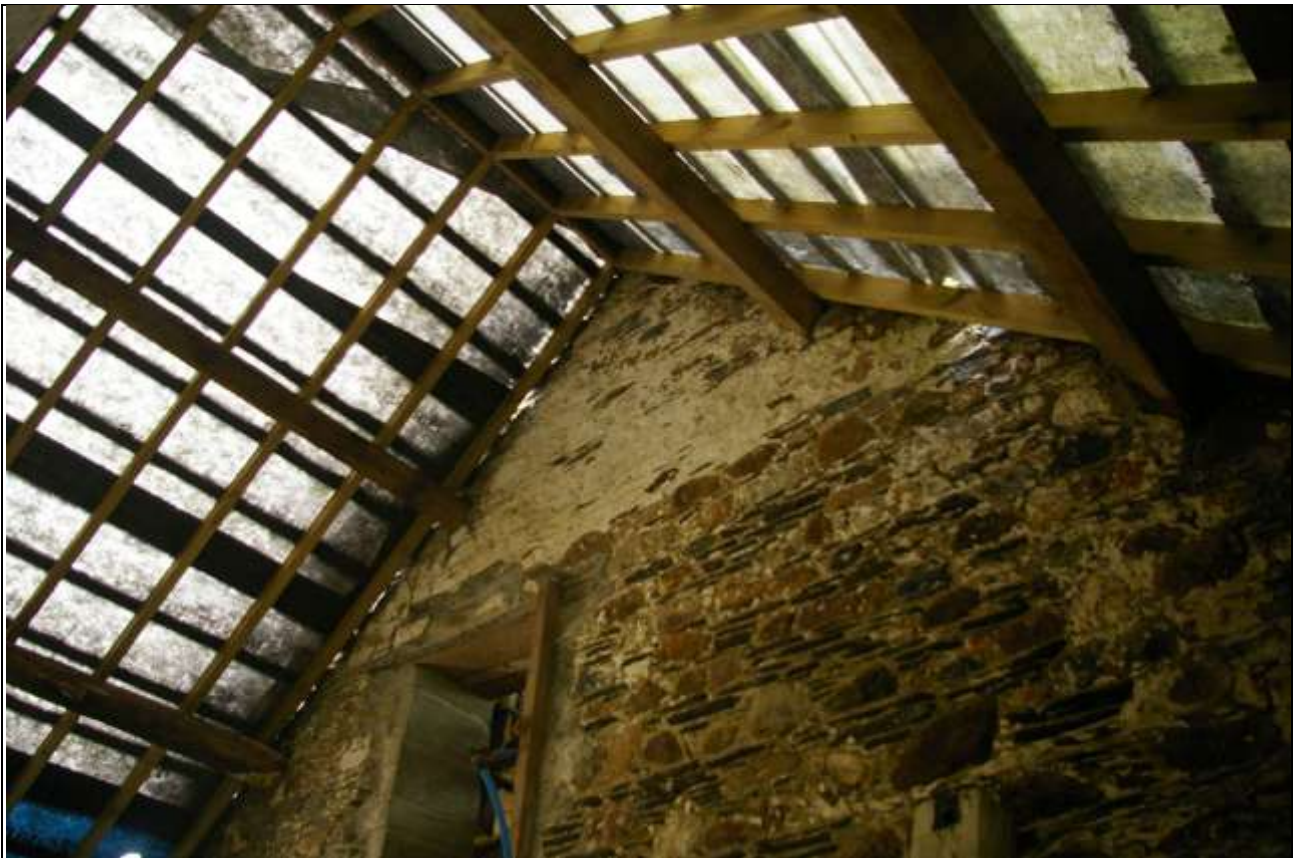
FIGURE 85: SIMPLE PURLINS TO THE WEST OF BARN D, AS IT ABUTS BARN B, POSSIBLY A REPLACEMENT ROOF; FROM THE NORTH-EAST.
