# THE BARN ANDERTON FARM LAUNCELLS CORNWALL

Historic Building Recording

South West Archaeology Ltd. report no. 170814

14<sup>th</sup> August 2017

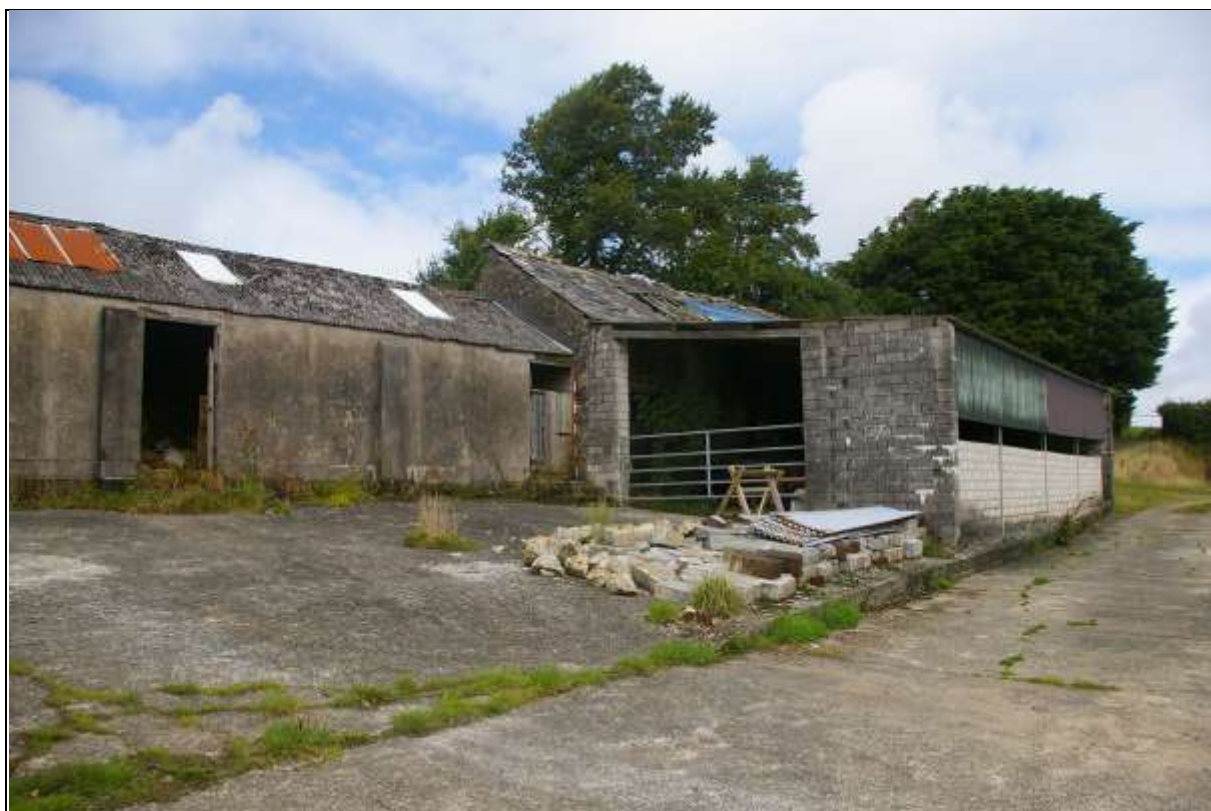
FIGURE 3: BARNs 1, 2 AND 3, VIEWED FROM THE SOUTH-WEST (2M SCALE).

The barn range is divided into three separate sections (see Figure 3), Barn 1, the original stone building, Barn 2, the concrete extension to the west and Barn 3, a lean-to metal framed and concrete block shed to the front of Barn 1.

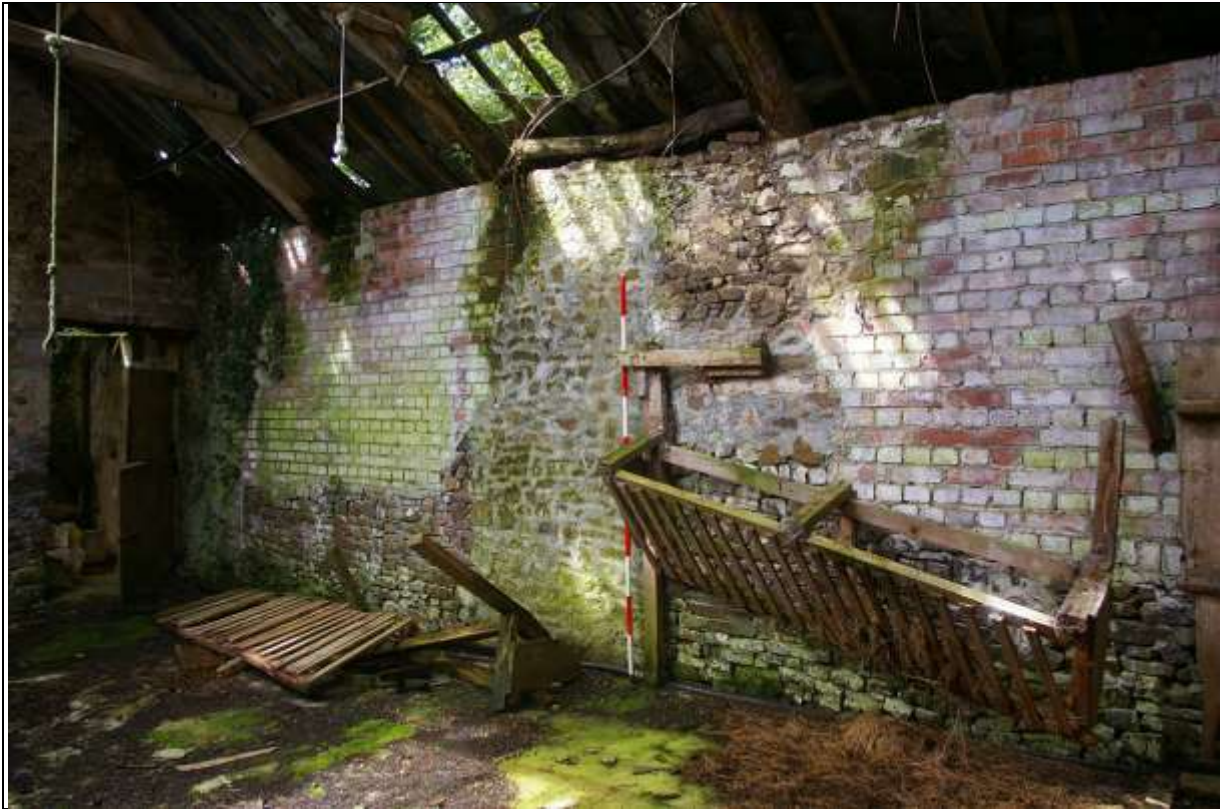
Barn 1 contains the oldest fabric within the range, with neat, coursed stonework surviving in three sections, rising to between 1-1.5m along the north wall of the building (Figure 4). This stonework is of small shaped, faced and dressed blocks of local slatestone, set in a clay bond and later re-pointing. This stonework is finer and of better quality than the rest of the build and may relate to the earlier courtyard complex, most likely a surviving boundary wall from pre-1800, or the remains of a demolished range. There is some similarity to the style of build seen in the house and its immediate outbuildings, but so little survives, that more conclusive dating would be impossible. The rest of the barn is of regularised slate rubble build, of typical 19<sup>th</sup> century style, in a lime mortar, with quoins and timber lintels to openings, significantly patched with English bond brickwork in a clay/lime mix mortar, repointed in a harder cement mortar, then repaired again quite extensively with concrete blocks. The roof is of traditional scantle slates with terracotta ridge. The roof structure is of basic A-frames, utilising two historic phases of timbers, one of heavy oak, one of chamfered pine, as well as more modern, poorer quality, roughly shaped pine logs.

FIGURE 4: THE NORTH WALL WITHIN BARN 1 (COMPARTMENT 1), WITH VARIOUS PHASES VISIBLE; FROM THE SOUTH-EAST (2M SCALE).

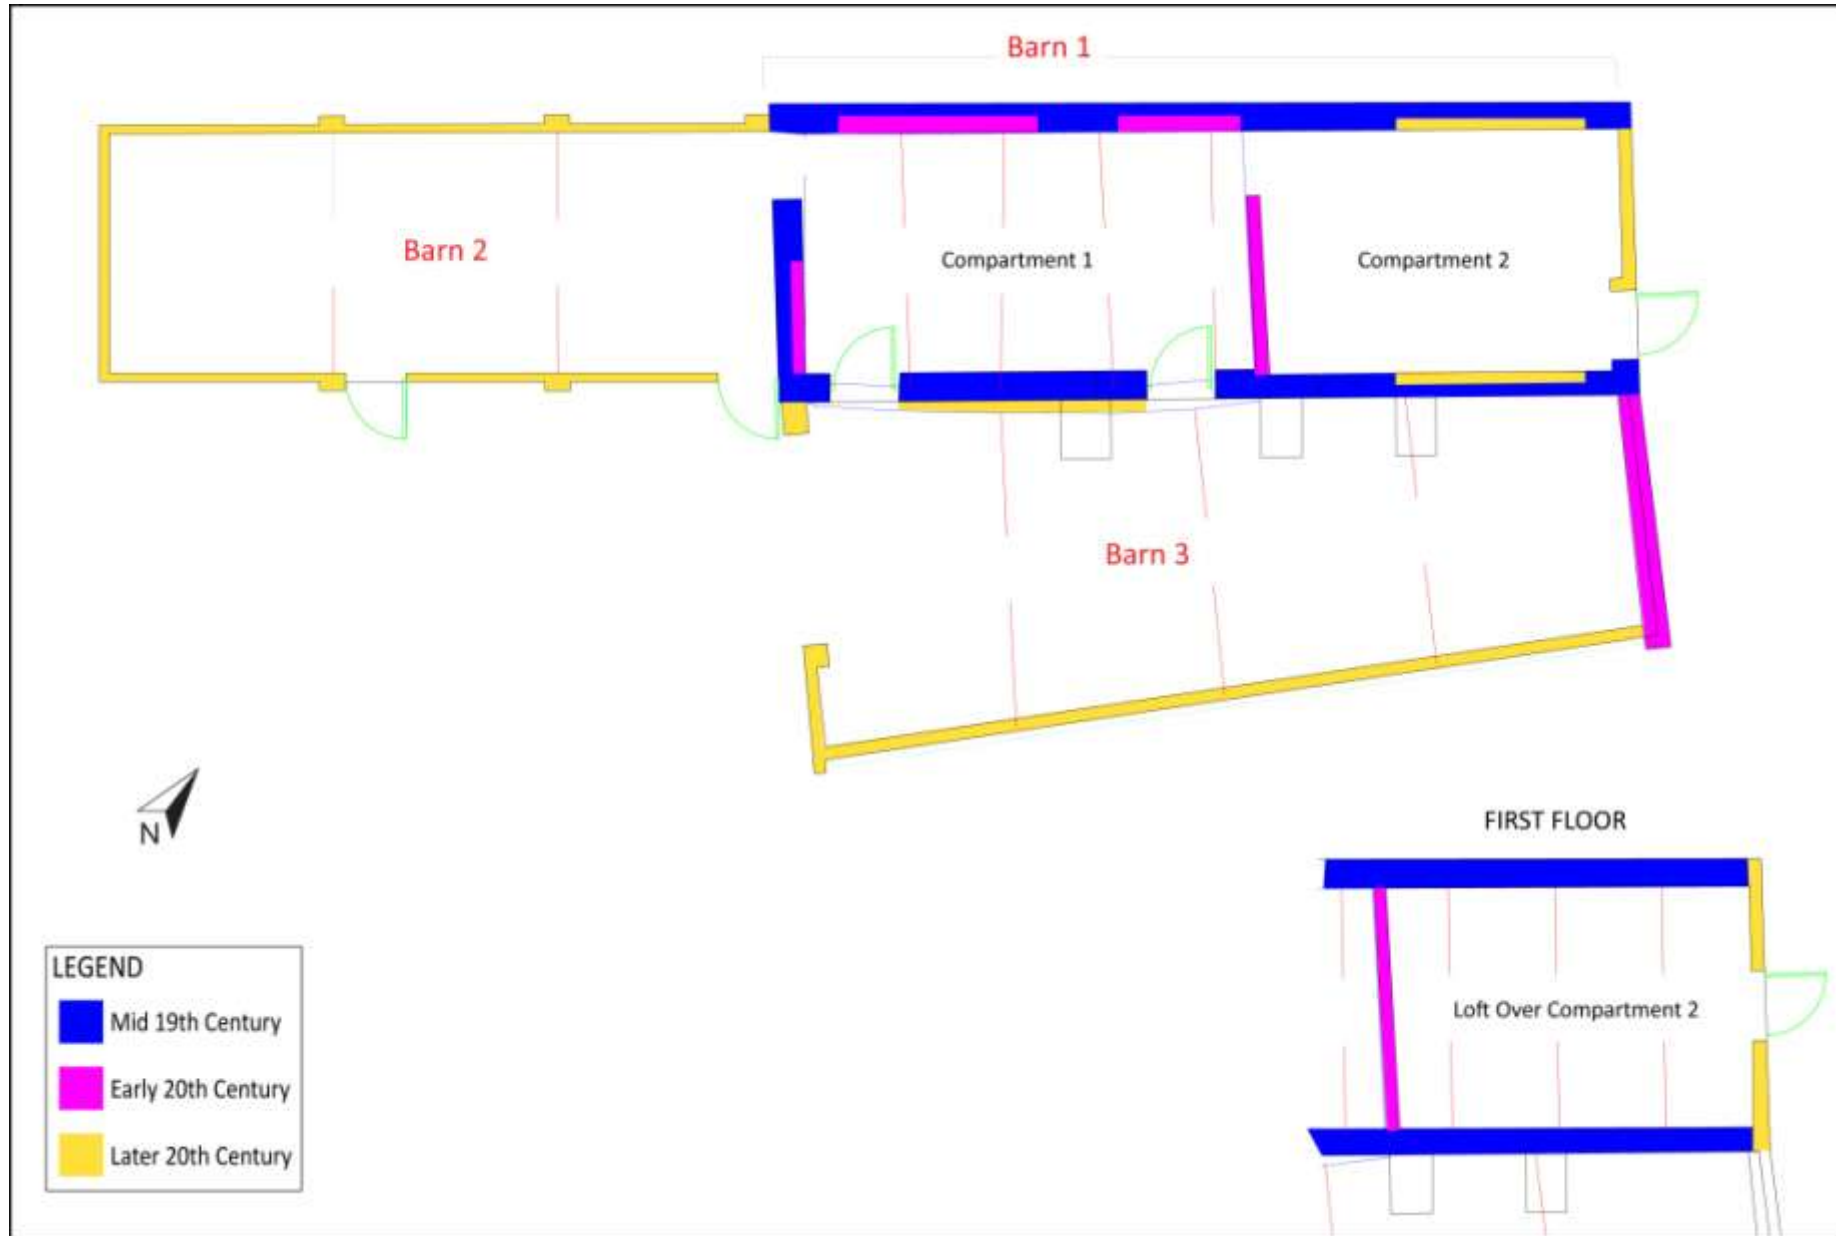
FIGURE 5: PHASE PLAN OF THE BARN.  
South West Archaeology Ltd.

Barn 1 contains the earliest upstanding fabric within the barn range. At the base of the north wall there are surviving sections of pre-1800 stonework, possibly boundary walling, dating to the 17<sup>th</sup> century.

The rest of Barn 1 probably dates to the mid 19<sup>th</sup> century. This was built over and around the earlier building to the west (Barn 2) and possibly the boundary wall. The building was purposefully built as a barn, the focus of the site having become primarily agricultural and potentially dropped in status at this point. The good chamfered and pegged heavy pine truss blades may date to this period. The west gable elevation is of much better build, as is the base of the south wall, areas which have received less alteration, and indicate this barn was initially quite well built.

The historic mapping suggests that by 1907 the range has been significantly remodelled and is of one continuous width with a return to the west. This may account for the poorer quality of build higher up the north, south and west walls in Barn 1, where the stonework appears to have been poorly repaired. The English bond brickwork patching, inserted partition wall and the brick and stone buttresses may relate to this phase, suggesting the barn was in poor condition. The mismatched trusses of the current roof structure will most likely date to this phase. The farmyard markedly changes in appearance in the later 19<sup>th</sup> and early 20<sup>th</sup> centuries, with all the farm buildings potentially replaced or remodelled in some aspect.

Barn 1 has undergone several potential periods of dereliction or decline, since it has required repair and remodelling several times in a relatively short history. In the late 20<sup>th</sup> century the east gable needed to be rebuilt, concrete patching applied to several of the walls and at least one additional buttress was built. Barn 2 was wholly rebuilt in this phase and Barn 3 newly constructed, infilling a space in the yard.

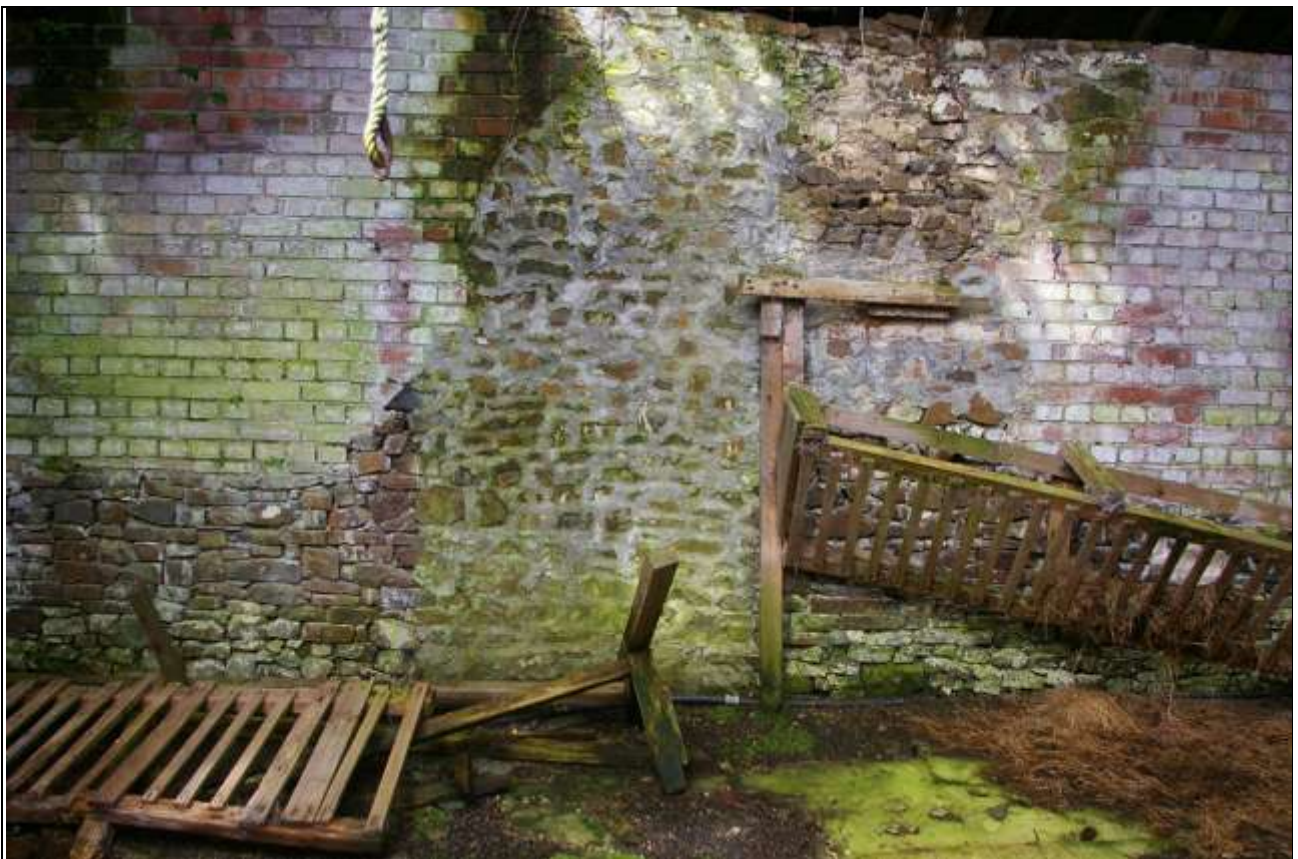
THE LONG REBUILT SECTION IN THE NORTH WALL OF BARN 1, COMPARTMENT 1; FROM THE SOUTH.

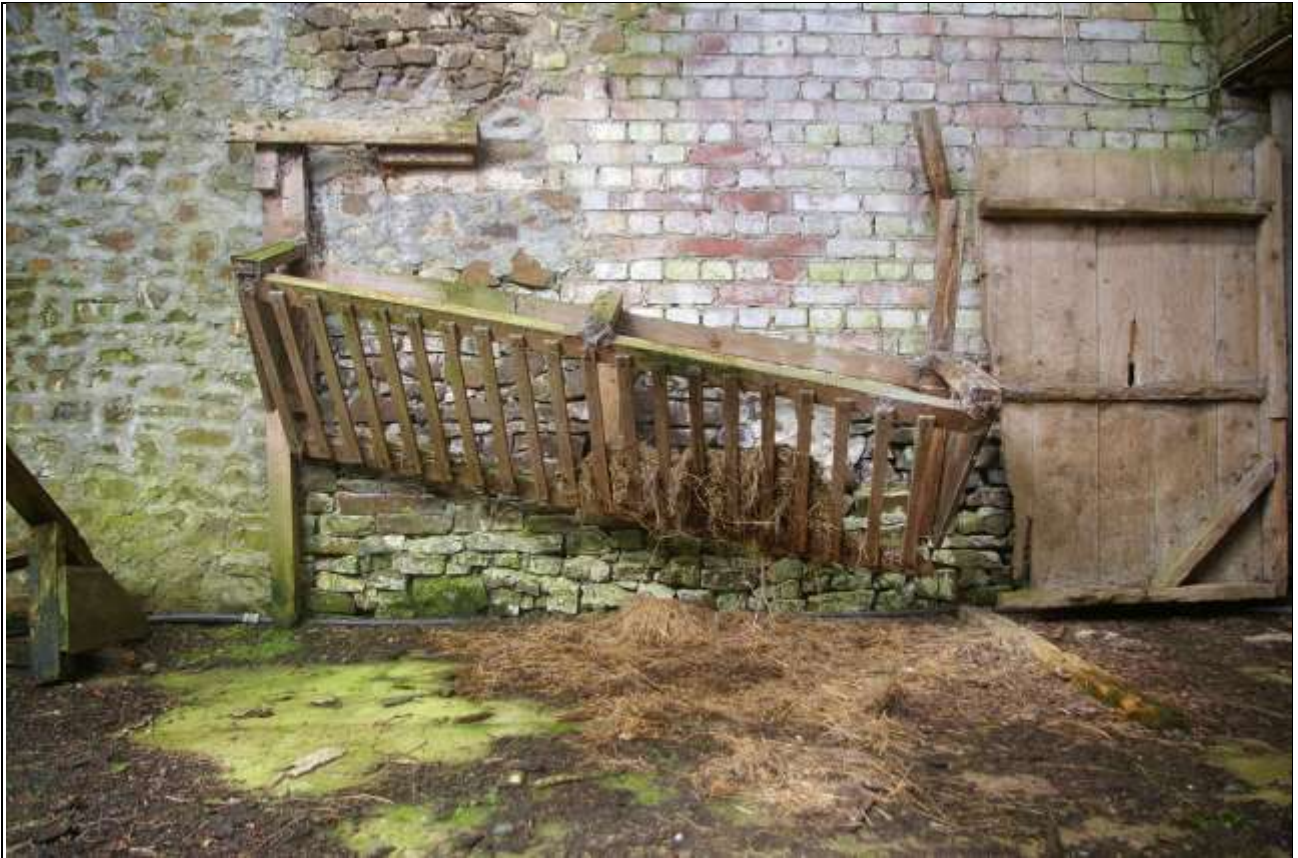
AS ABOVE.

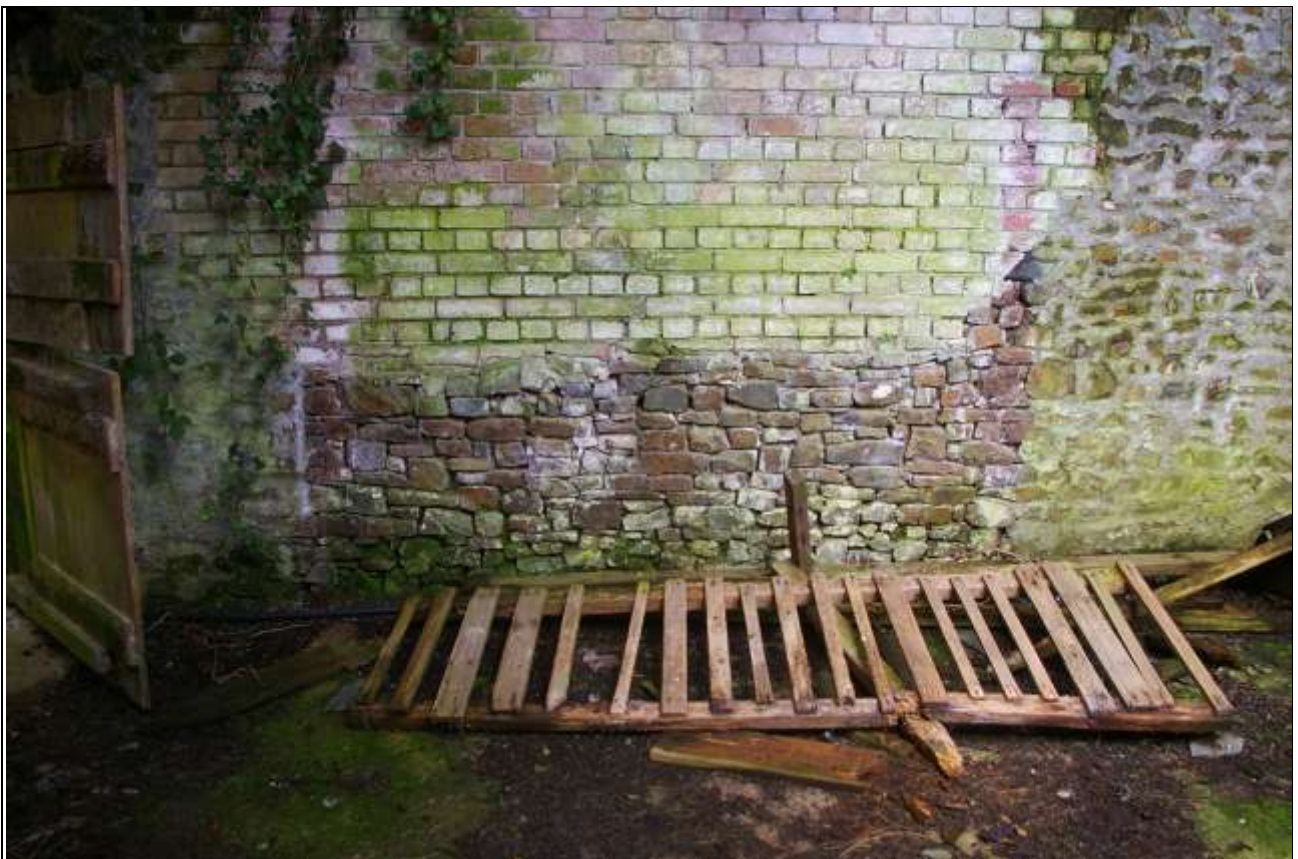
THE BETTER QUALITY STONEMWORK IN THE BASE OF THE NORTH WALL WITHIN BARN 1; FROM THE SOUTH, WITHIN COMPARTMENT 1.

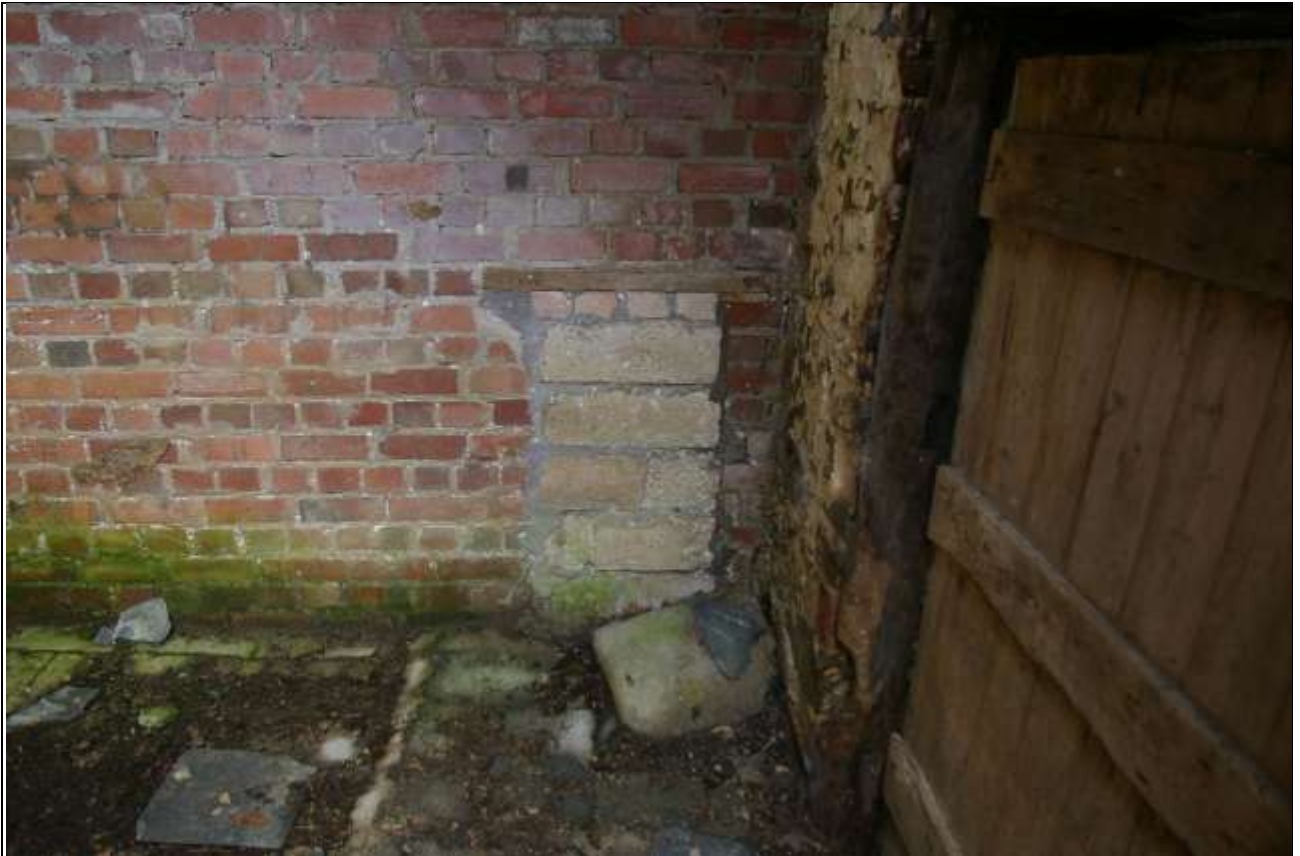
THE BLOCKED OPENING IN THE PARTITION WALL; FROM THE WEST.

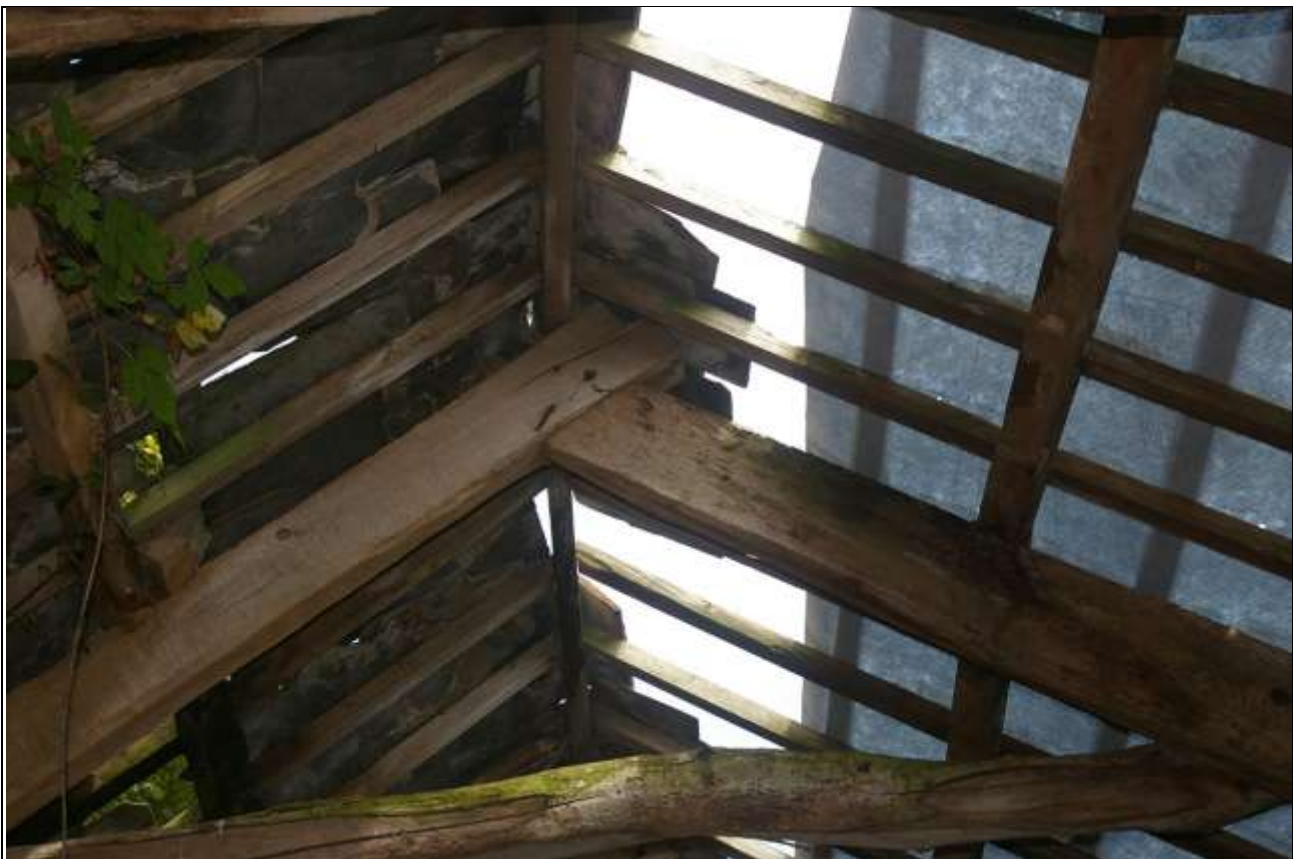
DETAILS OF THE RIDGE AND APEX OF SEVERAL OF THE TRUSSES, SHOWING CUT OFF MORTICE AND TENONS; FROM THE WEST.

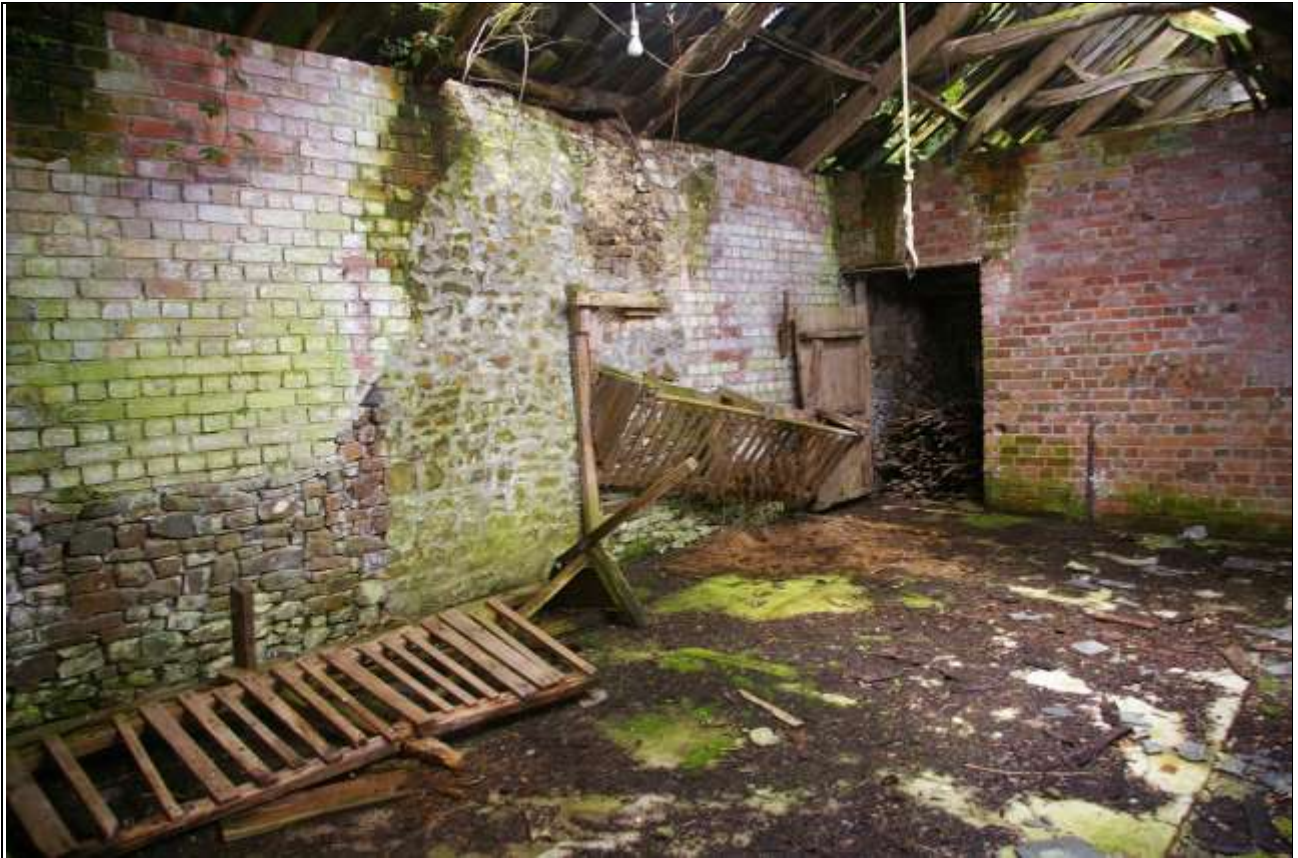
THE NORTH WALL OF BARN 1, SEEN WITHIN COMPARTMENT 1, SHOWING SIGNIFICANT PHASING; FROM THE SOUTH-WEST CORNER.

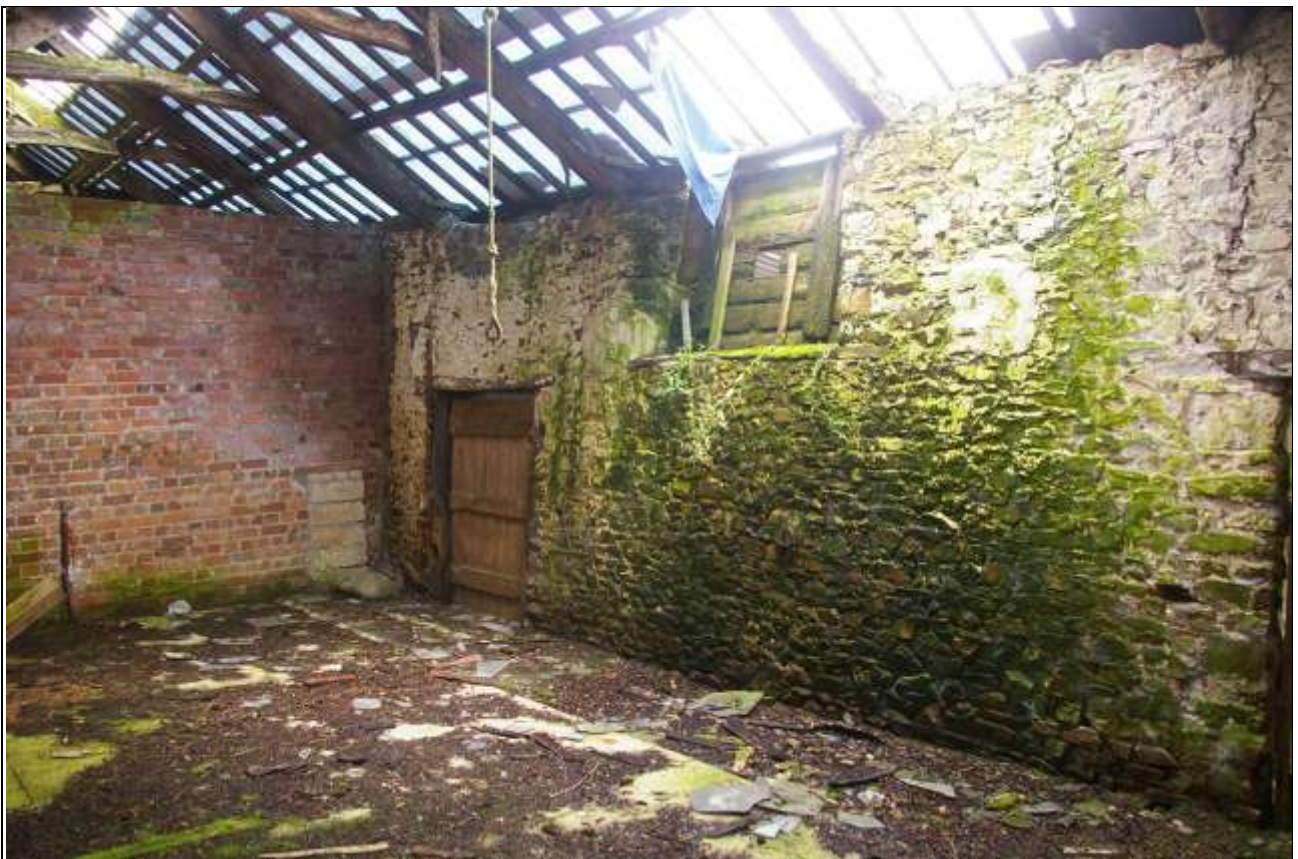
THE SOUTH WALL OF BARN 1, SEEN WITHIN COMPARTMENT 1, SHOWING MARKED SLOPING OF THE WALL; FROM THE NORTH-WEST.

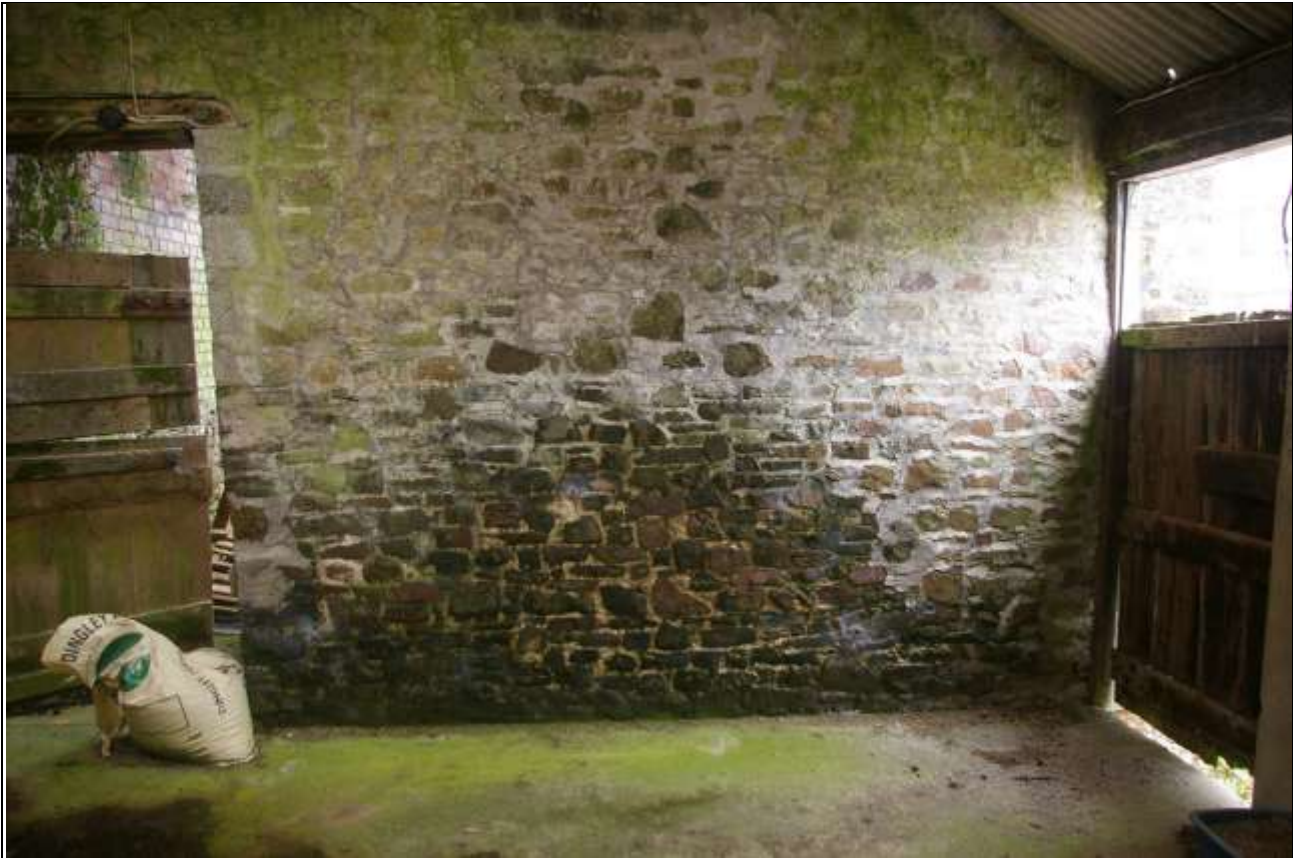
Fabric Description		Two storey gable end wall. Regularised rubble build, better quality than the south and north walls, in a lime mix mortar, heavy repointing to the exterior face with cement. Roughly dressed quoins to the corners. Clear blocked opening to the exterior elevation. The interior face of the wall has been significantly rebuilt in English bond brickwork, a late 19 <sup>th</sup> or early 20 <sup>th</sup> century repair. This can be seen to repair the wall and block an opening, with narrow timber lintel still visible. The bricks used have been reused from elsewhere with different colours of paint and plaster on them, being of two types of terracotta, a blue-red and an orange-red. Limewash or whitewash survives to the interior face, but the wall has been repointed in cement too, where further cracks have formed. Above the roofline of Barn 2 the elevation is exposed to the weather, cement and tin sheeting to flashing of roof for Barn 2. There are the possible remains of cement render, or an excessively heavy cement repointing.

THE GOOD QUALITY REGULARISED RUBBLE BUILD OF THE LOWER PART OF THE WEST GABLE END OF BARN 1, THE STONEMWORK BEING MORE DISTURBED FURTHER UP THE WALL; FROM THE WEST.

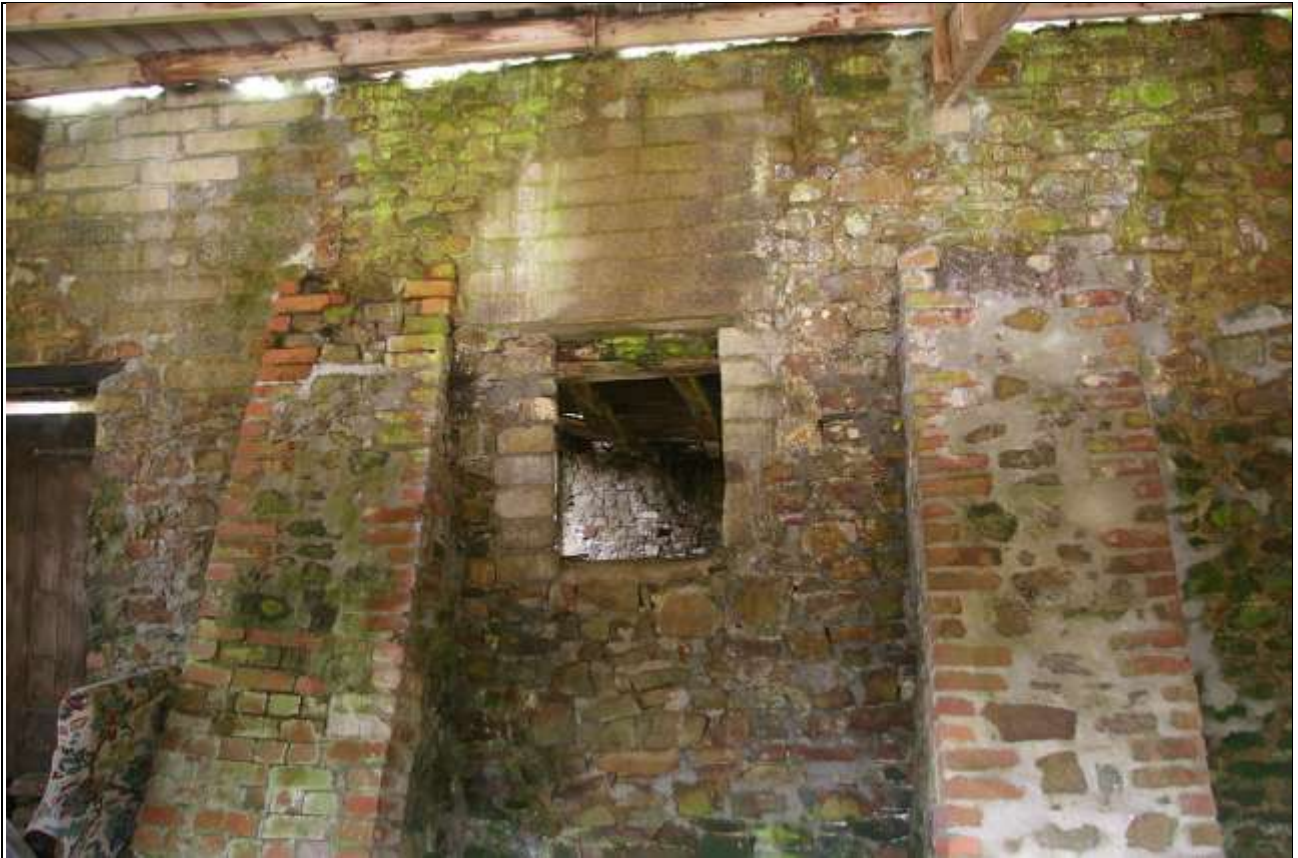
THE BRICK FRAMED BUTTRESSES AND FORCED WINDOW IN THE SOUTH WALL OF BARN 1, COMPARTMENT 2; FROM THE SOUTH-SOUTH-EAST.

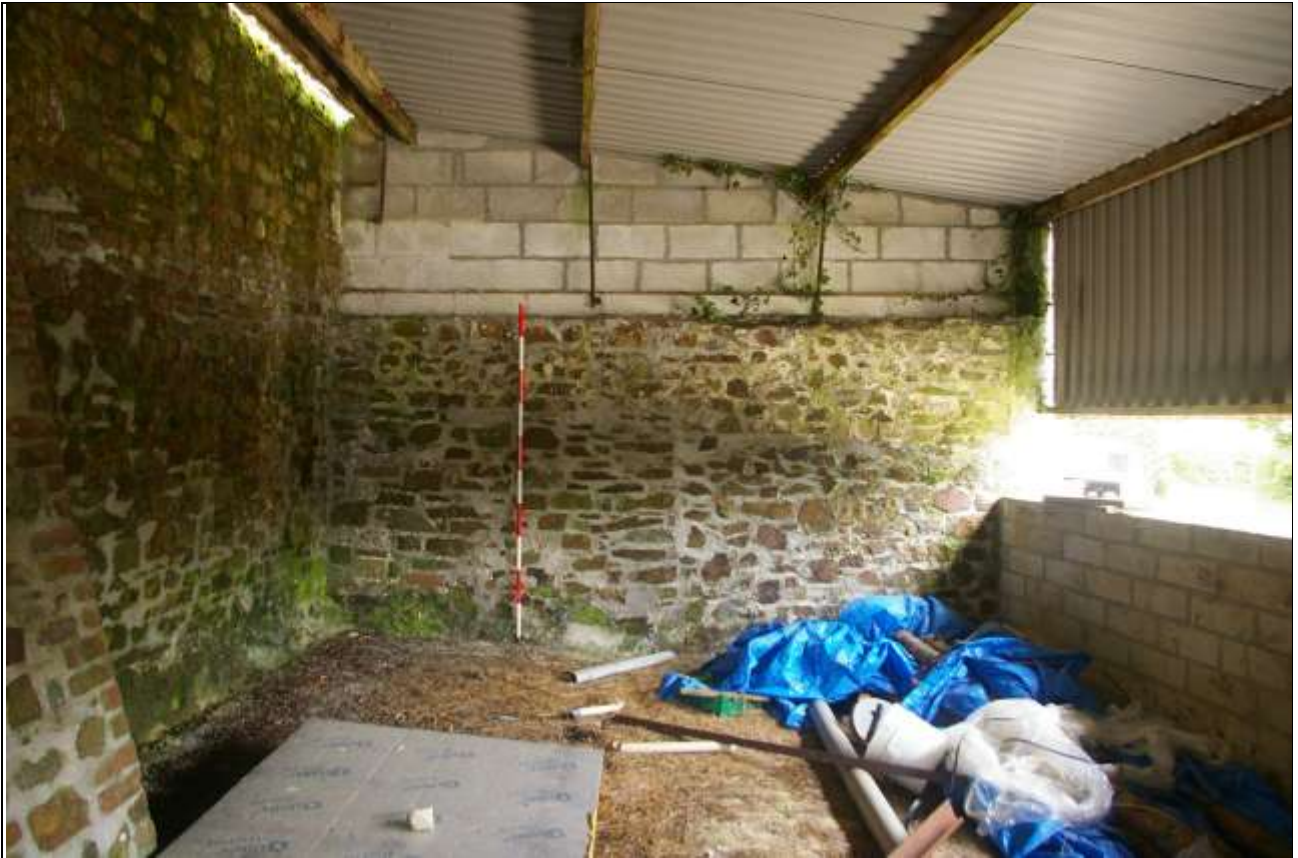
THE EAST WALL OF BARN 3, SHOWING CLEAR PHASING WITHIN THIS SHORT SECTION OF WALLING; FROM THE WEST (2M SCALE).

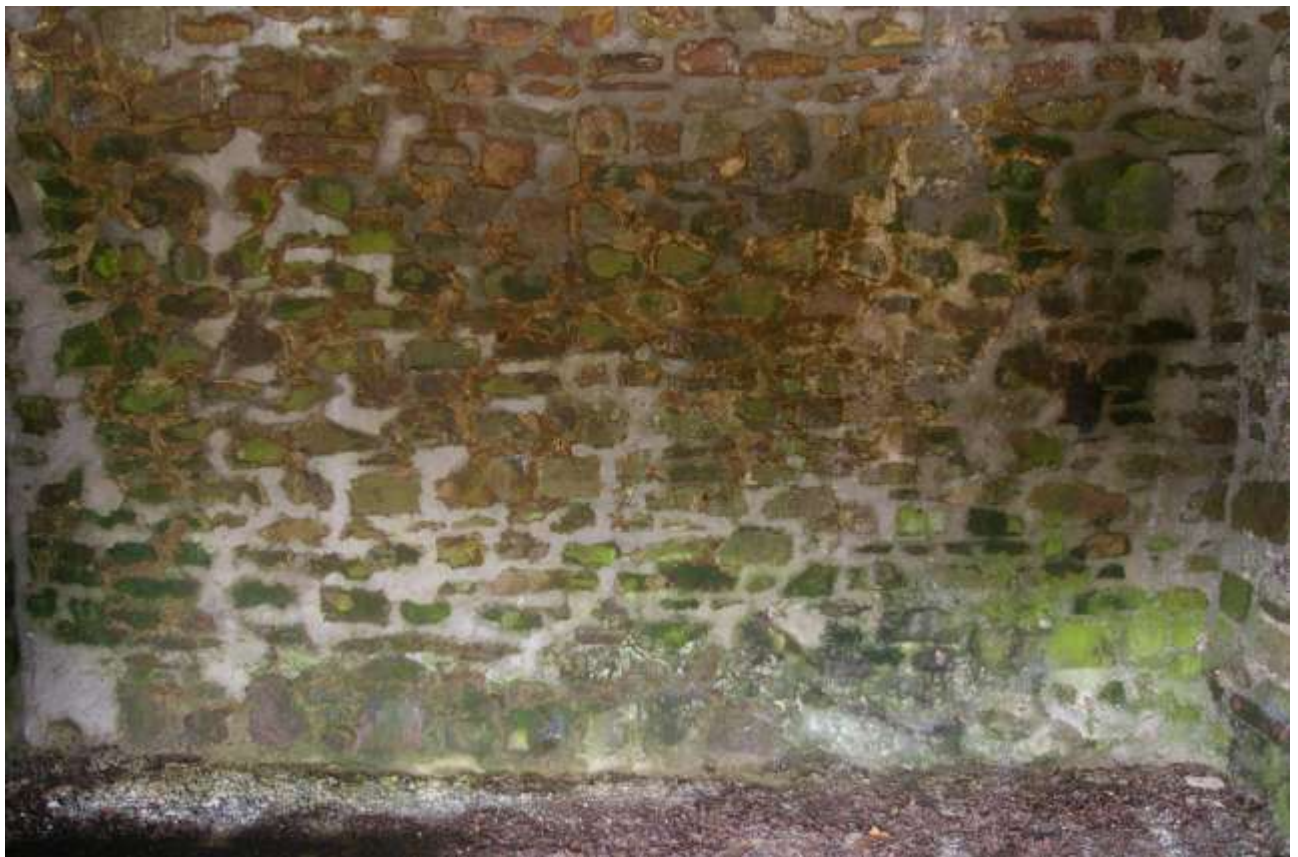
AREA OF MORE REGULARISED RUBBLE, HEAVILY OBSCURED WITH CEMENT MORTAR AND POINTING, MAY BE FROM THE OLDER HISTORIC COMPLEX; FROM THE SOUTH.

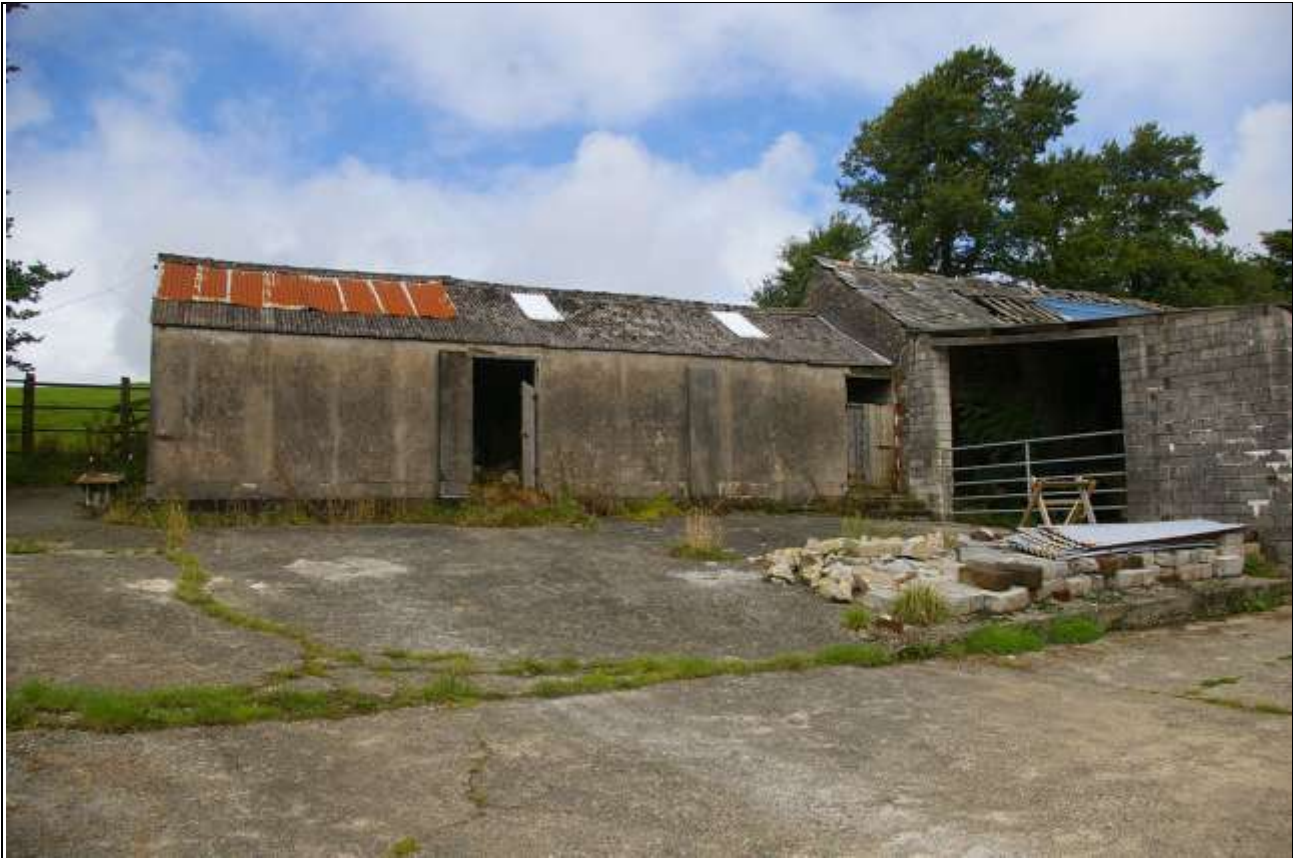
Significant Details:		There are two small buttresses which support the wall, as the slope of the yard here is quite marked and there are clearly quite a few structural cracks in the wall.
Relationships:		The south, west and north walls are all concrete block, modern and abut Barn 1 to the east end.
Comments		The steps which access the doors and the exposing of the rough concrete slab on the south side would suggest levels have changed here and the loosely laid poured concrete slabs and steep slope of the yard here may be the resulting of some kind of terracing or alteration, or the removal of a previous building.
<b>B2 Elevation WEST</b>		<b>Description</b>
Fabric Description:		Single storey gable end elevation, built of concrete block, rendered externally.
Roof Covering:		Gable end, but boarded eaves, corrugated sheeting roof.
Relationships:		The north, south and west walls are all of concrete blocks and are contiguous.

THE SOUTH WALL OF BARN 2, FROM THE SOUTH-WEST (2M SCALE).

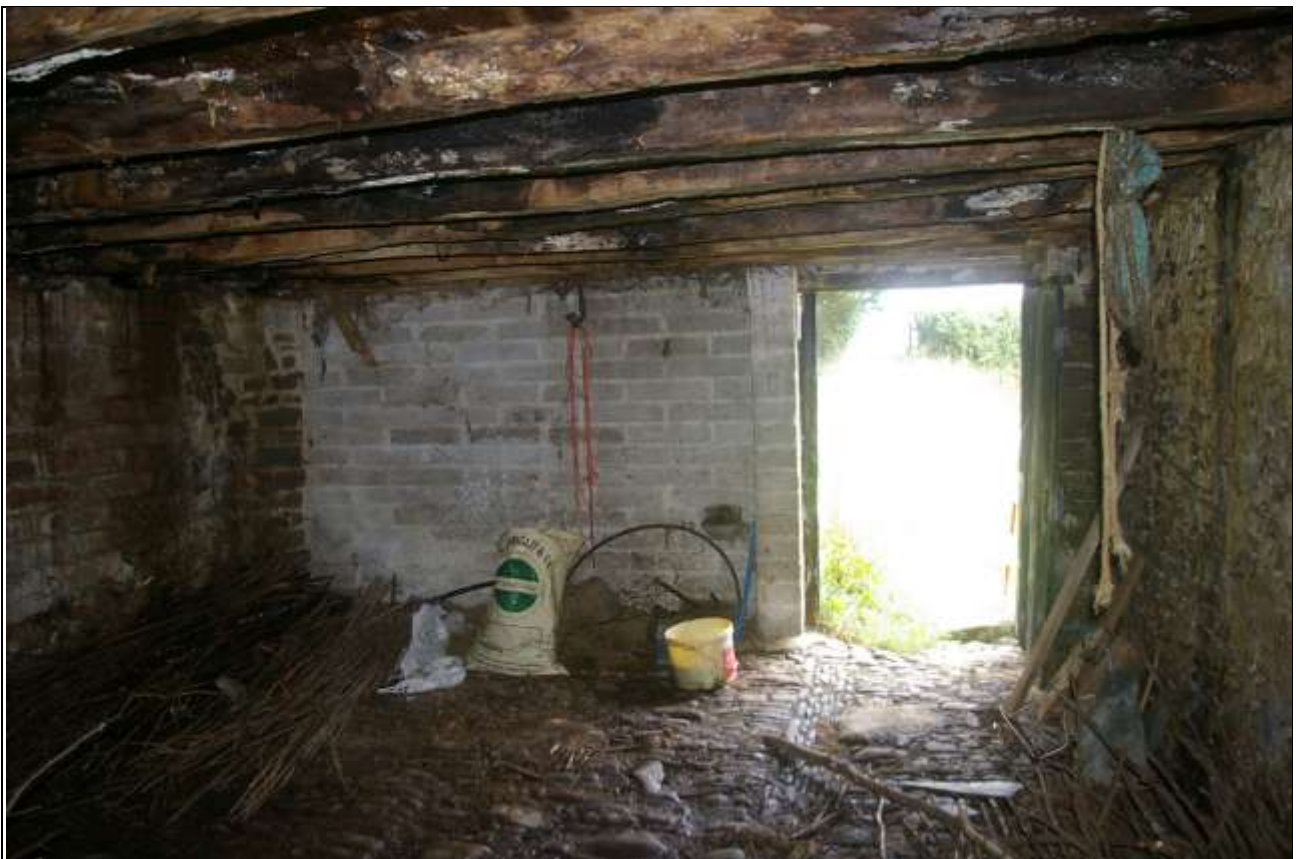
<b>Compartment 2</b>		
Walls:		<p>Exposed stone, whitewashed or limewashed to the south, small section of concrete block patching. Extensive patching in concrete block and cement to the north wall.</p> <p>The east wall is wholly rebuilt in concrete block.</p> <p>The west inserted partition wall is of English bond brickwork, unpainted.</p>
Floor:		Crude cobbled floor, of slate pebbles, several larger stones. Damaged and very irregular, with unusually large pebbles and stones used. Patched with cement in places.
Loft:		<p>Narrow even width chunky plank boards form a loft over this space, at quite low level. This is supported on unusually heavy beams. Several of these beams are almost square in profile and lie flat inside in the wall, an older form of build.</p> <p>Several are roughly chamfered, with squarish older sockets cut in them, as well as peg holes and a possible slot for a screen; reused from a much earlier building.</p> <p>Several of the other beams are slightly lighter in weight and more irregular, curving or twisting, the three to the west end of the loft are still partially embarked, more roughly shaped and resemble the rough collars on the roof trusses.</p> <p>The beams sit on chunky timber plank wallplates in the north and south walls.</p> <p>The heaviness and reused of such big beams indicates this loft was carrying immense weight, possibly grain at some point.</p> <p>Most of the beams which are reused have pintles, hooks or other inset ironwork indicating former uses within doorways, framing and possibly screens.</p>

THE EAST WALL OF BARN 1 COMPARTMENT 2 IS REBUILT WHOLLY IN CONCRETE BLOCK; FROM THE WEST-SOUTH-WEST.

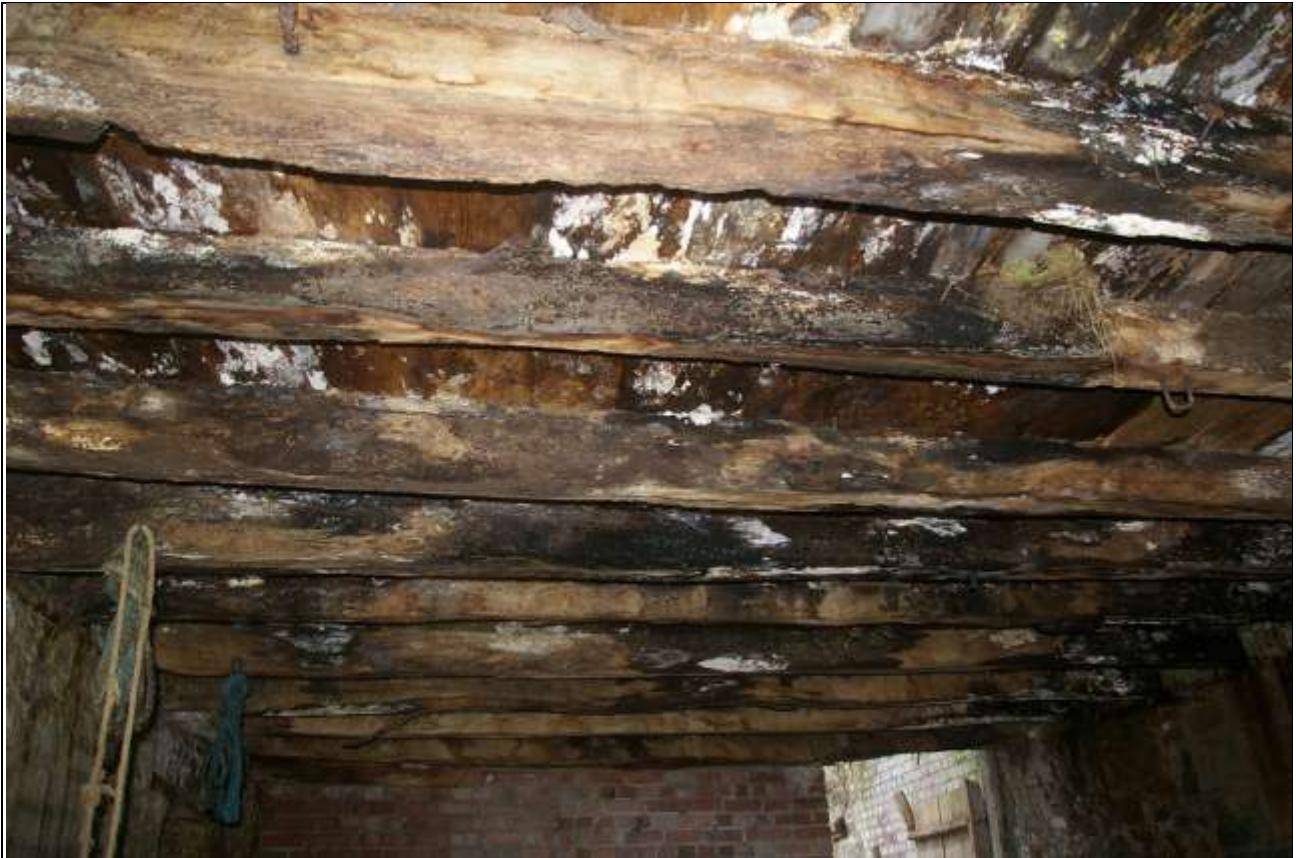
THE HEAVY TIMBER JOISTS OF THE LOFT FLOOR IN COMPARTMENT 2, INDICATING SOME REUSED TIMBERS; FROM THE EAST-SOUTH-EAST.
