# THE BARN ANDERTON FARM LAUNCELLS CORNWALL

Historic Building Recording

South West Archaeology Ltd. report no. 170814

14<sup>th</sup> August 2017

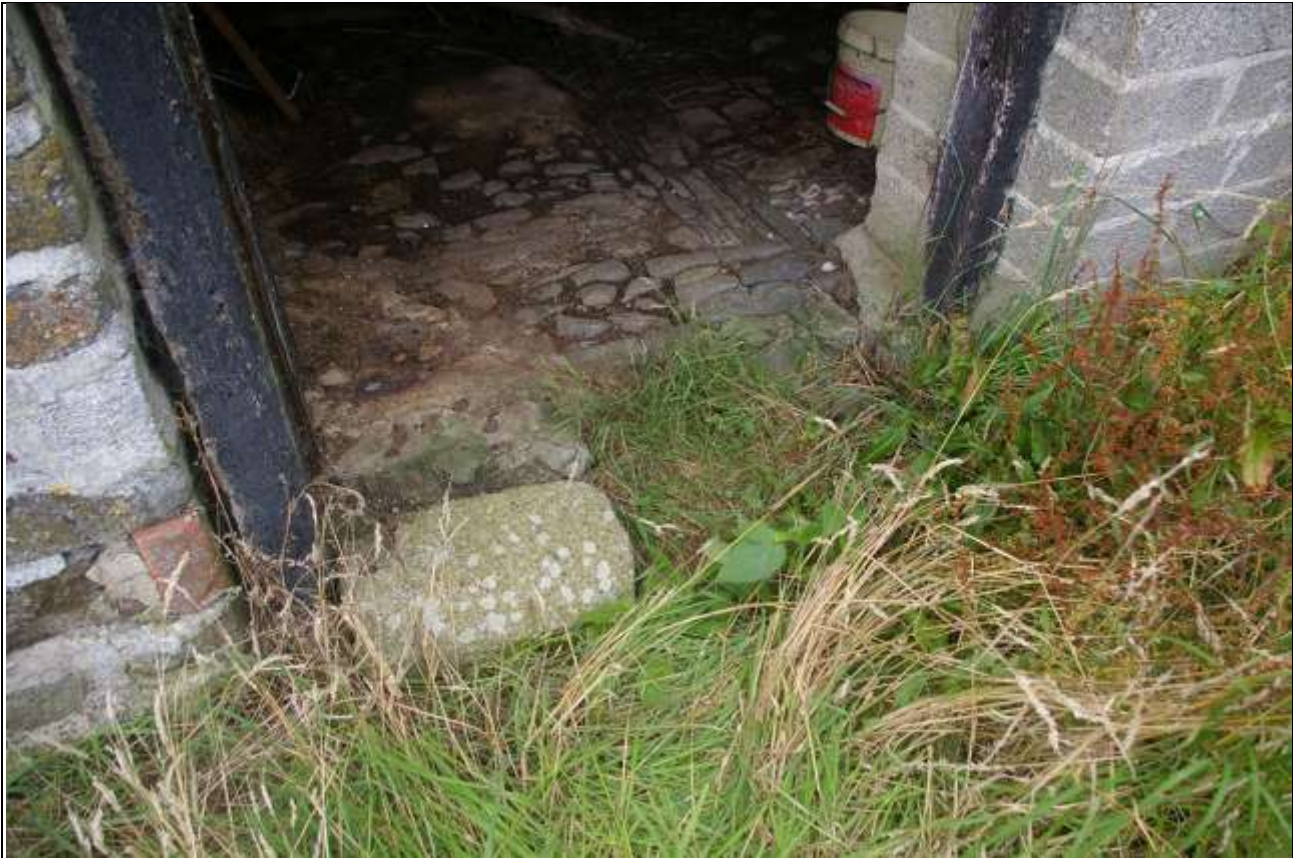
THE DOORWAY IN THE EAST GABLE OF BARN 1, WITH A REUSED GRANITE MULLION AS A KERB STONE; FROM THE EAST-SOUTH-EAST.
