# SESSLAND FARM SOUTH TAWTON CREDITON DEVON

Desk-Based Assessment & Historic Building Recording

South West Archaeology Ltd. report no. 180104

04<sup>th</sup> January 2018

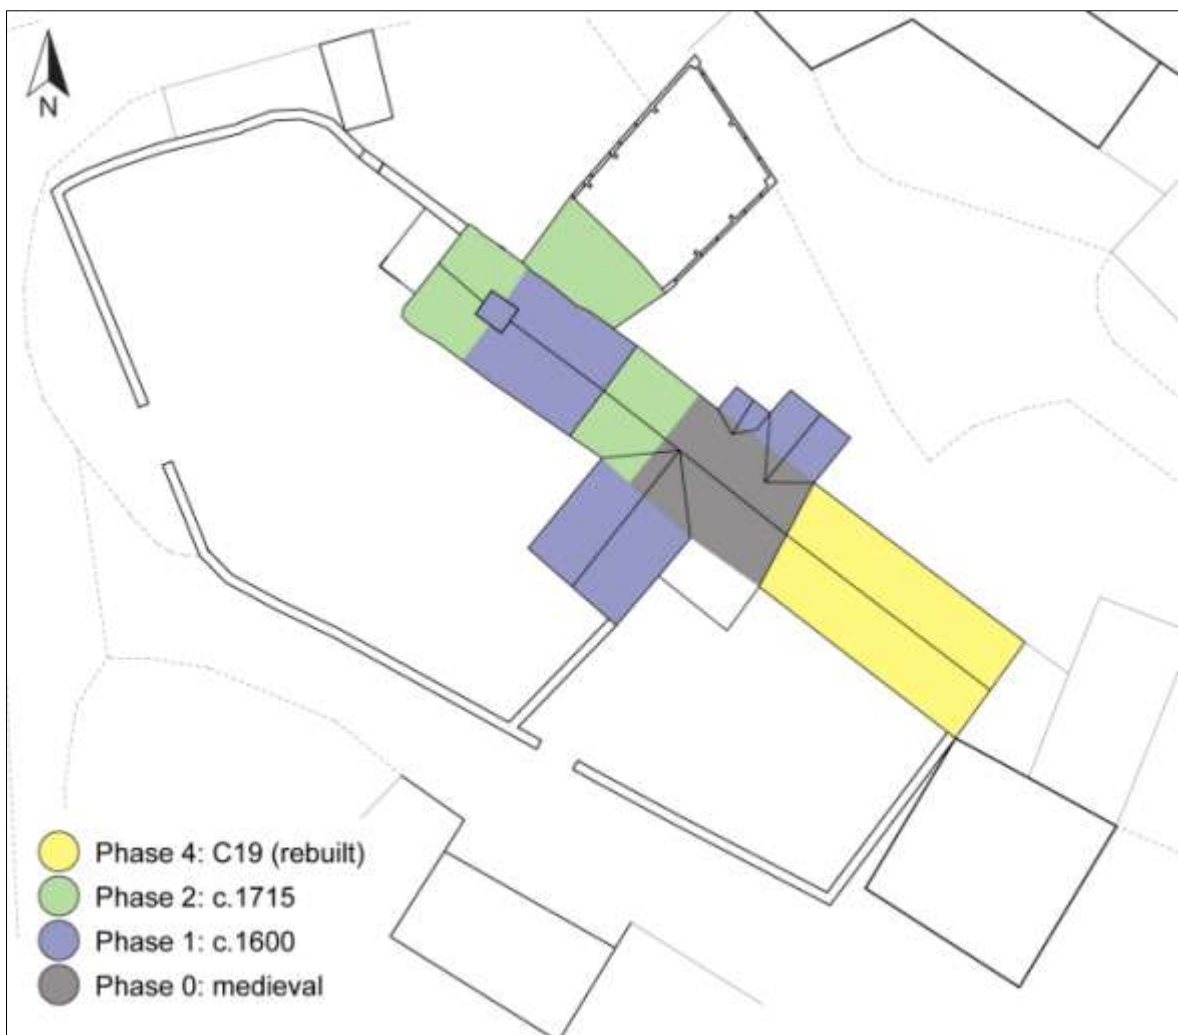
FIGURE 16: OUTLINE PHASING FOR THE FARMHOUSE, BASED ON A RAPID APPRAISAL (BASED ON SUPPLIED DRAWINGS).

Based on initial observations, we would suggest that there is a medieval core (in grey on Figure 14), but much of the medieval structure (in yellow) was derelict in the 19<sup>th</sup> century and was re-roofed between c.1847 and 1886 (note the house across the lane disappears by 1886). During the c.1600 phase of expansion (in blue) a crosswing was added to the south, a porch and lateral stack added to the north, and a (detached) kitchen block added to the west. The c.1715 phase of expansion (in green) added rooms and expanded others to cope with the larger workforce required to work the two farms. This narrative takes little account of the other known structures on the farm (i.e. Lower Sessland, and the house listed in the tithe apportionment across the lane), nor the possible structure in the angle between the Cottage and the crosswing shown on the tithe map. Further, more detailed analysis would be required to elaborate on those relationships.

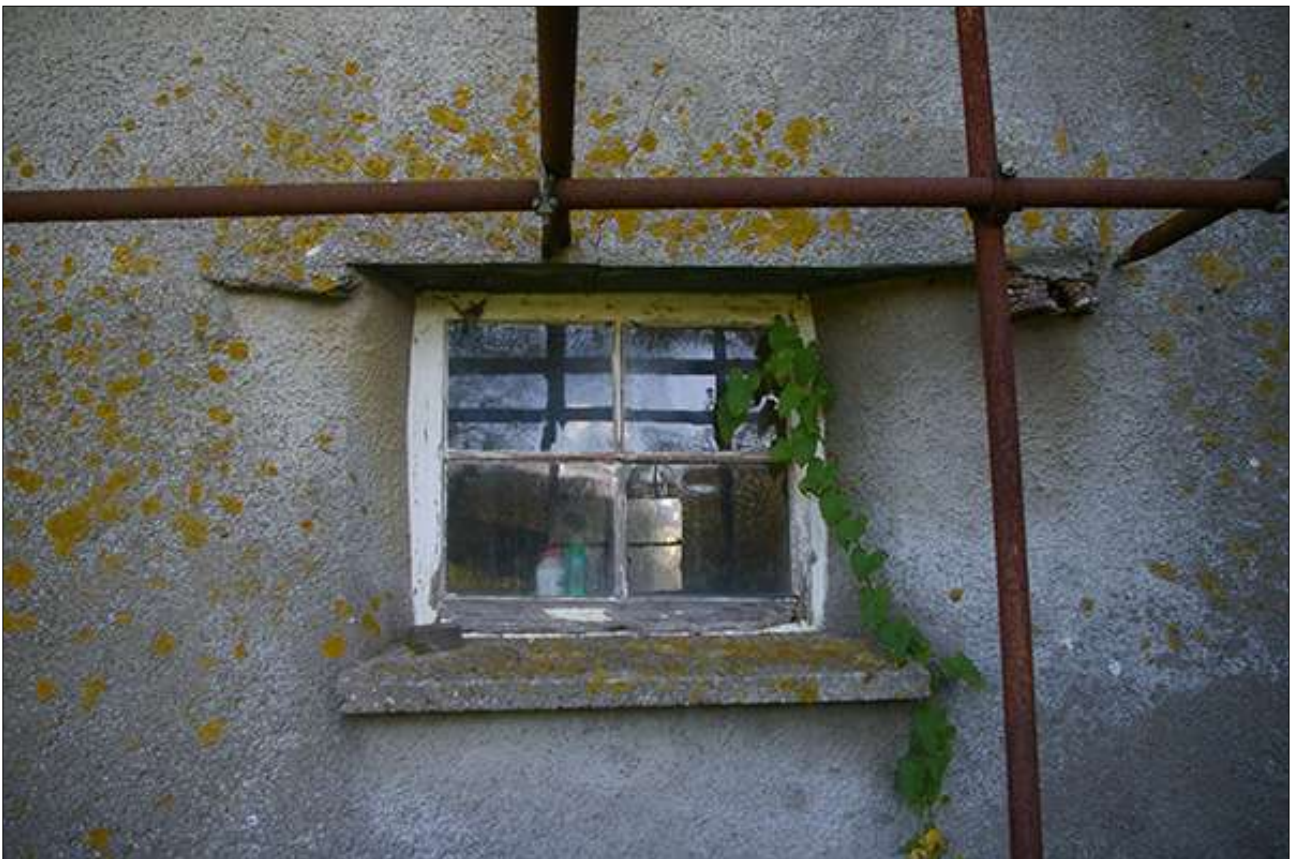
SOUTH-WEST ELEVATION, GF R1 EAST WINDOW, VIEWED FROM THE SOUTH-WEST. NOTE THE PROJECTING BEAM TOP RIGHT.

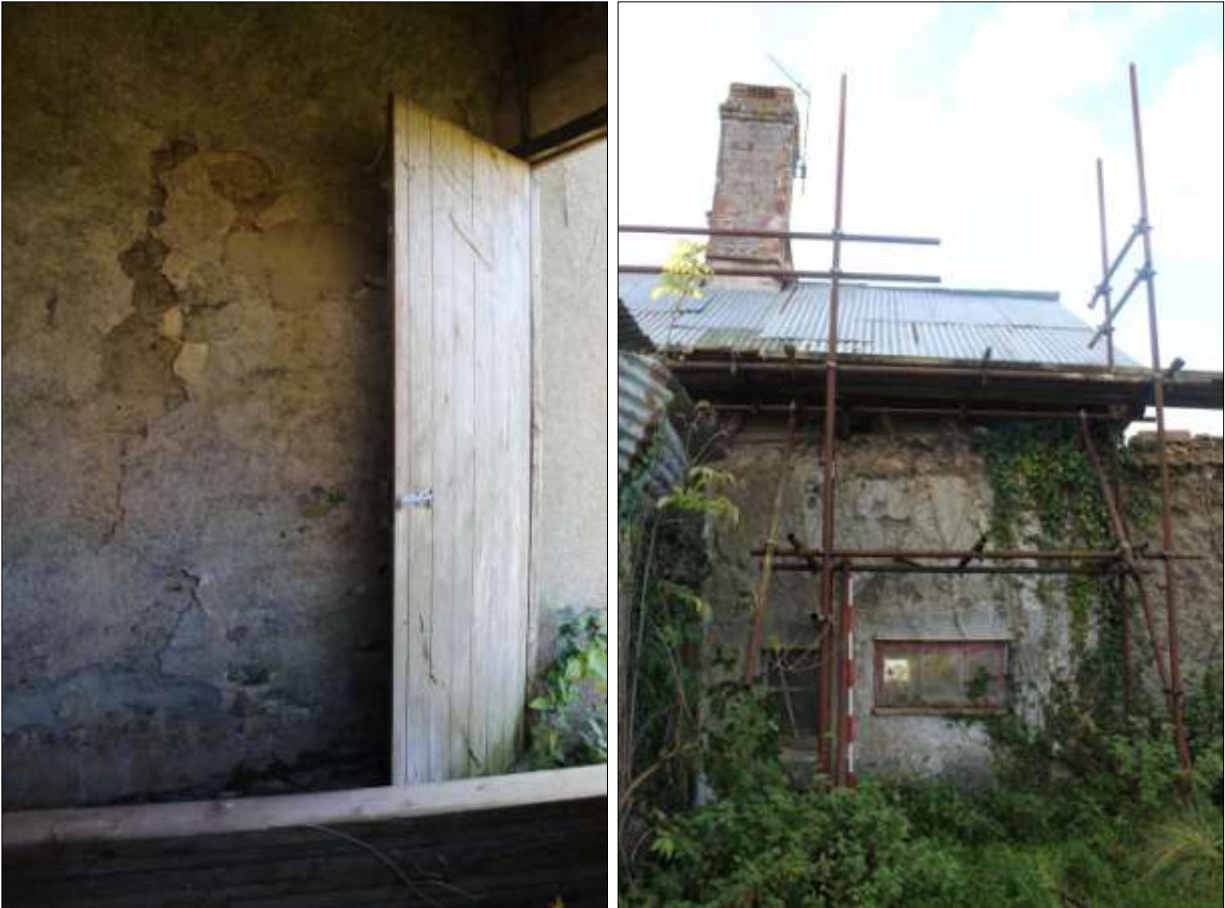
LEFT: INTERIOR OF B6, SHOWING THE BLOCKED OPENING; VIEWED FROM THE WEST.

RIGHT: THE NORTH-EAST ELEVATION, WESTERN END; VIEWED FROM NNE (SCALE 2M).

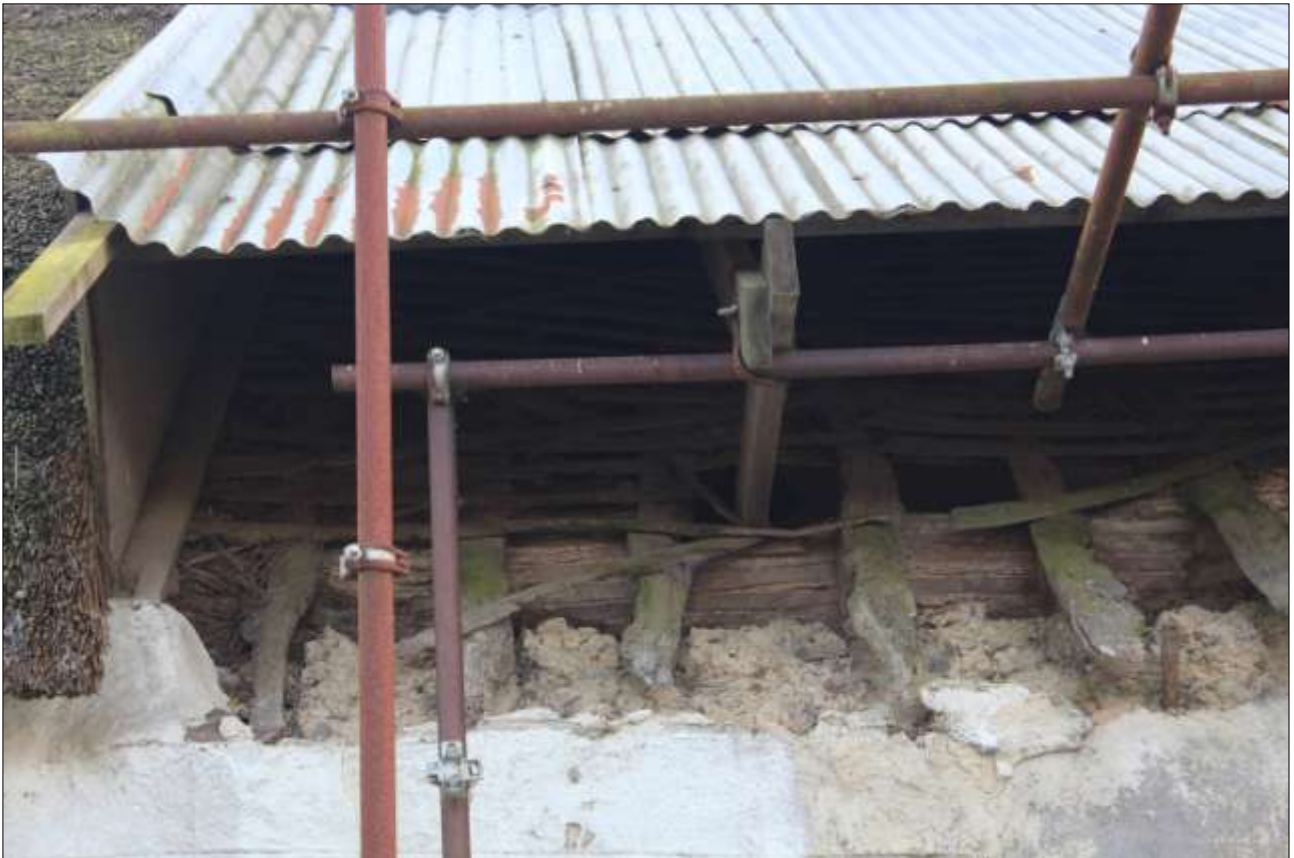
The building is currently protected by scaffolding and a corrugated sheet roof. The historic roof covering was thatch, but it was not maintained and water was allowed to enter the structure. The thatch has now largely been removed, but remnants survive within and between the structural timbers. The ingress on water also caused the timber roof structure to fail, causing it to drop and push the walls out. The exposed roofline scar on the chimney stack indicates the pitch was originally steeper. The roof structure consists of one full truss (T1), set centrally over the main room, with a single truss blade (T2) to the south side of the chimney stack. There are no trusses west of the stack, merely heavy-set purlins, and the purlins rest directly on the east gable wall. The single complete roof truss has been considerably altered and is reset in this position, having been jacked up on crude uprights set in the walls. It has wide, heavy, typically 17<sup>th</sup> century blades with through sockets for purlins. The three surviving truss blades are all of a similar style and form and appear contiguous with the two pairs of heavy scantling on-side butt purlins to each pitch. The quality of these timbers, their form and scantling weight would typically be associated with a much finer roof. In style and date they appear to be contemporary with the stone stack (c.1600). The roof on both sides of the stack features a heavy, roughly-shaped overlapping diamond ridgepole, with wide and irregular split rafters that are pegged above the ridge. The battens are also split laths and pegged to the purlins. The crude and rustic/agricultural character for the rafters is at odds with the surviving truss blades.

VIEW UNDER THE CORRUGATED SHEETING TO THE HISTORIC ROOF STRUCTURE; VIEWED FROM THE NORTH-EAST.

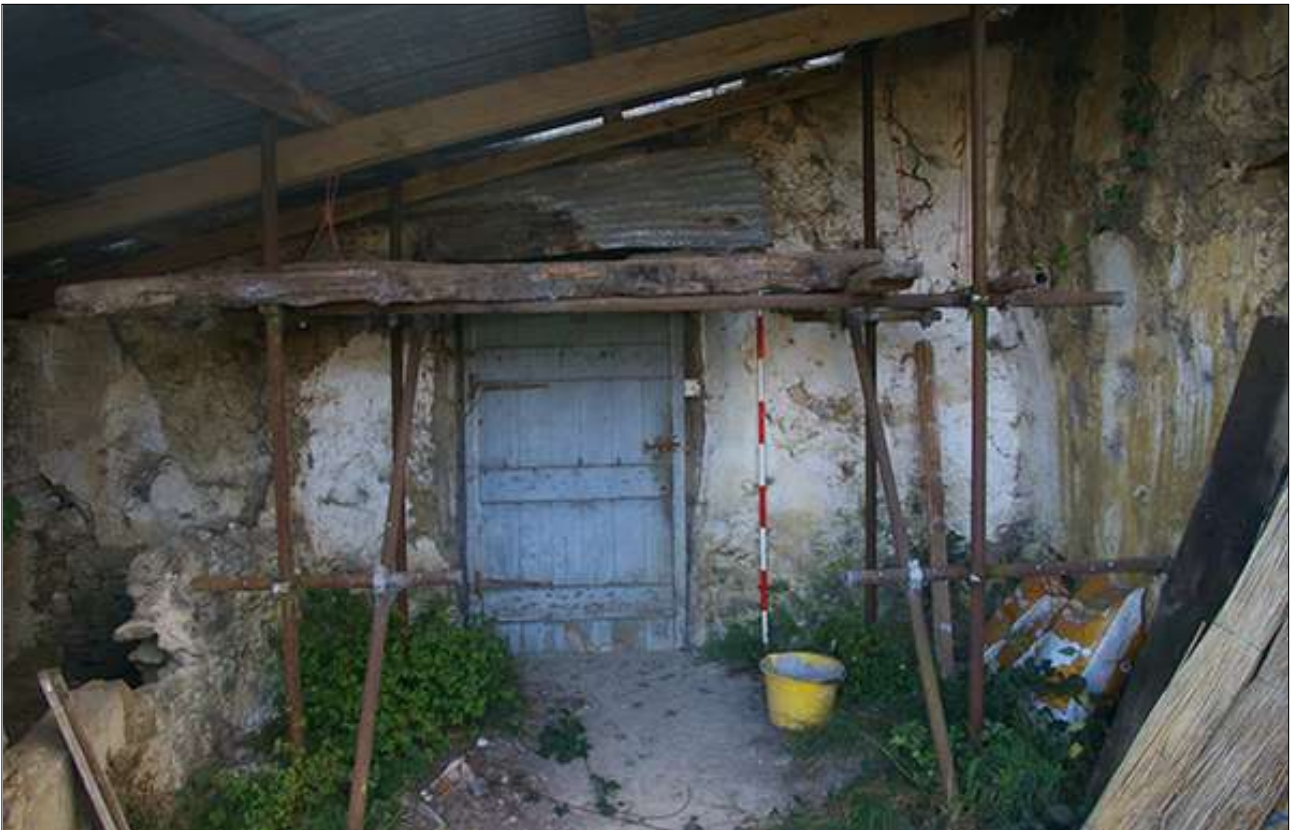
VIEW INTO THE SURVIVING SECTION OF HISTORIC LINHAY ABUTTING THE NORTH-EAST ELEVATION, WITH THE FORCED DOORWAY INTO R1; VIEWED FROM THE NORTH-EAST (SCALE 2M).

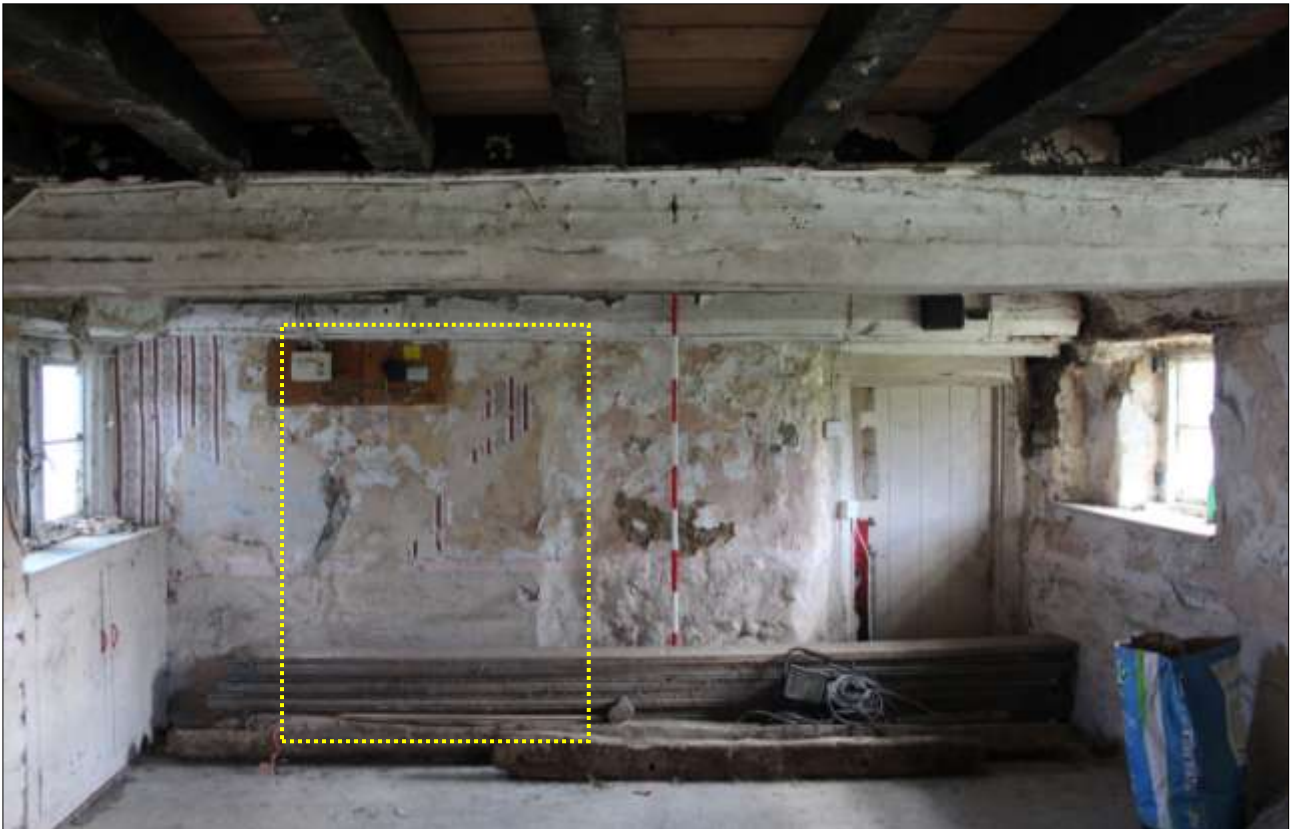
R1, SOUTH-EAST WALL FROM THE NORTH-WEST (SCALE 2M). THE BLOCKED OPENING IS INDICATED.

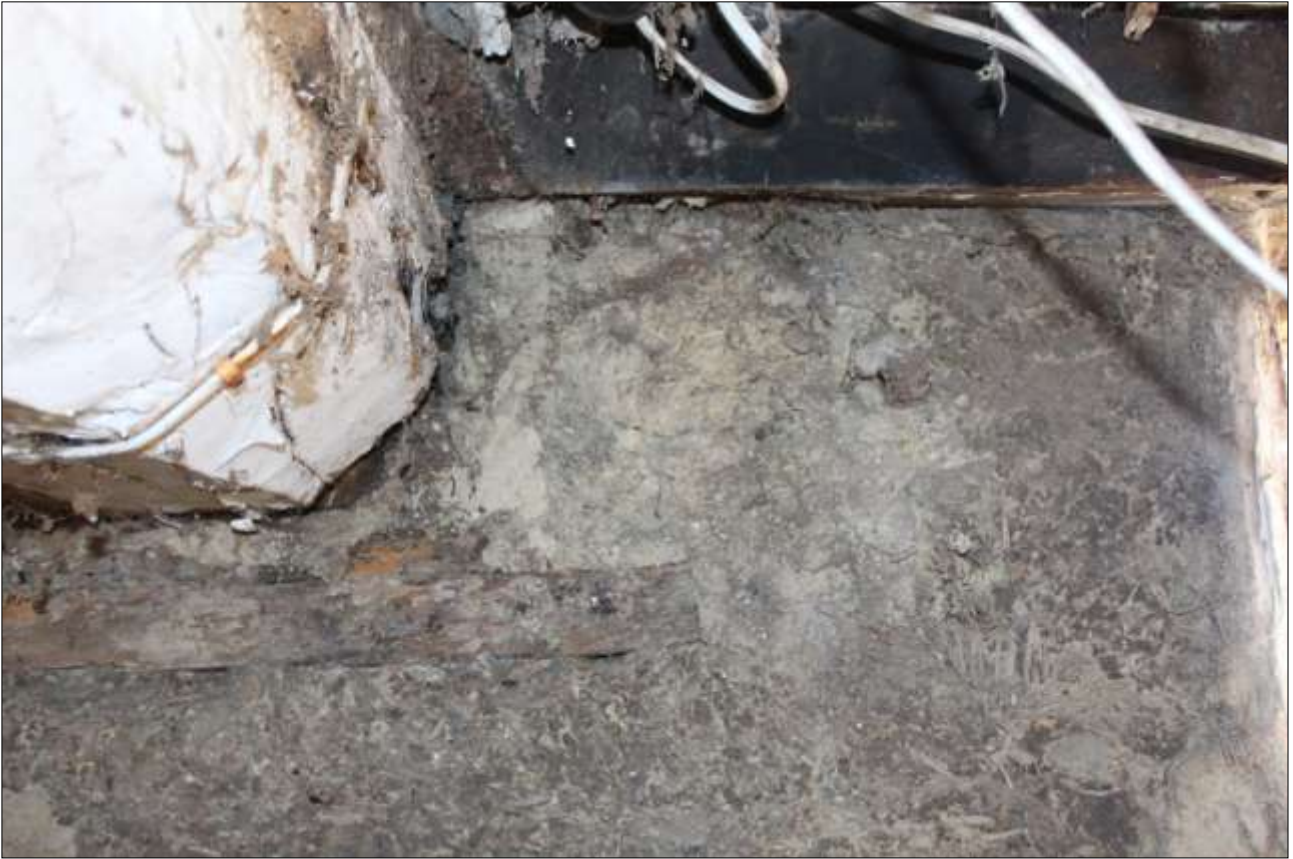
R1, DETAIL OF THE COB WHERE THE CENTRAL BEAM ENTERS THE SOUTH-WEST WALL; VIEWED FROM THE NORTH.

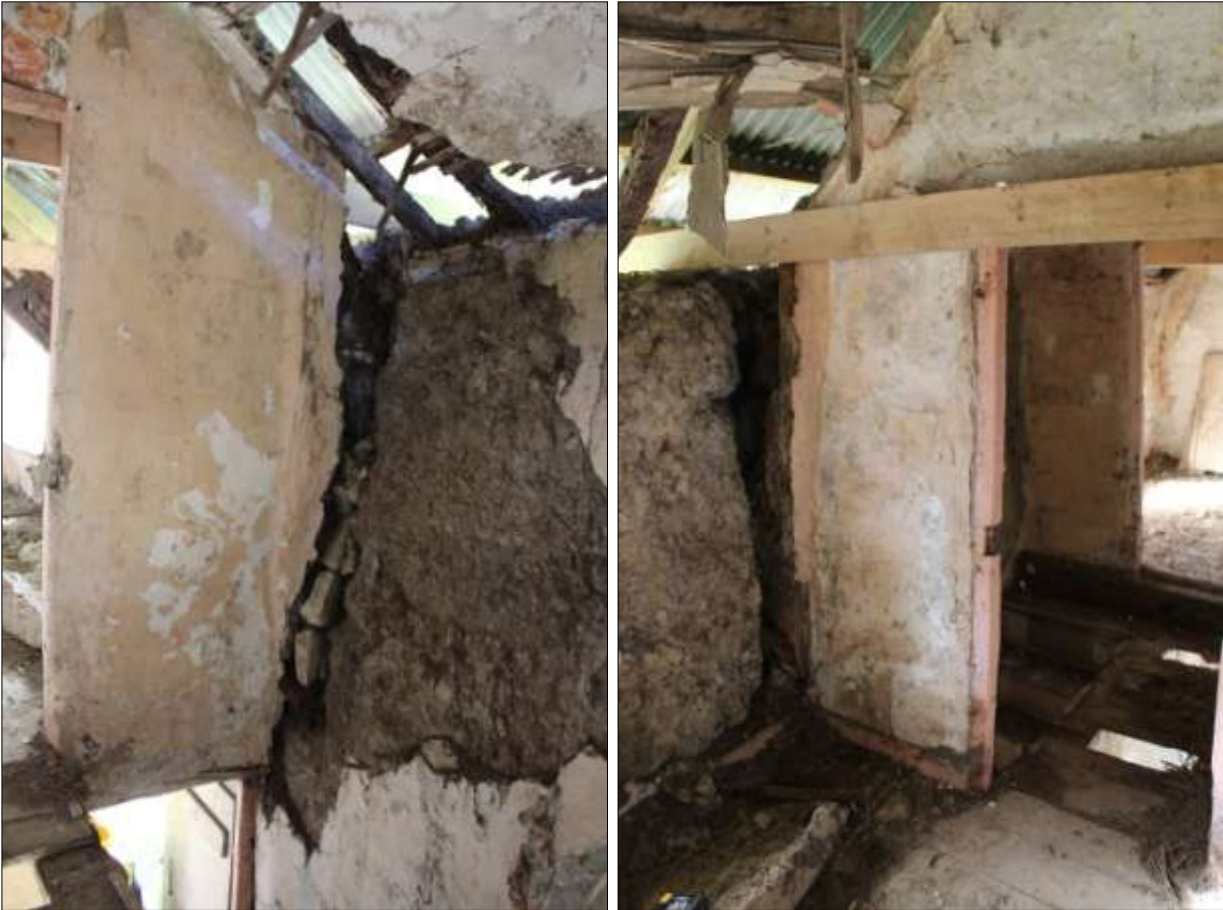
LEFT: THE SOUTH ANGLE OF R3, SHOWING THE EXTERNAL COB WALL FALLING AWAY FROM THE INTERNAL PARTITION; VIEWED FROM THE NORTH.  
RIGHT: THE WEST ANGLE OF R4, SHOWING THE SAME DETAIL; VIEWED FROM THE EAST.

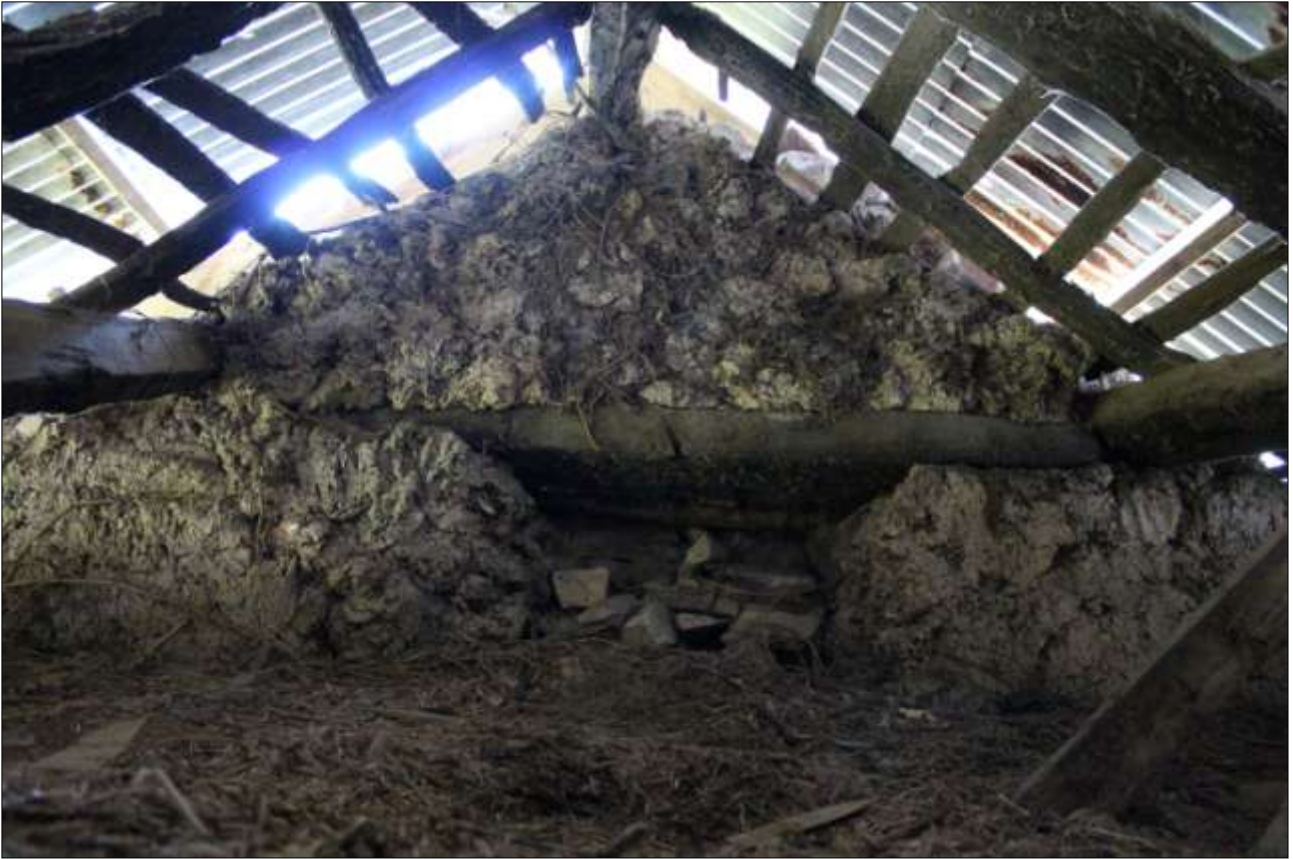
R5, THE BLOCKED SLIT VENT AT THE APEX OF THE NORTH-WEST GABLE; VIEWED FROM THE SOUTH-EAST.
