# THE LOWER DRY CHARLESTOWN St AUSTELL CORNWALL

Results of a Desk-Based Appraisal, Historic Building Assessment &  
Heritage Statement

South West Archaeology Ltd. report no. 170906

By B. Morris  
Report Version: 02  
29<sup>th</sup> September 2017

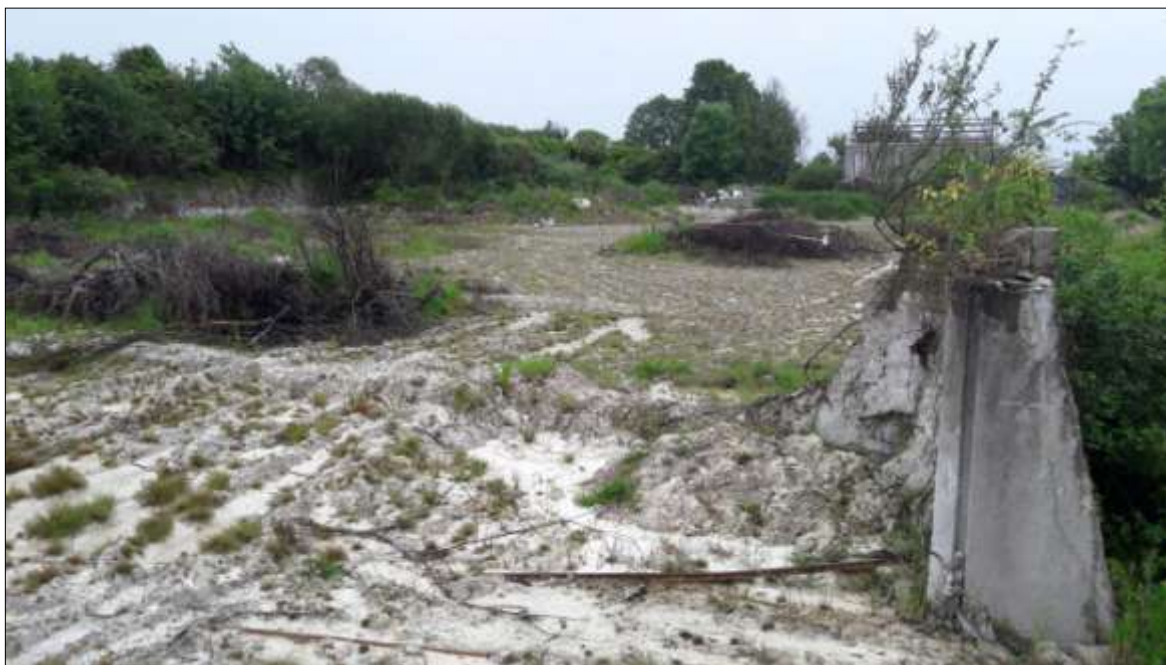
In 1907×08 eight tanks were constructed, covering an area c.115m by c.42m in extent. T1-4 are approximately half the size of T5-8 and it is possible that only 6 tanks were built originally. The tanks are terraced into the hillside by up to 4m, and the base of the tanks slopes gently down to B1. The walls are tremendously strong: at least 1m wide and constructed of poorly-sorted sub-angular granite blocks up to 0.5m across set in concrete with a concrete core. Slatestone is present, but appears to be used only to even up the crude coursing and just below the large flat capstones. The west wall (shared with B1) is battered to the west with projecting granite blocks to carry the wallplate; there are openings at the west end of each tank with grooves for a sluice. The inside faces of the downslope corners are curved for additional strength at a point of weakness. The upslope (east) walls of the tanks are stepped, with a wide walkway c.2m above the base of the tanks. The floor of the tanks appears to have been of concrete set with stone rubble; in T3 the narrow rails of a tramway are visible.

FIGURE 10: THE SETTLING TANKS, VIEWED FROM THE NNW.

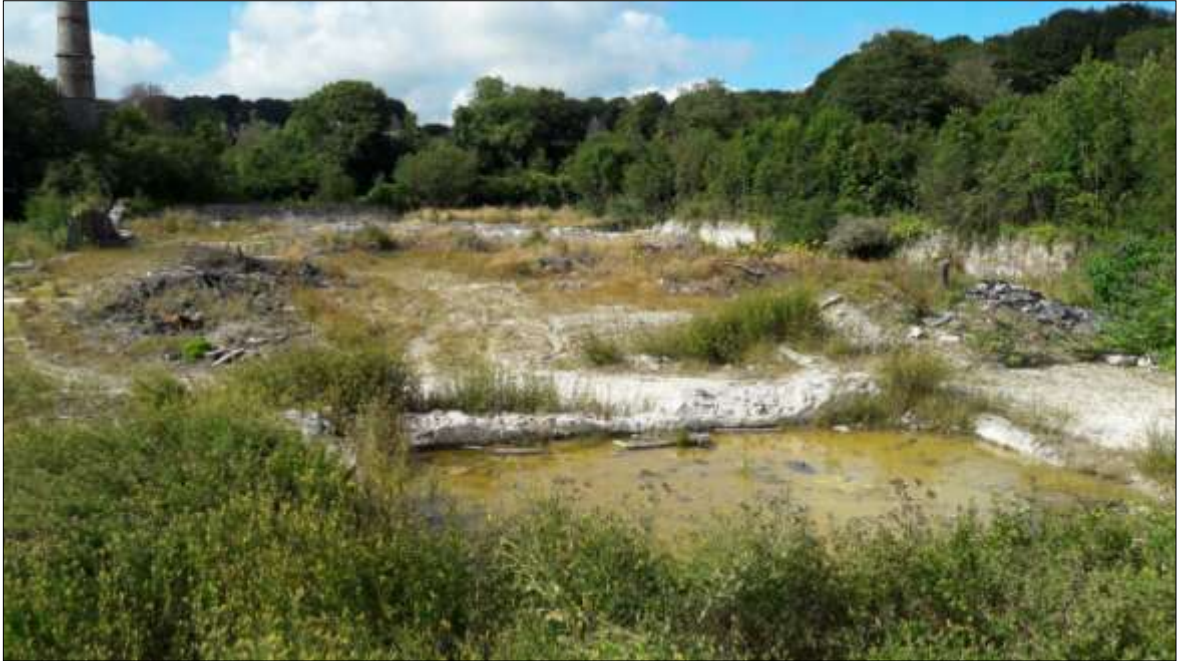
In 1945×55 T1-5 were abandoned and the contents (a deposit of china clay up to 1.2m thick) left *in situ*. It is probable most of the sluices were blocked at this time; pipework and a valve observed next to one of the blocked sluices would suggest the clay slurry was then pumped around the drying floor. T6-8 were maintained, T7 was subdivided by new walls into six smaller tanks with a building. The south wall of T8 was breached and a yard created, with two new buildings (B2 and

B3). These new walls were of concrete block with a concrete core with *ad hoc* steel reinforcing, and appear to be associated with (?partial) resurfacing of the tanks in concrete. The wider walls shown in Figure 3 were clearly used as elevated walkways, as railings of galvanized tubular steel were installed. Next to B3 the south wall of T8 features a line of reused floor tiles from the drying floor, perhaps as a wallplate for the building shown in Figure 5.

FIGURE 11: THE SETTLING TANKS, VIEWED FROM THE SSE.

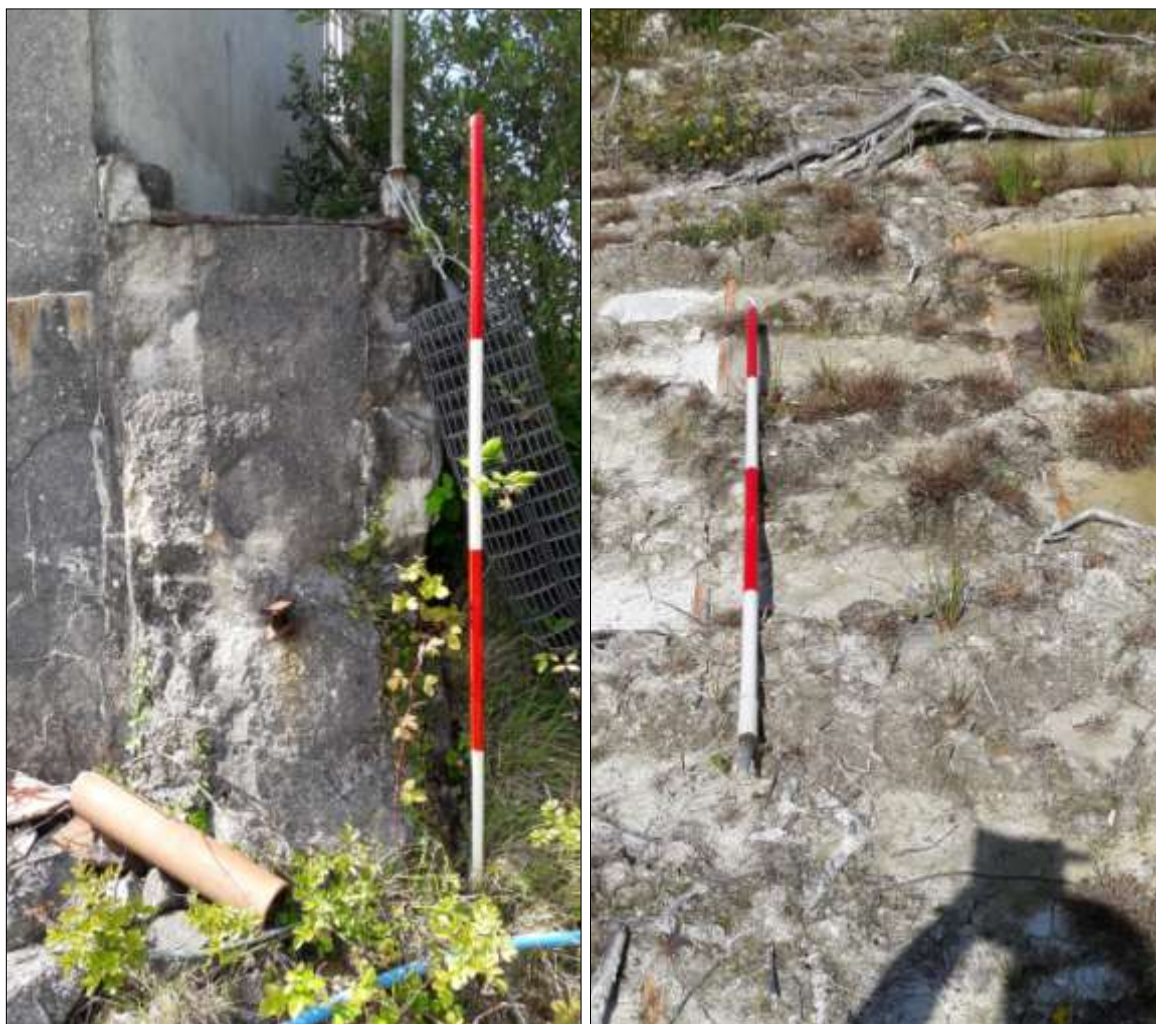
from the tanks, leaving only the eastern half of T1 with *in situ* deposits. The floors of the tanks are visible in places, but it is only in T3 that tram rails were observed. The site is partly vegetated (concealing detail, particularly in the area of the lost structure north of B2) and there has been much fly-tipping across the southern part of the site.

LEFT FIGURE 13: SECTION THROUGH THE 1945×55 TANK WALL ADJACENT TO B2; VIEWED FROM THE SOUTH (SCALE 2M).  
RIGHT FIGURE 14: THE TRAM RAILS IN THE BASE OF T3, VIEWED FROM THE WEST (SCALE 2M).

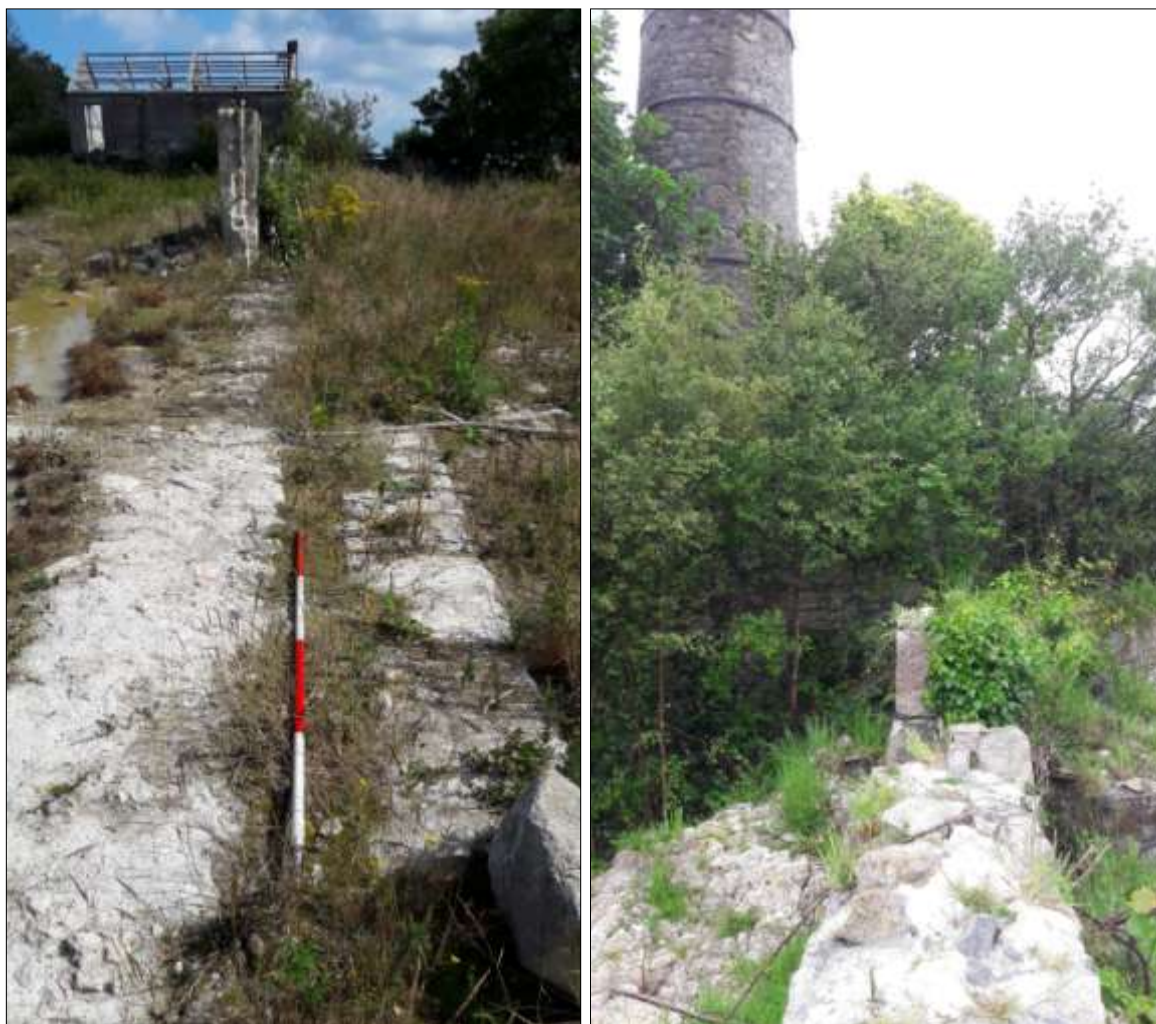
the drying floor was converted for use as a warehouse, it appears that the original floor and brick flues were taken up and a new (concrete?) surface installed c.0.6m below the level of the original floor. This left an elevated walkway capped with flat stones or tiles along the eastern side of the B1, and a wall c.0.6m high between the new floor and the compartments of the linhay.

LEFT FIGURE 16: THE EASTERN EDGE OF THE DRYING FLOOR, SHOWING THE LINE OF ?TILES; VIEWED FROM THE NNW (SCALE 2M).  
RIGHT FIGURE 17: THE BASE OF THE CHIMNEY, VIEWED FROM THE SSE.

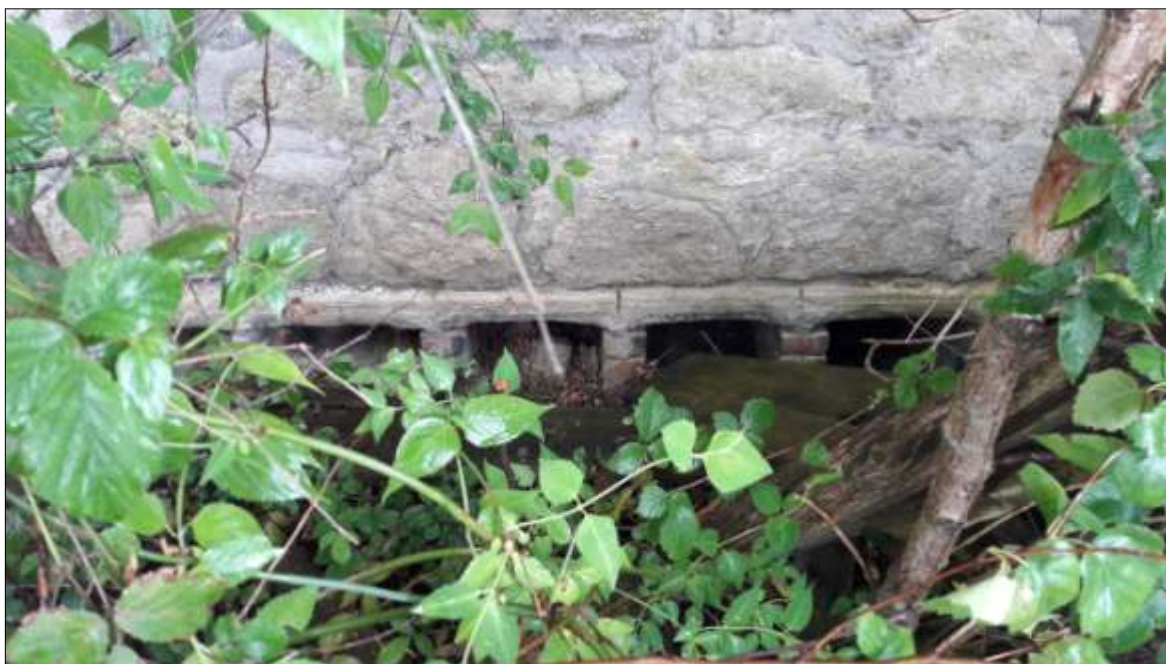
In 1945×55 the external corner of the chimney was walled-in and a building constructed immediately to the west; it is unclear what role these structures played. By 2017 the chimney was observed to be substantially intact, though detail of the flues and gable wall of B1 were heavily obscured by dumped china clay and vegetation. The northern side of the structure was not inspected as it is located on private land.

FIGURE 18: THE FLUES ENTERING THE BASE OF THE CHIMNEY, VIEWED FROM THE SSE.

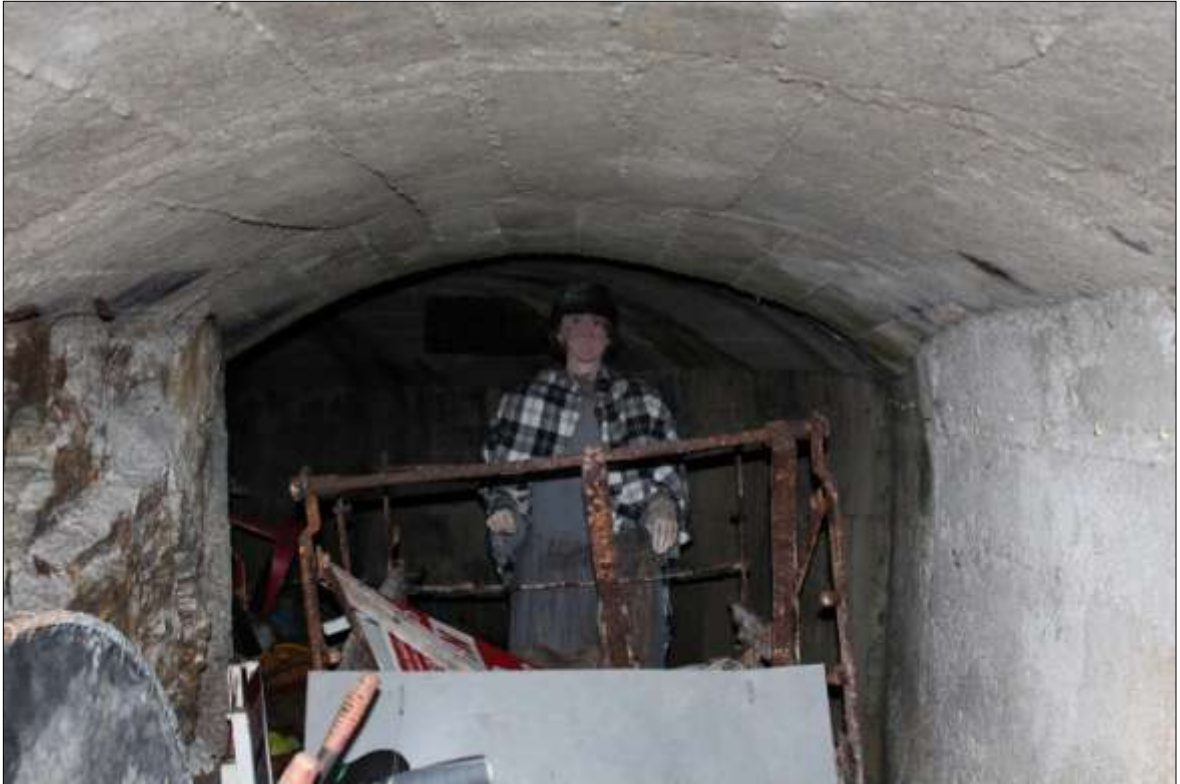
The tunnel was not observed on the site, but the accessible sections at the Heritage Centre were inspected. In the Heritage Centre it was c.1.4m wide and c.1.6m high, with a shallow arch and walls of shuttered concrete. The tunnel from the linhay enters the Heritage Centre at ground level from the north-east and terminates at a weighbridge. A hatch in the floor delivers to the clay to a tunnel below that leads to the harbour wall just below the level of the road. This lower tunnel also features shuttered concrete walls, but the lower section has a low arched roof of mortared

stone and rock-cut or mortared stone walls. It is clear these lower tunnels have been subject to some alteration, with patching and blocking in concrete block.

FIGURE 22: THE TUNNEL BELOW THE WEIGHBRIDGE IN THE HERITAGE CENTRE; VIEWED FROM THE SOUTH-WEST.

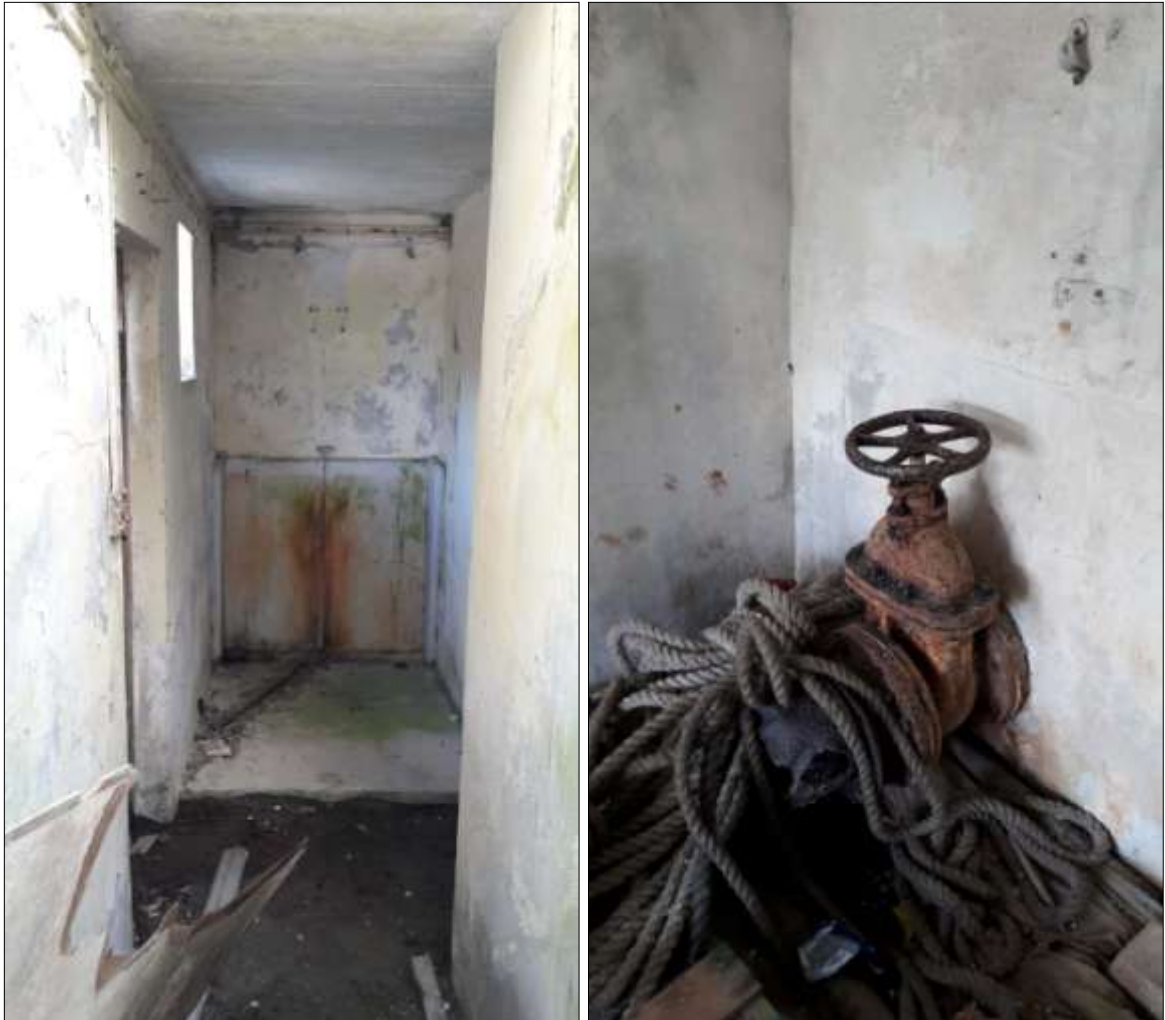
Almost all the fixtures and fittings have now been lost, including the stairs. Doorways have been forced through to the pump house on both the ground and first floor. Only the urinal, front door and window casements survive *in situ*, and the building is partly filled with rubbish.

LEFT FIGURE 26: THE URINAL IN THE STAFF WELFARE, VIEWED FROM THE ENE.

RIGHT FIGURE 27: THE SURVIVING VALVE IN THE PUMP HOUSE, VIEWED FROM THE SOUTH-EAST.

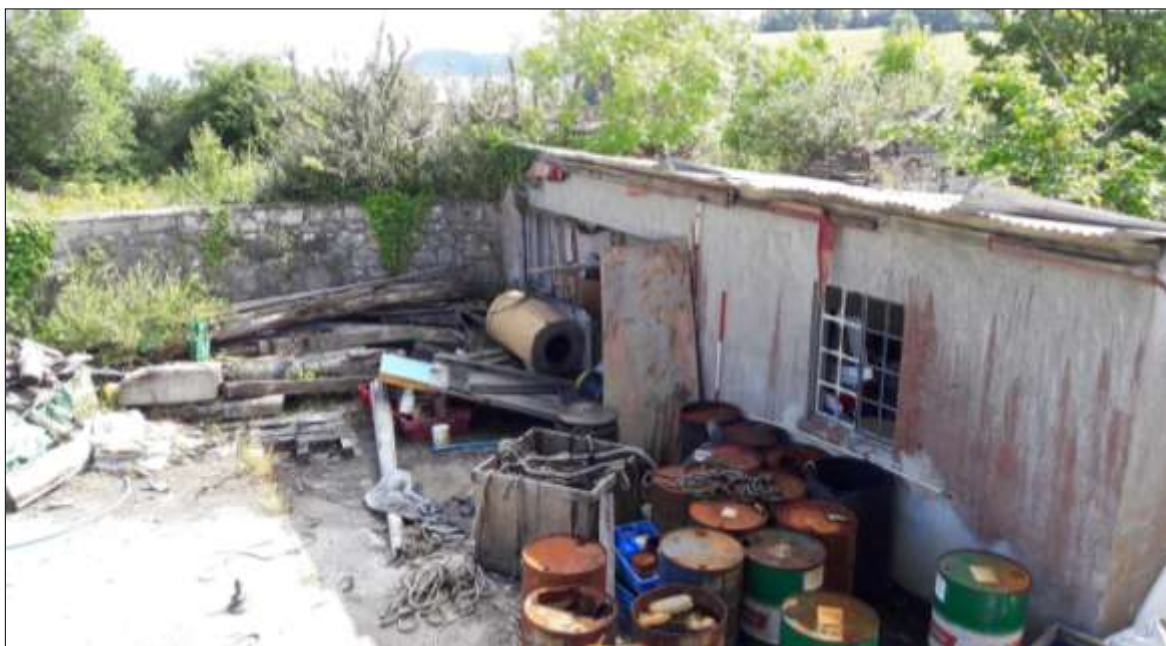
The wide garage opening was subsequently partly blocked in narrow (4") concrete block with a timber three-light window above; the remaining opening features a set of wooden garage doors (now fallen). The wall dividing the two rooms has since been partly demolished, and only the uprights for the benches survive. The roof has been replaced with corrugated iron sheets.

FIGURE 30: B3, VIEWED FROM THE NORTH (SCALE 2M).

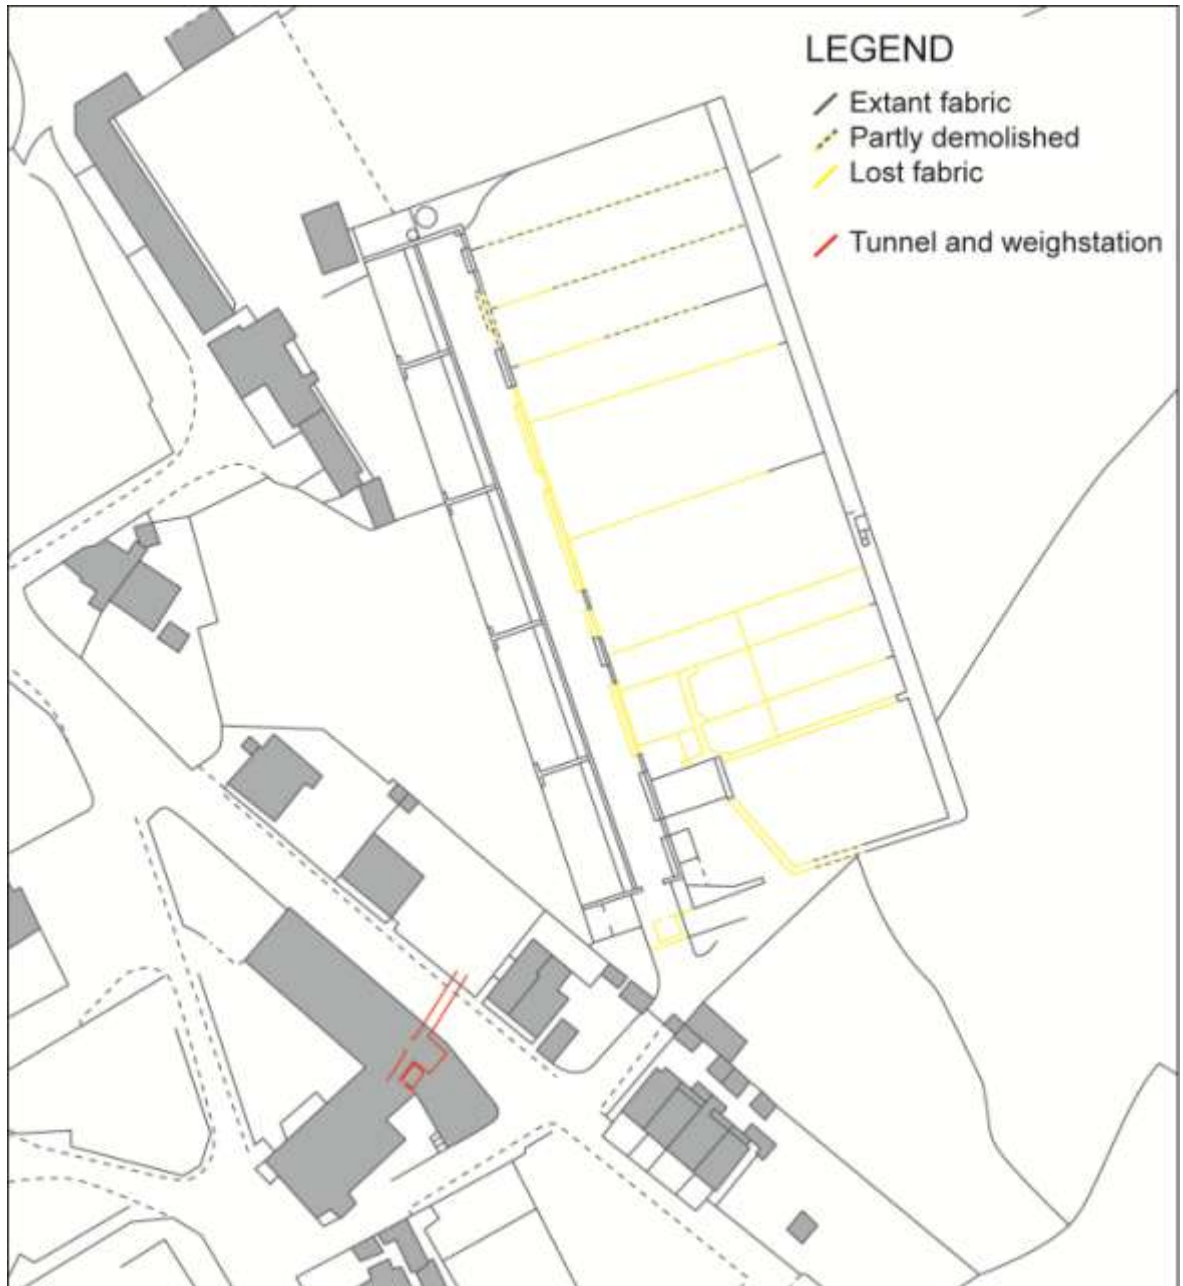
In terms of the significance of the physical structure itself, it is only the tunnel that sets this clay dry apart from contemporary examples. Physically, approximately 60% of the original internal tank walls, and 90% of the 1950s walls, have been lost, as has 50% of the wall dividing the tanks from B1. The roof structure of B1 has been lost, as has the asbestos roof covering from B2 along with most of the internal fittings and fitments (see Figure 33).

FIGURE 31: SKETCH PLAN SHOWING THE SURVIVAL OF HISTORIC FABRIC.

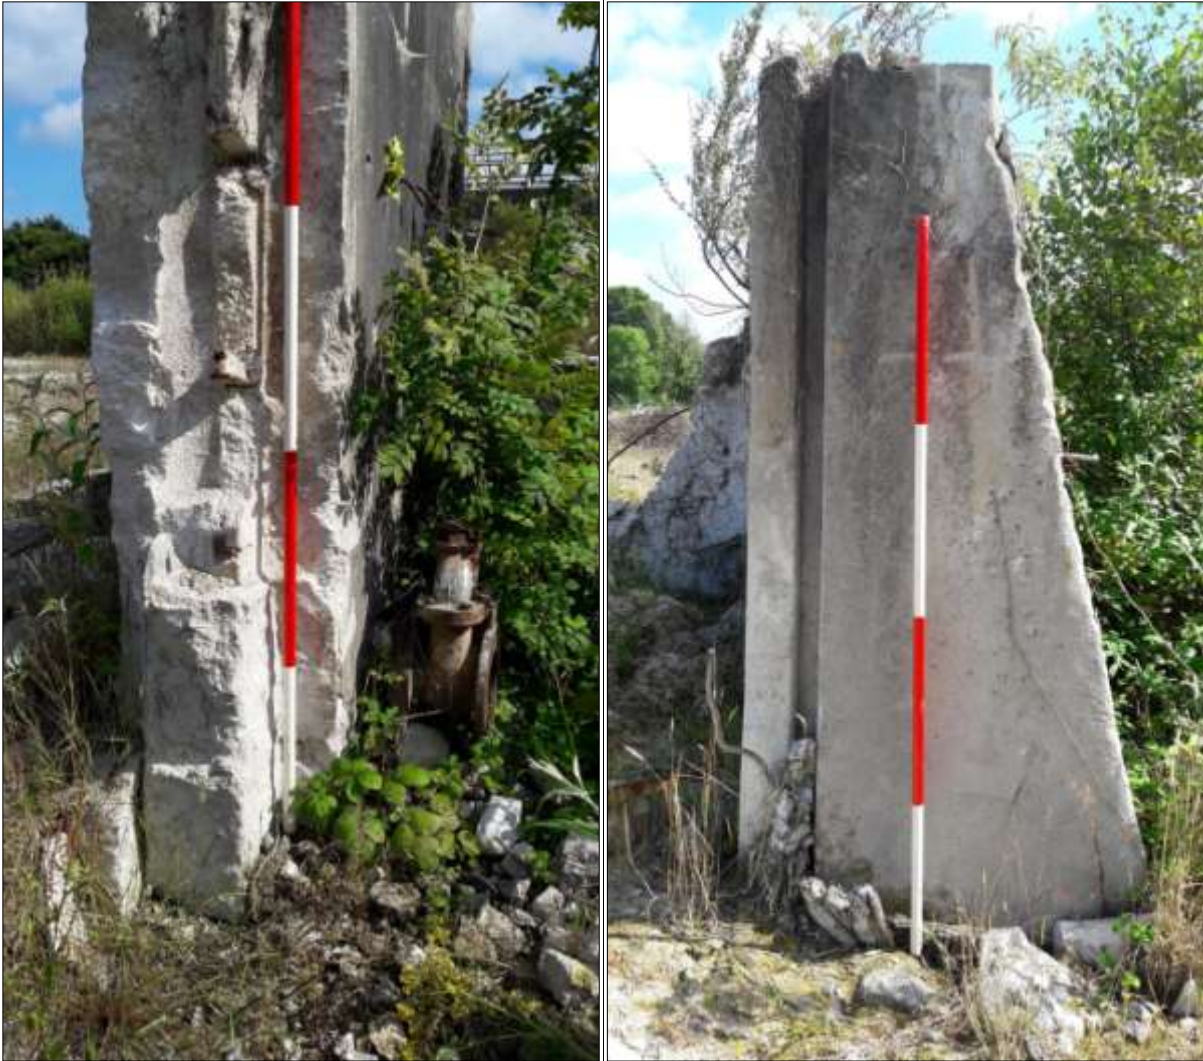
LEFT: Surviving section of the west wall – one of the blocked sluice gates; viewed from the north (scale 2m). Note the iron pipework and valve, similar to the one in the pump house.

RIGHT: Surviving section of the west wall – one of the original sluice gates; viewed from the north (scale 2m).

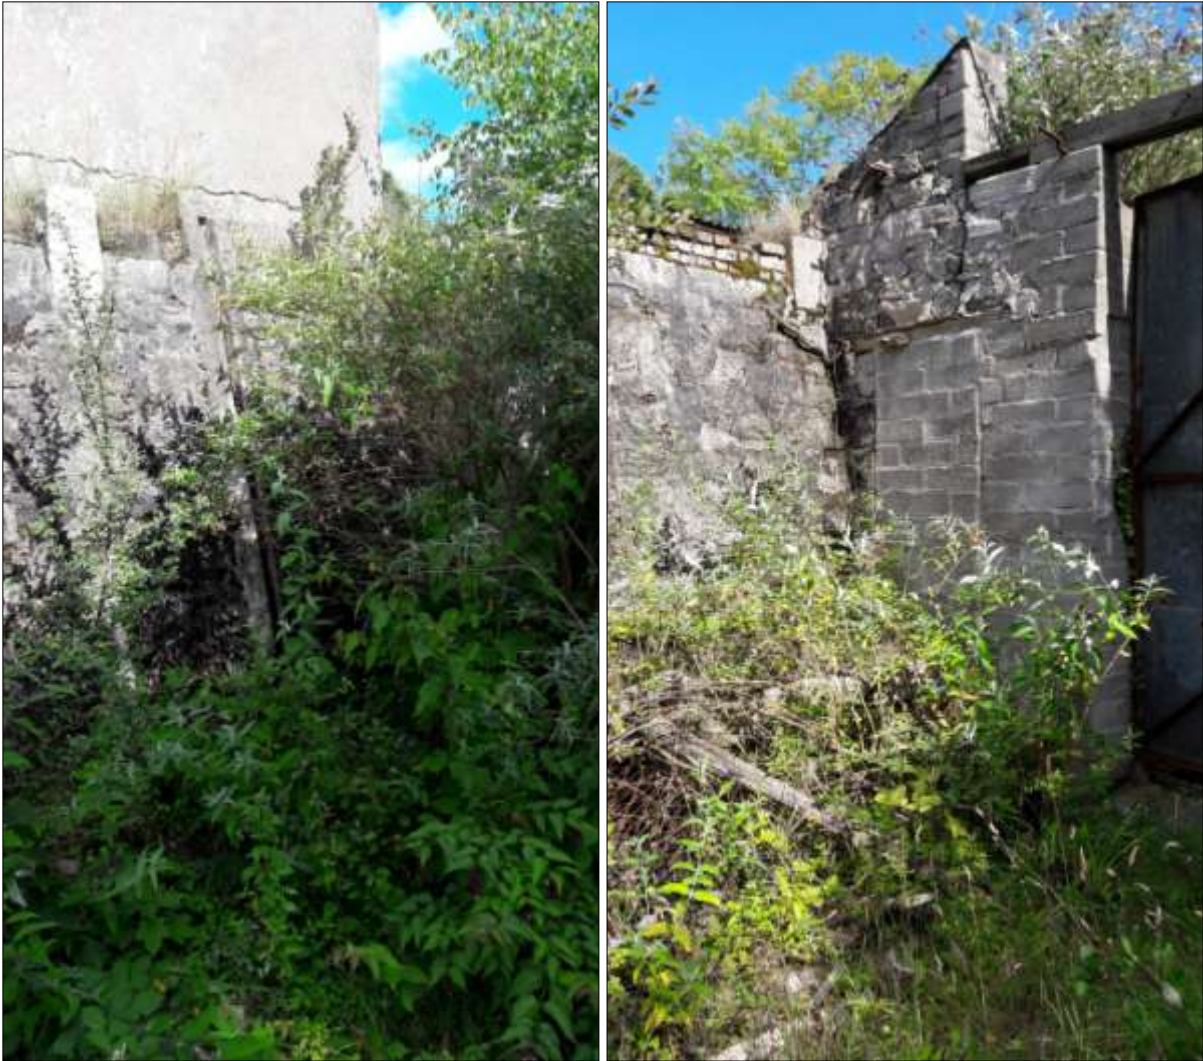
LEFT: The west wall of T7 below B2, showing a concrete gully running down the battered surface of the wall; viewed from the north-west.

RIGHT: The south wall of the drying floor, showing the concrete reveals of the double steel doors and the blocked doorway above; viewed from the north-west. Note the use of brick (probably from the flues) on the wall top.

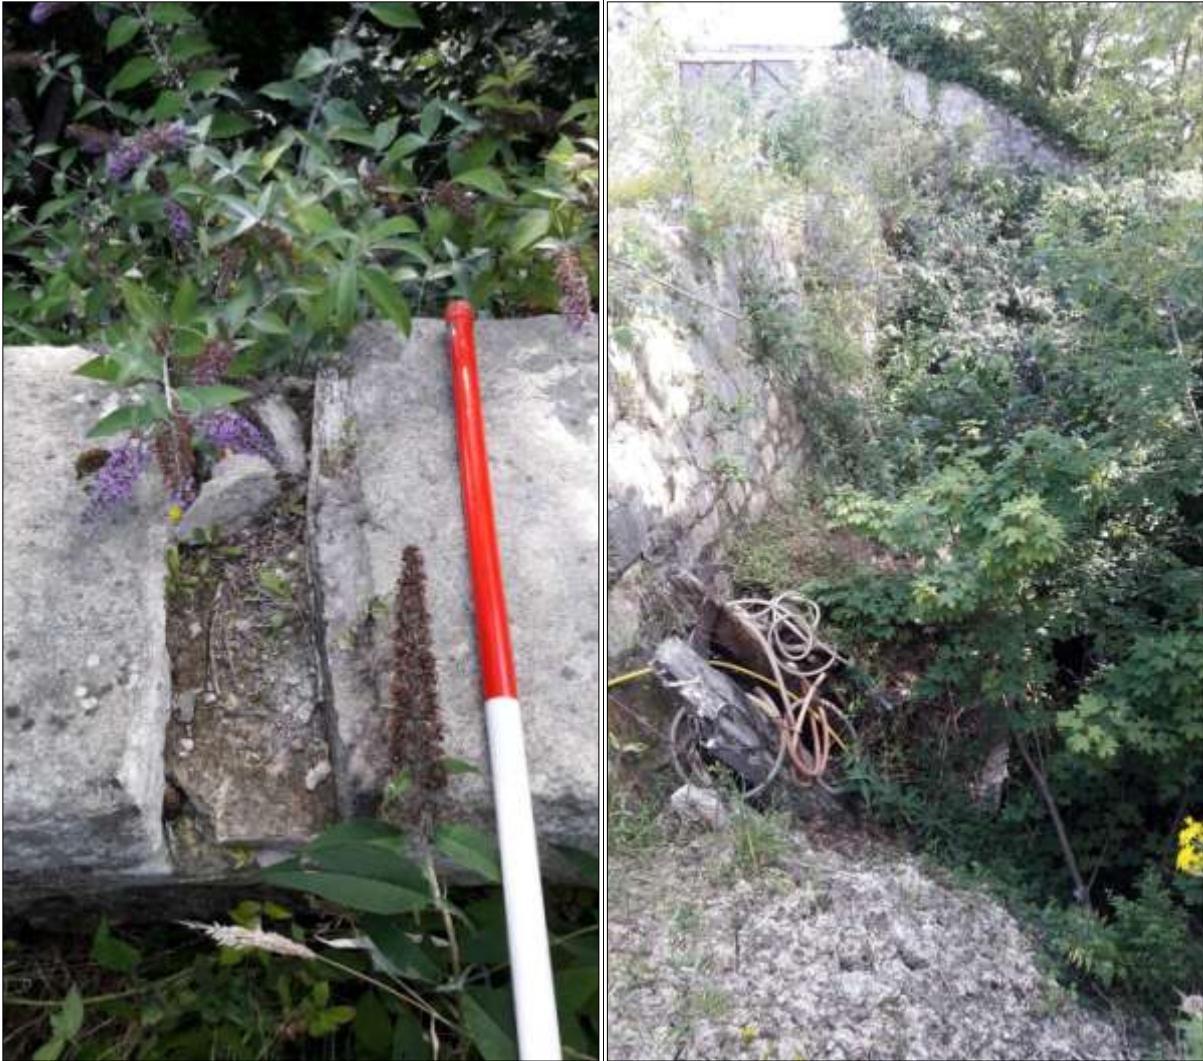
LEFT: A groove cut in the wall separating the drying floor and the linhay, corresponding to the concrete gully below B2 (above).

RIGHT: The east wall of the linhay in C5, viewed from the north.

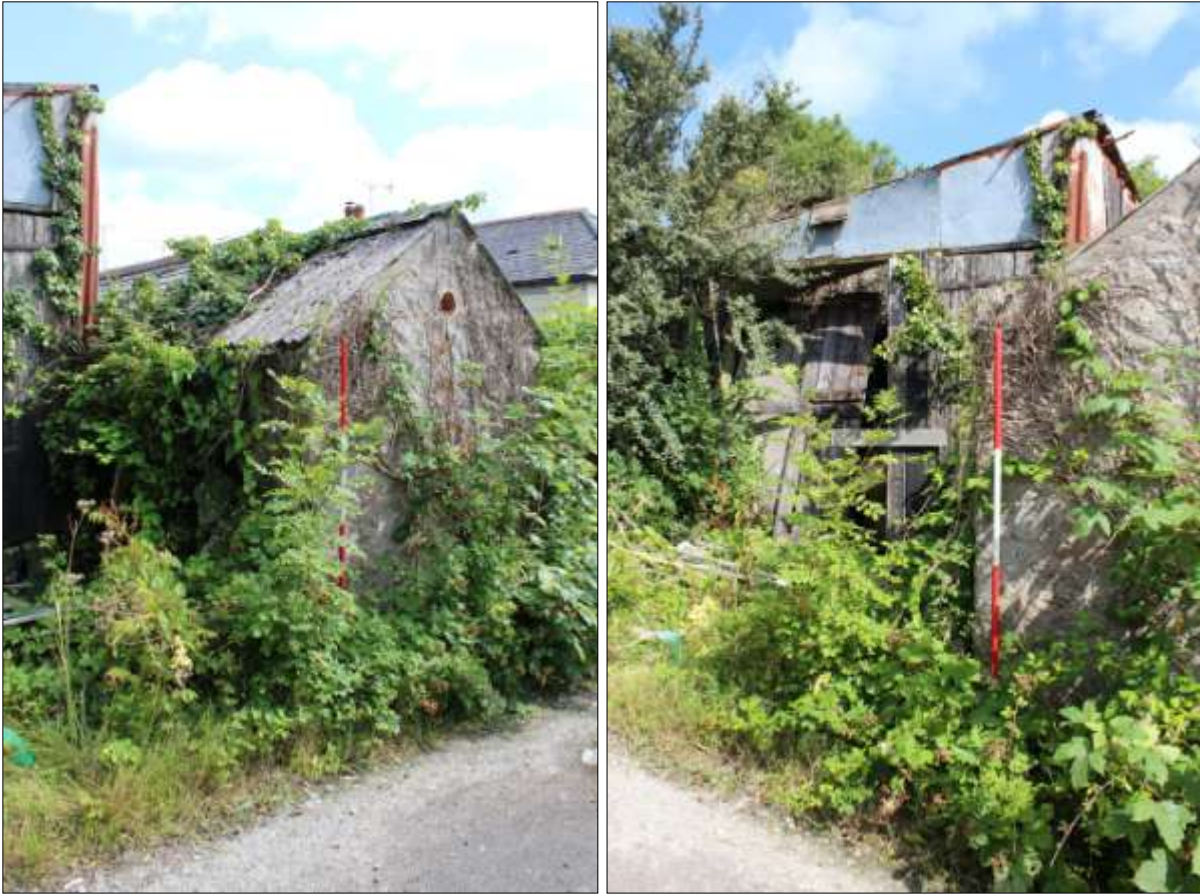
LEFT: The possible privy (separately owned), just inside the site entrance; viewed from the north-east (scale 2m).  
RIGHT: The collapsed mono-pitch shed adjacent (separately owned); viewed from the west (scale 2m).
