**YOUNGCOTT BARN
MILTON ABBOT
WEST DEVON
DEVON**

Historic Building Recording

South West Archaeology Ltd. report no. 170913

By N. Boyd & E. Wapshott
Report Version FINAL
13th September 2017

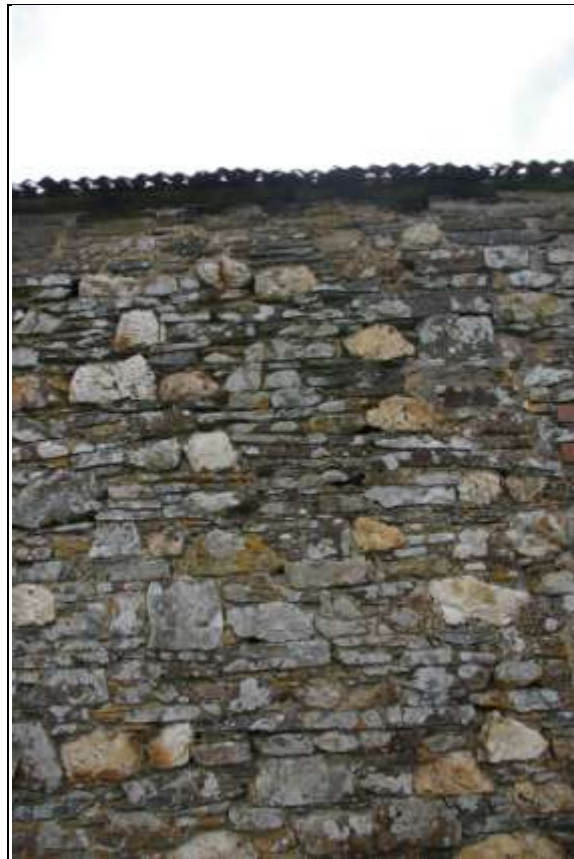
Area of disturbed slatestone which may indicate a blocked air vent in the west elevation of Barn 2; from the west.

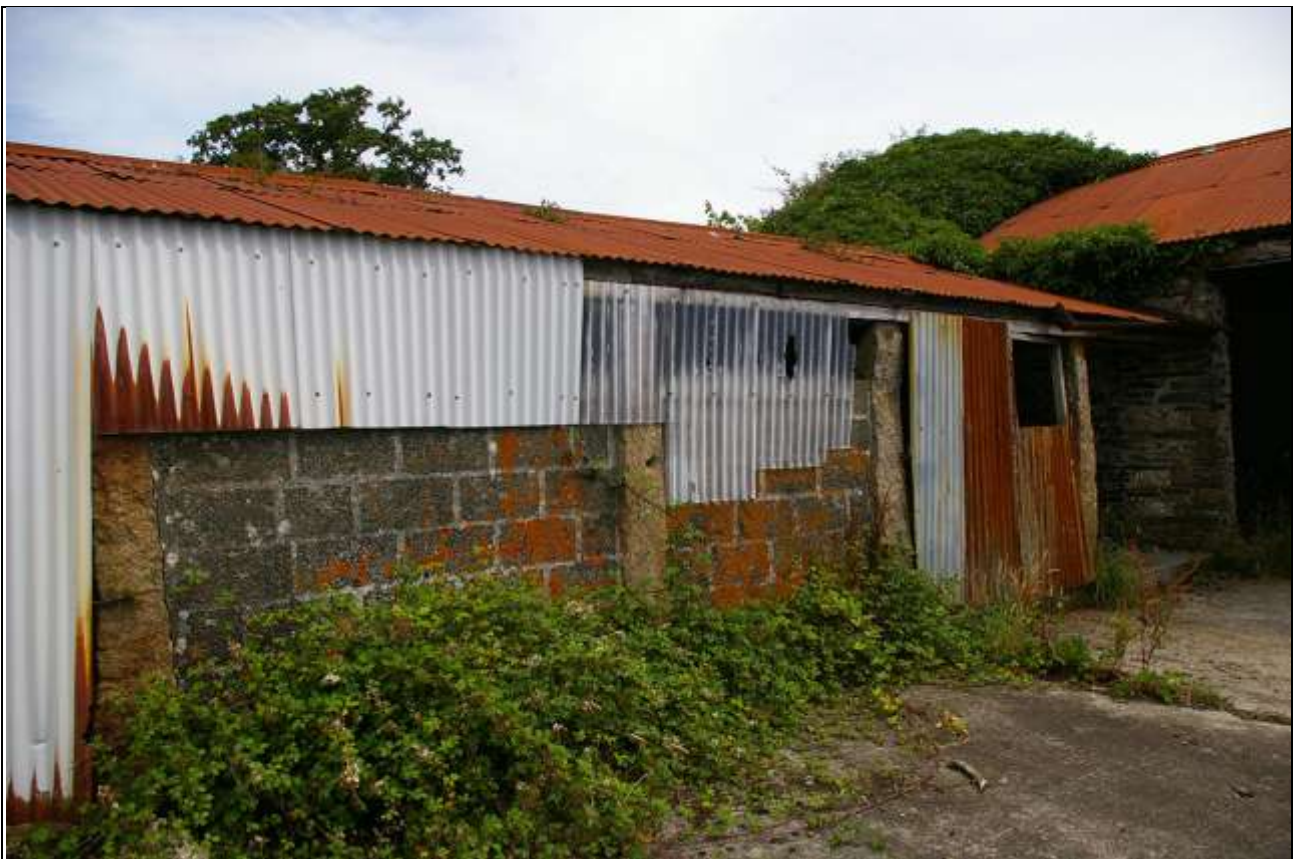
The south open-front of Barn 3, infilled with corrugated sheeting and concrete blocks; from the west-south-west.

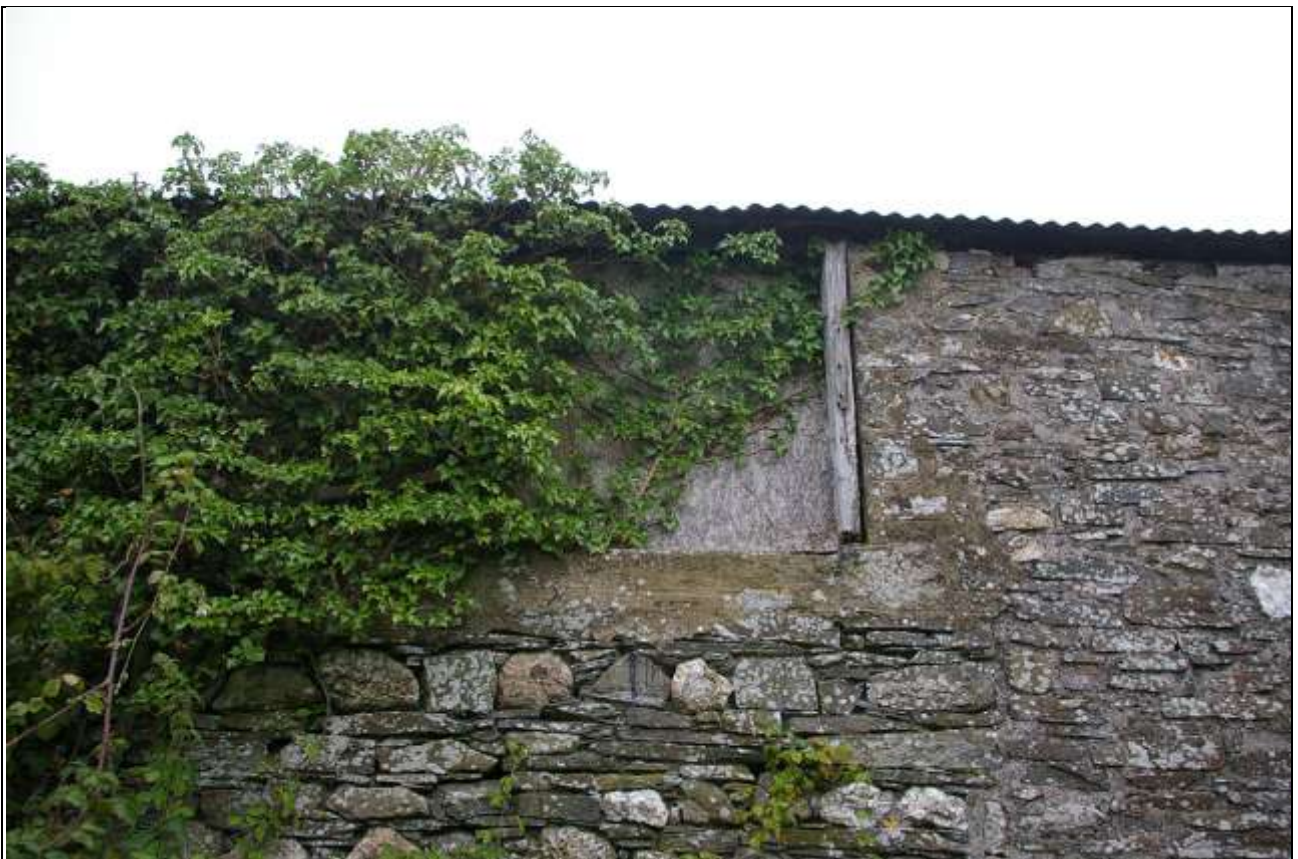
The forced loading door opening in the east elevation of Barn 2; from the east.

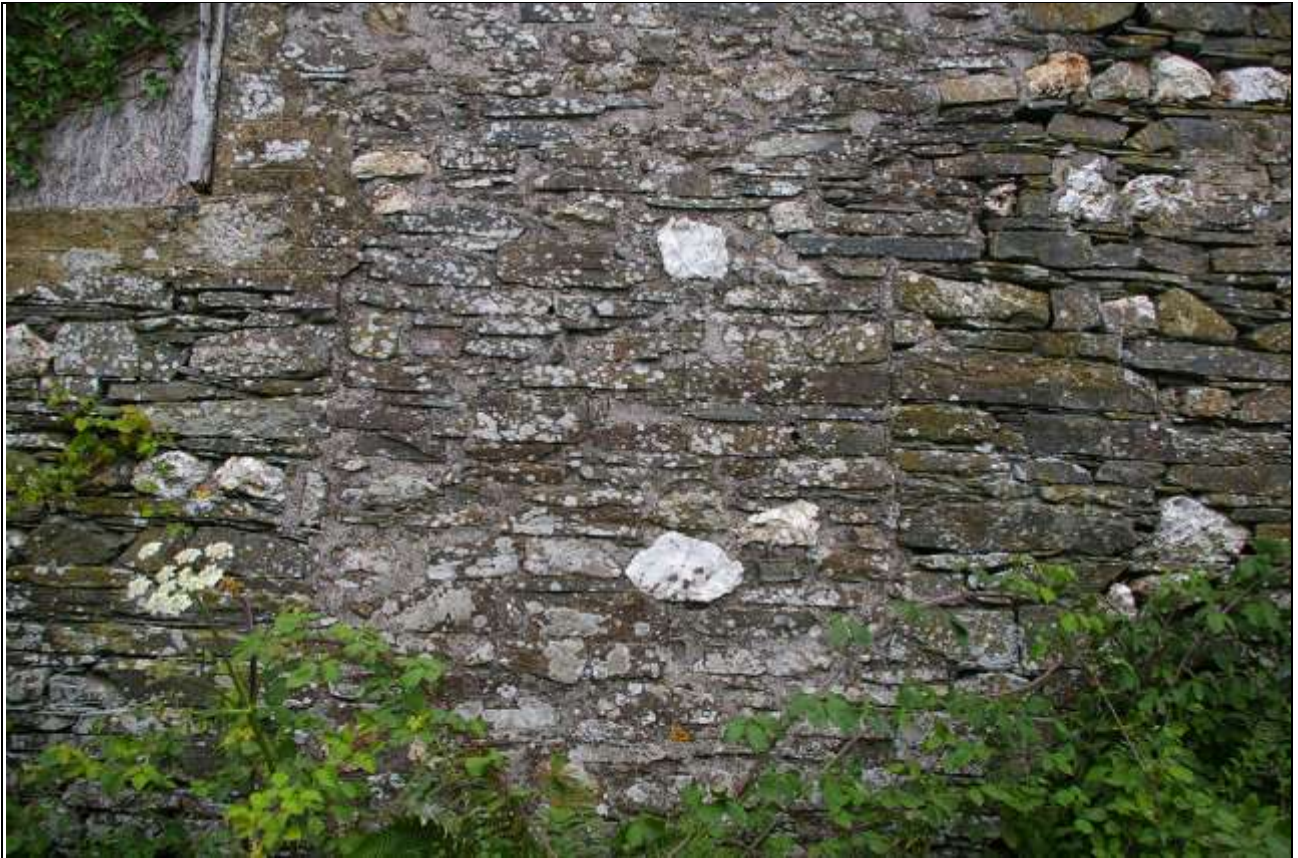
The blocked doorway in the east elevation of Barn 2; from the east.

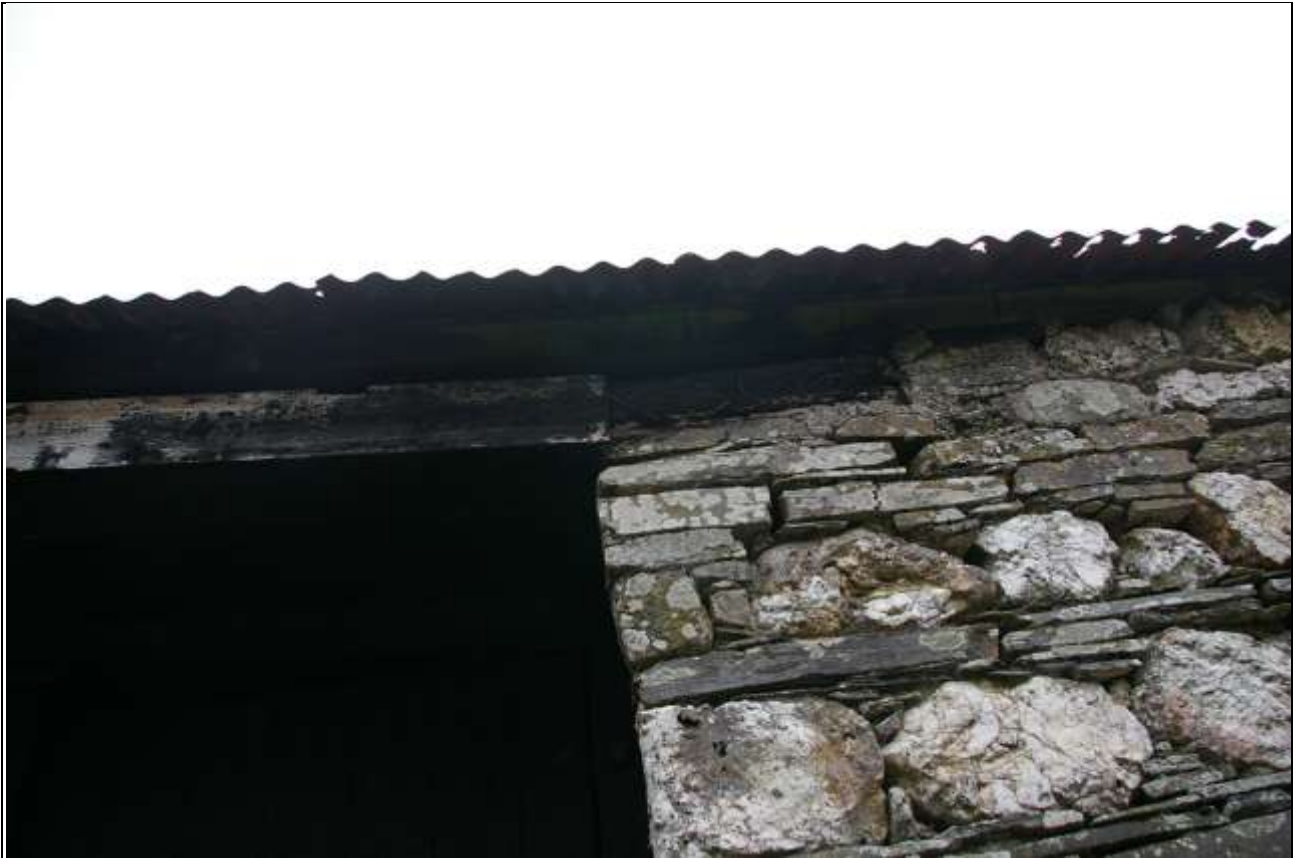
The heavy timber lintel over the opening in the east wall of Barn 1, with possible charring; from the east-south-east.

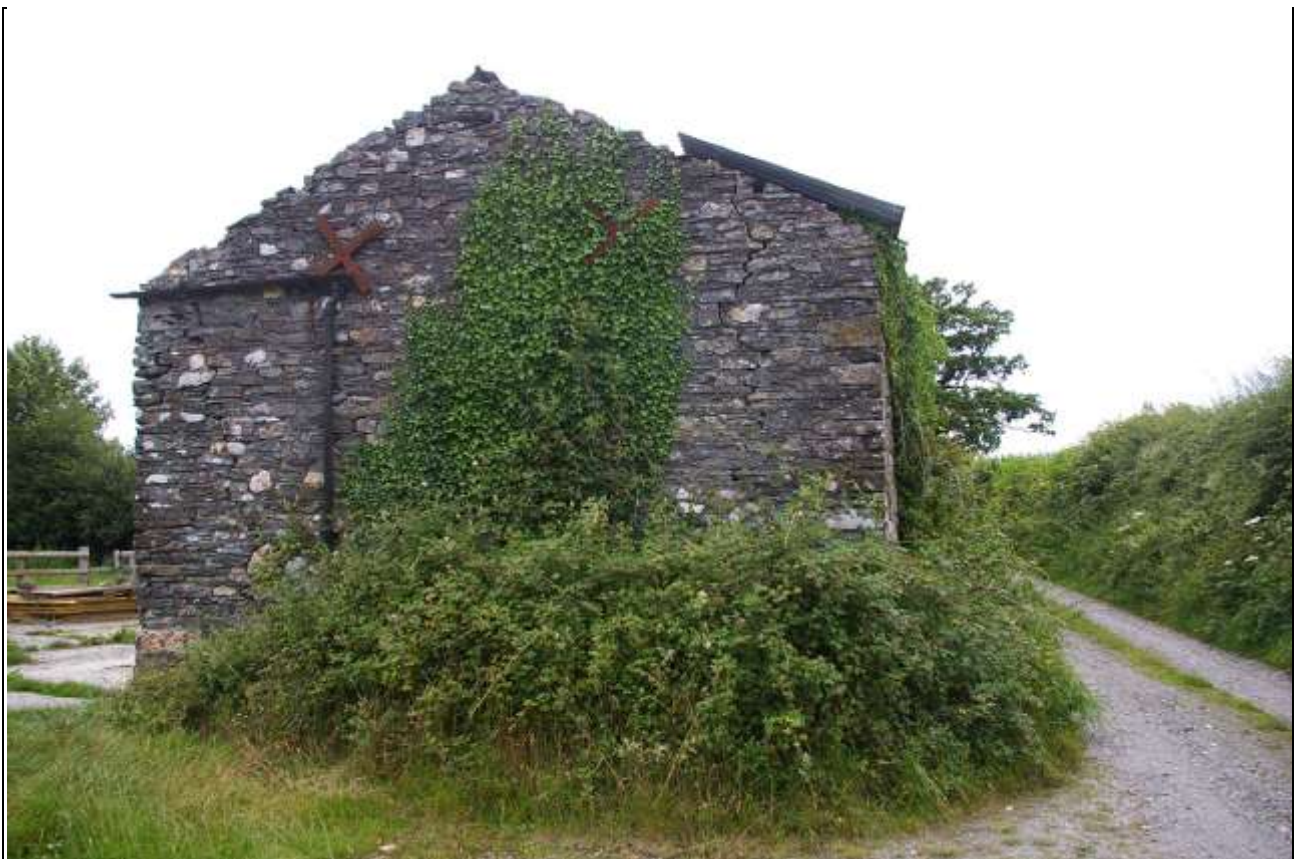
The roofline of both the gable ends of Barns 1 & 2 have clearly been altered, now offset to the side, the ragged nature of the build here suggests an awkward lowering of the pitch and the lack of rebuild or repair to the gables, probably given the poor quality in the 20th century. The roof trusses, which are common to both Barn 1 & 2, have been reused and reset with holes for previous fixings and empty sockets. Indeed, some of the trusses may be from the earlier roof, reused here. We also know that at some point in the later 19th century two farmhouses disappeared from the historic mapping on both Higher and Lower Youngcott, as well as some other barns and buildings. Wood for reuse would therefore be plentiful immediately on the holding.

The south elevation of Barn 2, with x-ties and large structural cracks. The change in roofline is very clear; from the south-east.

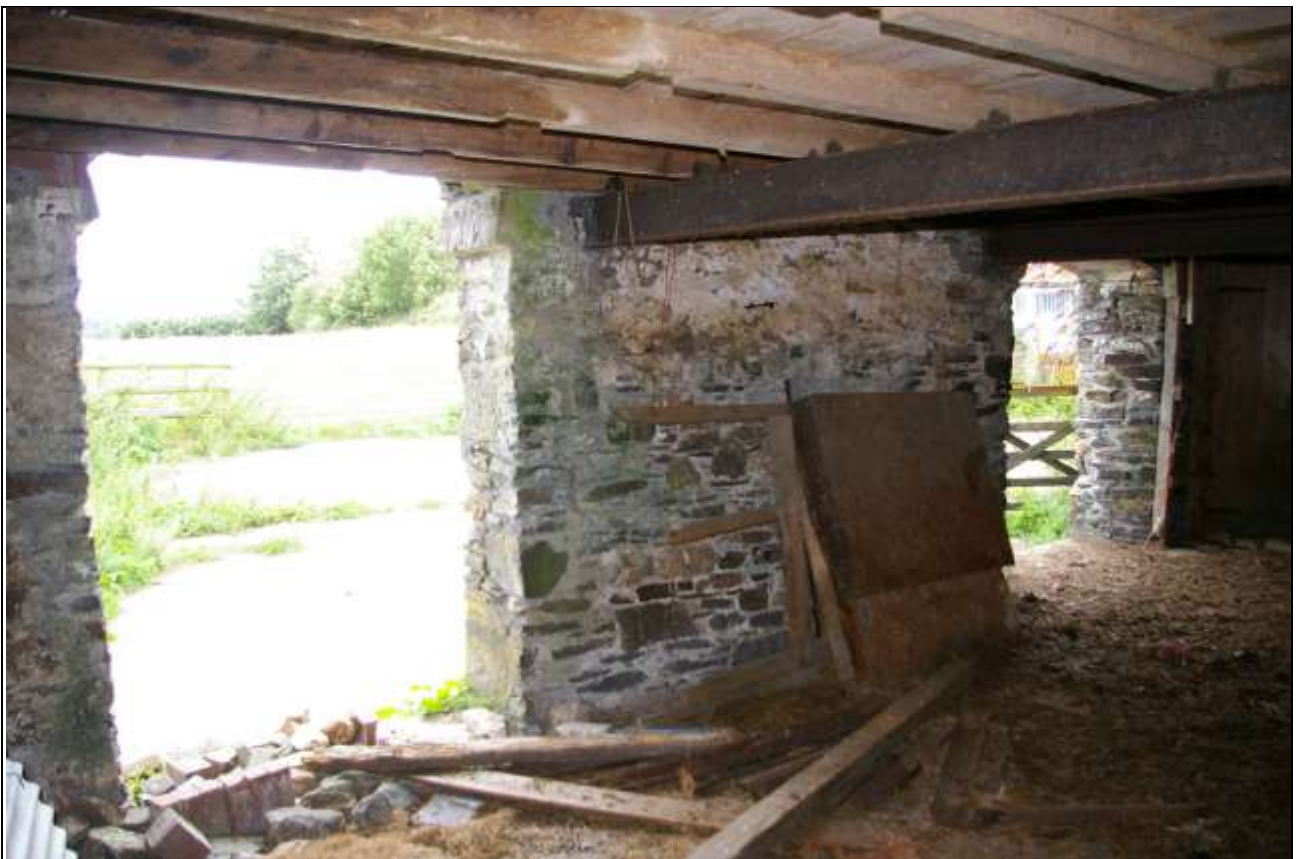
Barn 2 has undergone adaptation, a large doorway in the east elevation was blocked when the troughs were built and the two openings in the west elevation, former stable doors, were enlarged and heightened, with brick arches inserted. It appears that the south gable has received a substantial reconstruction or repair, sitting at an oblique angle to the rest of the structure. Barn 2 shares a common roof with Barn 1, the whole replaced in the early to mid-20th century, probably pre-1945. The roofline of the south gable end of Barn 2 has been altered, as Barn 1, the height reduced, leaving the tops of the wall ragged. The interior of the barn has been wholly worked over in the 20th century, with a narrow boarded loft carried on iron girders, rubble built troughs and modern hayricks occupying the east wall and the floor concreted over, raising its height, forming a step up from the yard.

Interior face of the west wall of Barn 2, with two heightened doors; from the south-east corner.

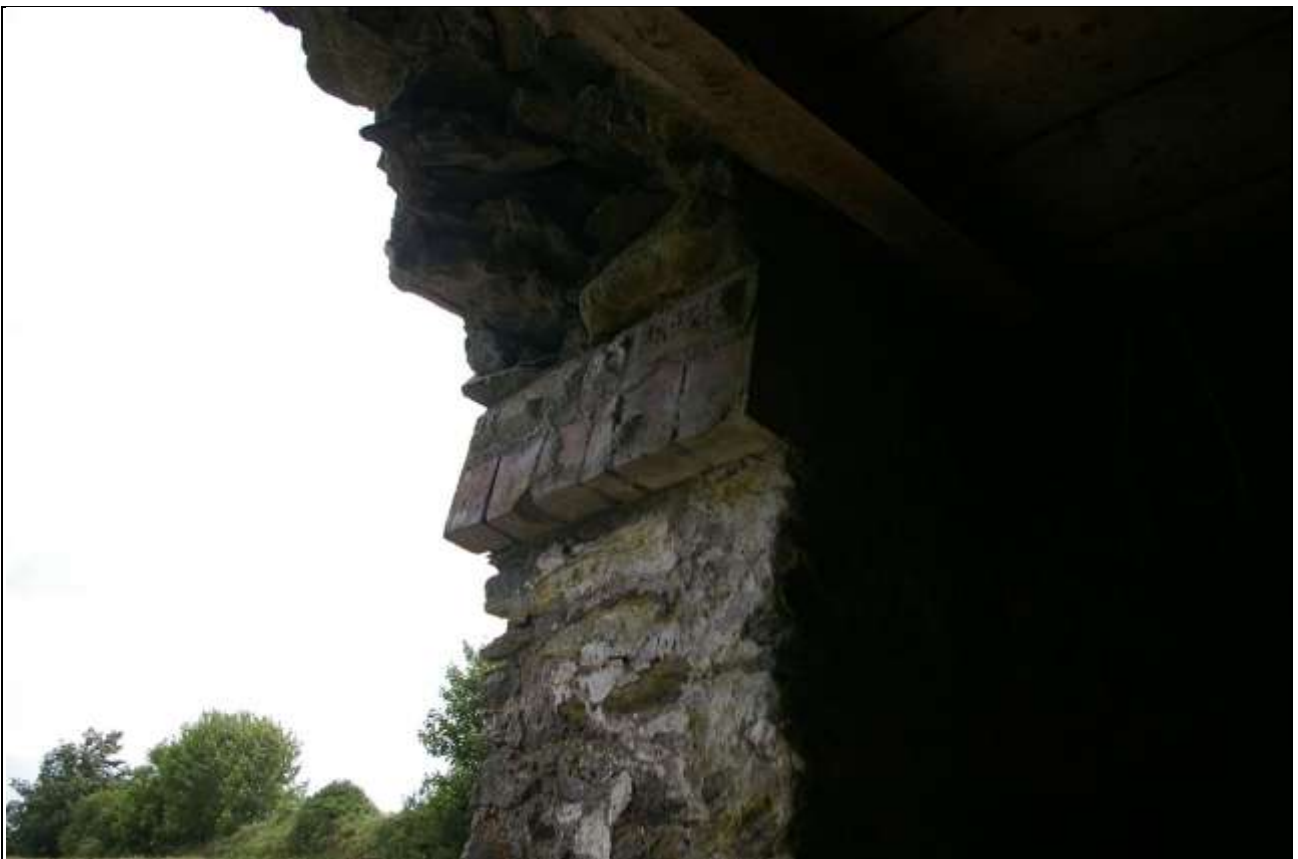
Detail of the collapsed brick arch in the southern opening in Barn 2's west elevation; from the south-east

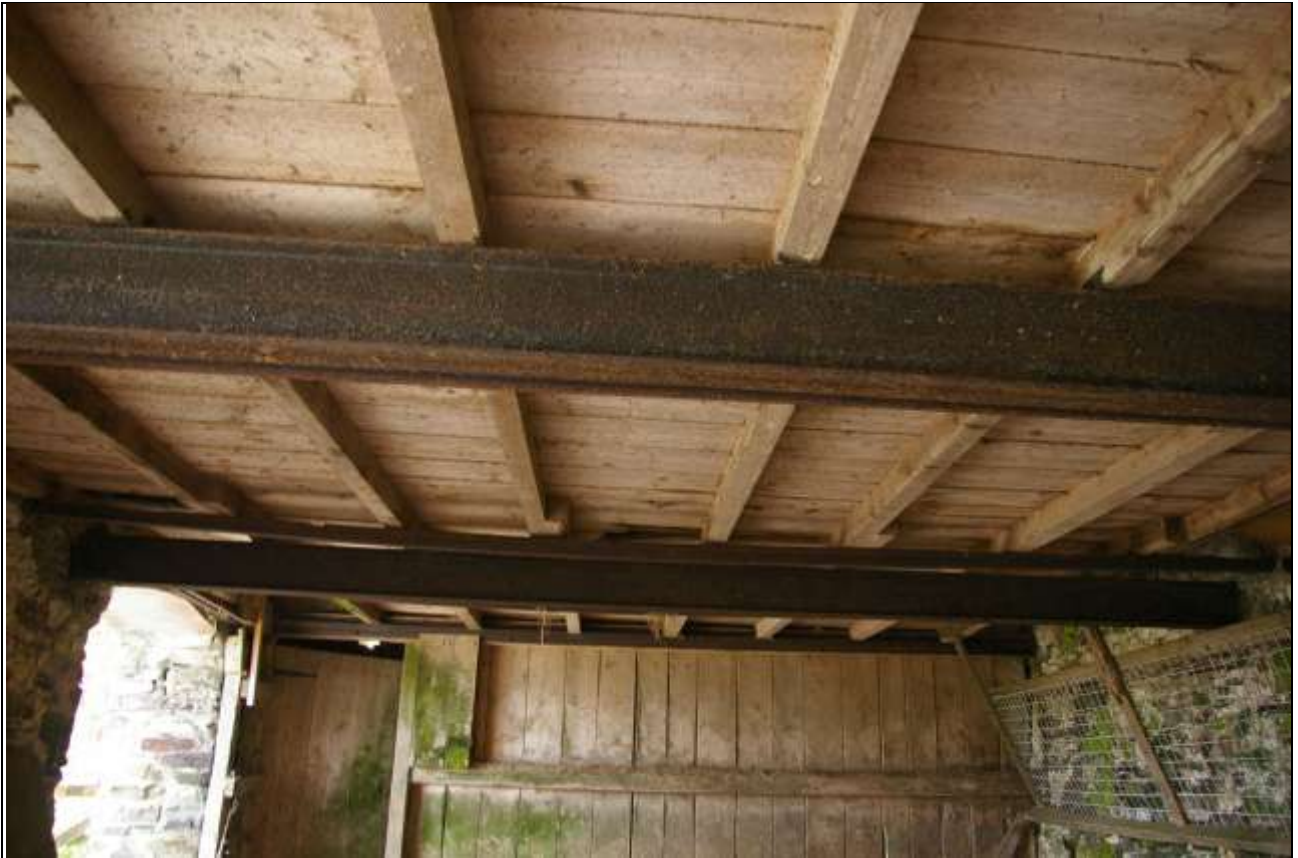
The rails, girders and other ironwork seen used in the bracing of the 20th century loft structure within Barn 2 have certainly been sourced from elsewhere, as scrap or similar. The rails, two long sections, one shorter and one short welded section; are heavy cast and of small gauge, for a tram or small engine. However, without a stamp or identity/makers mark to directly associate with the nearby or other regional mine or mining heritage, there is no conclusive route to identify their original source. The entire ironwork framework is forced into the walls and patched and reset in cement repaired ragged holes, clearly a late and relatively poor quality repair/replacement to the loft.

View of the iron girders and loft floor in Barn 2; from the south.

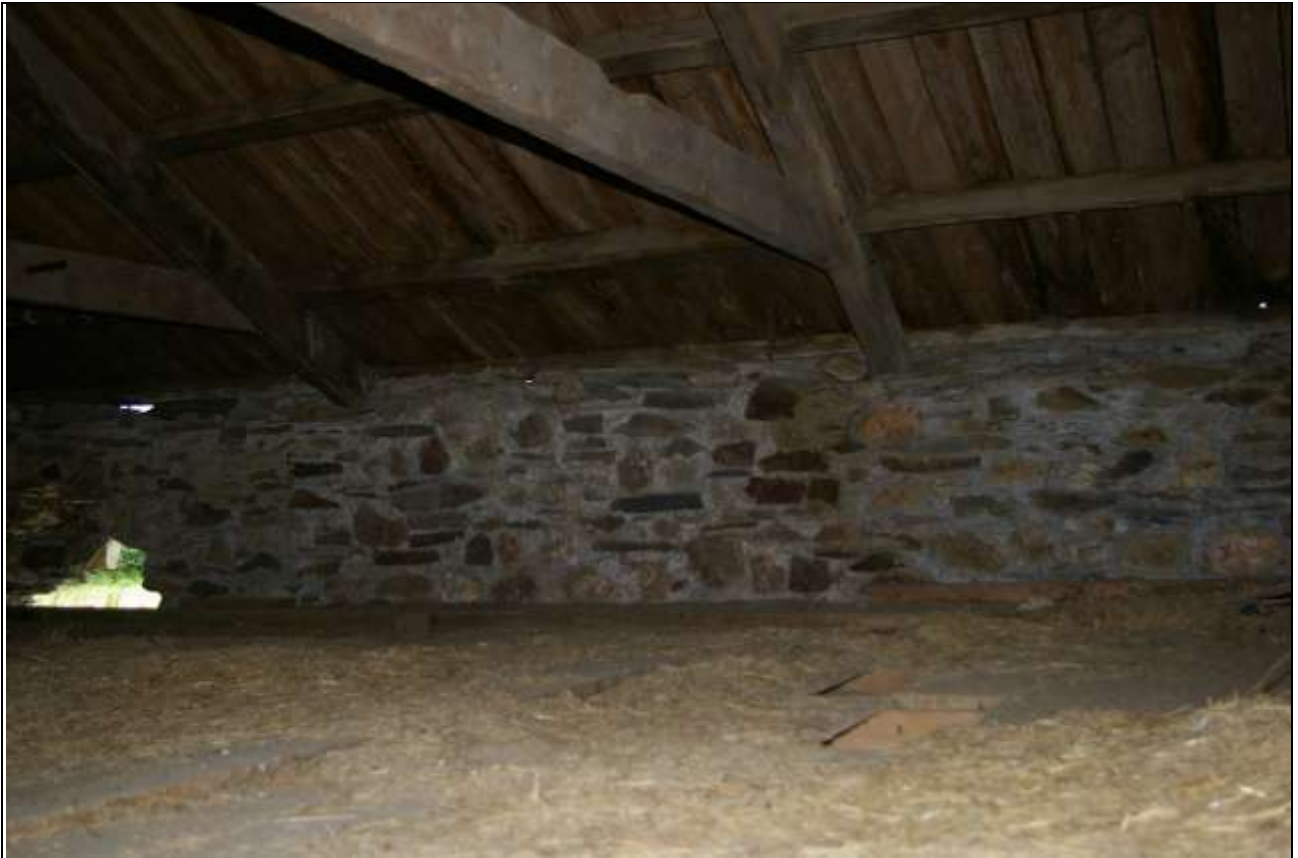
The upper west elevation of Barn 2, showing the blocked air vent, the repairs and that the elevation has been lowered; from the north-east.

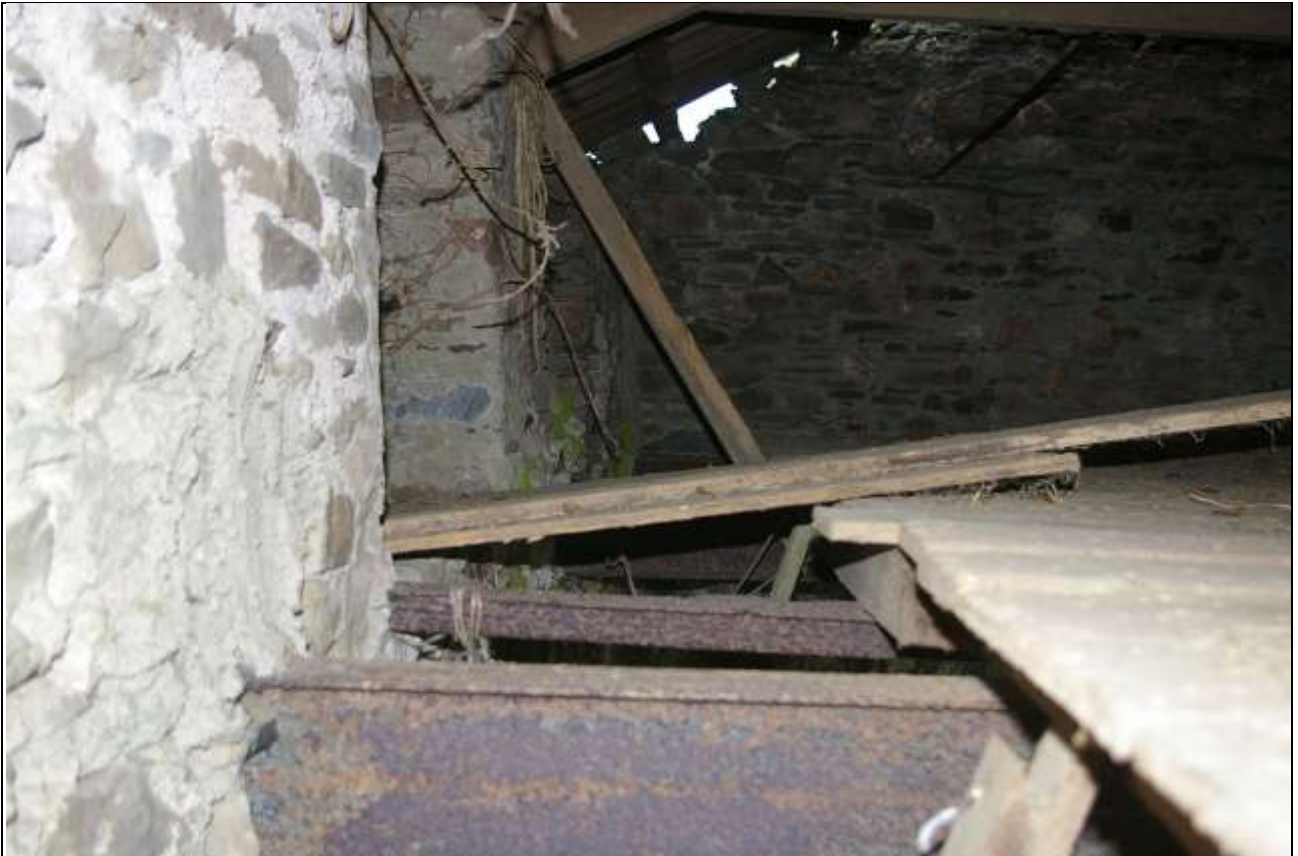
View along the east elevation of Barn 2, showing that it has been reduced in height and the ragged top of the south elevation; from the north.

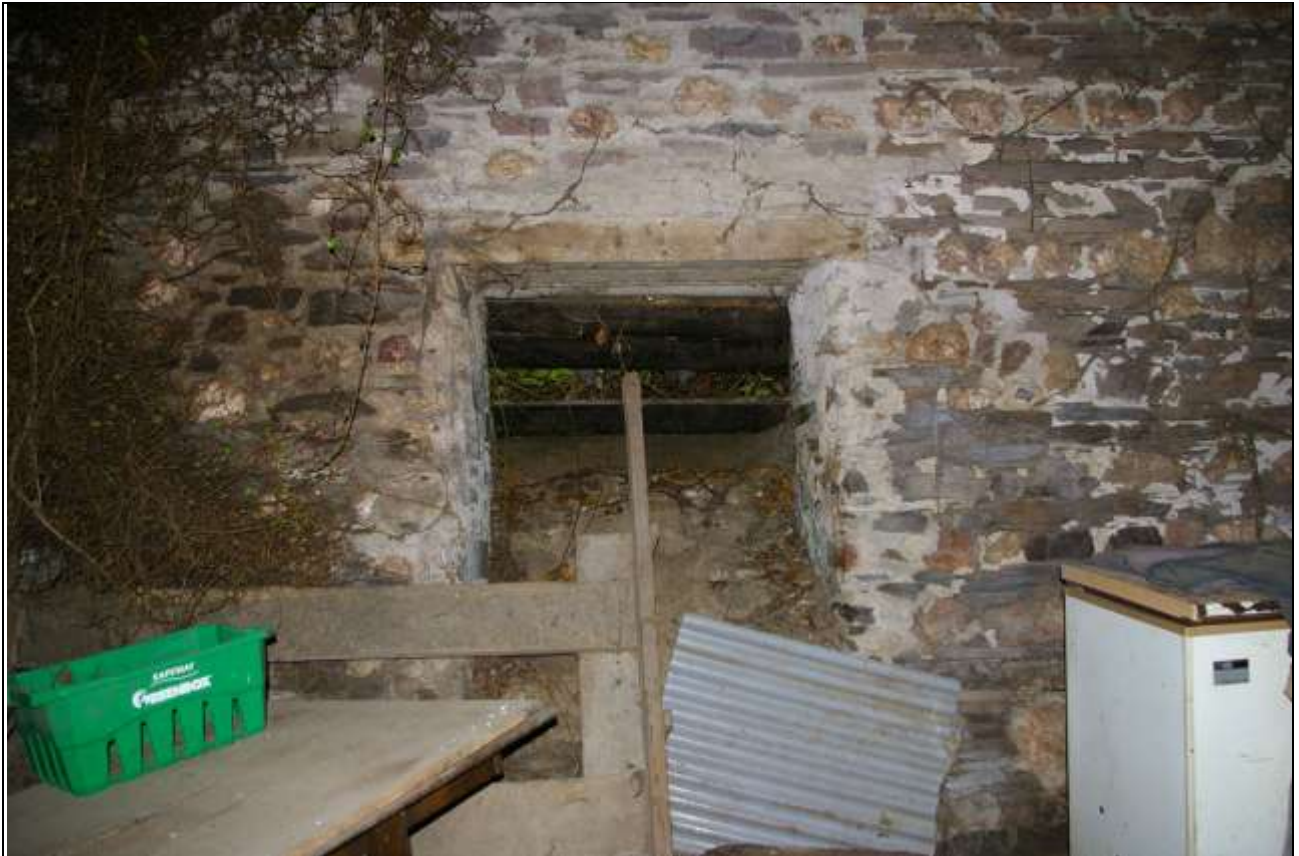
The opening in the north elevation, possibly forced as sides rebuilt and patched with cement; from the south.

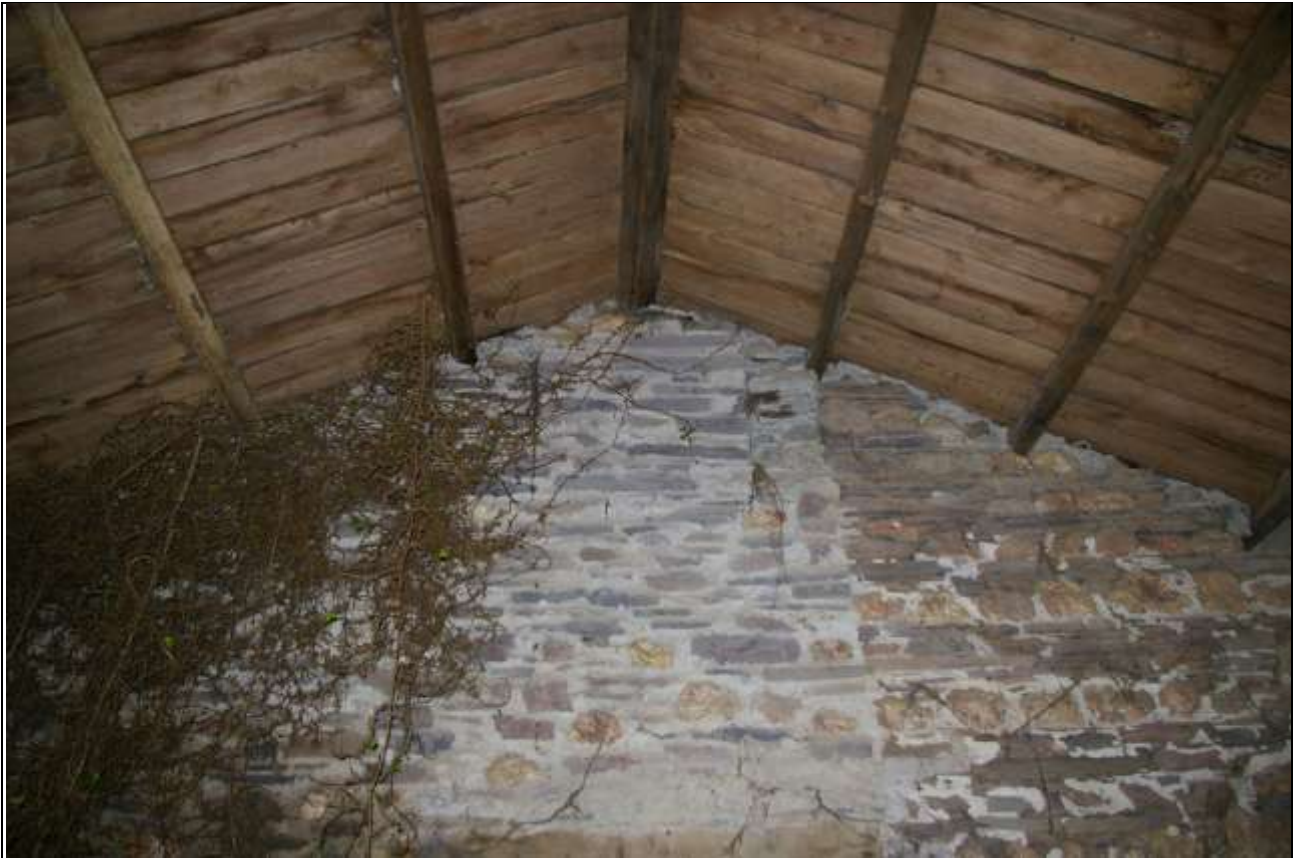
Blocked Openings - Doors	1	There is one blocked slit air vent in the apex of the gable. This air vent has been truncated awkwardly on the east side, indicative of the gable having been truncated and reduced in height, the ridge then offset to the west side.
Significant Details:		The roofline of this gable has been altered. The ridge is offset to the west side of the roof, with a longer lower slope to the east side, the pitch unusually shallow.
Relationships:		The north elevation is cohesive with the east and west walls of Barn 1. It is abutted on its west side by the north elevation of Barn 3, which is set slightly back into the bank.
B1 Elevation SOUTH		Description
Fabric Description:		Timber plank partition wall between Barn 1 and 2. The base of the wall is of heavy slate slabs, with a bracing base beam above. The vertical wall planks are spiked to a chunky timber frame. They have been cut off awkwardly at the roof, where the roofline has been altered and a loading door hole has been crudely cut at first floor level, respecting the more modern loft level in Barn 2. The current loft structure in of Barn 2 has been bolted to this heavy partition wall.

The slit air vent blocked in the north gable end of Barn 1, showing the roofline has been altered and the elevation reduced; from the south.
