MAYOR'S AVENUE TRAVIS PERKINS

DARTMOUTH

Desk-Based Assessment & Historic Building Recording

South West Archaeology Ltd. report no. 181127

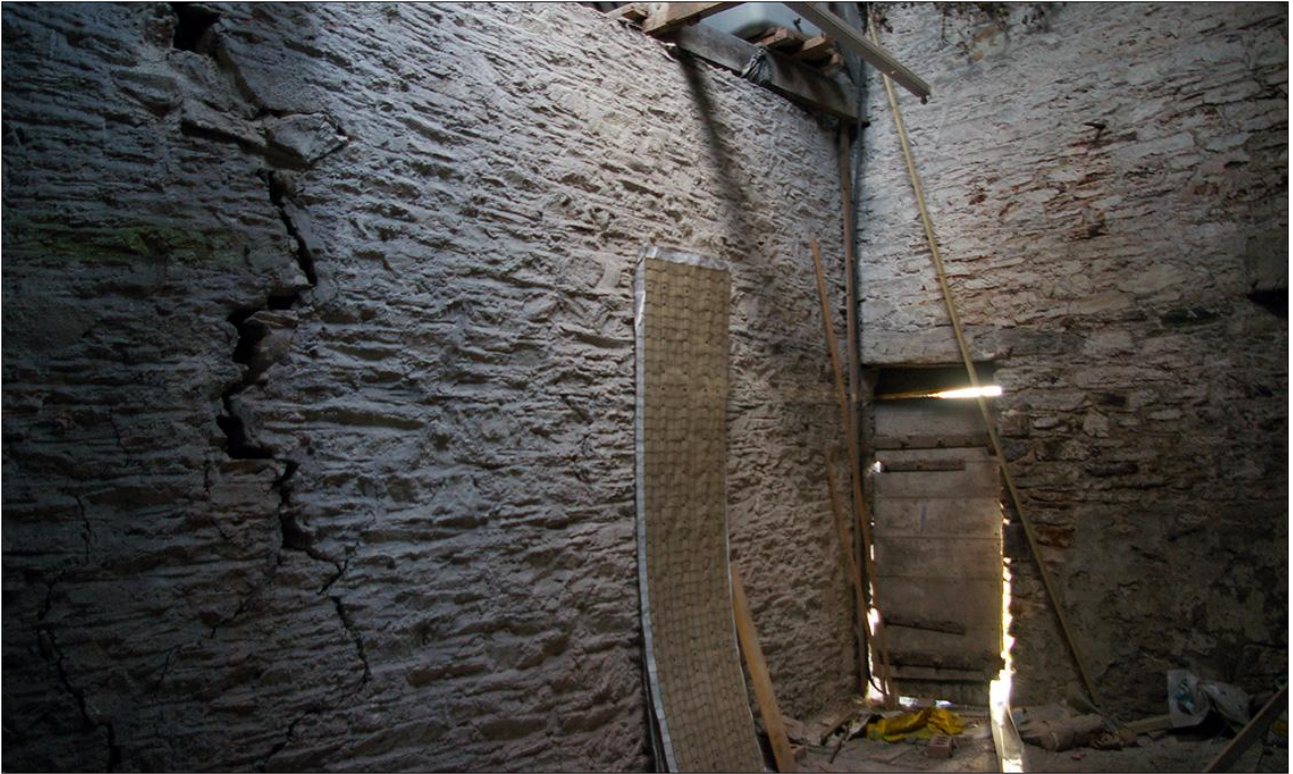
74. B1 FF R2, VIEW OF THE STRUCTURAL CRACK IN THE WEST WALL, AND D22 IN THE NORTH WALL; VIEWED FROM THE SSE.

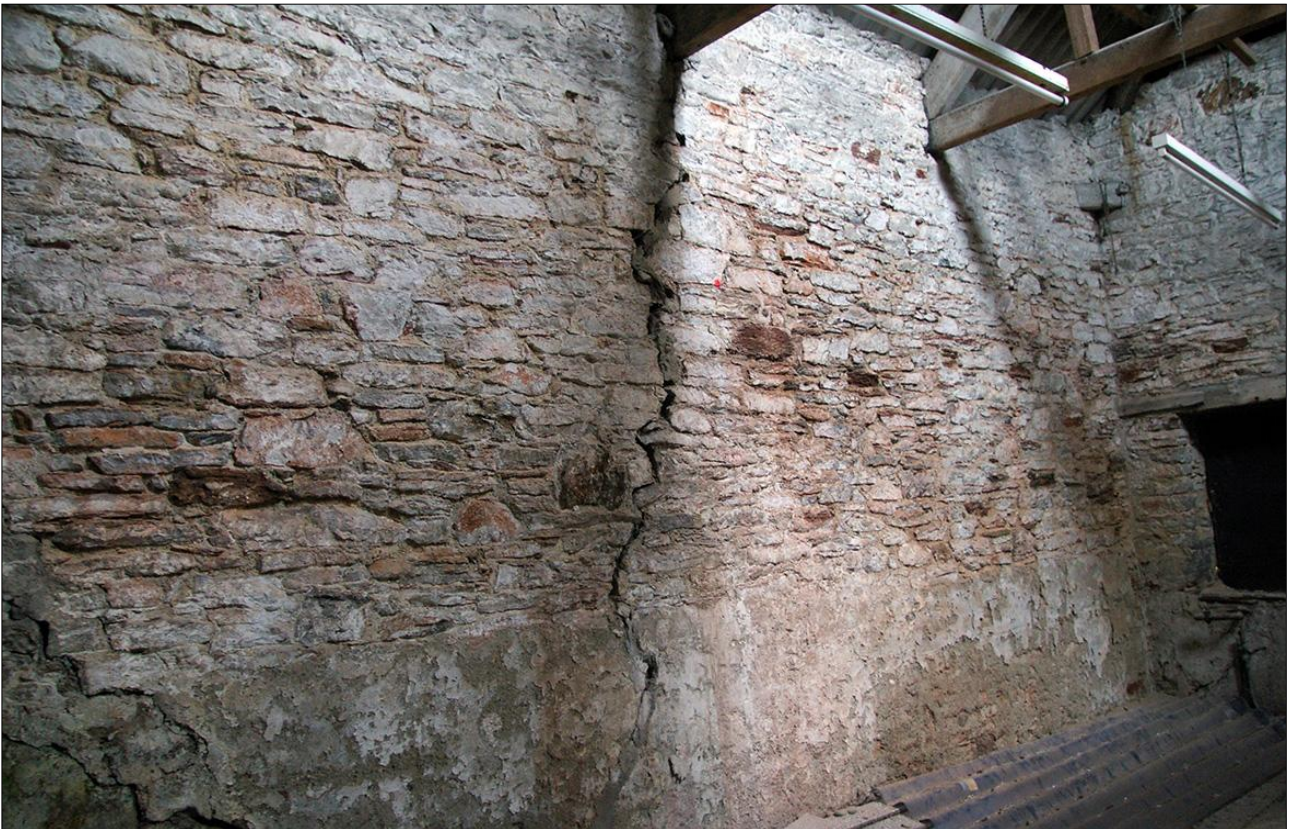
83. B1 FF R3, THE WEST WALL OF R3 SHOWING ITS STRUCTURAL CRACKS; VIEWED FROM THE SOUTH-EAST.
