# GREAT LAKES FARM HOLSWORTHY HAMLETS TORRIDGE DEVON

Desk Based Appraisal and Historic Building Recording

# GREAT LAKES FARM BARNs, HOLSWORTHY HAMLETS, TORRIDGE, DEVON

## HISTORIC BUILDING RECORDING

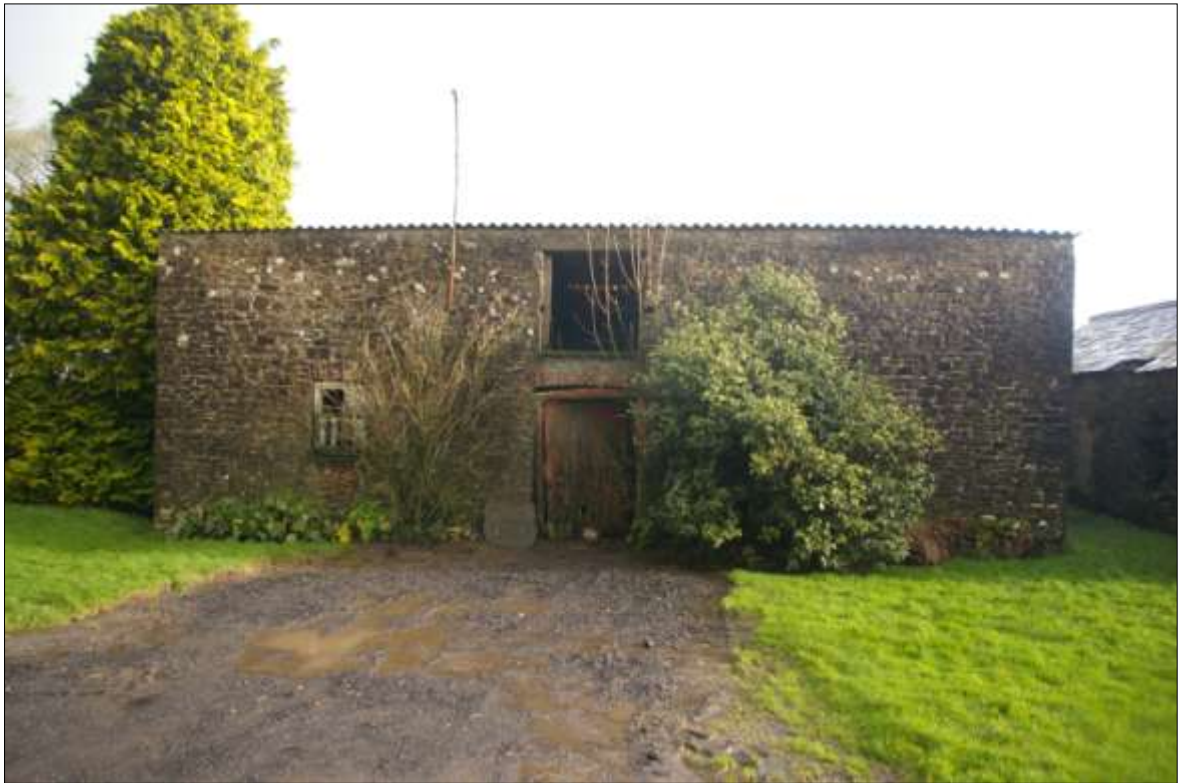
FIGURE 7: BARN 1, VIEWED FROM THE WEST.

A rectangular 1½ storey barn of stone rubble with a mono-pitch roof; this was originally a two-storey barn with a pitched (probable) slate roof. The pitch of the roof is very shallow and slopes to the east, with corrugated asbestos sheet with cemented eaves and some surviving guttering carried on simply modern timber rafters. The principal surviving elevation is to the west, with access to the interior via a wide central doorway flanked by two small windows, all with shallow brick relieving arches, with a central loading door above that provided access to the lost first floor. There is a narrow forced doorway in the east wall that leads out into a paddock to the rear (east). The north and south end walls are blind, the upper portions rebuilt or heavily repaired with hard cement mortars following the removal of the original roof. The interior has been stripped of all historic features and fitting, consisting of a single open space subdivided by concrete walls into a four cattle pens with a feed passage along the west wall. The forced doorway in the east wall is braced with concrete and appears contemporary with these pens. The north, east and south walls are all of a similar build, of local slatestone rubble with small but poorly-sorted and fairly irregular stones in a heavy pinkish-beige lime mix mortar with grit inclusions. There are no good quoins to this build, but slightly larger and roughly dressed stones have been used at the corners. The west wall markedly different in style, with larger and more regularised stone rubble laid in crude courses. Some of the stones show signs of shaping and the quality of the stonework is higher. The change of build may simply reflect the fact this was the presentation elevation, and thus greater care was taken; it is also possible that Barn 1 was originally open-fronted and infilled later. The exterior stonework has been repointed (ribbon pointing) in a pale cement mortar. The overall character of the stonework is typical of farm buildings in this area and is usually dated to the 19<sup>th</sup> century.

Barn 1 is a single-phase structure (late 19<sup>th</sup> century), with a significant phase of alteration in the later 20<sup>th</sup> century, when the pitched roof was replaced and the former gables rebuilt or repaired. The concrete cattle pens and the forced doorway in the east wall may have been inserted during the same phase of works.

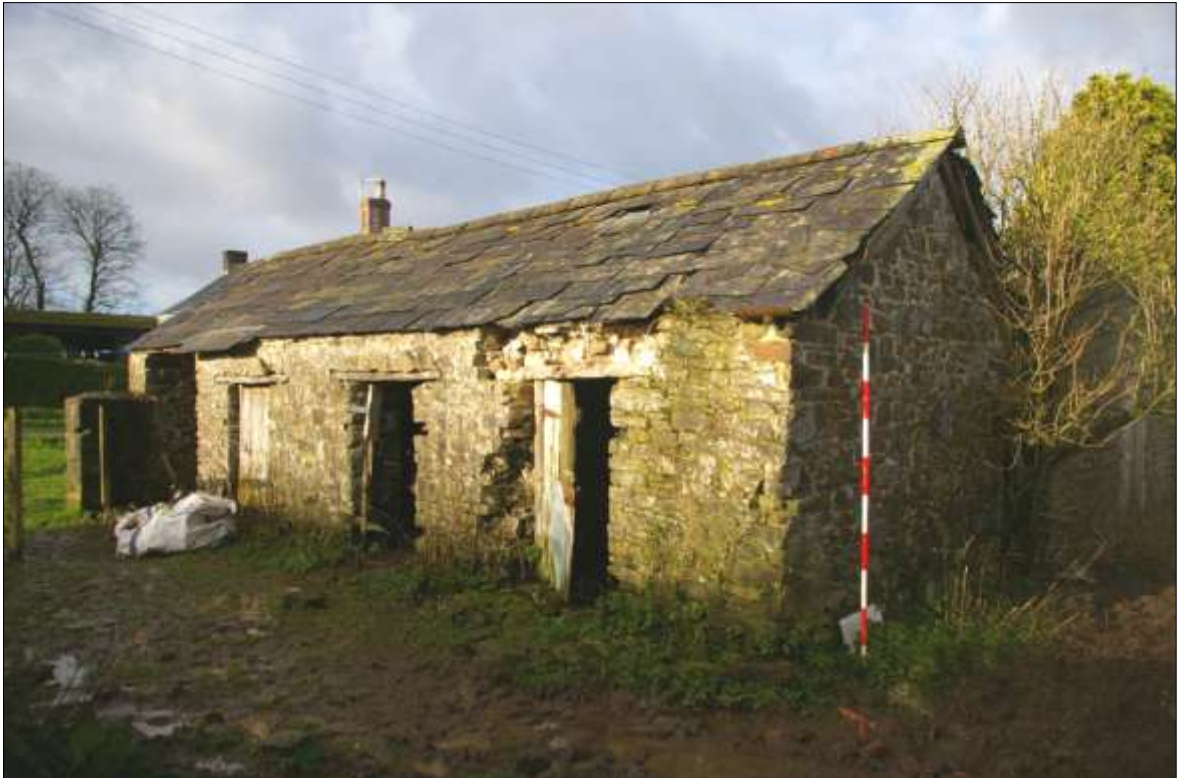
FIGURE 8: BARN 2, VIEWED FROM THE SOUTH-EAST (SCALE 2M).

A narrow rectangular single-storey pigsty of stone rubble with a pitched roof of reset scantle slates carried on simple 20<sup>th</sup> century common rafters. Four heavy tie beams at eaves height brace the long north and south walls. There is an associated cobbled yard to the south. The build is consistent throughout, of stone rubble using small, neat, blocky stones, closely packed in a pale brown lime and clay mortar mix with slate fragments. The roof is of heavy pale grey-blue scantle slates with massive peg holes for iron spikes, some of which are present. All the slates have been reset in a mismatched pattern of sizes and widths with plain modern terracotta ridge tiles and one

surviving black-glazed roll-moulded ridge tile. Barge boards survive in places and to the east gable, together with sections of moulded cast-iron guttering. The eaves of the building have been infilled and rebuilt in concrete mortar and loose stone rubble. The building is divided into three evenly-spaced pens with an additional narrow open compartment to the west end, either for shelter within the yard or for farrowing/mating. The pens were divided from one another by upright slate slabs pinned with iron spikes, although only one slab survives intact. The three pens are each served by a low doorway in the south wall, with crude stone quoins, narrow timber lintels and plank boarded doors. Each pen had a feed hatch with timber frames and plank shutters in the north wall; the middle hatch is blocked in concrete block and the western hatch has lost its shutter. The central and western pens are now enclosed by a timber screen of mismatched planks forming a poultry shed.

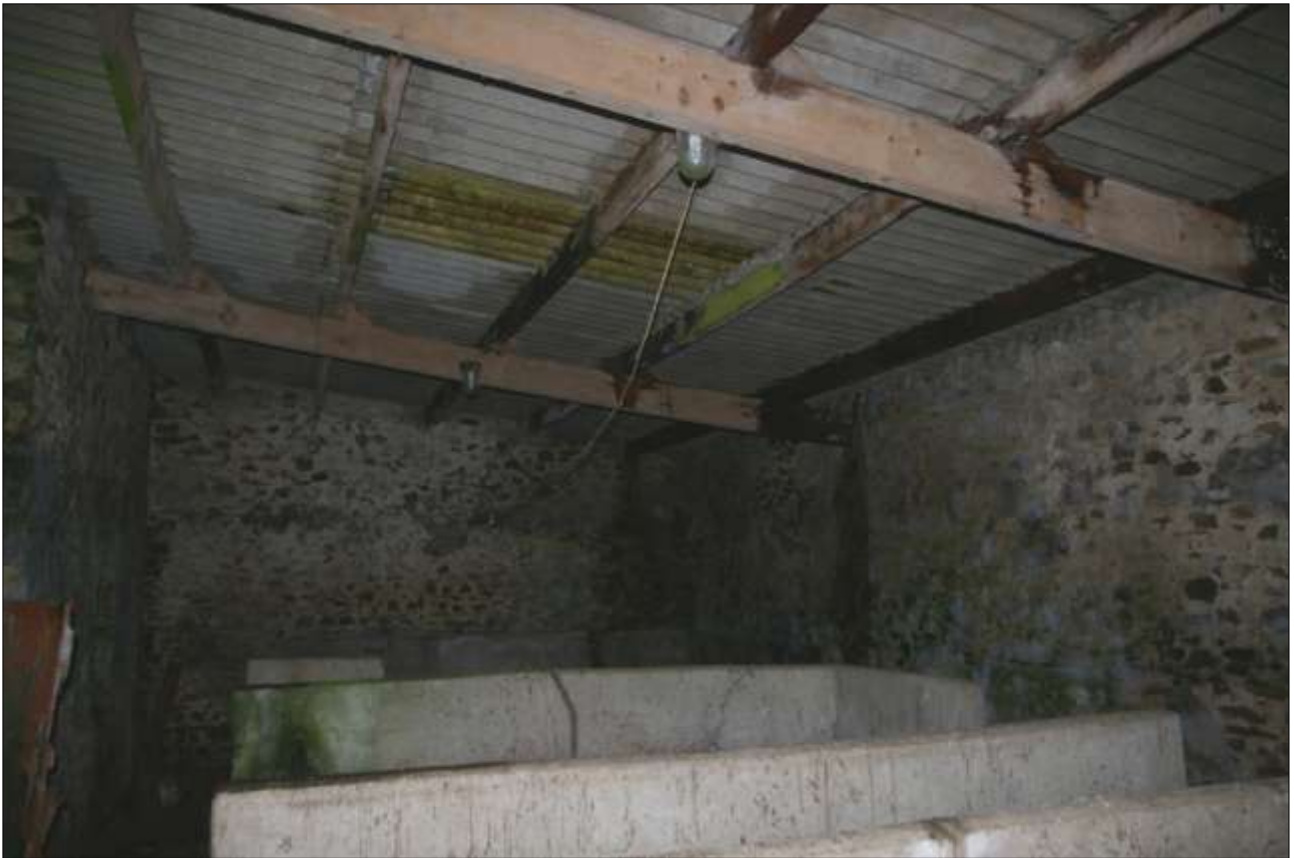
THE INTERIOR OF BARN 1: SHOWING THE MONO-PITCH REPLACEMENT ROOF OF CORRUGATED ASBESTOS; VIEWED FROM THE SOUTH-WEST.

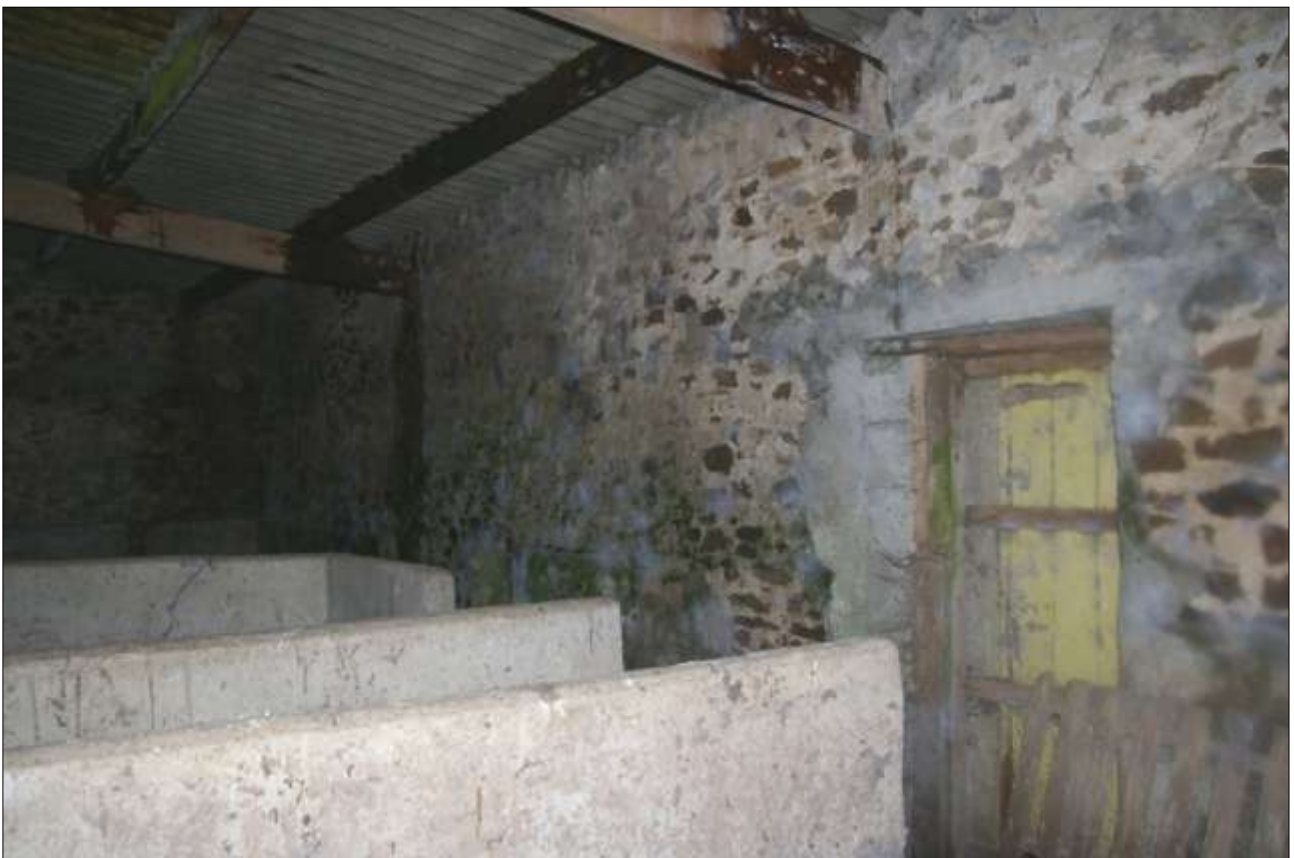
THE INTERIOR OF BARN 1: THE EAST WALL WITH FORCED DOORWAY; VIEWED FROM THE SOUTH-SOUTH-WEST.

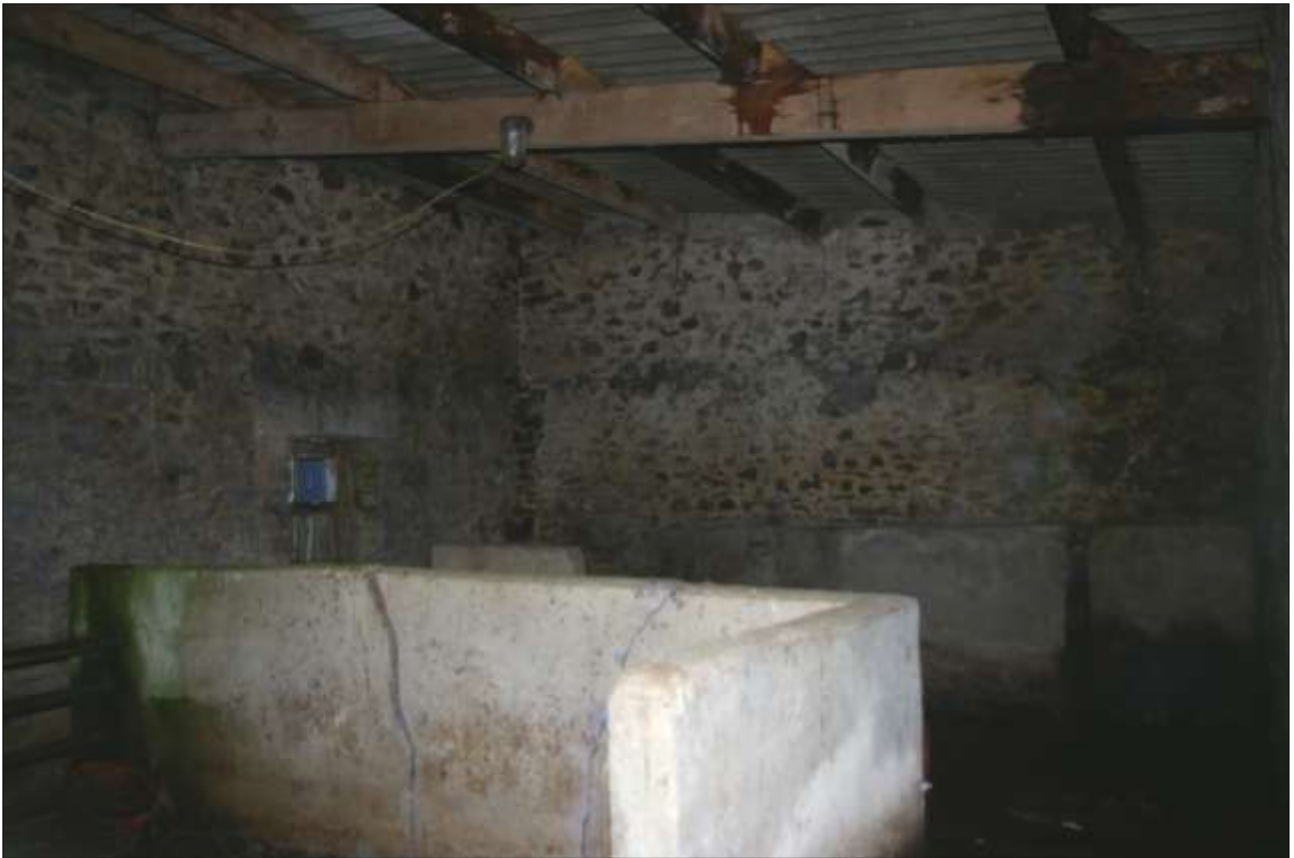
THE INTERIOR OF BARN 1: THE CONCRETE PENS IN THE BARN; VIEWED FROM THE SOUTH-EAST.

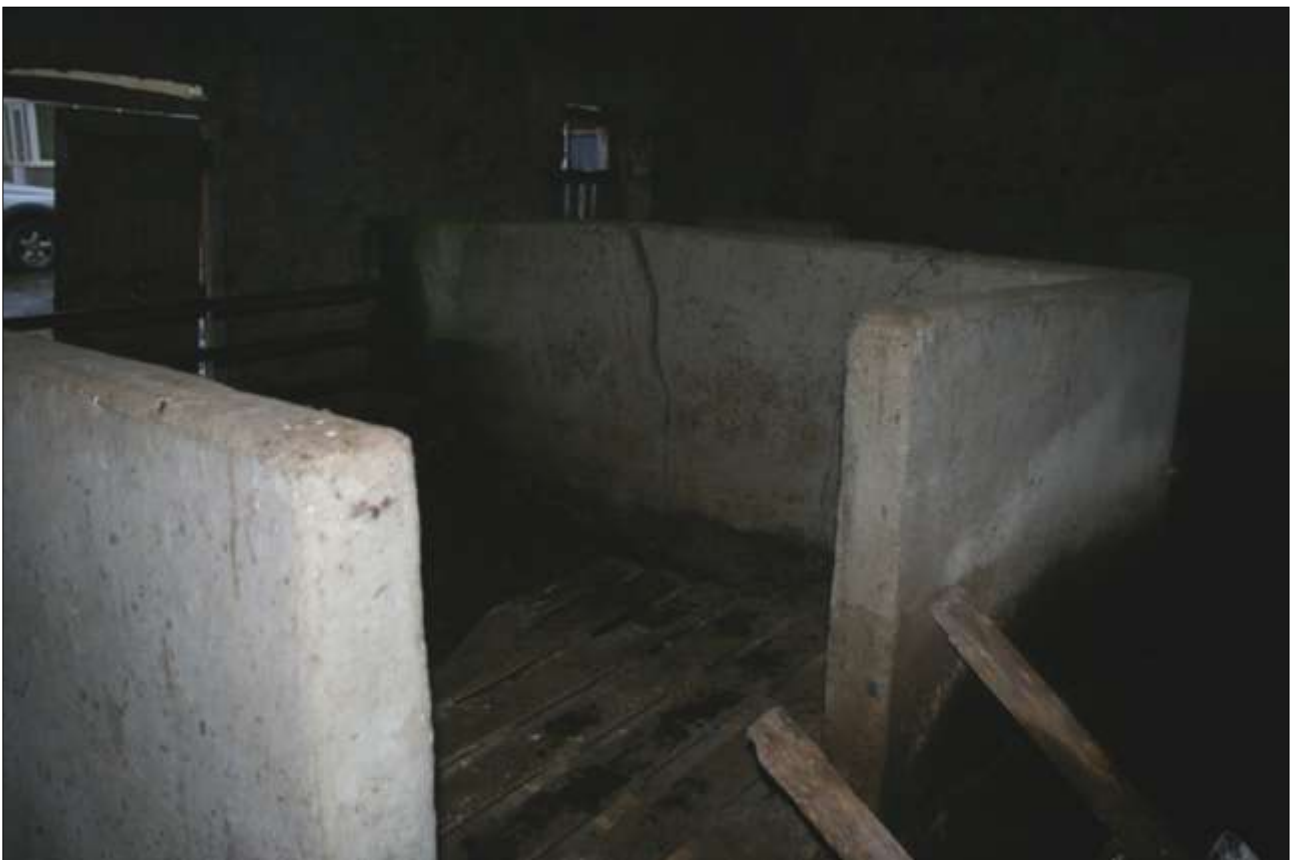
THE INTERIOR OF BARN 1: DETAIL OF THE PRE-FABRICATED CONCRETE PENS; VIEWED FROM THE SOUTH-EAST.

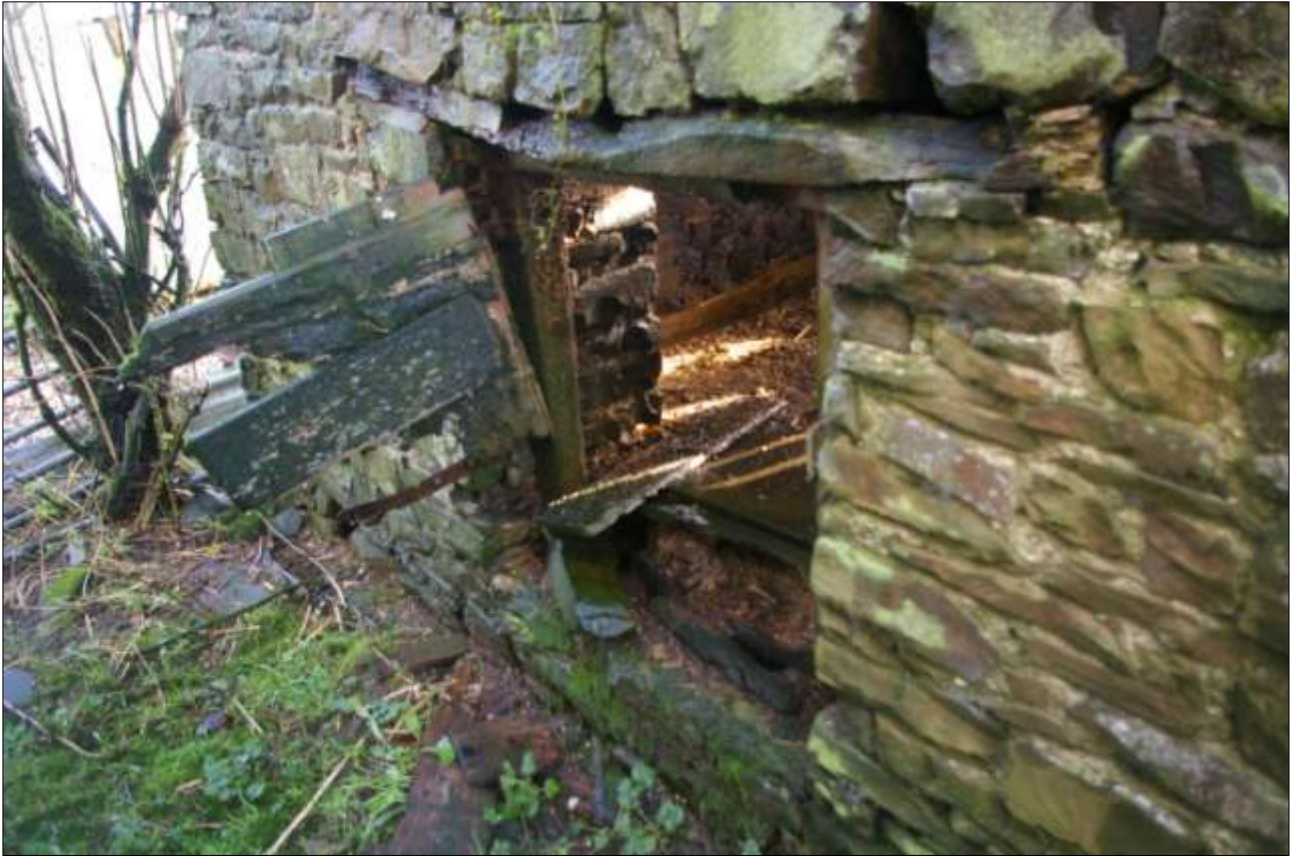
THE PARTLY SURVIVING PLANK SHUTTER TO THE EAST ON THE NORTH ELEVATION OF THE PIGSTY (BARN 2), SERVING THE FORMER FEED HATCH TO THE PEN; FROM THE WEST, NORTH-WEST.

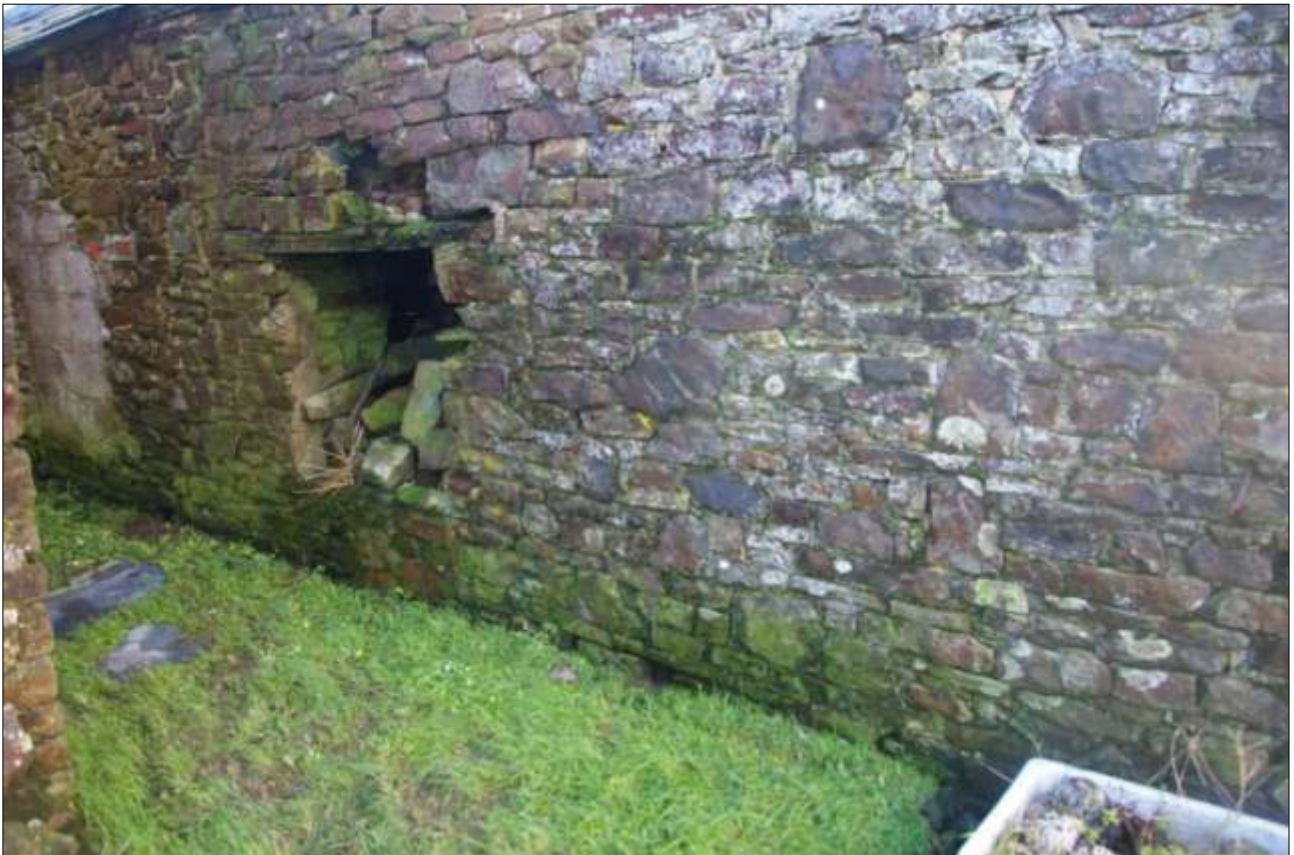
POSSIBLE BLOCKED OPENING IN THE WESTERN END OF THE NORTH WALL OF THE PIGSTY (BARN 2); FROM THE NORTH-WEST

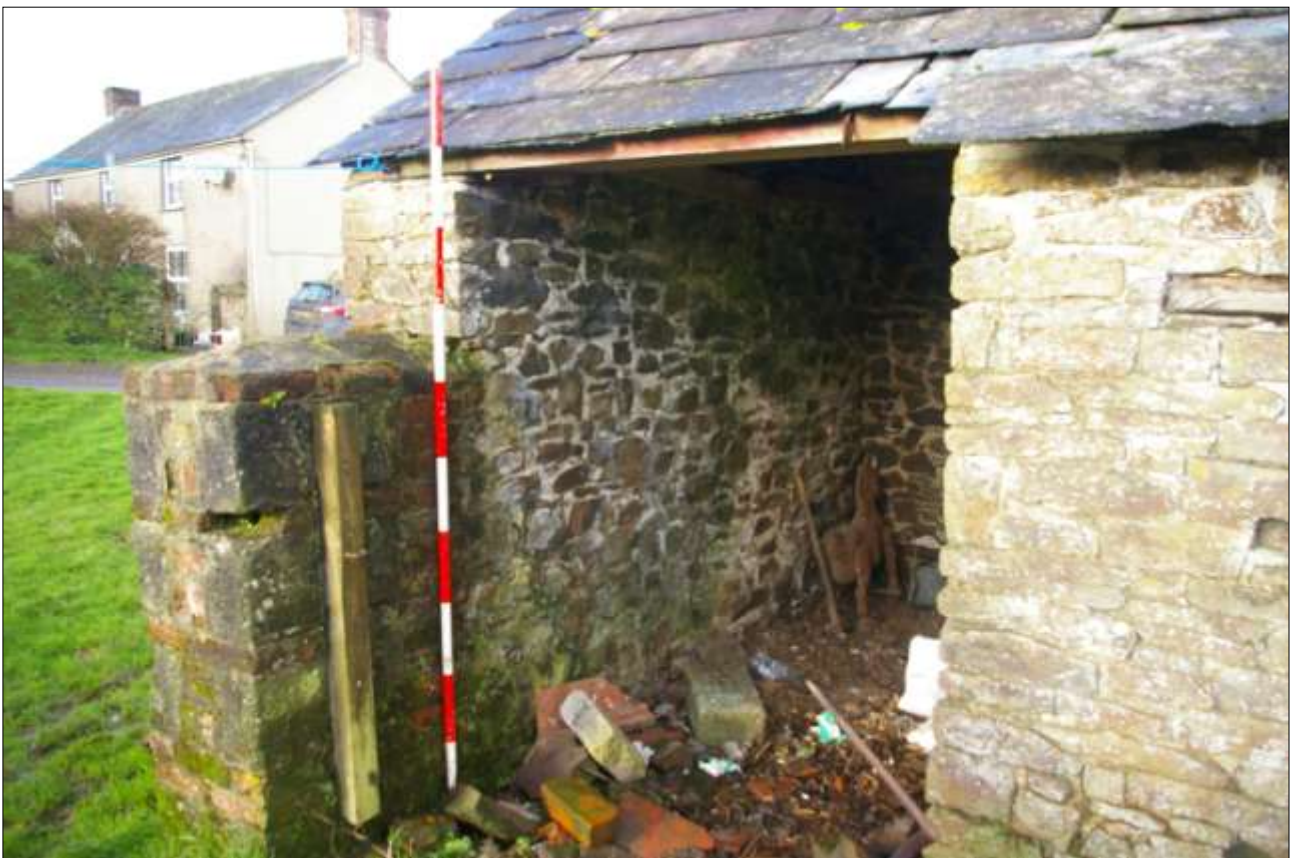
THE BRICK AND CONCRETE BLOCK PIER ADDED TO THE WEST GABLE END WALL OF THE PIGSTY (BARN 2), WITH 2M SCALE; FROM THE SOUTH-EAST.

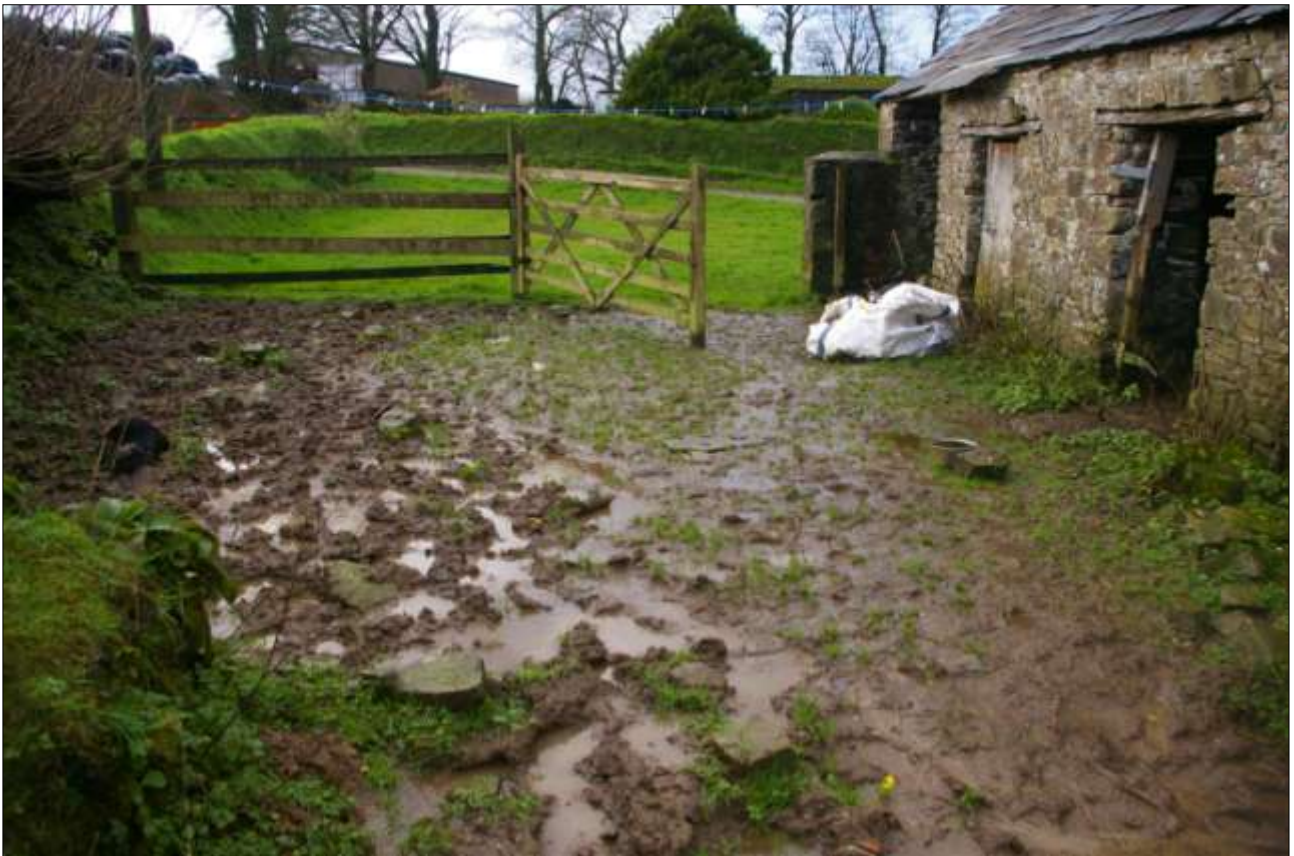
THE YARD TO THE SOUTH OF THE PIGSTY (BARN 2), SHOWING MUD OVER REMAINING COBBLES; FROM THE EAST.

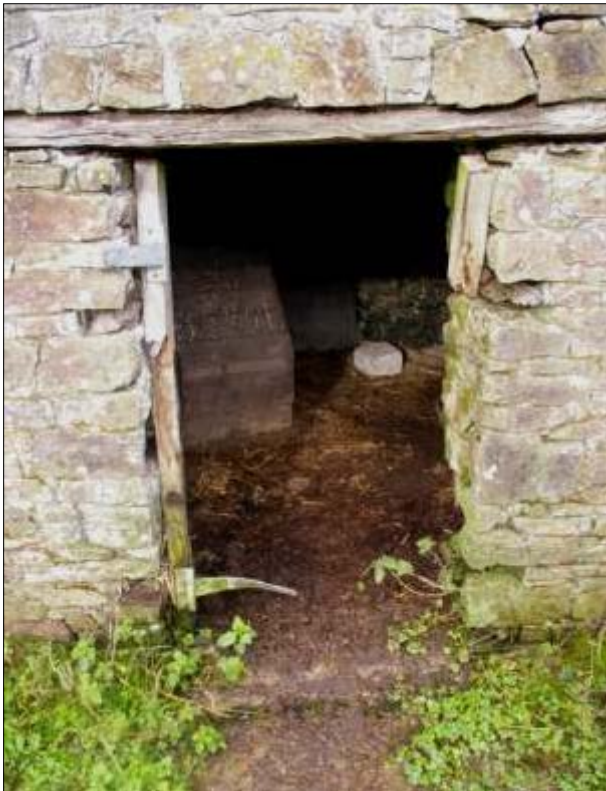
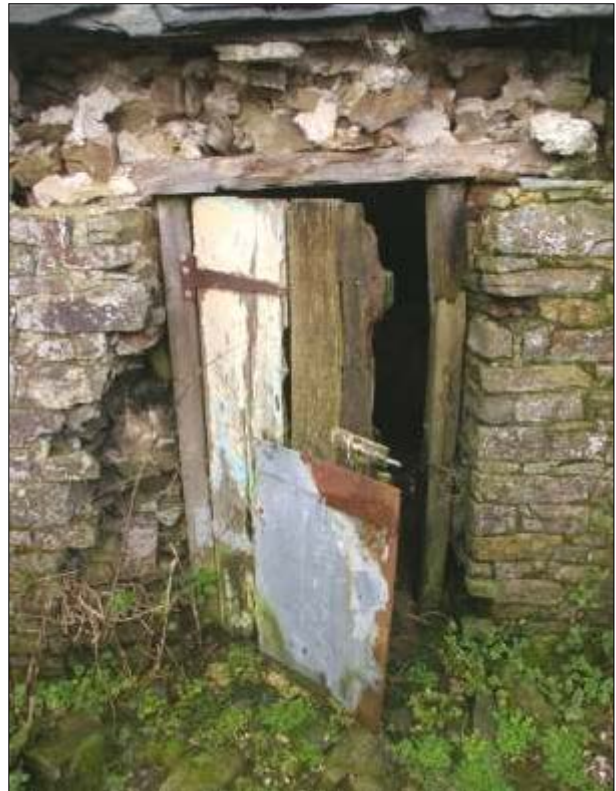
LEFT: THE CENTRAL DOORWAY IN THE SOUTH WALL OF THE PIGSTY (BARN 2), WHICH HAS LOST ITS DOOR; FORM THE SOUTH.  
 RIGHT: THE EAST DOOR TO THE EAST PEN IN THE PIGSTY (BARN 2) SOUTH WALL; FROM THE SOUTH.

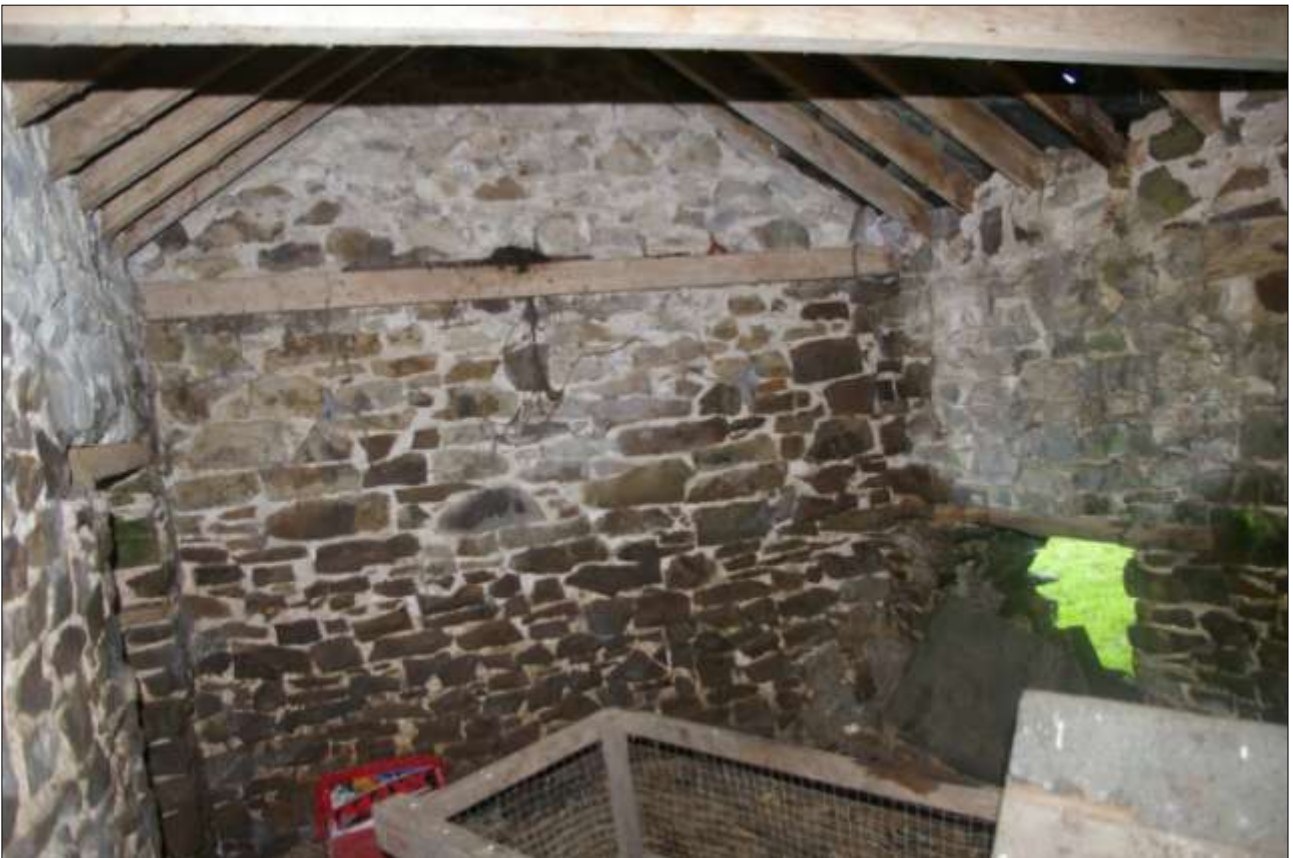
THE WESTERN PEN AND CENTRAL PEN (BARN 2), CONVERTED TO A POULTRY SHED; FROM THE SOUTH-EAST.

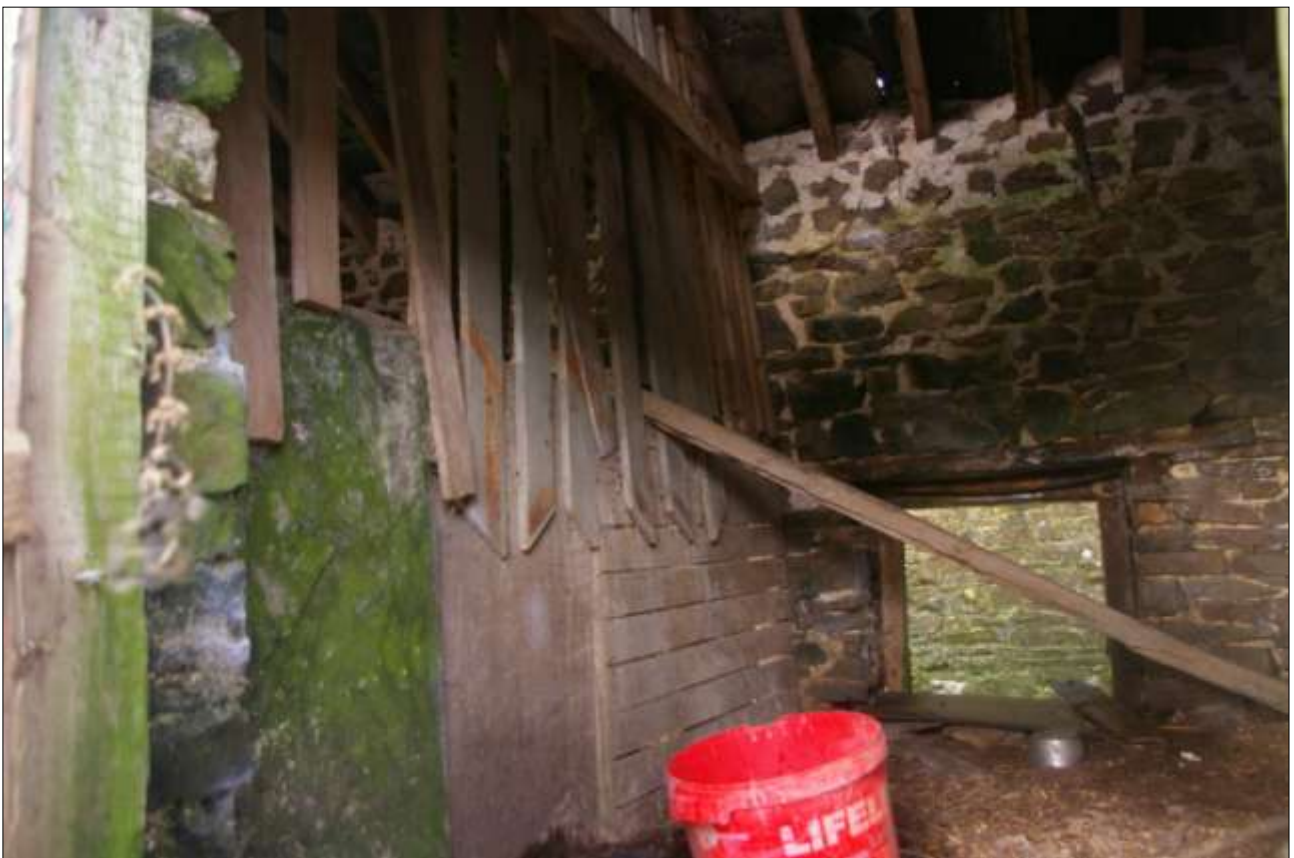
ONE OF THE PENS FORM THE LOW DOORWAY OF THE EAST PEN (BARN 2), SHOWING THE MORE MODERN TIMBER SCREEN ERECTED BETWEEN IT AND THE CENTRAL AND WEST PEN, FORMING A MORE MODERN POULTRY SHED TO THE WEST END OF THE FORMER PIGSTY; FROM THE SOUTH, SOUTH-EAST.
