# HOLY TRINITY CHURCH ILFRACOMBE NORTH DEVON DEVON

HISTORIC BUILDING RECORDING

South West Archaeology Ltd. report no. 171006

## Holy Trinity Church, Ilfracombe, Devon Historic Building Recording

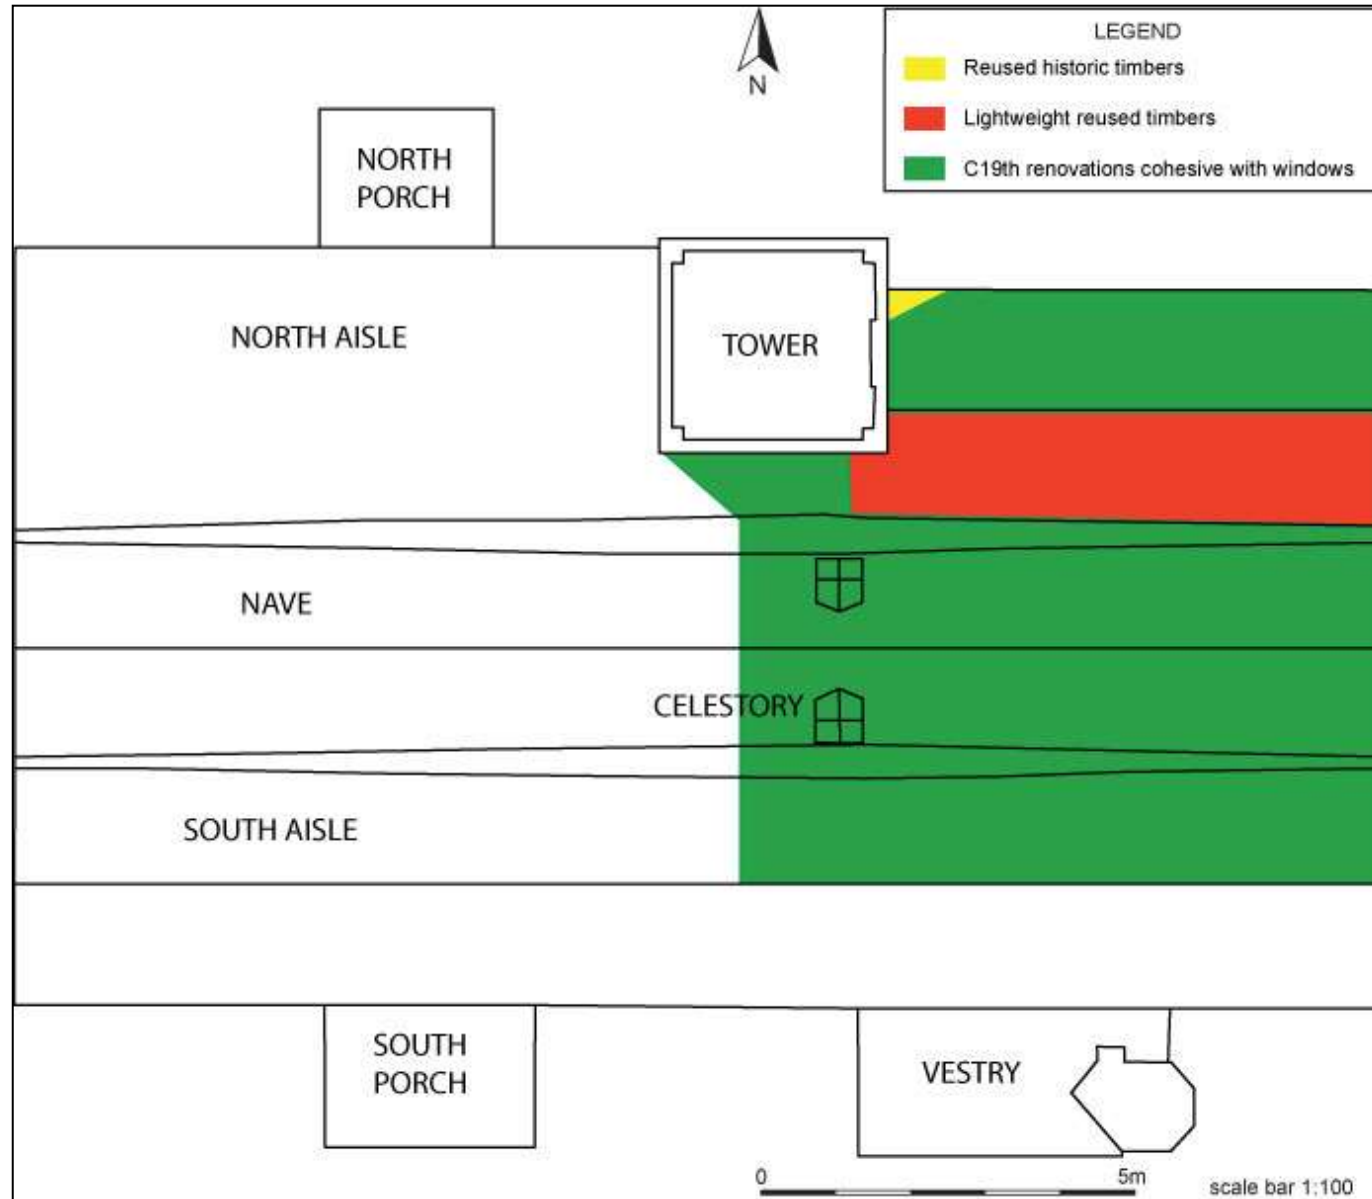
FIGURE 2: SKETCH PHASE PLAN FOR THE EXPOSED ROOFS.

The observed roof works confirmed or highlighted the known phasing within the building, as interpreted by Pevsner. For example, the timbers of the north chancel aisle are of a lighter scantling than those to the widened north nave aisle and the south aisle. This matches the expected phasing of the north chancel aisle as a later addition, when the chancel was further extended in the early 15<sup>th</sup> century. The widening of the rest of the aisles occurred in the later 15<sup>th</sup> century. This confirms a slow expansion and aggrandisement of the church from the 13-15<sup>th</sup> centuries.

The main value of the recording work was in confirming the extent to which medieval fabric survives within the church and how, despite appearances, much of the 19<sup>th</sup> century work was cosmetic, such as outer skims to walls and window insertions. Of particular note is how the timbers/trusses of the roofs are predominately surviving medieval structures with little modern interference save lightweight overlays carrying the modern slate roofing. Generally, the late 19<sup>th</sup> century ceiling decoration or alterations are limited to the interior plaster elements of the roofs. Both south aisle and north chancel aisle roofs exhibit good surviving carpenters marks on the beams and the sequenced numbers indicate little to no later supplanting of truss blades, but some bracing and cutting out of localised rotten sections appears to have occurred in the 1940s phase of works on the south aisle, at the ridge.

The roof of the church has undergone several phases of repair in the early 1900s, the early 20<sup>th</sup> century and in the 1940s. This phase used iron nails and larger slates, of a more even width and size. The south aisle roof particularly was sagging (the aisle was extended and is now surprisingly wide, the roof therefore under more stress). Modern timbers were attached to the back of the truss blades and battens braced off them, to make the roof more even and spread the weight of the slates. These timbers were all attached with iron nails and were very lightweight. On the north aisle roof, they were nailed to the backs of the truss blades to carry the battens but were required to balance out any sag in the roof (the north aisle is much narrower) so only shorter sections of reused narrow timber were used.

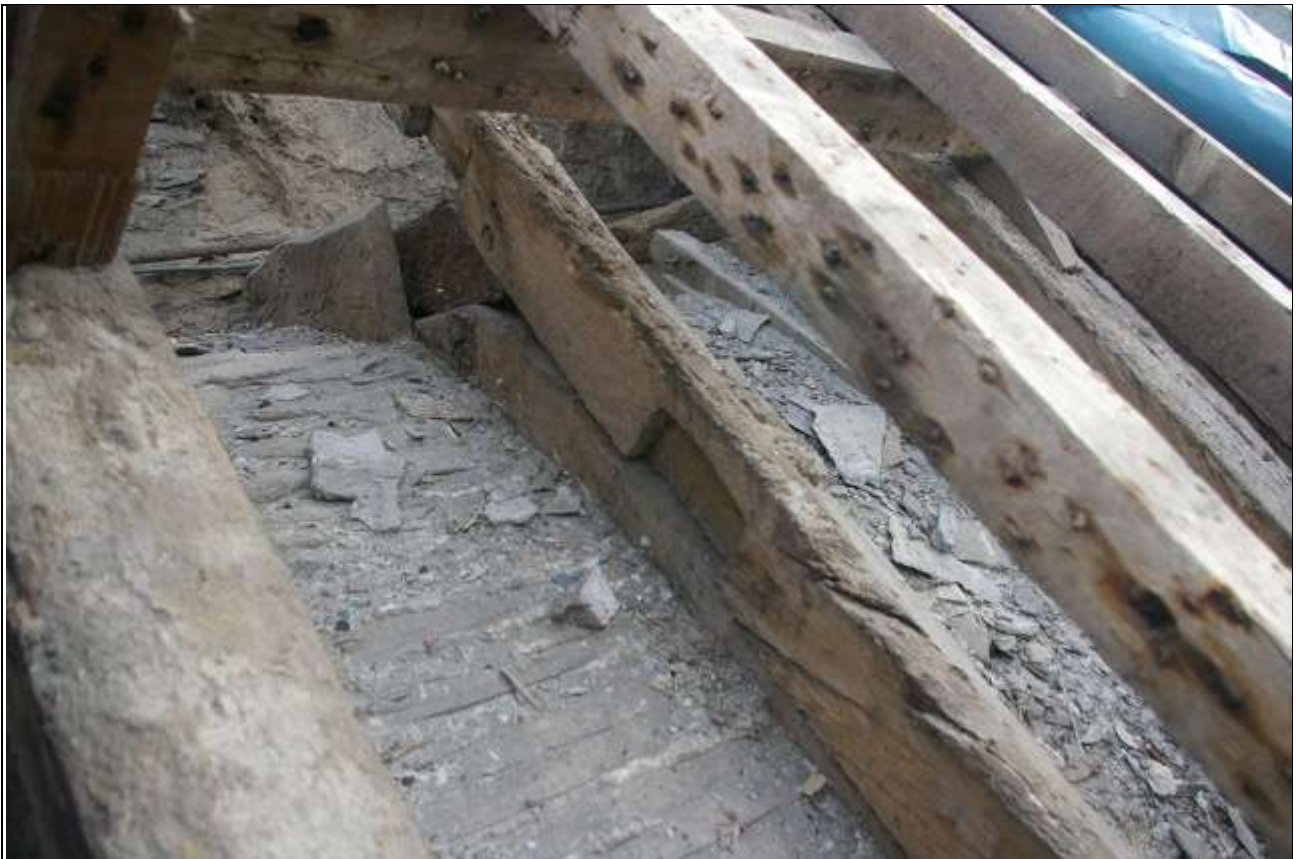
Of note is the reuse of elaborated timbers in the restructuring of the roof around the celestery and between the nave and the tower. This indicates that at least some of the late medieval decoration work within the church was altered/removed and upgraded in the newer fashionable 19<sup>th</sup> century Gothic style during the major restoration works. It also indicates the celestery, with some evident phasing, dates structurally to one of the 19<sup>th</sup> century phases of alteration, the whole area of the roof reworked.

SOCKETS IN ONE OF THE REUSED BEAMS, SOUTH SIDE OF THE TOWER, SHOWING OTHER REUSED BEAMS USED TO FORM THE BARREL CEILING; FROM THE SOUTH-WEST.

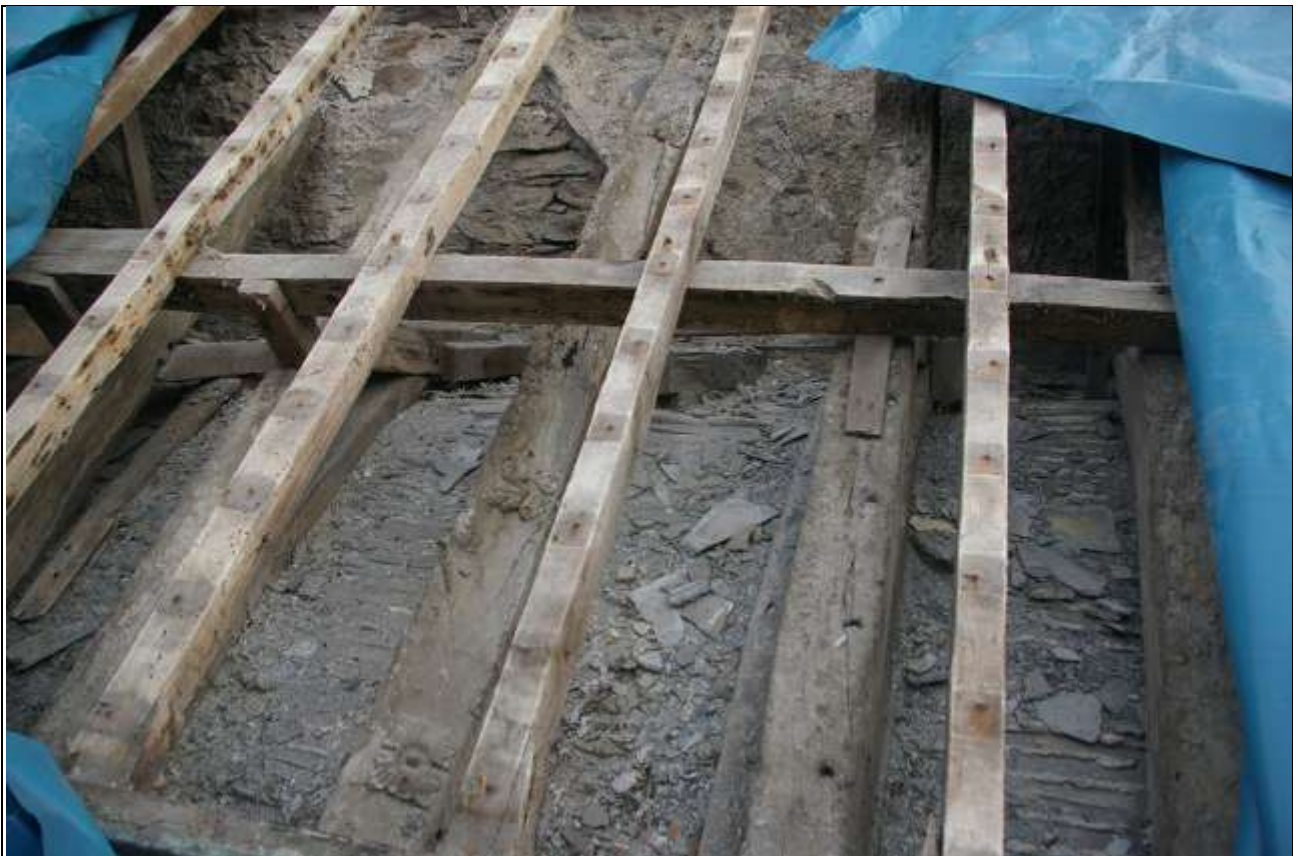
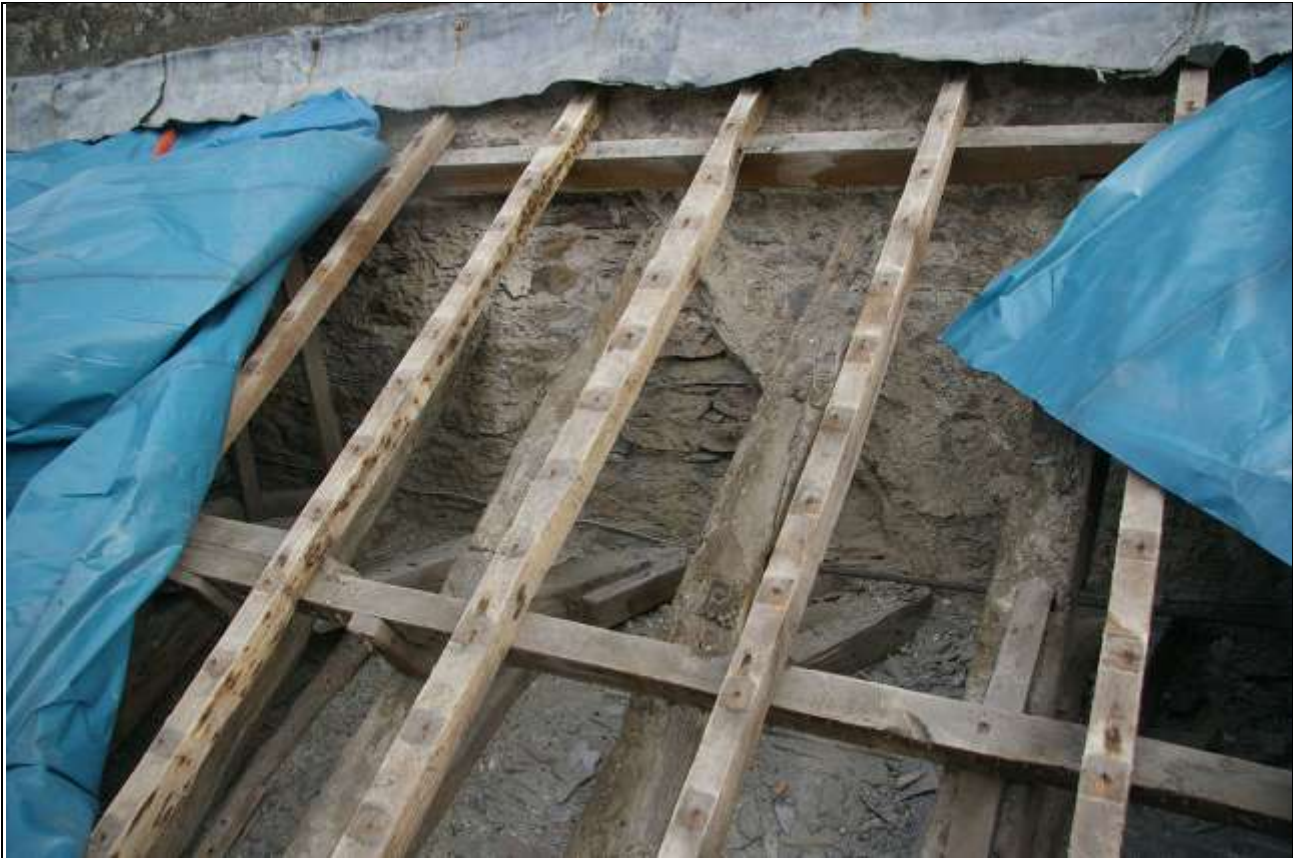
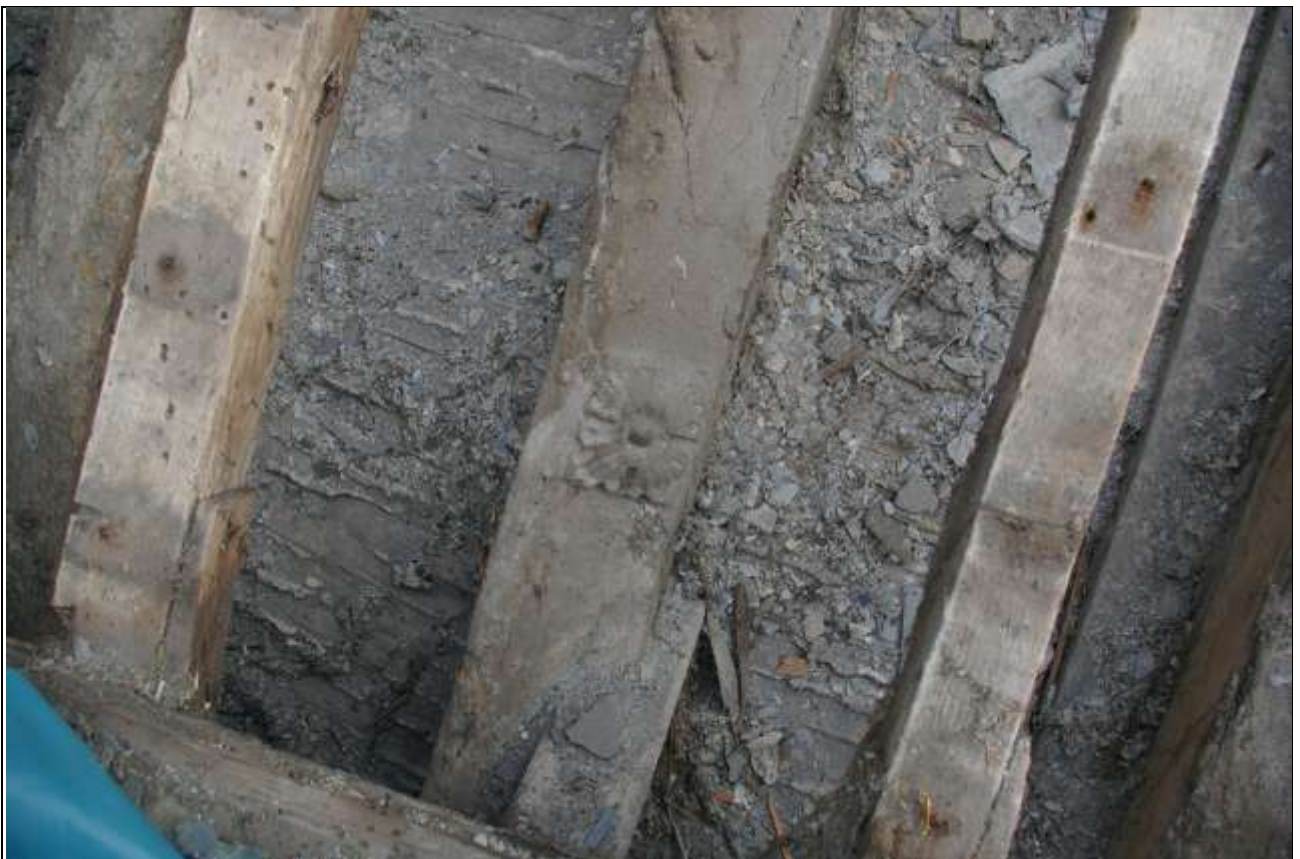
Reused timbers in the south face of the north aisle roof and the surprisingly lightweight timbers used on this north section confirm it as a different phase than the south section, which has more substantial trusses. One of the reused timbers has alternating square foliate and floral geometric plaque carvings of bas relief positioned along its length; this timber is probably a 15<sup>th</sup> century wall plate. Other timbers in the same section of reworked roof have smaller socket holes for partition rails, and larger cut sockets, having been purlins or former timber frames. Some of the timbers used are crudely cut to fit a length required and the whole is both pegged and nailed in areas; the nails are all large square-ended and handmade. Some of the timbers have heavy nail mark staining indicating they have been part of lathe and plaster ceilings. All the trusses here are reused and indicate this whole section of roof was significantly reworked. The early 20<sup>th</sup> century thin timbers which carry the current slated nailed roof are applied over these reused timbers so they are at least 19<sup>th</sup> century in their construction.

DETAIL OF REUSED TIMBERS IN NORTH AISLE ROOF, SOUTH FACE, AGAINST TOWER; FROM THE SOUTH, SOUTH-EAST

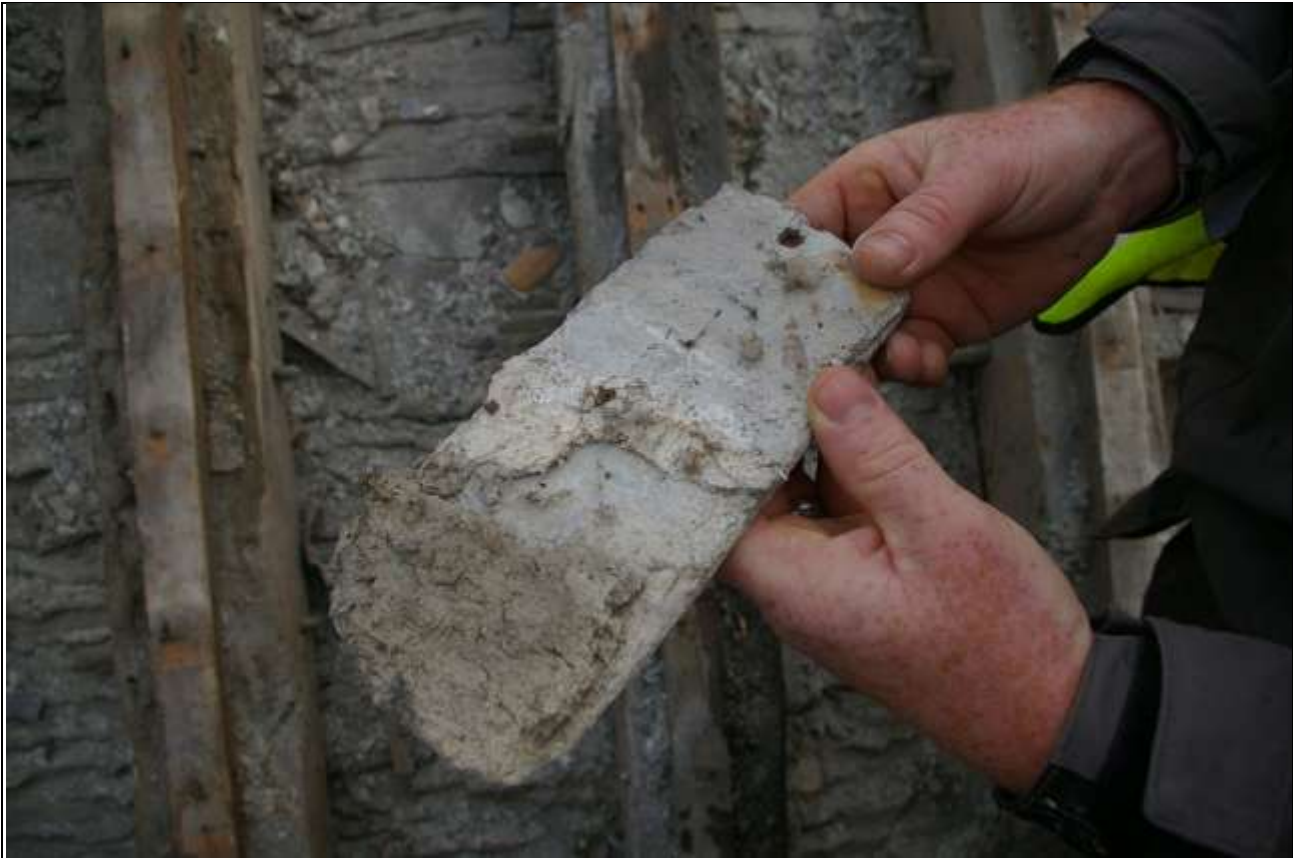
An earlier phase of roofing used oak pegs and heavier thicker lime torching, was of scantle form and may have been an earlier 19<sup>th</sup> century phase of roof slating and repair, or even pre-1800, possibly associated with the first phase of celestery works/alterations at the juncture of nave and chancel.

PEG SLATE, INDICATING SCANTLE SLATE ROOF WITH OAK PEGS, RECOVERED FROM SOUTH FACE OF NORTH AISLE ROOF.

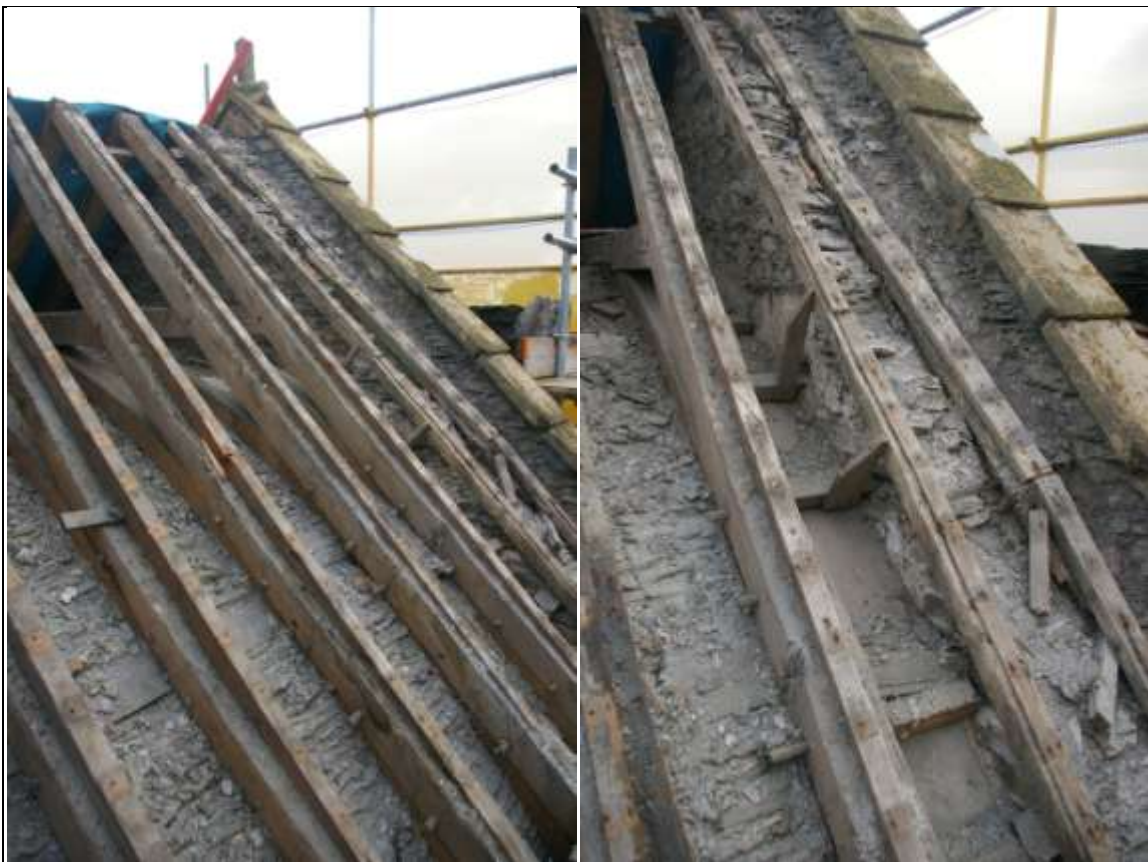
There is a secondary crude outer skim of rubble stone, using smaller neater stones, closer set, in a harder lime mortar, capped with limestone coping. The inner rubble is heavier, in a chunkier more rustic lime/clay mortar. It is likely that the outer walls have been 'neatened up' with an outer skim and additional 19<sup>th</sup> century carved stone detailing has been added as a further aggrandisement.

LEFT & RIGHT: THE THICK EAST STAGGERED RUBBLE WALL OF THE NORTH AISLE, SHOWING POSSIBLE 19<sup>TH</sup> CENTURY OUTER SKIM REBUILD, WITH STONE COPING; FROM THE SOUTH-WEST.

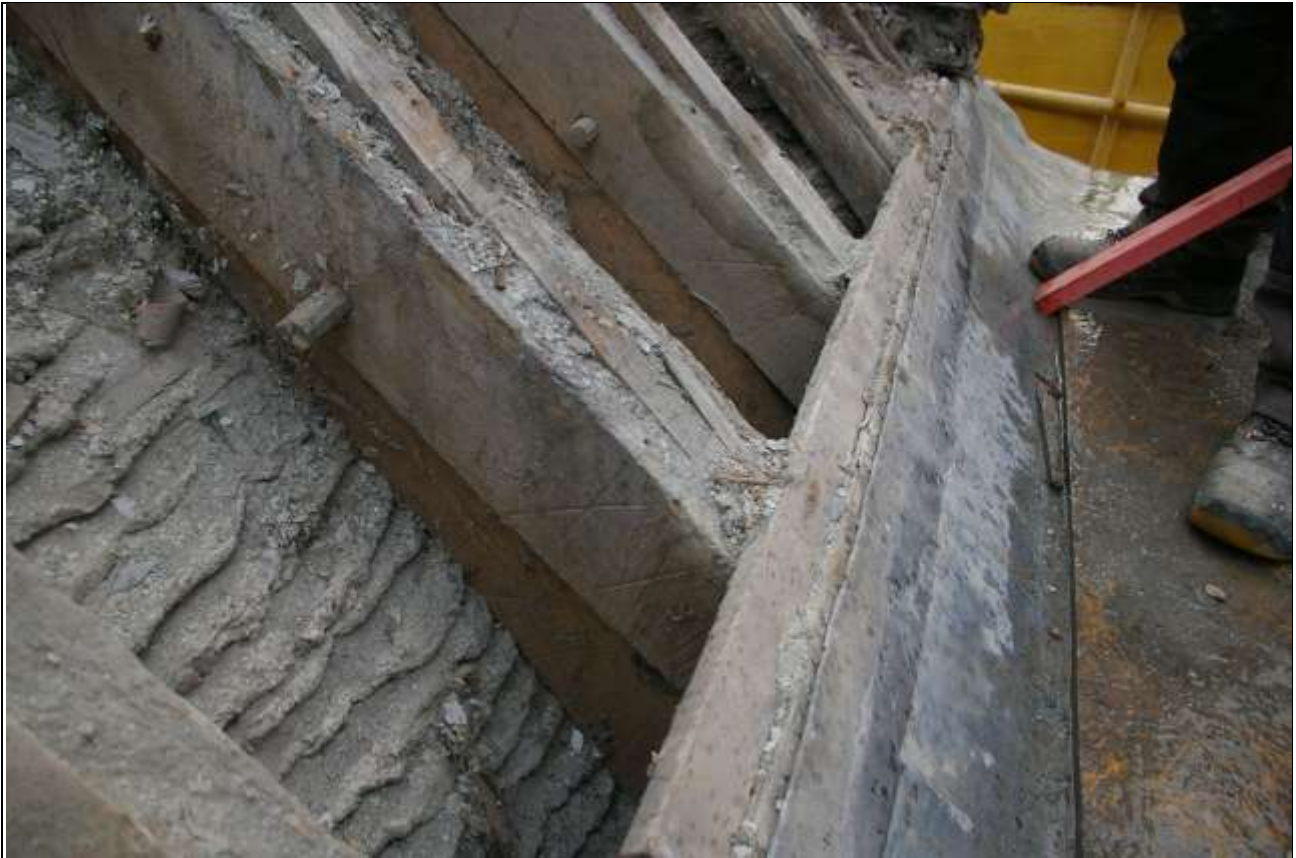
THE CARPENTERS MARKS ON THE NORTH AISLE ROOF TIMBERS; FROM THE WEST-SOUTH-WEST.

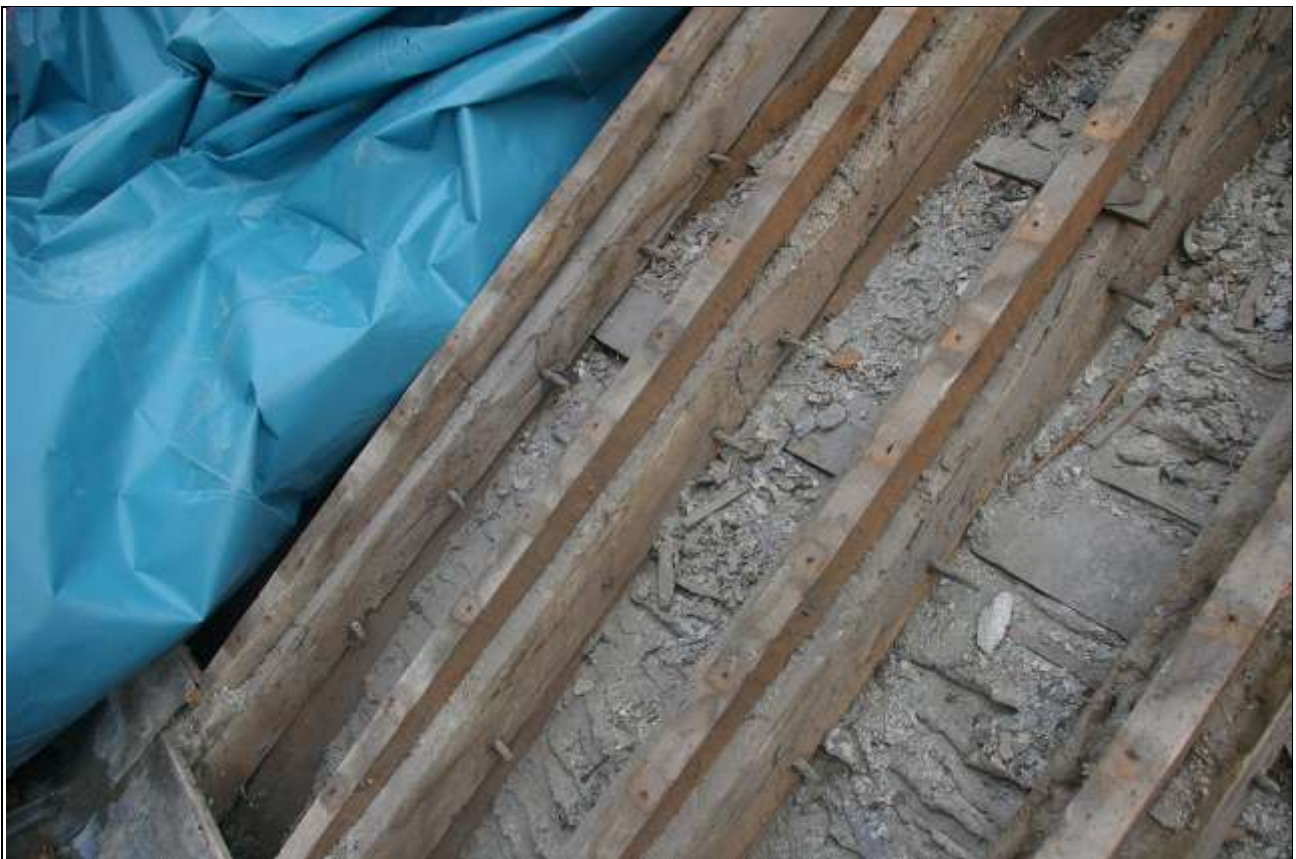
LIGHTWEIGHT JOINTED TRUSSES WHICH CARRY THE BARREL VAULTED CEILINGS OVER THE NORTH AISLE, SHOWING PEGGED JOINTS AND MODERN TIMBERS ATTACHED TO BACK OF BLADES TO CARRY THE SLATED ROOF; FROM THE EAST, SOUTH-EAST.

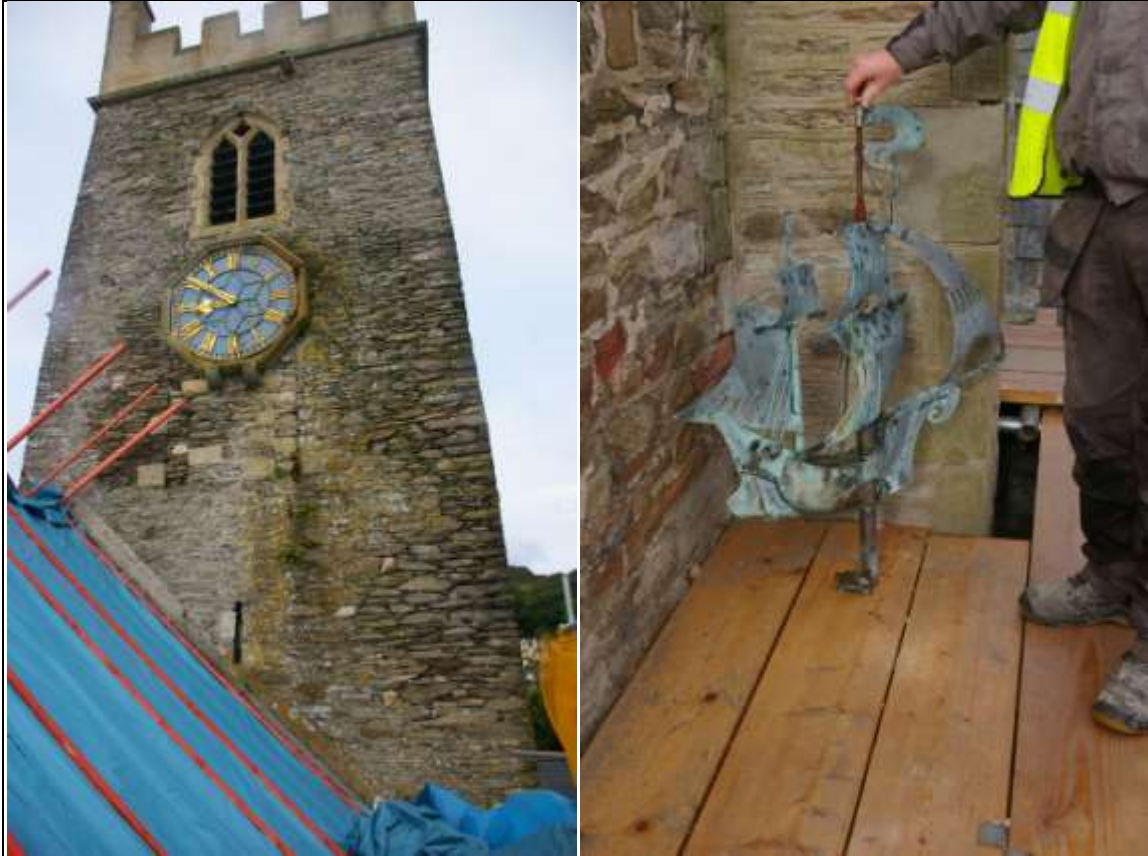
There is a blocked opening in the upper stage of the church tower, with dressed blocks forming rough quoins to reveals, seen under a blue-faced octagonal clock; the opening blocked in at least two phases. This suggests that the bell chamber may have been set lower in the tower. A lower and simpler terminus would better suit the proportions of this tower; the obvious battering of the tower

LEFT: DETAILED VIEW OF THE TOWER, SHOWING THE EAST SIDE AND BLOCKED OPENINGS, INDICATING PHASING, ALSO SHOWING ODD ANGLE OF ROOFLINE WHERE ATTACHED TO TOWER; FROM THE EAST, NORTH-EAST.

RIGHT: 19<sup>TH</sup> CENTURY ELABORATE WEATHERVANE IN FORM OF HISTORIC SAILING VESSEL; FROM THE ROOF OF THE VESTRY

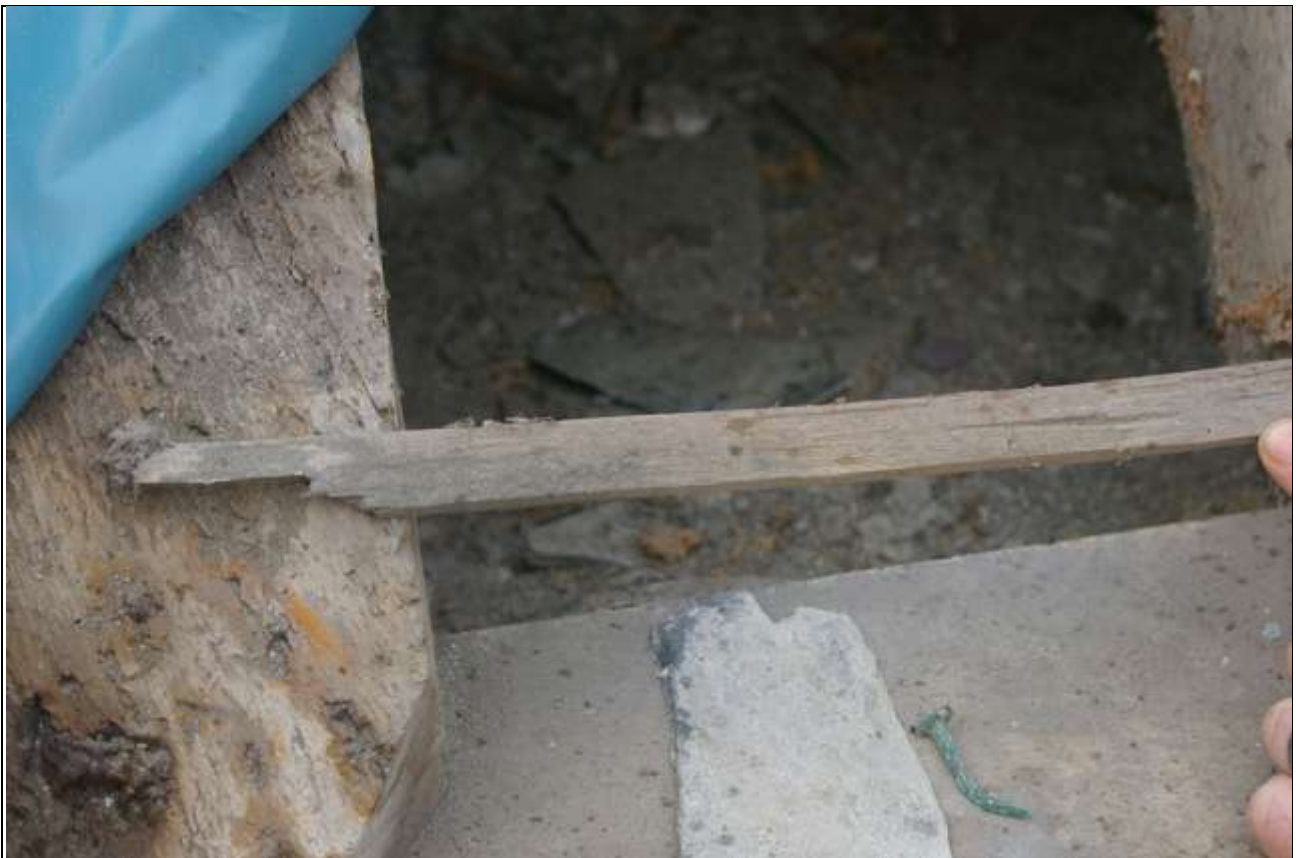
SPLIT OAK LATHE USED IN SCANTLE SLATE ROOF, RECOVERED FROM THE SOUTH FACE OF THE NORTH AISLE ROOF.

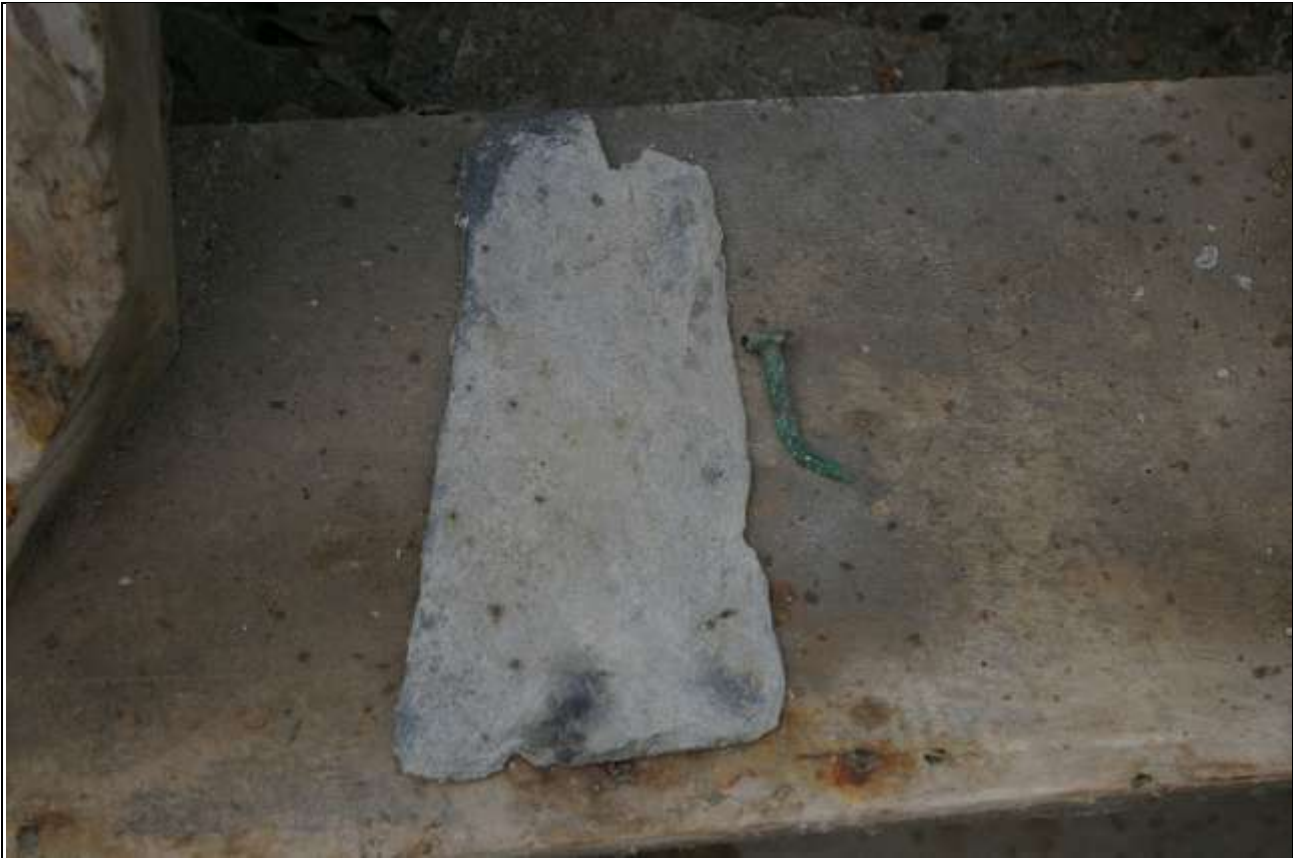
Previous 19<sup>th</sup> century phases used copper tacks and were of typical graduated scantle form, with some lime torching. Changes to the celestery area include changing the roofline markedly, using timbers from the church, probably in the first 1860s phase of restoration works.

PEG SLATE, FROM SCANTLE ROOF COVERING OVER NAVE AND NORTH AISLE, WITH ORIGINAL COPPER PIN/PEG.

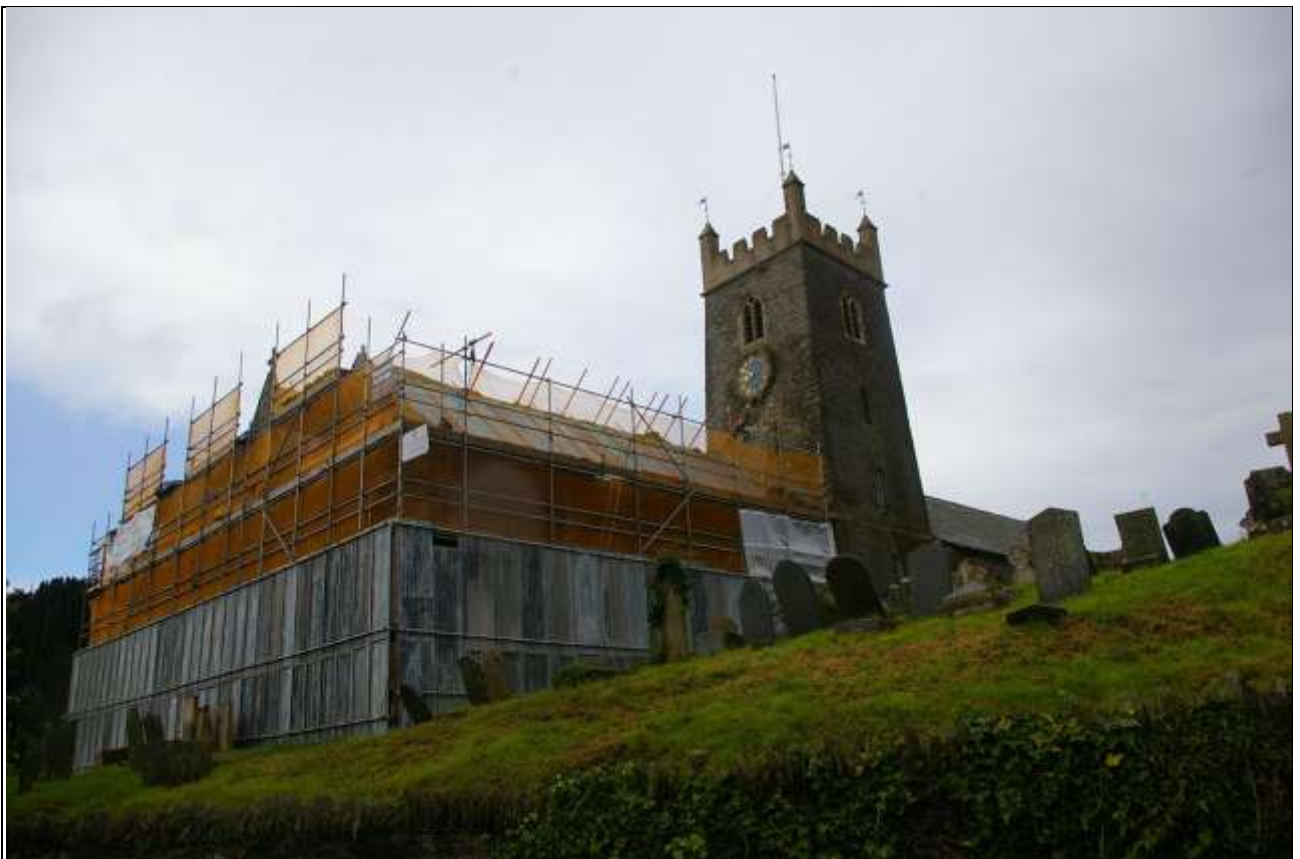
THE CHURCH AND TOWER VIEWED FROM THE NORTH-EAST, SHOWING THE NORTH END OF THE NAVE, NORTH AISLE, AND NORTH TRANSEPTAL TOWER.

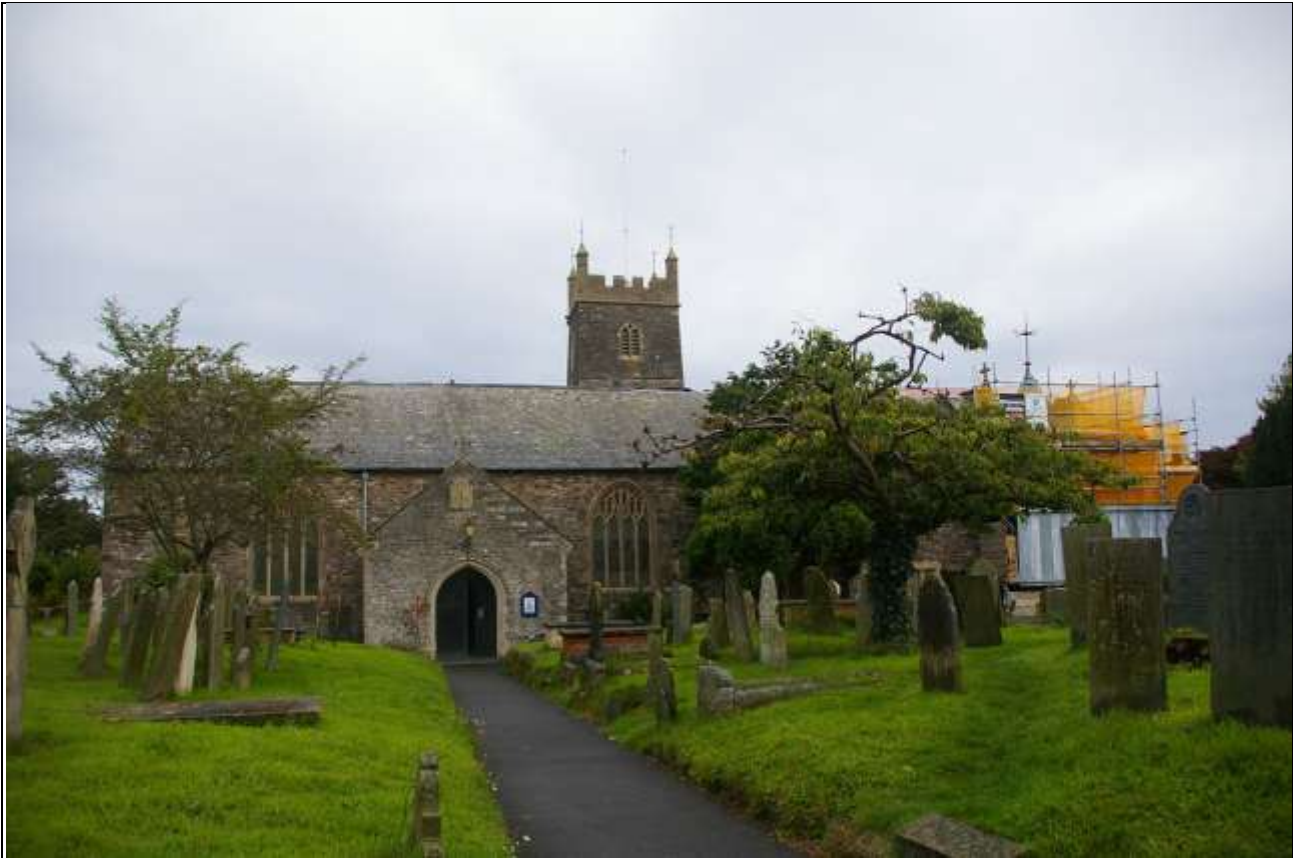
VIEW OF THE CHURCH, FROM THE LYCHGATE, SHOWING SOUTH PORCH, SOUTH AISLE AND THE LARGE 19<sup>TH</sup> CENTURY REPLACEMENT PERPENDICULAR STYLE STONE WINDOWS; FROM THE SOUTH-WEST.

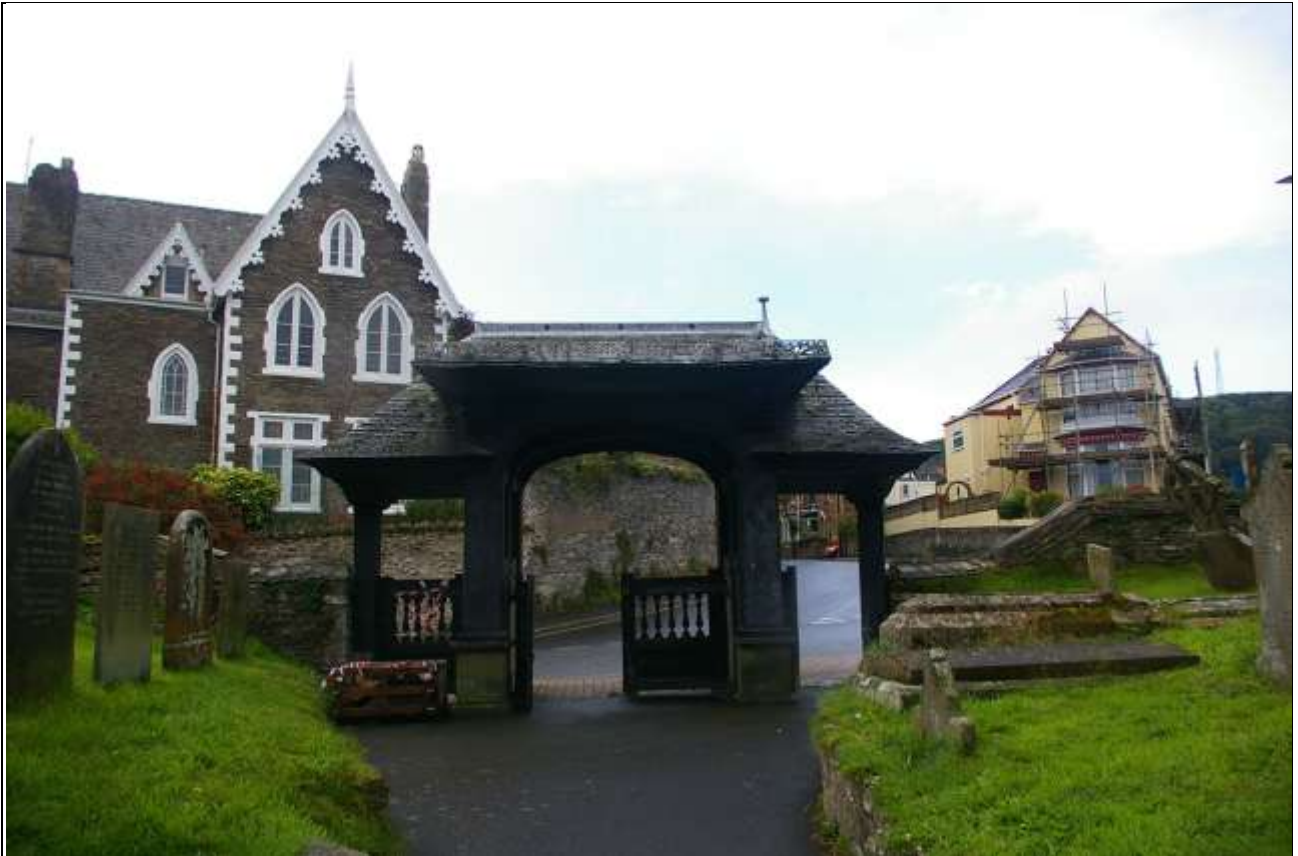
ELABORATE LYCH GATE WITH SCANTLE SLATE ROOF AND PEGGED TIMBER FRAME, DATED 1836; FROM THE NORTH-WEST.

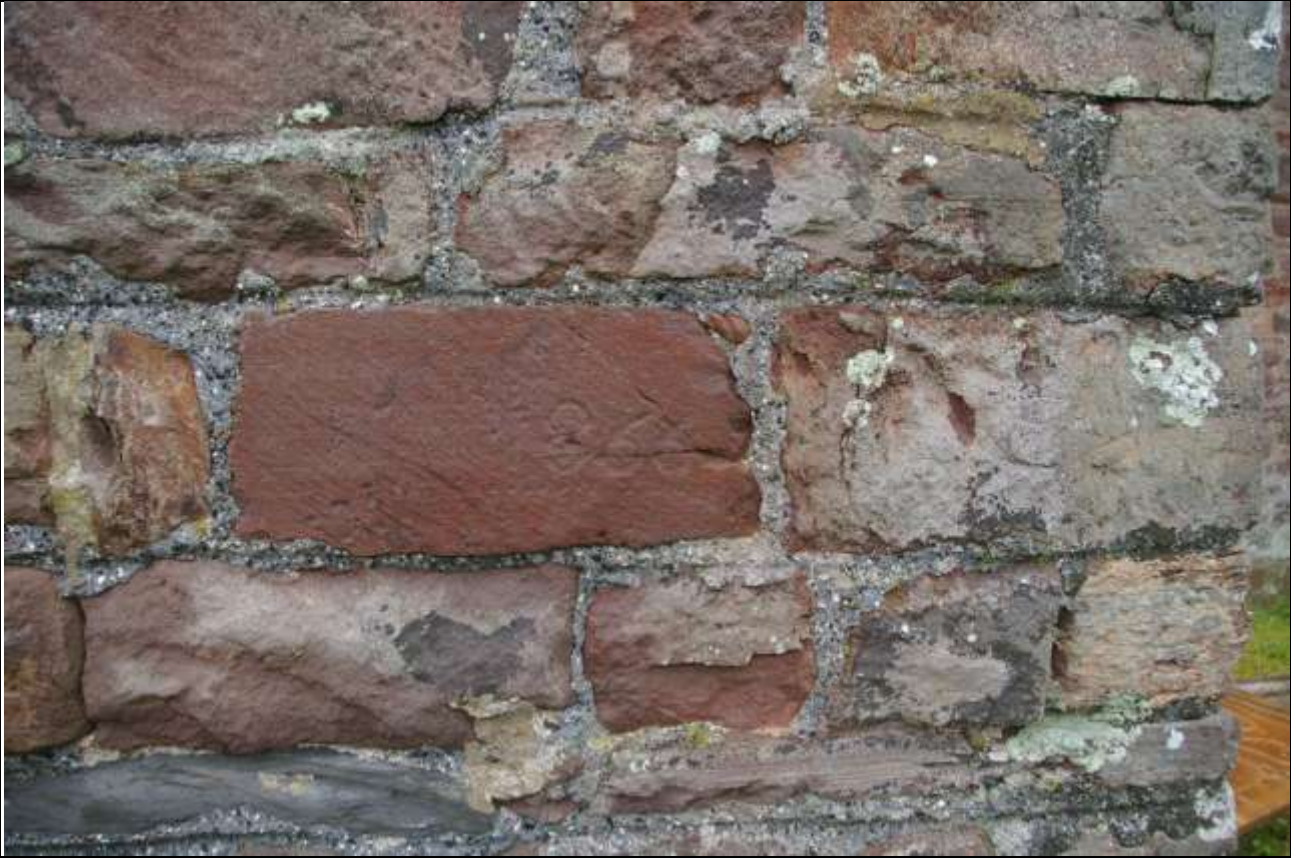
INSCRIBED STONE TO RIGHT OF ARCHED OPENING TO NORTH PORCH, WITH DATE OF 1866; FROM THE NORTH.

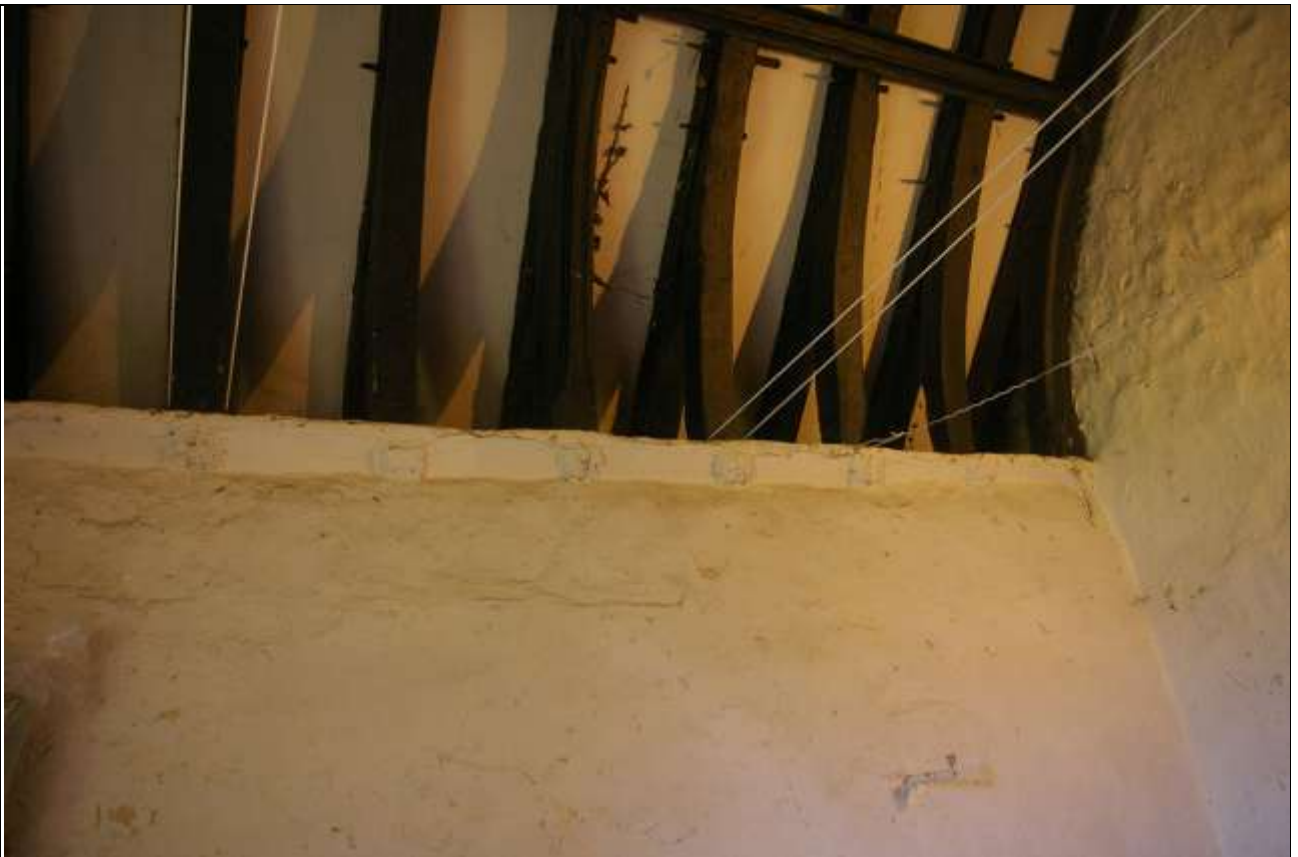
The north porch contains an inscribed stone, with the date 1866, to the right of the arched opening. The open wagon roof has a crispness of carving to the moulded ribs and lighter scantle to some beams suggesting heavy restoration or a wholly 19<sup>th</sup> century date of reconstruction, reusing timbers. Two sections of wallplate have plaques of bas relief of geometric alternating foliate and floral motif. This wall plate is identical to that reused in the roof against the north tower and is probably 15<sup>th</sup> century in date.

THE OPEN WAGON ROOF IN THE NORTH PORCH, SHOWING THE SECTIONS OF WALLPLATE WITH SQUARE LEAF AND FOLIATE GEOMETRIC DESIGNS, THE SAME AS THAT ON THE REUSED TIMBERS IN THE NORTH AISLE ROOF; FROM THE NORTH-WEST.

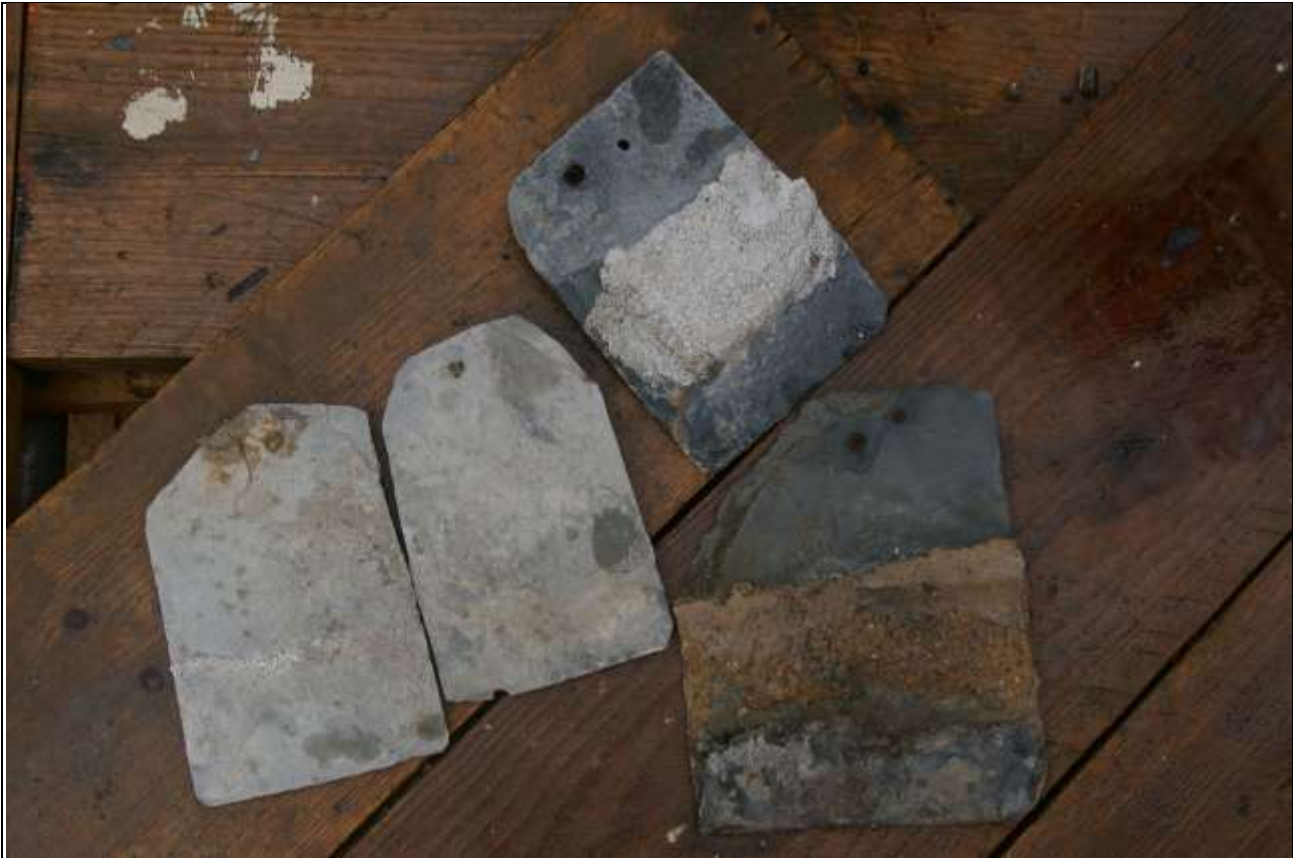
PEG SLATES, SHOWING TWO HOLES, INDICATING AT LEAST ONE REUSE, WITH LIME TORCHING REMOVED FROM THE NAVE AND NORTH AISLE ROOFS, ONE WITH INTACT OAK PEG.
