# HOLY TRINITY CHURCH ILFRACOMBE NORTH DEVON DEVON

HISTORIC BUILDING RECORDING

South West Archaeology Ltd. report no. 171006

## Holy Trinity Church, Ilfracombe, Devon Historic Building Recording

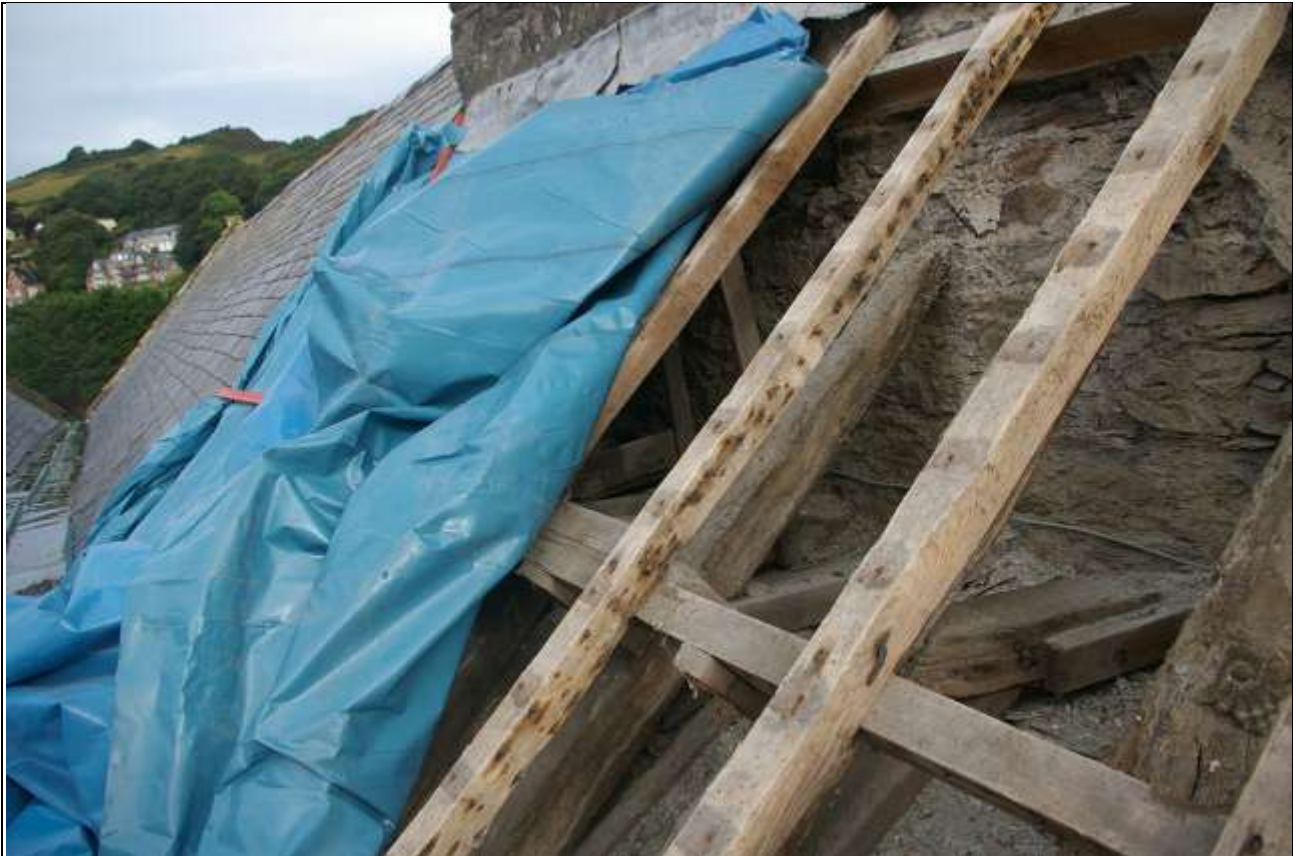
On the south face of the tower, within the pitch of the north aisle roof, there is a previous roofline with scarring from lead flashing and lime plaster. This roofline was gabled, with a double pitch, running north-south indicating a wholly different orientation and structure to the roof at the point where it would abut the celestory on the nave. Pevsner discussed the celestory in some detail in his text, with an overview of it probably being 18<sup>th</sup> century, with 19<sup>th</sup> century alterations, most notably the inserted 1899 windows by Fellowes Prynne. The marked change in roof structure at this point would seem to confirm significant changes from its intended late medieval design.

HISTORIC ROOFLINE, SHOWING COMPLETELY DIFFERENT PITCH WITHIN ROOF SPACE AGAINST SOUTH SIDE OF TOWER; FROM THE SOUTH-EAST.

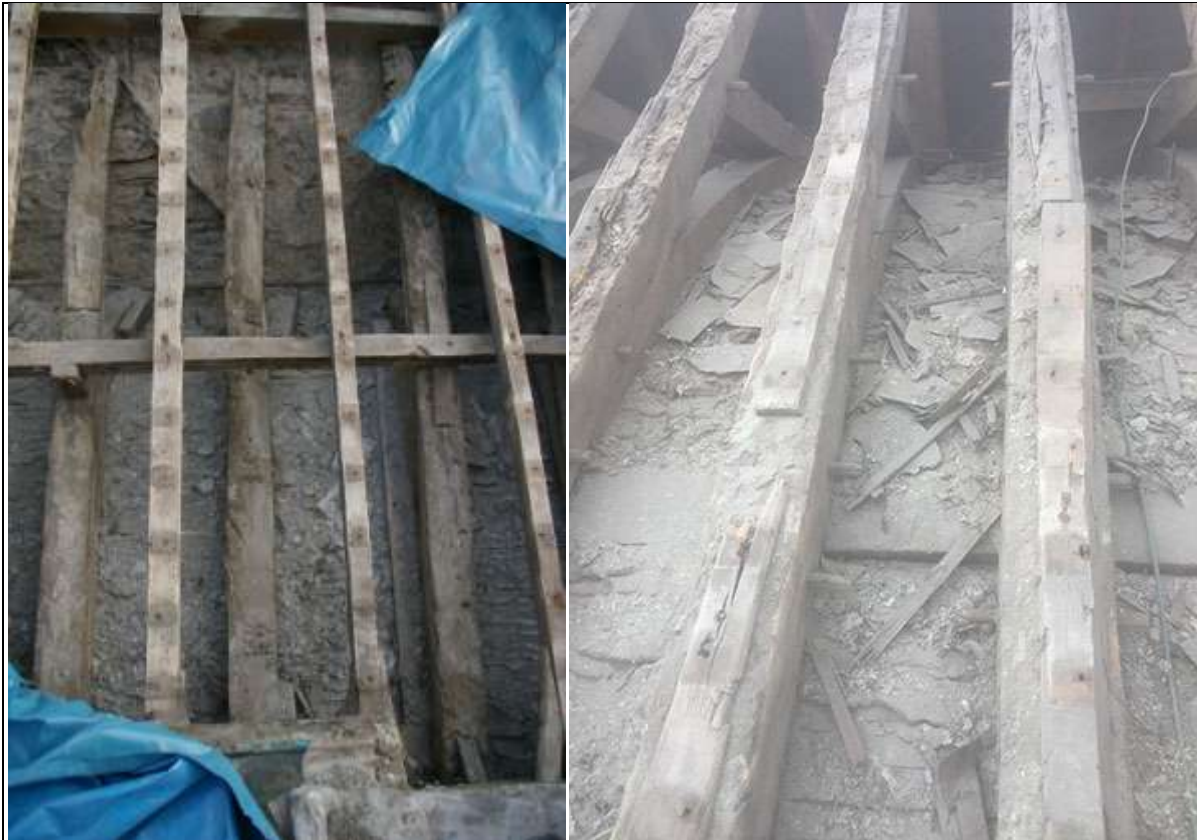
LEFT: THREE REUSED TIMBERS WITHIN ROOF OF NORTH AISLE, BUILT AROUND NORTH TRANSEPT TOWER, PART OF A FORMER PARTITION; ALSO SHOWING FORMER ROOFLINE ON TOWER WALL, FROM THE SOUTH-SOUTH-EAST.  
RIGHT: HEAVIER TRUSSES OVER THE SOUTH AISLE ROOF.

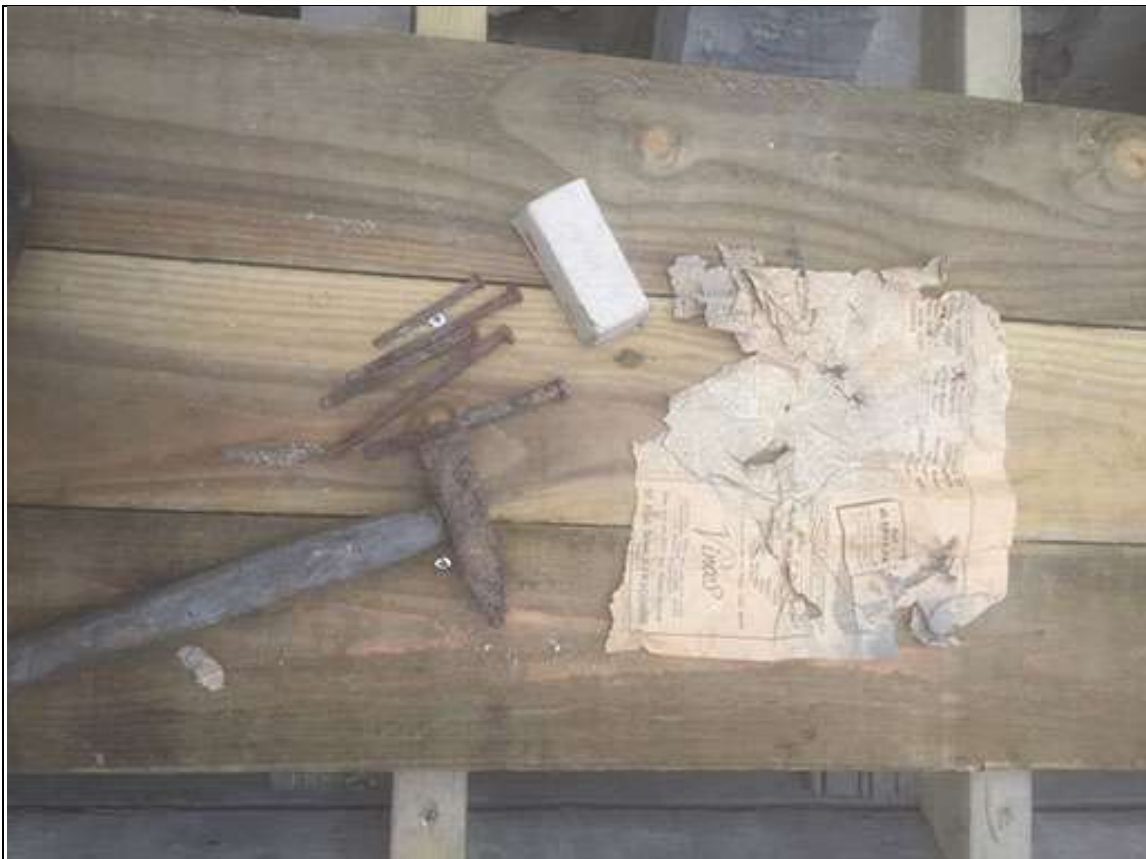
HAMMER AND HANDMADE IRON TACKS/NAILS FOR ROOFING, FOUND IN SOUTH AISLE ROOF, INDICATING AN EARLY 20<sup>TH</sup> CENTURY PHASE OF RESLATING/REPAIRS.

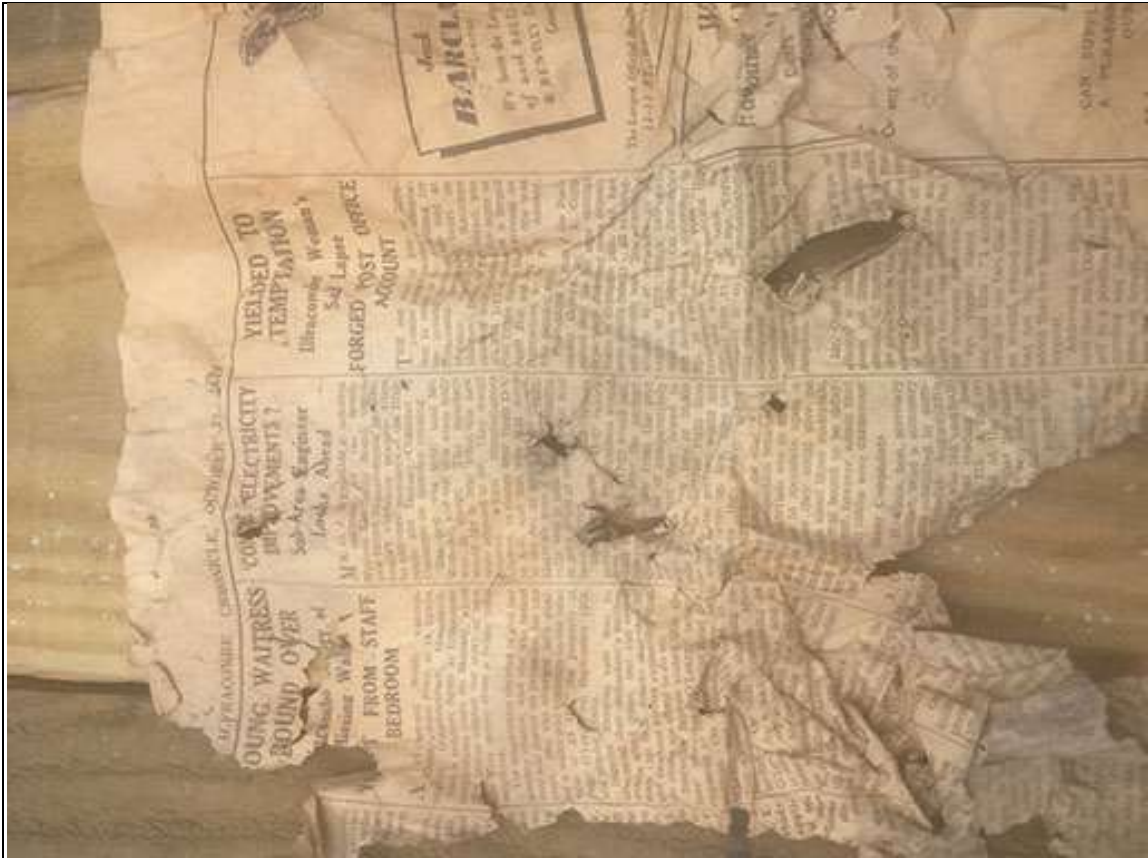
NEWSPAPER FROM 1948, THE ILFRACOMBE CHRONICLE, FOUND IN SOUTH AISLE ROOF.

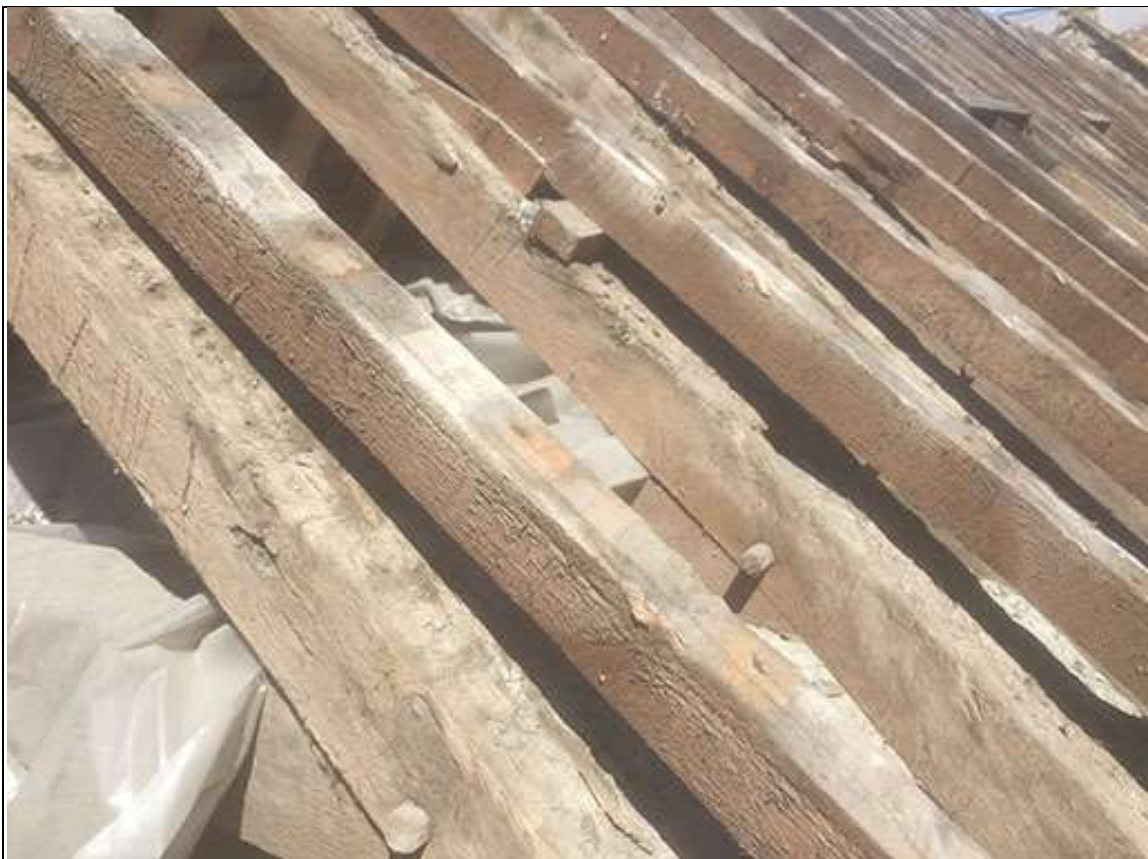
CARPENTERS NUMBERING MARKS ON THE SOUTH AISLE TRUSSES.

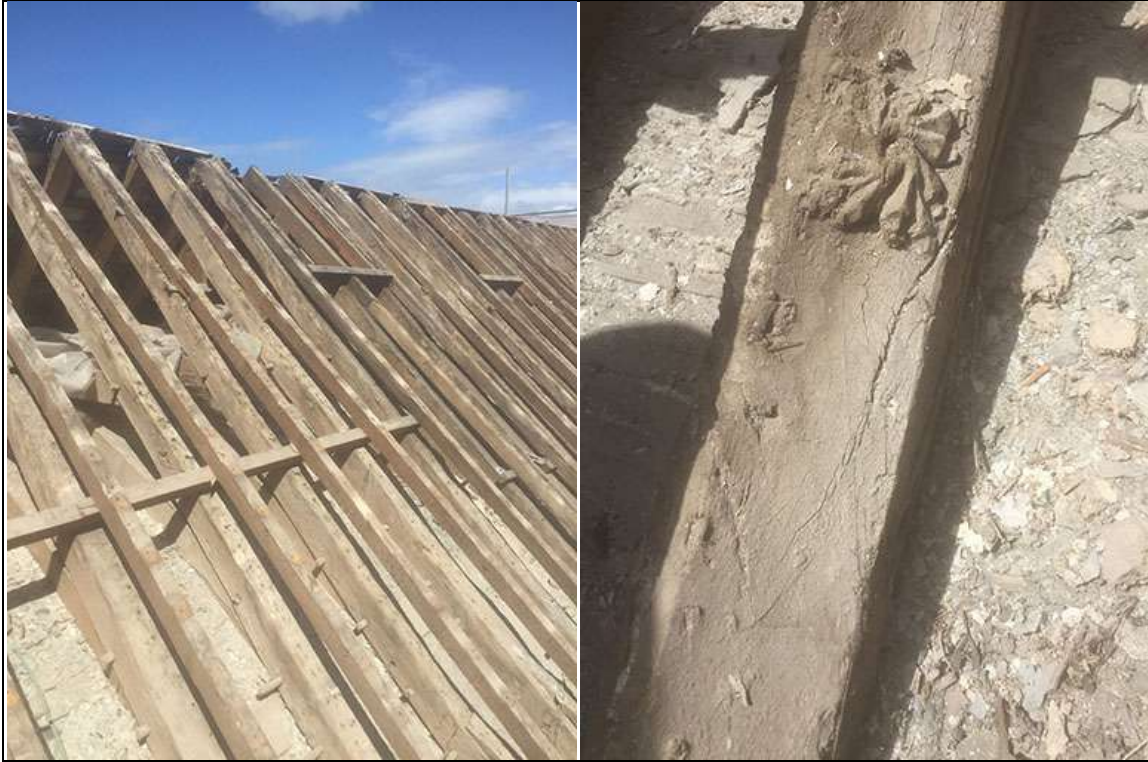
The roof of the church has undergone several phases of repair in the early 1900s, the early 20<sup>th</sup> century and in the 1940s. This phase used iron nails and larger slates, of a more even width and size. The south aisle roof particularly was sagging (the aisle was extended and is now surprisingly wide, the roof therefore under more stress). Modern timbers were attached to the back of the truss blades and battens braced off them, to make the roof more even and spread the weight of the slates. These timbers were all attached with iron nails and were very lightweight. On the north aisle roof, they were nailed to the backs of the truss blades to carry the battens but were required to balance out any sag in the roof (the north aisle is much narrower) so only shorter sections of reused narrow timber were used.

LEFT: 20<sup>TH</sup> CENTURY TIMBERS NAILED TO TRUSSES ON SOUTH AISLE TO CORRECT SAGGING AND BRACE AND REPLACE ROTTEN SECTIONS, SHOW A PHASE OF EARLY 20<sup>TH</sup> CENTURY REPAIR AND RESLATING.

RIGHT: DETAILED VIEW OF THE CARVING ON REUSED TIMBER SEEN IN NORTH AISLE, AGAINST TOWER.

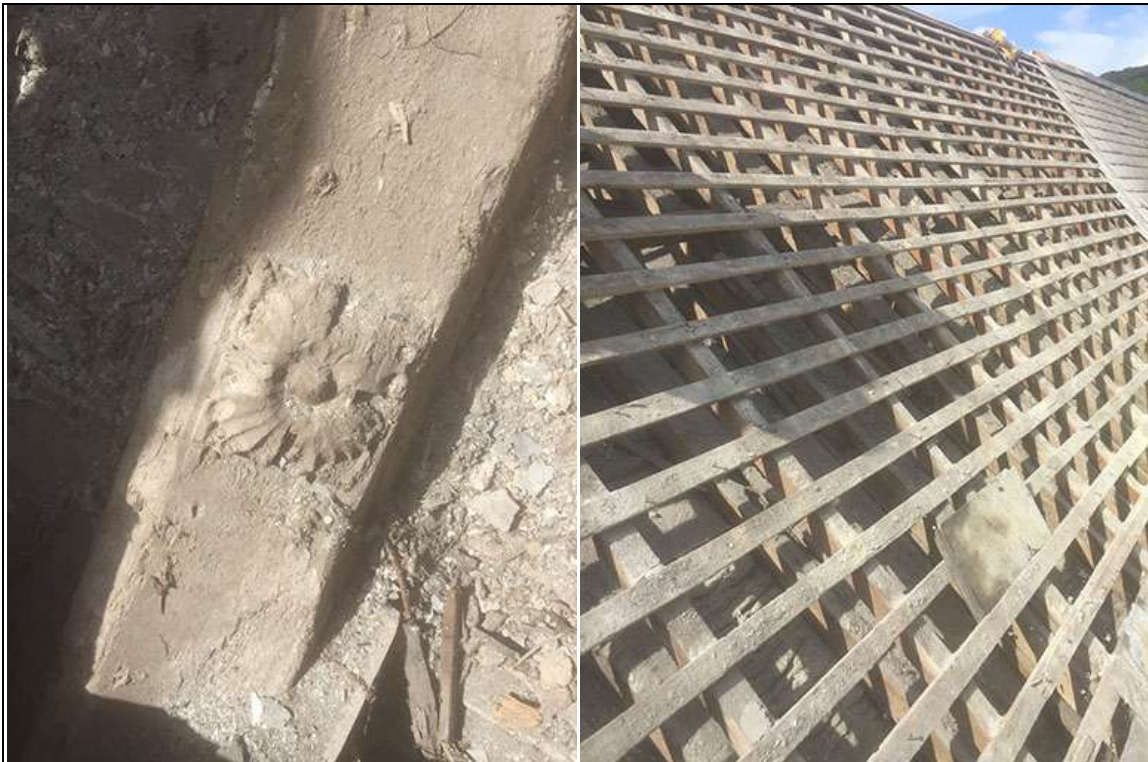
LEFT: AS ABOVE.

RIGHT: NORTH SIDE OF CHANCEL ROOF, WITH MODERN TIMBERS AND BATTENS OVER THE ORIGINAL ROOF STRUCTURE BENEATH.

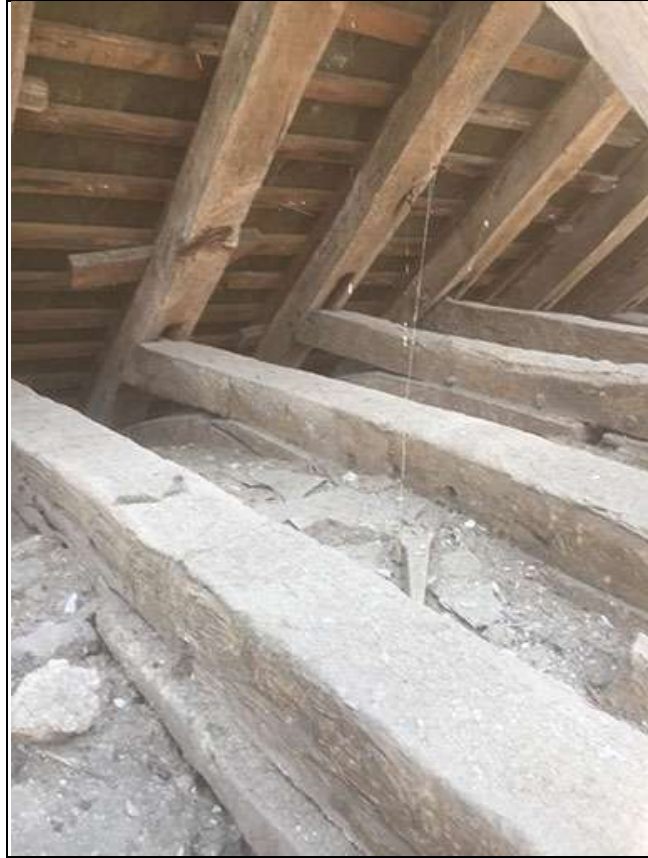
VIEW INSIDE THE NORTH AISLE ROOF SHOWING ITS RELATIVELY NARROW WIDTH COMPARED TO THE OTHERS.
