TREGERLES FARM MITCHELL St NEWLYN EAST CORNWALL

Desk-Based Assessment & Historic Building Recording

South West Archaeology Ltd. report no. 171812

18th December 2017

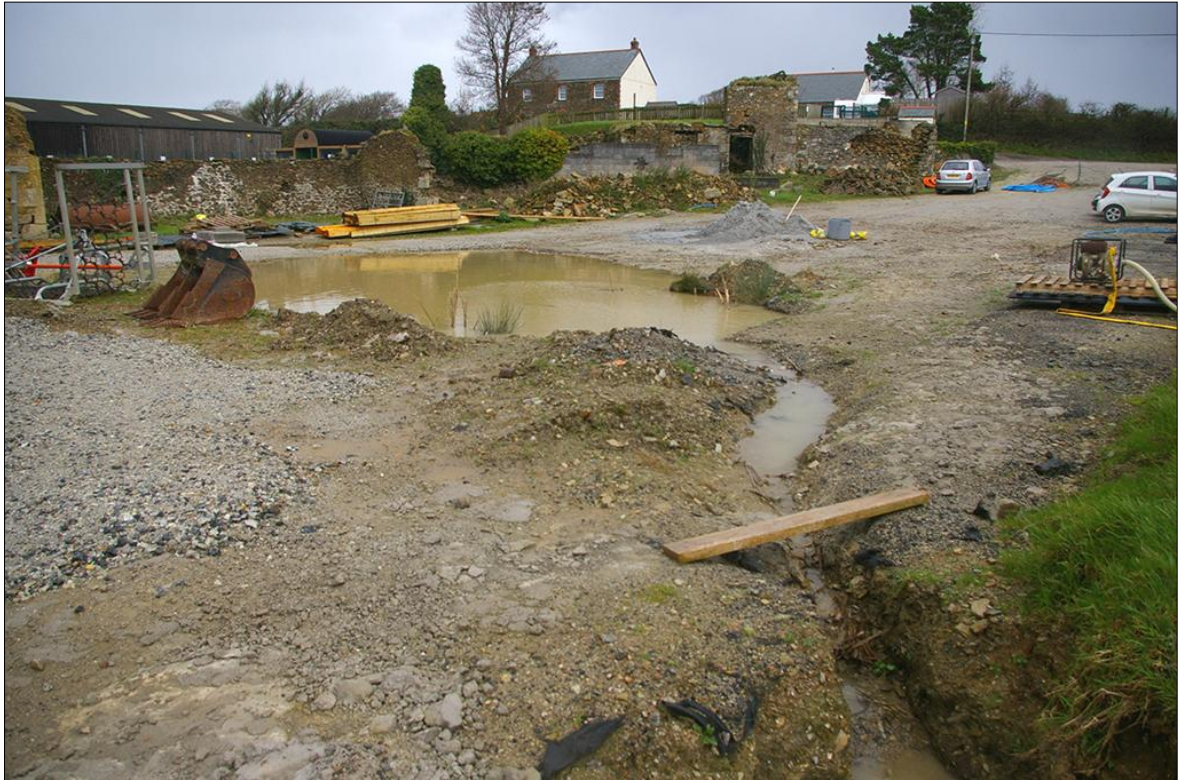
FIGURE 10: VIEW ACROSS THE FORMER YARD FROM THE SOUTH-WEST, LOOKING NORTH-EAST.

The farmyard is divided from the pasture field to the south by a low (1.2m) hedgebank; this hedgebank has slumped, forming a gently-profiled earth and stone bank topped with overgrowth hedge shrubs, but seems to have (once) had a pitched stone face. There is a ditch on the yard side of this hedge, and the level of the ground is higher (c.1.0m) on the field side; topsoil from works since c.2005 has raised the level of this field by c.0.35m (Client, *pers. comm.*).

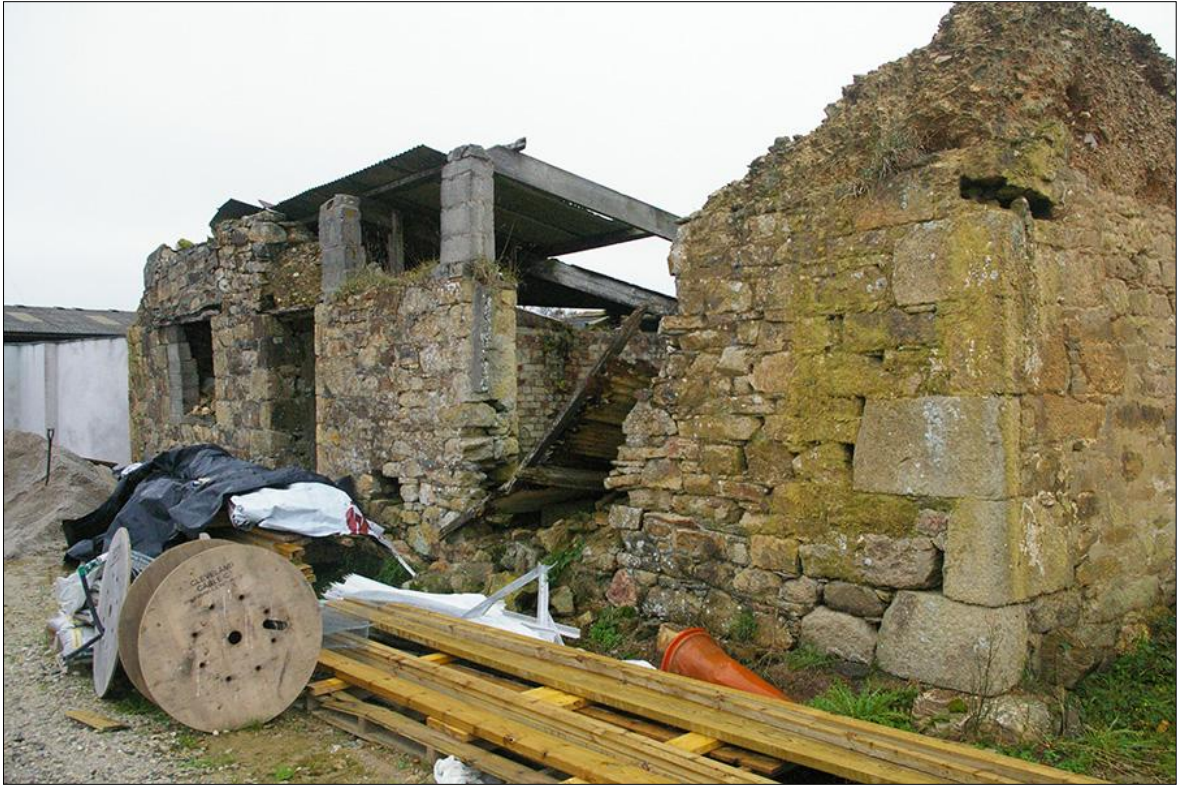
The surviving element of this structure is a single-storey two-cell building, the rooms divided by a 20th century brick wall. The west wall has recently been demolished, and the rear (north) was demolished and rebuilt in shuttered concrete in line with the back of B2 in the 20th century. A replacement mono-pitch roof of reused (20th century) wooden rafters carrying a simple corrugated iron roof survives over the west cell; the east cell is roofless. The two surviving original walls are of mixed sandstone, slatestone, granite, and quartz rubble, with a raise in similar, but poorer-quality stone rubble and coarse pale buff-brown cob, which form an upper ½ storey (loft). The surviving openings are all in the south wall, consisting of an off-centre doorway with windows to each side; a doorway has been forced through the window serving the east cell. The build to west and east is markedly different: to the east it is of neat semi-coursed regularised stone rubble with shale levelling courses, with dressed quoins to the south-east corner. This coarse sandstone is a pale yellowish buff-brown colour, pointed in a pale creamy lime mix and bonded with yellowish-brown clay. To the west the stonework is less accomplished; the build includes quartz and granite, with larger and more irregular roughly-coursed stone blocks with roughly-dressed quoins set in a lime mortar, repointed with a hard grey mortar. The thickness of these walls also varies – that to the east is only c.0.55m thick; that to the west is c.0.75m thick. There may have been a loading door at first-floor level above the off-centre doorway, now blocked in cob. The east gable is the least-altered and in the best condition. It featured a large fireplace, of which only part of the north side with a granite post survives; there is a scar on the wall where the south wall of the hearth was removed.

This was the original farmhouse/cottage, heavily-altered in the mid 20th century, presumably when a replacement farmhouse was built to the SSE [SW8616655674]. Those changes include: the rear wall was demolished and brought in line with that of B2; the south side of the hearth was removed; a doorway was forced through the east window; and a simple mono-pitch corrugated iron sheet roof was installed. The change in build quality across the structure, and the raise, would indicate three phases, but all 19th century in date. The historic photographs show this building as lacking its original roof by c.1960.

FIGURE 11: THE SOUTH ELEVATION OF B1; VIEWED FROM THE SOUTH-EAST.

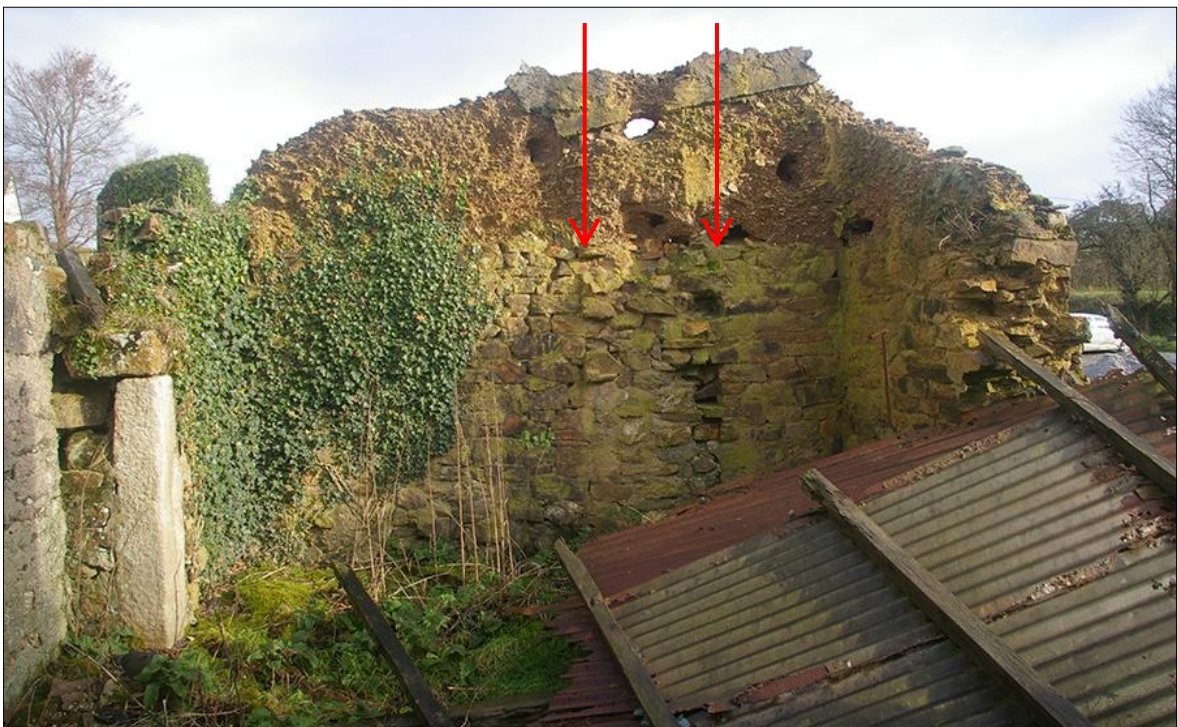
- Chimney stack scar to east gable;
- Dressed stone upright to left of former hearth.

FIGURE 12: INTERNAL EAST GABLE OF B1, SHOWING THE FIREPLACE (LEFT) AND WALL SCAR (INDICATED); VIEWED FROM THE WSW.

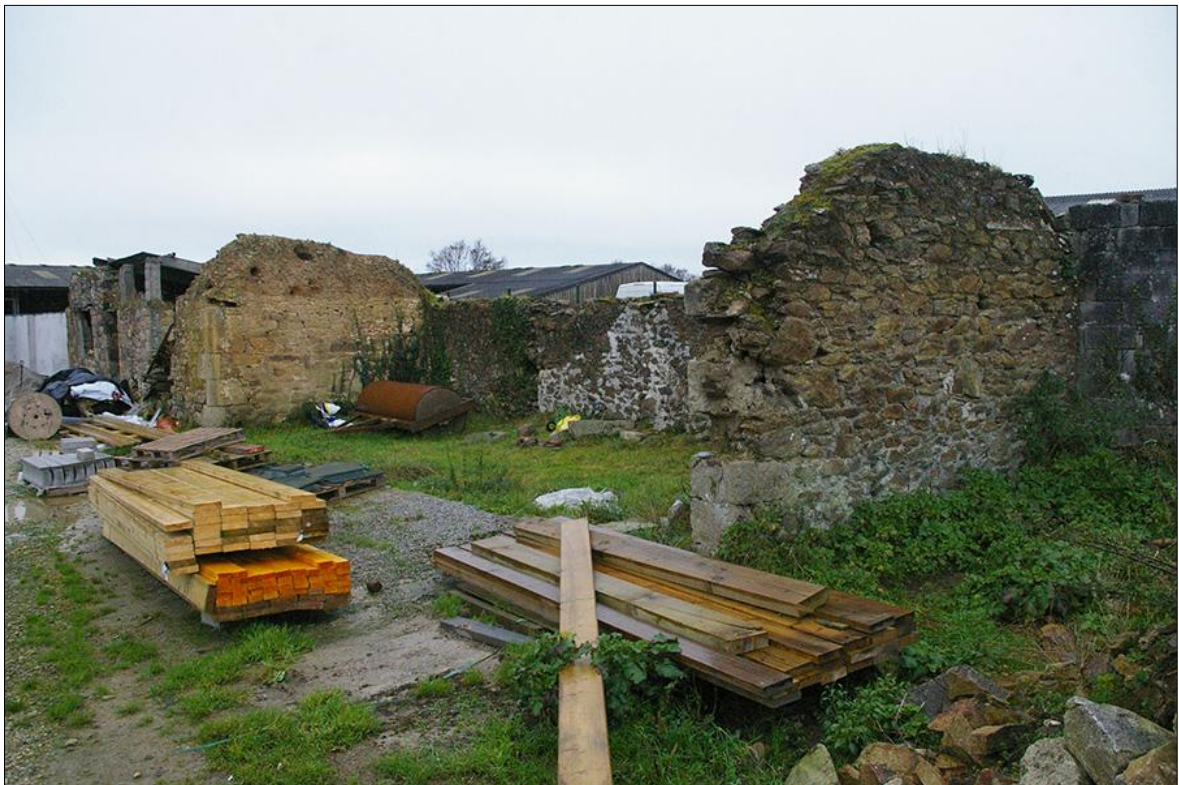
Single-storey open-fronted shed of stone rubble, consisting of a long and much-patched north wall and eastern pitched gable of 1½ storeys. The walls are of weathered slatestone, yellowish-brown mudstone and sandstone, with good roughly-dressed quoins on the south-east corner, in a lime mortar with cement repointing. There is some variation in the build, with larger slatestone blocks to the lower 0.5m, and the scar for a lost internal partition. The floor is concrete. All features and fittings, including the roof, have been lost. The historic photographs show this building as having a pitched slate roof.

The building is open-fronted, which would suggest a cart shed or similar. However, historic photographs show the building as closed with a series of doors that would indicate the south wall was demolished and removed, probably in the mid 20th century.

FIGURE 13: B2, VIEWED FROM THE SOUTH-EAST.

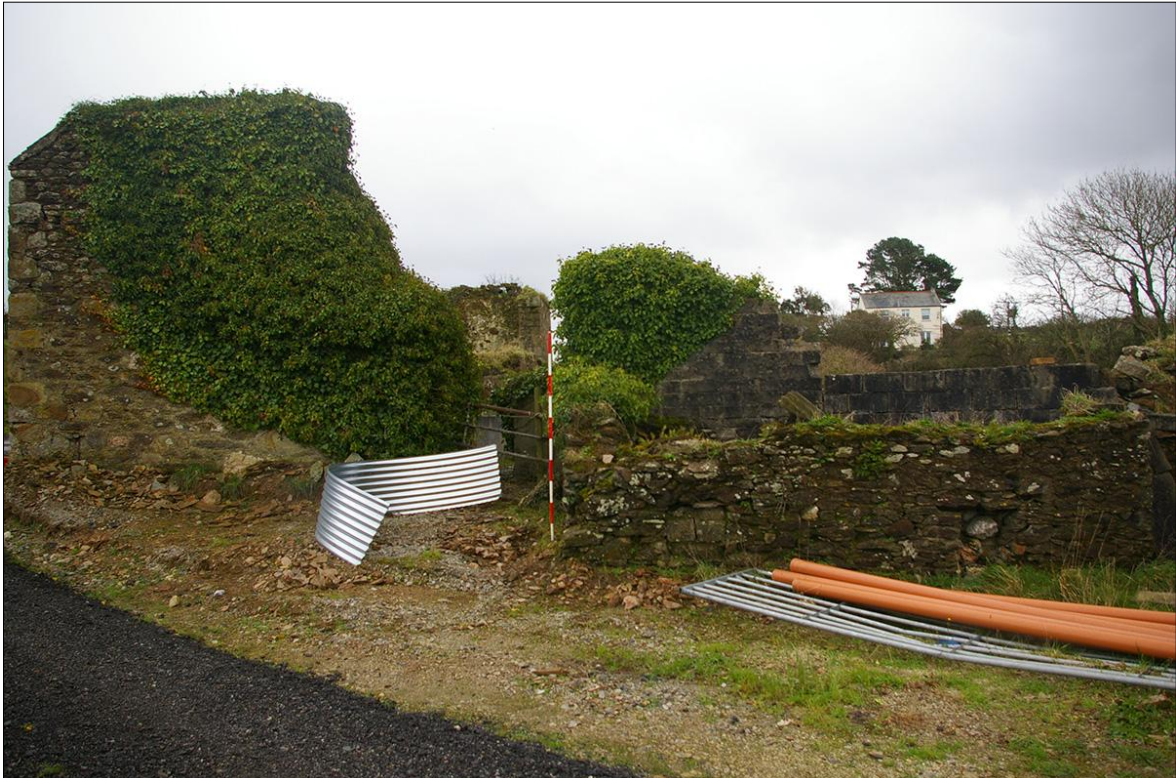
A small rectangular building divided into two sub-square pens, of slatestone rubble build; the walls are only c.1-1.5m high, with trace lime mortar and a loose clay and rubble-packed core, patched in hard grey cement. There are two (blocked) doorway openings in the south wall facing onto the yard, and two small feed hatches at low level in the rear (north). The feed hatches have timber lintels and the remains of boarded plank shutters. The interior contains loose rubble and is

overgrown with weeds. The doorways are blocked with concrete block. The historic photographs show this building as having a low pitched slate roof.

A former pigsty with individual pens and feeding doors.

FIGURE 14: B3, VIEWED FROM THE NORTH (SCALE 2M).

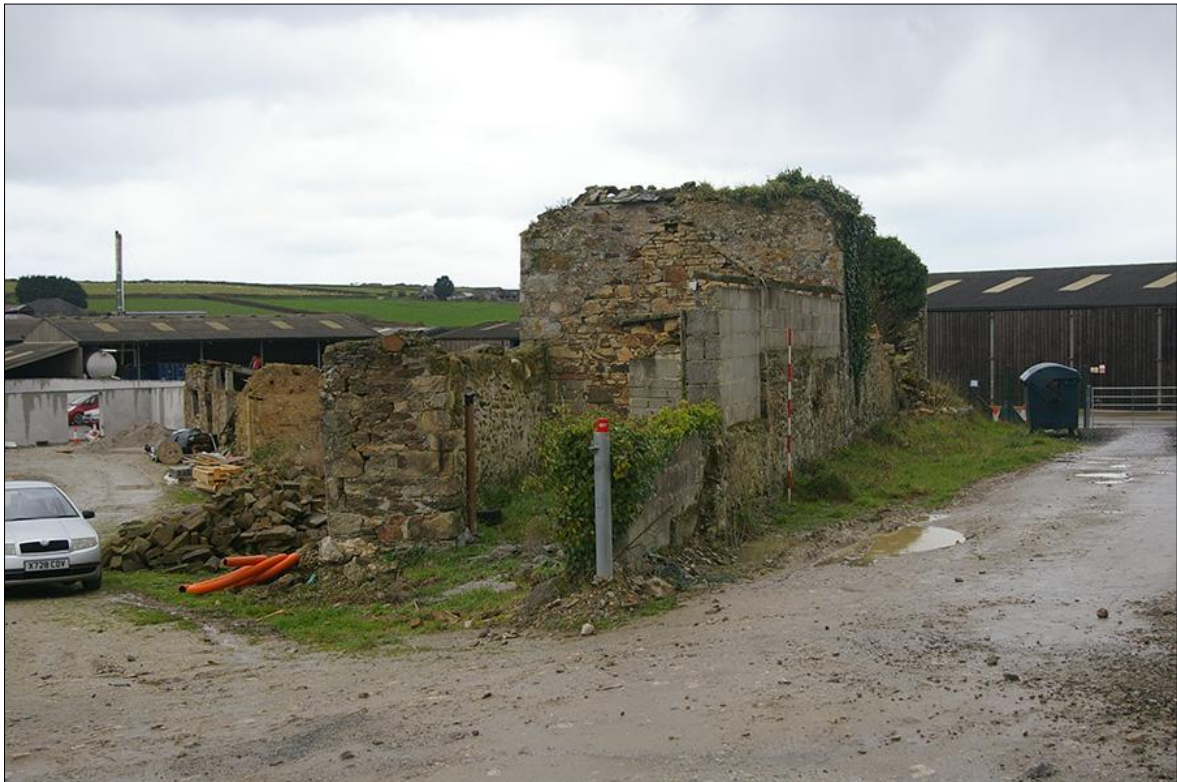
A long barn range, divisible into three separate elements: B4a, B4b and B4c. B4a (north-west end) was a two-storey barn, of which only the north-west gable stands to full height. B4b (centre) is a two-storey bank-barn, of which the south-east part of survives to full height. B4c (south-east end) is a single-storey shed with wide cart opening to the south-west gable. This structure possessed external stairs to first-floor level at the rear (north-east), and a horse-engine to the north-west, but both have now been lost. The modern access to the farm now runs behind this building. The build of all of these structures is very similar, yellowish-brown slatestone with roughly-dressed quoins to the corners and reveals, including some granite examples. The gable of B4a is of poorly-coursed stone rubble with roughly-dressed sandstone quoins; its profile and historic photographs indicate the roof was half-hipped. The gable features some scarring from the lost horse-engine, but vegetation (ivy) concealed the evidence for blocked openings. The rear (north-west) wall has collapsed; the historic photographs show a single doorway at first-floor level. The front (south-west) wall has been replaced in double-skin concrete block to 1.2m. The historic photographs show two doorways in this wall at ground-floor level, one with a segmental brick arch, and a third and wider central forced opening; at first floor level there was a window (blocked) and a wide

forced opening/loading door, perhaps an enlargement of the wide forced opening at ground-floor level. The floor is concrete. B4b is a more complex structure. The stonework is quite fine, with well-coursed stone rubble similar to that of B1 (east). At ground-floor level there are two doorways with failing timber lintels in the front (south-east) wall (one blocked to form a window), three slit vents in the rear wall (two blocked), and a narrow opening (blocked) in the south-east gable; the latter opening may have been for a belt to drive internal machinery. The north-western part of the first floor has been lost, leaving one side of a central loading/threshing door in the front elevation, and the slate window cill of a window in the rear elevation. There are sockets for joists in the south-east gable wall, indicating an axial bean below the threshing doors at first-floor level. The floor is concrete. Both B4a and B4b once had half-hipped roofs of scantle slurried slate. B4c was a single-storey shed with a pitched roof with walls of poorly-coursed stone rubble, extended and repaired in concrete block to the rear (north-east). The pitched roof was of slate, replaced with a mono-pitch roof of corrugated iron sheeting. The front wall has blown and collapsed into the yard. The floor is concrete.

B4b was a bank (chall) barn with opposed threshing doors at first-floor level, with housing for animals below, or perhaps machinery for grinding or winnowing. This is a surprisingly-modest example of its type, with only a single room at each level. Two-storey B4a would have had space for the storage of fodder at first floor, and perhaps machinery relating to the lost horse-engine on the ground floor. B4c was a cart shed, or animal pen/storage adapted as a cart shed.

FIGURE 15: THE SOUTH-EAST END OF B4; VIEWED FROM THE SOUTH-EAST (SCALE 2M).

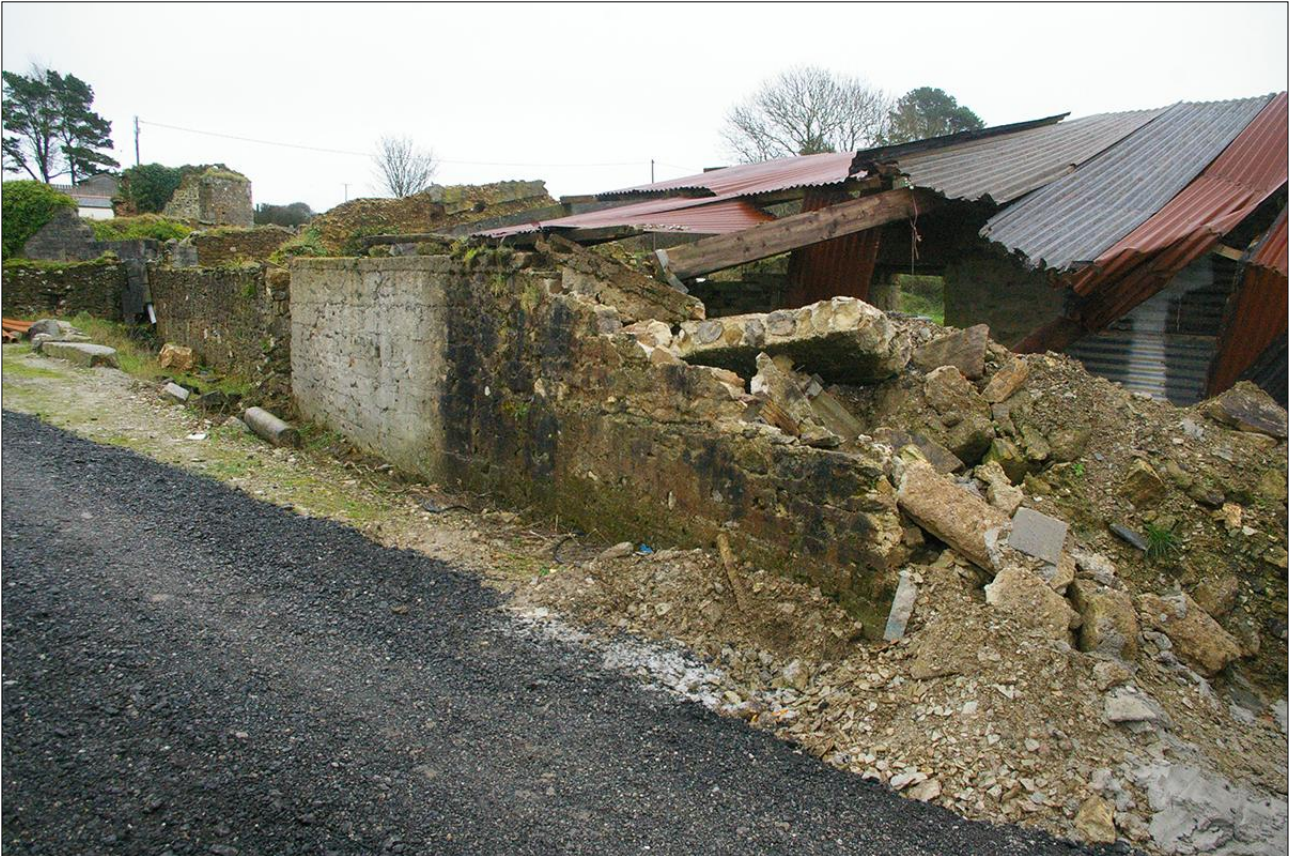
THE SHUTTERED CONCRETE NORTH WALL OF B1; VIEWED FROM THE NORTH-WEST.

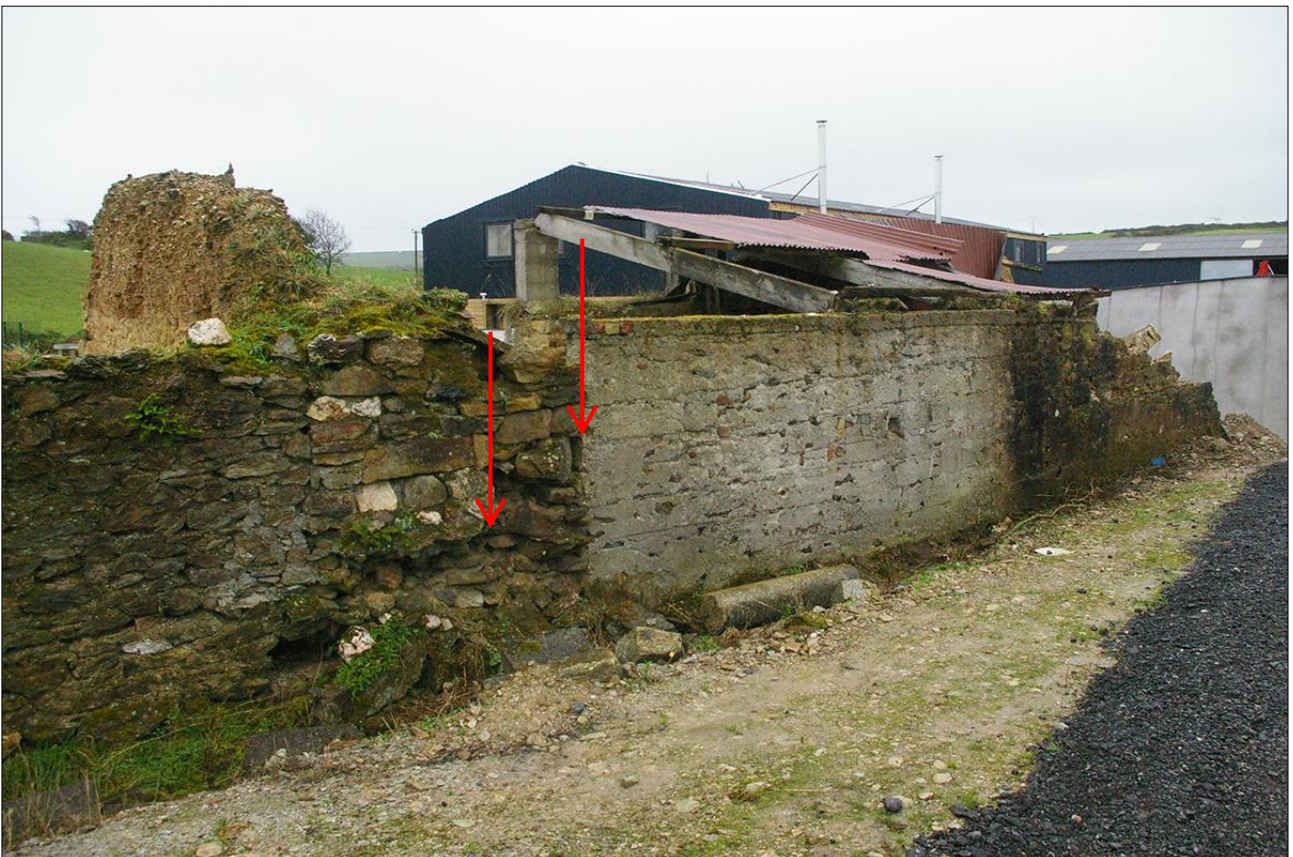
AS ABOVE; THE RAGGED MASONRY (INDICATED) IS WHERE THE NORTH SIDE OF THE FIREPLACE HAS BEEN REDUCED IN WIDTH. VIEWED FROM THE NORTH-EAST.

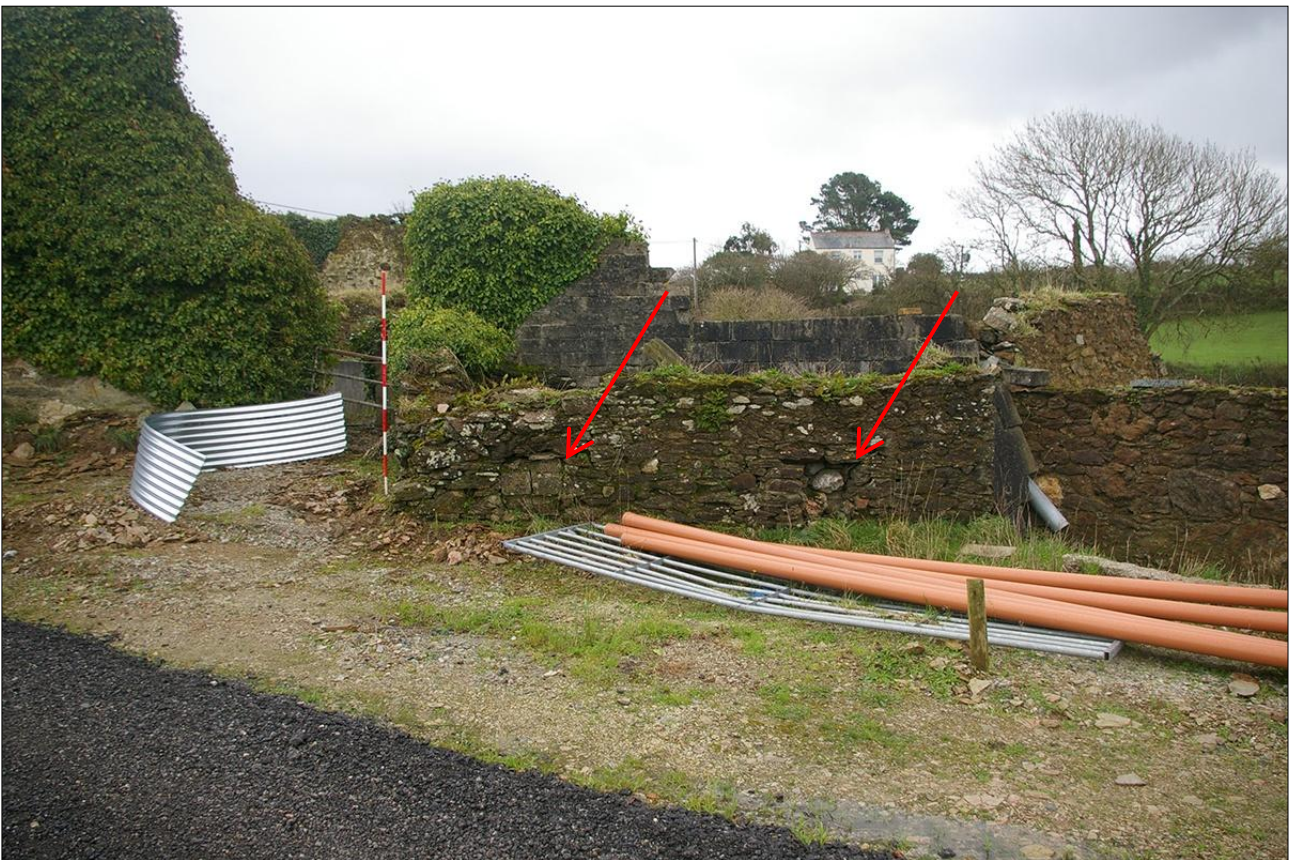
THE NORTH-WEST ELEVATION OF B3, WITH FEEDING HATCHES INDICATED; VIEWED FROM THE NORTH-WEST (SCALE 2M).

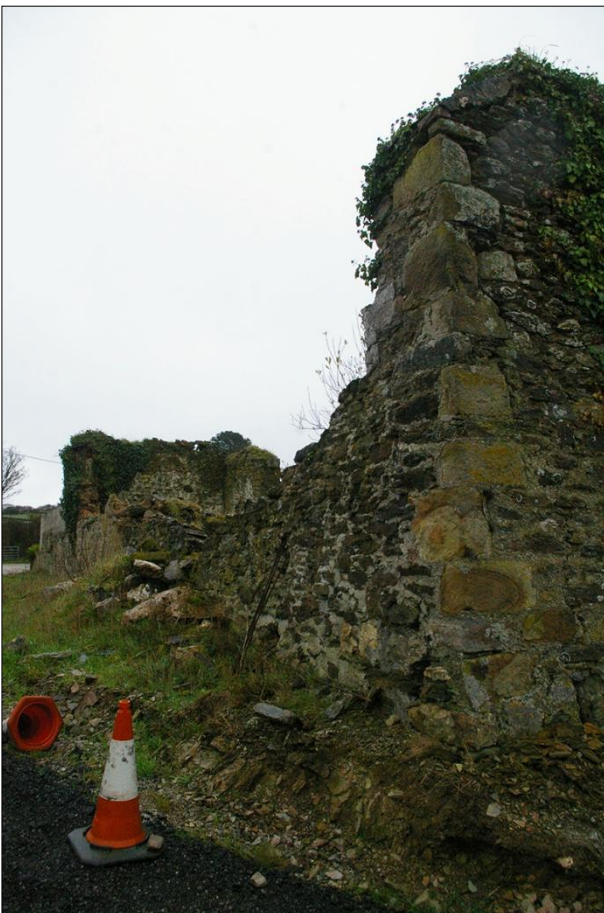
THE NORTH-WEST CORNER OF B4A AND COLLAPSED REAR WALL; VIEWED FROM THE NORTH-WEST.

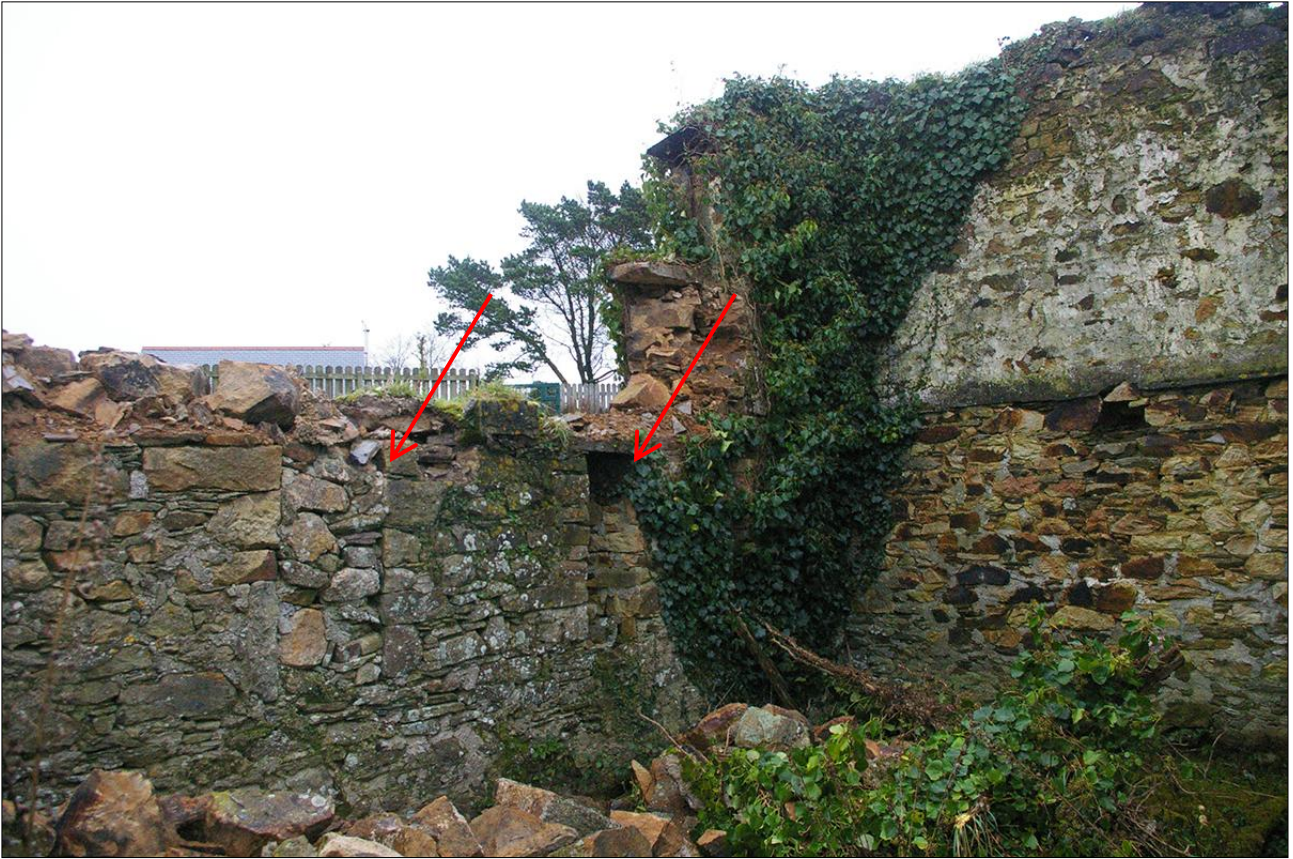
THE INTERIOR OF B4B (SOUTH-EAST CORNER) SHOWING THE SLIT VENTS (INDICATED); VIEWED FROM THE NORTH-WEST.
