# EMPACOMBE HOME FARM MOUNT EDGCUMBE MAKER CORNWALL

Statement of Significance & Heritage Impact Assessment

South West Archaeology Ltd. report no. 171207

7<sup>th</sup> December 2017

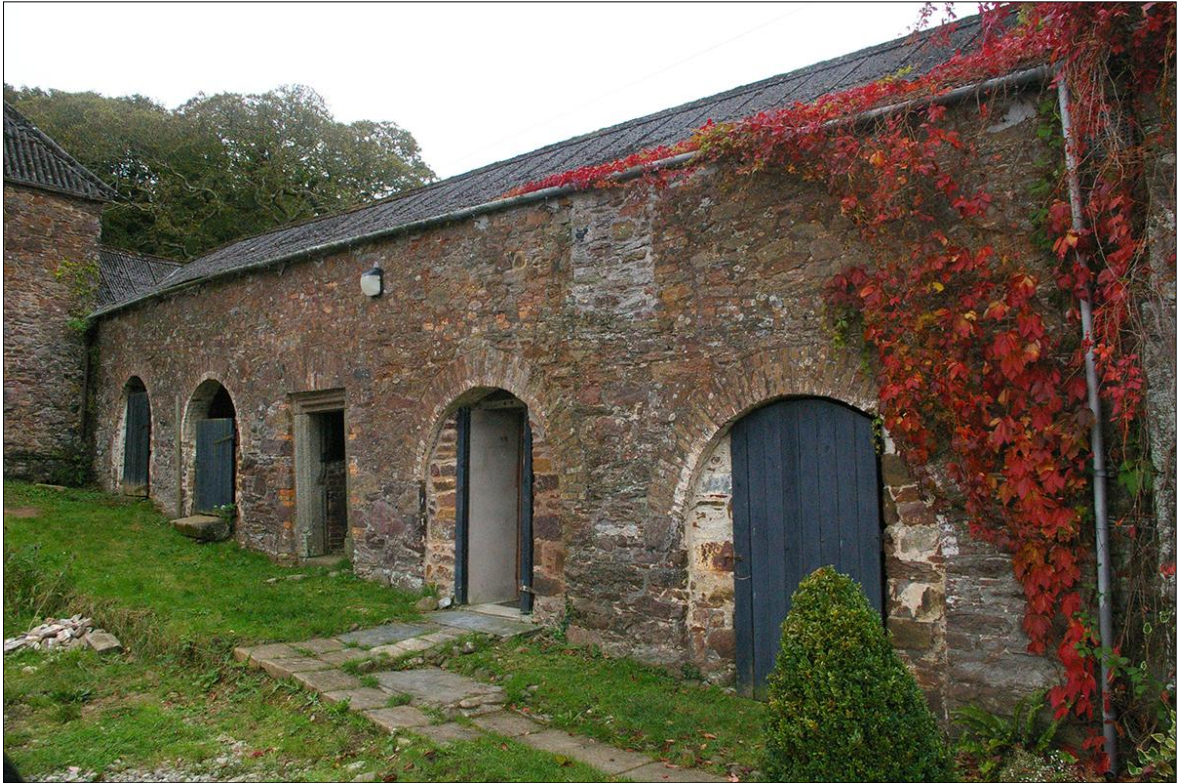
This is a single-storey barn terraced into the slope and adjoining the farmhouse to the west. The north (presentation) wall is of semi-coursed stone rubble that has been raised from a one storey to 1½ storey; the lower part of the wall containing the openings is much thicker, and the raise is marked by a brick string course. The building has a pitched roof of corrugated asbestos sheets supported by scissor trusses. To compensate for the narrowed front wall, the feet of the trusses sit on short timber pads that project from the wallplate; as a result, the trusses are failing at the collar. The presentation elevation faces down the coombe and contains four wide (7ft) round-arched full-height openings (all partly-blocked) with a central doorway. The four wide openings have brick segmental arches and stone quoins. The central doorway has a replacement flat gauged arch with raised keystone with brick above, and alternating brick and stone quoins. This doorway features an inserted 17<sup>th</sup> century granite doorcase with roll moulding to match the door in the rear elevation. B4 has a similar central doorway, but has a round-headed arch, indicating the granite doorcase and flat arch were inserted into an existing building. There is a single blocked window at first-floor level towards the western end. The rear (south) wall is of coursed blocky stone rubble and is a later rebuild. This elevation is abutted by a stone-rubble lean-to with a slate roof, and features three short ventilation slits and a single central doorway with a simple brick segmental arch. This doorway corresponds to the central door in the north elevation, and features a matching reused granite doorcase. The east (former gable) wall is of stone-rubble to the level of the eaves, and boarded-out with timber above; there is a doorway with 19<sup>th</sup> century door to B1.2 in this wall. The raise apparent in the north wall may have been undertaken to create a hayloft, as some joist sockets are visible. The interior lacks historic features, but features a brick-walled cross passage with cobbled floor and sturdy 19<sup>th</sup> century wooden doors. East of the cross-passage there is an earth floor. West of the cross-passage the groundfloor has been adapted with black walls and concrete floors to provide single-storey store rooms for the house. Abutting the rear of B1.1 is a small, single-cell building of stone rubble with a mono-pitch slate roof and a door with bull-nosed brick to the reveals.

FIGURE 18: THE FRONT (NORTH) ELEVATION OF B1.1; VIEWED FROM THE NORTH-WEST.

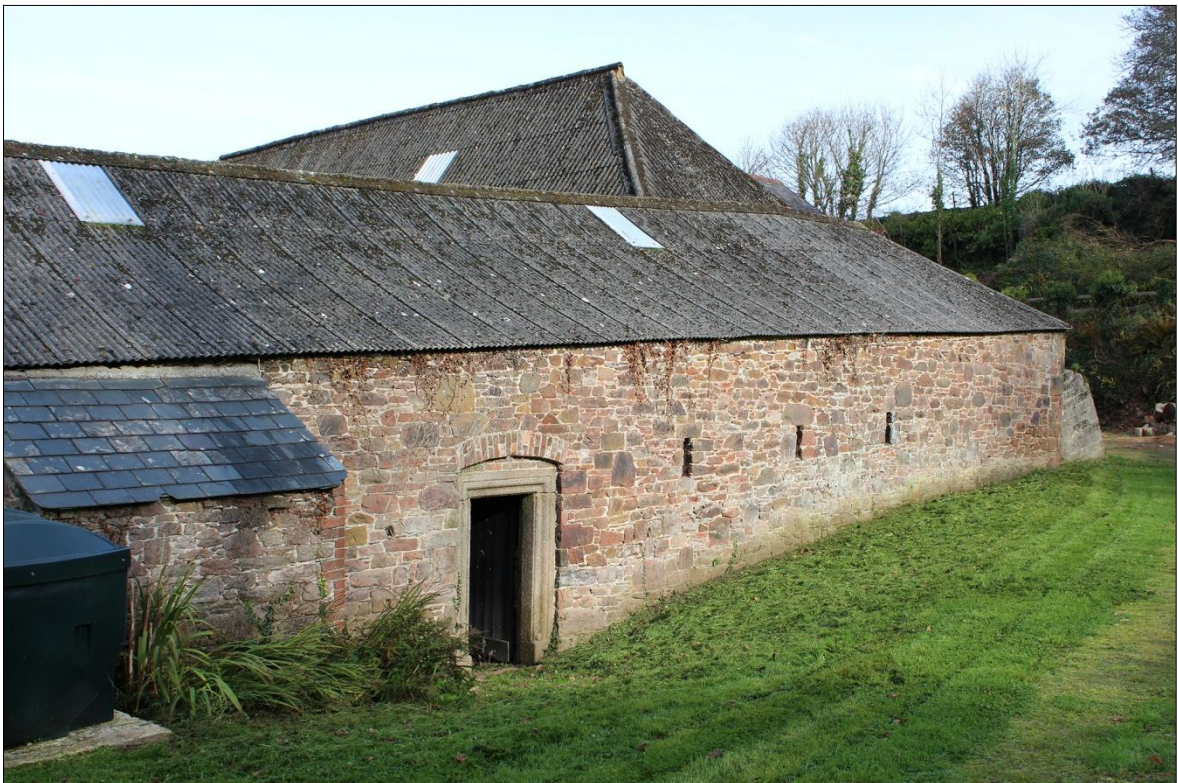
FIGURE 19: THE REAR (SOUTH) ELEVATION OF B1.1; VIEWED FROM THE SOUTH-WEST.

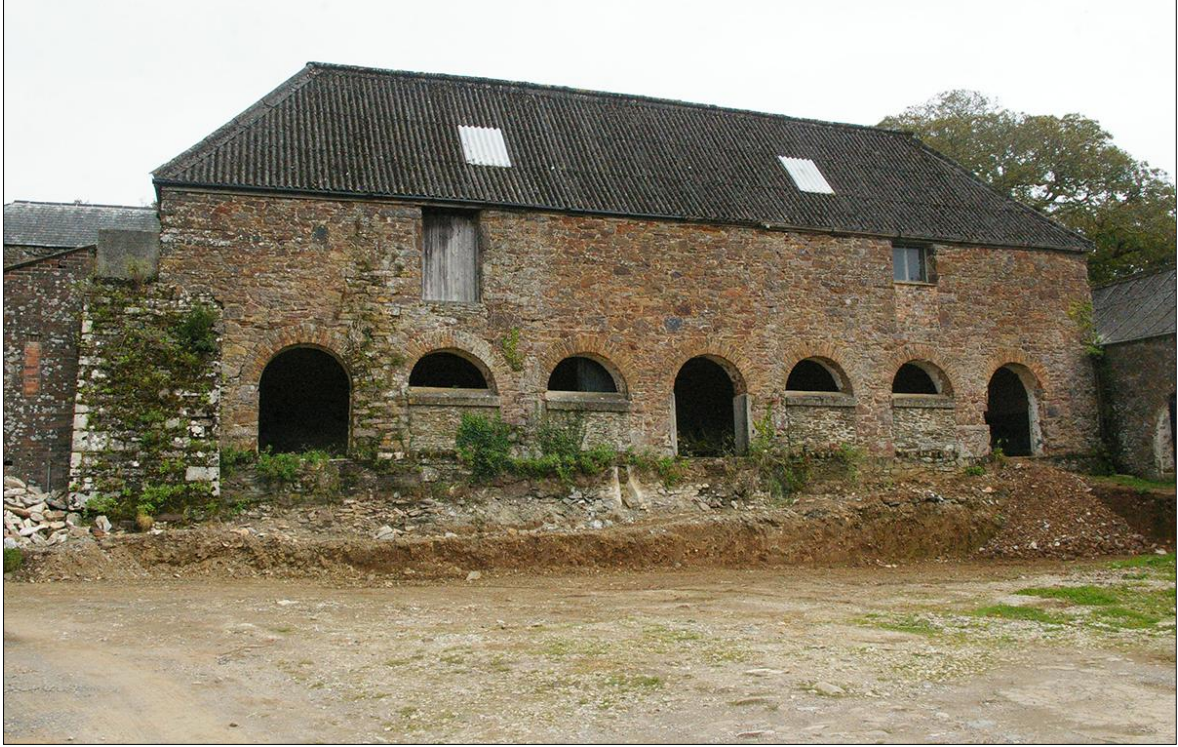
FIGURE 21: THE FRONT (WEST) ELEVATION OF B1.3; VIEWED FROM THE WNW.

The main issue is the potential effect on the historic fabric of the buildings. These buildings are now redundant and in declining condition – the north-west corner of B1.3 is in need of attention, and the scissor trusses in B1.1 are all failing – so a sympathetic development that ensures the survival of these buildings is to be encouraged. In broad terms the proposed development is preferable to a residential development, in that the large internal spaces would be preserved. The ground floor in B1 throughout is largely lacking in historic detail, and historic fittings in B1.3 on the first floor would be retained as part of the conversion process. Similarly, B2 is largely lacking in internal features. It is proposed to remove the stone rubble walls blocking the arched openings in B1.3, and remove the walls and roof of B1.5b and B1.5c. Opening up the archways would restore the original appearance of the building. The lean-to is likely to date to Phase 4 (early 19<sup>th</sup> century), but providing the flywheel in B1.5c is protected, and the 19<sup>th</sup> century door and frame are relocated, this is an acceptable loss. The roof is not original, the wall has been rebuilt in the 20<sup>th</sup> century (client *pers. comm.*), and the walls lack historic features and fittings. The aesthetic value of this range of buildings lies in the elevations that face onto the yard – not the ones to the rear – so great care should be exercised to ensure sympathetic treatment of these presentation elevations.

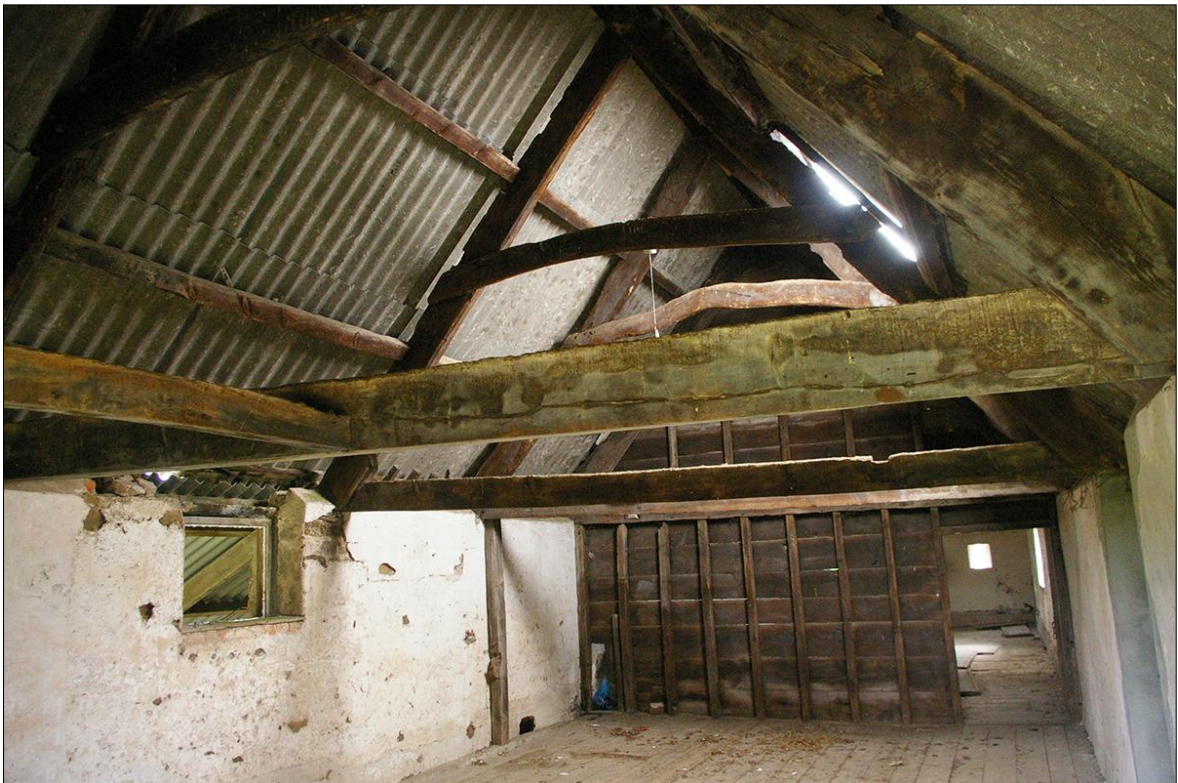
FIGURE 22: THE FIRST-FLOOR INTERIOR OF B1.3; VIEWED FROM THE NORTH.

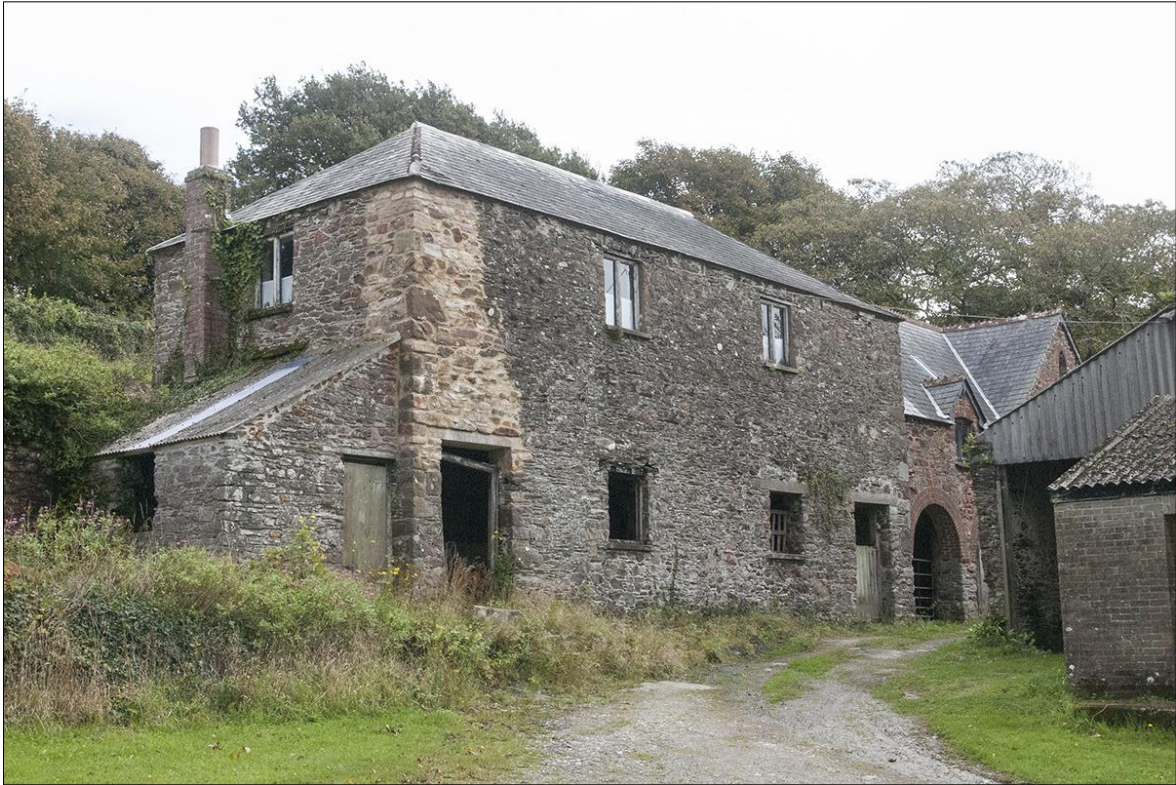
FIGURE 25: THE NORTH AND EAST ELEVATIONS OF B2.1, WITH B2.3 TO THE LEFT; VIEWED FROM THE NORTH-WEST.

B2.1 is a two-storey bank barn built of slate and shale rubble cut back into the solid rock; the north-west corner above the door has been recently rebuilt and the lintels replaced. The hipped roof of blue slate is carried on 20<sup>th</sup> century roof trusses with tie beams and queen posts. The principal elevation is to the west, with two doors and two windows at ground floor level opening onto a single room. The openings have flat lintels of thin timber; some have been replaced in concrete. The north-west door has a weathered oak frame with beaded moulding. At first floor level there are two glazed timber windows in the west elevation, and one in the north elevation. Access to the first floor is from ground level to the east via a wide loading door next to a blocked window, or from a forced doorway in the south wall into B2.2. The internal east wall at ground floor level steps back at ceiling height, supporting very heavy, but rather crude, transverse beams; these beams go into the west wall, but are now supported on heavy timber uprights. There is a blocked doorway into B2.2, with a timber shelf above, and the remnants of a stone-rubble trough along the base of the east wall. Next to the blocked opening within B2.2 an architectural fragment has been incorporated into the stonework. The first floor has been converted and is used as an artist's studio.

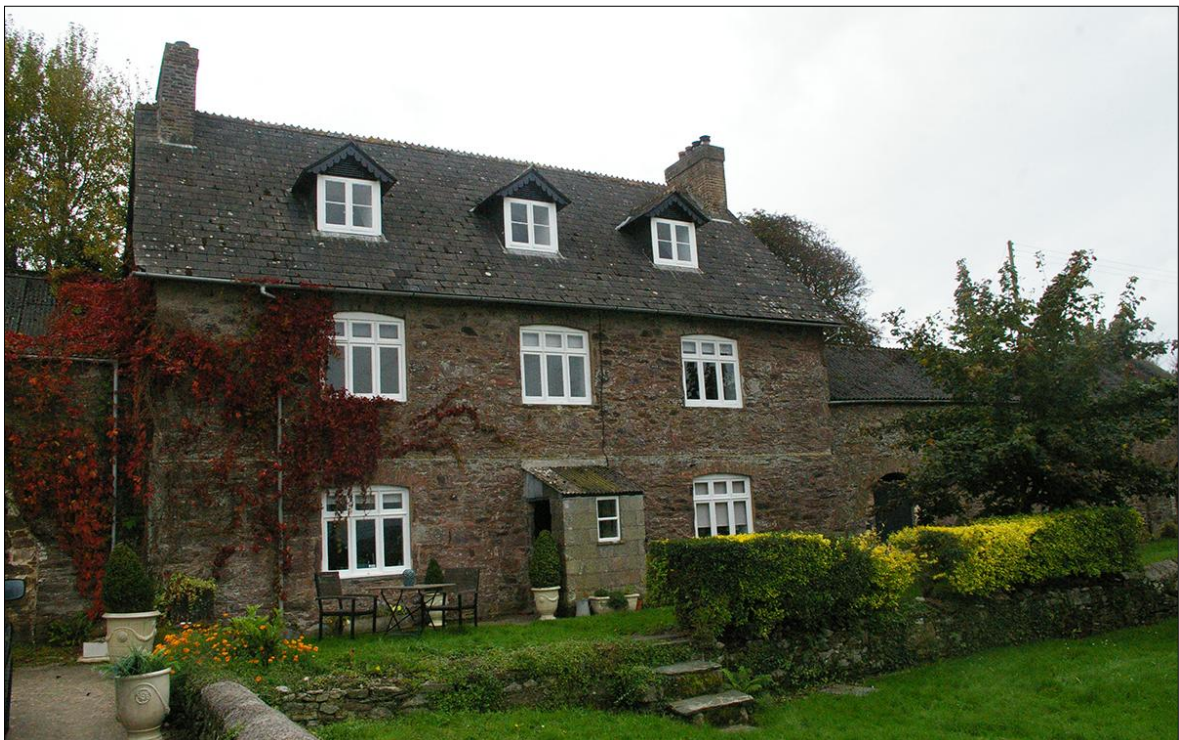
FIGURE 27: THE FRONT (NORTH) ELEVATION OF B3; VIEWED FROM THE NNE.

blocks; the used of narrow upright quoins to the window and door openings is similar to the forced openings in B5. The front (north) elevation is symmetrical with a 2/1/2 windows and a central door. There are three dormers above. The window casements are timber, but appear to be replacements; the central door and frame have original beaded detailing. There is a mean concrete-block porch with a mono-pitch asbestos sheet roof. The rear (south) elevation is similar to a bank barn, in that it is accessed at first-floor level, with windows identical to those at the front flanking a central door. There are three dormers above. The interior was not inspected, but the east wall of the kitchen (abutting B1.1) features three deep arched openings. A number of the doors on the ground floor feature are of very wide (0.3-0.4m) boards with bead moulding; some of the doors on the first floor feature H-hinges. This would indicate reused 18<sup>th</sup> century doors and fittings.

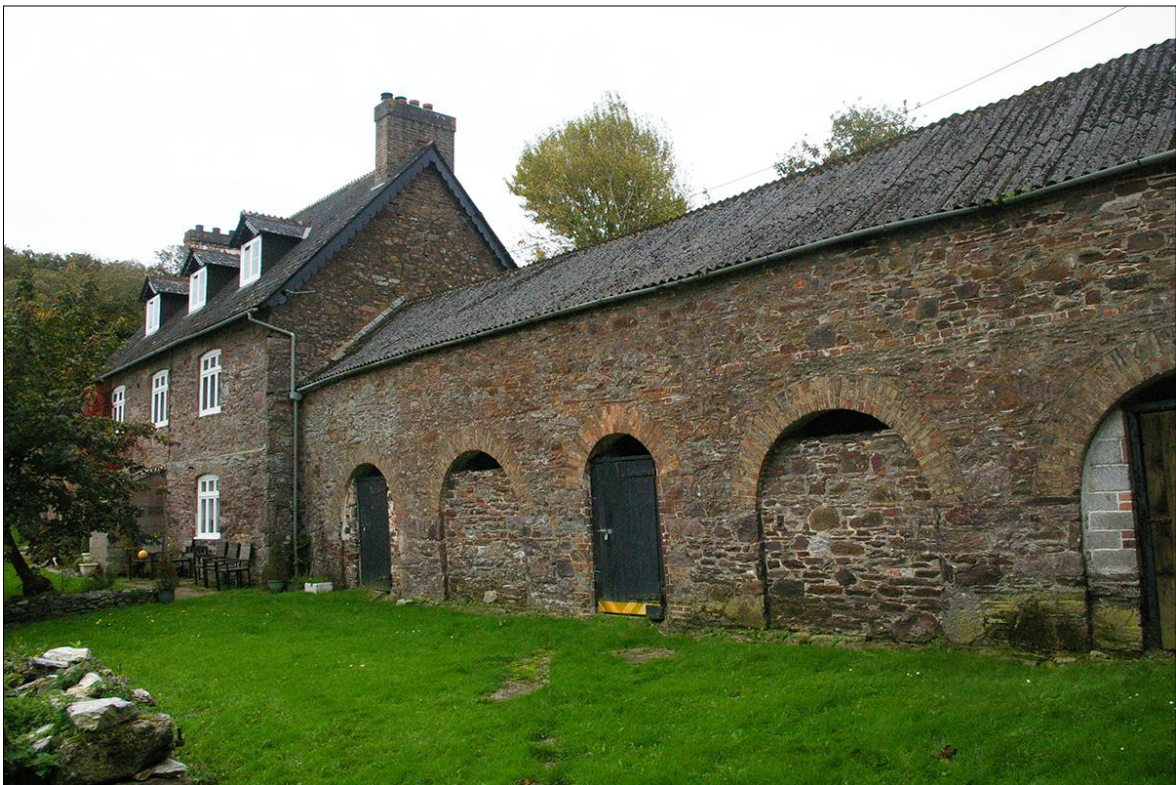
B4 is almost identical to B1.1. It features the same arched openings, roof structure and structural development. It differs from B1.1 in that there are no door openings in the south wall, and the central door opening in the north wall features a round-headed brick arch rather than a flat gauged brick arch, and it lacks the inserted granite doorcase. In exposed west gable there is a wide opening with an elliptical arch of brick containing some gauged brick; this is blocked with concrete block. To the rear of B4 is a small, single-cell stone-rubble mono-pitch building with double garage doors.

FIGURE 28: THE FRONT (NORTH) ELEVATION OF B4; VIEWED FROM THE NORTH-WEST.

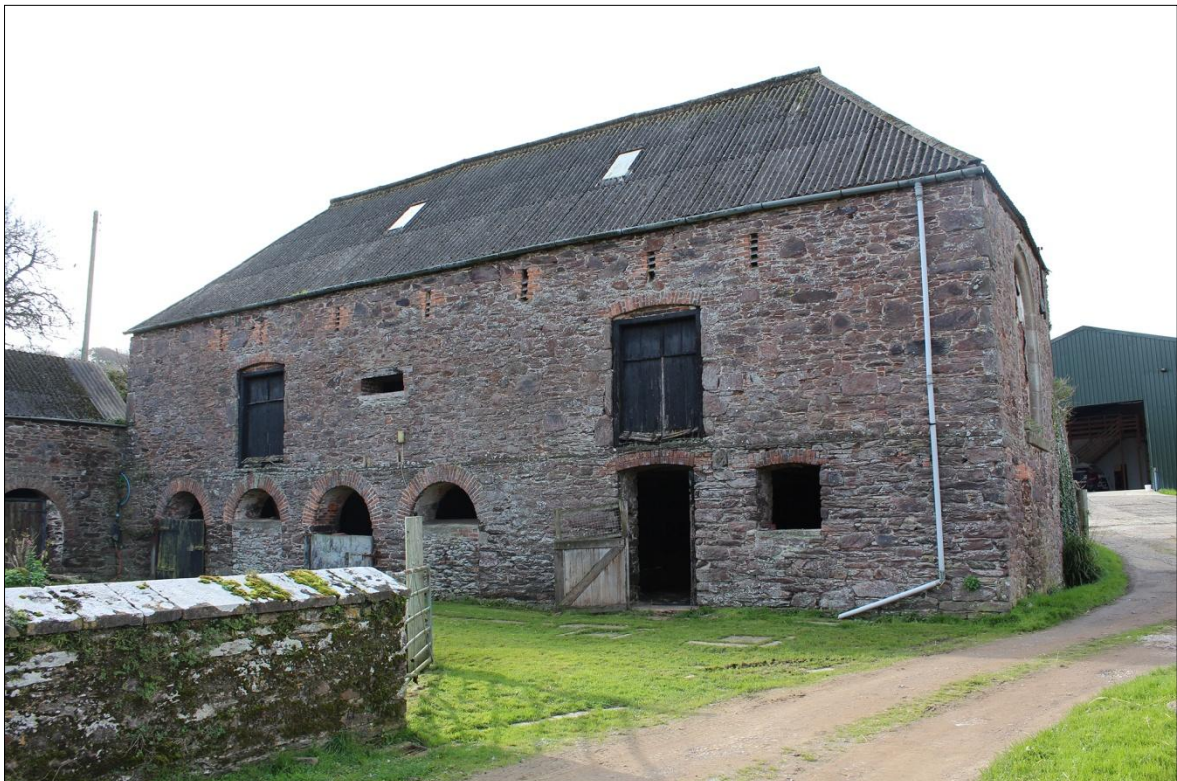
B5 is the most interesting structure. It is ostensibly a large bank barn with opposing threshing doors at first floor level, with housing for animal below. However, its structural history is much more complex. It is a large rectangular structure of good quality stone rubble build with prominent quoins, with the ground floor forming a slight plinth to the first floor. It has a tall hipped roof of corrugated asbestos sheets carried on oak trusses with half-lapped pegged notched collars; the feet of the trusses and the underside of the collars are slightly chamfered, and the purlins are original. The style and form of these trusses would suggest a later 17<sup>th</sup> or very

early 18<sup>th</sup> century date, reused in this position. However, the north and south trusses above the hips are different, in a similar style but in reused and heavier timber. Also, one of the collars on the early trusses is upside down, suggesting the roof is reset. Tie beams and queen struts have been attached later to provide additional strength. At ground floor level there is a blocked doorway and a slit vent in the north wall, and a doorway and window in the east wall; the doors and windows feature brick segmental arches. There are four other openings (two partly-blocked in stone rubble) in the east wall, each with round-headed brick arches and stone quoins. At first-floor level there are two sets of opposing threshing doors have been forced into the east and west walls; the doors to the west have been provided with porches. The frames and doors appear to be original. The ground to the rear has been built up, and there is a retaining wall with half-arch running the length of the rear wall; to the north end there is a structure (?cistern) integral to this. There is a forced loading door with a brick segmental arch in the south gable, and there is a narrow forced window opening in the middle of the east elevation. Above the level of the threshing doors is a line of short slit vents with brick reveals and slate louvres; these adapt existing slit vents, or are forced. In the north gable a large (1½ storey) 17<sup>th</sup> century style shallow roll-moulded granite round-headed window frame has been inserted, with the remnants of a plastered internal field that once carried a painting of the Earl of Mount Edgcumbe's heraldic device. Internally, the low ground floor is divided into two rooms by a stone wall: the northern room (served by the door with window) has a concrete floor; the southern room (served by the round-arched openings) has a cobbled floor. Both feature very substantial beams and joists, some of which are have beading and appear domestic in character. There is a double-plank floor between the threshing doors, and numerous shaped treenails have been hammered into the underside of the floor to secure the planks. At first-floor level the tall internal space is used as a carpenter's workshop and store, and original features are not readily apparent. However, adjacent to the narrow forced opening in the east wall is a (probably early 20<sup>th</sup> century) grain cleaner bearing the name-plate S.E. FRY & SON ENGINEERS TEDBURN ST MARY. The scale and build of this building is dissimilar to the other structures, which are more appropriately-scaled farm buildings.

FIGURE 29: THE FRONT (EAST) ELEVATION OF B5; VIEWED FROM THE NORTH-EAST.

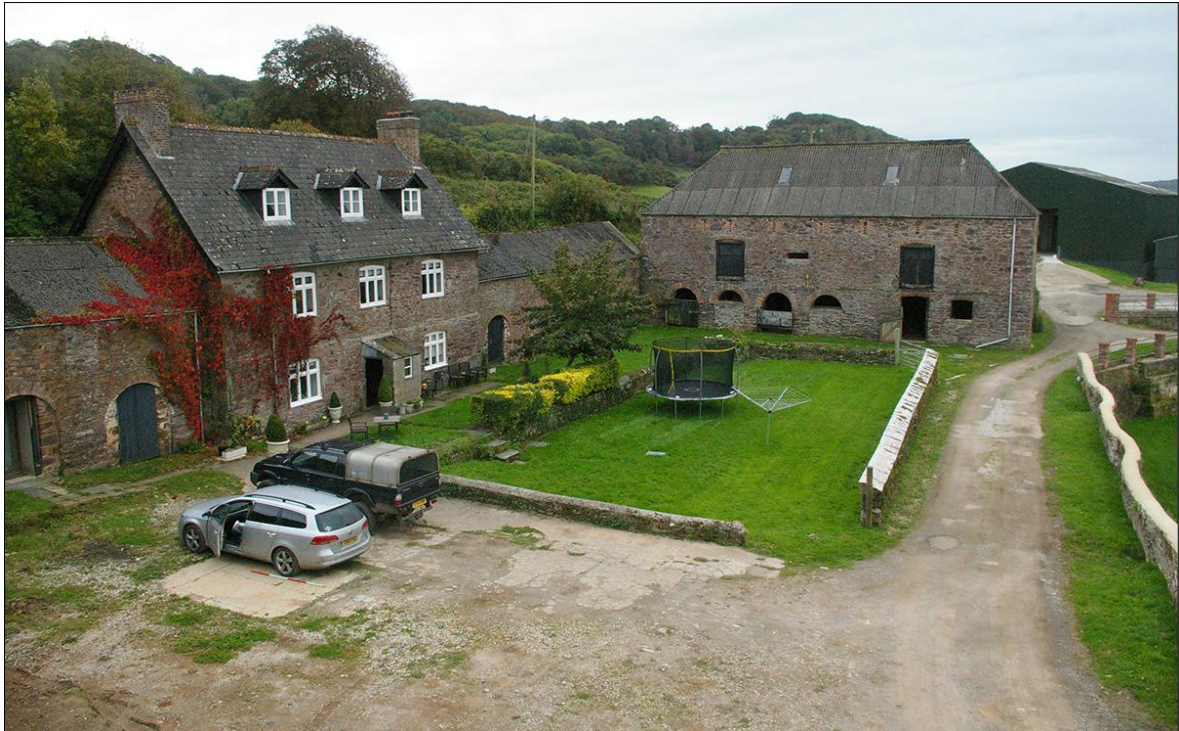
FIGURE 30: THE CENTRAL YARD FROM THE TOP OF THE EXTERNAL STAIRS TO B1.3; VIEWED FROM THE NORTH-EAST.

The farmhouse and the main range of buildings face onto a central yard. The yard is fairly level, but that is because a retaining wall was built across the head of the coombe and ground levels south of that wall raised to the level of the buildings. The retaining wall is of particular interest in its own right. There are four pillars of well-executed mortared masonry separating sections of rather crude pitched dry stone walling in a style similar to a hedgebank or perhaps a harbour wall. Above this is a narrow mortared stone wall. The differential settling of the dry stone sections has caused the wall above to warp and twist. The upper part of the walls enclosing the adjacent kitchen garden are missing at this point, facilitating views to this wall. That would suggest the wall itself, or whatever structures preceded it, was intended to be a focal point. There is a spring behind the farmhouse which descends through a culvert below the yard and runs down the coombe through the kitchen garden. Based on contemporary parallels, this may have carried nitrogen-rich water from the yard/ central muckheap down through the garden in a very progressive way. Alternatively, it is possible there might have been a water feature built into the yard itself.

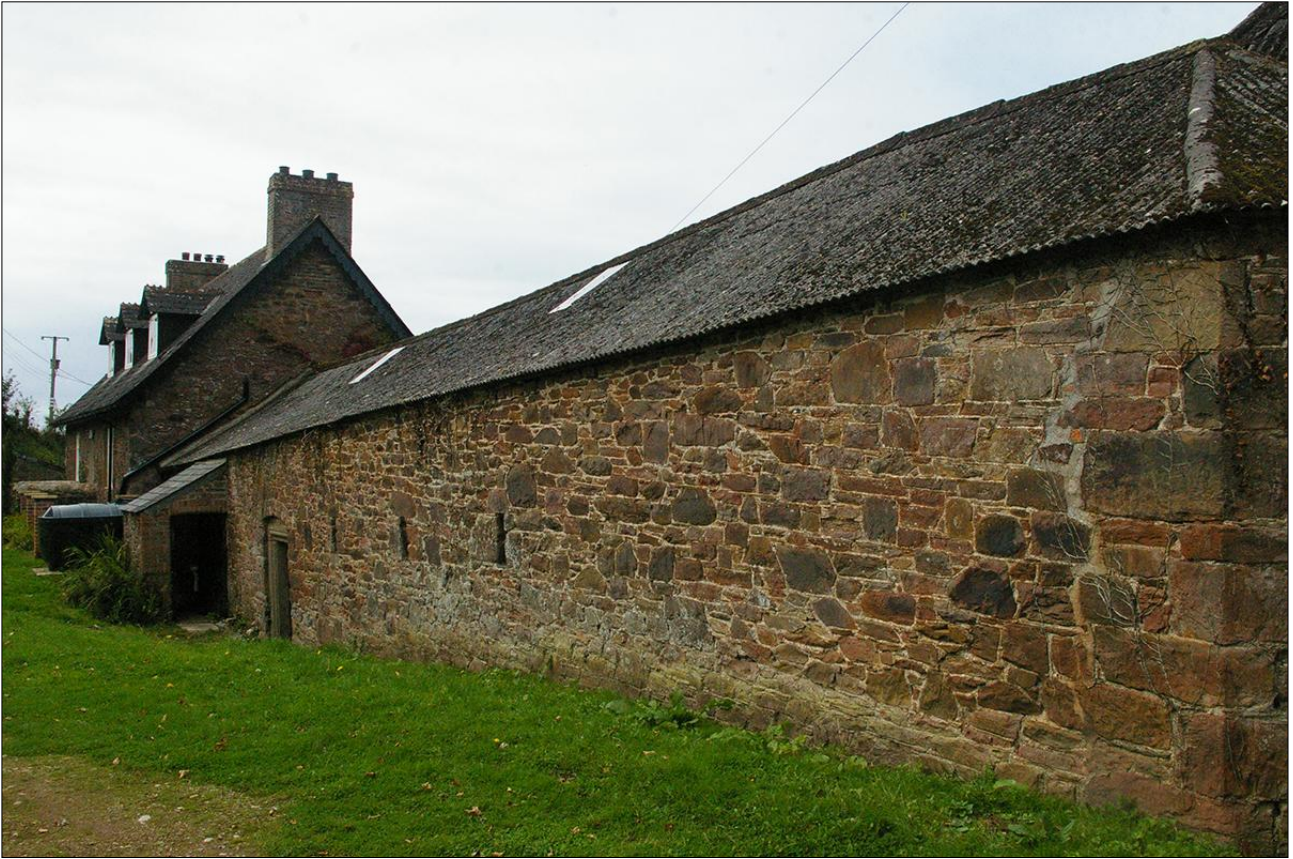
THE REAR (SOUTH) WALL OF B1.1, SHOWING THE CONTINUOUS BUILD; VIEWED FROM THE SOUTH-EAST.

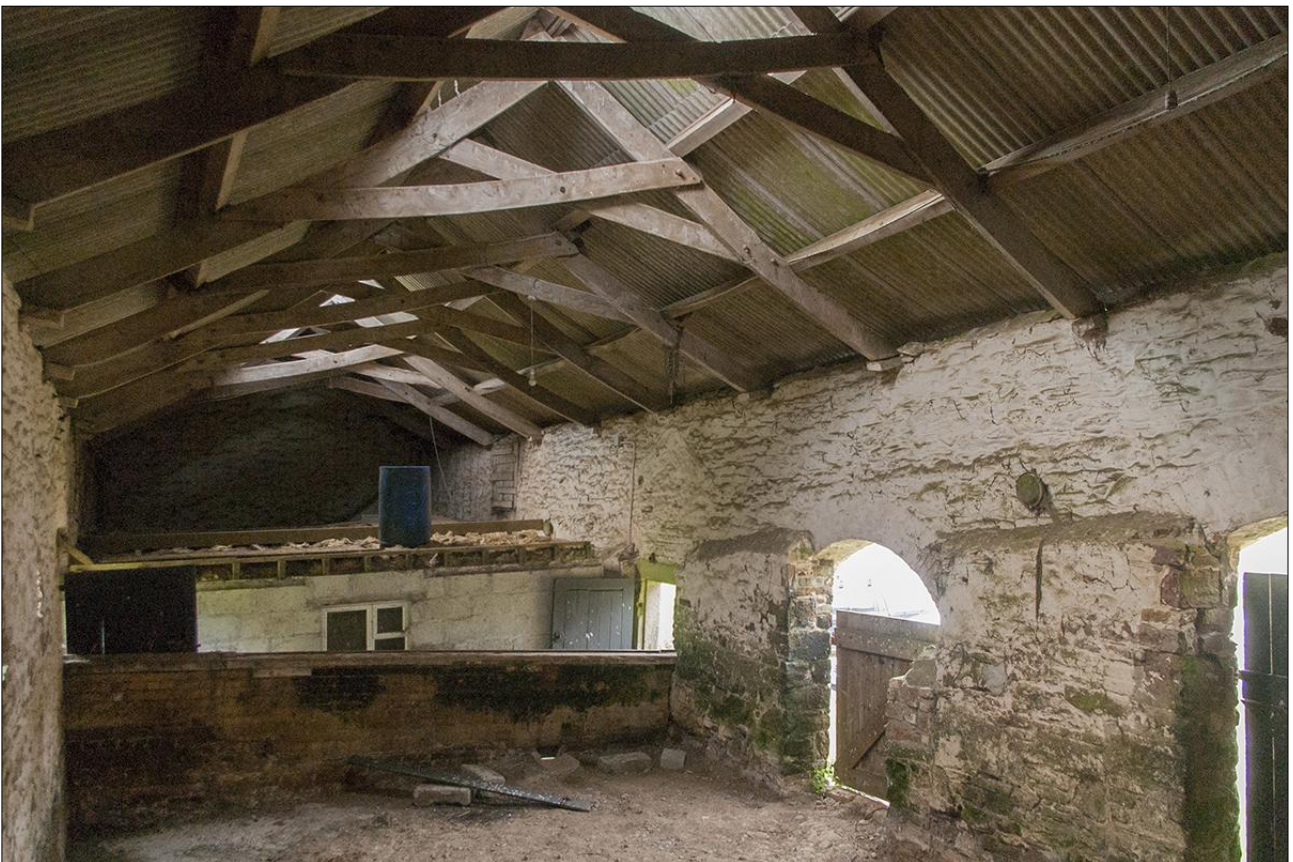
THE INTERIOR OF B1.1; VIEWED FROM THE SOUTH.

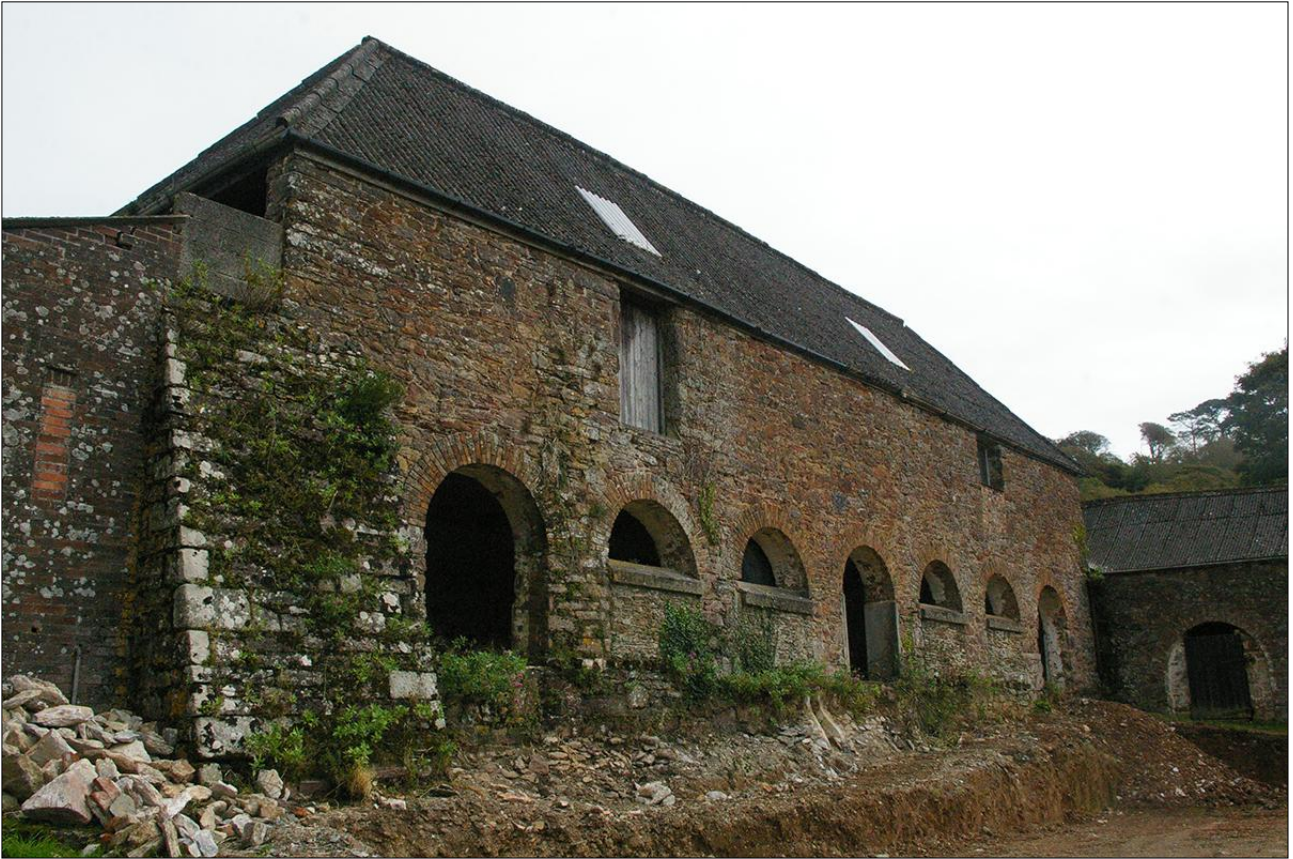
THE FRONT (WEST) ELEVATION OF B1.3, WITH HEAVY BUTTRESS IN THE FOREGROUND; VIEWED FROM THE NORTH-WEST.

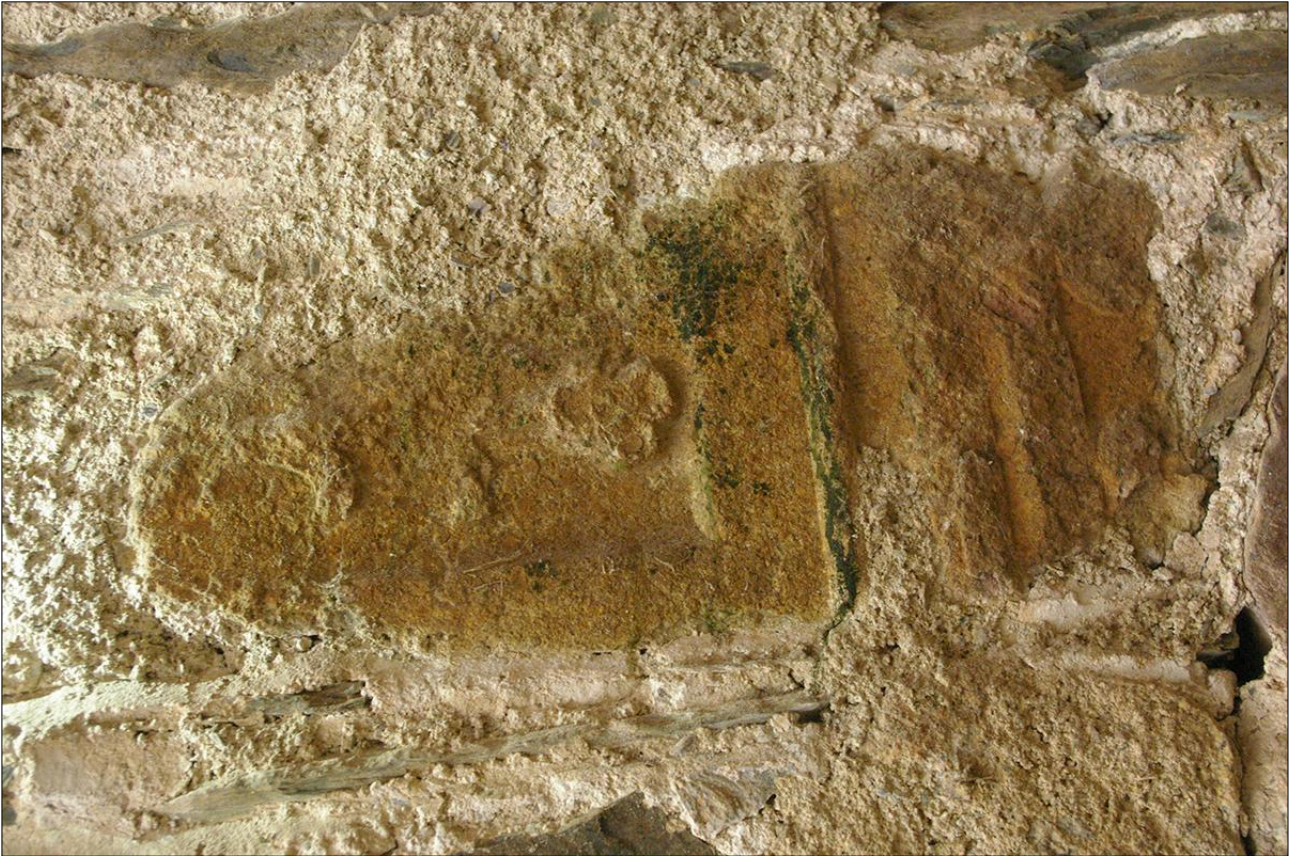
THE ARCHITECTURAL FRAGMENT BUILT INTO THE SOUTH WALL OF B2.1.

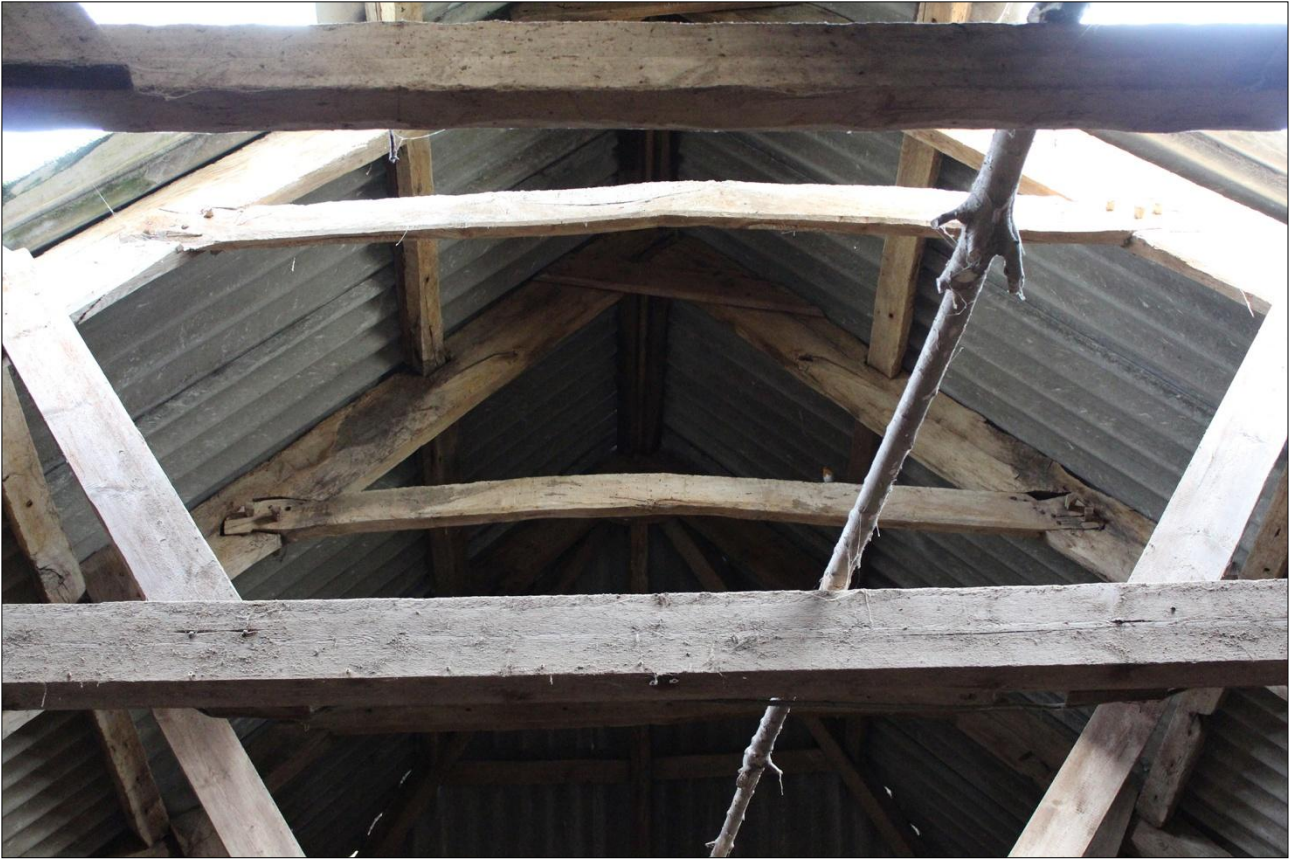
DETAIL OF THE ROOF STRUCTURE IN B5, SHOWING THE UPSIDE DOWN NOTCHED LAPPED COLLAR; VIEWED FROM THE SOUTH.

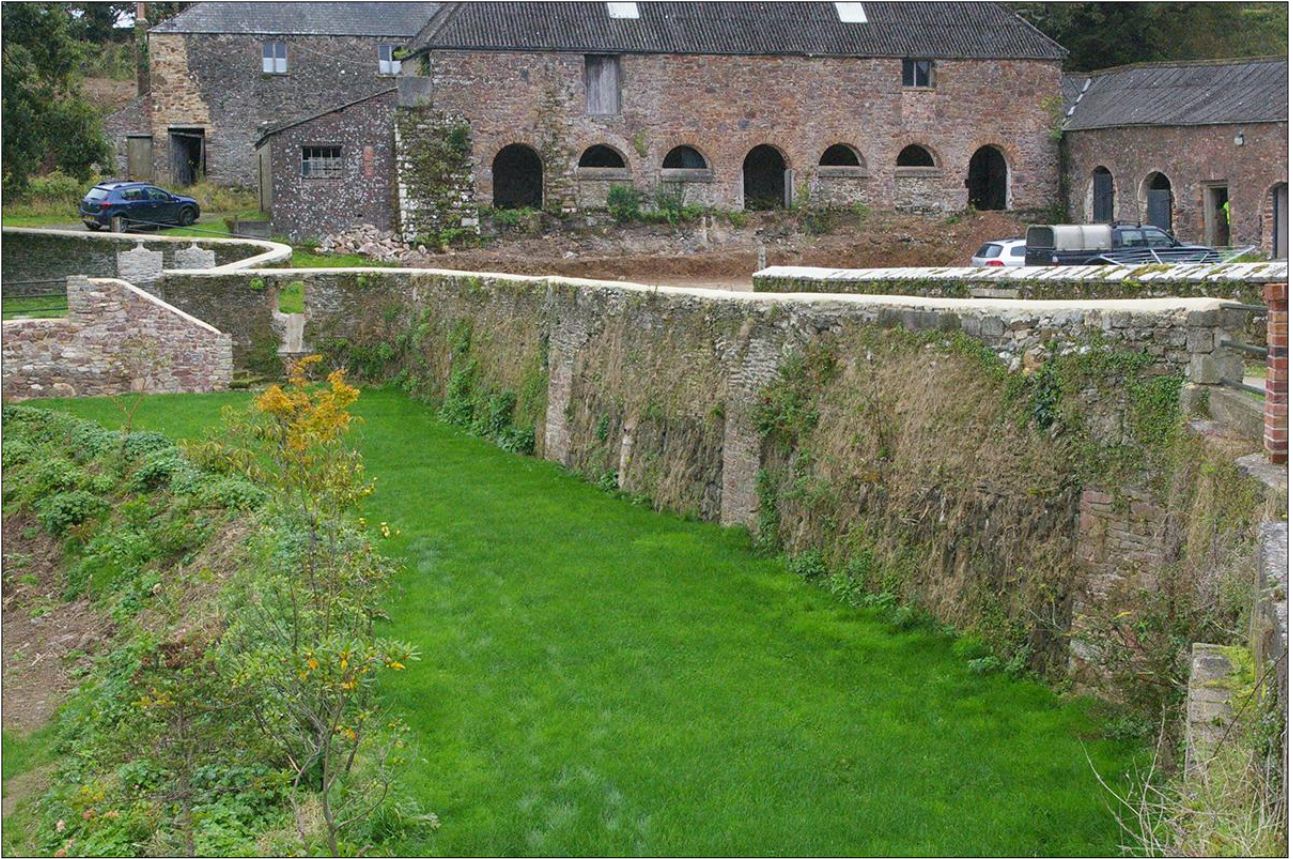
AS ABOVE, DETAIL OF THE RETAINING WALL SHOWING THE PILLARS OF DRESSED MASONRY SEPARATED BY PITCHED DRY STONE WALLS; VIEWED FROM THE NORTH-WEST.

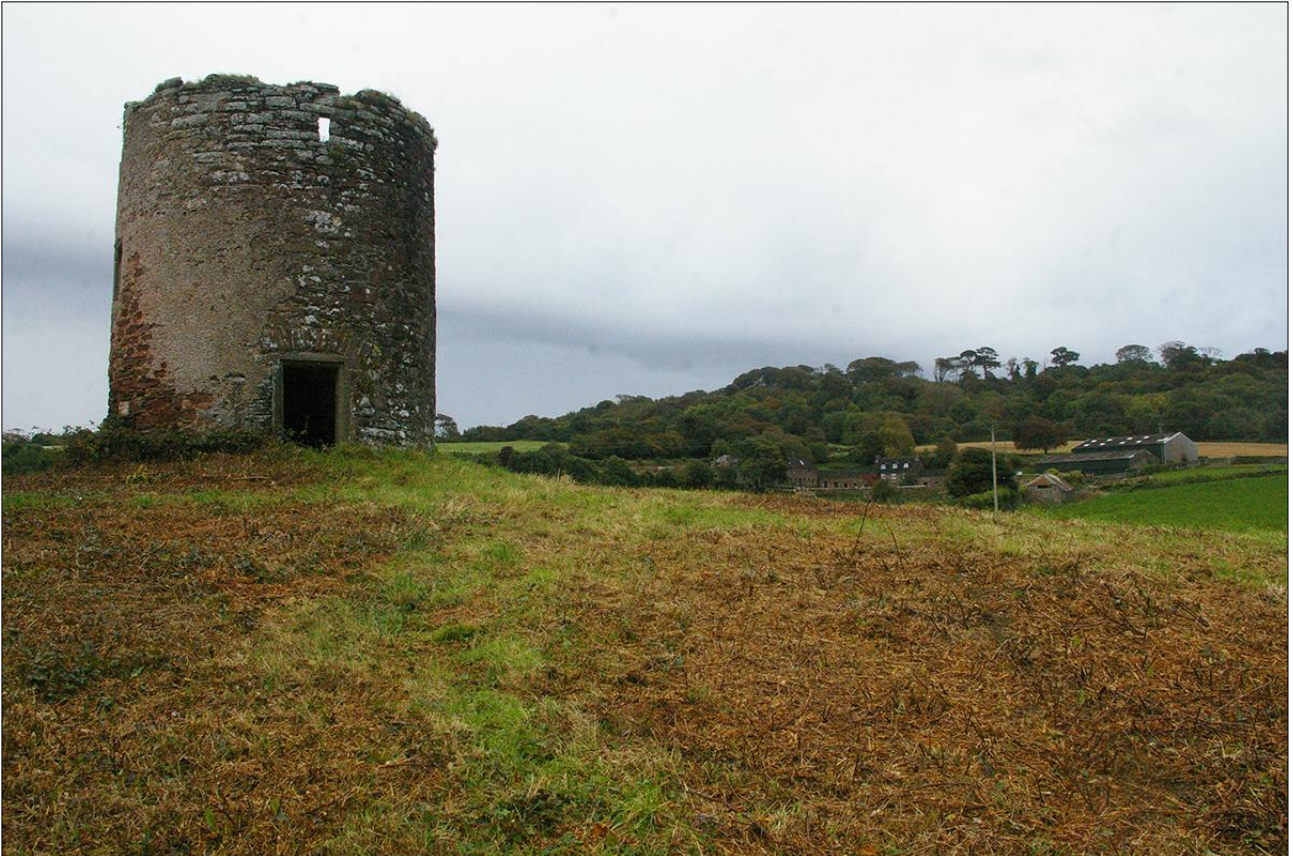
THE RUINED WINDMILL TOWER WITH THE FARM IN THE BACKGROUND; VIEWED FROM THE NORTH-WEST. NOTE THE USE OF INSERTED GRANITE WINDOW AND DOOR FRAMES.
