BARNs AT LAMELLYN LADOCK ROAD PROBUS CORNWALL

Desk Based Appraisal and Historic Building Recording

BARNS AT LAMELLYN, PROBUS, CORNWALL
HISTORIC BUILDING RECORDING

By E. Wapshott and F. Balmond
Report Version FINAL
26th March 2018

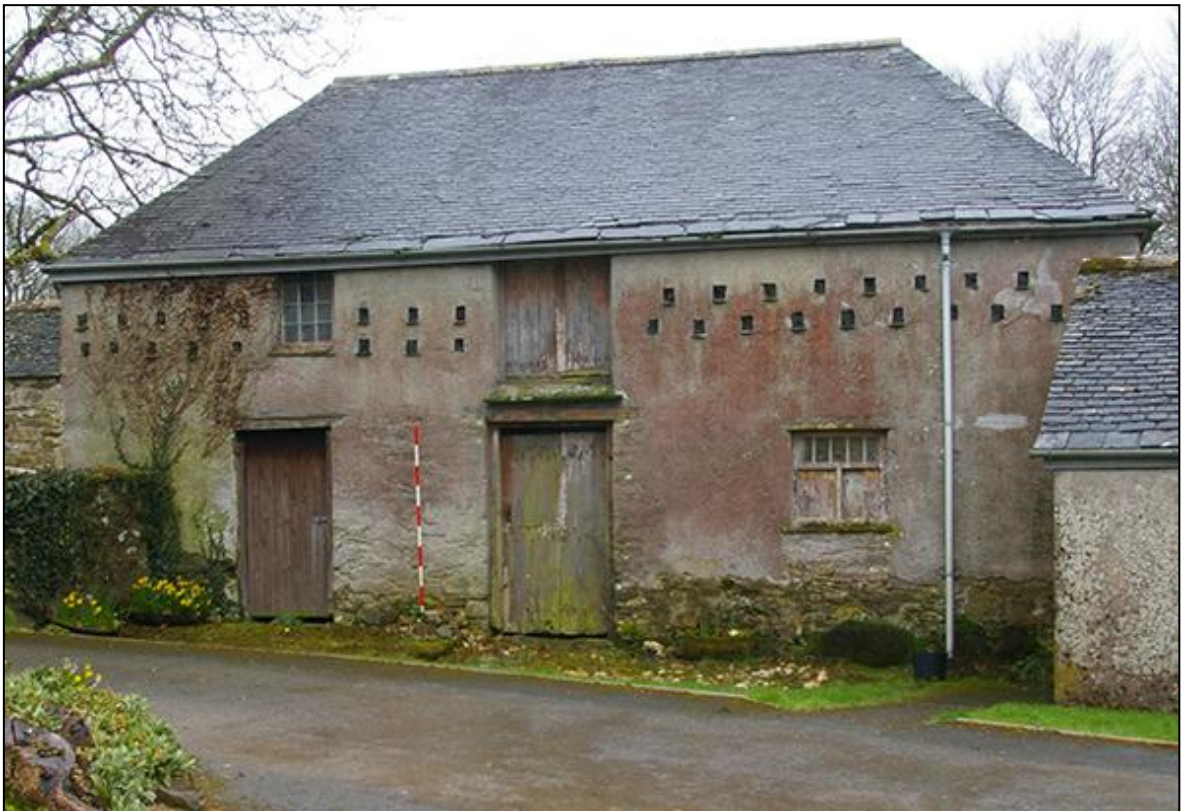
FIGURE 7: BUILDING 1, VIEWED FROM THE NORTH

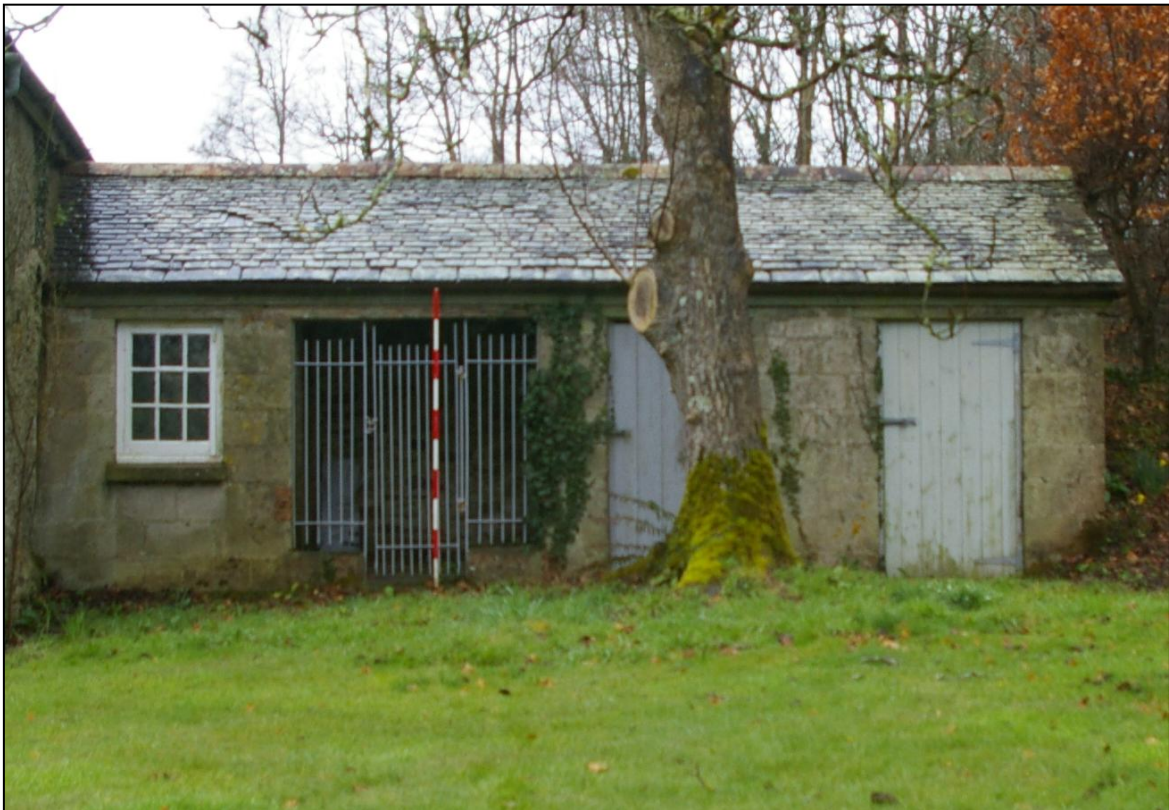
FIGURE 8: BUILDING 2, VIEWED FROM THE SOUTH, 2M SCALE

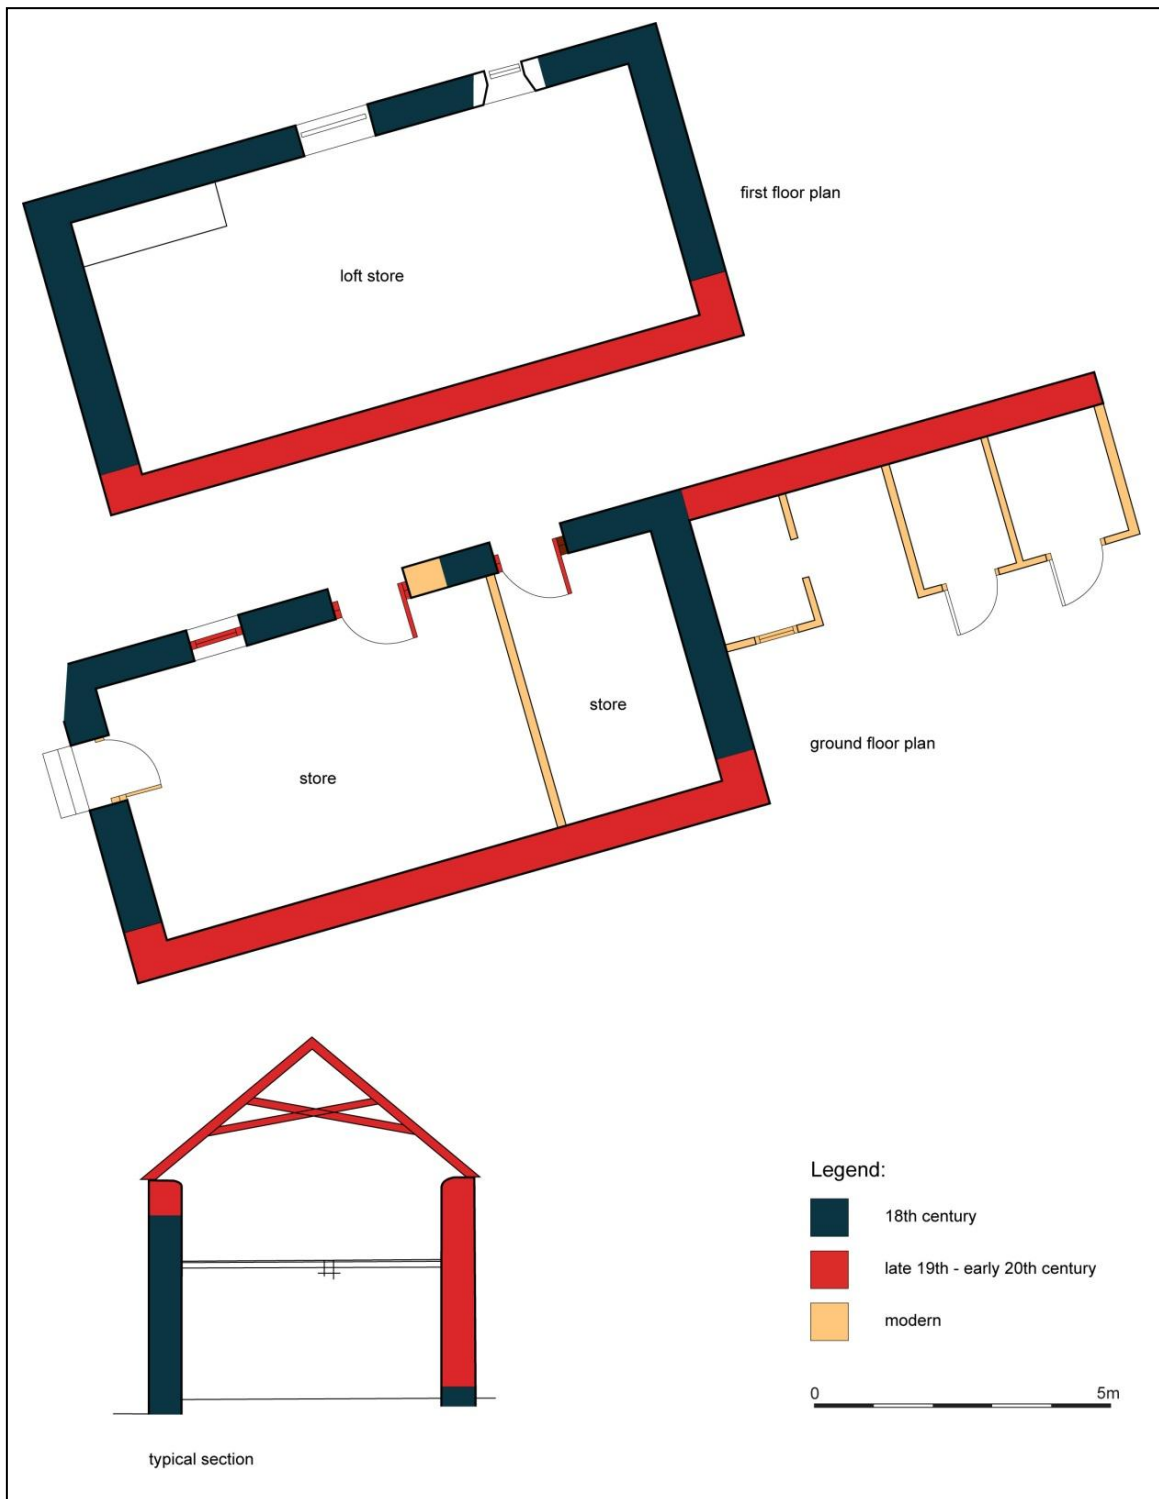
FIGURE 9: PLAN SHOWING THE PHASING OF THE TWO BUILDINGS.

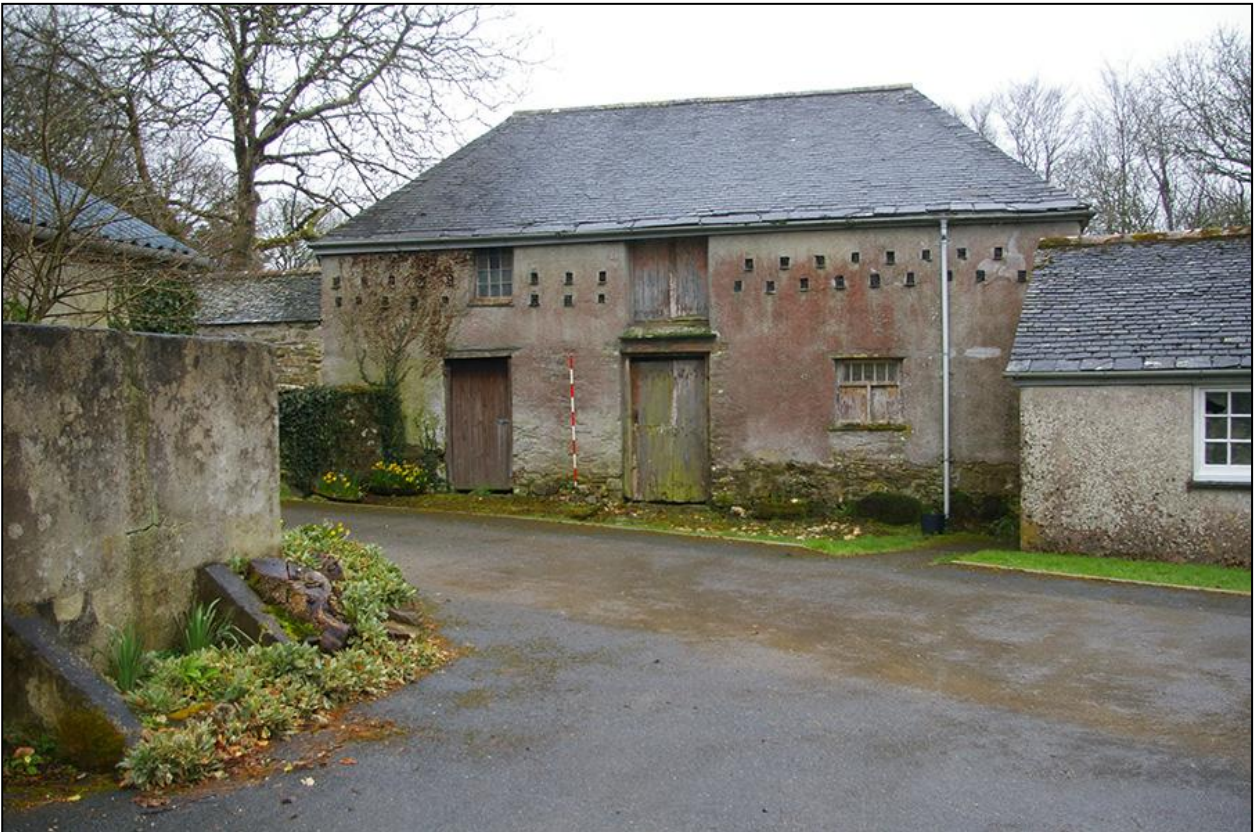
THE NORTH ELEVATION OF BUILDING 1, WITH 2M SCALE; FROM THE NORTH.

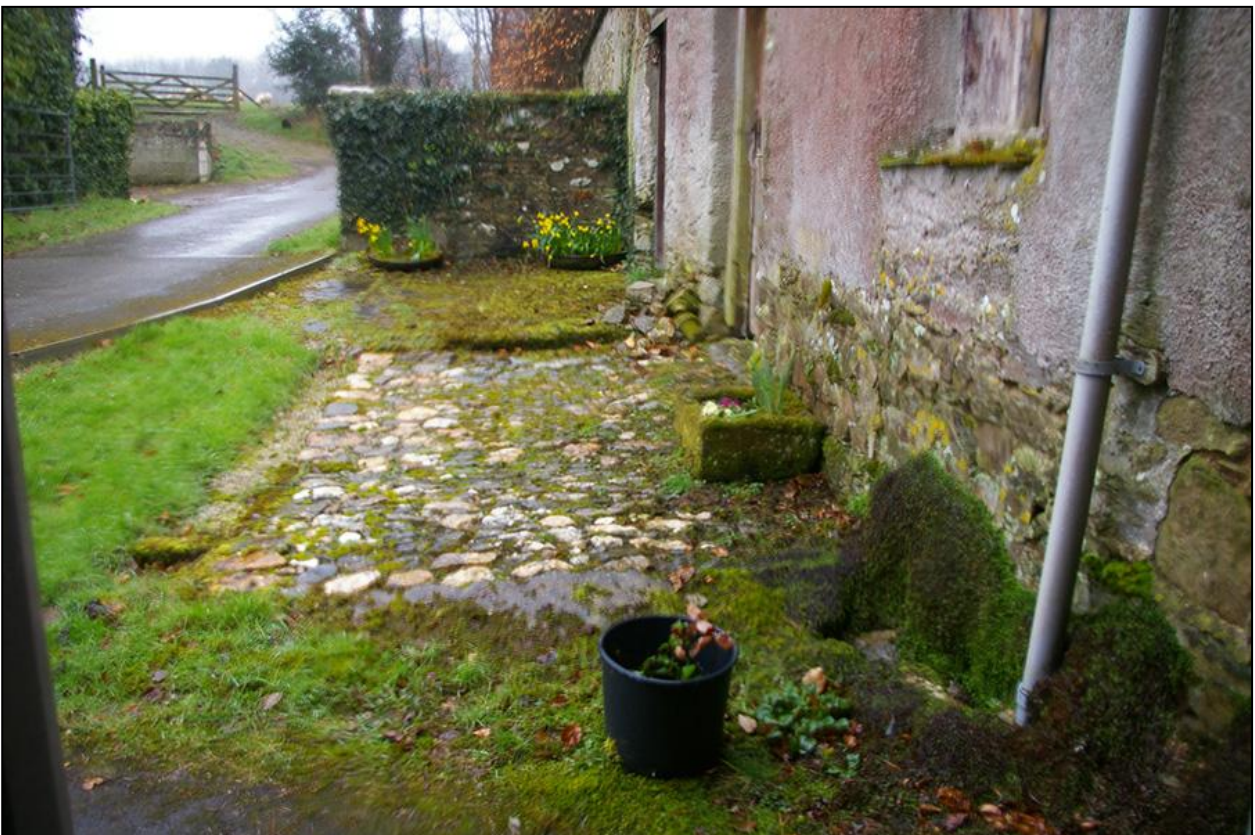
THE COBBLED AND QUARTZ PEBBLE FORMER YARD SURFACE WHICH SURVIVES ALONG THE NORTH ELEVATION OF BUILDING 1; FROM THE WEST.

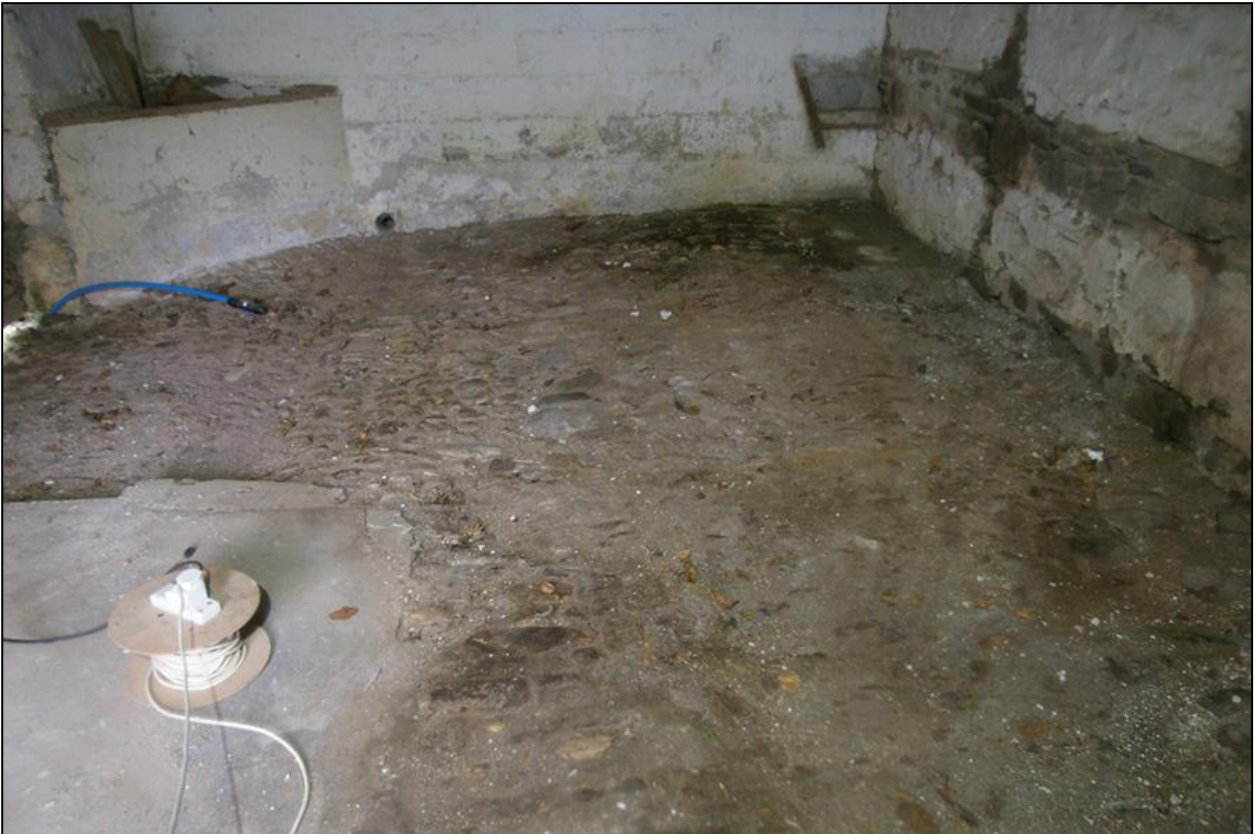
THE COBBLED FLOOR IN THE WEST COMPARTMENT, VIEWED FROM THE WEST.

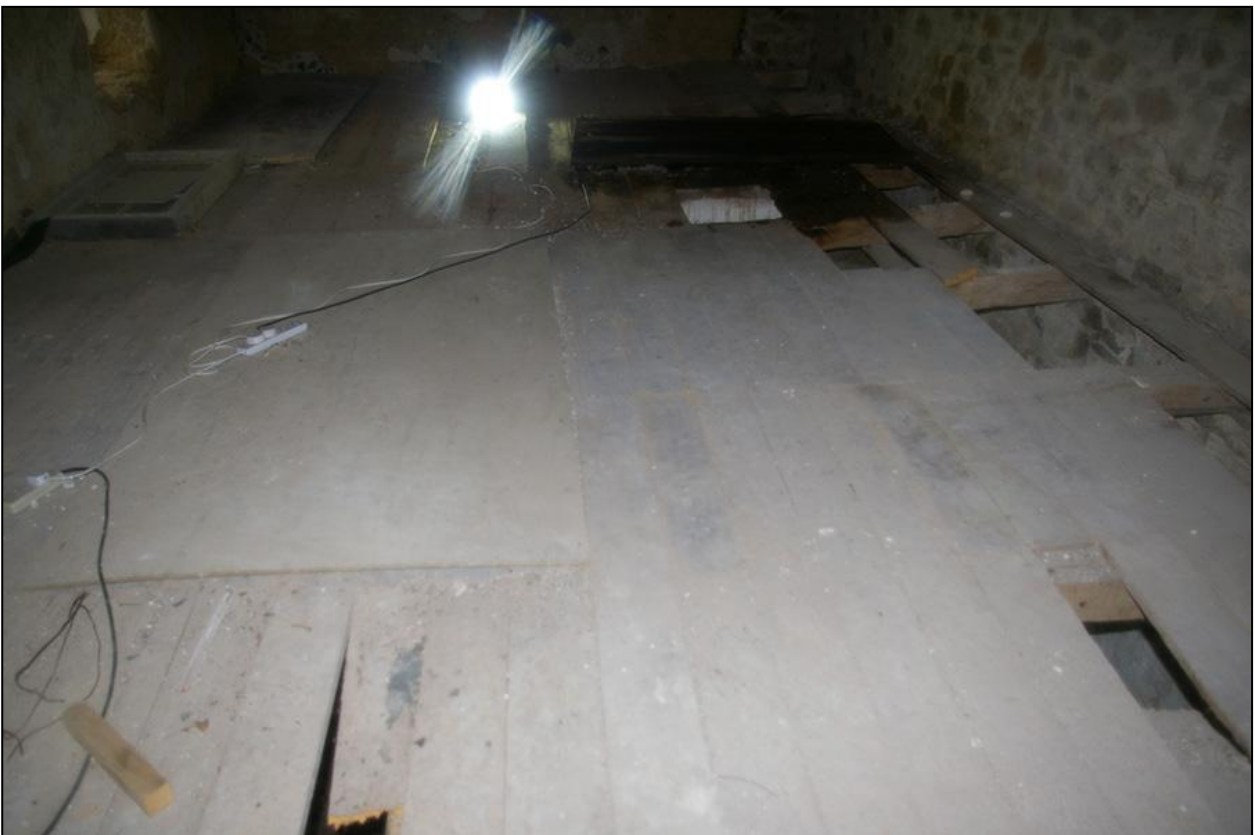
Floor:		The floor is mostly narrow even width pale pine planks and nailed to the joists below. In an area to the north-east there are some significantly more weathered, wider and chunkier pine planks, which have been messily re-laid. These may survive from the earlier loft, before it was rebuilt with the south wall. The loft floor has failed in many areas due to a leaking roof.
Roof Structure:		Five scissor trusses, of pine, with bolted joints. Lightweight scantling; all joints are bolted with small modern looking bolts, with quite crisp screw threads. Overlapping ridge is nailed. Two purlins to each pitch, chunky modern looking rafters and closely set battens. The slates are torched underneath with lime plaster.
Opening – Loading Doors:	1	One wide and low loading door in the north wall, to the centre. Pegged chunky plain frame. Doors sit on large iron pintles in the frame with large handmade rounded ended blacksmith strap hinges. Wide uneven width plank doors, ledged to rear, ledging bars fixed with spikes. Wooden catch held by a spike at top and later iron bolt at bottom on the internal side.

THE LOFT FLOOR, WHICH HAS FAILED AND IS VERY ROTTEN DUE TO ISSUES WITH THE ROOF IN THE PAST; FROM THE WEST.

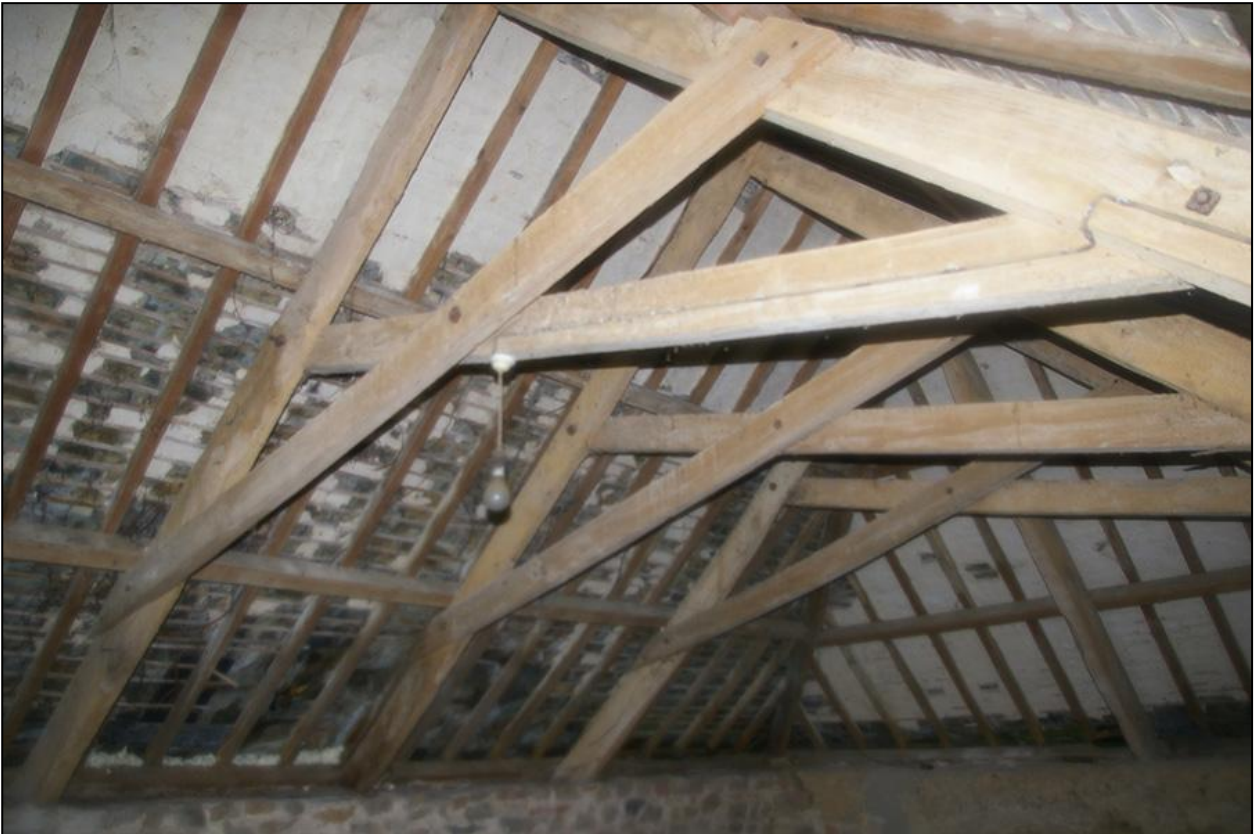
THE ROOF OF BUILDING 1, SHOWING THE TORCHING UNDERNEATH THE SLATES; FROM THE NORTH, NORTH-EAST.

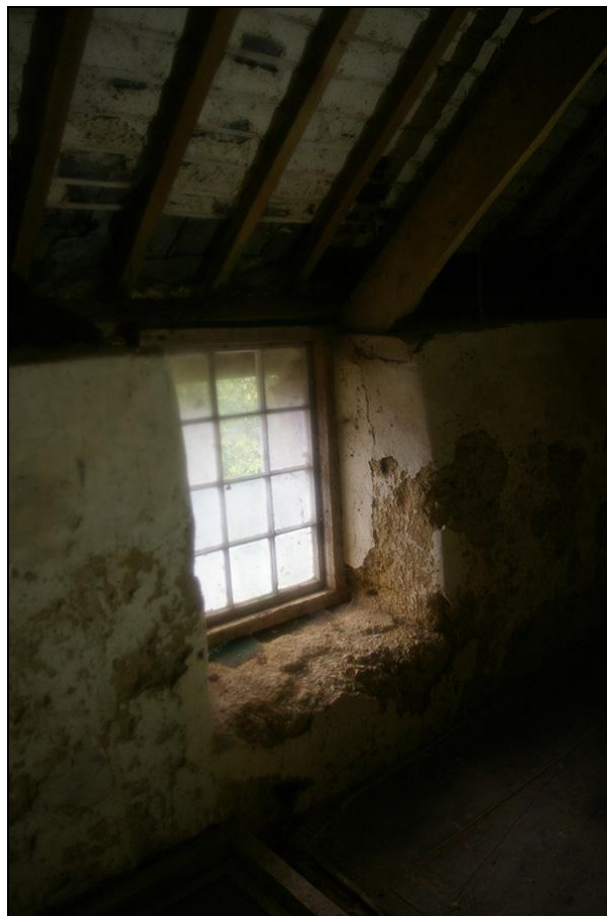
THE FORCED WINDOW IN THE EAST END OF THE LOFT IN BUILDING 1, WITH INSET RECYCLED SASH WINDOW; FROM THE SOUTH-WEST.

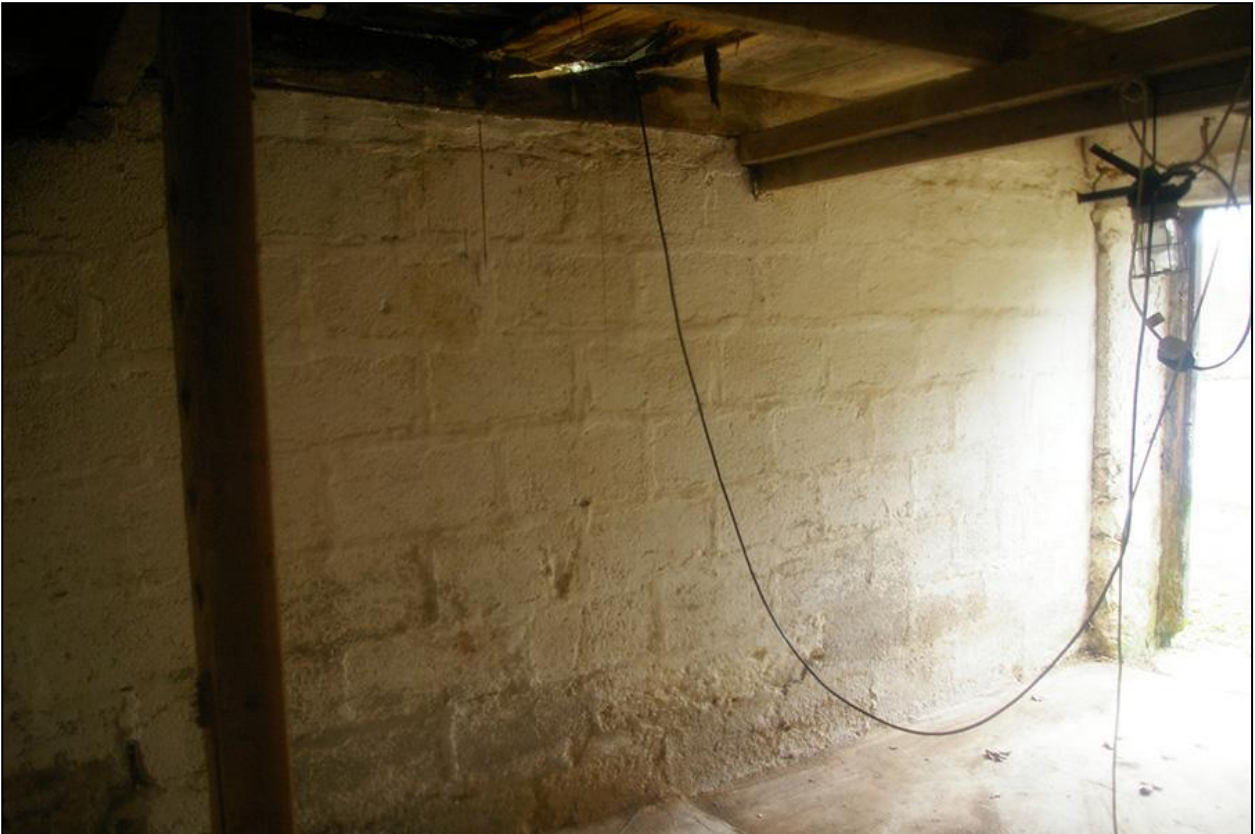
THE CONCRETE PARTITION WALL WHICH SEPARATES THE EASTERN COMPARTMENT FROM THE REST OF THE GROUND FLOOR OF BUILDING 1; FROM THE SOUTH-EAST.

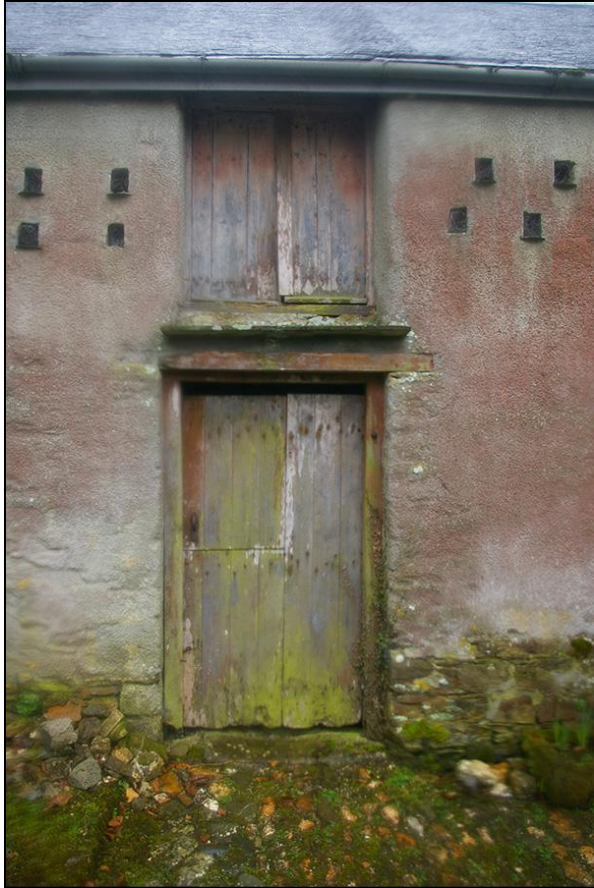
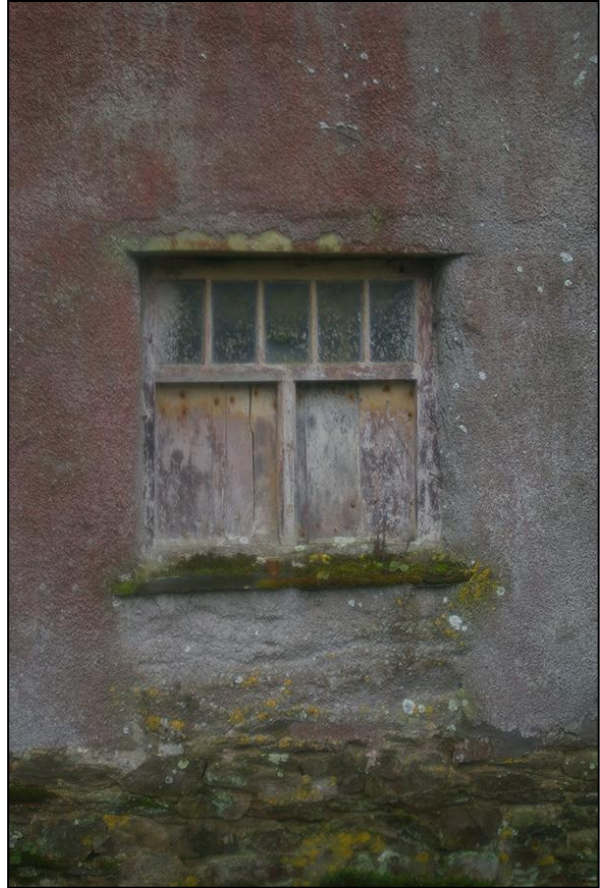
THE CENTRAL DOOR IN THE NORTH ELEVATION OF BUILDING 1 AND THE LOADING DOOR ABOVE; FROM THE NORTH [LEFT]. THE WINDOW TO THE WEST, GROUND FLOOR OF BUILDING 1, SET INTO A BLOCKED DOORWAY; FROM THE NORTH [RIGHT].

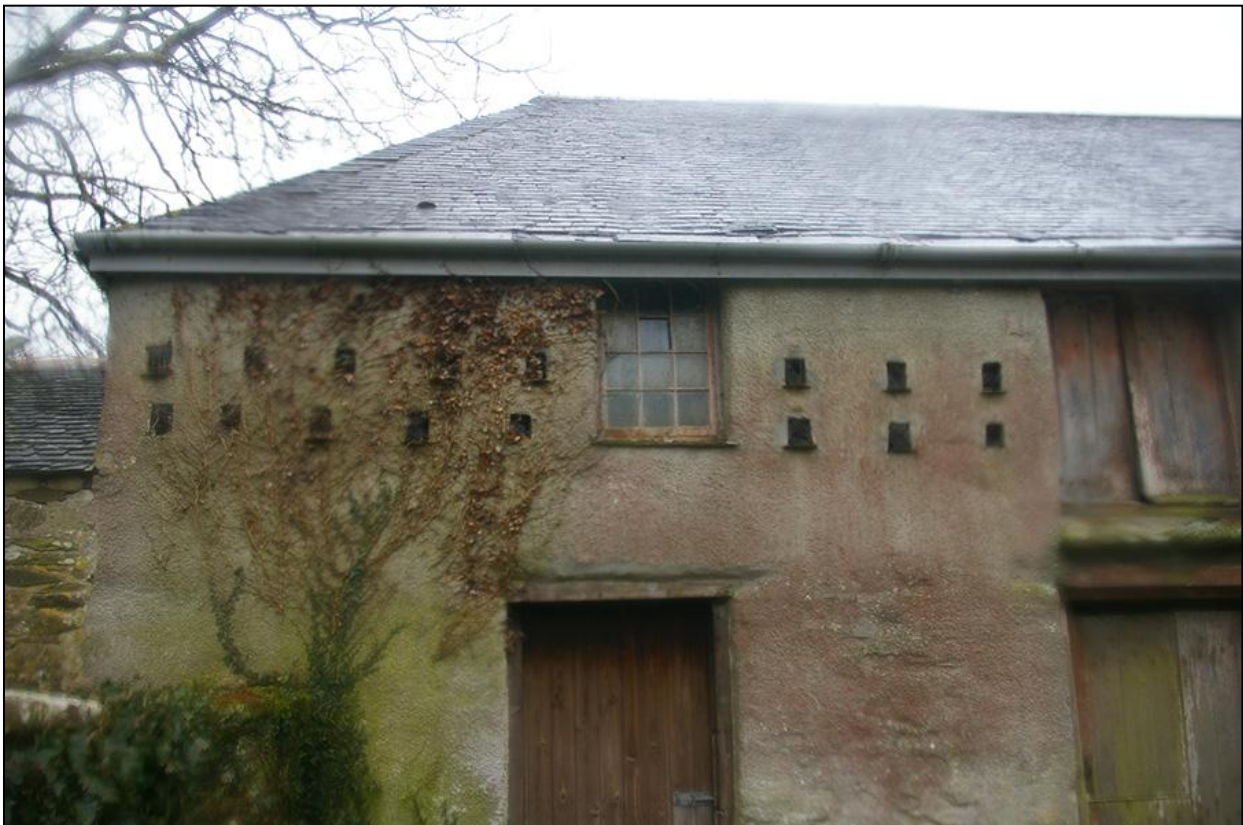
THE ROWS OF DOVE HOLES IN THE NORTH ELEVATION OF BUILDING 1, THOSE TO THE EAST; FROM THE NORTH.

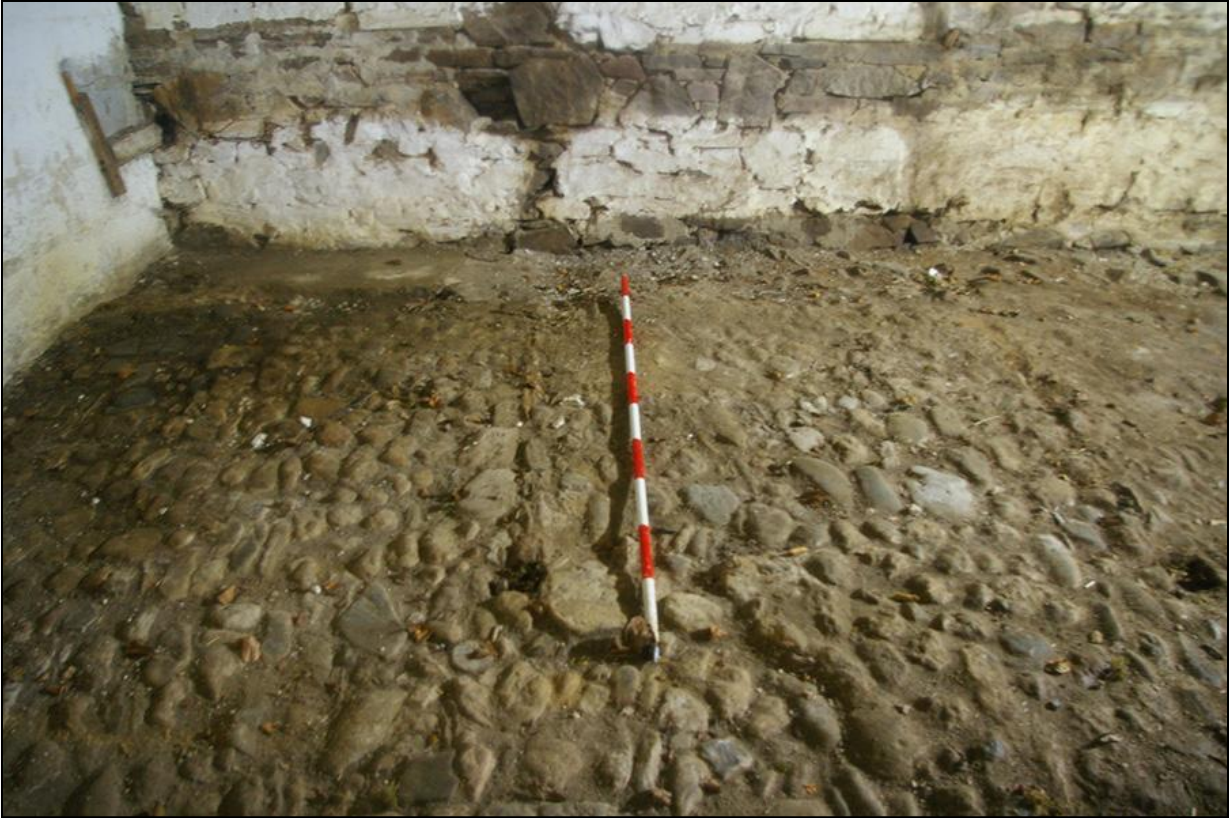
THE PARTITION SLOTS AND SOCKETS, INDICATING THE FORMER WIDE STALLS IN THE COBBLED FLOOR OF BUILDING 1, WITH 2M SCALES; FROM THE NORTH.

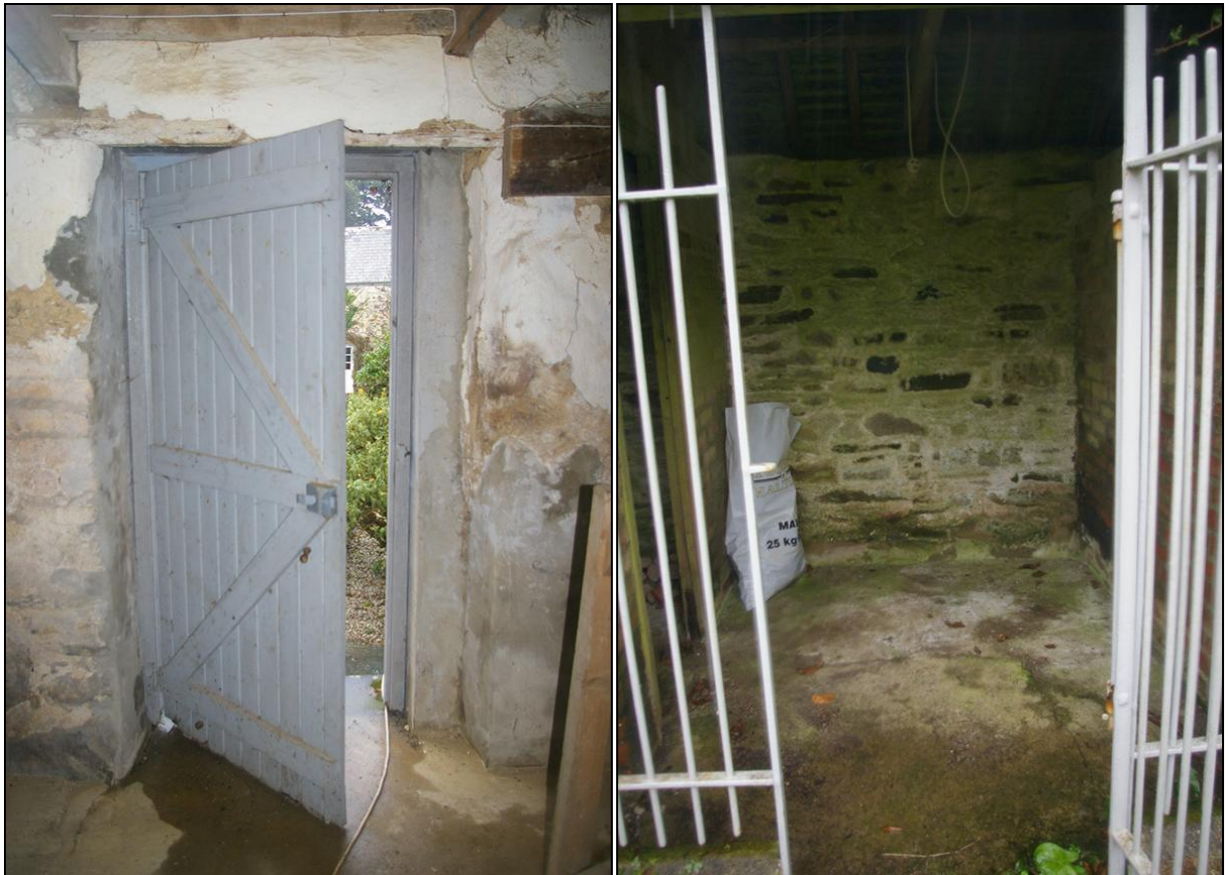
THE WEST DOOR IN THE WEST WALL OF BUILDING 1, SHOWING THE FORCED AND REPAIRED SIDES AND INSERTED RECYCLED TIMBER LINTEL; FROM THE EAST [LEFT]. THE KENNELS, AN OUTER PEN AND INNER CLOSED ROOM, SET WITHIN BUILDING 2, TO THE WEST END, AGAINST BUILDING 1; FROM THE SOUTH, SOUTH-EAST AND NORTH-EAST [RIGHT].

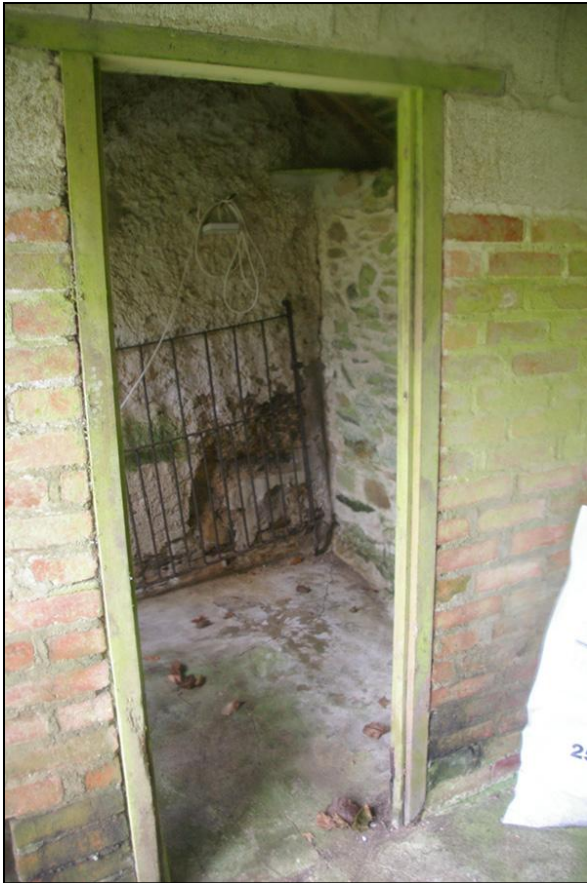
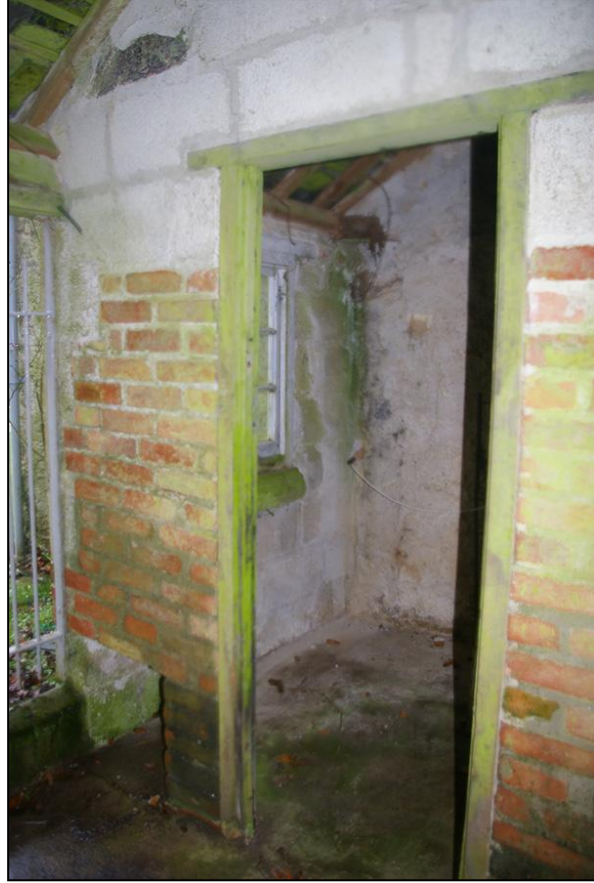
THE KENNELS, AN OUTER PEN AND INNER CLOSED ROOM, SET WITHIN THE WEST END OF BUILDING 2 AGAINST BUILDING 1;
FROM THE SOUTH, SOUTH-EAST AND NORTH-EAST.

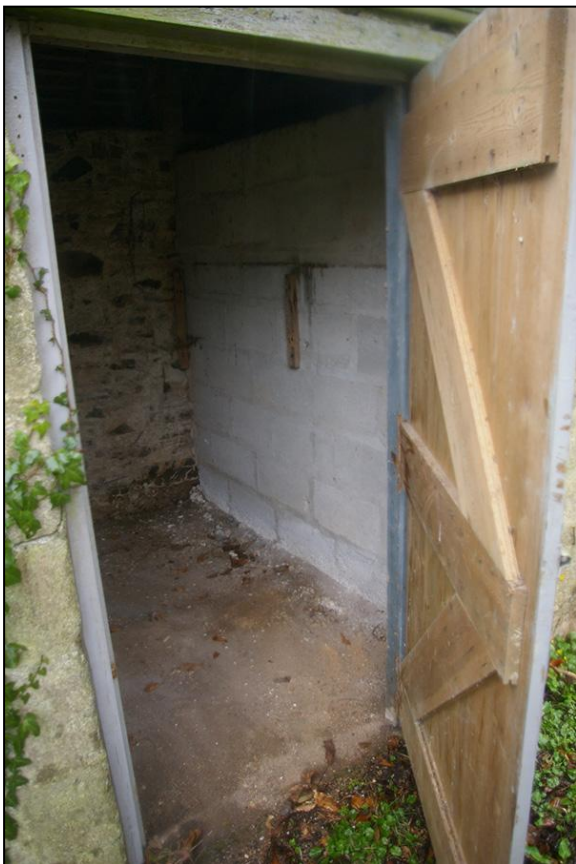
ONE OF THE STORES TO THE EAST END OF BUILDING 2, DIVIDED
BY CONCRETE BLOCK PARTITION WALL, ENCLOSED BY PLANK
BOARDED DOORS TO THE SOUTH; FROM THE SOUTH-WEST.
